# **INVESTIGATION OF THE OCTOBER 30, 2003, FATAL PARKING GARAGE COLLAPSE AT TROPICANA CASINO RESORT, ATLANTIC CITY, NJ**

U. S. Department of Labor  
Occupational Safety and Health Administration

April 2004

This report was prepared by  
Mohammad Ayub, P.E., S.E.  
Office of Engineering Services  
Directorate of Construction

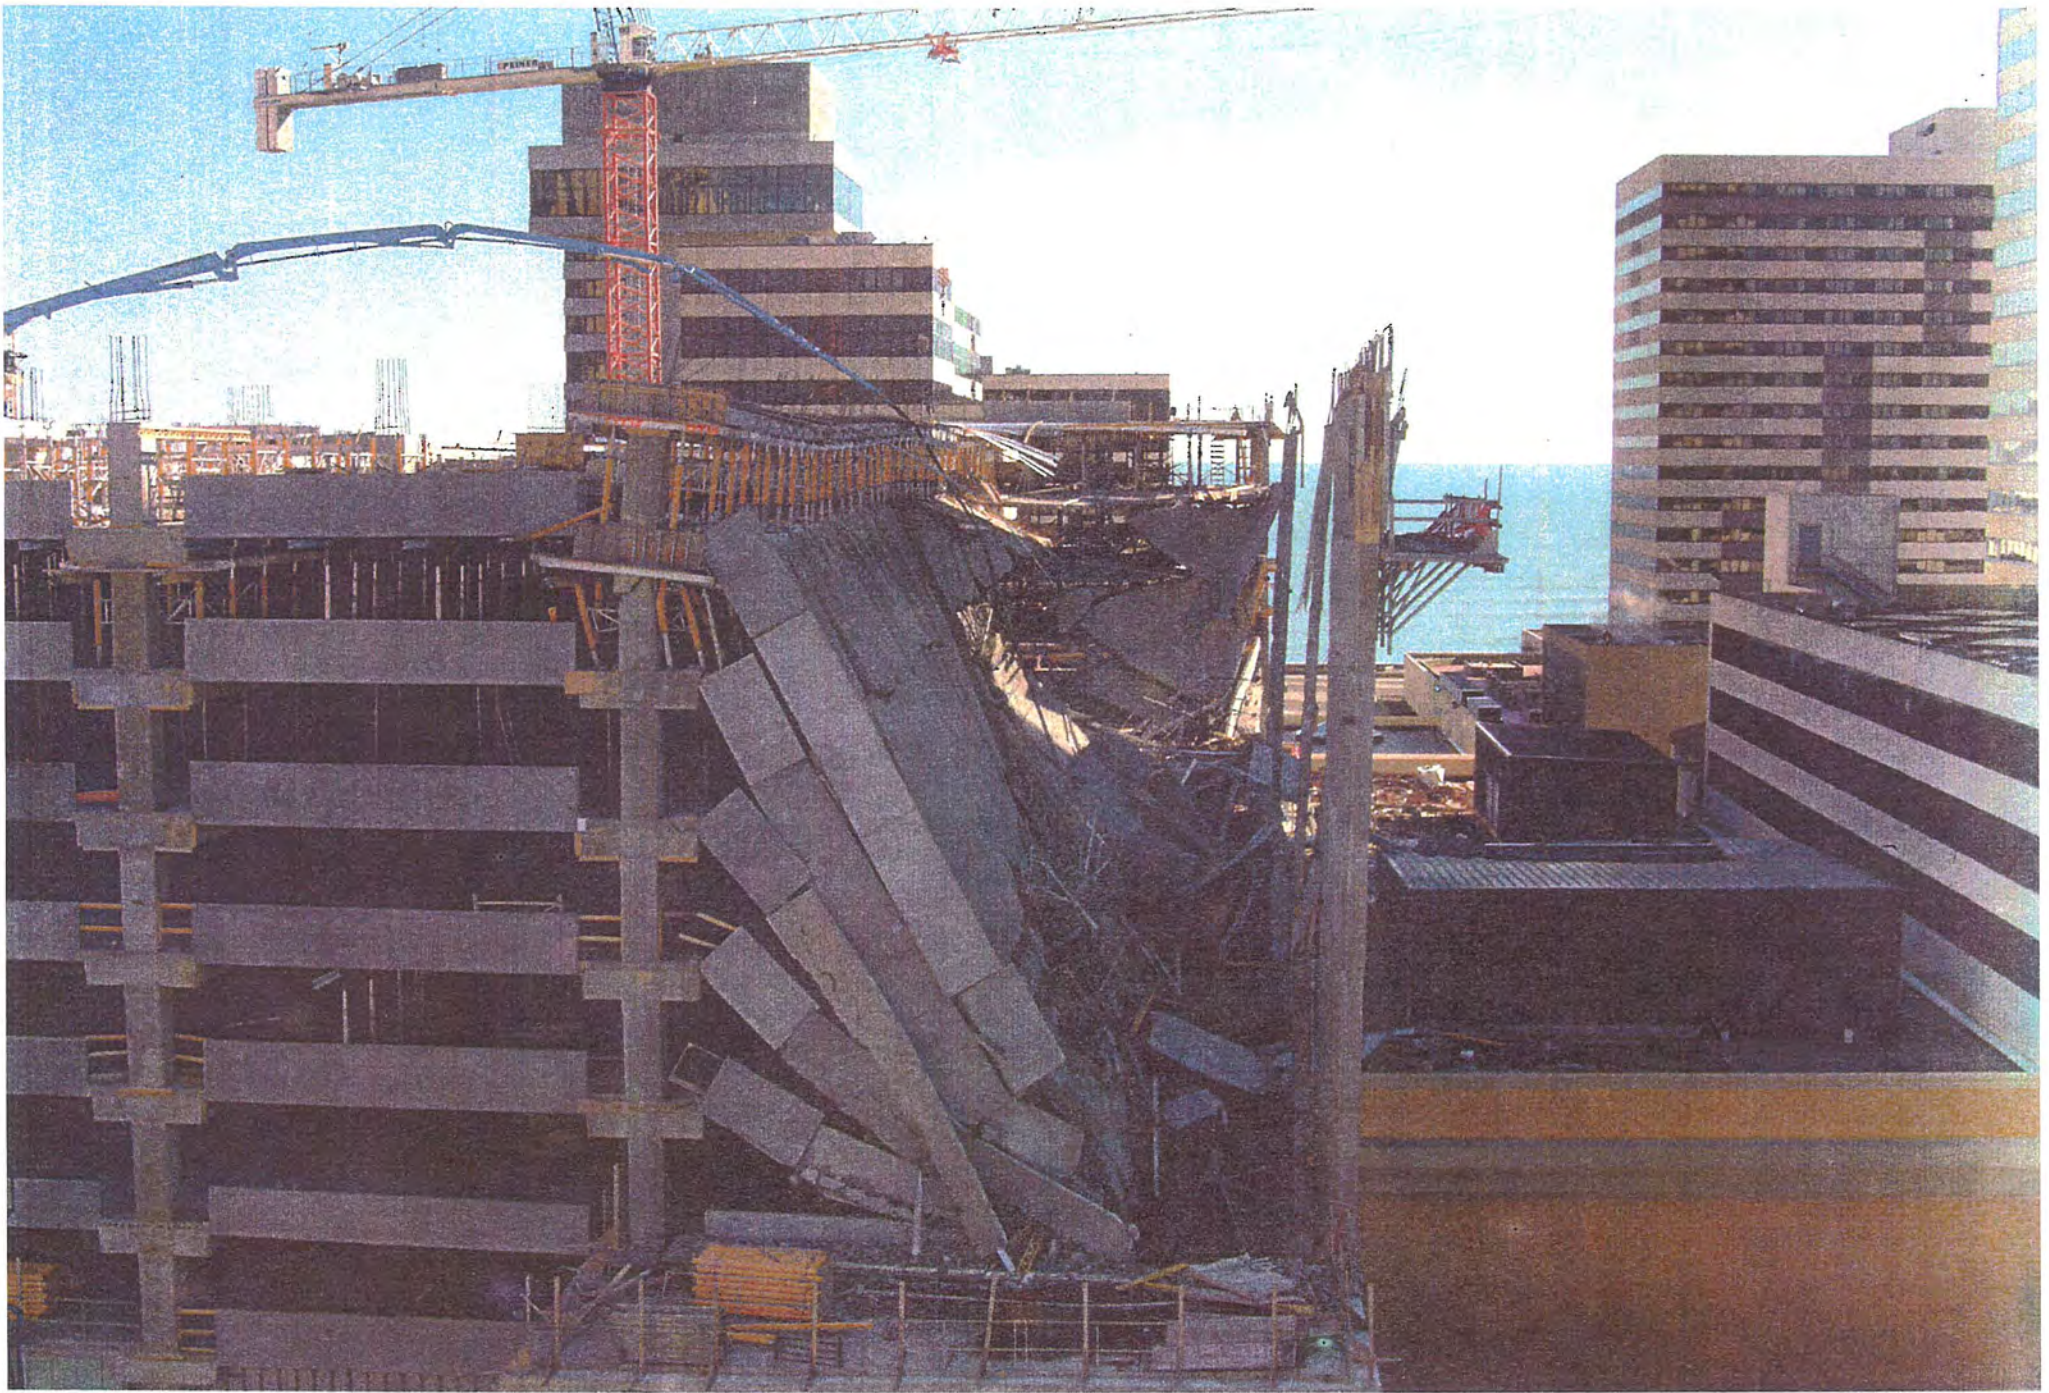
Figure 1. General View of the Collapsed Portion of the Parking Garage (Looking toward the Project South).

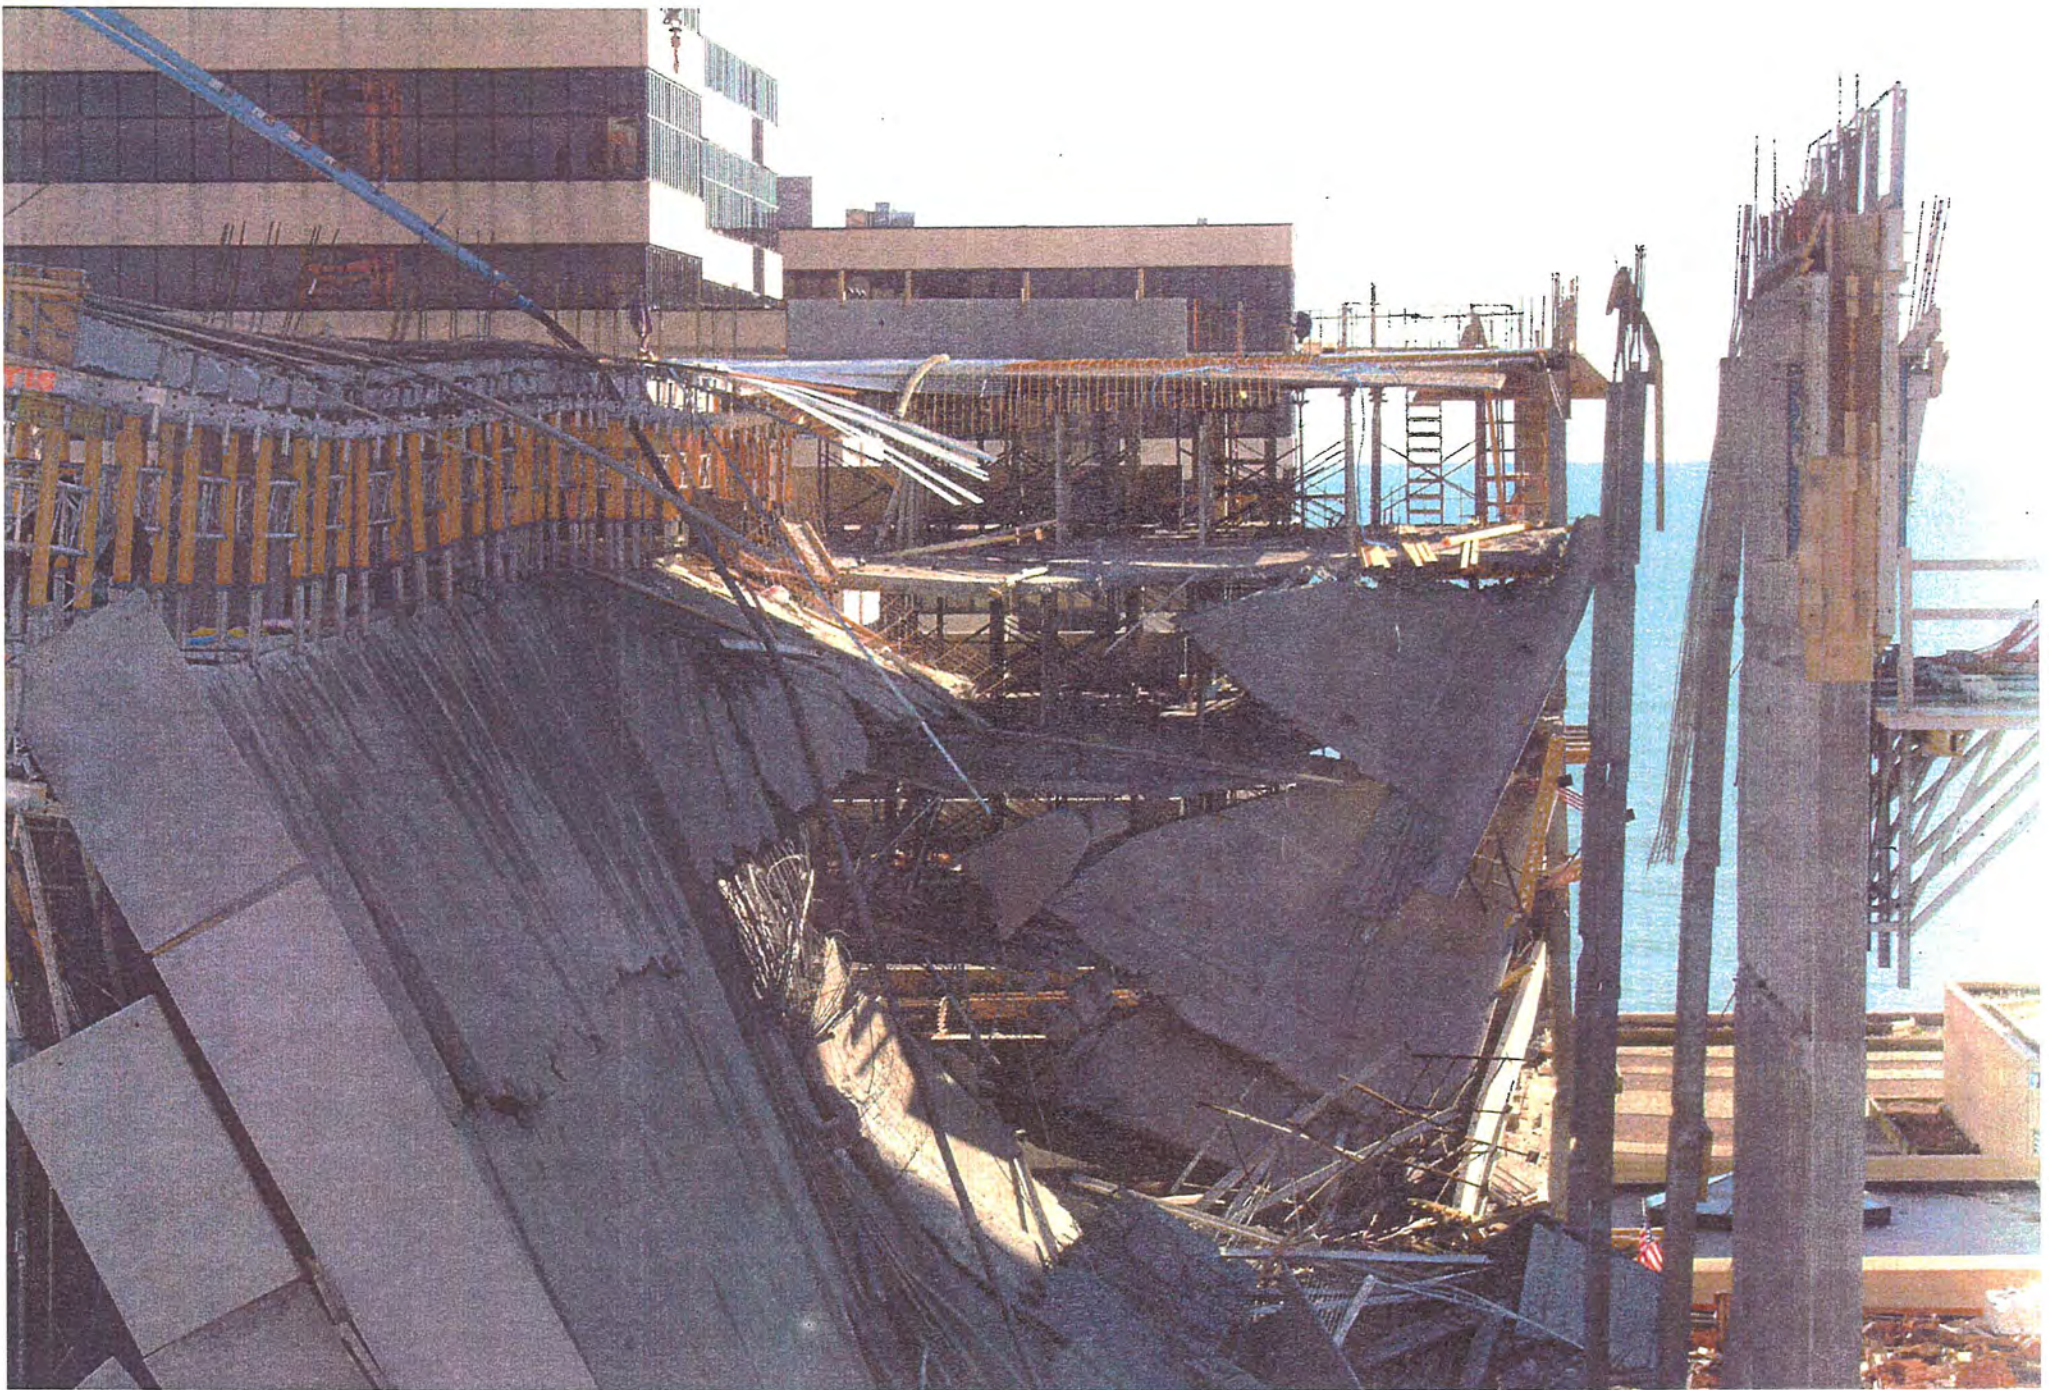
Figure 2. General View of the Collapsed Portion of the Parking Garage (Looking toward the Project Southeast).

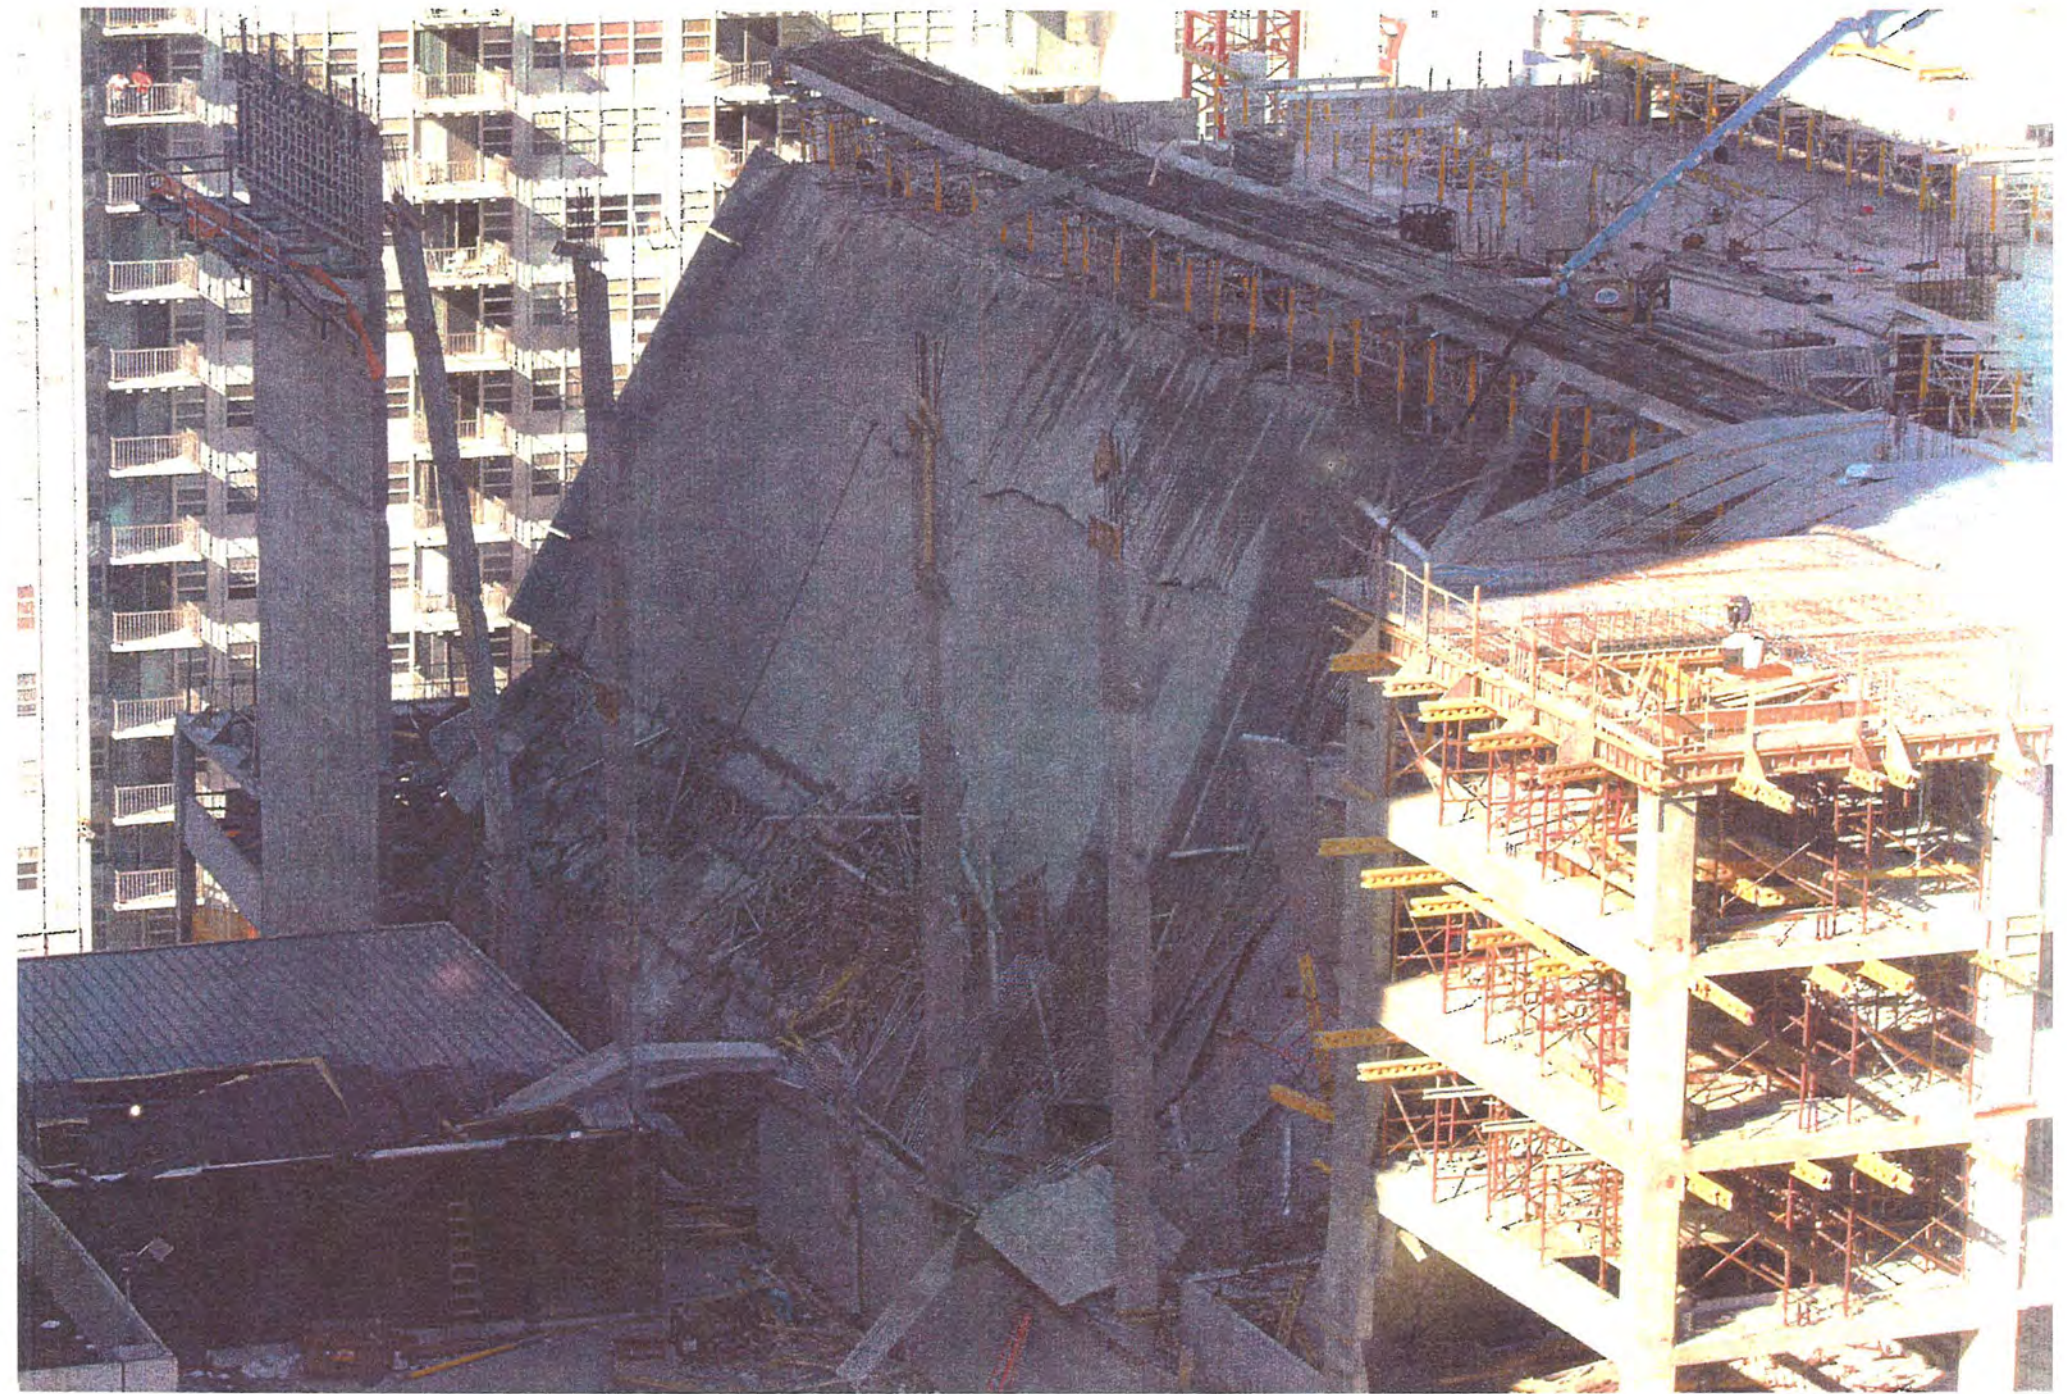
Figure 3. General View of the Collapsed Portion of the Parking Garage (Looking toward the Project Northeast).

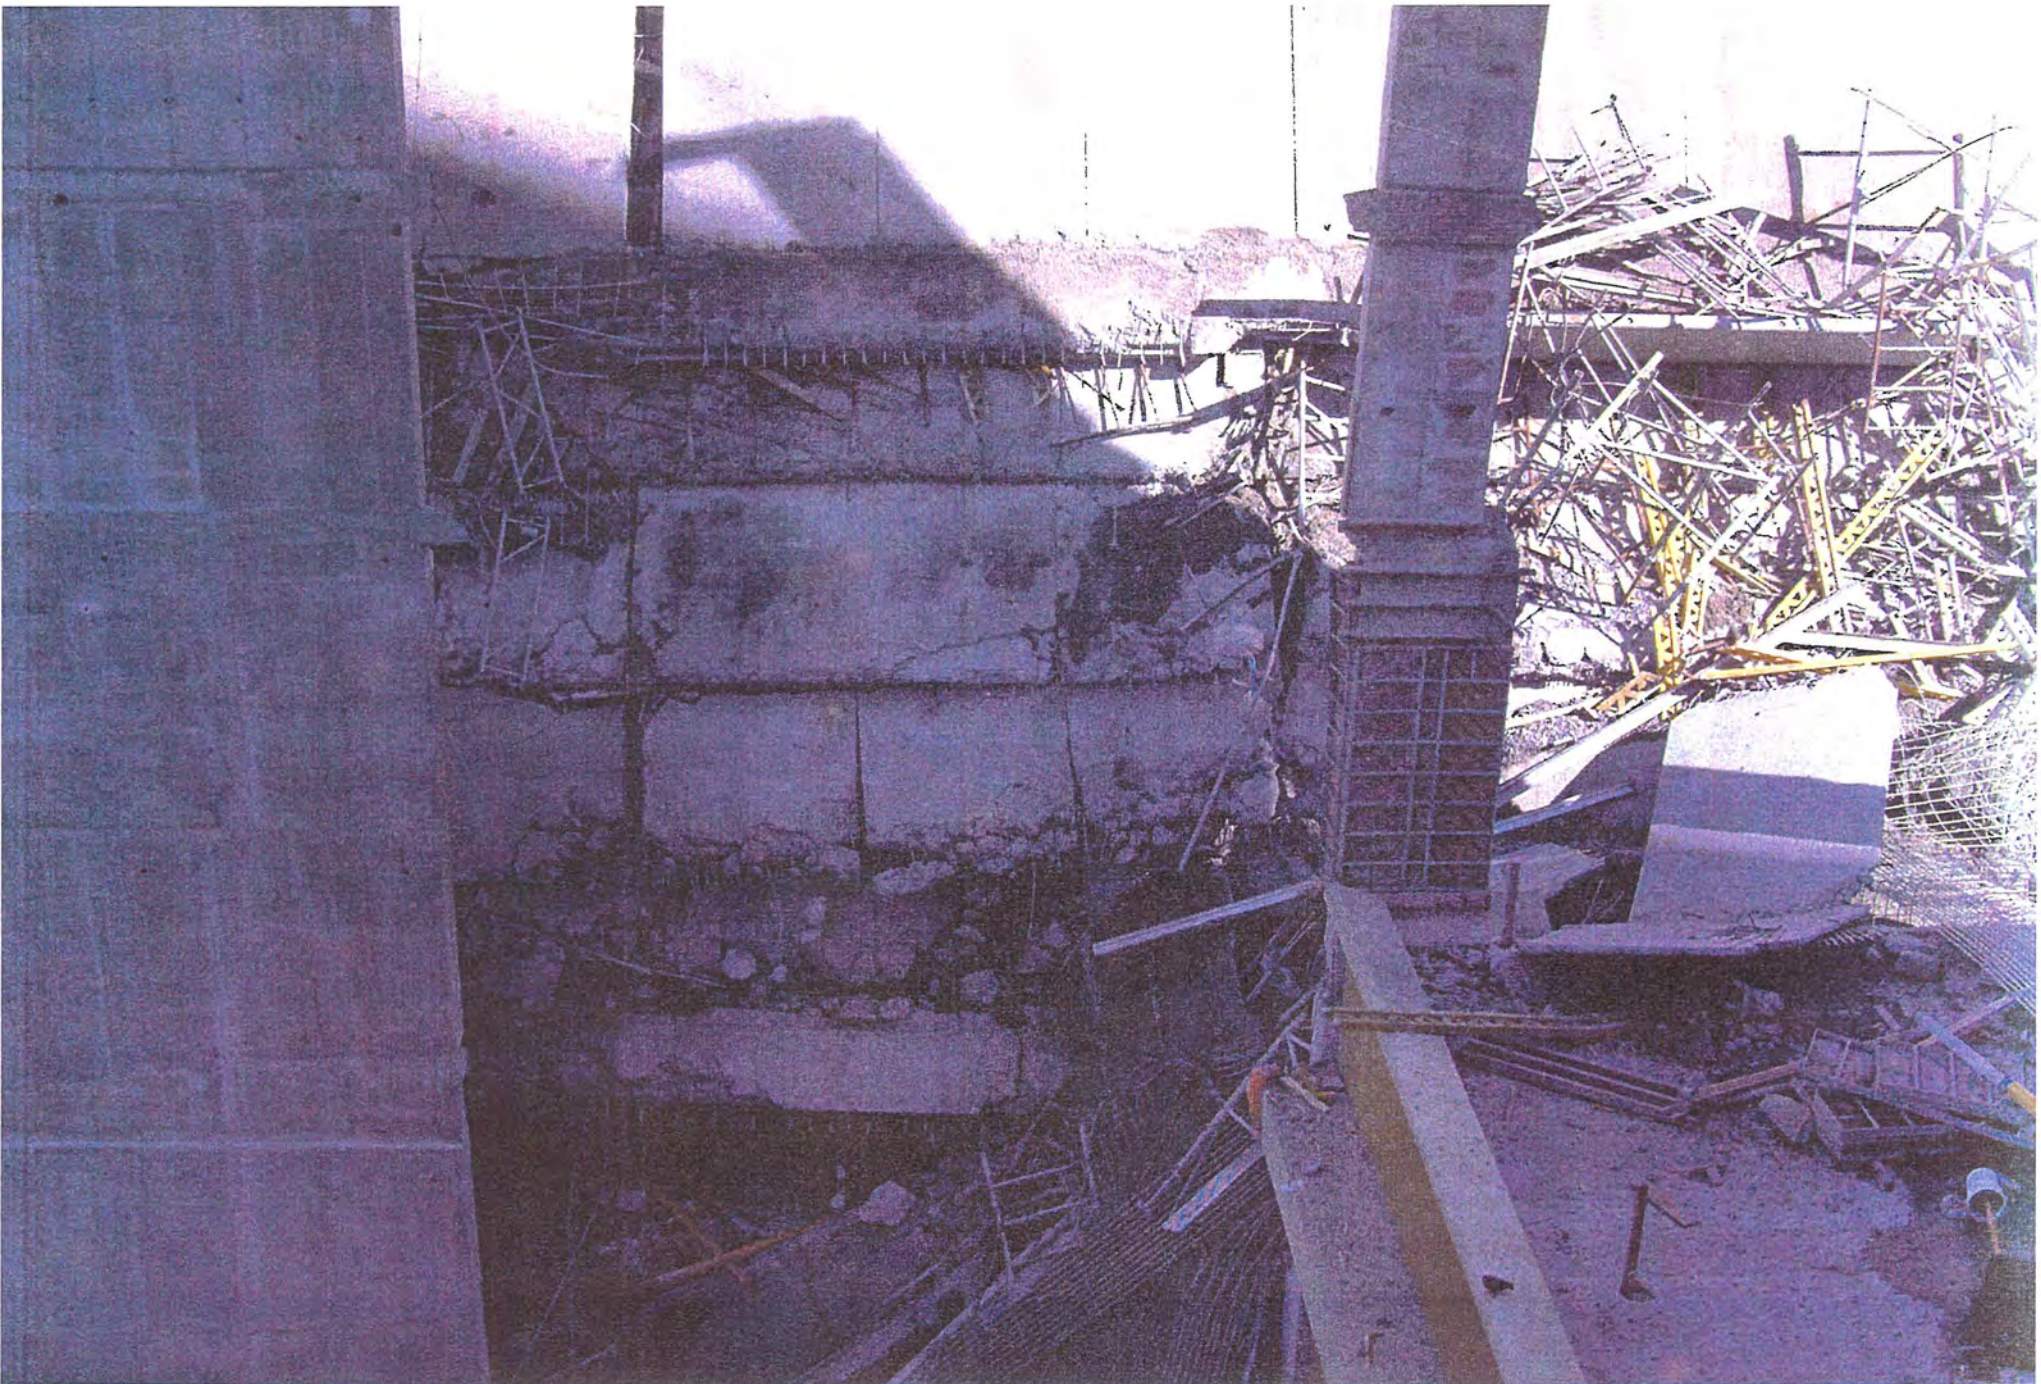
Figure 4. Surface of the Collapse between Shear Wall and Column 1-D (Looking toward Project East).

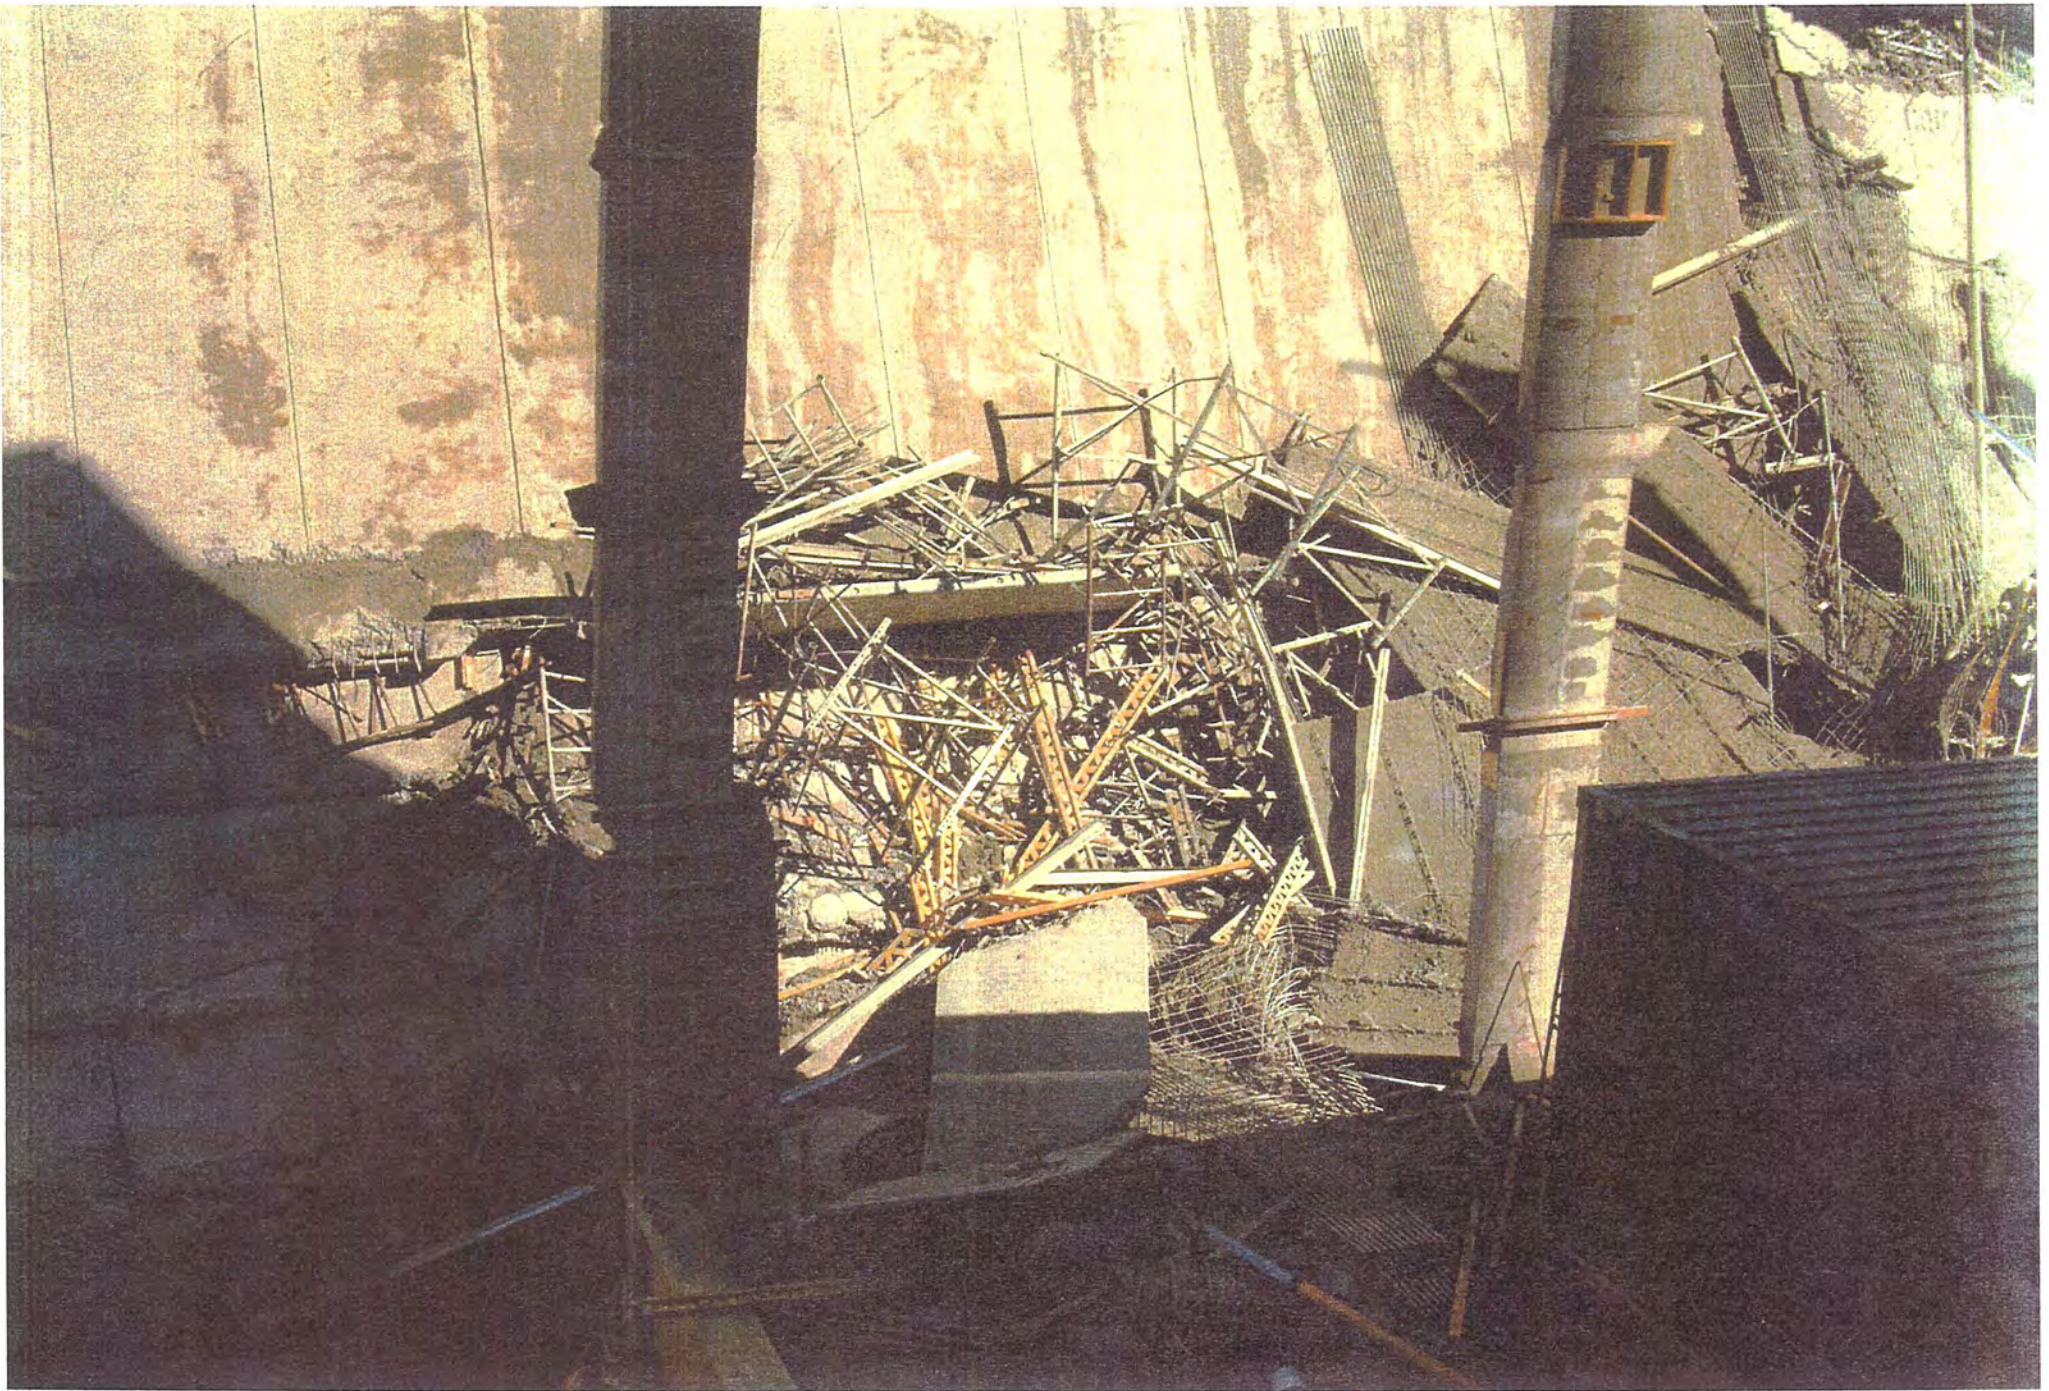
Figure 5. Surface of the Collapse between Columns 1-D and 1-D.5 (Looking toward Project East).

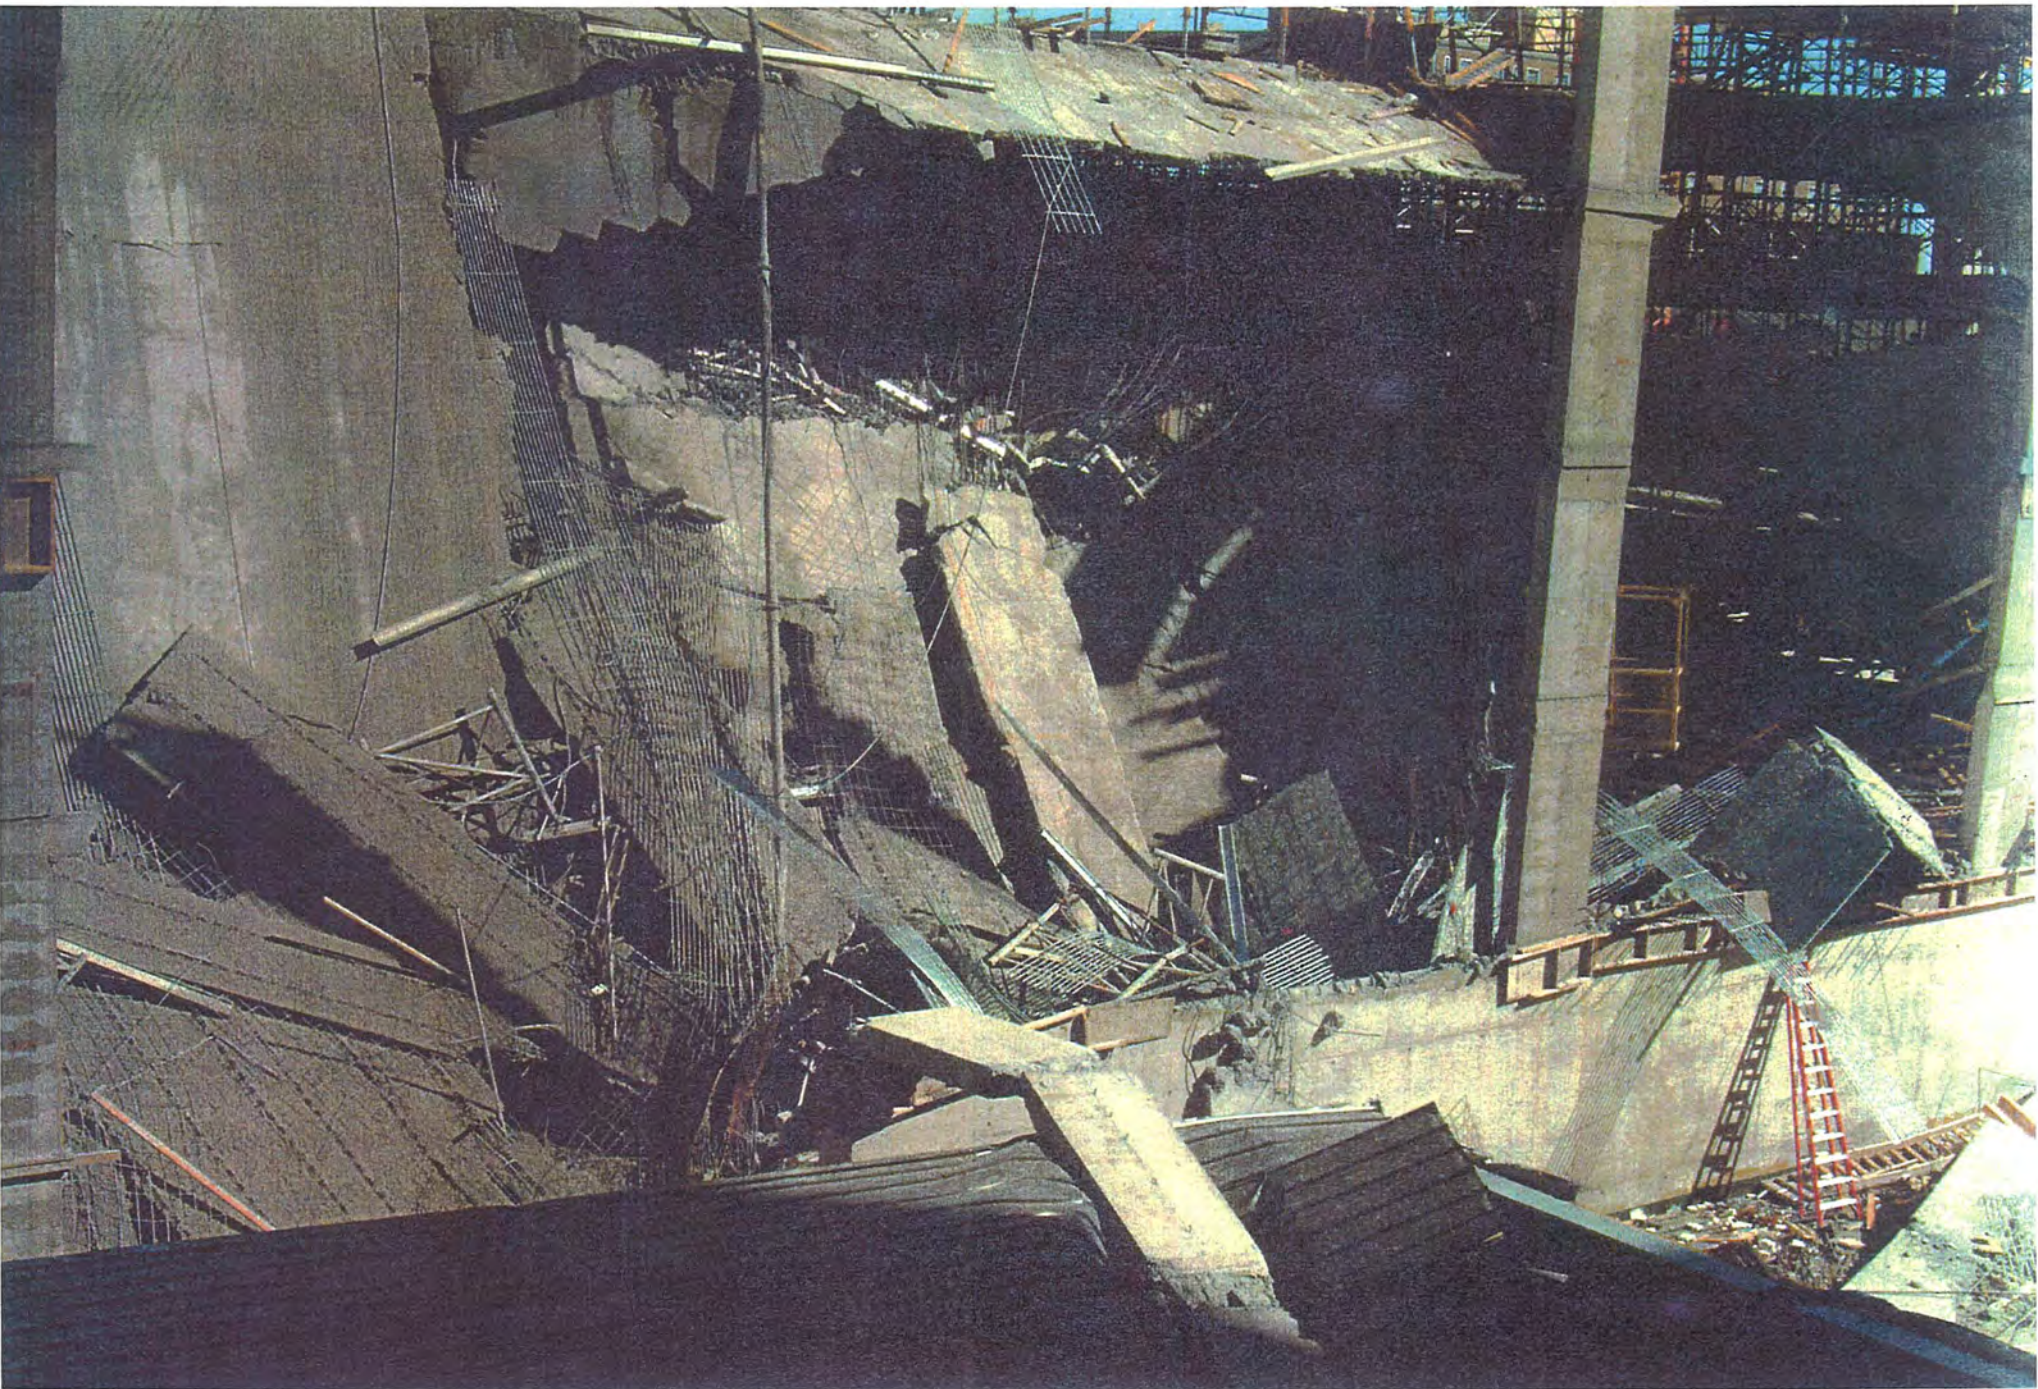
Figure 6. Surface of the Collapse between Columns 1-D.5, 1-E (Fallen), 1-E.7, and 1-F (Looking toward Project East).

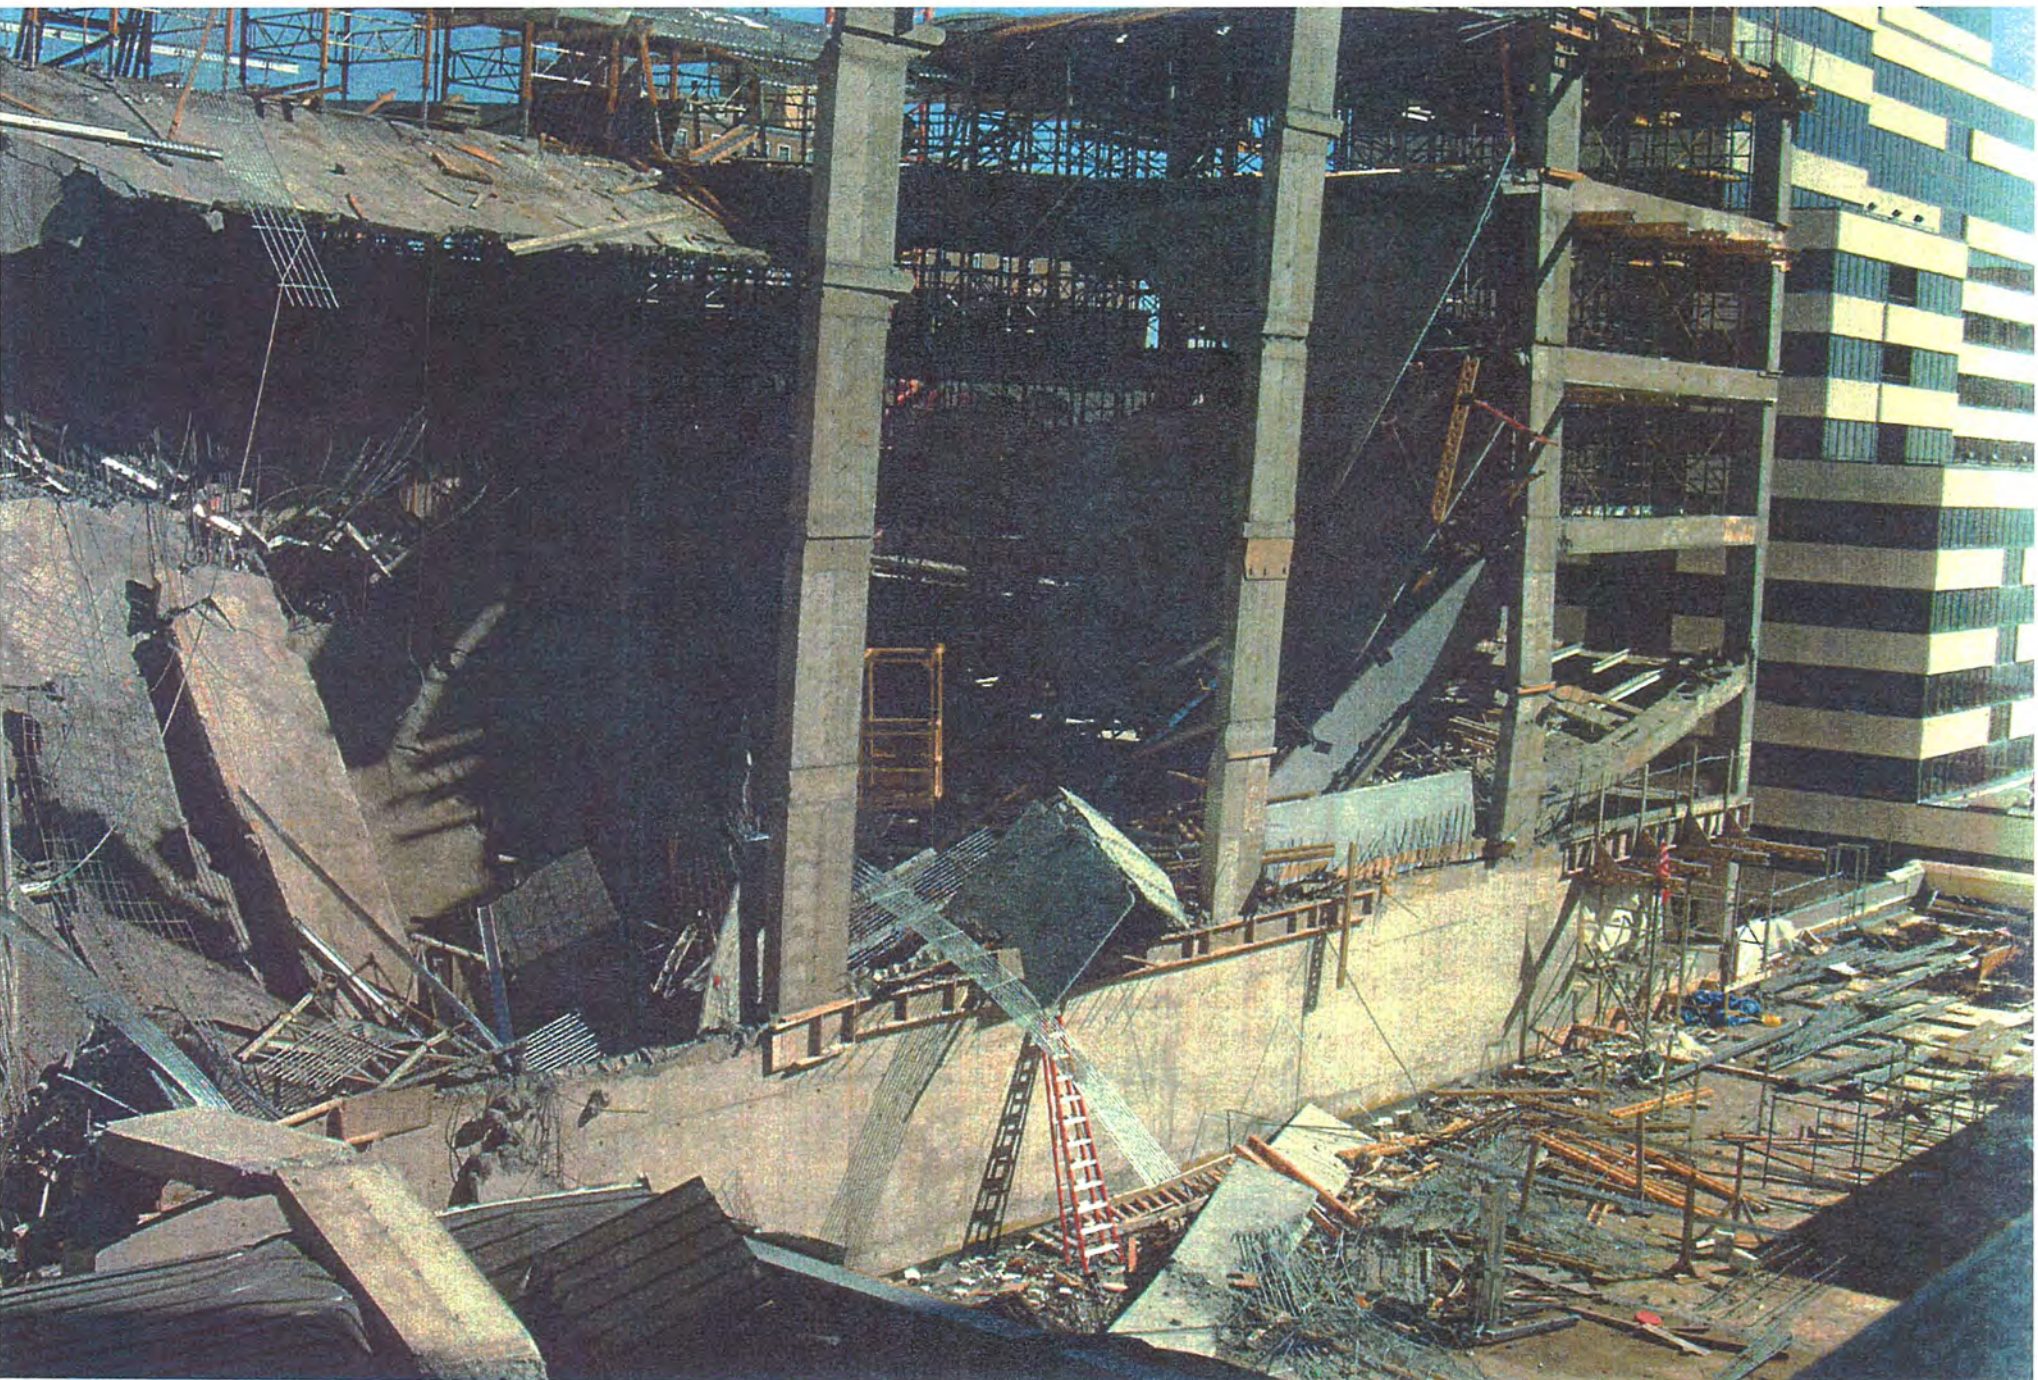
Figure 7. Surface of the Collapse between Columns 1-E (Fallen), 1-E.7, 1-F, 1-F.6 and 1-G1 (Looking toward Project Southeast).

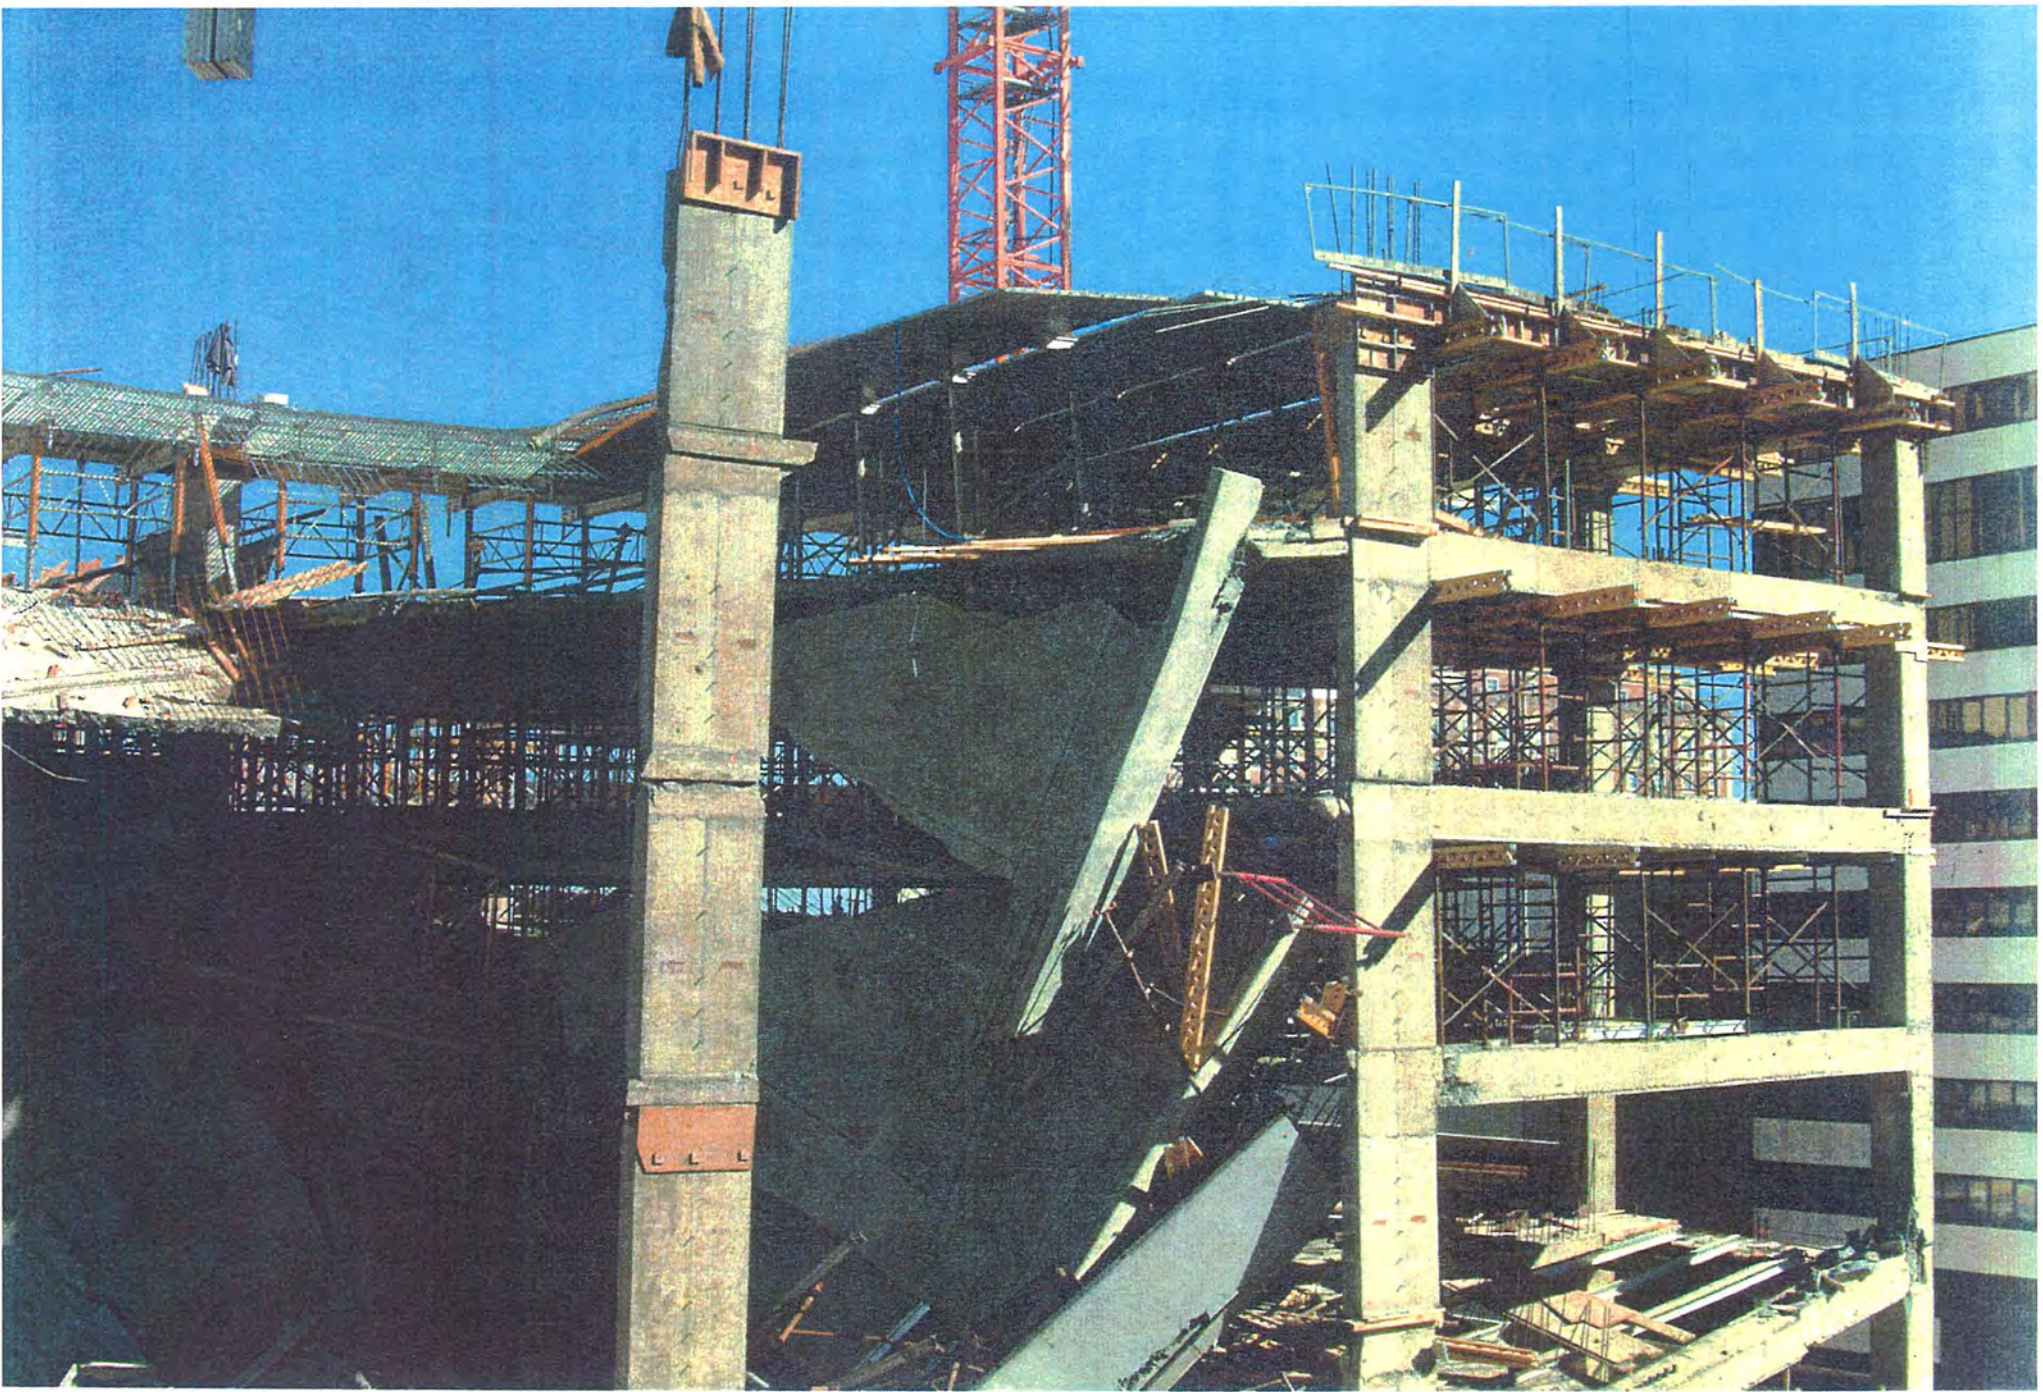
Figure 8. Surface of the Collapse between Columns 1-F, 1-F.6 and 1-G1 (Looking toward Project Southeast).
