# **INVESTIGATION OF THE OCTOBER 30, 2003, FATAL PARKING GARAGE COLLAPSE AT TROPICANA CASINO RESORT, ATLANTIC CITY, NJ**

U. S. Department of Labor  
Occupational Safety and Health Administration

April 2004

This report was prepared by  
Mohammad Ayub, P.E., S.E.  
Office of Engineering Services  
Directorate of Construction

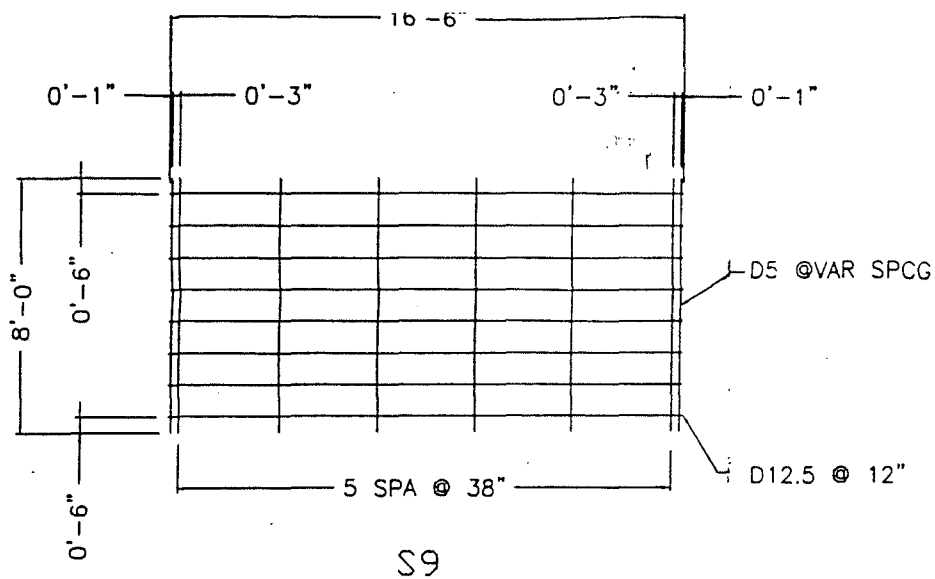
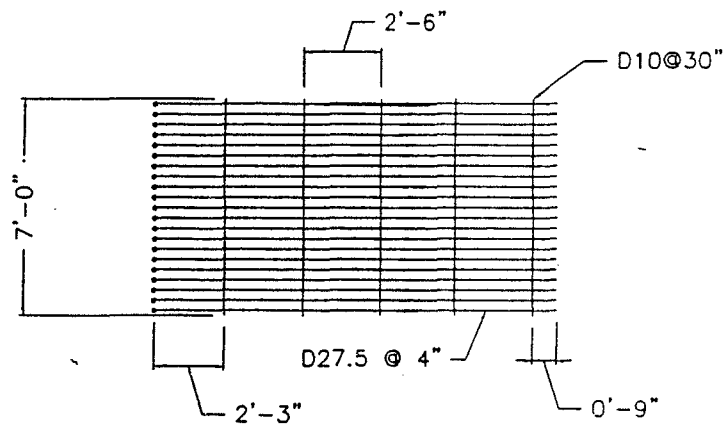
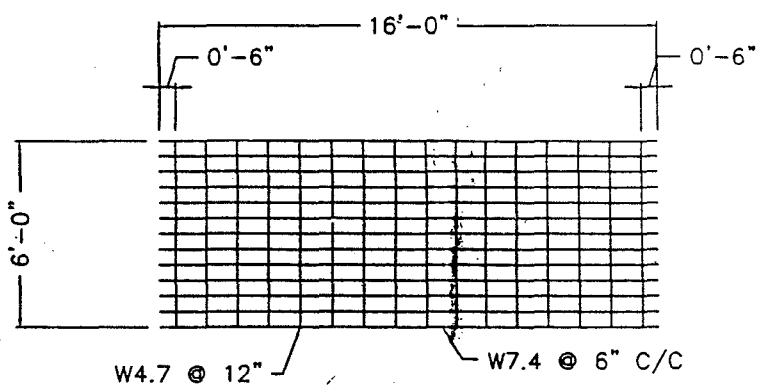
## DETAIL OF S9, S21 AND TMP4 REINFORCEMENT

With the concurrence of the SER and for the sake of economy, Fabi replaced T418 and T66¾ reinforcing steel (see figures 12 and 13) with welded wire fabric mesh, marked as S9 and S21 (see figures 30 and 31) respectively on the mesh shop drawings. S9 and S21 provided an amount of steel equivalent to T418 and T66¾ respectively. But to develop the full strength of S9 and S21, the mesh must be embedded in the column for a specific length of embedment, as per American Concrete Institute (ACI) code. If the mesh placement is inadequate, the efficacy of the reinforcing steel is greatly compromised and the desired flexural strength is significantly reduced, thus compromising the integrity of the structure. These deficiencies were observed in the post collapse inspection of the columns on grid line 1, levels P4 thru P7.

The ACI 318-95 provisions contained in section 12.7 requires S9 mesh to be embedded at least a distance of 8" and S21 a distance equal to 9" to develop full strength. Consistently at all levels, P4 thru P7, the mesh was observed to have been embedded in the column at varying lengths. At some locations, the embedment length was only 1 ½", rendering the steel unable to support any load (see Appendix B for embedment lengths of S9 and S21 mesh). The S21 and S9 mesh did not meet the required embedment length at all locations.

Second, they were unable to meet the shop drawing requirement for placing mesh extending up to the outer edge of the column. The S9 and S21 mesh were prefabricated in widths of 8-feet and 7-feet respectively (see figures 30 to 32). As the span of the beams and location of columns were not multiples of the width of the mesh, the employees generally placed the mesh up to the inner column vertical reinforcing steel. The failure to comply with the shop drawing and standard industry
