Investigation of the December 6, 2007 Fatal Parking Garage Collapse at Berkman Plaza 2, Jacksonville, FL

U.S. Department of Labor
Occupational Safety and Health Administration
Directorate of Construction

May 2008

Report Prepared by
Mohammad Ayub, PE

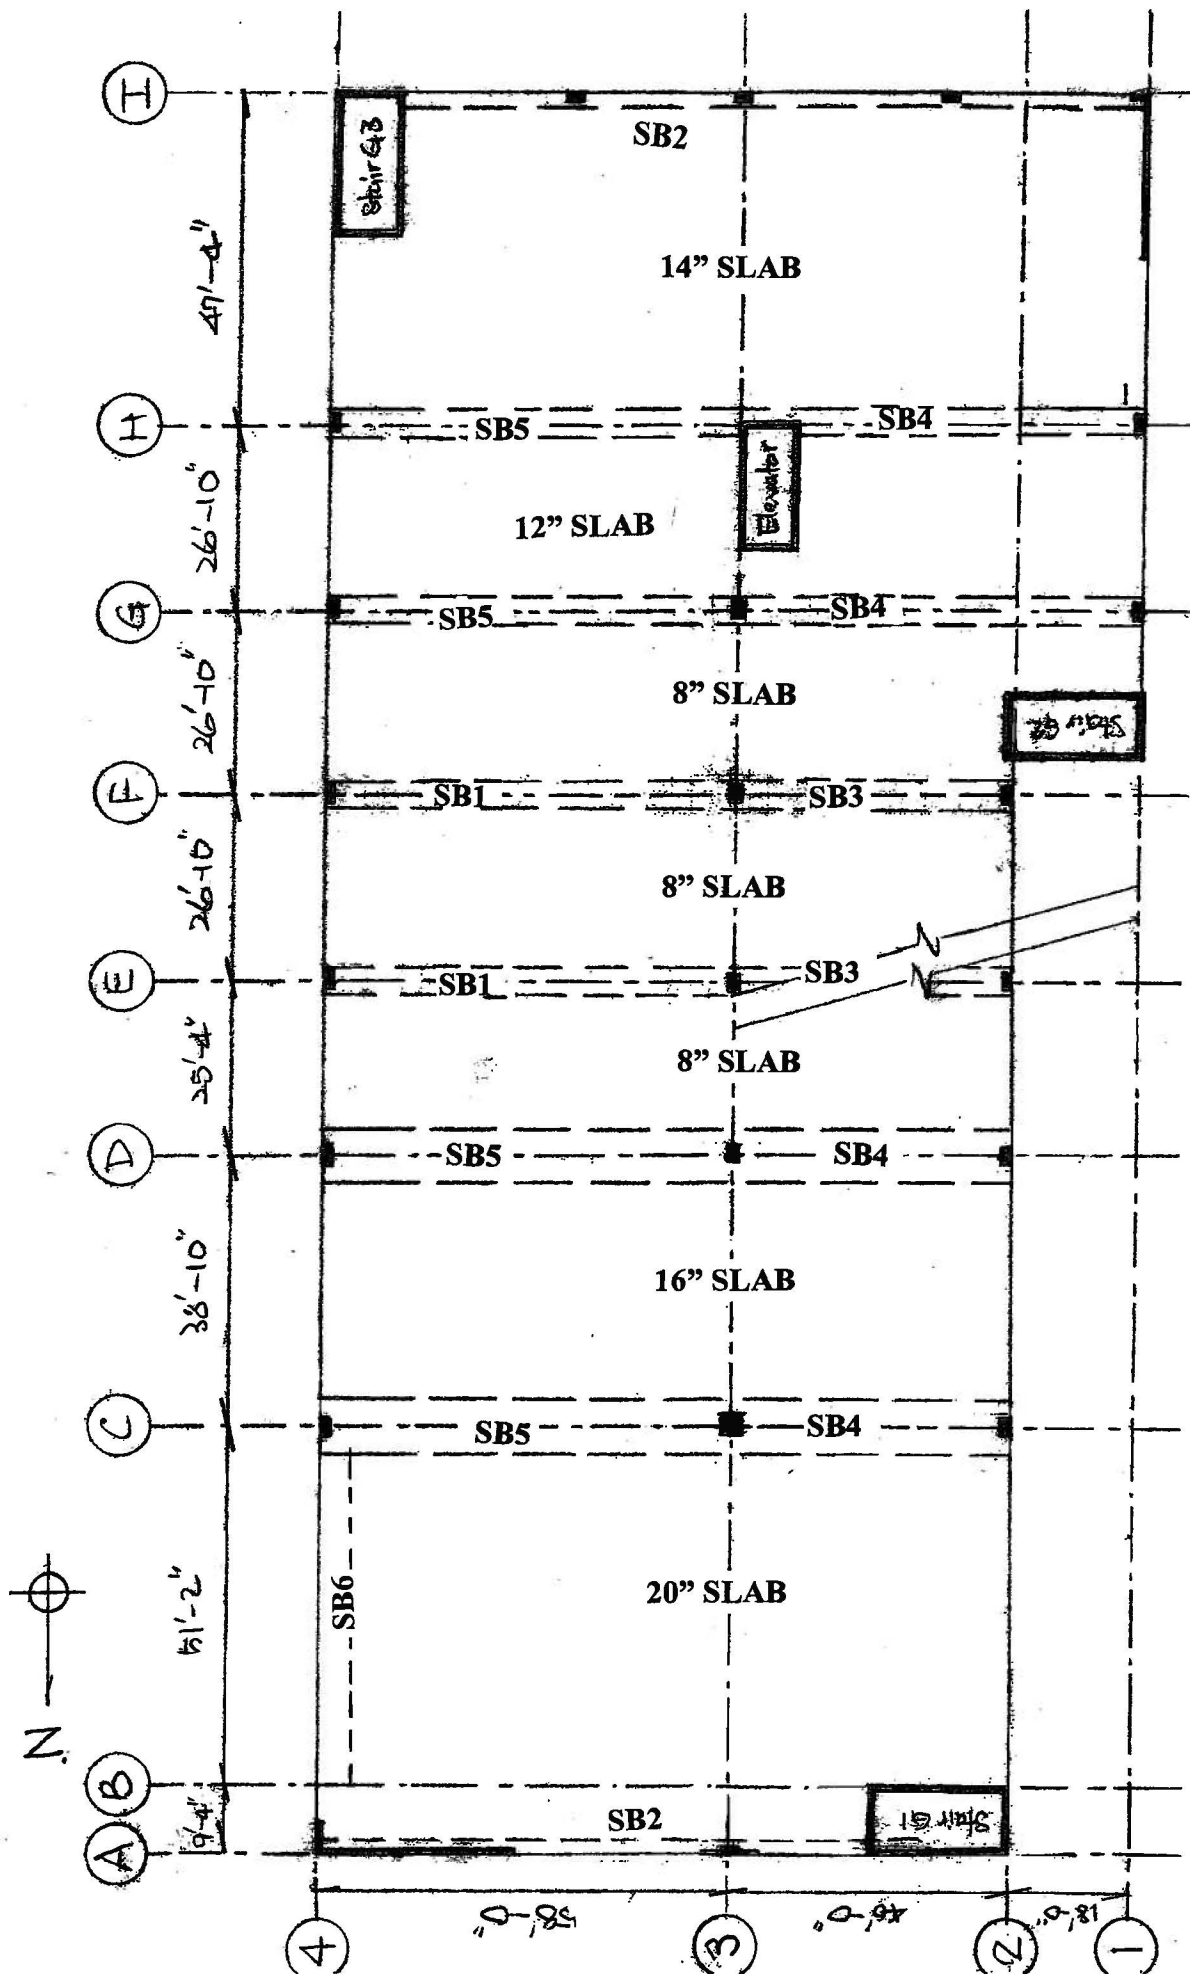
The schedule of beams taken from the structural drawings is shown in Figure 2. For location of beams, see figure 1. For our evaluation, 6,000 psi was considered to be the strength of the concrete although the contract documents specified 5,000 psi as the concrete strength. Testing laboratory documents indicated that 6,000 psi was the required strength for beams and slabs (see Table 4). There were five different beams provided, SB-1 thru SB-5. The most critical beam of significance to this investigation was SB-5 that was the most heavily loaded as it supported wider spans of the slabs.

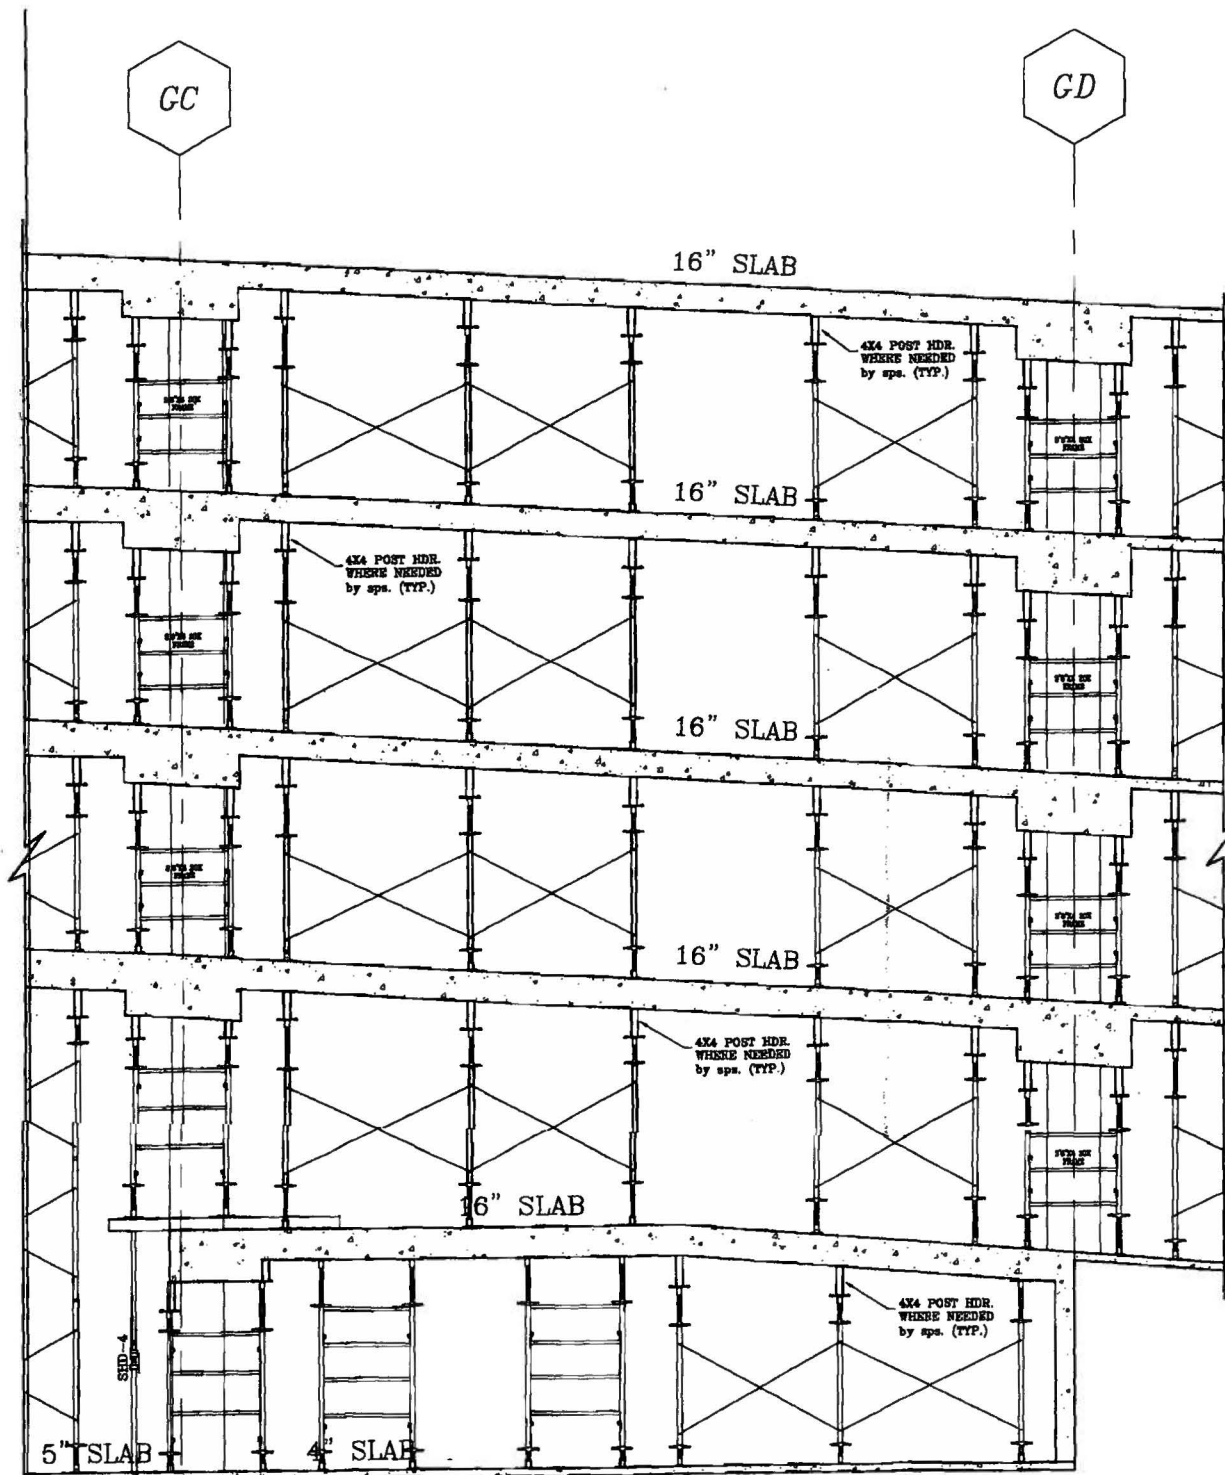
FIGURE 3

Southern retained Patent to design the formwork and to prepare formwork layout drawings including shoring and reshoring. Patent prepared the drawings showing the layout of the formwork, shores and reshores. The first three drawings bore a signature dated May 4, 2007 and the last five drawings had the same signature dated June 12, 2007. On drawings No. 7 & 8,

number 8607K038, re-shores were indicated extending down to the 1st level. It required that at the time the 6th level was cast, all levels below the 6th level must be shored/reshored. See, Fig. 3.

There are conflicting reports about why Southern removed the reshores under the 3rd level despite the fact that the Patent drawing showed the reshores extending down to the 1st level. When OSHA asked Synergy why, as a threshold inspector, it would permit placement of concrete on the 6th level without the reshores under the 3rd level, it responded that the SER, in response to its e-mail seeking clarification of where re-shores were required, advised that reshores were only required under a certain slab requiring repairs, and at no other place. Synergy, therefore, did not raise the issue with the contractor of the lack of reshores under the 3rd level. See, attachment D, showing copies of the e-mails. It was discovered earlier that 61 top #5 mild steel reinforcement bars, 46-feet long, were inadvertently not placed in the ramp, from 2nd to 3rd level slab bounded by column grid lines D & E, and 2 & 3. To correct the structural deficiency created by the lack of rebars, SER recommended certain repairs to the slab and asked that the slab in question continue to be reshored until repairs were completed. OSHA asked SER about the e-mail. SER stated that his response was not meant to address the necessity for or lack of reshores anywhere in the garage except in the areas needing repairs. SER further explained that methods and means of construction are solely the responsibility of the contractor, and the contractor should determine whether shoring and reshoring are required.

6. The shoring subcontractor disregarded the shoring plans prepared by its subcontractor which indicated that the 3rd level should be reshored down to the 1st level. There were no

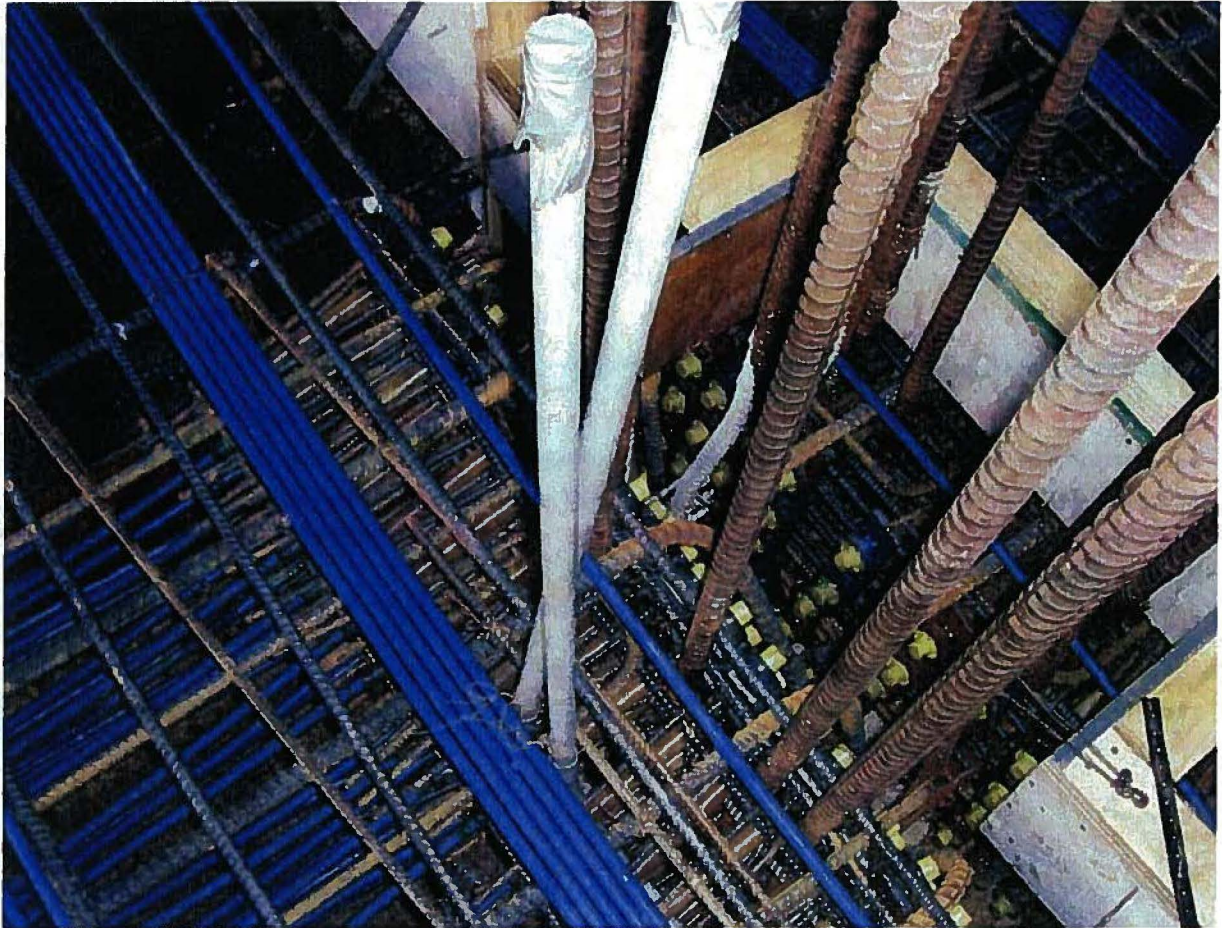
FIGURE 4

The construction of the parking garage included many minor and major issues. It was reported to OSHA by a number of sources that the difficulties were compounded by the fact that the SER was not forthcoming in resolving the questions, and had a nonchalant and dispassionate attitude towards the structure he designed. SER denied this during an interview with OSHA. The majority of the issues arose at the beam-column joints from the congestion created by a large

number of post-tensioning cables, top and bottom mild reinforcements of the beam, and longitudinal reinforcements and dowels in the column. See Fig. 4 for the number of reinforcements at the dead end of a post-tensioned beam. Honeycombing and voids were reported at the beam-column joints. For example, the 5th level beam on column line G between grid lines 1 & 3, the 2nd level beam on column line G between grid line 3 & 4, and the 5th level beam on grid line E between grid lined 2 & 3 could not be post-tensioned due to honeycombing at their ends.
