# Structural Investigation of the January 20, 2014 Plant Collapse at International Nutrition Facility in Omaha, NE

U.S. Department of Labor  
Occupational Safety and Health Administration  
Directorate of Construction

July 2014

Report Prepared by  
Mohammad Ayub, P.E., S.E.  
Office of Engineering Services  
Directorate of Construction

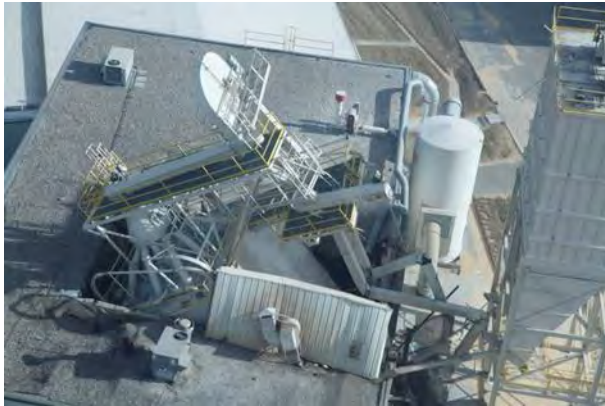
**Fig.1** Aerial view of collapse

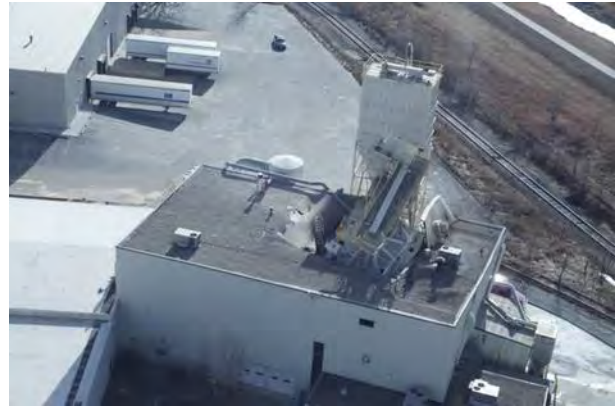
**Fig. 2** Aerial view of collapse

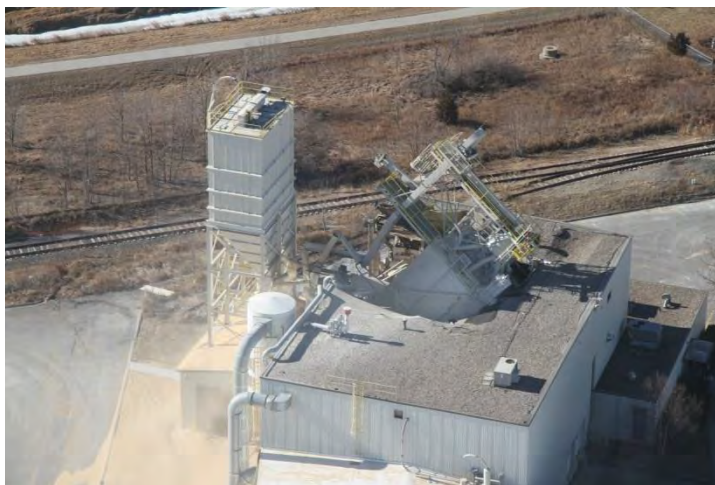
**Fig. 3** Aerial view of collapse

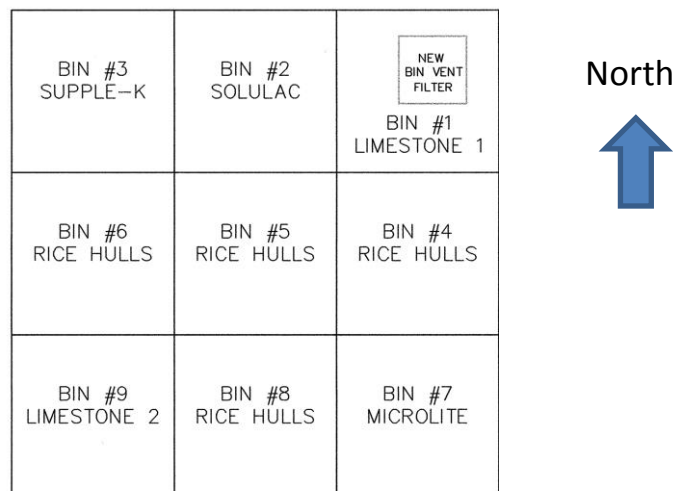
**Fig. 8** Bin layout (Taken from drawing F1.8 by Ken Bratney Company, 1996)

We understand as per KBC that the drawing merely indicated what KBC believed to be the current practice at that time. Microlite and Supple-K generally weighs 75 and 85 pounds per cubic foot (pcf), respectively. Limestone weighs approximately 90-95 pcf, and Rice Hull is approximately 20 pcf.

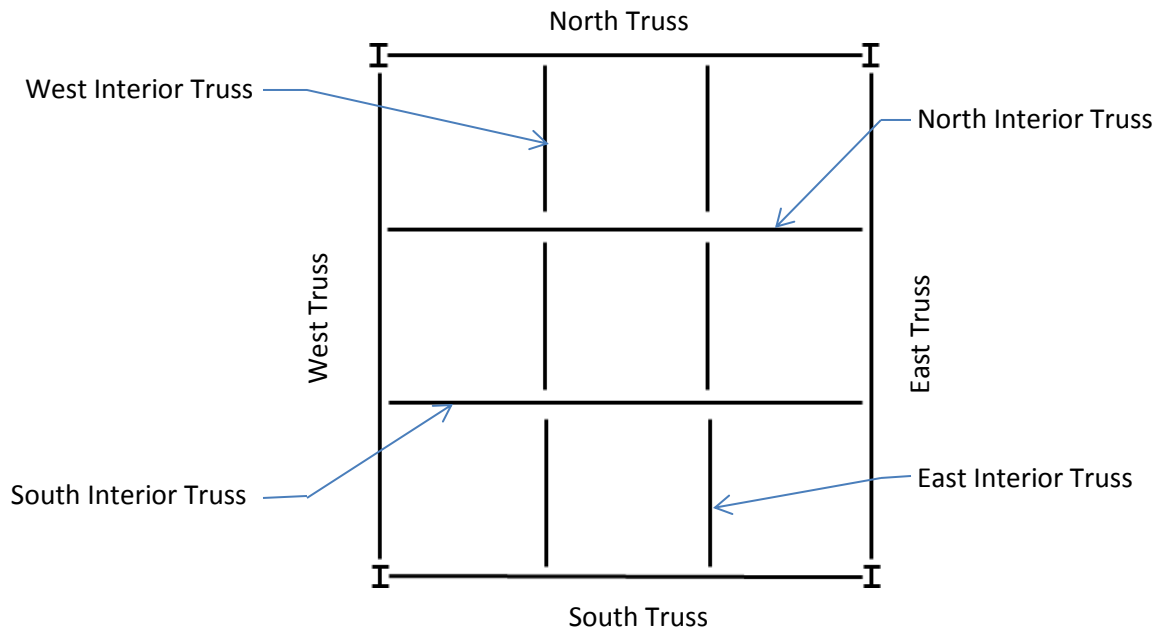
**Fig. 106** Bin supporting structure

Two exterior trusses ran in an east-west direction and were directly supported over the steel columns resting on the concrete columns at the east and west ends of the bins. The other two exterior trusses ran in a north-south direction, and were framed to the steel columns through seated connections welded to the flange of the columns. Two interior trusses ran in the east-west direction framed to the east and west primary trusses. Similarly, two interior trusses ran in the north-south direction and were framed to the north and south primary trusses. The connections of the interior trusses to the exterior trusses were through the seated connections projecting from the top chord of the exterior trusses.

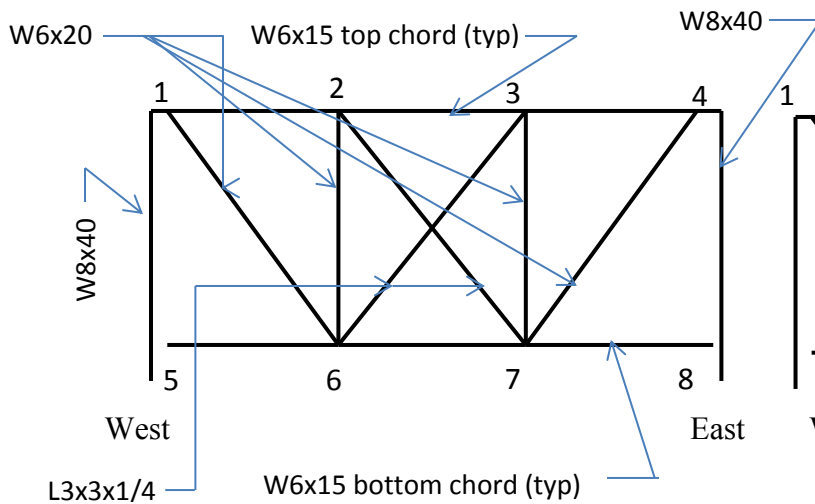
All four beam-bearing connections on the east and west exterior trusses failed when the 3/8" stiffener plate buckled. The four connecting bolts remained mostly intact, see Figs. 34, 39 and 44. The north and south trusses are shown in Figs. 86 and 87 respectively. Their joints are shown in Figs. 16 thru 33 below.

**Fig. 86 North Truss**

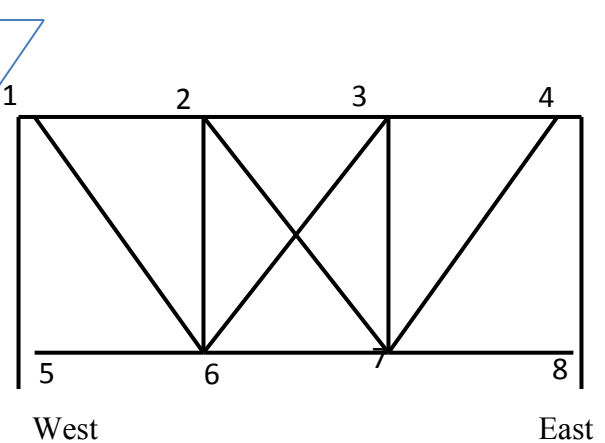
**Fig. 87 South Truss**

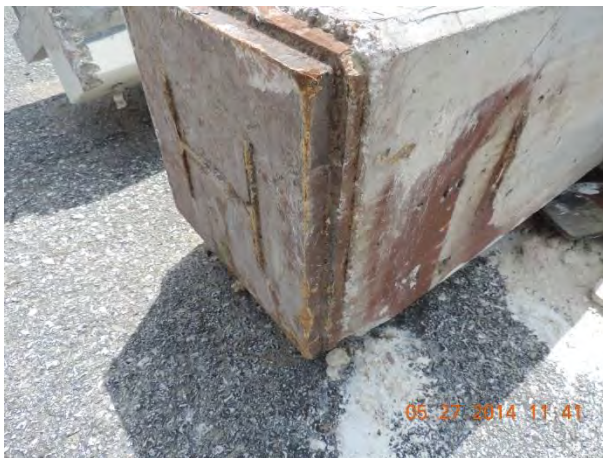
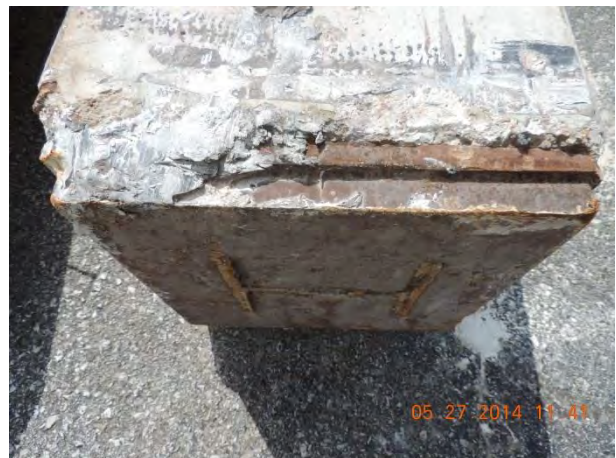
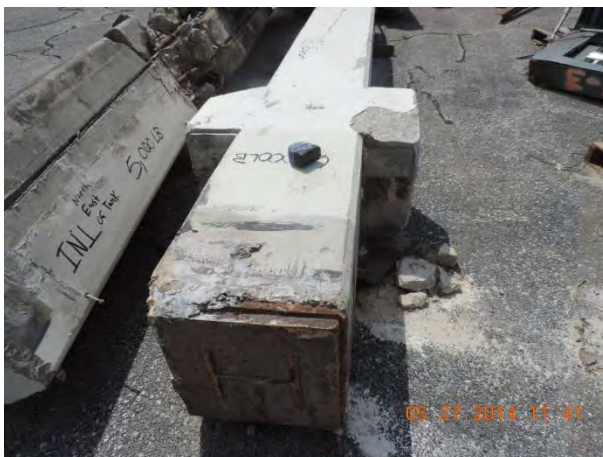
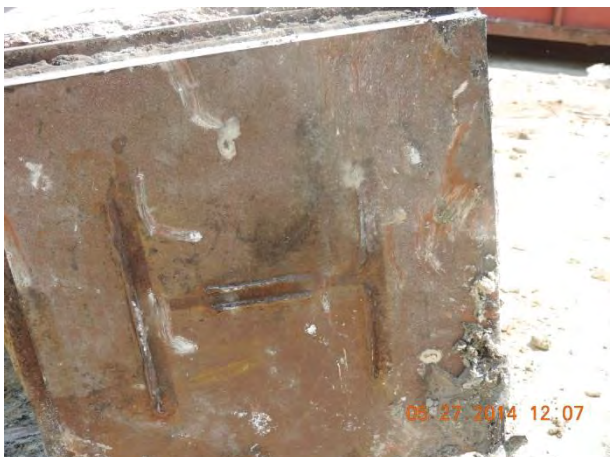
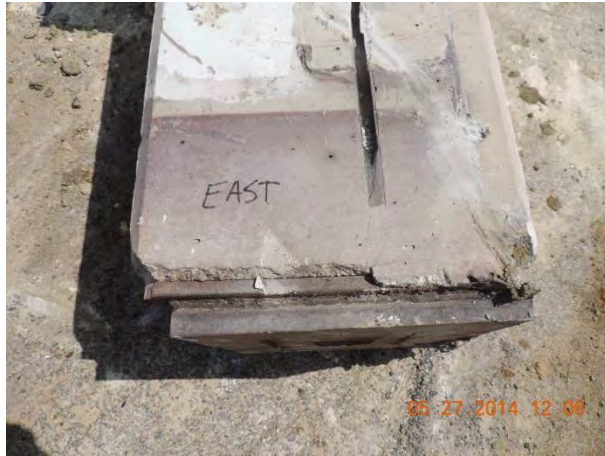
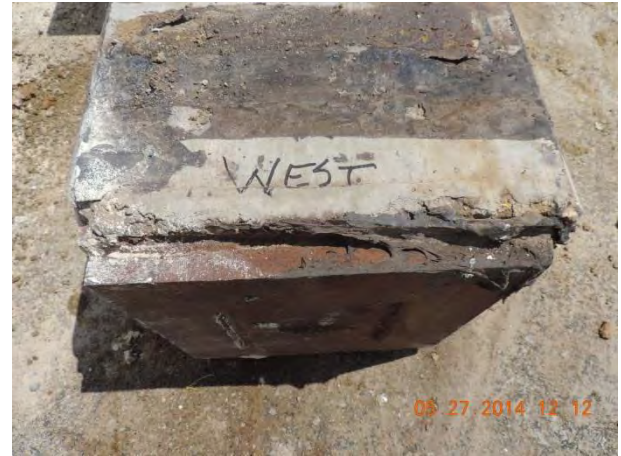
The four corner columns, W8x40, remained intact and did not exhibit any signs of distress. The failure occurred at the bottom of the columns where the welds to the column base plate failed, see Figs. 78 thru 85. The column base plate remained connected to the embed plates of the concrete columns; see Figs. 78 thru 85 and 95. For typical hoppers pictures after they have been retrieved from the debris, see Figs. 96 thru 98.

**Fig. 78 – W8x40 base plate**

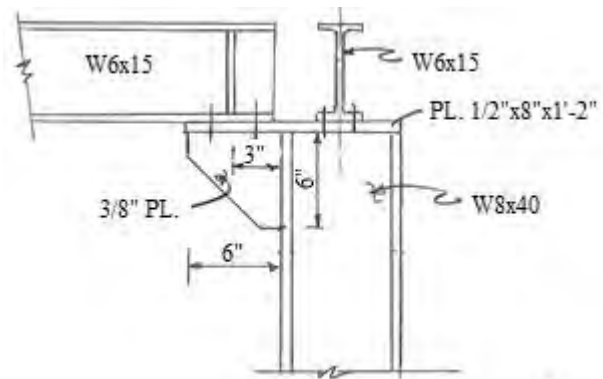
**Fig. 93** Elevation  
(Seated beam connection of the  
east and west truss)

1. The cause of the collapse was the failure of the four seated connections of the east and west exterior trusses at their north and south ends under the loads of limestone placed in the corner bins and other products in the remaining bins at the time of the collapse. The four seated connections were provided with only one stiffener plate unlike other similar connections of the interior trusses which were provided with two plates. If either two stiffener plates were provided instead of the one, or if one end of the east and west trusses was placed on a sliding pad, the collapse would not have occurred in spite of the limestone in the corner bins, and other products in other bins.

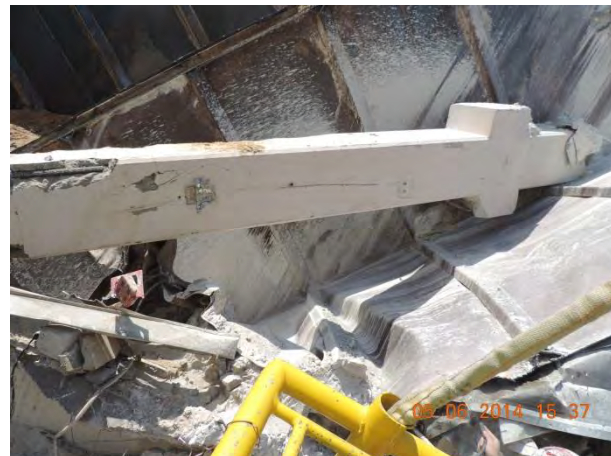
During the collapse, all four concrete columns remained intact except the NE column which was sheared at approximately the level of the inverted tee beam at the third floor, and was found inside bin No.1 during the demolition and recovery. The reason of the shear at that location was the lack of adequate lap splice of the longitudinal bars on one face of the column, see Figs. 99-103.

**Fig. 99** – NE corner column lying in bin No. 1

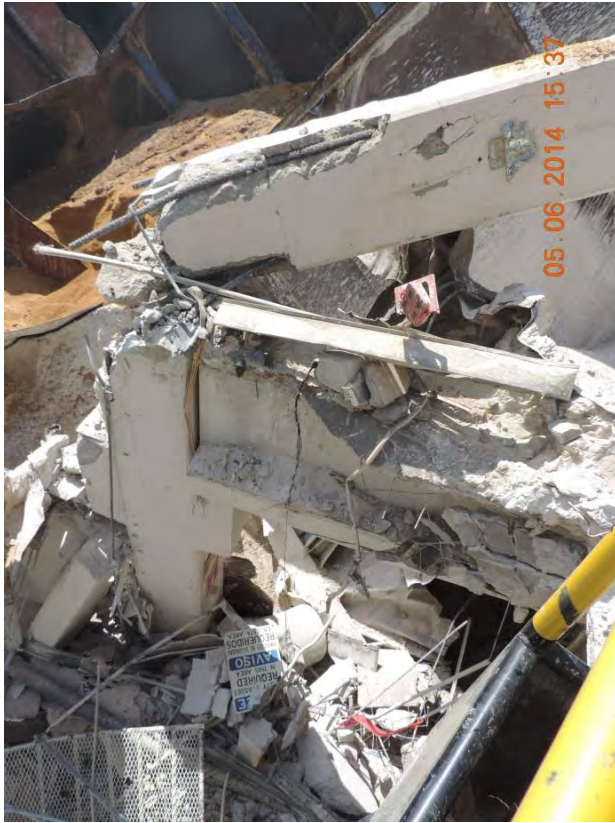
**Fig. 100** Fracture of NE corner column  
at 3<sup>rd</sup> floor

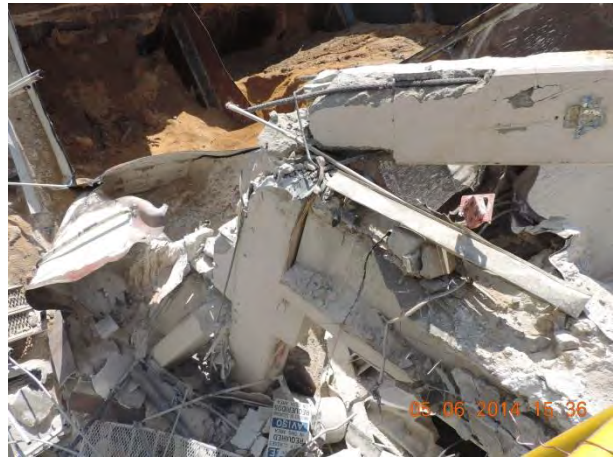
**Fig. 101** Another view of fracture of NE  
column at 3<sup>rd</sup> floor

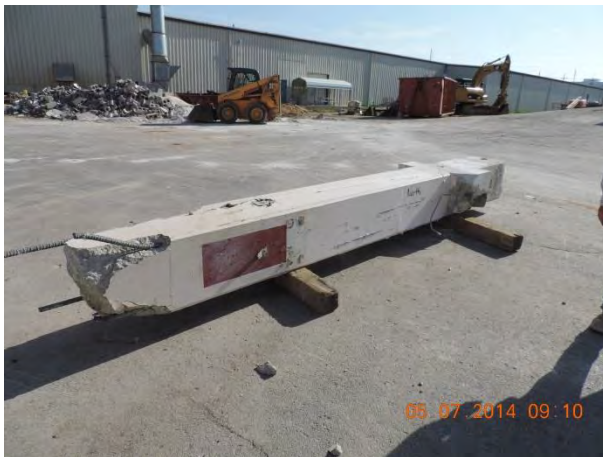
**Fig. 102** NE corner column showing  
inadequate lap splice

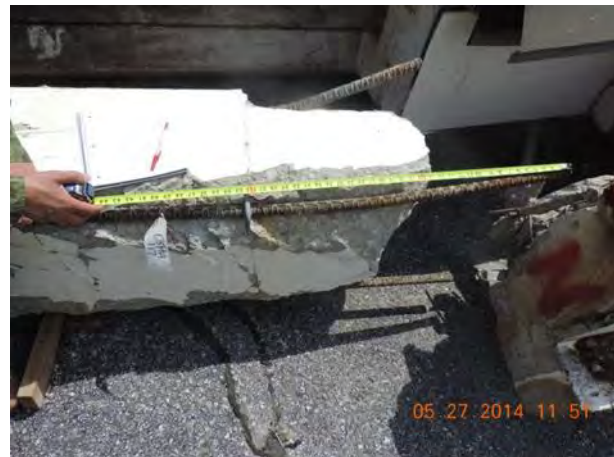
**Fig. 103** NE corner column showing  
inadequate lap splice

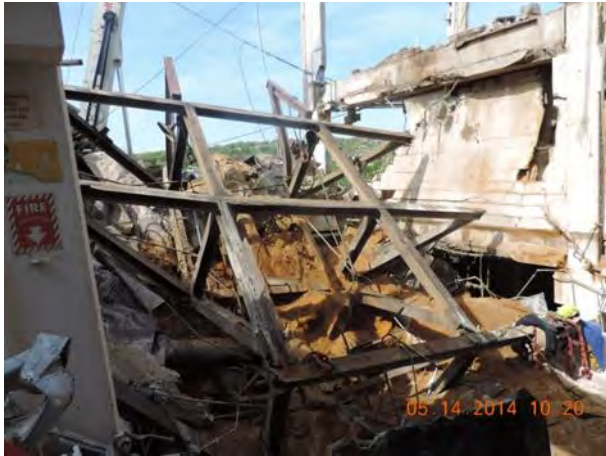
The four interior trusses escaped serious damage and emerged relatively intact from the debris see Figs. 104 and 105. The top chords of the north and south interior trusses were continuous

**Fig. 104** Interior trusses lying in debris

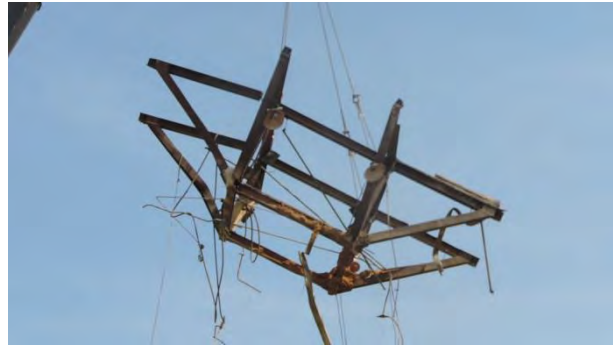
**Fig. 105** Interior trusses being retrieved
