Investigation of the Failures of Three Hammerhead Cranes on September 10, 2017, in Miami and Fort Lauderdale in the Wake of Hurricane Irma

U.S. Department of Labor
Occupational Safety and Health Administration
Directorate of Construction

September 2018

**Report Prepared by
Mohammad Ayub, P.E., S.E.
Alan Lu, Ph.D., P.E.
Office of Engineering Services
Directorate of Construction**

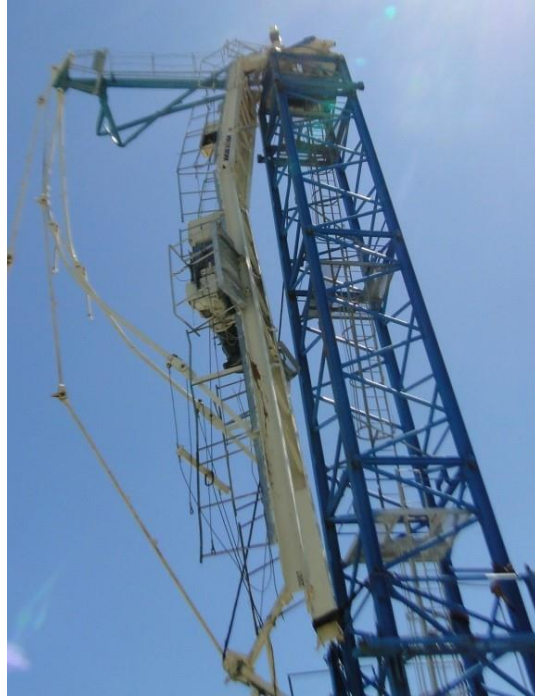
Figure 9 Tower top and counterjib after the incident – the first failure

The failure occurred at approximately 10 a.m. The counterjibs rotated 90 degrees and were hanging upright, though still connected to the turntable. The pendants remained connected to the counterjibs at both locations. The tower top structure also bent 90 degrees toward the counterjib. The two tower-top columns on the counterjib side buckled at approximately mid-height between the top pin and the brace. The jib came off the pinned connection, flipping 270 degrees, and fell over the completed structure with a 90-degree bend where the A-frame (a.k.a. queen post) was located. The last pin of the pendant connecting to the top chord of the jib, and the last pin of the other pendant connecting the A-frame, were opened as the cotter pin loosened. All five pieces of the counterweight fell over the interior of the building, damaging the already-completed floor slab; none fell outside the perimeter of the building. The engineer of record examined the building and

recommended repairs to the slabs. Refer to Figure 9 for the collapsed crane tower top after the failure.

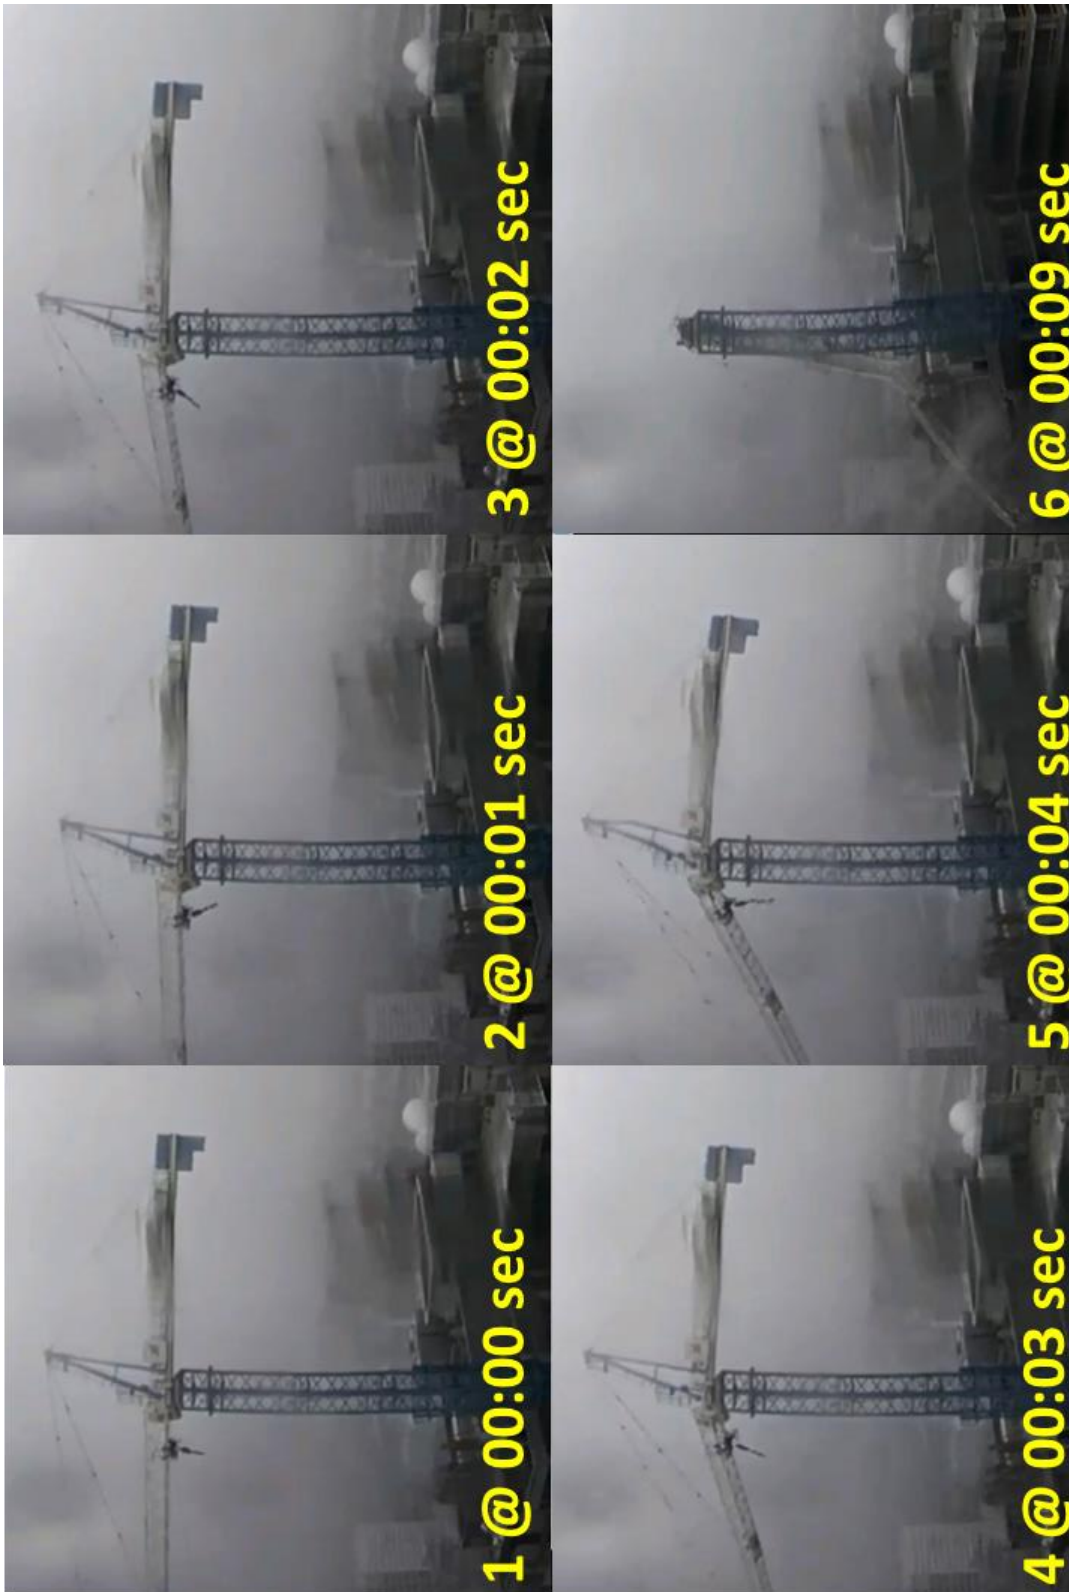
Figure 10 Image sequence showing the crane collapse
(Courtesy of Nick Tangredi)

A YouTube video was later discovered that showed how the collapse occurred (see Figure 10 for pictures extracted from the video footage). It was discovered that the jib itself swayed toward the right, and the left bottom jib chord detached from the turntable. As the jib continued swaying toward the right, the right bottom jib chord separated suddenly from the turntable and the jib started falling. During the fall of the jib, the two jib pendants were unloaded. The tower top changed in seconds from being loaded from both sides to being loaded only from the counterjib side. Then the two tower top columns, swaying toward the counterjib, failed under the change of the transient load.

1. Jib started to sway to the right, and the left jib bottom chord detached from the turntable;
2. Jib kept swaying to the right, and the jib knocked the cabin;
3. Jib kept swaying to the right, and the counterjib started shaking;
4. Jib kept swaying to the right, and the right jib bottom chord detached from the jib foot. Therefore, the entire jib was no longer mounted to the turntable;
5. Jib fell, and the two jib pendants were not loaded. The tower top was loaded from the counterjib pendants only. The two tower top columns, swaying toward the counterjib side, buckled; and
6. The tower crane collapsed.

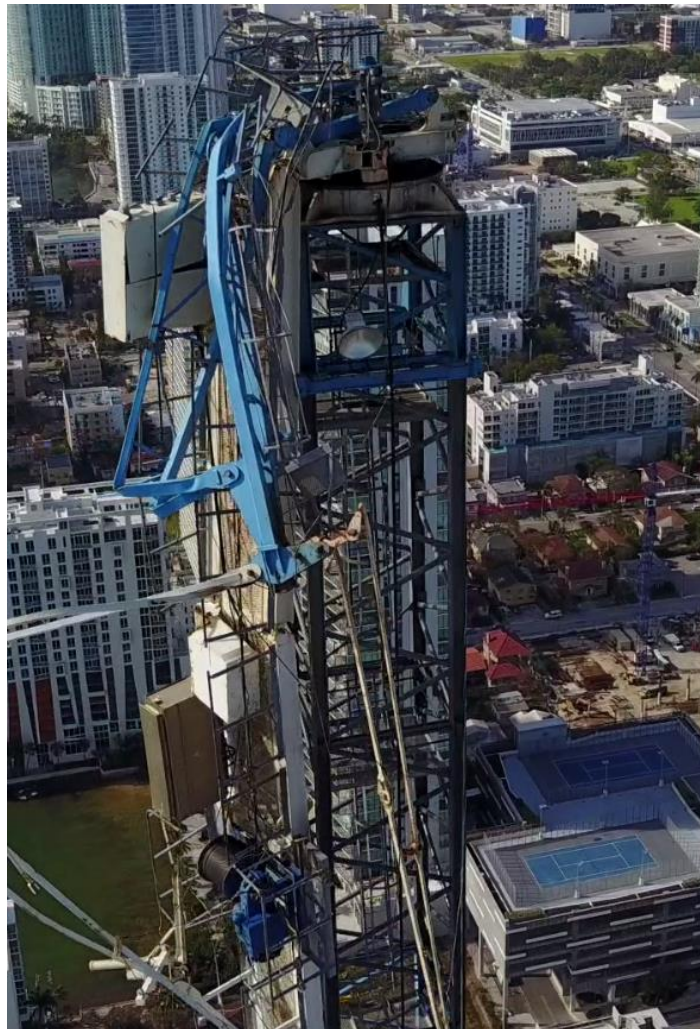
Figure 12 Tower top and counterjib after the incident – the second failure site

The failure of the tower top occurred in a manner similar to the first failure. The counterjib beams rotated 90 degrees and were hanging straight down by the side of the crane mast. The tower also rotated approximately 90 degrees. Again the tubular columns on the side of the counterjib buckled very distinctly between the top pin and the solitary brace about the major axis. All four counterweight pieces fell on the street below piercing the pavement. The City of Miami had ordered an evacuation of adjoining apartments and condos. The street was therefore deserted, and there were no injuries. The jib came off its pinned bearing connection and was bent in a V-shape at the location of the A-frame. During the failure, all pendants remained connected to the jib, and all pins interconnecting the pendants remained intact. A photograph of the crane tower top taken after the crane collapse is shown in Figure 12.

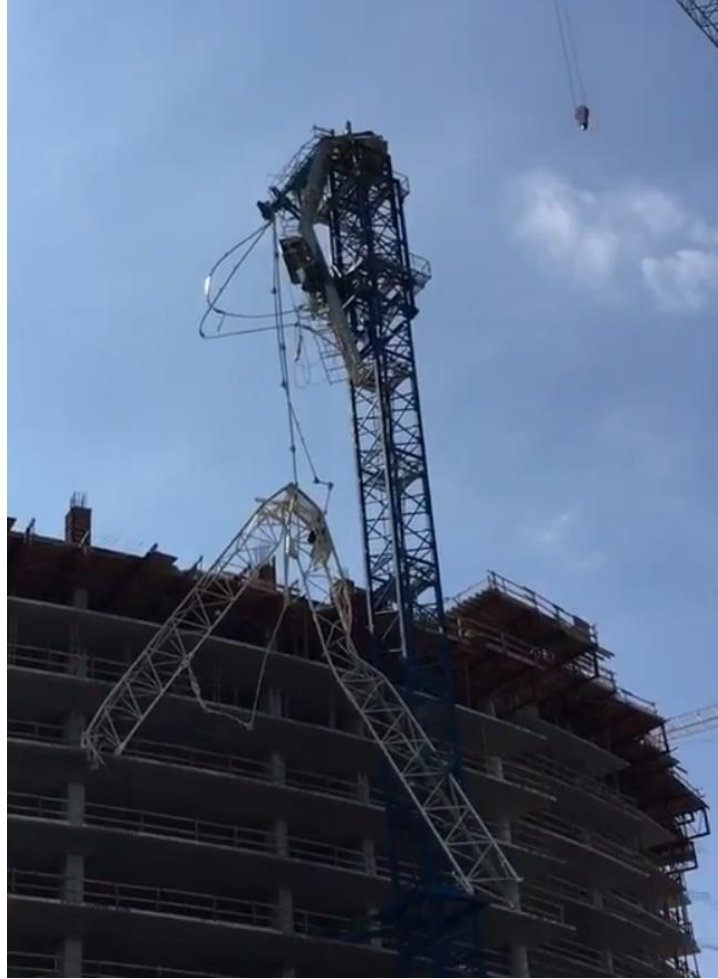
Figure 15 Collapsed crane after the incident – the third failure site

The failure of the tower top occurred in a manner similar to the first two failures. The counterjib beams rotated 90 degrees and were hanging straight down by the side of the crane mast. The tower also rotated approximately 90 degrees. Again the tower top columns toward the counterjib buckled very distinctly between the top pin and the solitary brace about the major axis. All four counterweight pieces fell, but there were no injuries. The jib came off its pinned bearing connections and was bent in a V-shape at the location of the A-frame. During the failure, all pendants remained connected to the jib, and all pins interconnecting the pendants remained intact. A photograph of the crane tower top taken after the crane collapse is shown in Figure 15.

Later, the remnants of the failed crane were examined at the storage yard in Orlando on December 12 and 13, 2017 by the OES structural engineers. Interestingly the inspection indicated similar failure where the tubular frame of the tower on the counterjib side failed at about the same location. All three failures were identical, see Figures 9, 12 and 15.

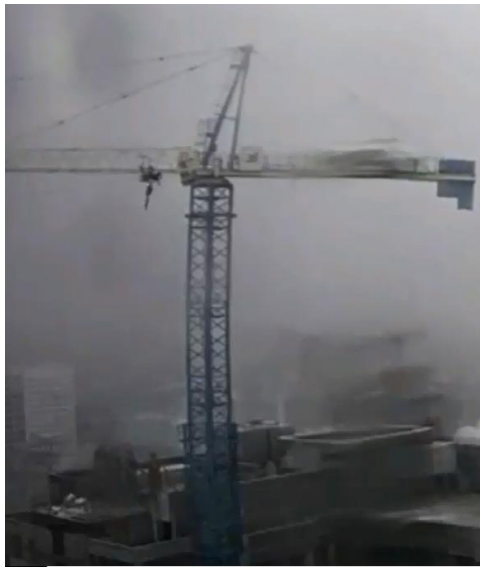
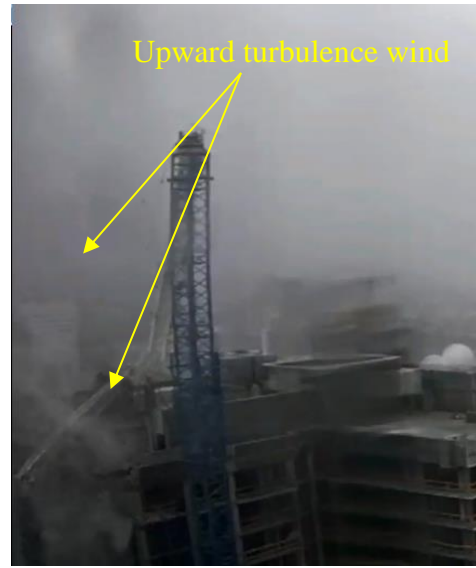
Figure 19 Upward turbulence wind detected when the crane collapsed at the first failure site (Courtesy of Mr. Nick Tangredi)

a) Jib jumped off the left bearing connection

b) Upward turbulence wind detected right after counterweight blocks hit the building

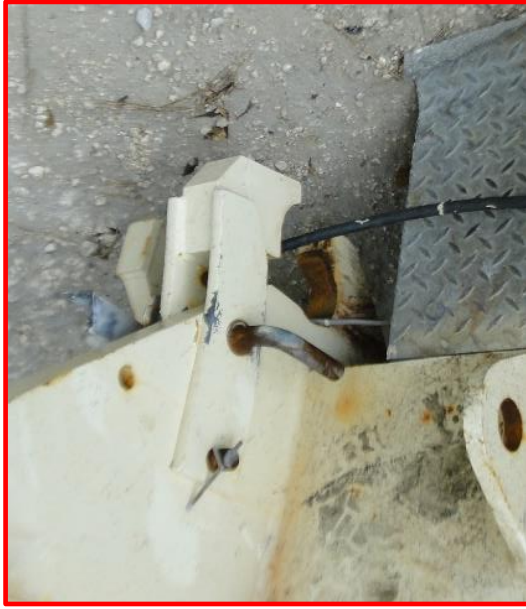
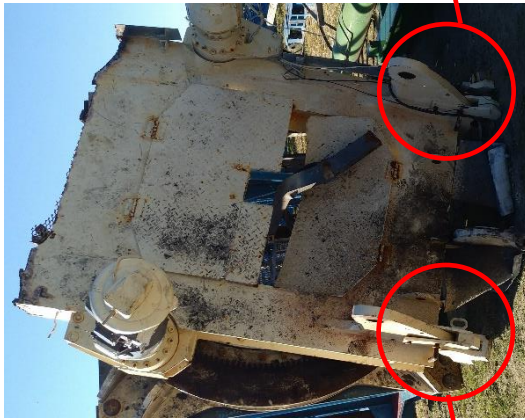
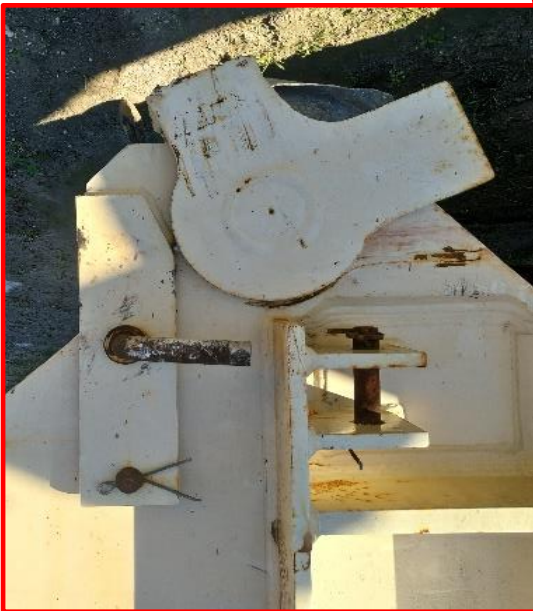
Figure 28 Jib foot bearing connections – turntable side (the first failure)

The right bearing cradle and the right clamp remained intact. However, the right bottom jib chord broke at the weld between the bottom chord tube and the end plate, as shown in Figure 30. The field structural observation is consistent with the collapse of the crane shown in Figure 10. The left jib bottom chord detached from the left turntable cradle because the jib swayed to the right. Once the jib separated from the left turntable cradle, the jib was only supported at the right turntable cradle and the two jib pendants. As the jib continued rotating to the right, the right bottom chord foot broke at the weld between the tube and the end plate, and the jib started falling.

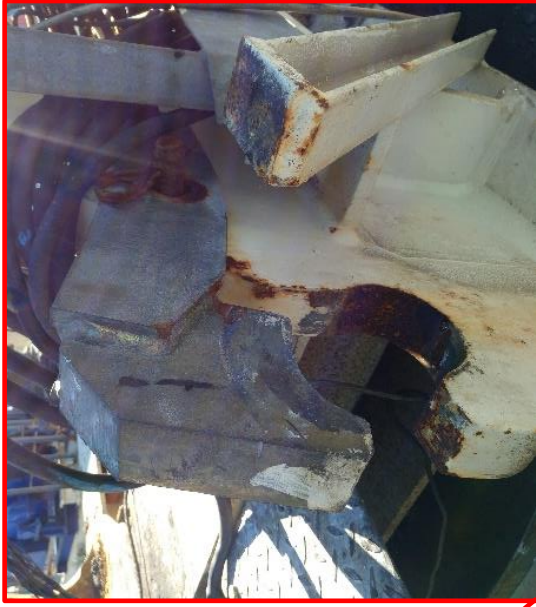
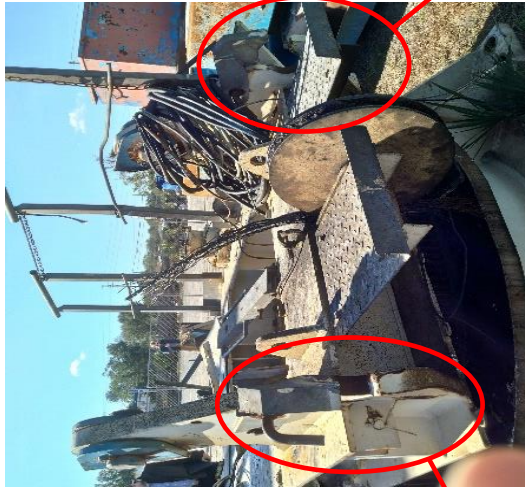
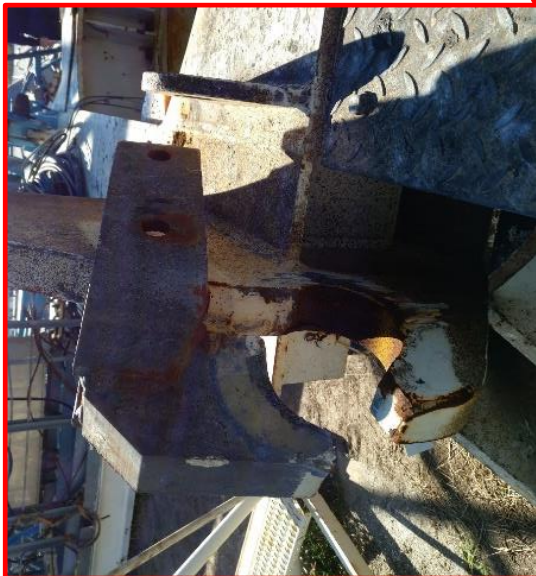
Figure 31 Jib foot bearing connections – turntable side (the second failure)

The front part of the turntable, including the two bracket cradles, is shown in Figure 31. The two jib bottom chord foots after the collapse are shown in Figure 32. It was observed in Figure 32 that the clamp of the left cradle bent vertically and meanwhile, the left bottom jib chord foot remained intact. The clamp of the right cradle bent upward and to the right, while the right bottom jib chord foot, including the end bracket, bent to the right, as shown in Figure 32. The field structural observation indicated that the left jib bottom chord detached from the left turntable cradle because the jib rotated to the right. As the jib continued rotating to the right, the right bracket cradle and the right bottom chord bent to the right till the right bottom chord detached from the right bracket cradle. Per the field observations of the damaged structures the failure modes of the first two cranes' jibs are identical.

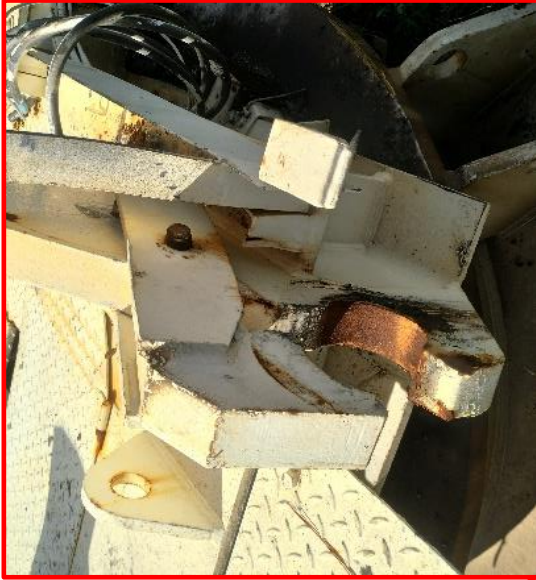
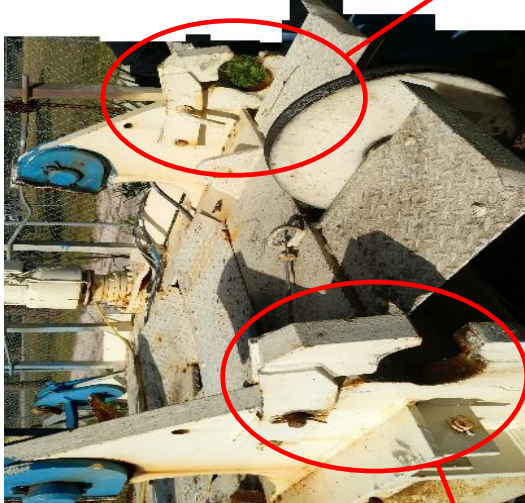
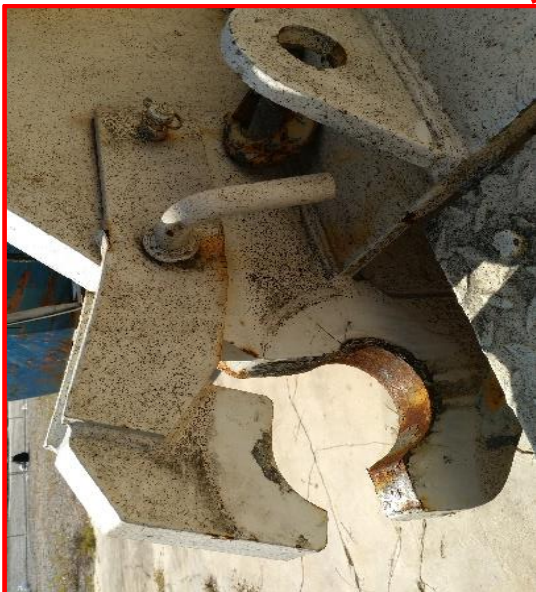
Figure 33 Jib foot bearing connections – turntable side (the third failure)

The front part of the turntable, including the two bracket cradles, is shown in Figures 33, 34, and 35. The two jib bottom chord foots after the collapse are shown in Figure 36. It was observed in Figures 33 to 35 that the clamp of the right cradle bent vertically and, meanwhile, the right bottom jib chord foot remained intact. The clamp of the left cradle bent upward and to the left, while the left bottom jib chord foot remained intact, as shown in Figure 36. The field structural observation indicated that the right jib bottom chord detached from the right turntable cradle first because the jib rotated to the left. As the jib continued rotating to the left, the left bracket cradle bent to the left until the left bottom chord detached from the left bracket cradle. According to field observations of the broken structures, the failure modes of the three cranes' jibs are similar.

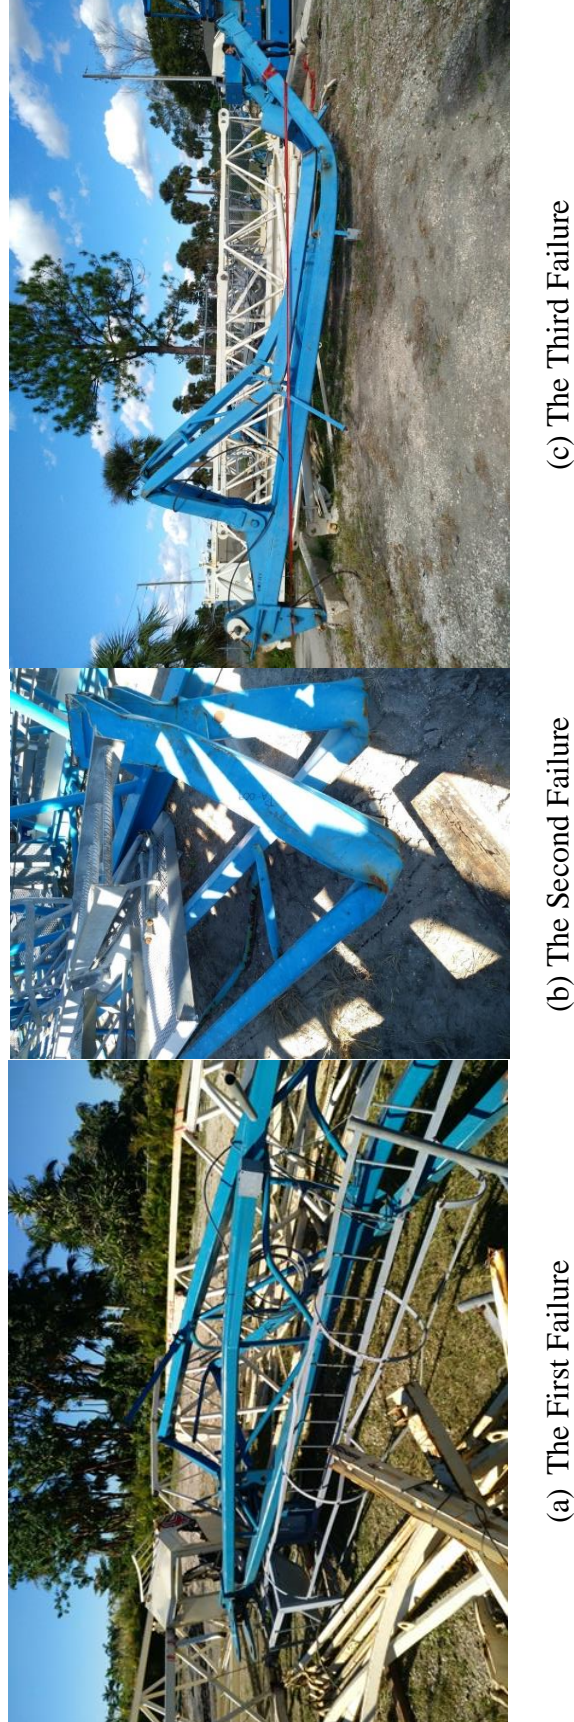
Figure 37 Tower tops of the three cranes after the collapses

Figure 37 shows the collapsed tower tops from the three failures. All three tower structures bent 90 degrees toward the counterjib. The two tower top columns toward the counterjib bent at approximately mid-height between the top pin and the brace. Considering the crane tower failure of the first incident as shown in Figure 10, it is believed that the tension forces at the tower apex from the two jib pendants disappeared suddenly due to the falling of the jib, and the tower was only loaded from the counterjib pendants. Therefore, compression forces in the two columns on the counterjib side were elevated rapidly, and the two columns failed under the transient forces.

10. To prevent catastrophic collapses of the crane tower top in the future, it is recommended that tower tops be evaluated and designed with a higher safety margin, and the design should also be based with loads applied from only the counterjib.

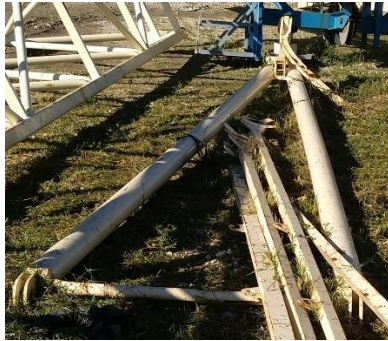
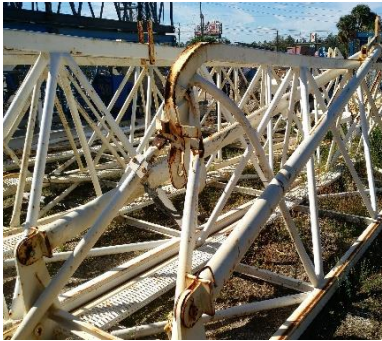
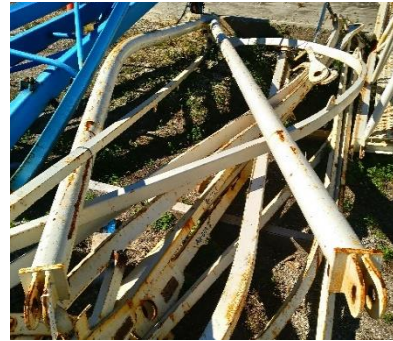
The A-frames of the cranes involved in the first two failures remained intact after the collapses. The two posts of the A-frames remained straight after the collapses, and no bend in the posts could be detected. The A-frame of the crane involved in the third failure was found deformed: the right hand post bent at about the mid-height. It is not clear if the post bent when the jib was falling.

11. The jibs in all three cranes were suspended by single pendants. In the event that the jib begins to sway to the sides, the single pendants could not be expected to secure the stability of the jib. It is, therefore, recommended that two symmetric pendants or cables be considered in the design of the tower cranes. Terex should consider adding pendants to the existing SK-315 models.
12. Although the National Hurricane Centre issued warnings to the residents in South Florida that heavy Squalls with embedded tornadoes were sweeping across South Florida, no tornadoes formed at any of three failure sites on September 10, 2017. However, localized high-altitude strong vortexes cannot be ruled out.
