INVESTIGATION OF OCTOBER 17, 1991 ROOF CABLE STRUCTURE ACCIDENT AT GEORGIA DOME CONSTRUCTION SITE, ATLANTA, GEORGIA

U.S. DEPARTMENT OF LABOR
OCCUPATIONAL SAFETY AND HEALTH ADMINISTRATION

March 1992

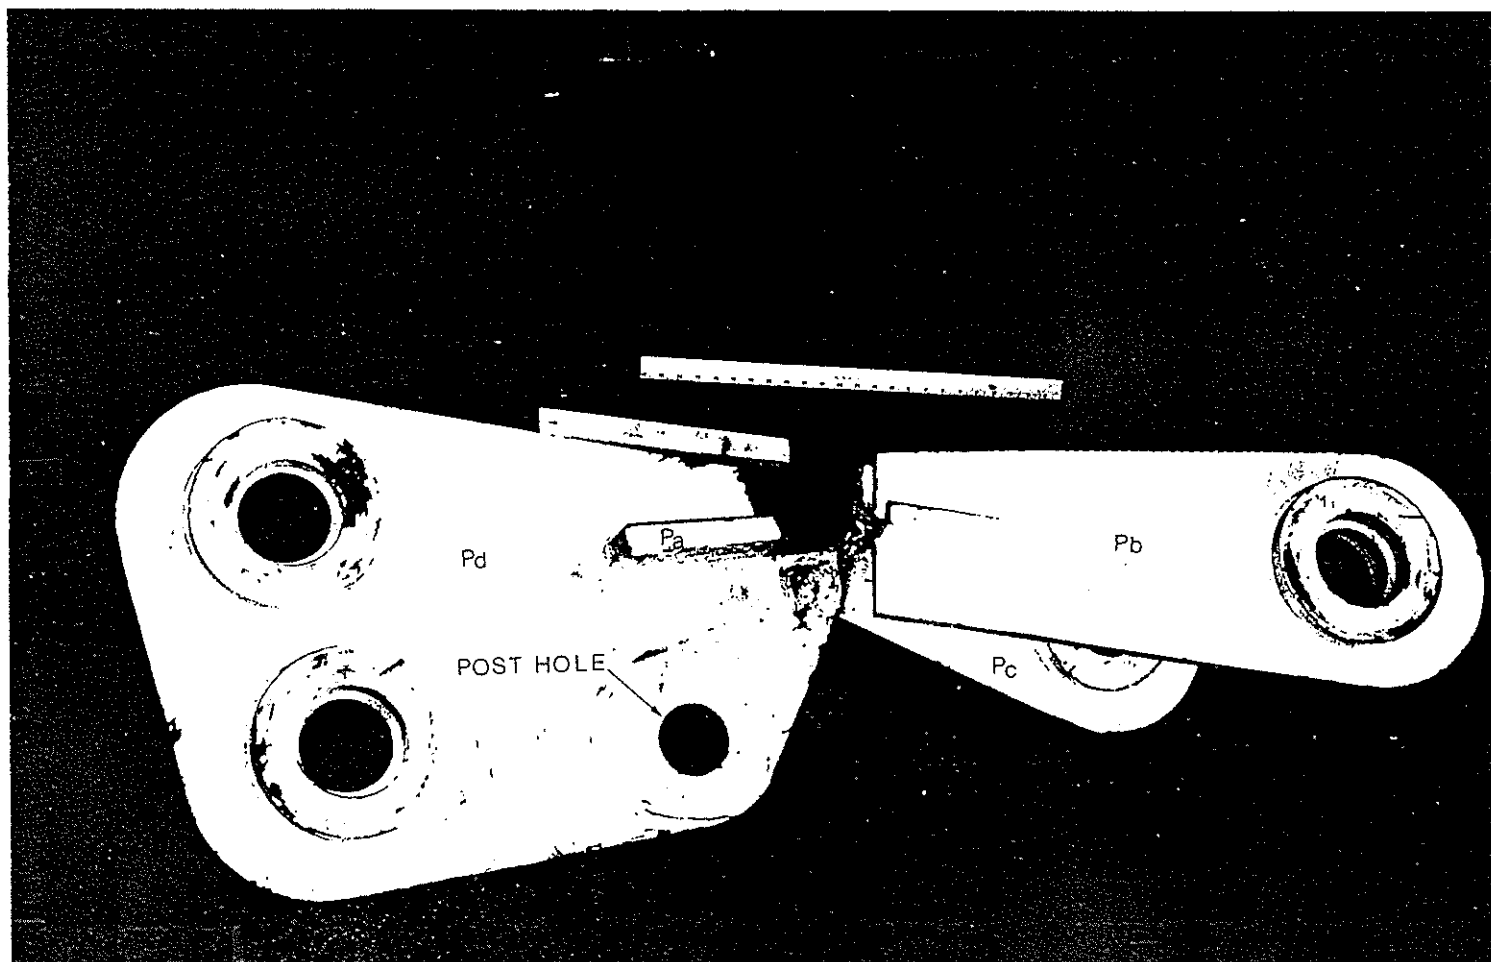
FIG. 2.11

PA ATTACHMENT PLATE AFTER THE ACCIDENT
SHOWING THE MATING SECTIONS

3. The groove welds between plates Pa and Pd were satisfactory and no evidence of defects like porosity, entrapped slag or cracks were found.
4. There were three origins of the fracture which were all located at the underside of plate Pa near the intersection of plates Pb, Pc and Pd. The examination of the fracture origins indicated that the failure was the result of overload tearing in a tough material. Inelastic (permanent) deformations had occurred at the surface of plate Pa adjacent to the fracture origins, and on the outboard surfaces of plates Pb and Pc adjacent to the end of plate Pa. The occurrence of inelastic deformation indicates that the connection had been subjected to loads, prior to fracture, which generated localized stresses in excess of the plate material's yield strength. Overload (overstress) condition precipitated the connection fracture.

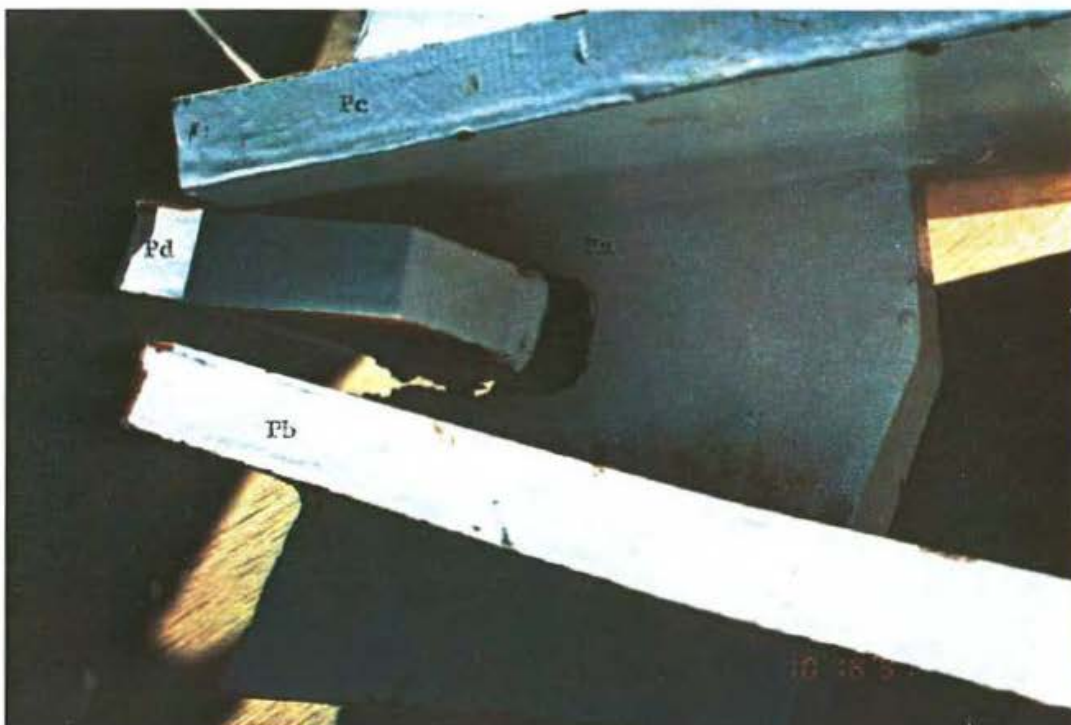
FIG. 2.12

EAST PORTION OF THE FRACTURED ATTACHMENT PA-7 PLATE

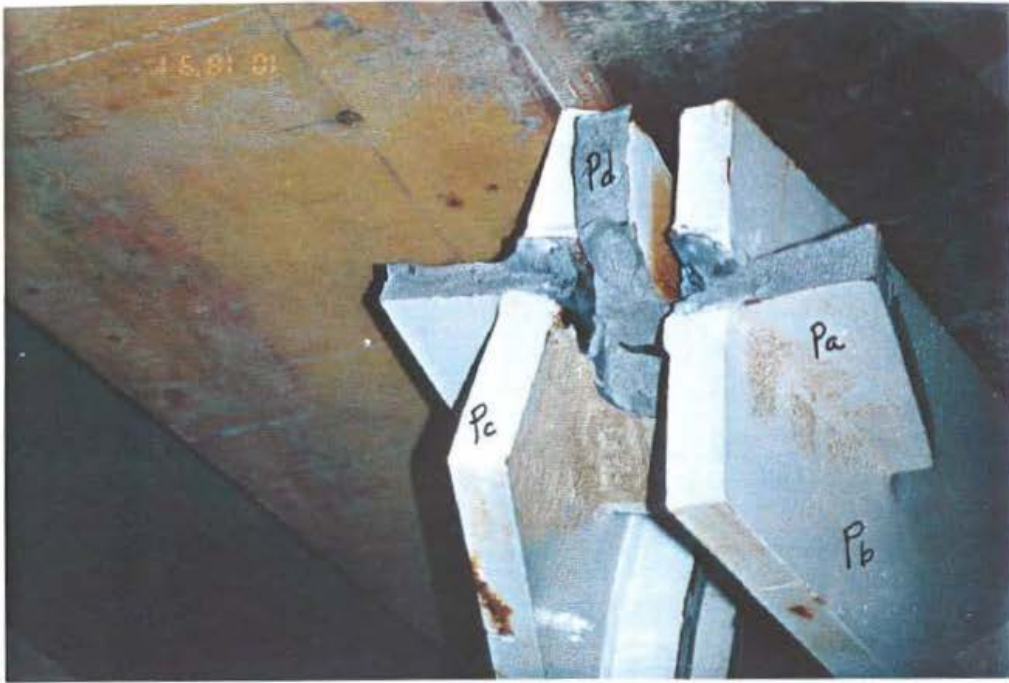
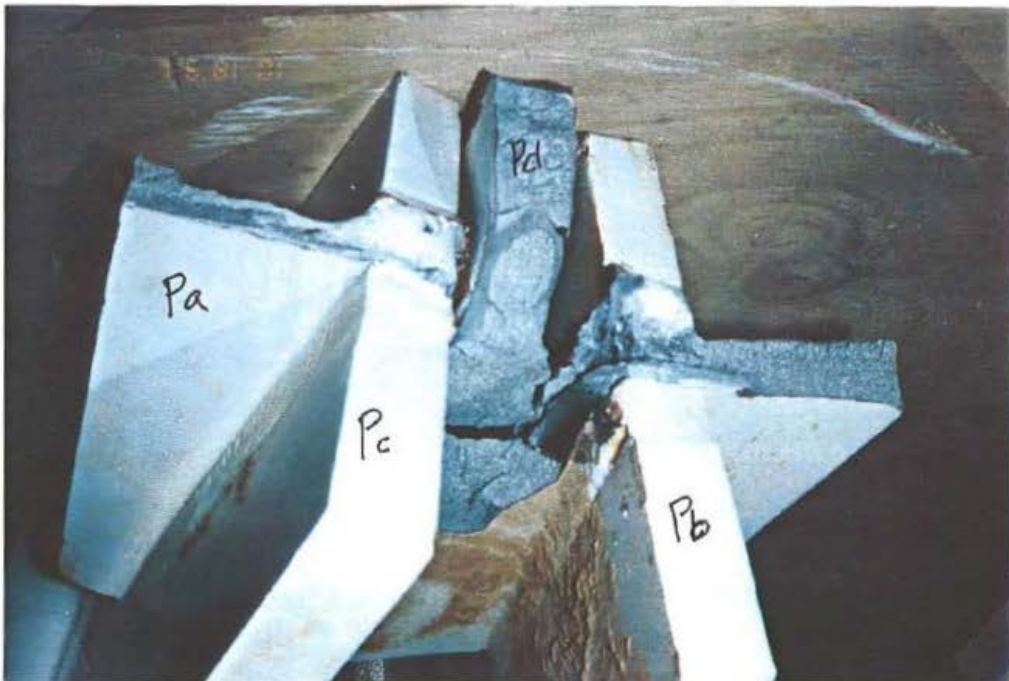
FIG. 2.13

EAST PORTION OF THE FRACTURED PLATE (ANOTEER VIEW)

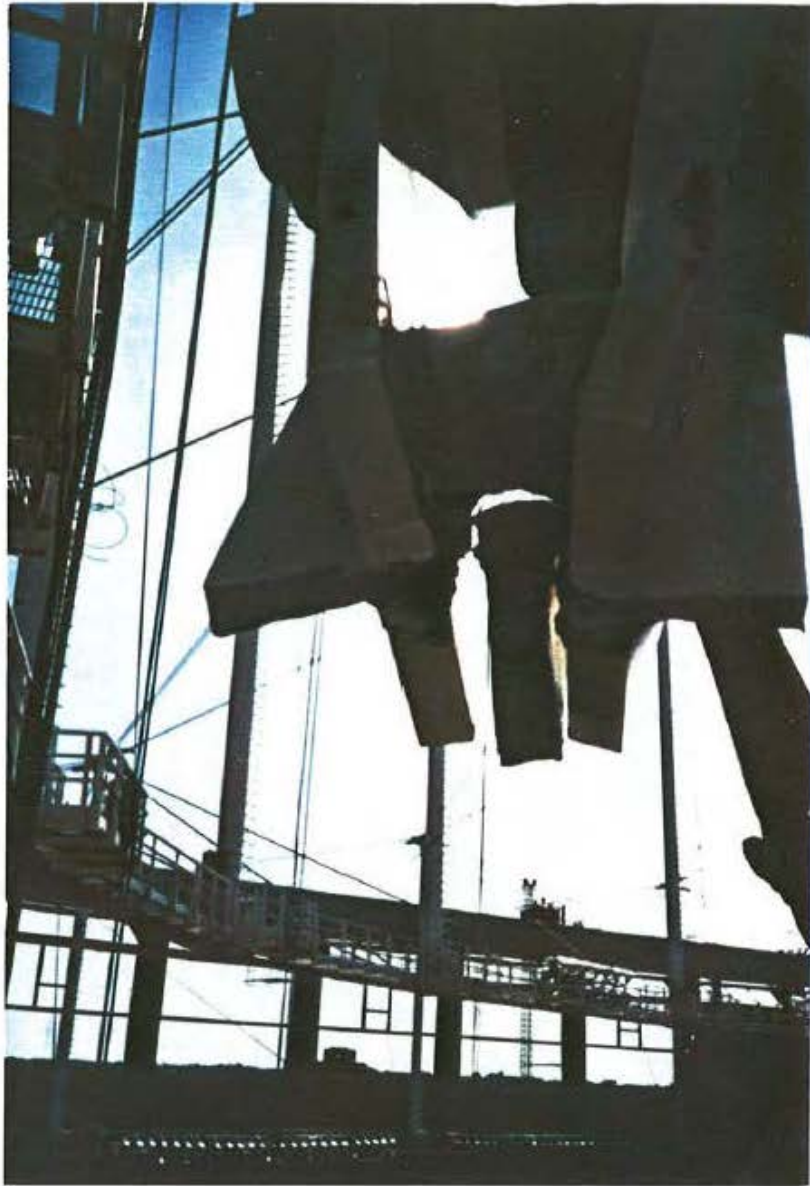
FIG.2.14

EAST' PORTION OF THE PLATE AFTER THE FRACTURE
IN AN UPSIDE DOWN POSITION.

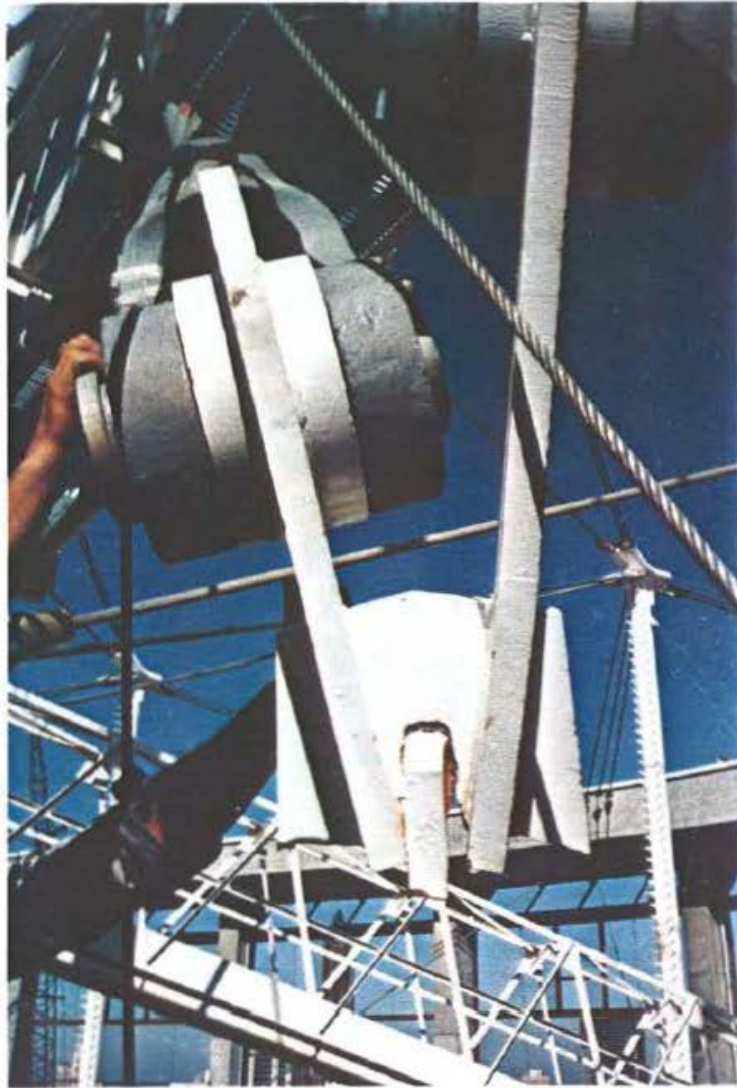
FIG.2.15

EAST PORTION OF THE FRACTURED PLATE

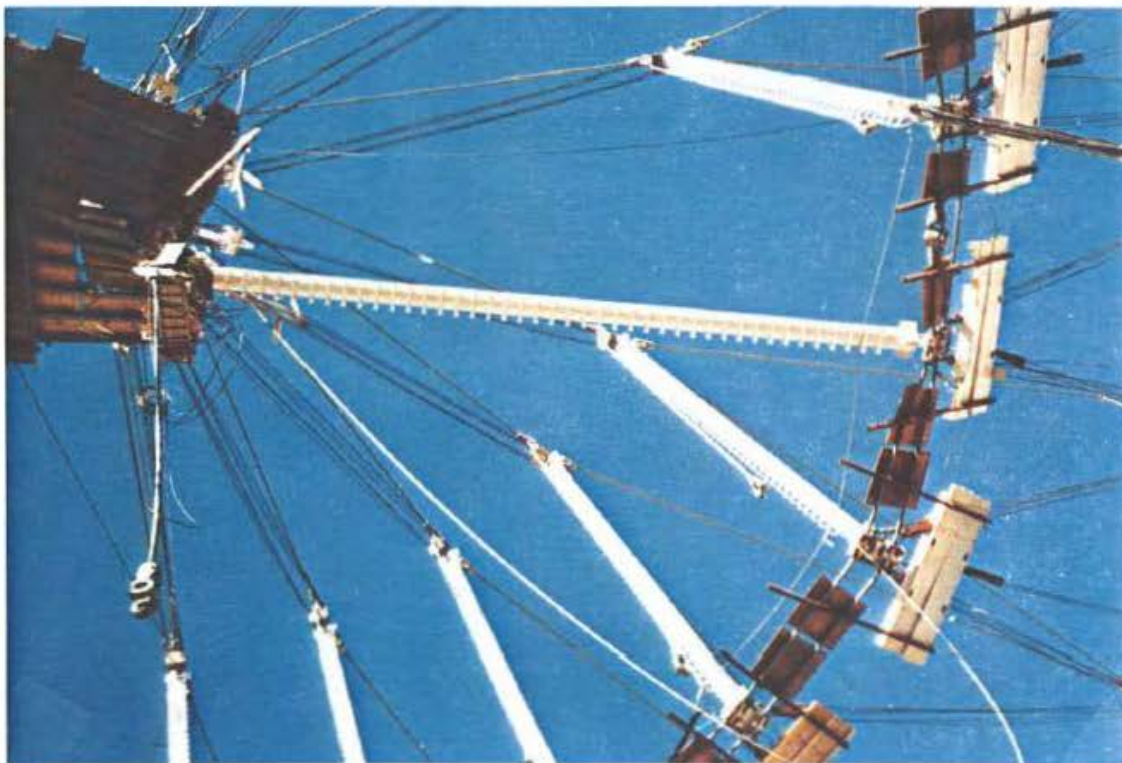
FIG. 2.16

higher force in the jacking cables caused the fracture of the top attachment of "PA" post at node 1308 location. Subsequent to the fracture of the plate, the post rotated towards the work platform and struck the platform.

POST PA IN THE ROTATED POSITION AFTER THE PLATE FRACTURE
POST HIT THE WORK PLATFORM AT THE LEFT SIDE

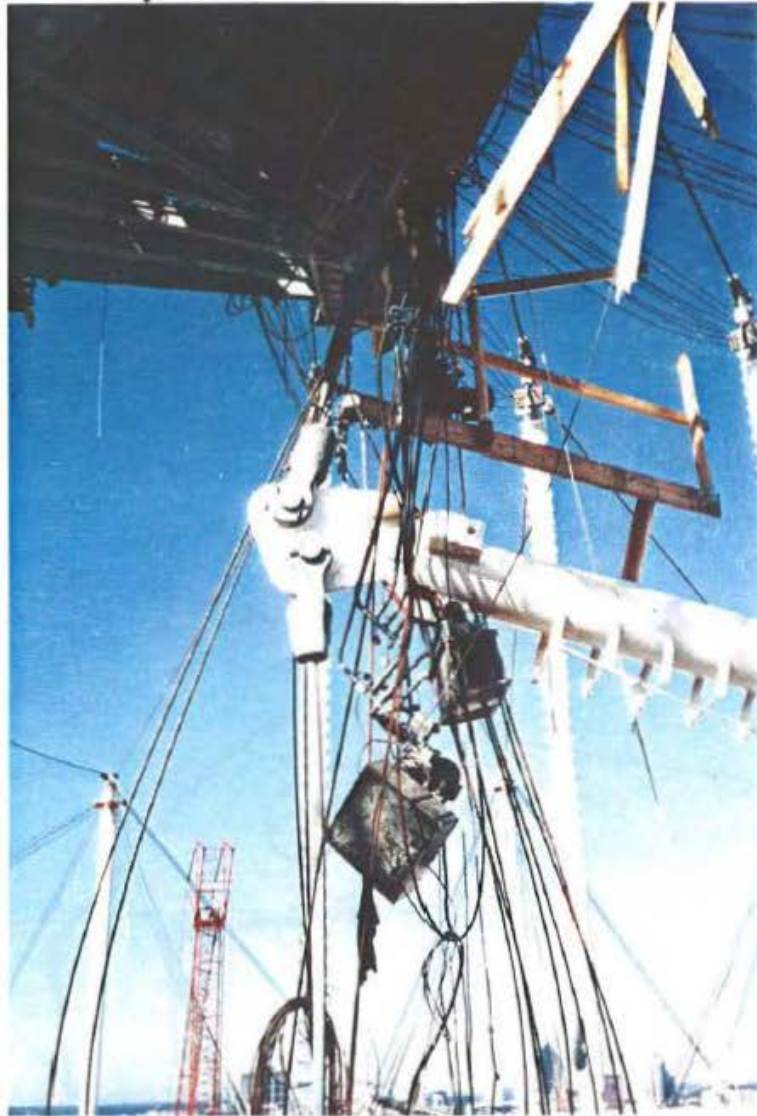
FIG. 2.17

POST PA AND THE WEST PORTION OF THE FRACTURED PLATE
ROTATED AFTER THE ACCIDENT

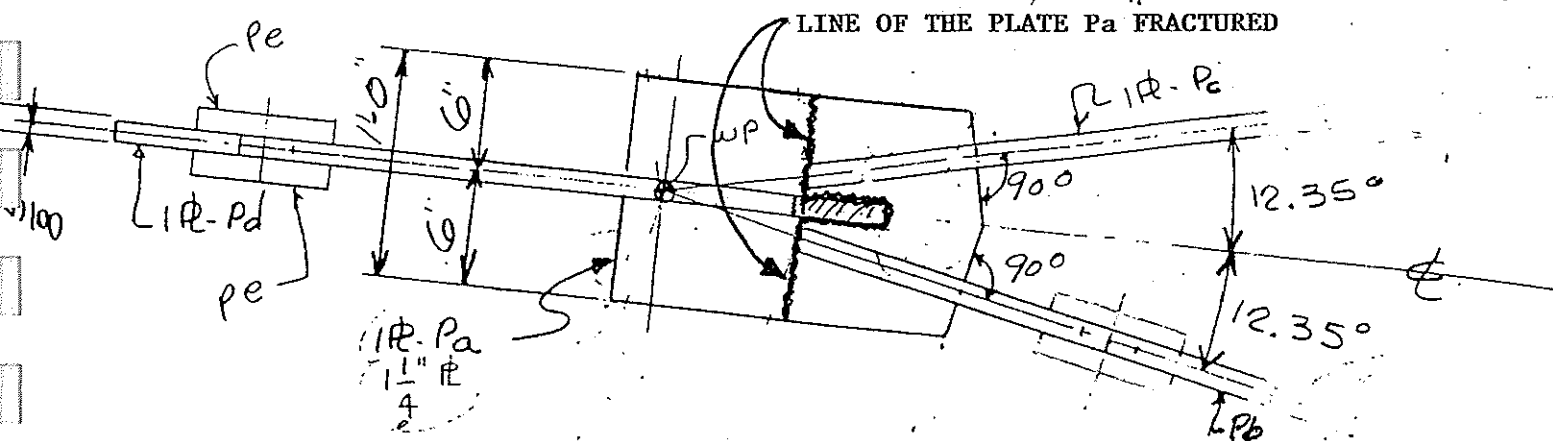
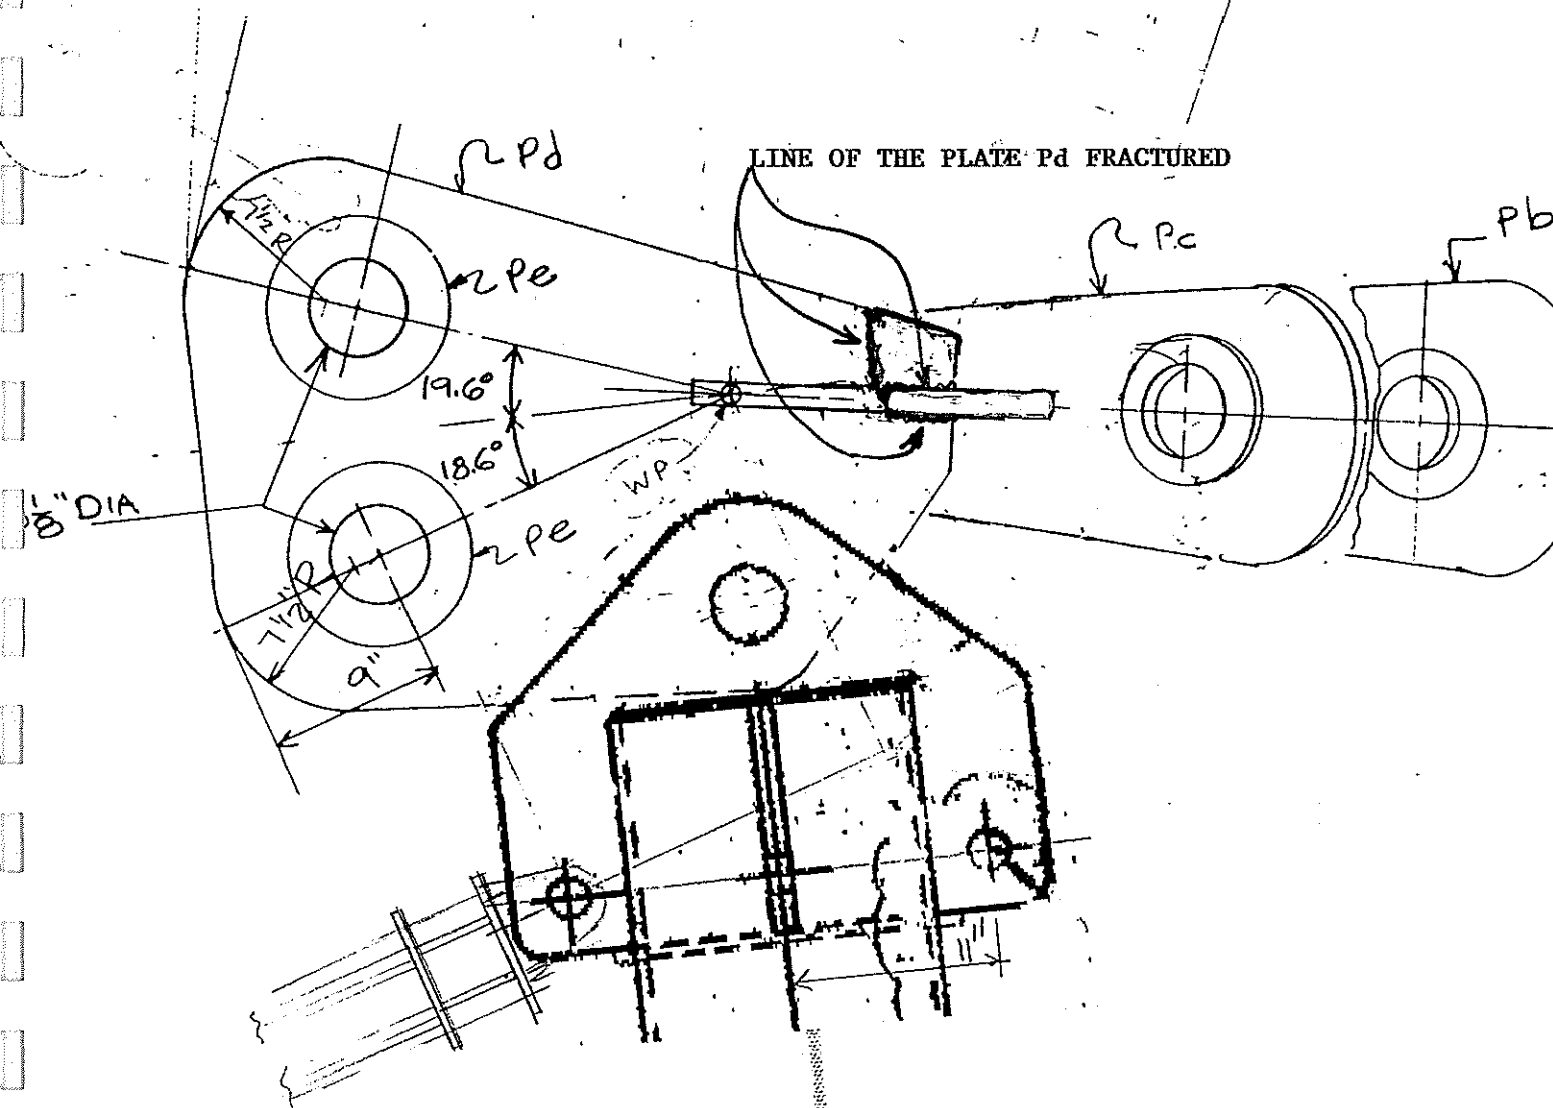
The top attachment plate which fractured is identified as TA-7 plate on the shop drawing. It is located at nodal point 1308 on the drawing prepared by the structural engineer of record. Figure 2.10 shows the elevation and plan of the plate assembly. The plate assembly is composed of four 1-1/4 inch thick steel plates identified as Pa, Pb, Pc and Pd. Plate Pd connects one ridge cable to the top and one diagonal cable to the bottom of the center truss end member. Plates Pc and Pd are the plates which connect the two cables from the top of post to the top of PB post of hoop "B" at nodes 1207 and 1208. The three plates Pd, Pc, and Pb are groove welded to a horizontal plate Pa, as shown in Figure 2.10. The assembly of all the four plates is then connected to the post top gusset plate with a 4 inch diameter bolt through a hole in the plate Pd, see Figs. 2.09 and 2.10. Fig. 2.09 also shows the temporary jacking strands connected to the top gusset plate of the post PA at the bracket with a 2" diameter high strength bolt. Plate Pa fractured along a horizontal plane adjacent to the end of plates Pb and Pc, plate Pd also fractured along a vertical plane at the end of plates Pb and Pc, and along a horizontal plane near the bottom side of the plate Pa, see Fig. 2.18 for fractured locations of the plate. Figures 2.12, 2.13, 2.14 and 2.15 are the east portion of the fractured plate TA-7. The west portion of the fractured plate was still attached to the top of the post in the rotated position, see. Figs. 2.16 and 2.17. Both portions of the fractured plate assembly were retrieved for examination by an independent testing laboratory by the construction managers.

ATTACHMENT PLATE TA-7 FRACTURED LOCATIONS

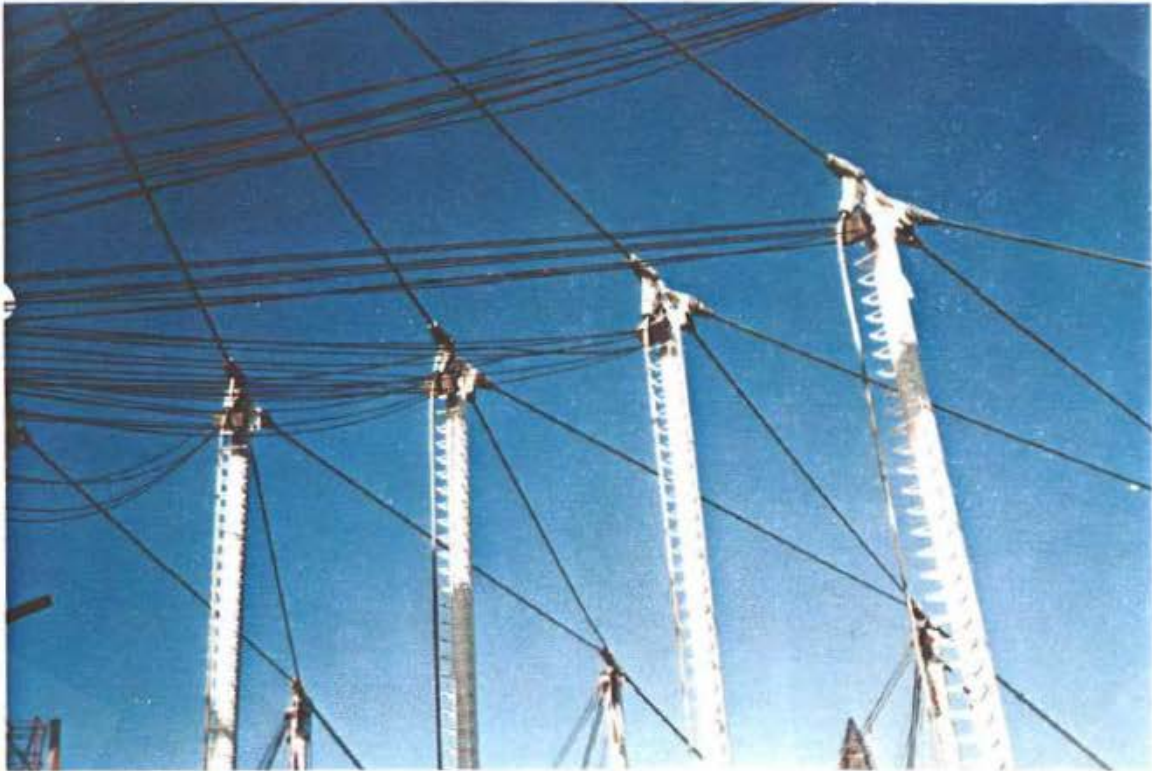
FIG. 6.02

TOP OF THE PA POSTS SHOWING THREE RIDGE CABLES,
STEEL POST, TEMPORARY JACKING STRANDS. THE
DIAGONAL CABLES WERE IN A SLACK POSITION.
