# Investigation of July 20, 1992 Offshore Drilling Accident, Massachusetts Bay, Massachusetts

U.S. Department of Labor  
Occupational Safety and Health Administration

December 1992

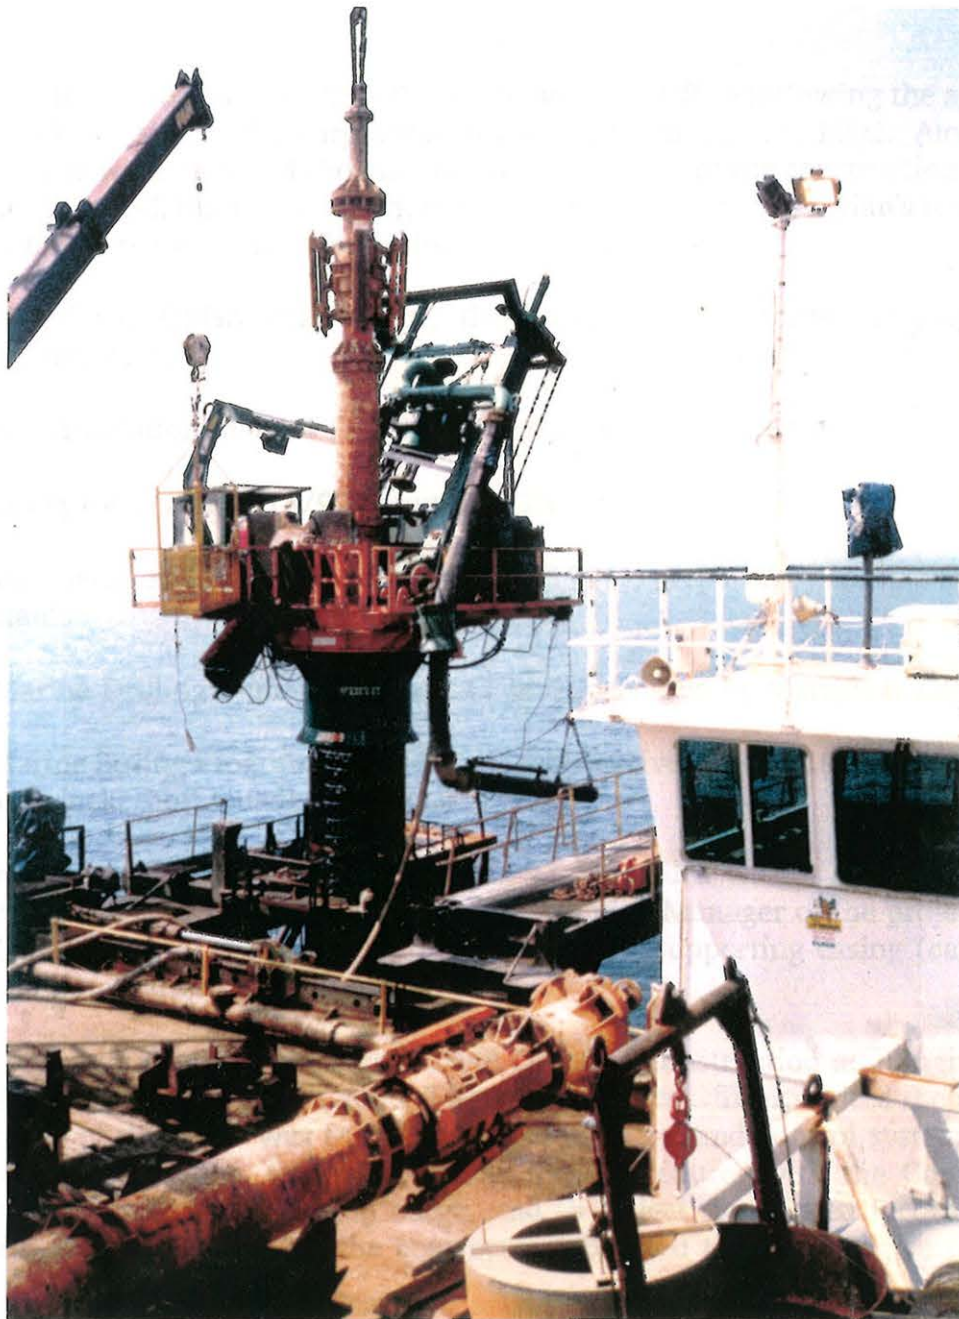
**Figure 1-3**

**A Close View of the Drill Unit.**

**(Note: This picture was taken within six hours after the accident the 90 feet long bottom hole assembly was still hung vertically from the crane through the center of the drill unit to the inside of the 68-inch diameter supporting casing.)**

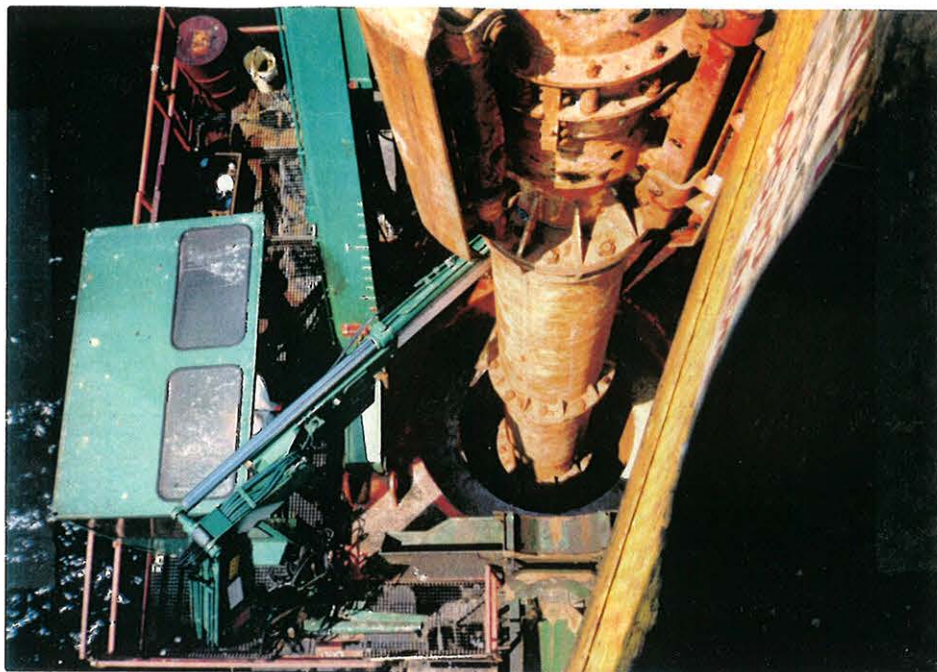
Figure 3-8

- o Picked up the BHA and lowered it into the casing A. (See Figure 3-8) When the BHA was entirely inside the casing A, the drill platform doors and its locks were closed to support the BHA.

A Downward View of the BHA Partially in the Casing A.

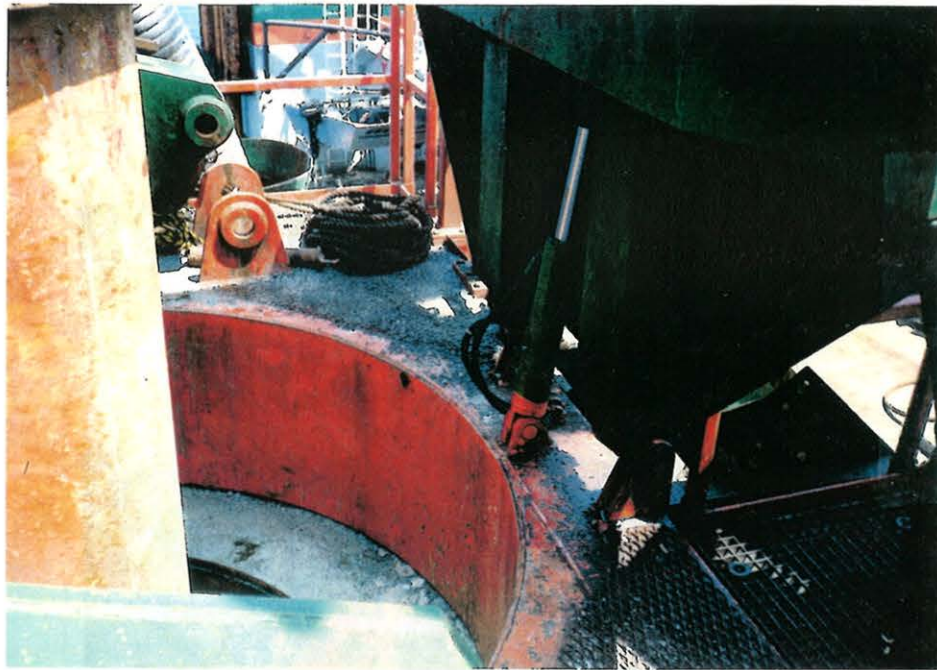
- o At this point, approximately at 6:30 am, as the total weight of the BHA was being released on top of the drill unit, a sudden drop of the casing A and the drill unit of approximately 25 feet occurred. At the same instance, the weight of the BHA was immediately supported again by the crane hoist lines thus keeping the BHA near stationary. Consequently, the drill platform doors were pushed upward by the wider part of the BHA below the doors. (See Figure 3-9). The hydraulic operating cylinders for the platform doors were destroyed. (See Figures 3-10 and 3-11)

Figure 3-10 Lower Side of the Platform Door with the Repaired Hydraulic Jack.

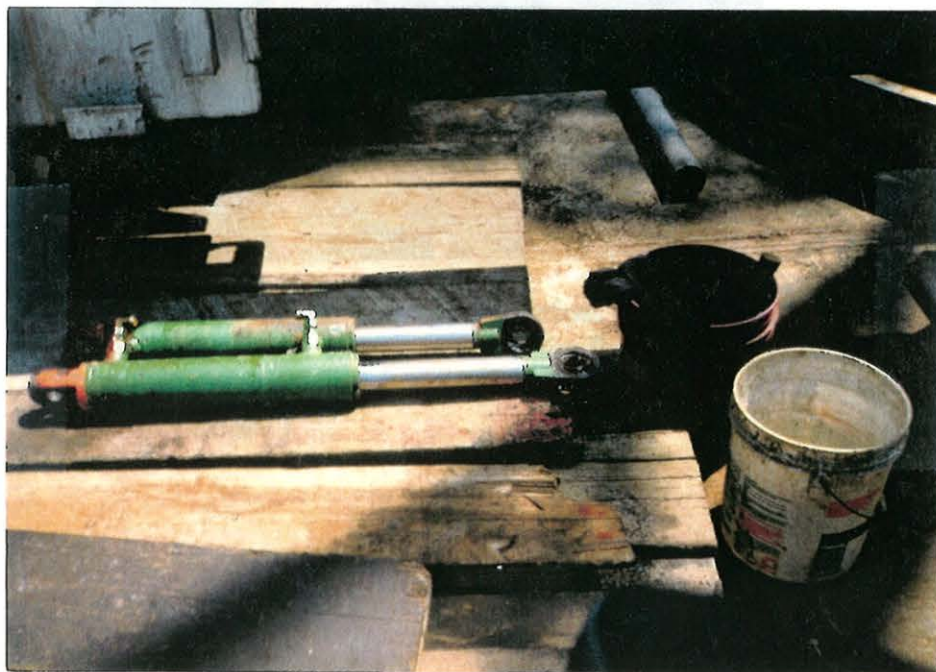
Figure 3-11 Two Damaged Hydraulic Jacks as a Result of the Accident.

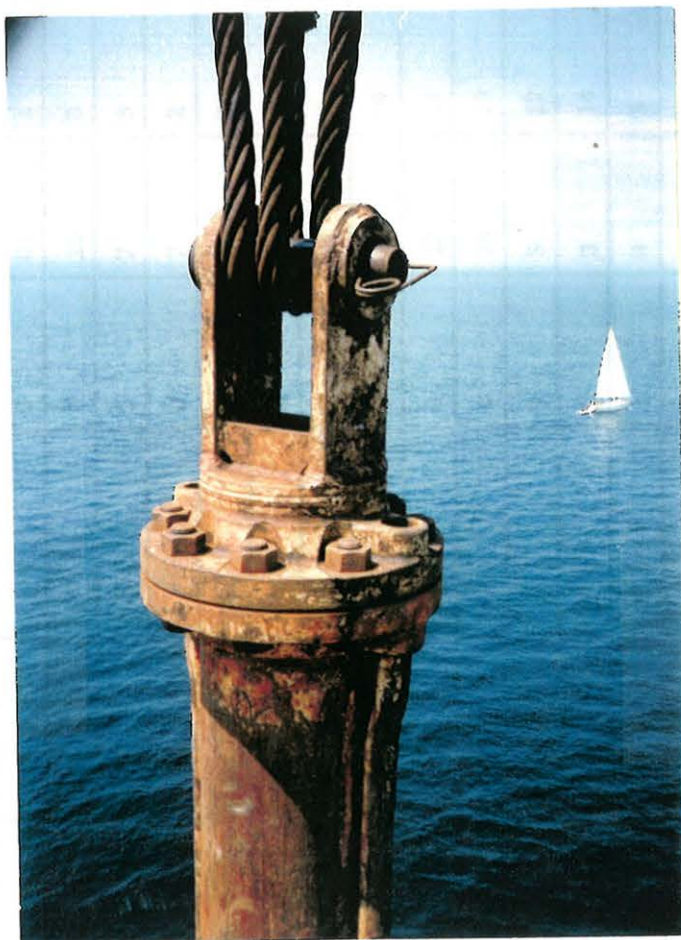
**Figure 3-12**

- o The drilling foreman and two drillers were positioned on the drill unit to operate the platform doors, close the locks, remove the bolts of the hoist flange (See Figure 3-12) of the BHA and to perform other activities.

**A Close View of the Hoist Connection.**

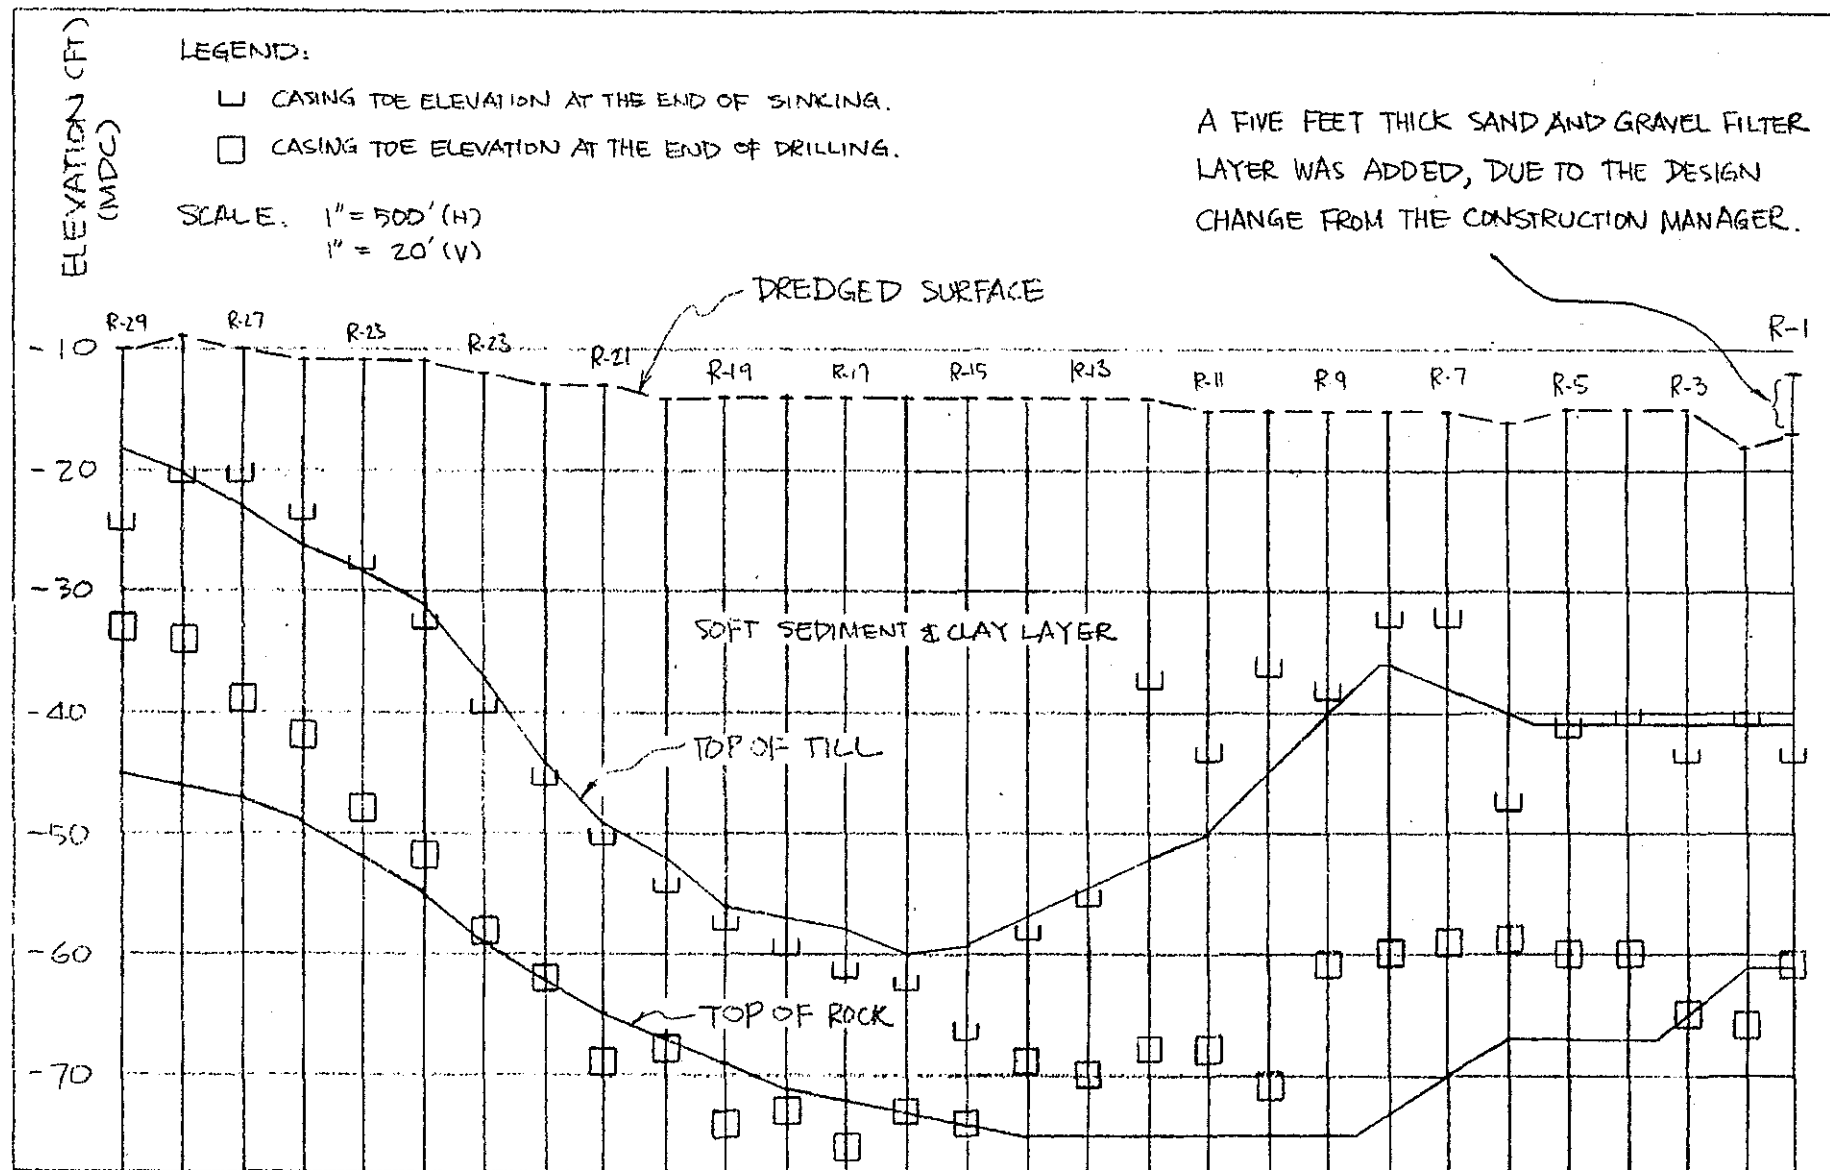
In order to identify the cause of the accident, all the settlement data relating to the casing A were tabulated in Tables 4-1 through 4-3. In addition, Figures 4-1 and 4-2 presented the correlation between the geological profile and the casing toe evaluation at different stages. Based on the review of the above information, OSHA arrived at the following findings:

- (1) The damage of the casing A from driving was due to the hard driving (5 blow/in) of this casing in the till layer.
- (2) It appeared that no such damage would occur, if limited driving (1 blow/in) of this casing in the till layer would take place.
- (3) There was no information to demonstrate that the casing would be damaged from driving in the soft sediment and clay layer.
- (4) Under the weight of the casing, the drill unit and the BHA, the sinking depth of the casing A was approximately equal to the entire thickness of the soft sediment and clay layer.
- (5) The geotechnical information contained in the contract documents closely reflected the existing site conditions and should have been sufficient to properly install casing A.

Figure 4-1 Correlation of the Casing Toe Elevation in Different Stages with Geological Profile.

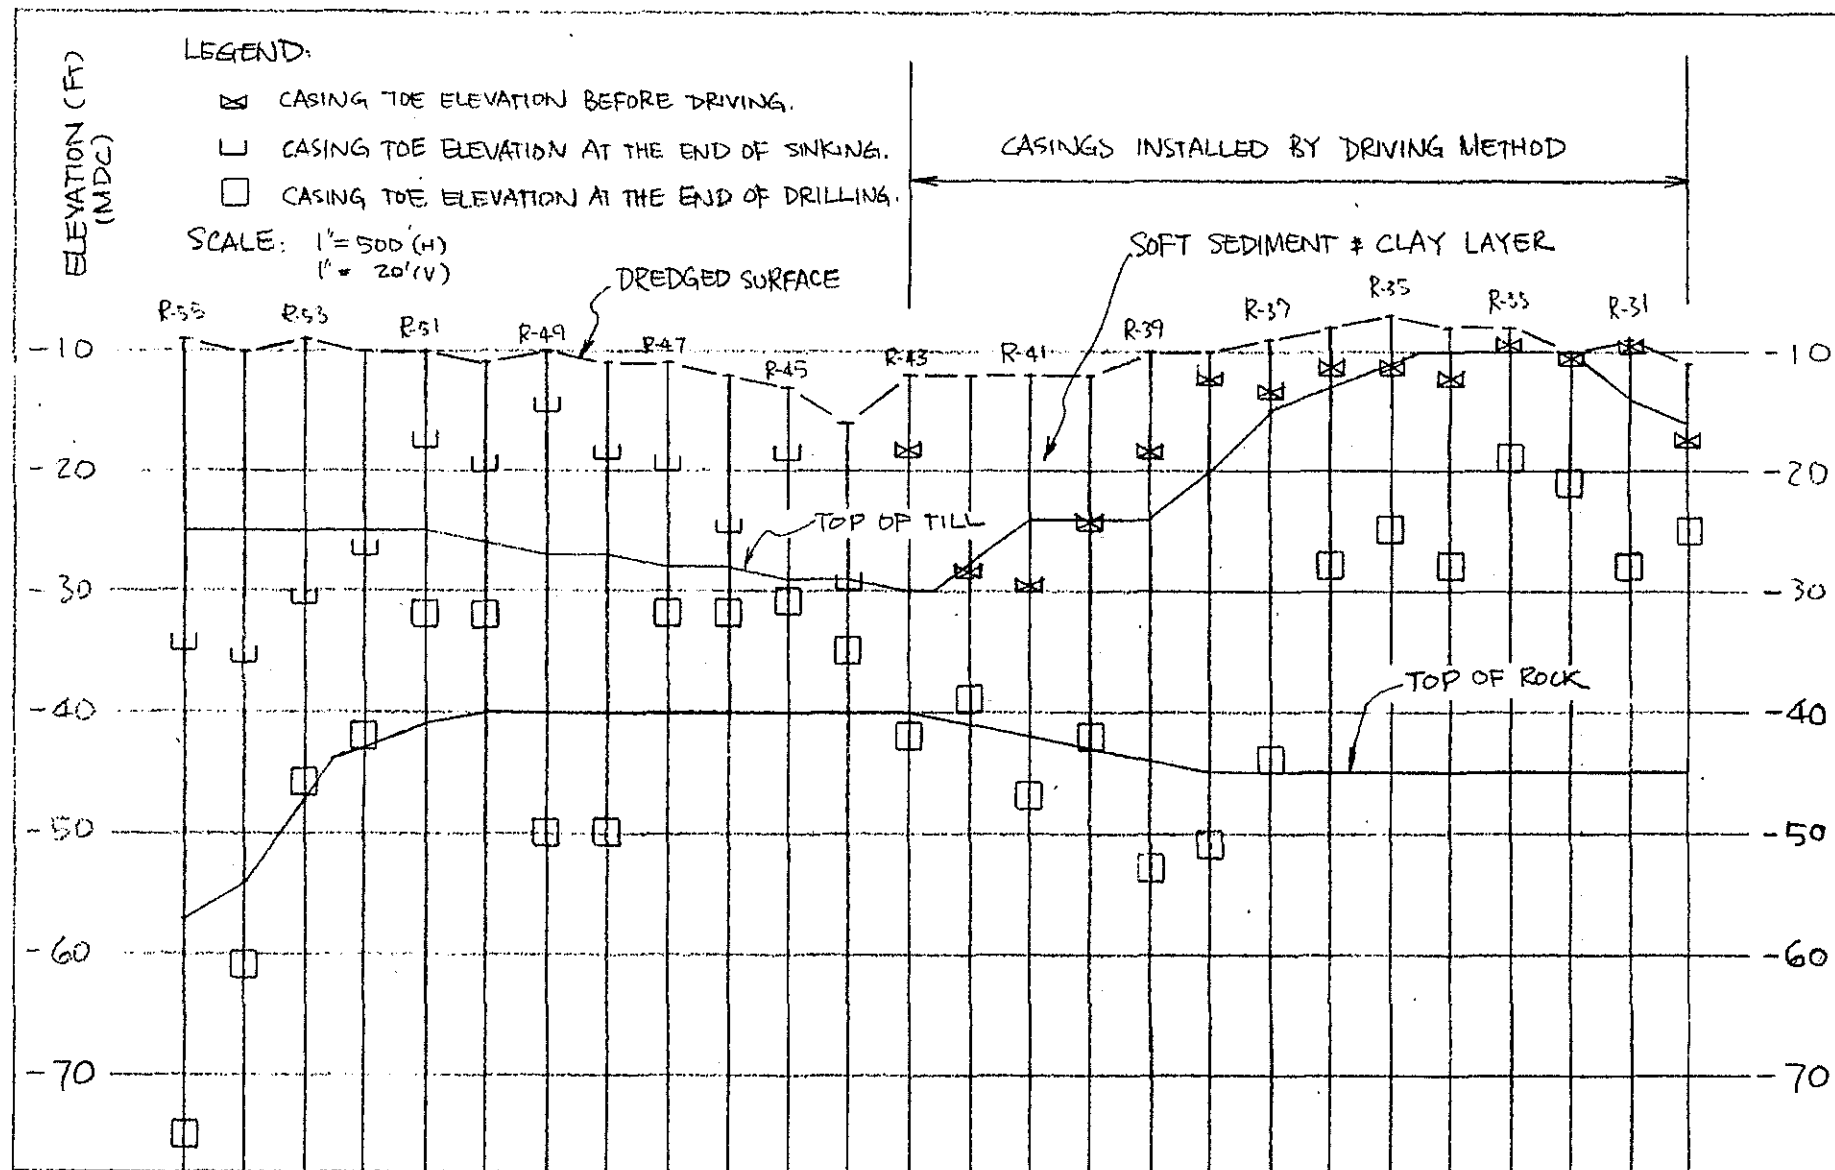
Figure 4-2 Correlation of the Casing Toe Elevation in Different Stages with Geological Profile.

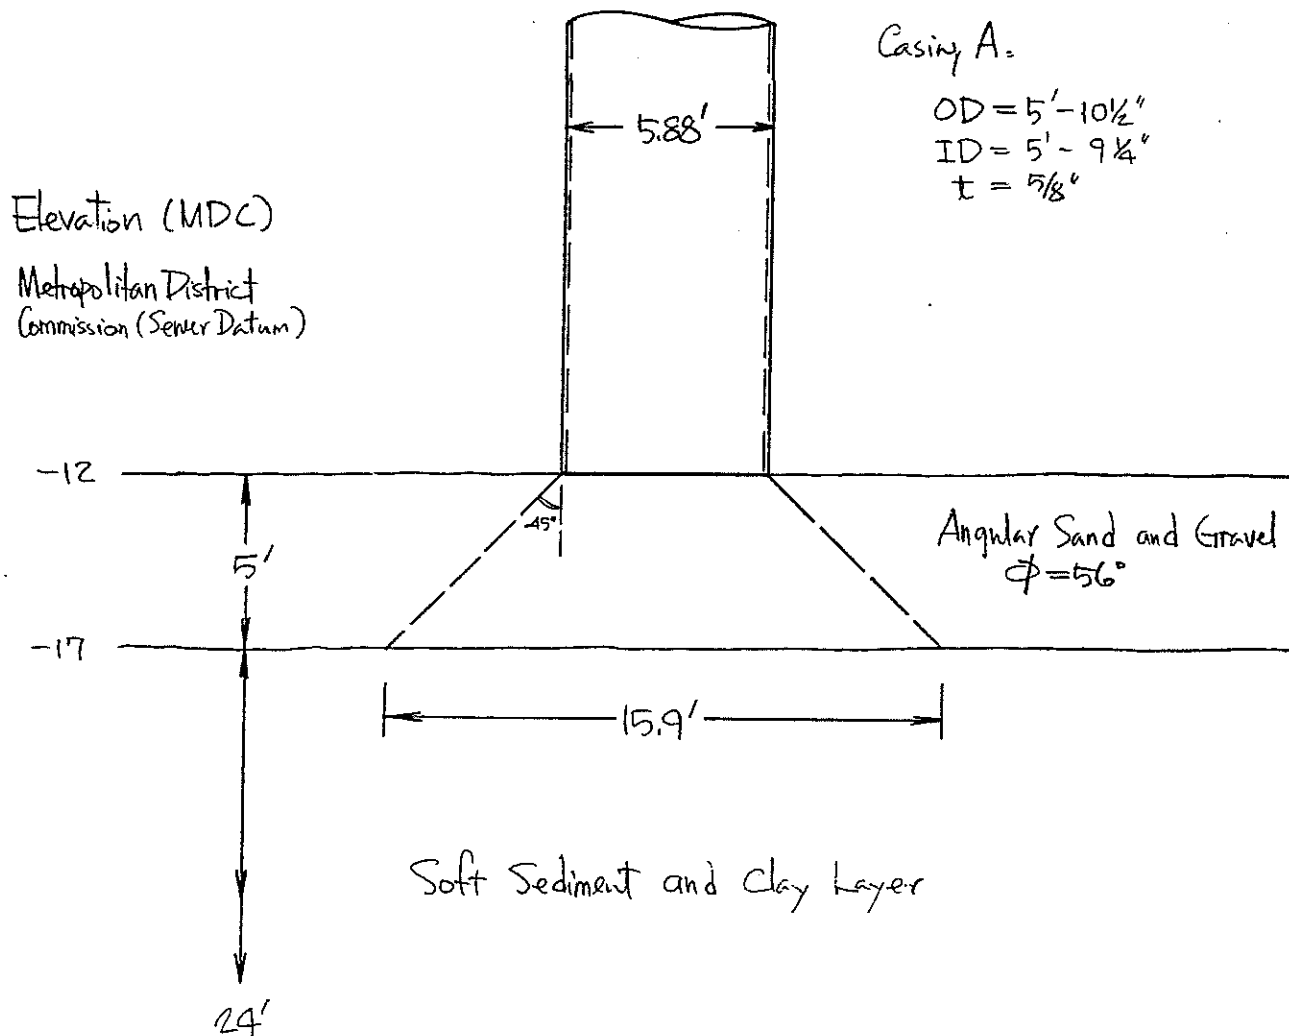
Figure A-1 Simplified Soil Profile near the Toe of the Casing A.

As the casing A penetrated through the angular sand and gravel layer, this granular material lost all the confinement due to the dilation effect. This material lost all its frictional characteristics. Consequently, the casing A lost all its bearing area except over its cross-sectional area. Thus, the ultimate bearing capacity in this condition is:

- o When the 85 ton load of the casing A and the drill unit was imposed on the backfill layer, the system did not fail because the ultimate capacity of the soft sediment layer, computed to be 127 tons, was higher than the imposed load.

- o When the bottom hole assembly was added to the system, the total weight was increased to 161 tons, greater than the ultimate bearing capacity of the soft sediment layer. The soft sediment layer, therefore, failed first following which the granular backfill lost all its confinement and its internal friction. Then, the casing A penetrated through the granular backfill losing most of its bearing area. The bearing capacity was reduced from 127 tons to 0.64 ton. Even with the weight of the bottom hole assembly supported by the crane after the initiation of the sudden drop of the casings, the casing A had to penetrate a total of 30 feet to develop adequate skin friction from the clay to balance the 81 ton load.
