# Investigation of the April 14, 2021, Collapse of a Bridge Span under Demolition, Herbert C. Bonner Bridge, Dare County, NC

U.S. Department of Labor  
Occupational Safety and Health Administration  
Directorate of Construction

December 2021

Report prepared by  
Alan Lu, Ph.D., P.E.  
Office of Engineering Services  
Directorate of Construction

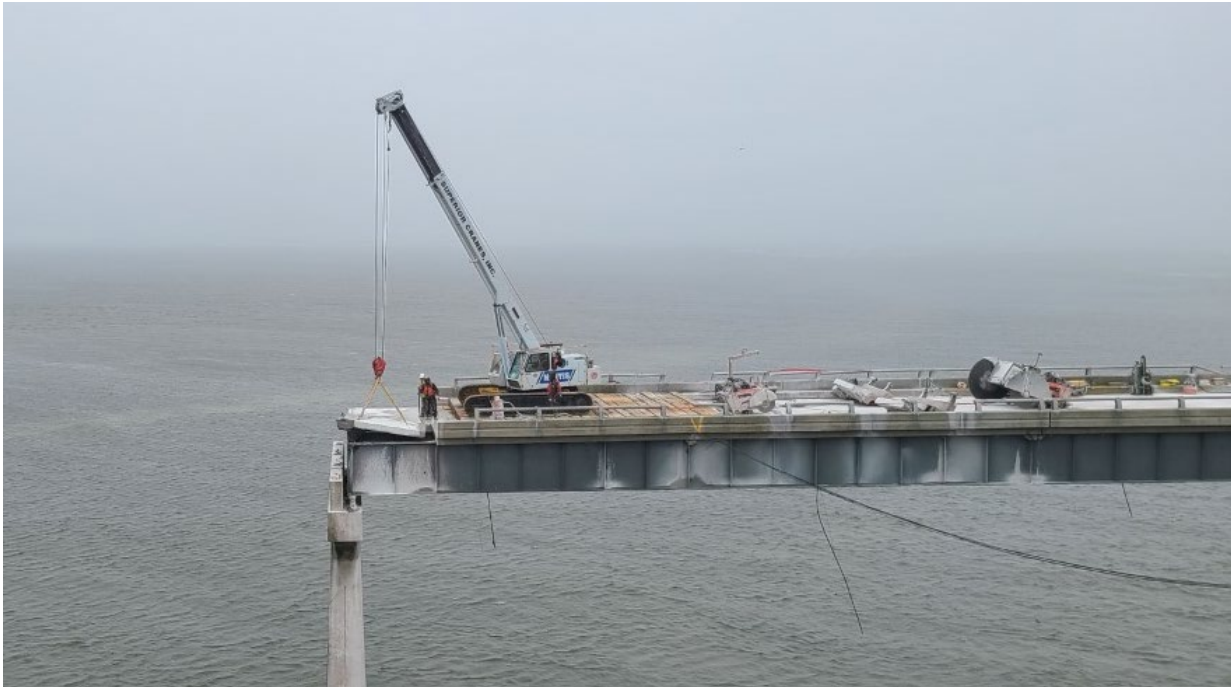
Figure 12 – Demolition of Span 144  
(photographed on 2/15/2021 by NCDOT)

February 15, 2021, PCL began saw cutting and removing concrete panels in Span 144 (see Figure 12, a photograph taken by NCDOT on 2/15/2021). PCL did not follow KCI's demolition plan from the initial of the demolition in that:

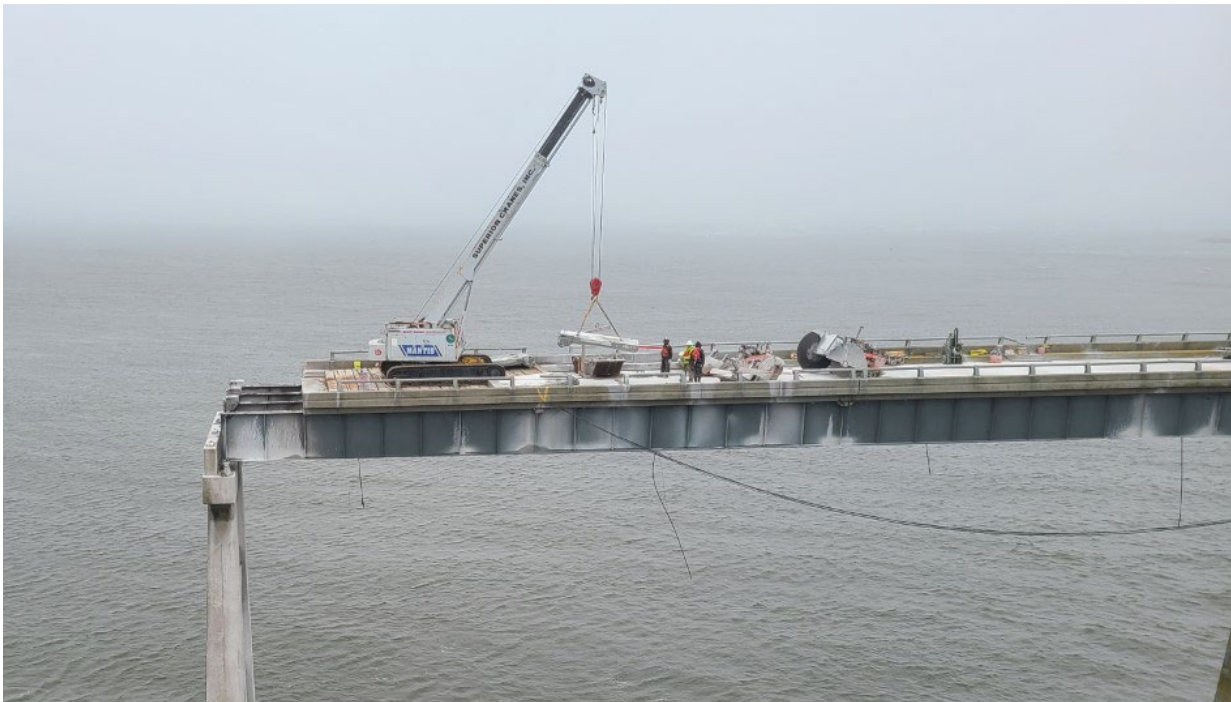
Figure 13 – Demolition of Span 144  
(photographed on 2/15/2021 by NCDOT)

1. PCL removed the center bay of the bridge deck immediately after removing the deck overhang and parapet sections in the same area. In contrast, KCI's demolition plan specified that the center bay of the bridge deck in a span could only be removed after all deck overhang and parapet sections within that span were removed.
2. PCL placed the removed sections of concrete on the deck behind the crane until they were placed on the barge (see Figures 13 and 14)

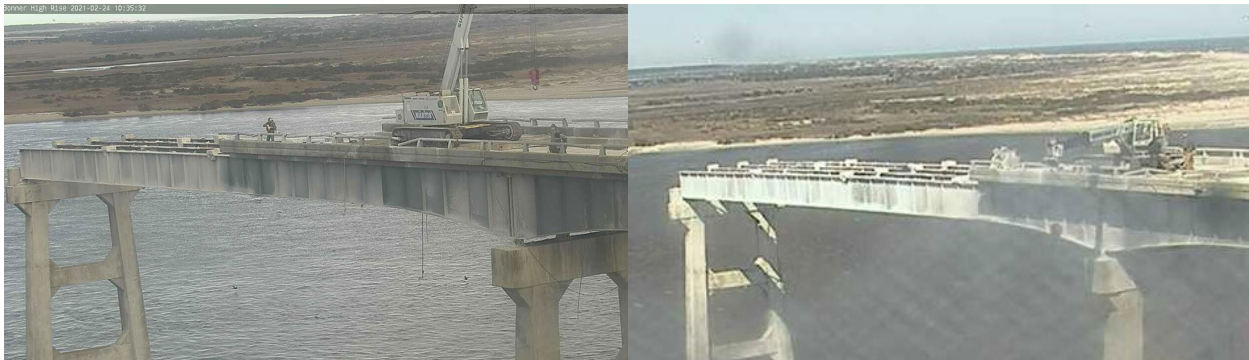
Figure 15 – Demolition of Span 144  
(photographed by NCDOT)

After examining the demolition progress photographs taken by NCDOT on February 24 and 25, 2021 (see Figure 15), OSHA found that PCL did not stop stacking concrete debris on the deck while they were coordinating the plan changes with KCI.

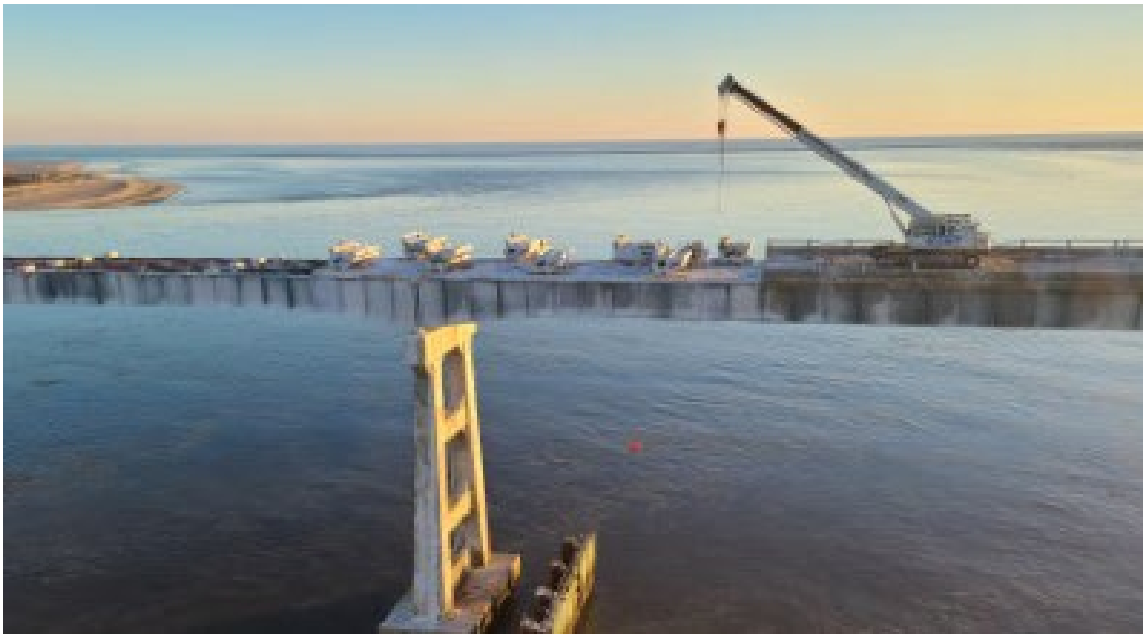
Figure 17 – Demolition of Span 145  
(photographed on 3/4/2021 by NCDOT)

March 2, 2021, PCL began cutting the concrete deck in Span 145 (see Figure 16). PCL stockpiled deck overhang and parapet segments on Span 145 (see Figures 17 and 18). PCL did not follow KCI’s demolition plan, nor the supplemental memorandum dated February 25, 2021.

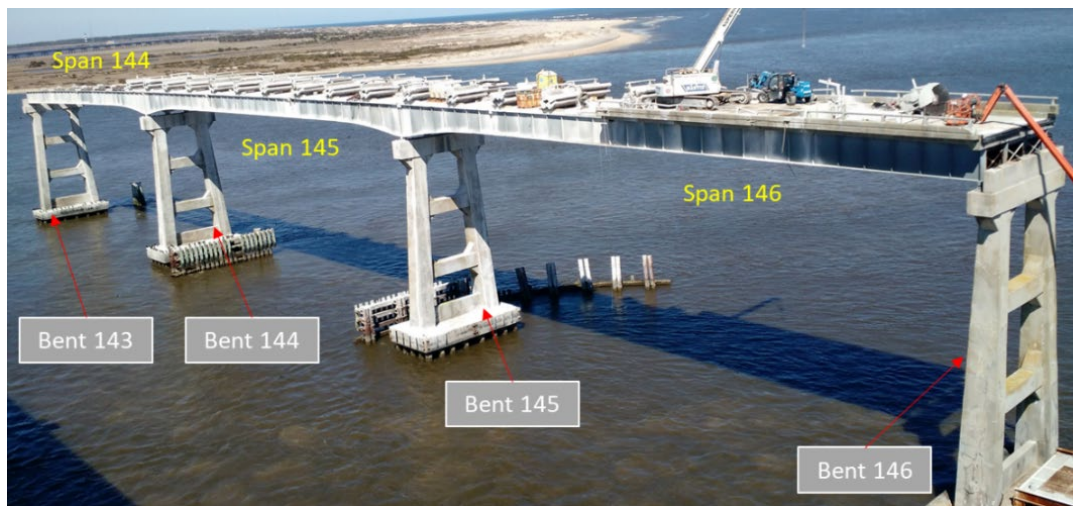
Figure 20 – Three steel girder spans under demolition – Looking north  
(photographed on 3/11/2021 by NCDOT)

March 10, 2021, PCL developed a plan for stacking deck overhang and parapet segments on Span 146 (see Figure 19). Figure 20 illustrates that PCL placed all overhang and parapet segments on Spans 145 and 146.

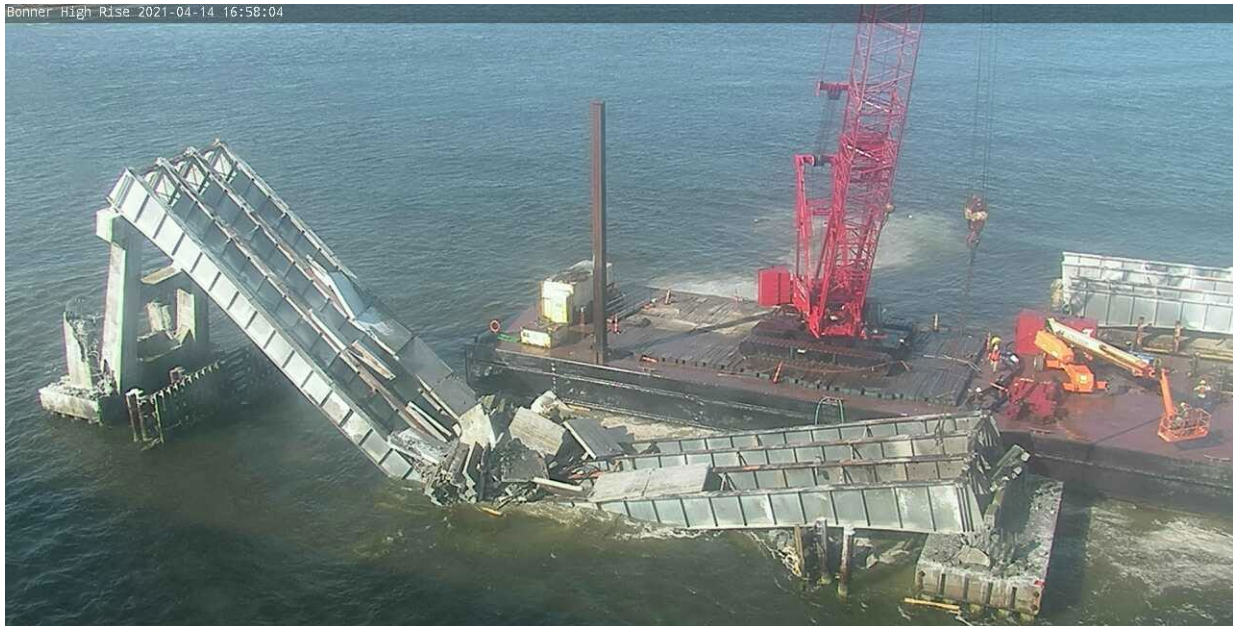
Figure 26 – Collapsed steel girders in Span 145  
(photographed on 4/14/2021 by NCDOT)

Figure 26 shows the condition and failure pattern of the girders in Span 145 after the collapse. The girders formed a “V” shape at failure, with concrete deck and parapet segments on top at the mid-span region, indicating a significant amount of bending took place in the middle of the span. Bent 145 crumbled completely, leaving the south ends of the girders resting on the footing (see Figure 27). The two columns of Bent 144 fractured at the construction joint approximately 18' above the waterline and dropped onto the footing (see Figure 28). The north ends of the girders remained attached to the cap of Bent 144 after the collapse occurred. All girder bearings were still attached to the bottom flanges of the four girders after the incident (see Figure 29).

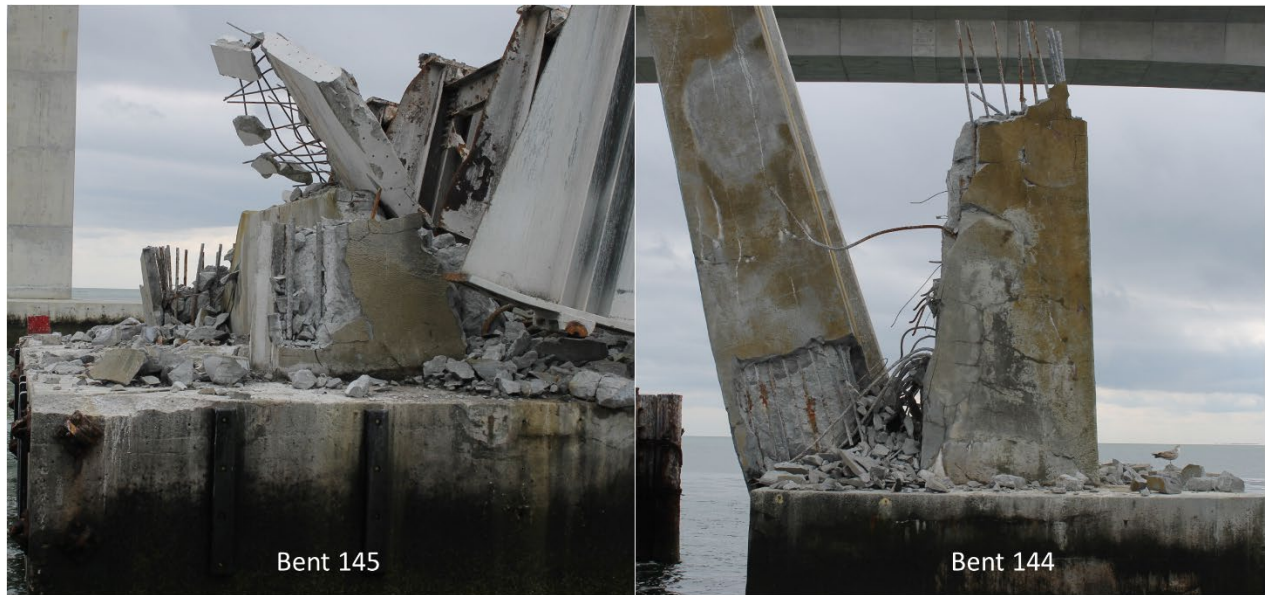
Figure 30 – Collapsed Bent 144/145

OSHA observed during its field investigations severe reinforcement corrosion and corresponding concrete deterioration, including scaling, delamination, spalling and cracking of the concrete in

the reinforced concrete columns of Bents 144 and 145 (see Figure 30). Photographs of Bents 144 and 145 taken before the demolition revealed signs of steel reinforcement corrosion and concrete spalling, i.e., concrete surface cracking, rust staining, and concrete plating (see Figure 31). The concrete deterioration is mainly due to the aggressive exposure conditions for these concrete structures in the marine environment. The structural integrity of the bridge bents might have been compromised before the incident.

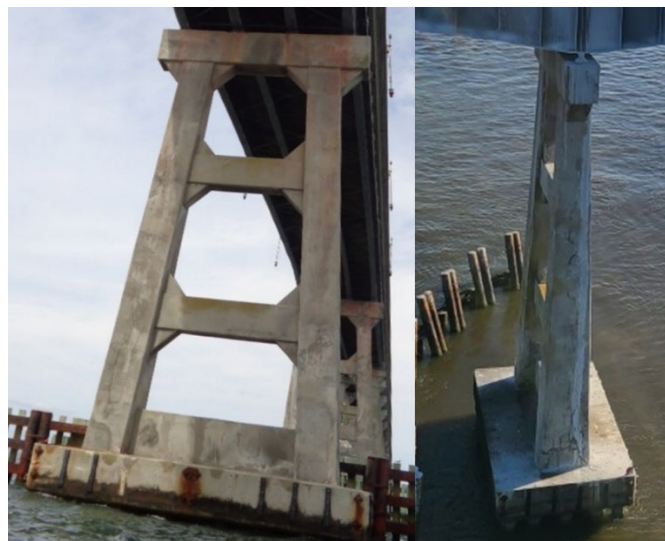
Figure 31 – Concrete deterioration

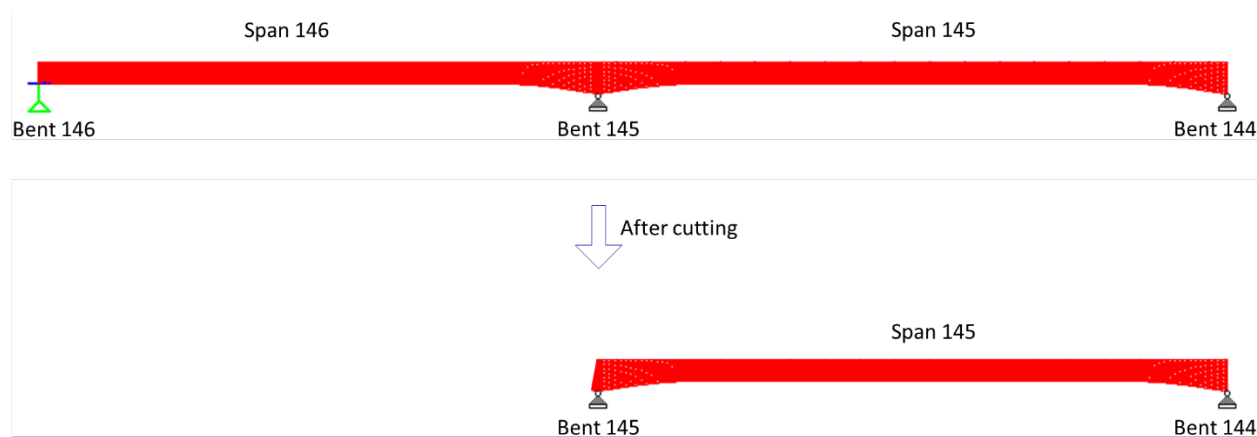
Figure 36 – Plate girders before and after cutting

On the day of the incident, before PCL cut the four plate girders in Spans 145 and 146 at Bent 145, these girders were 2-span continuous girders, extending over three supports at Bents 144 to 146 (see Figure 36). Once PCL cut the four girders at Bent 145, the girders remaining in Span 145 became simply supported girders with a much less load-carrying capacity than the 2-span continuous girders before cutting. Our FE analyses confirmed that the maximum Von Mises stress in the girders in Span 145 due to the imposed loads exceeded the yield stress of the A-373 steel, indicating that yielding of steel at some point in these girders occurred when the incident happened.

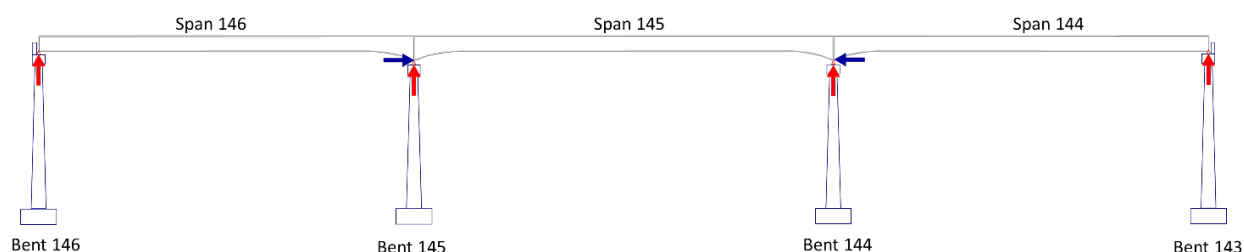
Figure 37 – Support reactions at Bent 144/145.<sup>14</sup>

Because the supports at both ends of the girders in Span 145 were pin supports, which allowed rotation but prohibited vertical and horizontal displacement, the bottom flanges of the girders were prohibited from extending when subject to tension caused by positive moment.<sup>13</sup> This restraint of the bottom flange extension resulted in substantial horizontal reactions at the pin supports on top of the two interior bents (blue arrows in Figure 37). As a result, the columns of Bents 144 and 145 were subjected to axial and transverse loads and bending moment.

OSHA’s analysis indicated that the weight of the steel and concrete in Span 145 overloaded Bents 144 and 145 at the time of the incident.
