Investigation of the August 5, 2002, Collapse of Tilt-Up Precast Concrete Wall Panel In Greensboro, NC

U.S. Department of Labor
Occupational Safety and Health Administration
Directorate of Construction

September 2002

Report prepared by
Mohammad Ayub, PE
Dinesh Shah, PE

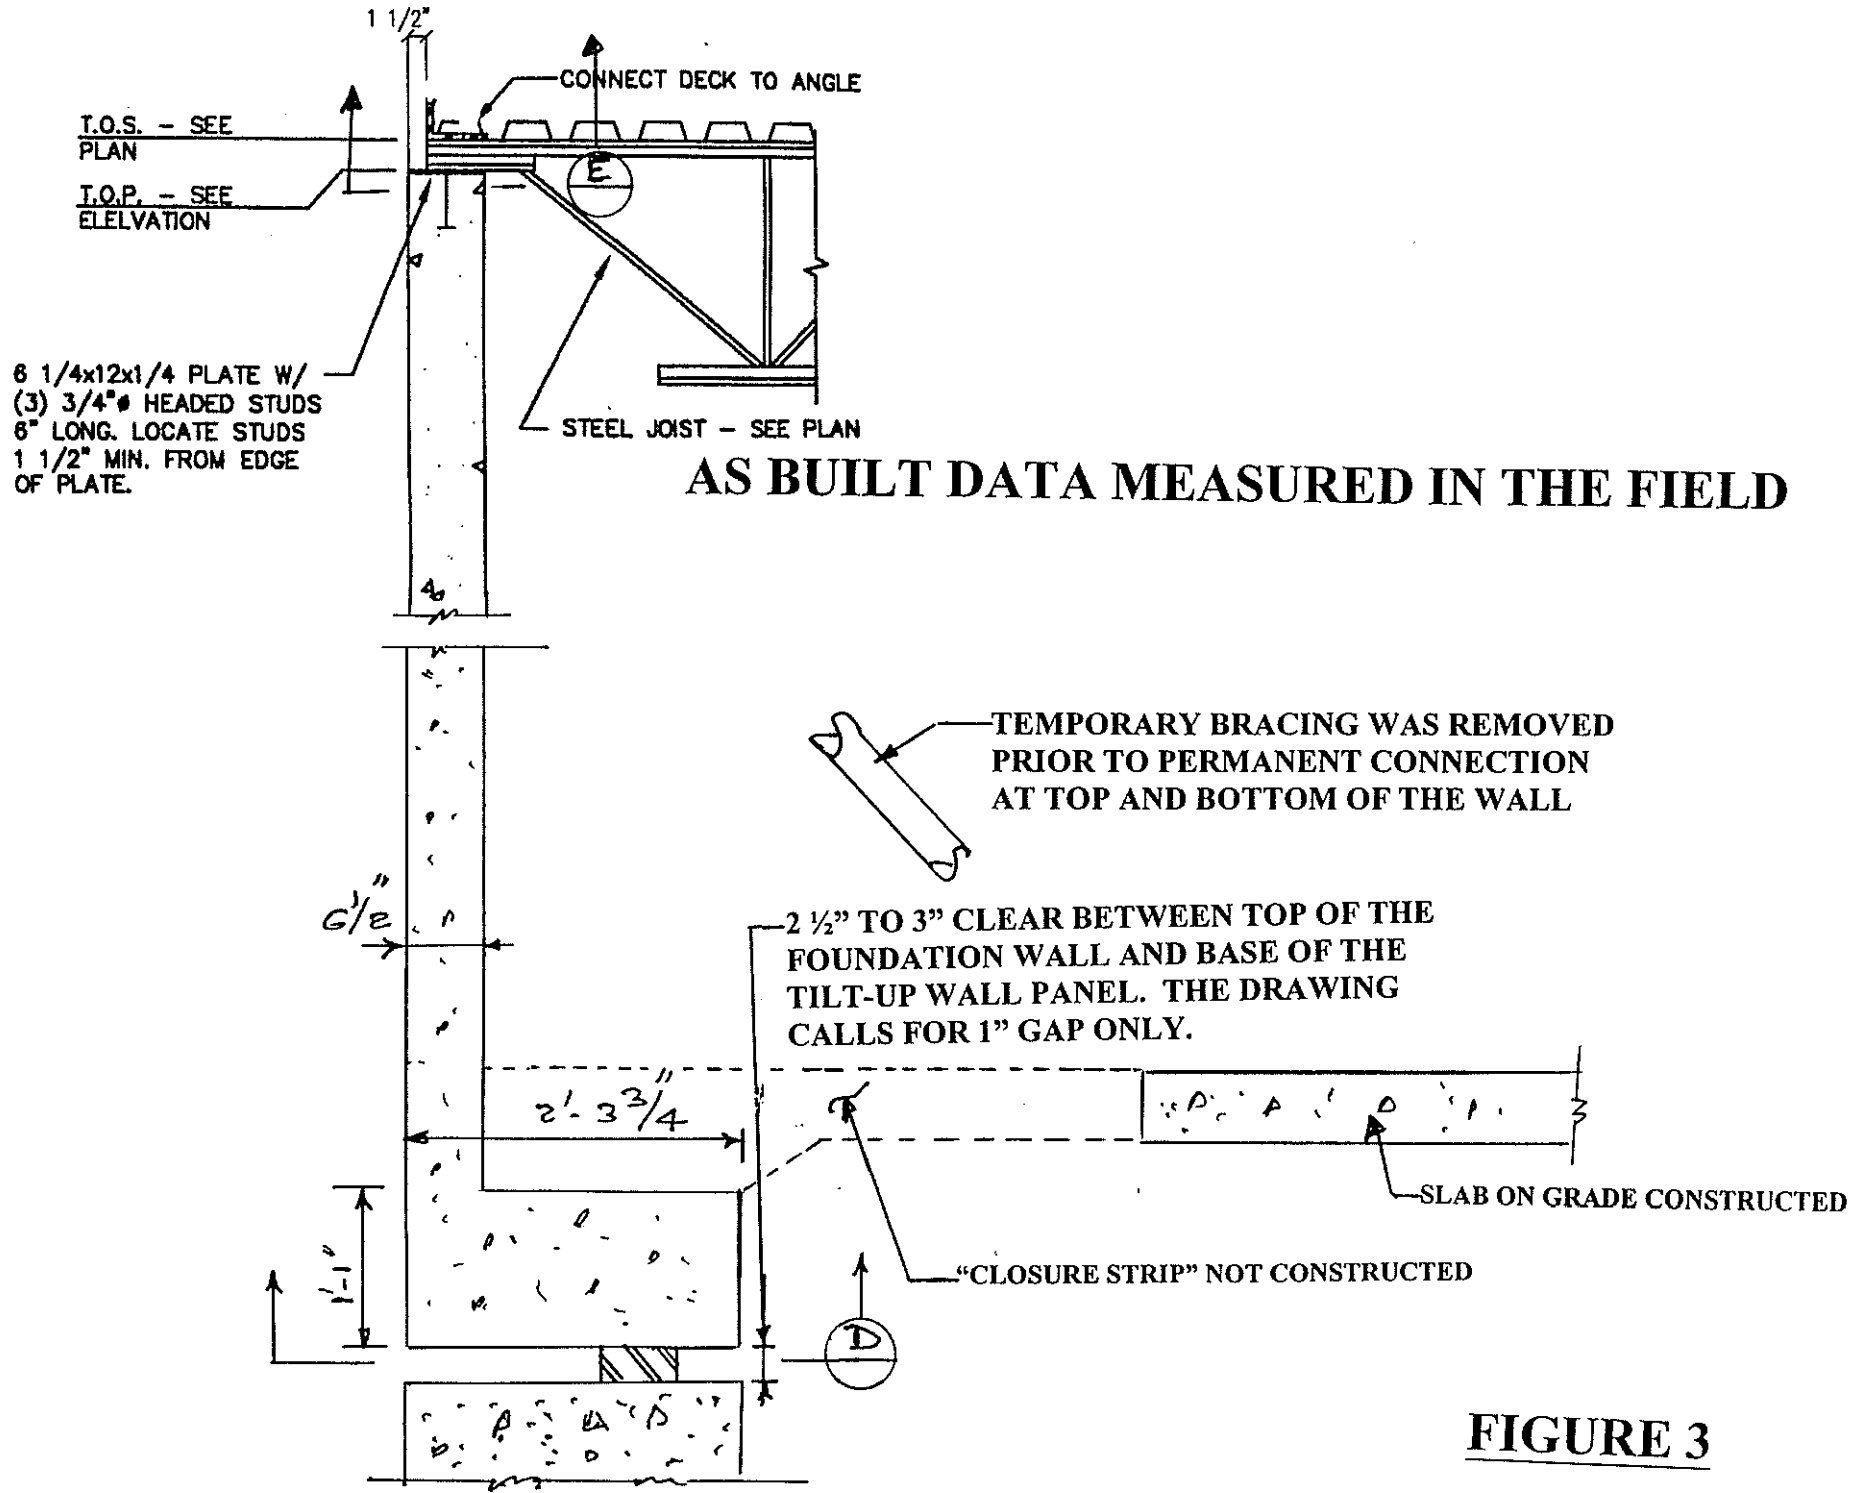
FIGURE 3

The wall fell on the west side. It was saw cut in two pieces of 18'-1" and 4'-11" during the rescue phase. The wall measured 19'-7 5/8" in width and 23' in height. The thickness was measured to be 6 1/2". See attached field measurements and shop drawing of the panel (figures 3, 4, & 5). No discrepancy was noted in the fabrication of the panel. The embed plates were measured to be 6 1/2" x 12" x 1/4", as called out on the contract drawings.

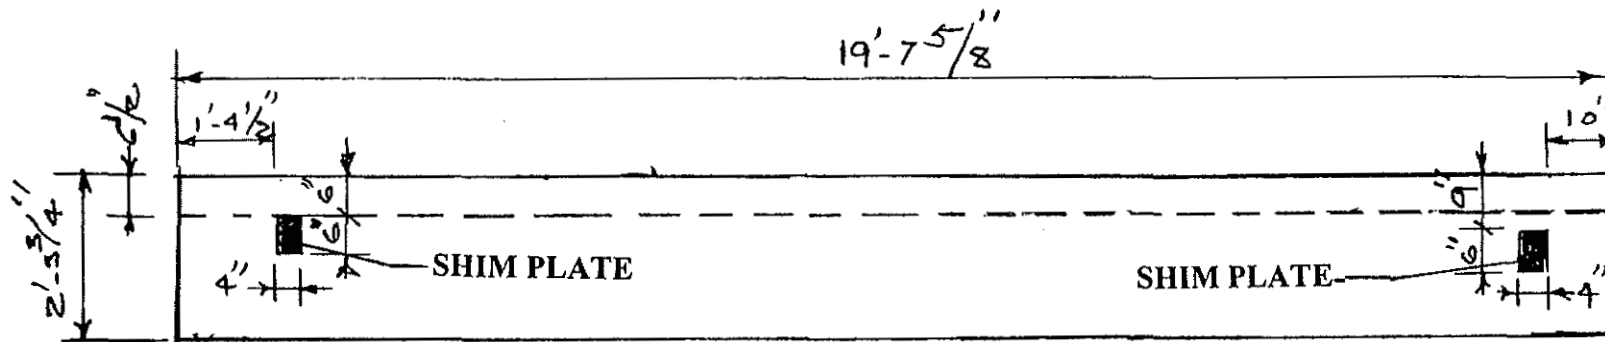
FIGURE 4

The three embed plates (figure 4, section E) were examined to determine whether or not any welding was done. The north embed plate shows a 1/2" long tack weld on the north side and a 1 1/2" long weld in the north-south direction. Please note that the welds were to be made in the east-west direction along the seat of the joist. The middle embed plate did not exhibit any weld.

The south embed plate showed a weld in the east-west direction but only on one side, i.e., on the south side. This weld did not indicate any failure. In addition, there was a deposit of weld at a corner of the plate, which was away from the bearing of the joist (figure 4, section E).

SECTION D (SHIM PLATE LOCATION AT BOTTOM OF TILT-UP PANEL)

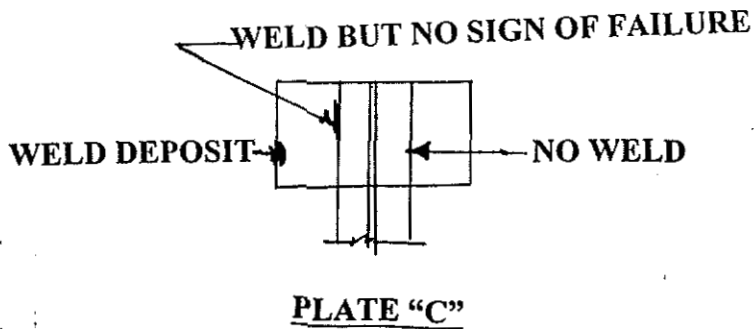
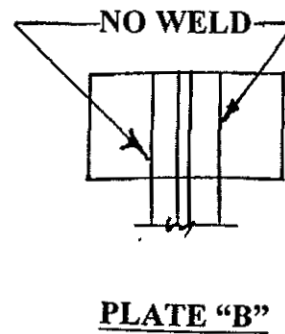
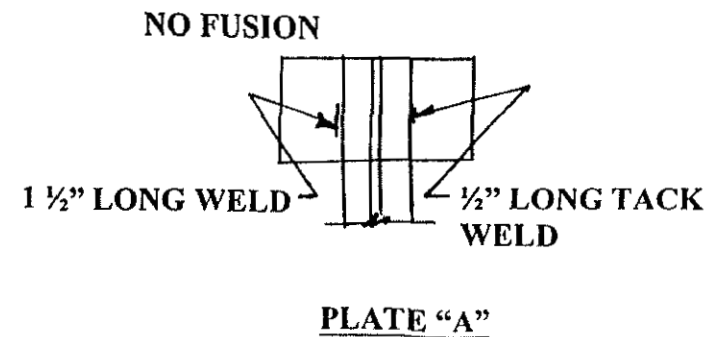
SECTION E (1/4" THK EMBED PLATE LOCATION AT TOP OF TILT-UP PANEL)

The three corresponding joist bearings were then examined. The joist bearing on the north end of the wall did not exhibit any significant remnant of the weld. It is therefore concluded that the tack weld seen on the north embed plate had no structural significance. The middle joist bearing angles were void of any welds. This observation corresponded with the findings of the middle embed plate. The south joist indicated that the north end of the bearing angles was welded. The south end of the bearing was observed to be clean. It is interesting to note that the south embed plate indicated welds on the south side where as the joist bearing angles showed welds on the north side. It is believed that the welder had at one time welded the joist at a location corresponding to the welds on the embed plate but later “burned” them. It appears that the joist bearing was later moved a few inches, and the welding at the new location was not completed.
