# Case Study Student Activity Answer Key

Case: 02WV040-01

## Logger in Training Dies After Being Struck by a Previously Felled Tree Which Rolled off of a Bank in West Virginia

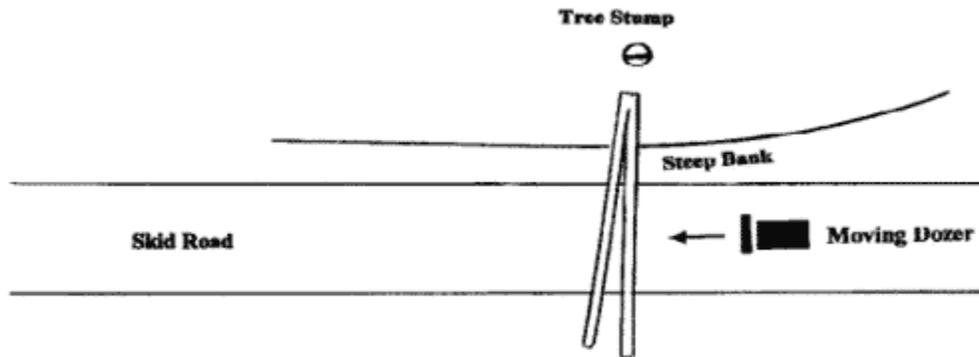
**Figure 1. This illustrates the tree's position as felled and topped.  
Note the segments are still attached at the base.  
Dozer is about to attempt to push the tree off the bank and road as one unit.**

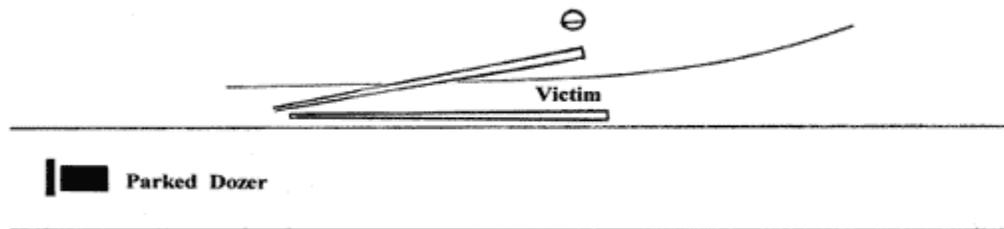
Discussion: In this incident, the dozer operator created the hazard when he attempted to push the tree segments off of the road. Upon clearing the road, the operator left one tree segment in the unsafe elevated position and continued further down the road to access other work. CFR 1910.266 d(6)(i) requires that employees shall be spaced and the duties of each employee shall be organized so the actions of one employee will not create a hazard for any other employee.<sup>2</sup> Having performed a brief post-operation visual inspection from the operator's seat, would have revealed the presence of the newly created and precariously positioned hazard. Once identified, this hazard could have been abated by pulling it off of the hillside prior to exposing other workers. This could have been accomplished by attaching the dozer's cable to the segment's non-elevated end and pulling it off of the bank. At the very least, it should have been flagged and avoided.

**Figure 2. This illustrates the parked dozer, final position of the tree segments,  
and the victim's position under the precariously elevated tree segment.**

***Recommendation # 2: Employers should ensure that dozer operators perform a post-operation visual inspection of sloped areas adjacent to roads and work areas for the purpose of identifying and abating newly-created hazards such as unstable tree segments.***

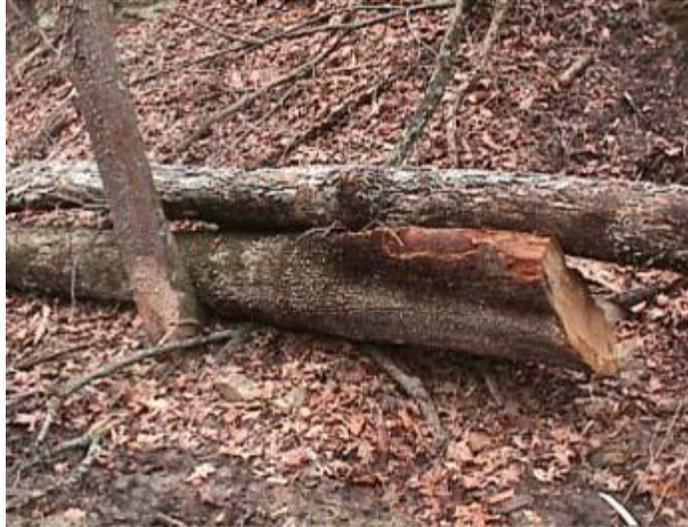
**Figure 3. This photo shows point where the victim was struck.**

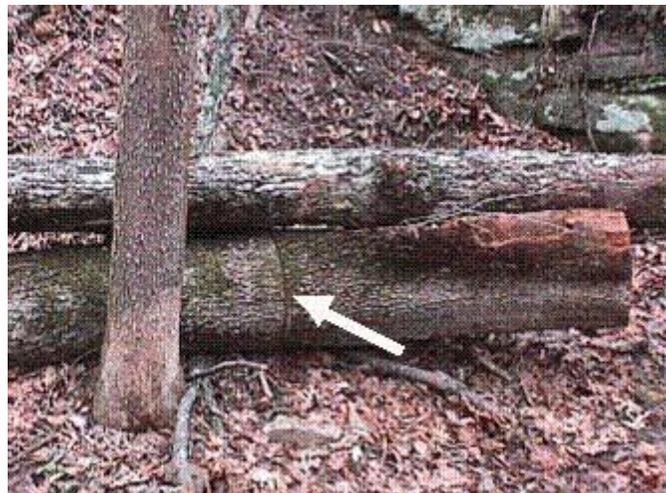
Discussion: In this incident the victim, without hesitation, positioned himself directly below an elevated load. The log's diagonally elevated orientation greatly reduced its potential for stability. Workers need to realize the importance of "working defensively" by taking the time to look things over from a safety perspective. Elevated loads of any type should be avoided at all

**Figure 4. The arrow points to the chainsaw kerf left by the victim as he attempted to butt the log. From this perspective, the victim was standing on the opposite side of the lower log, facing the camera, and reaching over beginning his cut when he was struck from behind.**

***Recommendation # 1: Employers should ensure that workers properly evaluate the area around the task to be performed prior to starting so that potential hazards can be identified and avoided.***
