ACCIDENT REPORT FATAL FACTS

ACCIDENT SUMMARY No. 11

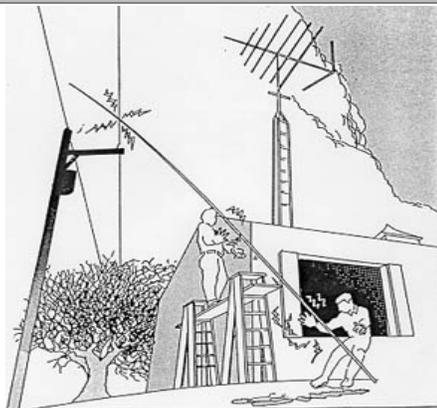
Two employees were installing aluminum siding on a farmhouse when it became necessary to remove a 36-foot high metal pole CB antenna. One employee stood on a metal pick board between two ladders and unfastened the antenna at the top of the house. The other employee, who was standing on the ground, took the antenna to lay it down in the yard. The antenna made electrical contact with a 7200-volt power transmission line 30 feet 10 inches from the house and 23 feet 9 inches above the ground. The employee handling the antenna received a fatal shock and the other employee a minor shock.

Following its investigation, OSHA issued one citation for two alleged serious violations of its construction standards. Had these standards been adhered to, the fatality might have been prevented.

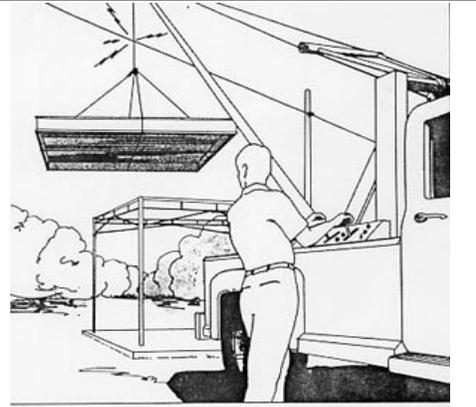
ACCIDENT SUMMARY No. 17

Employees were moving a steel canopy structure using a "boom crane" truck. The boom cable made contact with a 7200 volt electrical power distribution line electrocuting the operator of the crane; he was the foreman at the site.

As a result of its investigation, OSHA issued citations for four serious violations of its construction standards dealing with training, protective equipment, and working too close to power lines. OSHA's construction safety standards include several requirements which, if they had been followed here, might have prevented this fatality.

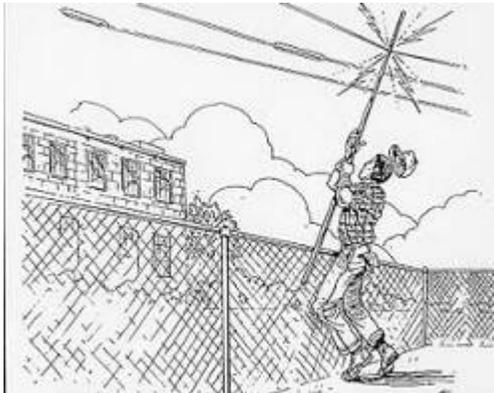
ACCIDENT SUMMARY No. 40

Five employees were constructing a chain link fence in front of a house and directly below a 7200-volt energized power line. They were installing 21-foot sections of metal top rail on the fence. One employee picked up a 21-foot section of top rail and held it up vertically. The top rail contacted the 7200-volt line, and the employee was electrocuted.

Following its inspection, OSHA determined that the employee who was killed had never received any safety training from his employer nor any specific instruction in avoiding the hazards posed by overhead power lines. The agency issued two serious citations for the training deficiencies.

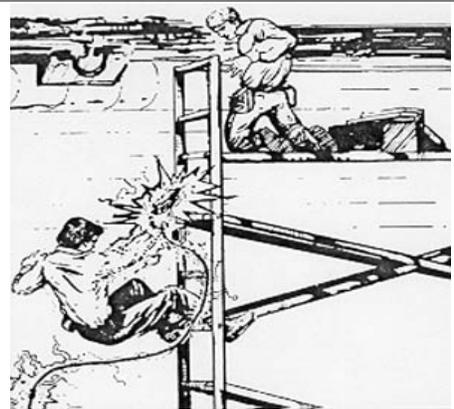
ACCIDENT SUMMARY No. 57

One employee was climbing a metal ladder to hand an electric drill to the journeyman installer on a scaffold about five feet above him. When the victim reached the third rung from the bottom of the ladder he received an electric shock that killed him. The investigation revealed that the extension cord had a missing grounding prong and that a conductor on the green grounding wire was making intermittent contact with the energizing black wire thereby energizing the entire length of the grounding wire and the drill's frame. The drill was not double insulated.

As a result of its investigation, OSHA issued citations for violations of construction standards.
