ACCIDENT REPORT FATAL FACTS

ACCIDENT SUMMARY No. 4

Accident Type:	Struck by Collapsing Crane Boom

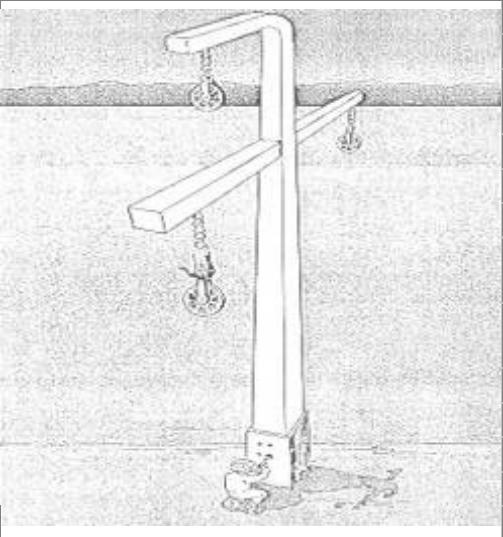
Accident Type:	Struck by Falling Object

Ball and socket connectors are used to attach conductor stringing blocks to insulators on the arms of 90 foot metal towers of electrical transmission lines. Normally stainless steel cotter keys secure the ball and socket connector in place. In this case, however, black electrical tape was wrapped around the socket to keep the ball in place rather than a cotter key. The tape apparently stretched and the ball came loose, dropping the stringing block approximately 90 feet onto the head of an employee below, one of a four-man erection crew.

As result of the its investigation, OSHA issued citations alleging three serious and two other-than-serious violations.

OSHA's construction safety standards include several requirements which, if they had been followed here, might have prevented this fatality.
