U. S. Department of Labor
Occupational Safety and Health Administration
Directorate of Science, Technology & Medicine
Office of Science and Technology Assessment

Hazards Associated with Strand Restraint Devices in Manufacturing
Prestressed Concrete Beams

Safety and Health Information Bulletin

SHIB 06-02-2004

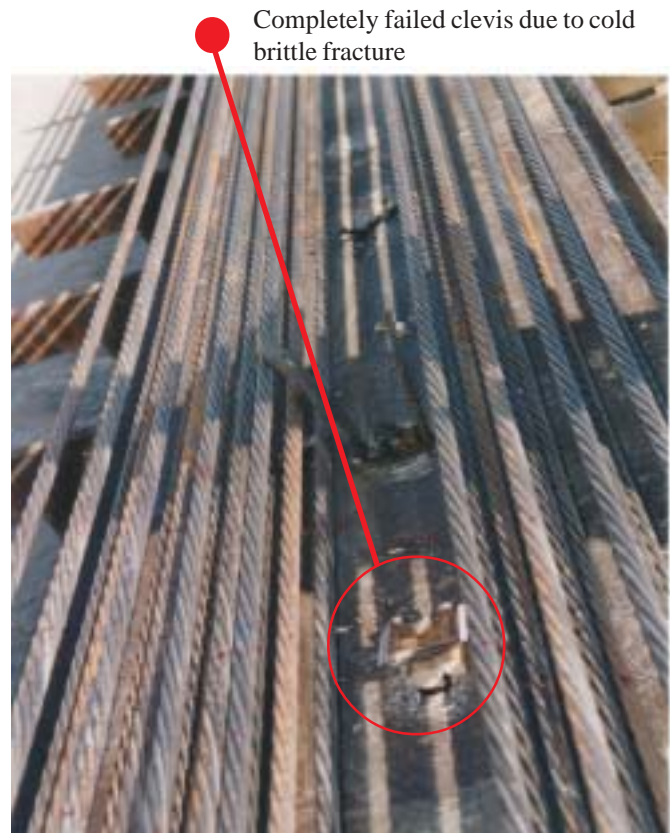
An employee was in the process of removing the shims when the two outside strand restraint devices (holding four cables) in one section failed. This, in turn, caused the two inside restraint devices (holding two cables) in the same section also to fail, but in a different manner. The two outside restraint devices failed at their base due to tensile and bending stresses. On the two inside devices the bolts holding the cables failed, possibly due to bending stresses. When the drape strand cables released, a cable struck an employee in the head, resulting in a fatality. Because of cold weather conditions at the time of the accident, cold brittle metal fracture also contributed to the restraint device (clevis) failure.

The non-pivoting design of the restraint devices also imposed bending (flexural) stresses in the base of the devices, which further contributed to the failure of the devices.

Figure #1
Failed clevises (restraint devices)

1. Ensure that strand restraint devices are engineered and designed to withstand the forces and moments imposed by the drape strands and to prevent cold brittle fracture

during cold weather. Several manufacturers make strand restraint devices that have been so engineered and designed. Pivoting or swiveling-type restraint devices can be used to prevent the bending (flexural) stresses in the base of the restraint device.

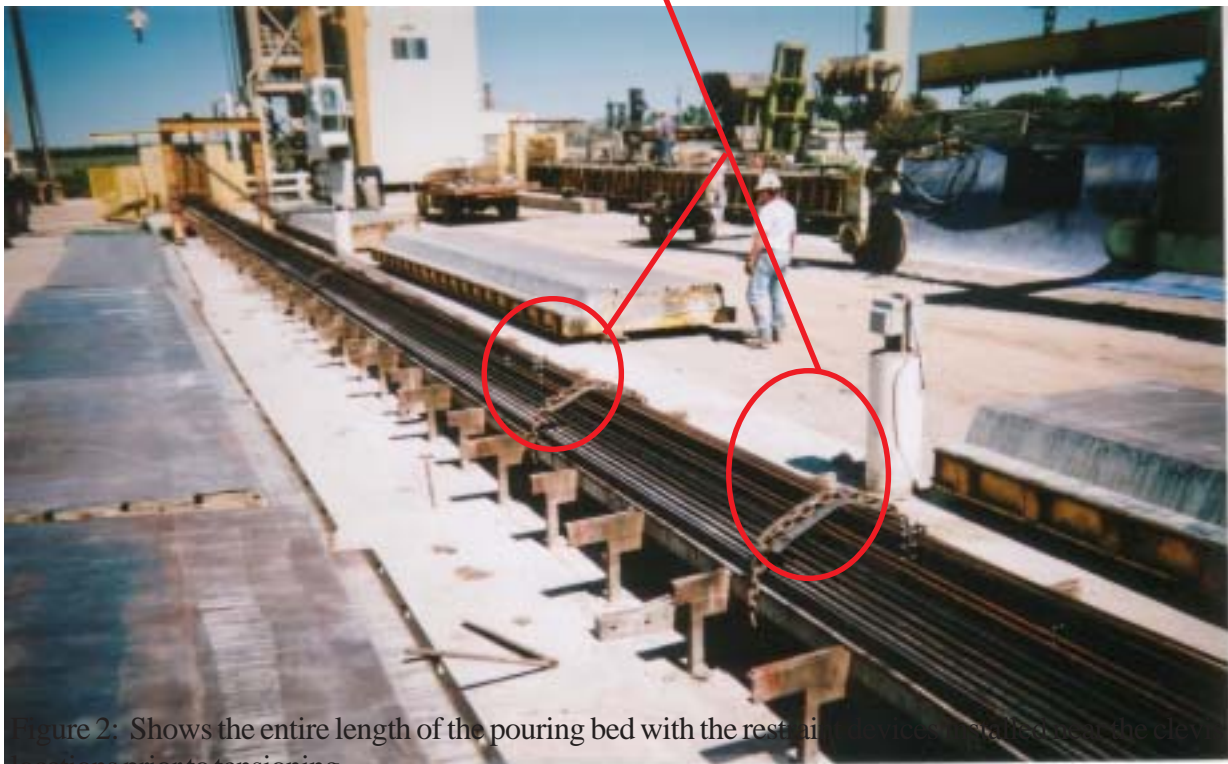
Figure 2: Shows the entire length of the pouring bed with the rebar reinforcement at the elevation locations prior to tensioning

Figures 2 and 3 show changes made to the process.
