Hazards Associated with Strand Restraint Devices in Manufacturing  
Prestressed Concrete Beams

Safety and Health Information Bulletin

SHIB 06-02-2004

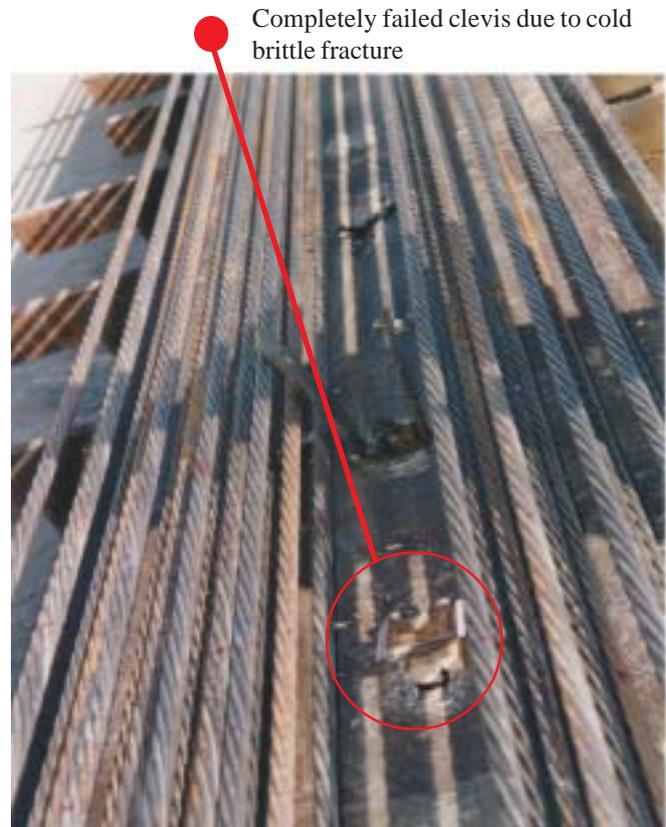
An employee was in the process of removing the shims when the two outside strand restraint devices (holding four cables) in one section failed. This, in turn, caused the two inside restraint devices (holding two cables) in the same section also to fail, but in a different manner. The two outside restraint devices failed at their base due to tensile and bending stresses. On the two inside devices the bolts holding the cables failed, possibly due to bending stresses. When the drape strand cables released, a cable struck an employee in the head, resulting in a fatality. Because of cold weather conditions at the time of the accident, cold brittle metal fracture also contributed to the restraint device (clevis) failure.

The non-pivoting design of the restraint devices also imposed bending (flexural) stresses in the base of the devices, which further contributed to the failure of the devices.

Figure #1  
Failed clevises (restraint devices)

1. Ensure that strand restraint devices are engineered and designed to withstand the forces and moments imposed by the drape strands and to prevent cold brittle fracture

during cold weather. Several manufacturers make strand restraint devices that have been so engineered and designed. Pivoting or swiveling-type restraint devices can be used to prevent the bending (flexural) stresses in the base of the restraint device.

2. Redesign the prestressed concrete pouring process so there is no need to install a wood shim under the restraint devices holding the drape strands. The elimination of the wood shim would prevent impact loading on the devices as a result of removing shims and reduce or eliminate employee exposure to the danger zone. Properly engineered strand restraint devices should eliminate the need to use wood shims.

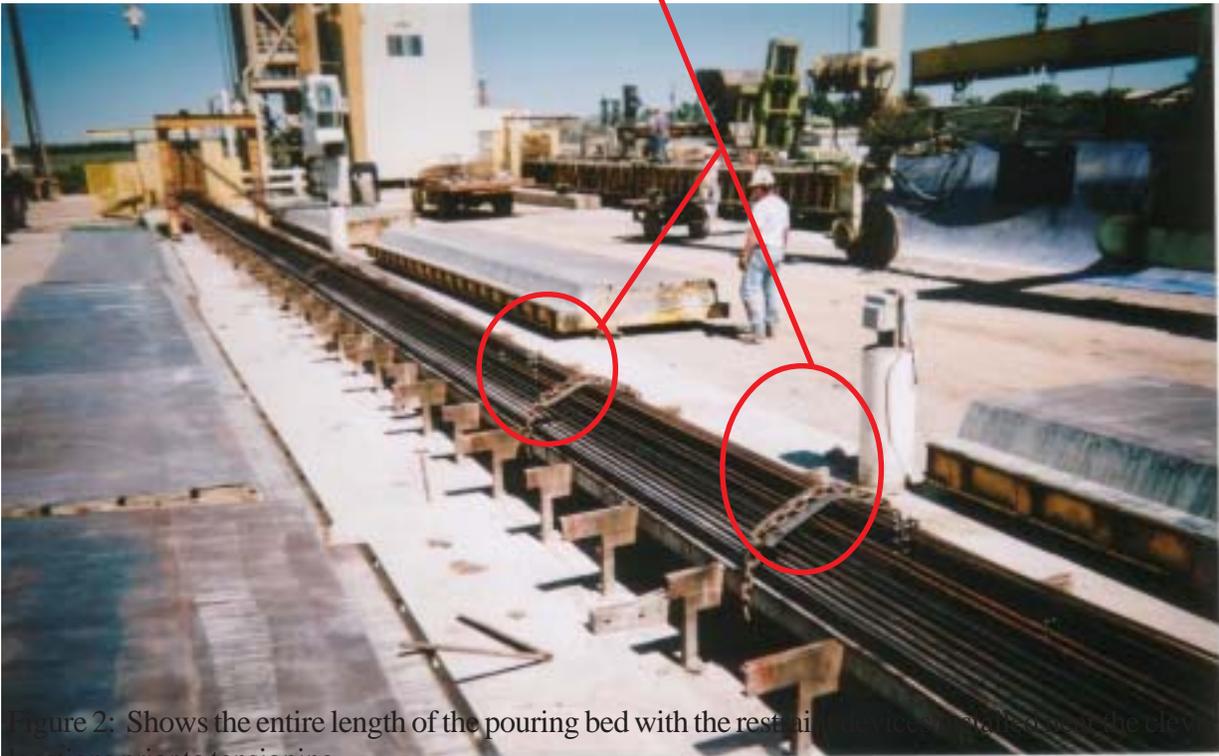
Figure 2: Shows the entire length of the pouring bed with the rebar reinforcement at the elevation locations prior to tensioning

Figures 2 and 3 show changes made to the process.

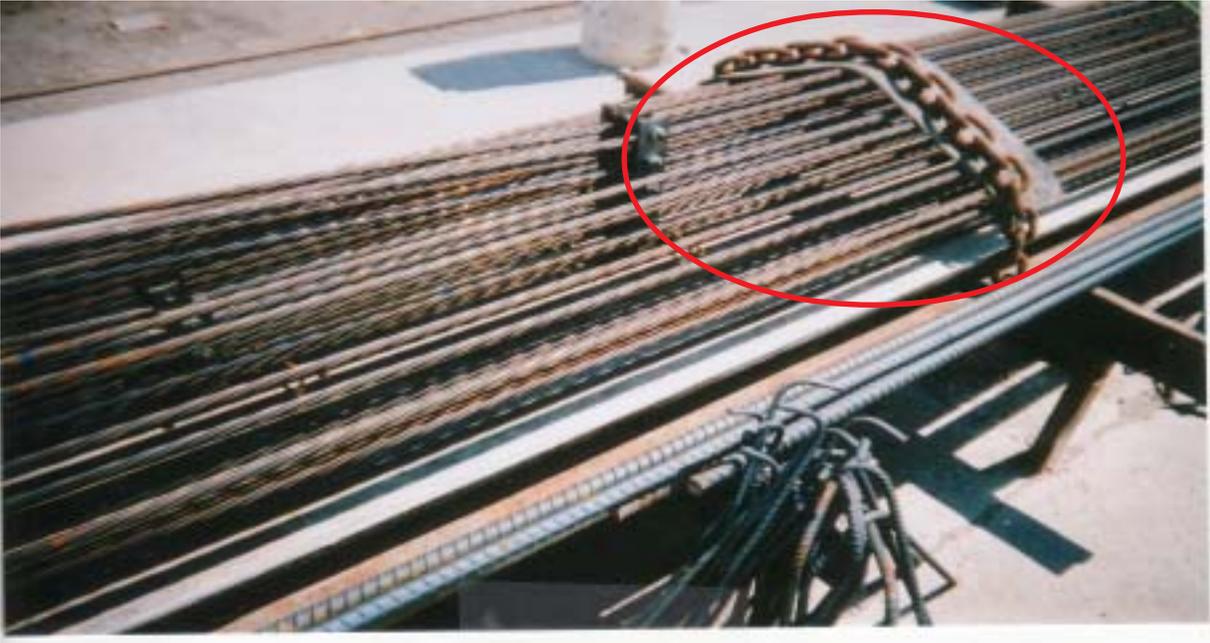
Figure 3. Close-up View of Restraint Device.

Figure 3: Shows a restraint device installed to prevent cables from releasing in the event of clevis failure during tensioning.
