Investigation of the June 20, 2001, Partial Collapse of the Mast Climbing Platform at Cambridge, MA

U.S. Department of Labor
Occupational Safety and Health Administration
Directorate of Construction

December 2001

Report prepared by
Mohammad Ayub, PE
Dinesh Shah, PE

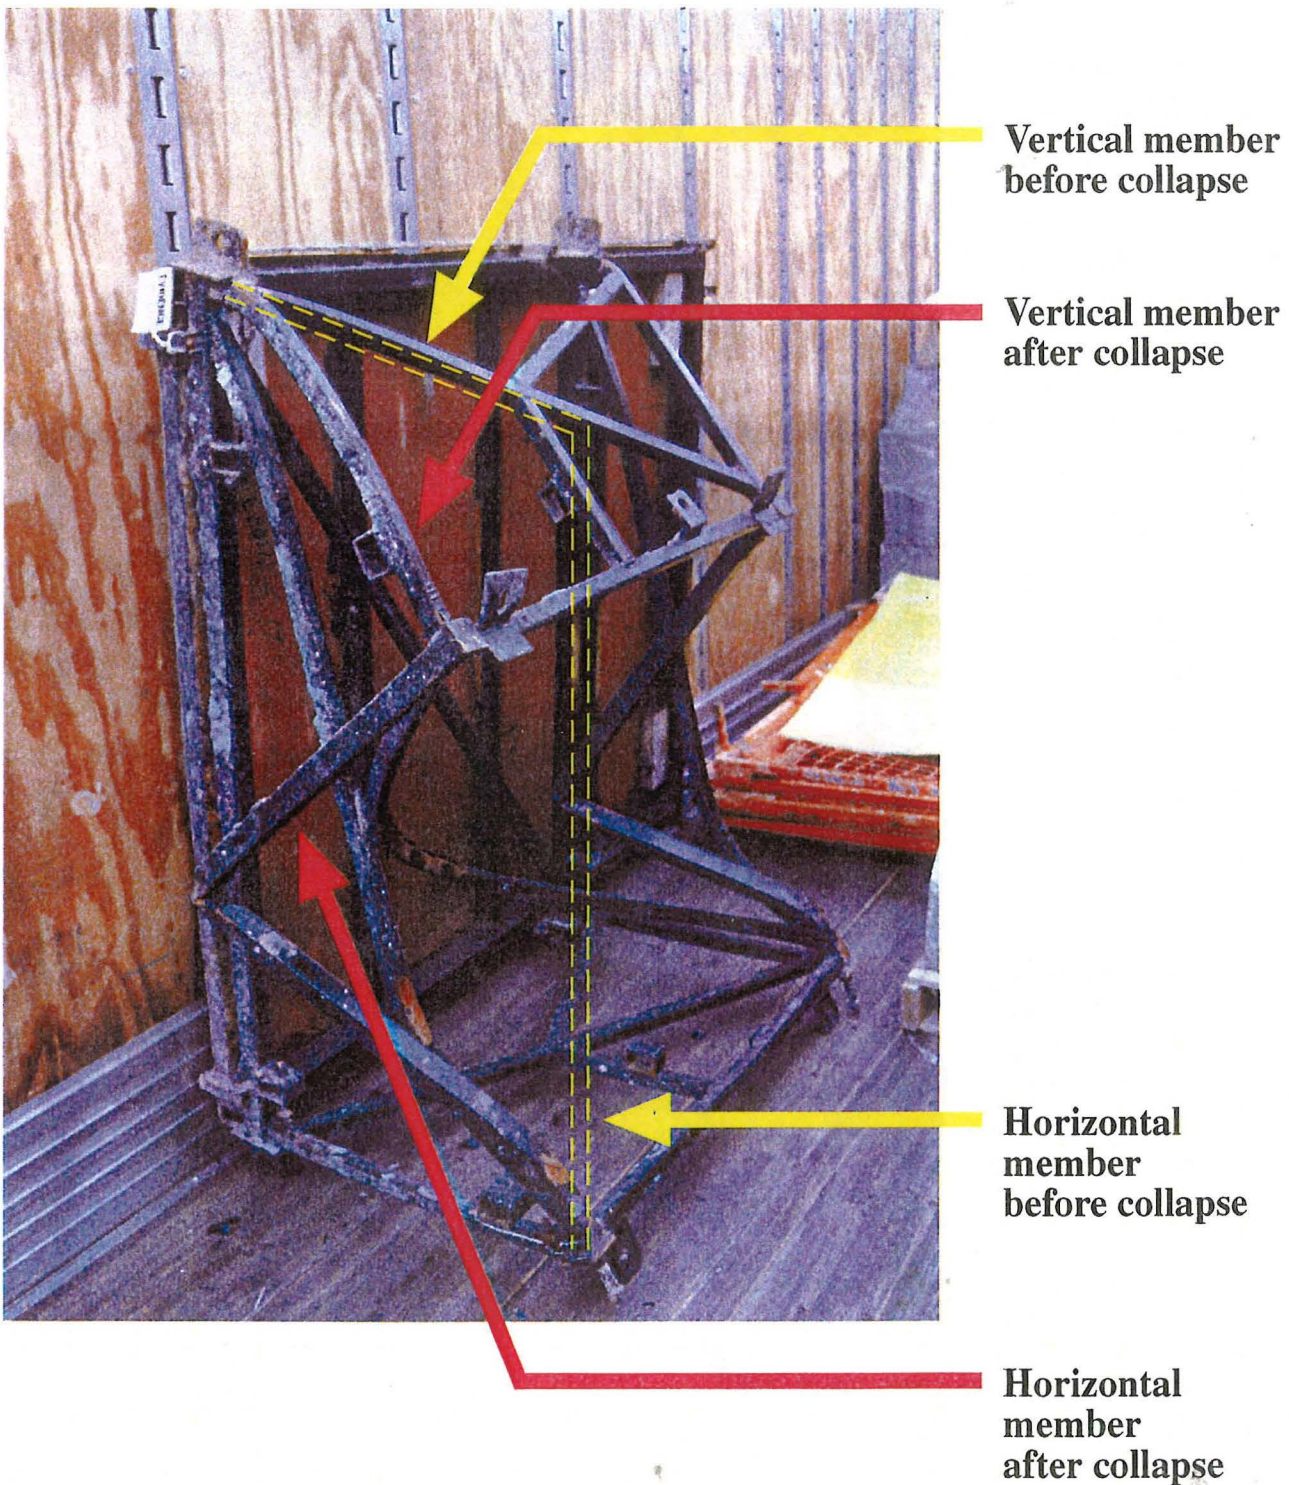
Figure 1:

The four sections involved in the incident were salvaged by the North Boston Area Office and placed in a trailer for future examination by interested parties. Observation of the sections revealed that only one section, hereafter called Section No.1, which was placed closest to the fixed platform, was damaged (figure 1, & 2). The remaining three sections were practically intact, free from any visual distress (figure 5). A number of observations were made during the site visit:

2. The two bottom horizontal members parallel to the longitudinal axis of the platform were sharply bent and deformed. Due to the deformation of the two bottom members, other members were also deformed and distressed.

3. The thickness of the structural tubes was reduced from their usual .125" to about 0.11" due to corrosive damage. It was observed that paint was applied over rusted steel.

As stated earlier, four sections were added to the fixed platform on one side and three on the other. Failure occurred on one side only, the side with the four sections. The most stressed and damaged section, Section # 1, was the one closest to the fixed platform (figure 1, & 2). The other three remained intact after the failure (figure 5). The Section # 1 was therefore analyzed to determine the stresses in each member and to determine whether or not the members were overstressed to the point of failure. Reactions due to the actual loads placed over the other three sections were applied on Section # 1. A total load of 5340 pounds including the weight of three workers were assumed, based upon the weight of the bricks and blocks recovered after the incident. The load was assumed to be uniformly distributed over the length of the platform (20 feet) and a width equal to 16 inches. This was based upon eyewitness statements that the bricks and blocks were placed towards the side of the building. Yield strength of steel was assumed to be 46 ksi. Member sizes and dimensions were based upon field measurements. Commercially available, STAAD III program was used to perform the three dimensional structural analysis.

Our analysis indicated that a bottom horizontal member parallel to the longitudinal axis of the platform was stressed beyond its ultimate capacity to the point of failure, due to the loads placed over four sections. The horizontal member was a compression member whose failure load was computed to be 16,700 pounds, based upon the full thickness of $1/8"$. However, if the thickness is assumed to be $0.1"$, as measured in the field, the failure load is reduced to 13,900 pounds. The member was subjected to a compressive load of 19,300 pounds due to the actual loads placed over four sections, and hence the failure. Compressive members are highly sensitive to loads

1. The cause of the collapse of the scaffold was overloading of the platform. The four sections were loaded well in excess of their safe capacities.
2. Overloading of the platform resulted in buckling of one of the bottom compression members of the section closest to the fixed platform.

Damaged First Section of Mast Platform

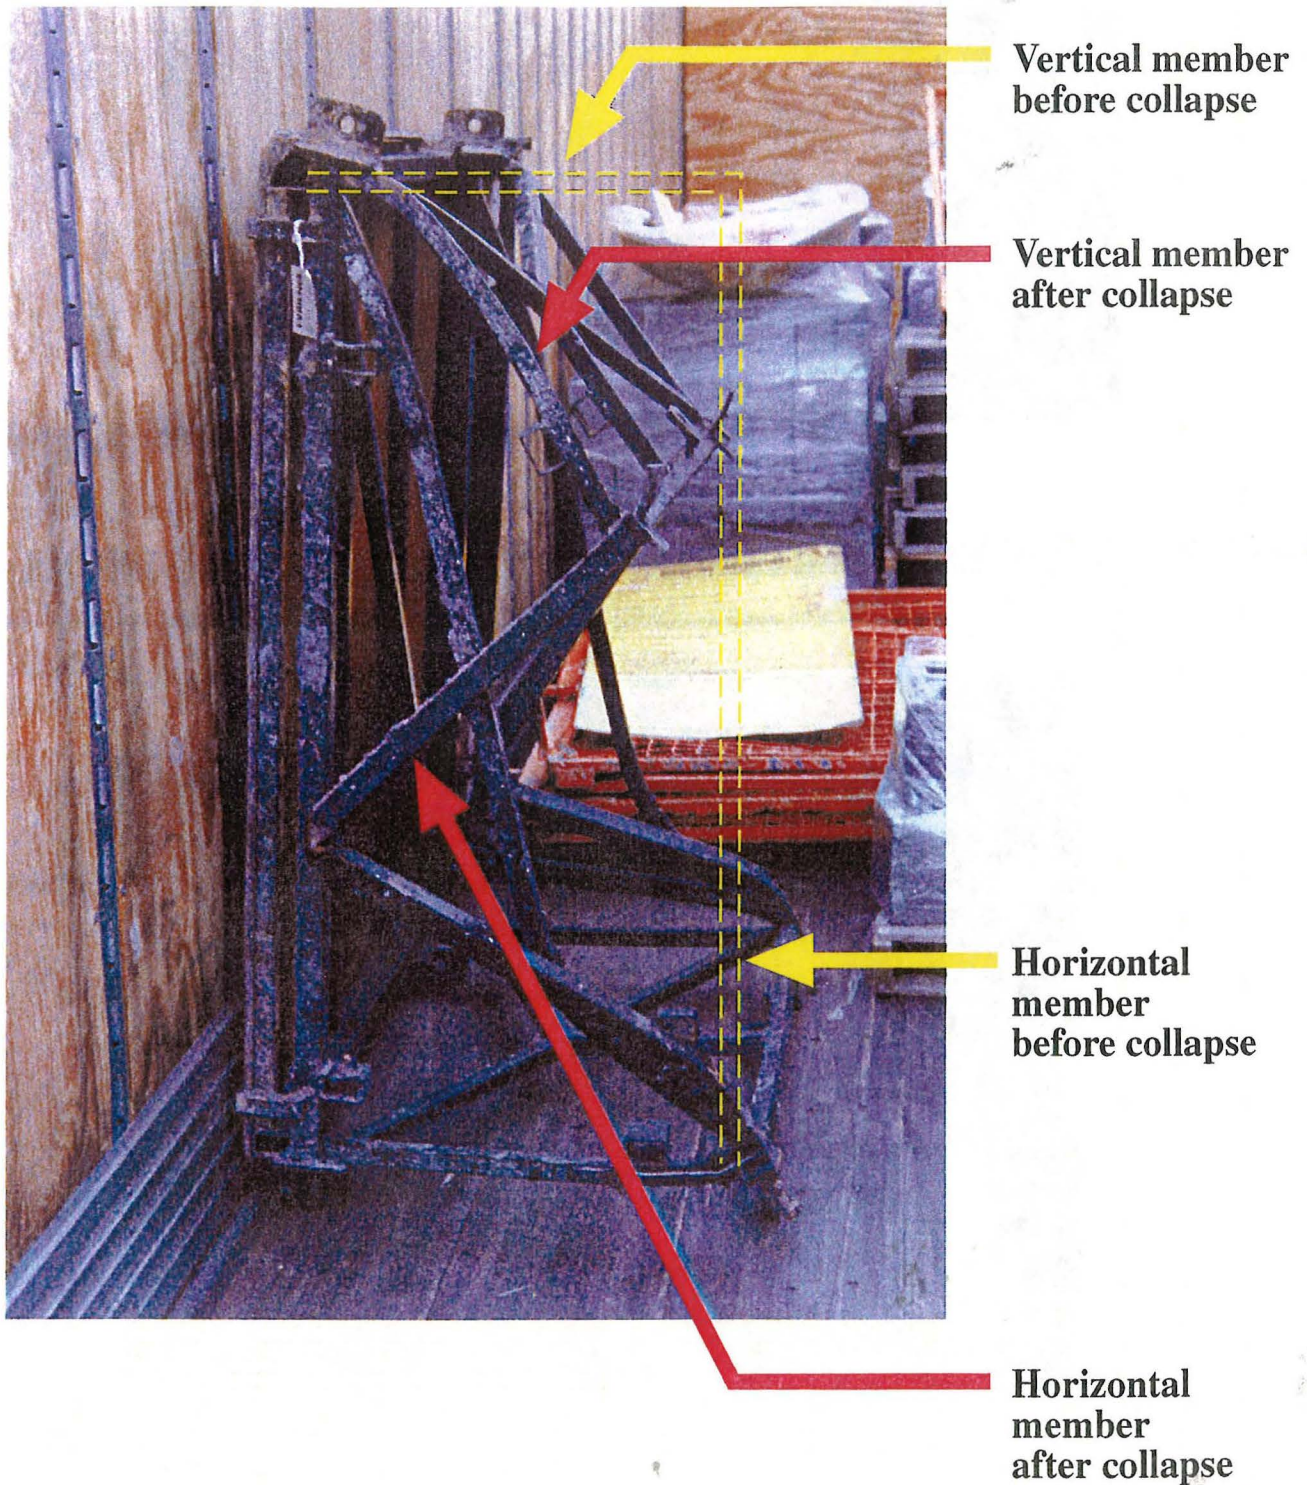
Figure 2:

Damaged First Section of Mast Platform

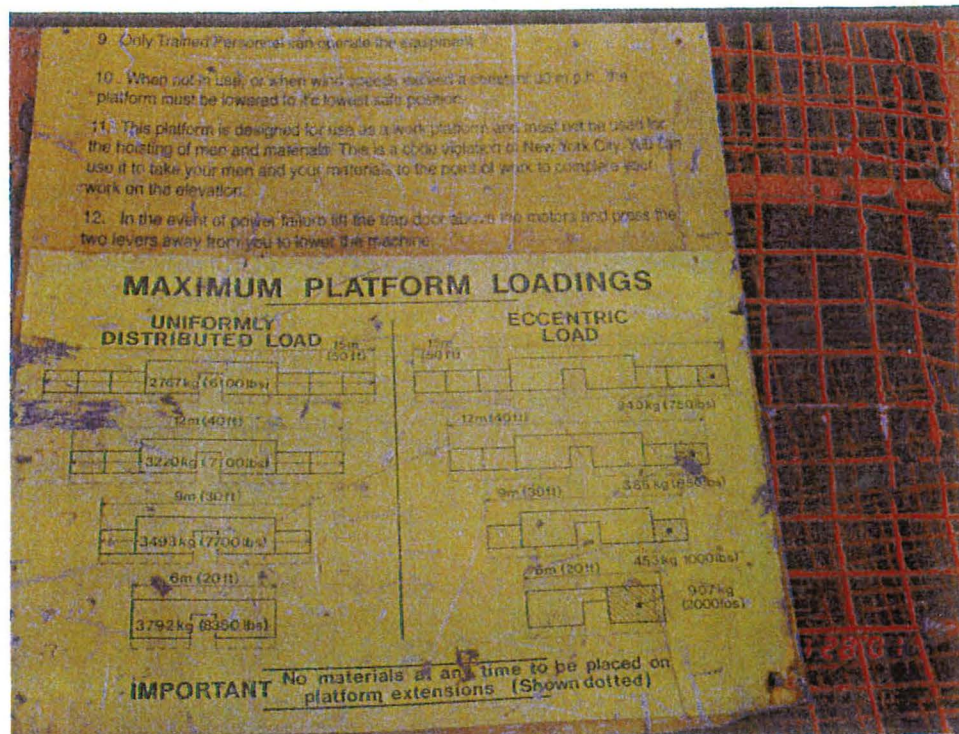
1. The structural framing layout of all four sections was different. No two sections were identical. This indicated that sections were mismatched and came from different models of mast climbing platforms. This invalidated the load chart posted at the site (figure 3, & 4). A competent person, knowledgeable in structural design, must analyze and determine the safe load carrying capacity of the platform before it could be placed in service.

FIGURE 3 (LOAD CHART FOR SAFE LOAD CAPACITY OF THE SCAFFOLD)

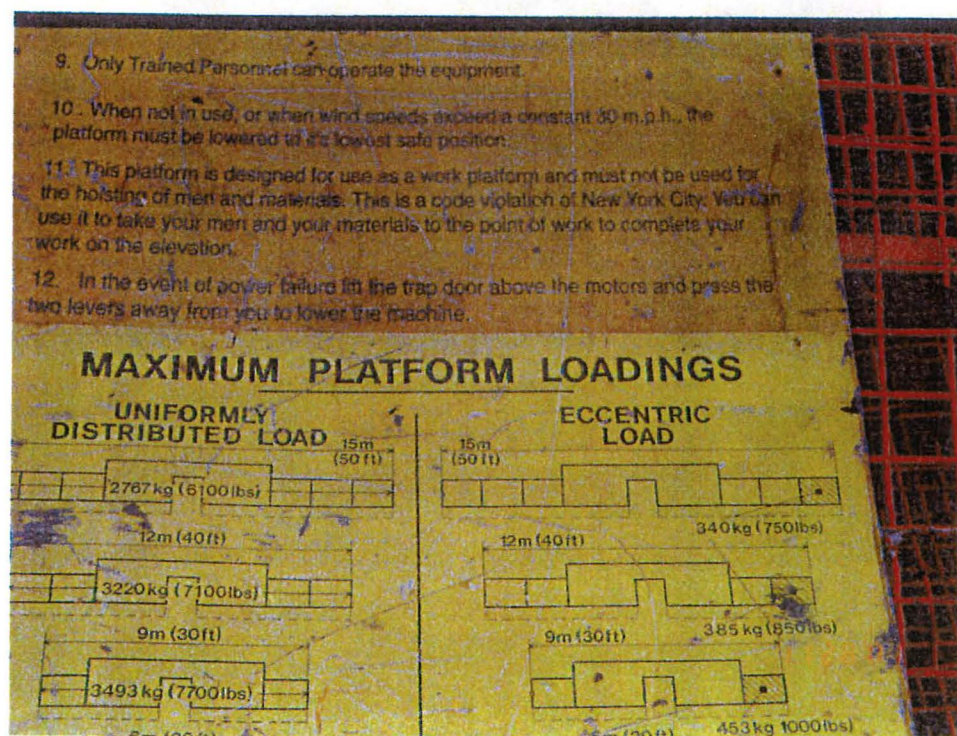
FIGURE 4 (LOAD CHART FOR SAFE LOAD CAPACITY OF THE SCAFFOLD)

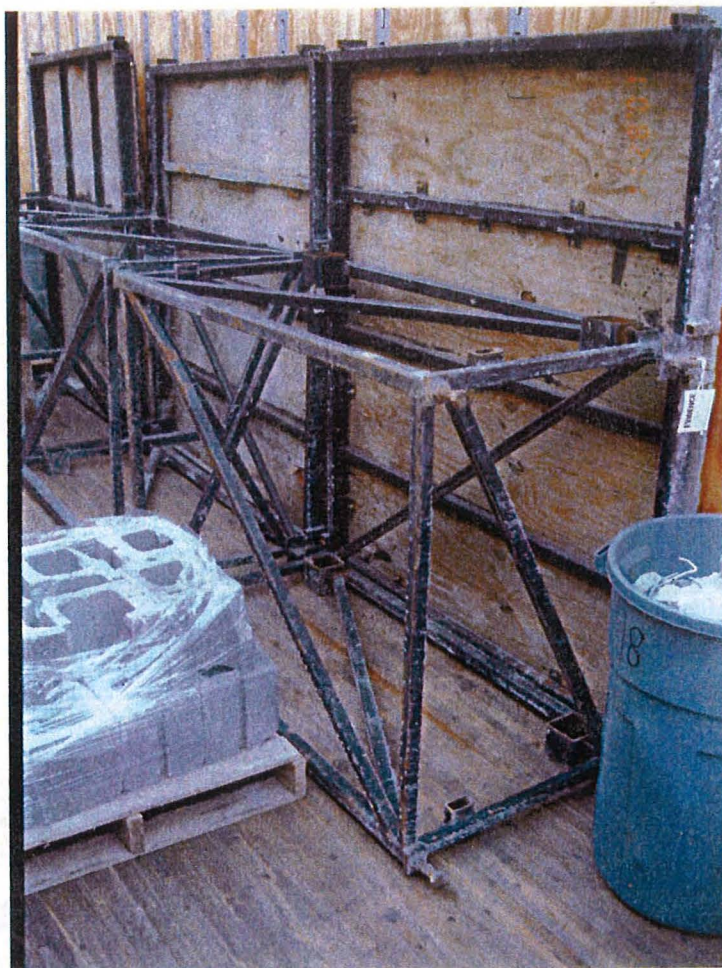
FIGURE 5 (UNDAMAGED LAST THREE SECTIONS OF MAST PLATFORM)

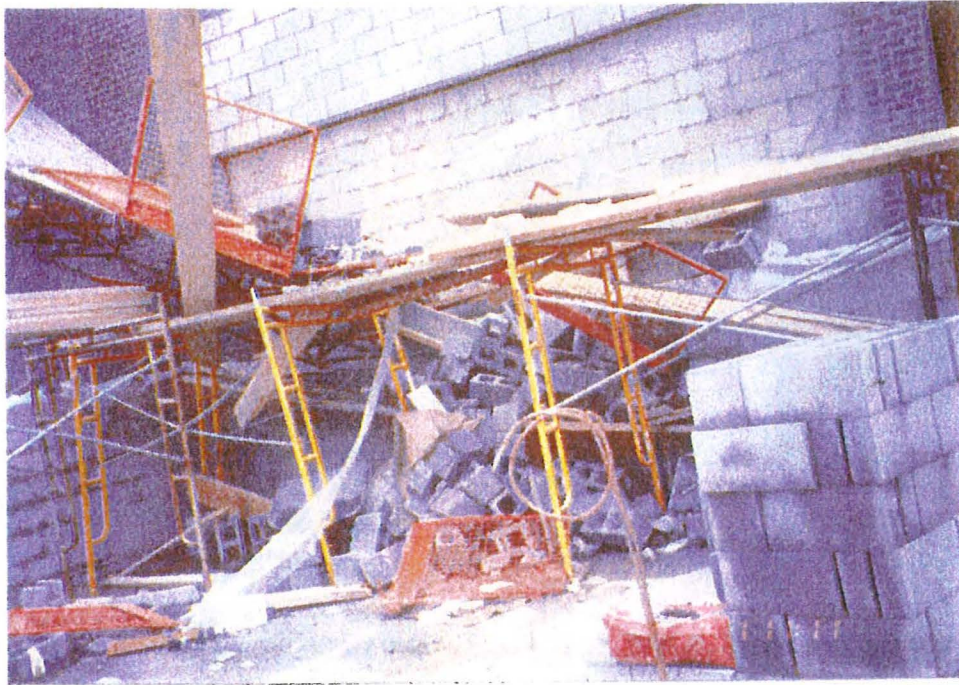
The entire mast-climbing platform did not fail. Only the side, which had four sections with the total length of 20 feet, collapsed (figure 6, & 7). The other side, which had three sections, remained intact and so did the tower and the fixed platform (figure 8 & 9).

FIGURE 6 (PARTIALLY COLLAPSED PLATFORM AT ONE END OF TOWER)

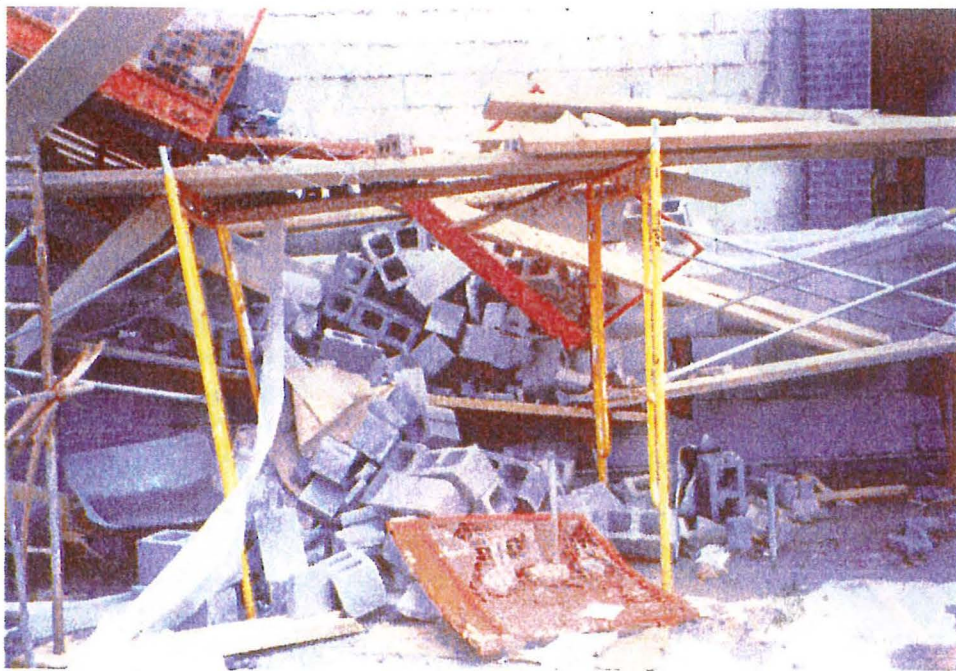
**FIGURE 7 (PARTIALLY COLLAPSED PLATFORM ALONG
WITH CINDERBLOCKS ON GROUND)**

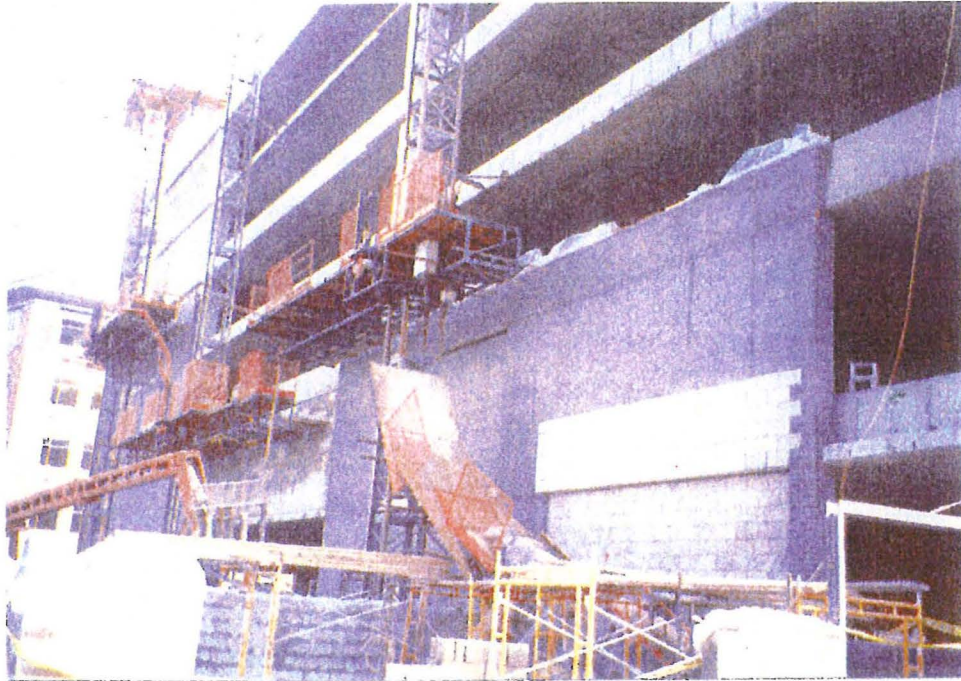
FIGURE 8 (UNCOLLAPSED PLATFORM AT OTHER END OF TOWER)

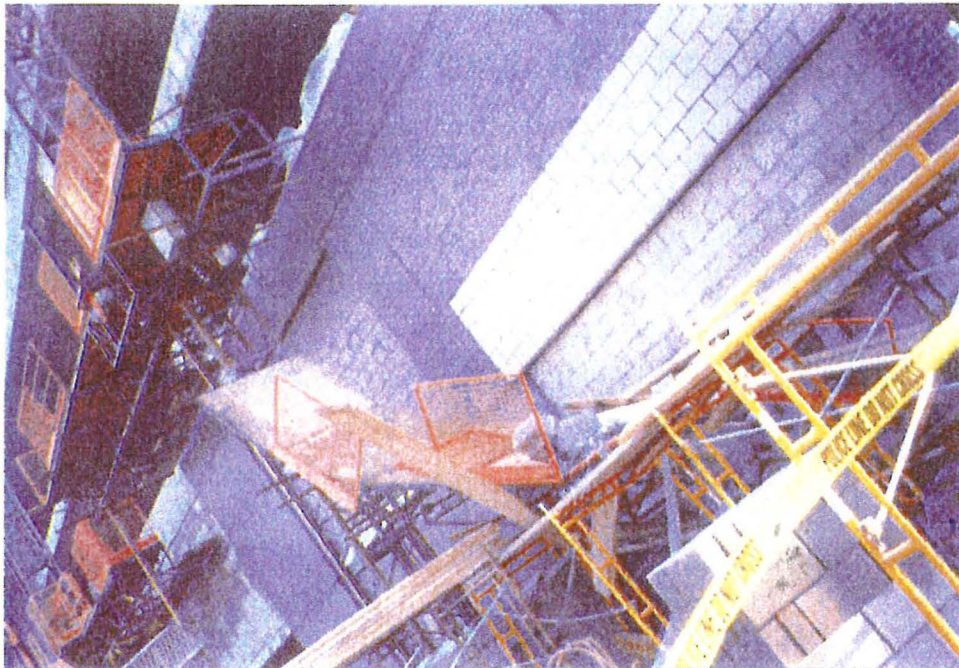
FIGURE 9 (UNCOLLAPSED PLATFORM AT OTHER END OF TOWER)
