Investigation of the August 3, 2005, Collapse of roof trusses at Natatorio de, San Juan, PR

U.S. Department of Labor
Occupational Safety and Health Administration

February 2006

Report prepared by
Mohammad Ayub, PE

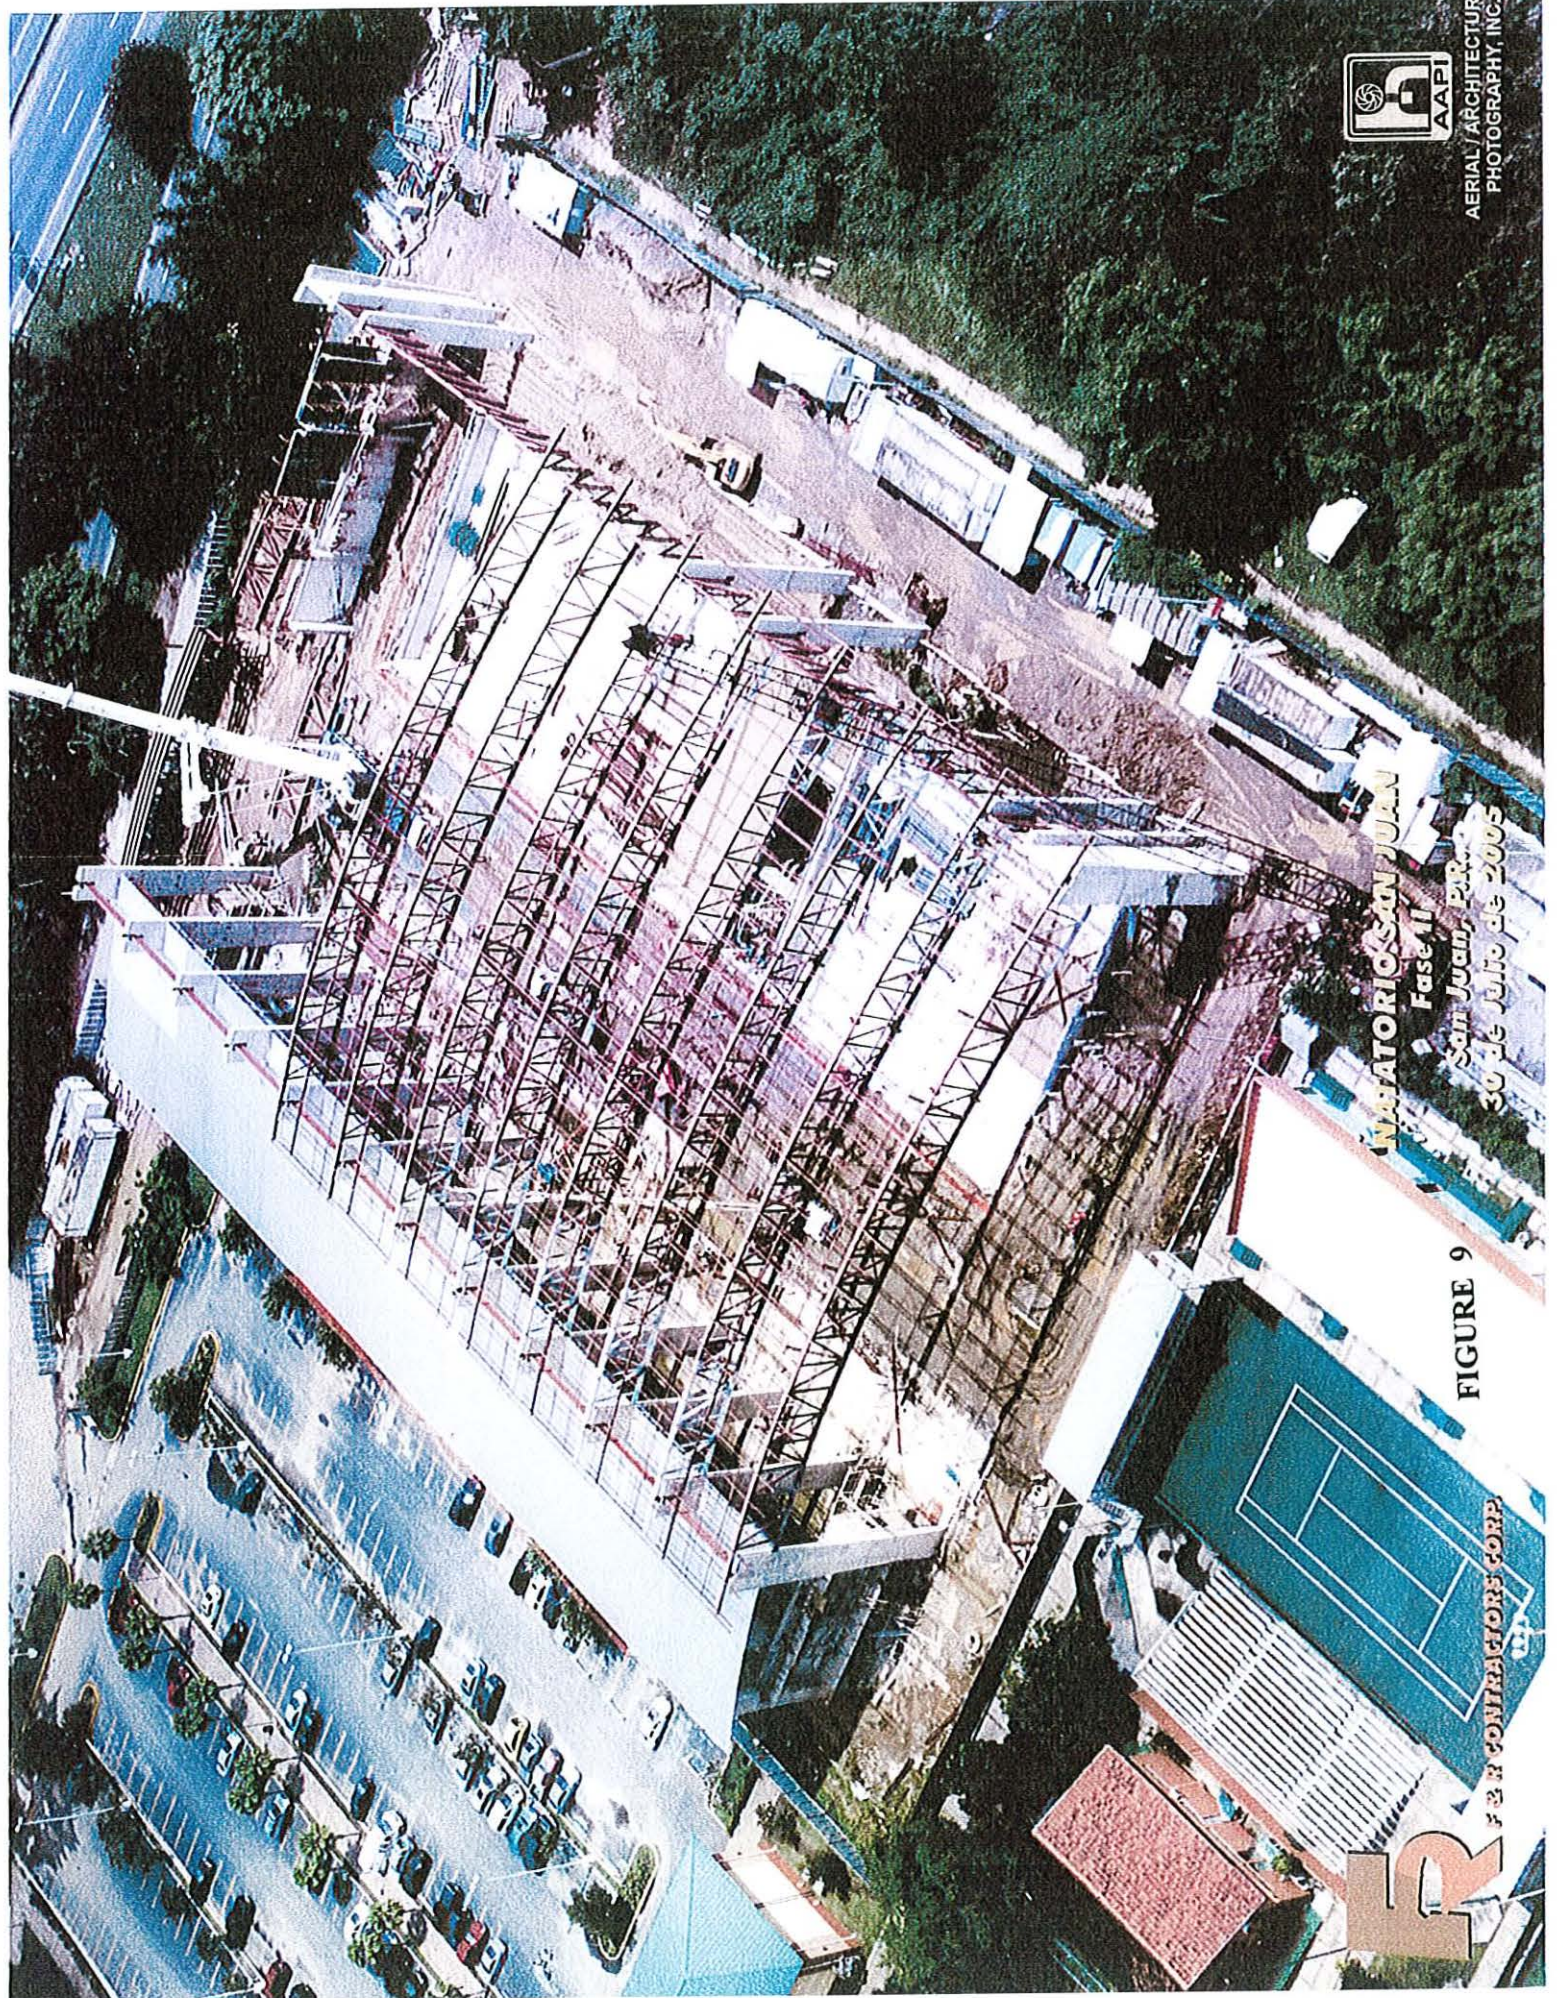
FIGURE 9

The first roof truss was installed on column line 20. The crane did not release the load of the first truss until another crane erected the adjoining truss on column line 17, and all bracings between the two trusses were completed. SM then proceeded to erect other trusses moving towards the north on column lines 16, 15, 14, 10, 9 and 7. The truss on column line 7 was the last truss to be erected about a week before the incident, see figure 9. The following are the dates of erection of truss girders and roof trusses:

After the roof trusses on column lines 10, 9 and 7 were erected, SM removed the two guy wires on the south side approximately one week before the incident, thus leaving the girder truss with only one set of guy wires on the north side. A few minutes before the incident, an SM foreman noticed that the truss girder T-153 was bowing out (deflecting laterally) towards the east and wanted to tension the wire rope but the failure occurred before he could correct the truss alignment. In fact, a construction aerial photo taken by FR (figure 9) showed that the bow of the girder truss existed since at least June 30, 2005 when the photograph was taken.

Bowing of the girder truss T 153 was evident since at least June 30, 2005. It should not have escaped the attention of the project personnel in the field as it was in the clear sight of everyone. Neither any corrective measures were taken by SM nor the structural engineer of record or SM's expert consulted to determine the cause of the bowing of the girder truss. If such actions were taken on a timely basis, the incident could have been avoided. Such bowing occurs when the compression flanges are not properly braced against lateral torsional buckling at regular intervals. The braces, to be effective, must be able to prevent lateral translation and rotation of the top chord.

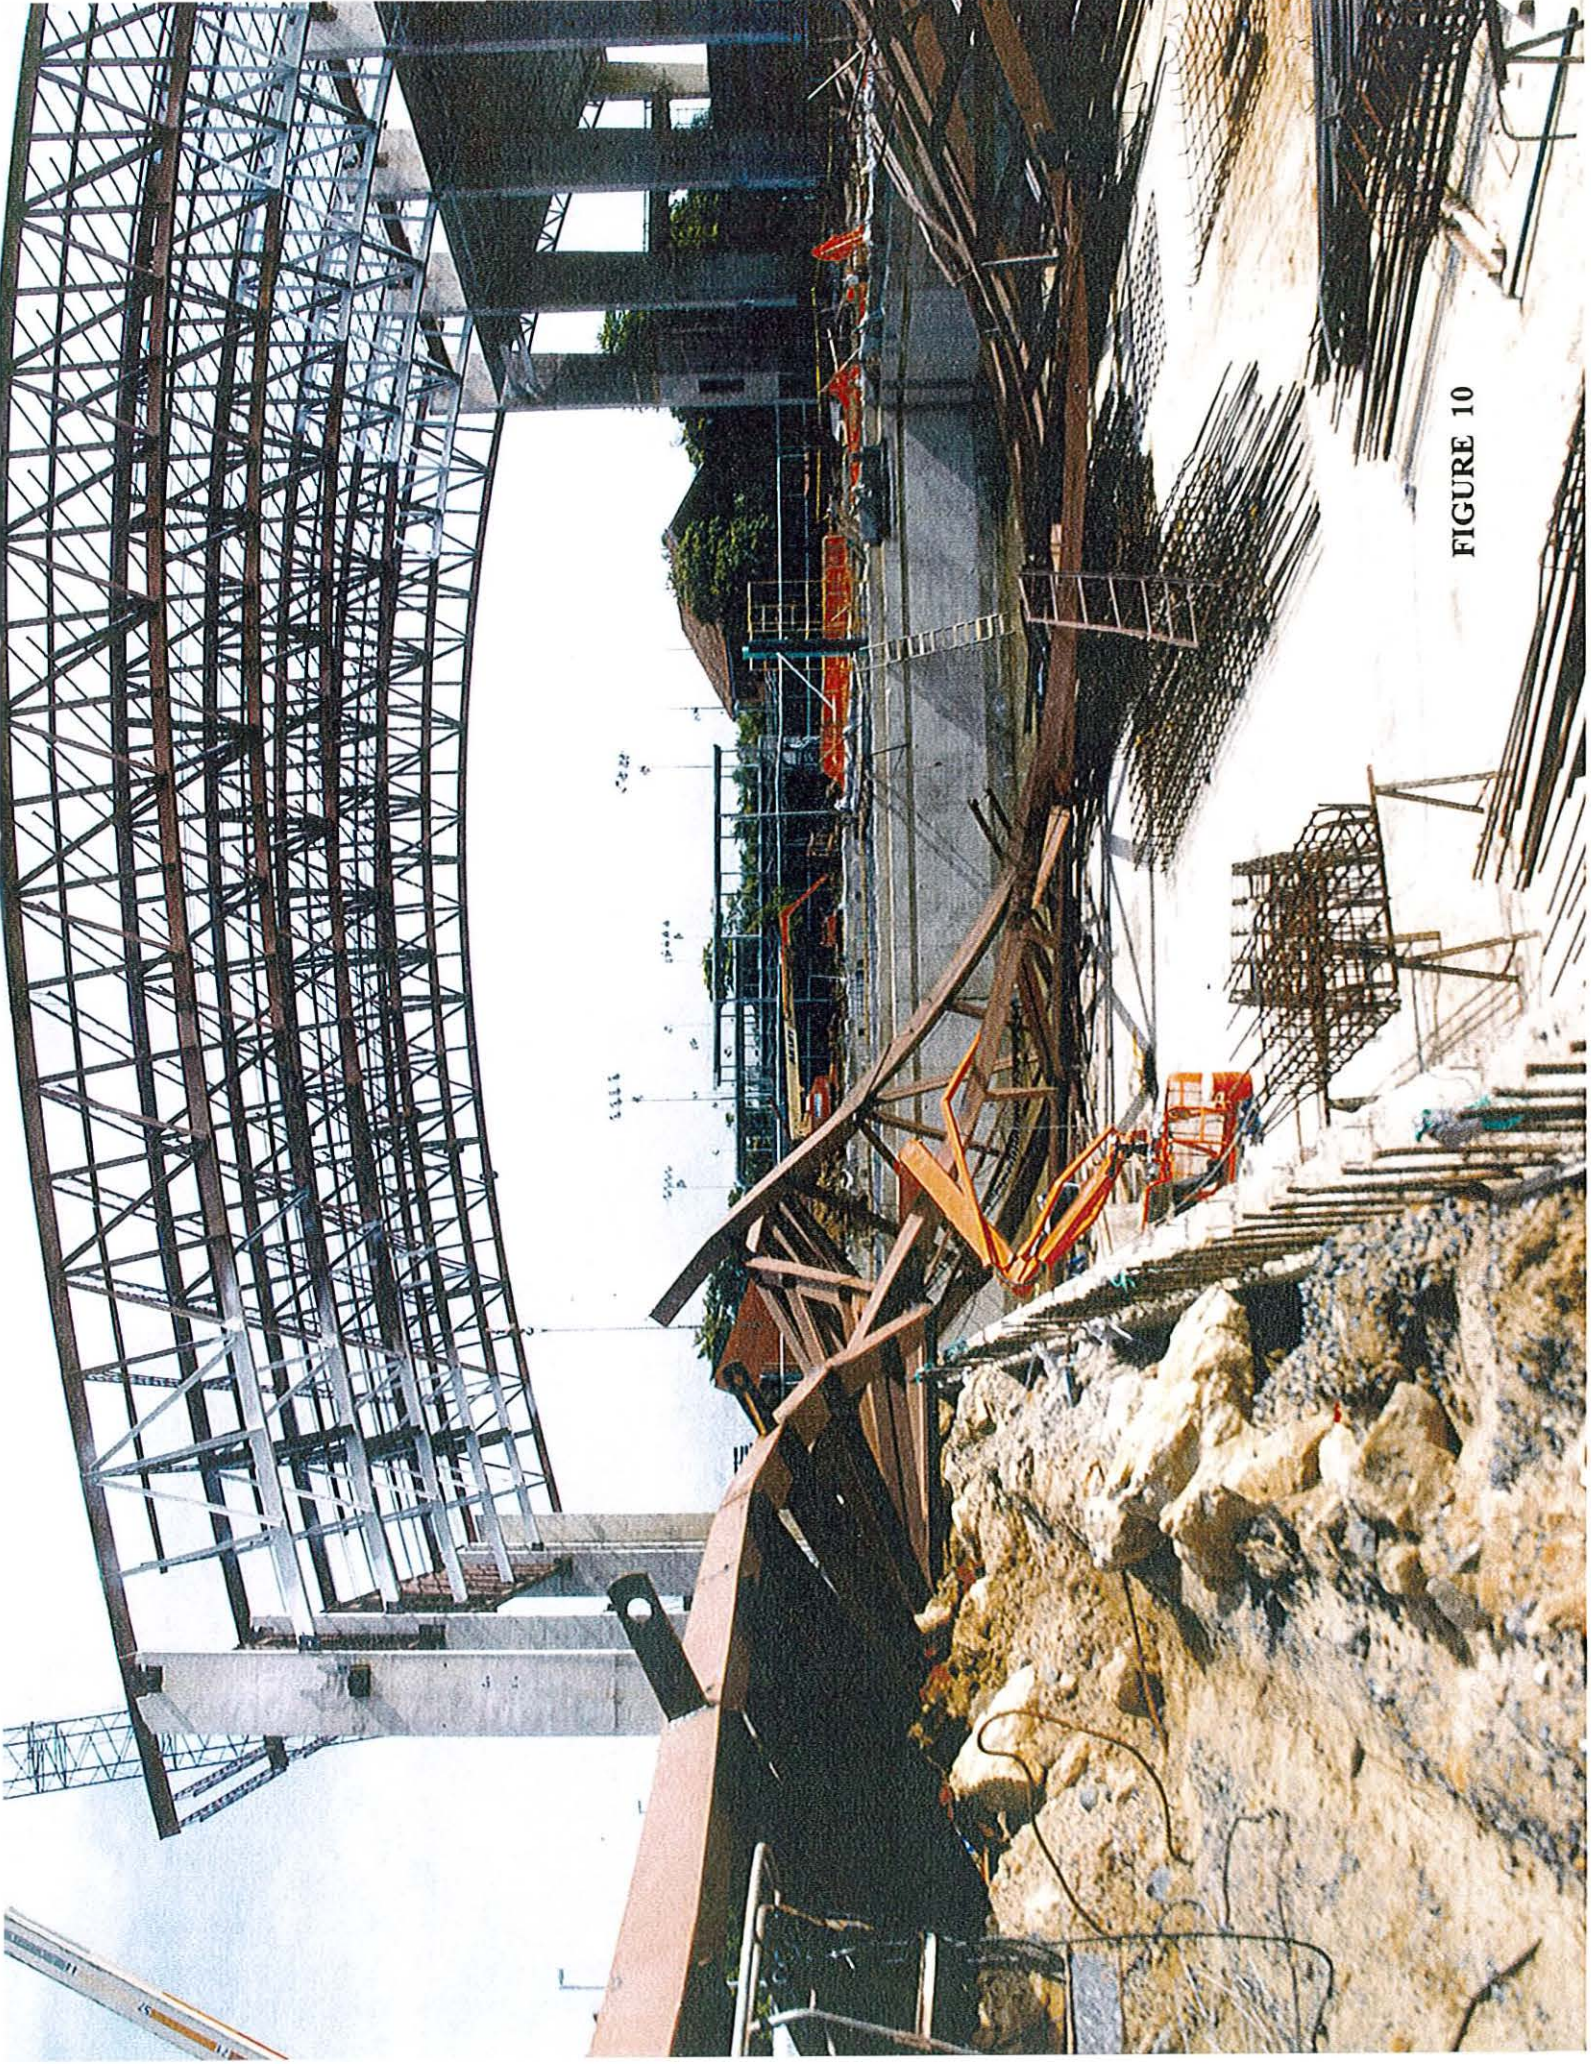
FIGURE 10

On August 3, 2005, workers went out for lunch at about 10:30 AM. On return from lunch at 11:30 AM, two SM employees prepared to go up in a boom basket to resume placing bar joists over the roof trusses between column lines 10 & 9, and between column lines 9 & 7. As the employees were halfway up to the roof, the truss girder on column line K and the roof trusses on column line 9 and 7 collapsed to the ground, injuring the two employees seriously. A third SM employee was on the ground and was fatally injured. An employee of the earthwork sub-contractor was also nearby and was fatally struck. The roof trusses and the girder truss each fell in one piece, though they were bent and crooked in shape. The truss girder slid away from both supports at the concrete columns on column lines 4 and 10, leaving the bottom and top supports at the concrete columns intact. The truss girder was wavy both in the longitudinal and transverse directions. The roof trusses also fell in a curved position but remained connected to the concrete columns on the west side and to the girder trusses on the east side. The roof joists were scattered over a large area. The guy wires did not break during the collapse, but the concrete block where the bottom ends of the guy wire was fastened moved longitudinally parallel to column line K. For the collapsed roof trusses, see figures 10 to 20.

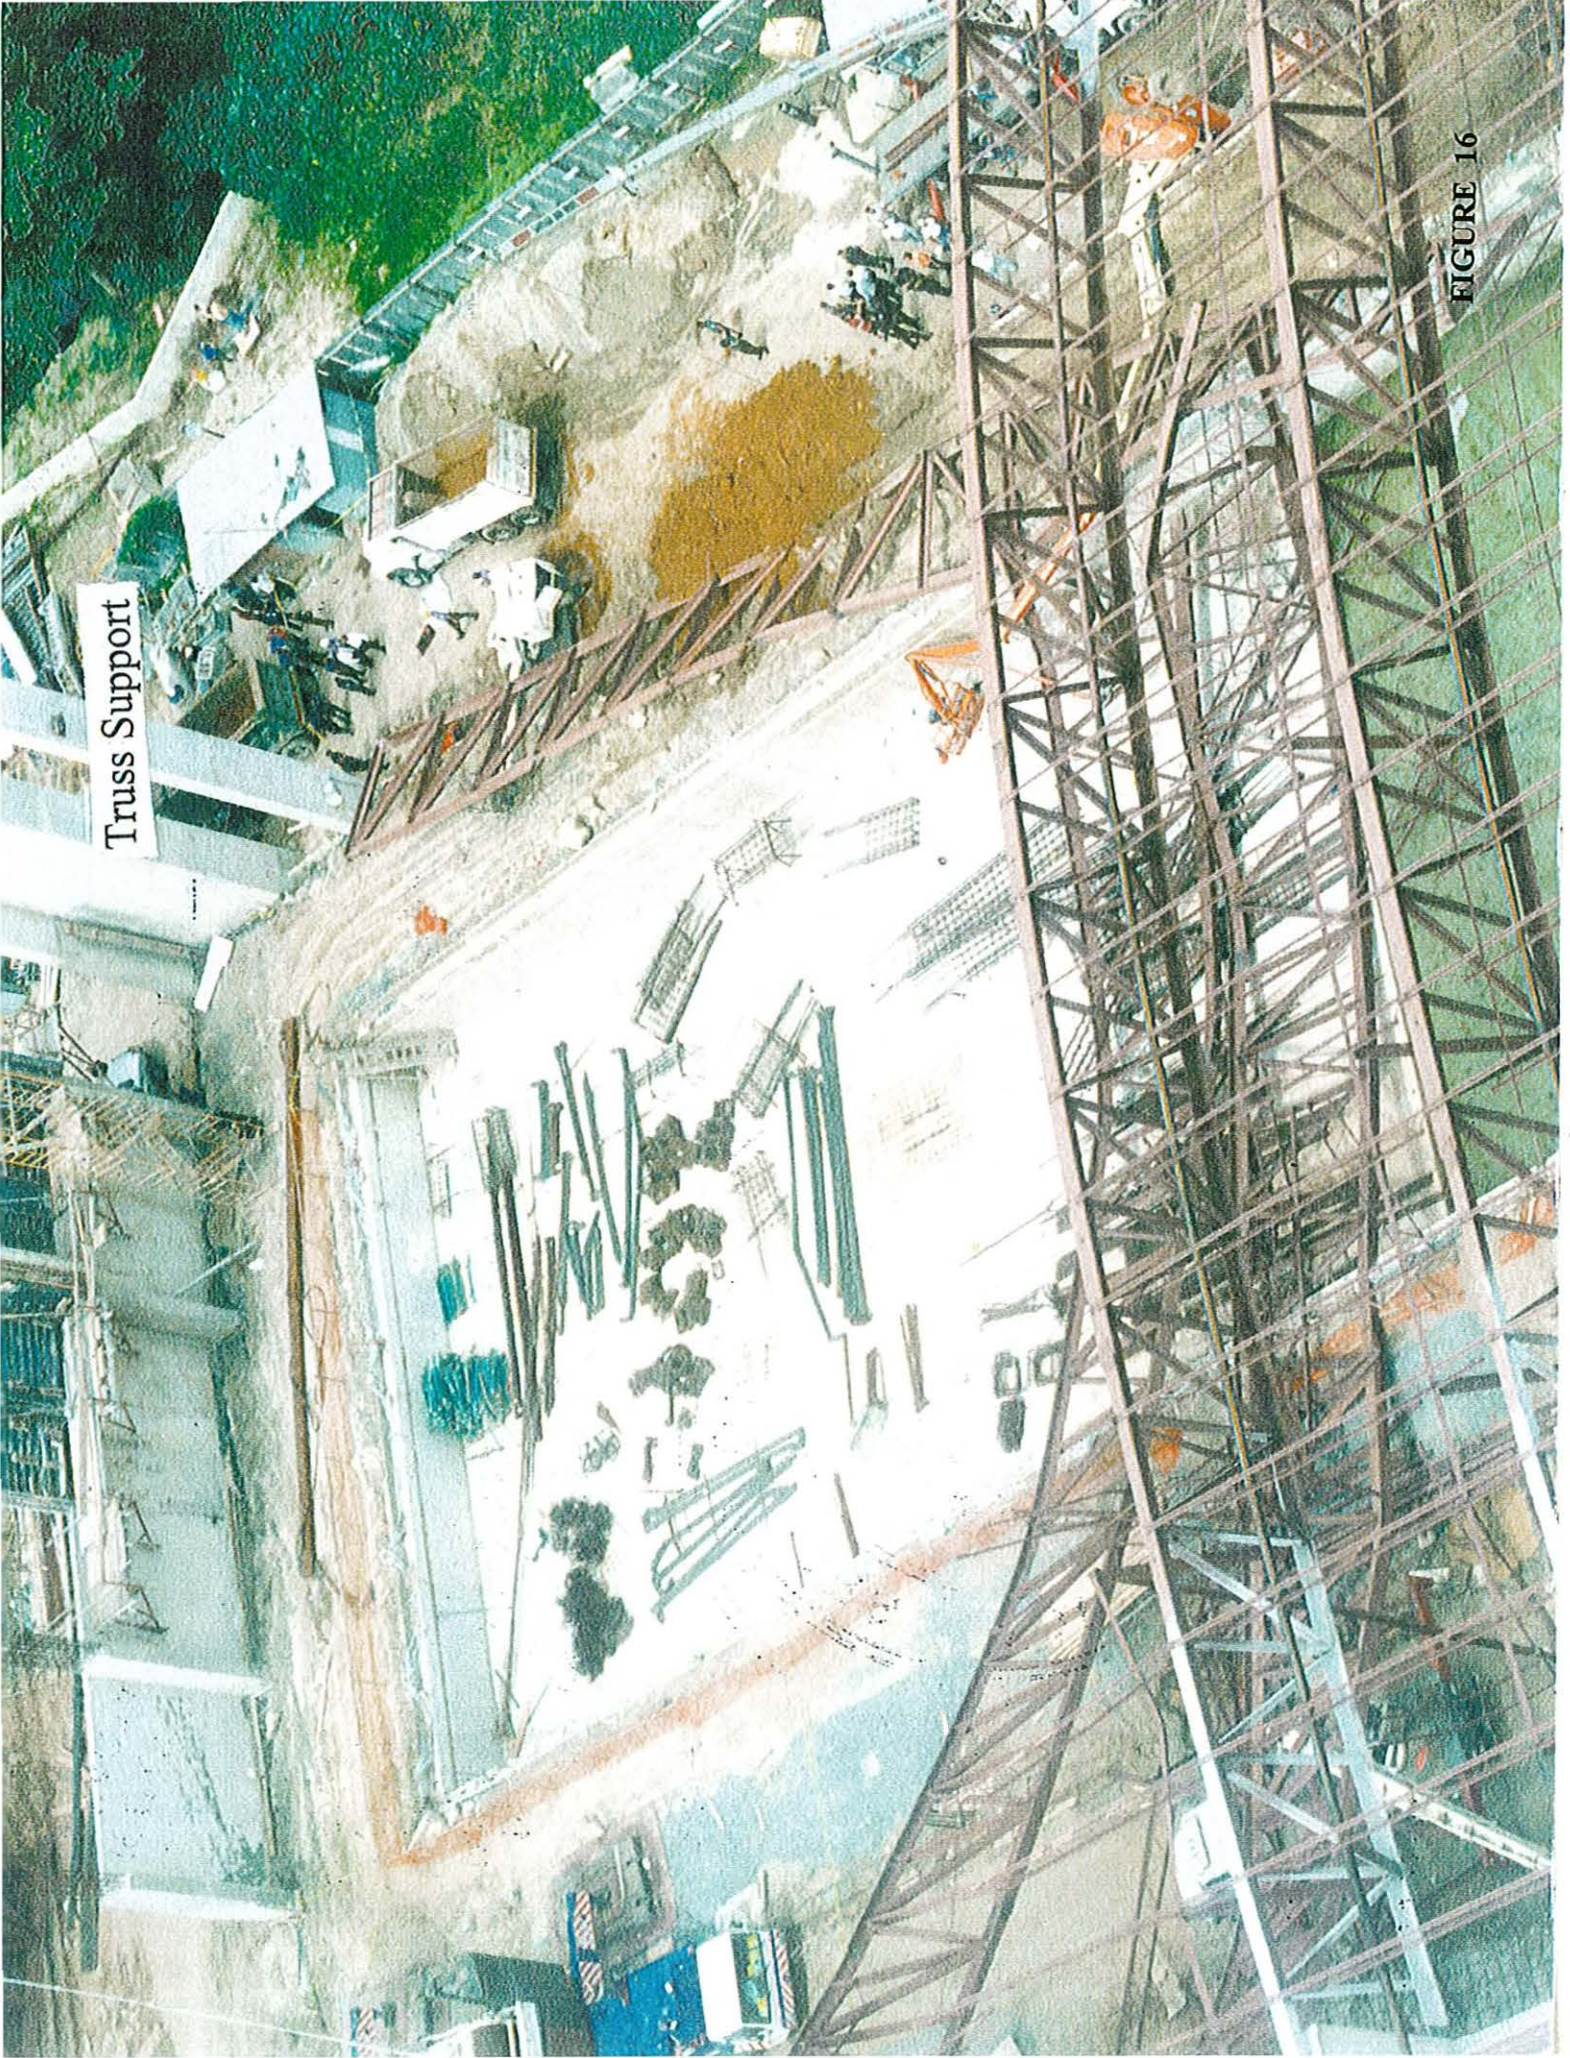
FIGURE 16

Truss Support

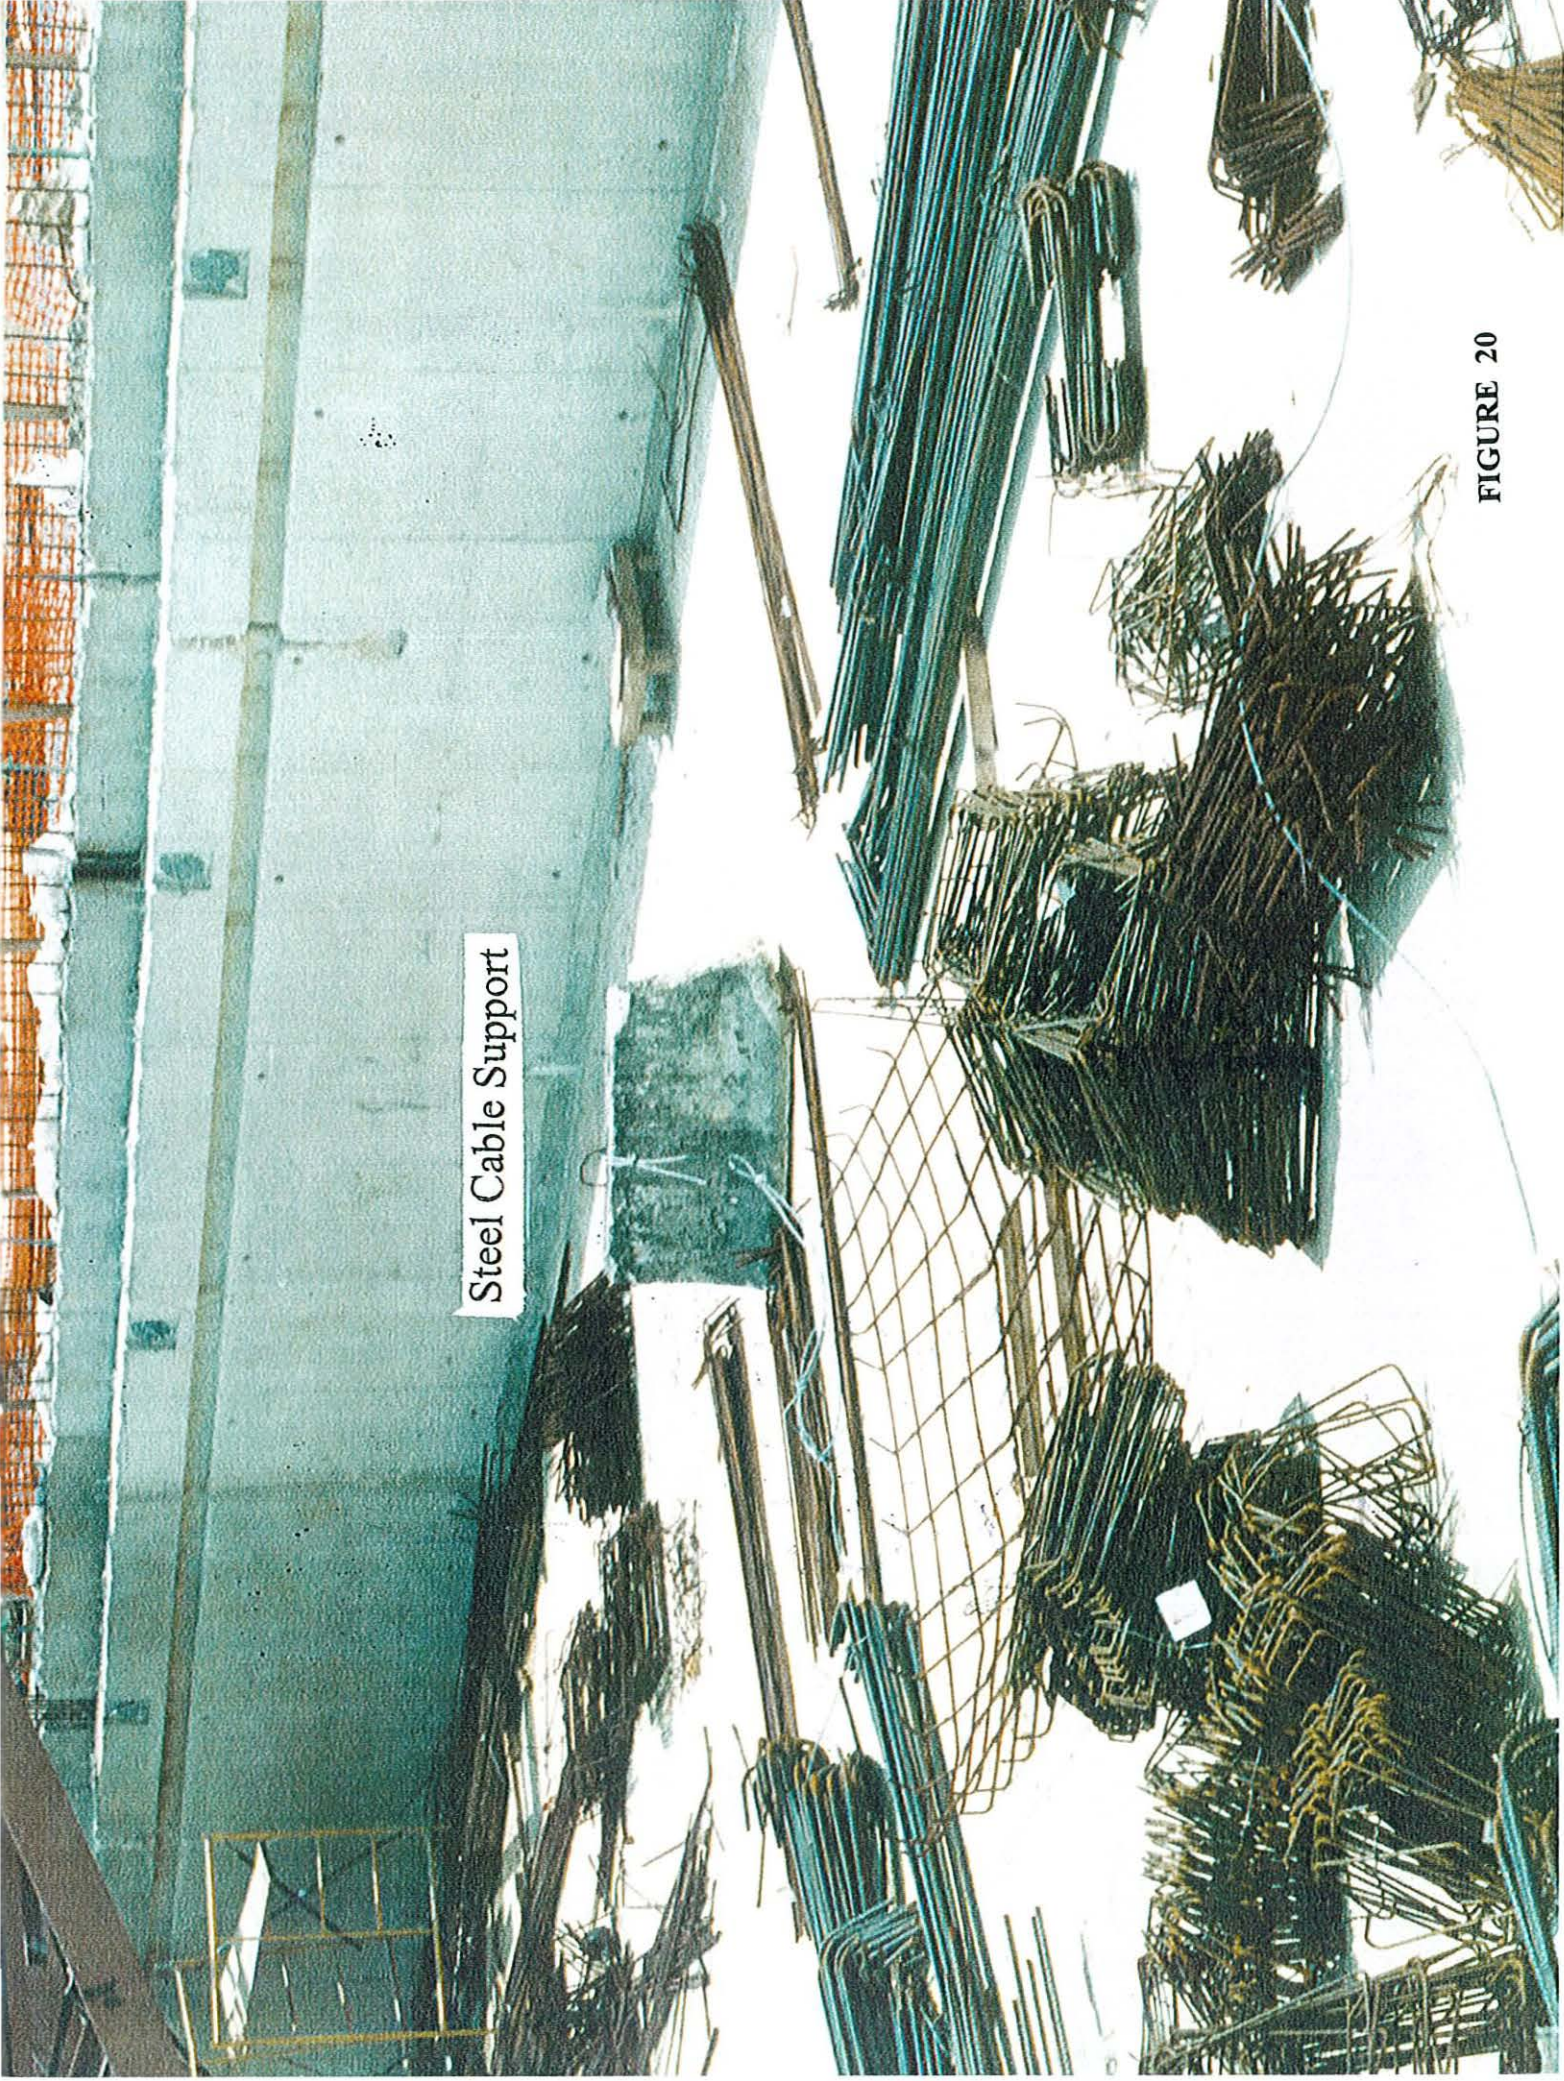
FIGURE 20

It is evident that the wire ropes were not tightened to the required tension because this was done only by human strength. Wire ropes do not lend themselves to be tightened around an 18-inch deep structural section without proper equipment. Wire ropes in such conditions would neither prevent the top chord's lateral translation nor its rotation. The wire ropes were therefore ineffective to act as braces. The following reasons support rejection of the use of wire ropes as viable braces to prevent lateral torsional buckling:

1. The wire ropes were loosely wrapped around the top chord. SM had no mechanism available to tighten the wire rope around the top chord or around the concrete dead man.
2. There were no turnbuckles to tighten the ropes
3. There was no monitoring of the condition and sag of the wire ropes after they were erected.
4. The wire ropes are flexible members, and under the conditions described above, could not have offered any restraint against translation and rotation of the top chord of the girder truss.

Steel Cable Support
