Investigation of the March 1, 2006, Collapse of Stripping Platform at San Marco Place, Jacksonville, FL

U.S. Department of Labor
Occupational Safety and Health

August 2006

Report Prepared by
Mohammad Ayub, PE
Office of Engineering Services
Directorate of Construction

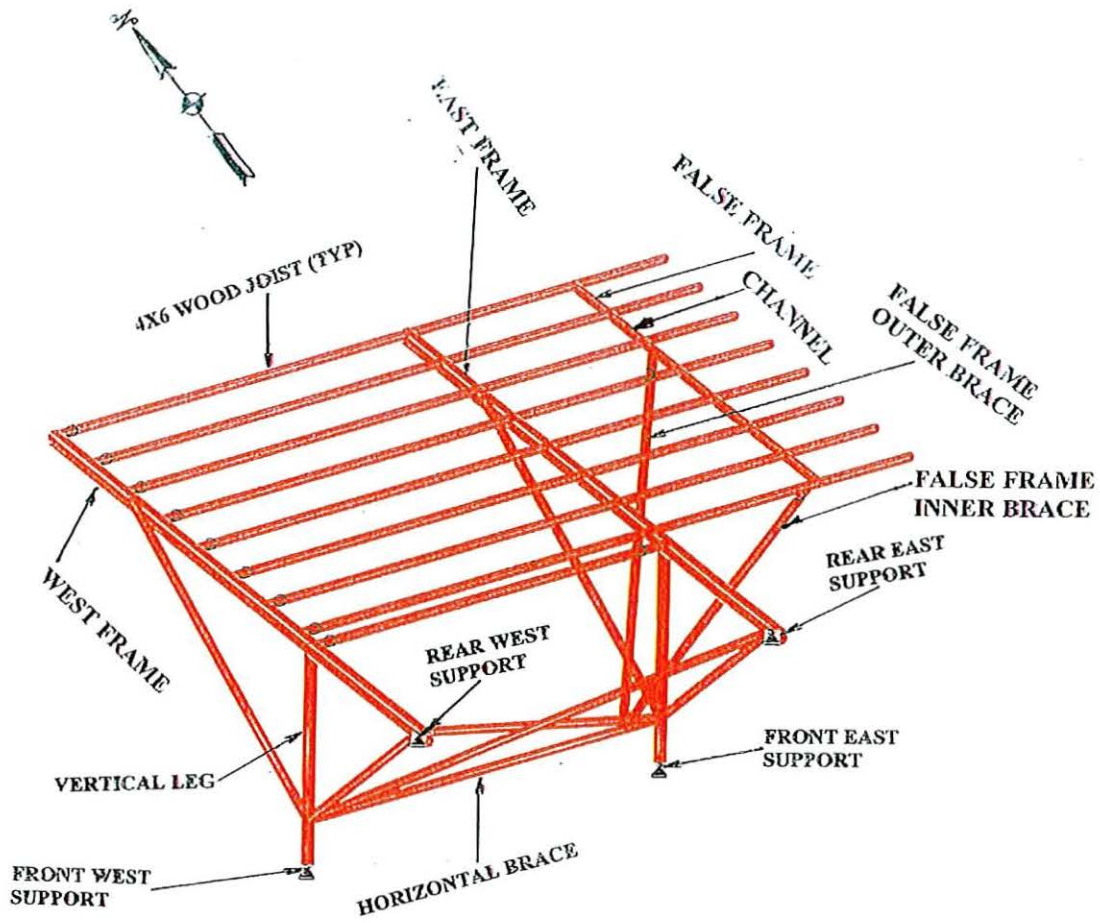
FIGURE 1

The false frame consisted of a horizontal steel channel member equivalent to C 4x7 running in a north-south direction. Unlike the east and west frames, the false frame was not supported by any vertical column. Instead, it was supported by two sloping braces, hereafter called the outside brace and inside brace. Both were approximately 1 $\frac{7}{8}$ " round pipes, see figures 1 thru 7.

THREE DIMENSIONAL OUTINORD STRIPPING PLATFORM FRAMING

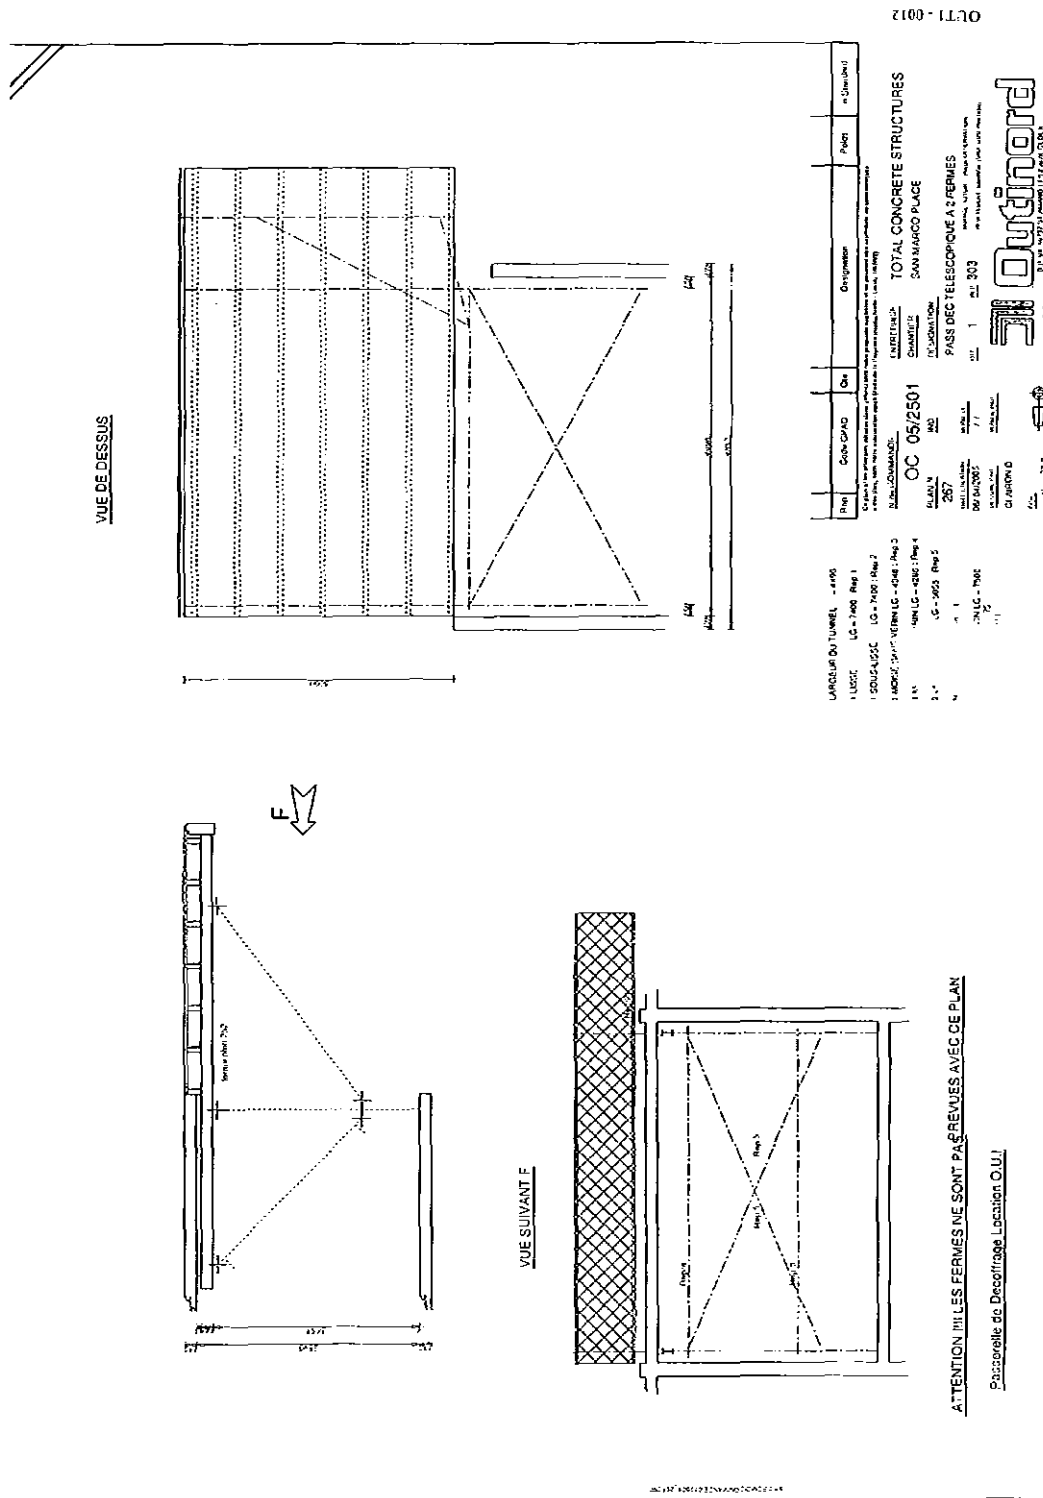
FIGURE 3

The area of interest where the platform failed was bounded by column lines F.5 to C.9.5 and 1 to 3.5. The platform was known as "Wood Platform 303", as per OT's drawings. The platform consisted of two layers of $\frac{3}{4}$ " plywood supported over 4x6 wood joists spanning in the east-west direction, spaced at about 2'-3" o.c. The wood joists were in turn supported by three steel frames; the east frame, the west frame and the outer false frame. The east and west frames were about 13'-9" apart. The false frame was approximately 6'-6" east of the east frame. The plywood platform and the 4x6 joists cantilevered about 3'-6" beyond the false frame. The east and west frames were identical and oriented in the north-south direction. The north end of the frames were facing the outside of the building. The frames consisted of a horizontal member, equivalent to W6x16, a $3\frac{1}{2}$ " round column, and two diagonal braces, on the north and south sides respectively. The exterior and interior braces were $3\frac{1}{2}$ " and 3" round pipes, respectively, see figures 1 thru 6. In addition to the main structural members, the east and west frames were braced by round pipes. Each of the east or the west frames was supported at two locations. The bottom of the columns was supported on the top of the 19th floor slab and the top of the interior brace was supported on the underside of the 20th floor slab, see figures 3 thru 5.

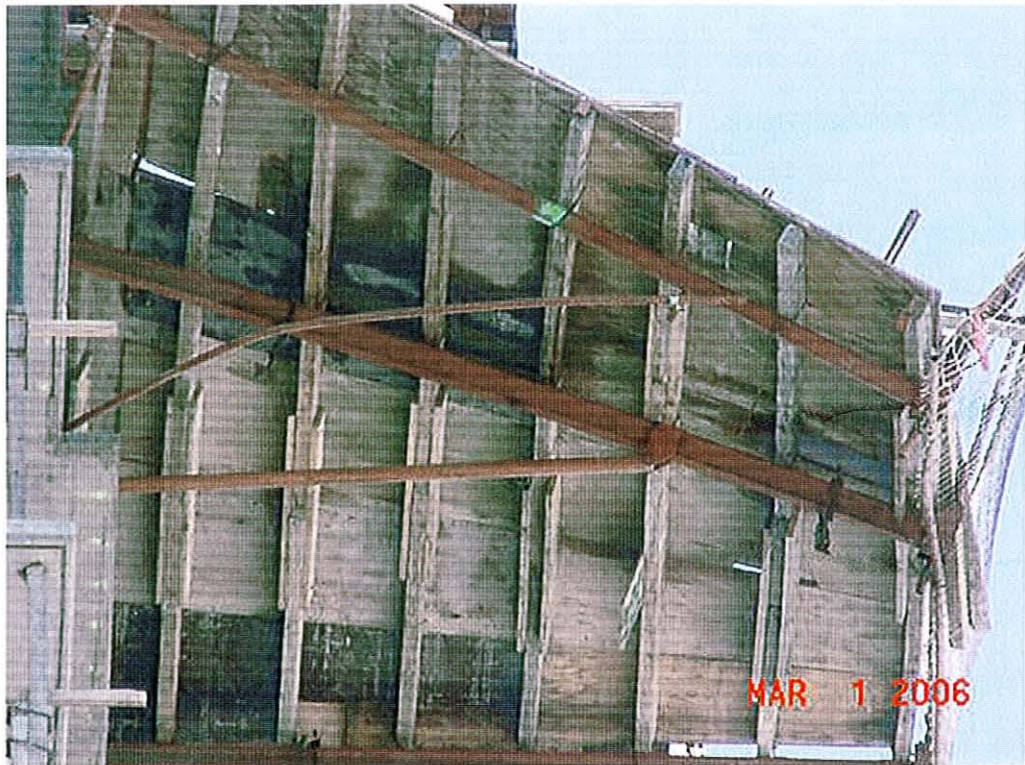
Figure 7

The failure resulted in the platform tilting downward at the northeast corner. The column of the east frame buckled making a right angle at about 1'-8" above the base. The exterior and interior braces of the east frame bowed approximately 2" and 4", respectively. Most significantly the outside brace of the false frame buckled about 15". The inside brace of the false frame also buckled approximately 5½". Other bracing members also were distressed, see Figures 7 thru 18.
