INVESTIGATION OF THE AUGUST 22, 2006, FATAL EXCAVATION COLLAPSE AT RED HOOK, ST. THOMAS, U.S. VIRGIN ISLANDS

U.S. Department of Labor
Occupational Safety and Health Administration

February 2007

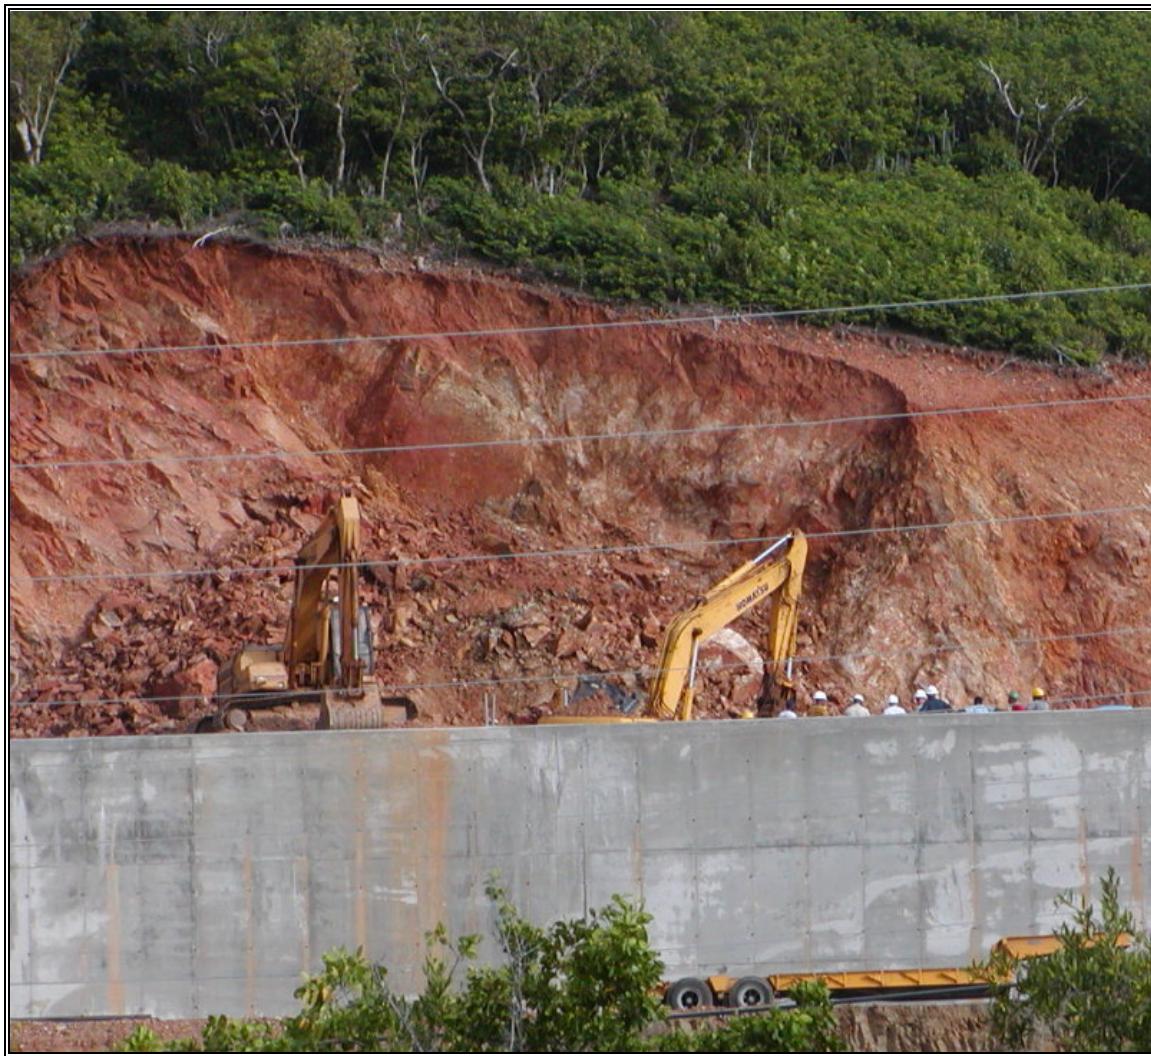
Cover photo was provided by
GEC, LLC
St. Croix, U.S. Virgin Islands

The figure on the cover of this report presents the overall shape of the collapse. As shown, the collapse was in a near circular or spoon shape. Based on references presented in Figures 23 and 24, a collapse of this shape would mostly occur in overburden soil, weathered rock, waste rock or heavily fractured rock. Therefore, the earth deposits in the collapsed area could only be residual soil, weathered rock or heavily fractured rock. They were more soil-like than rock-like deposits.

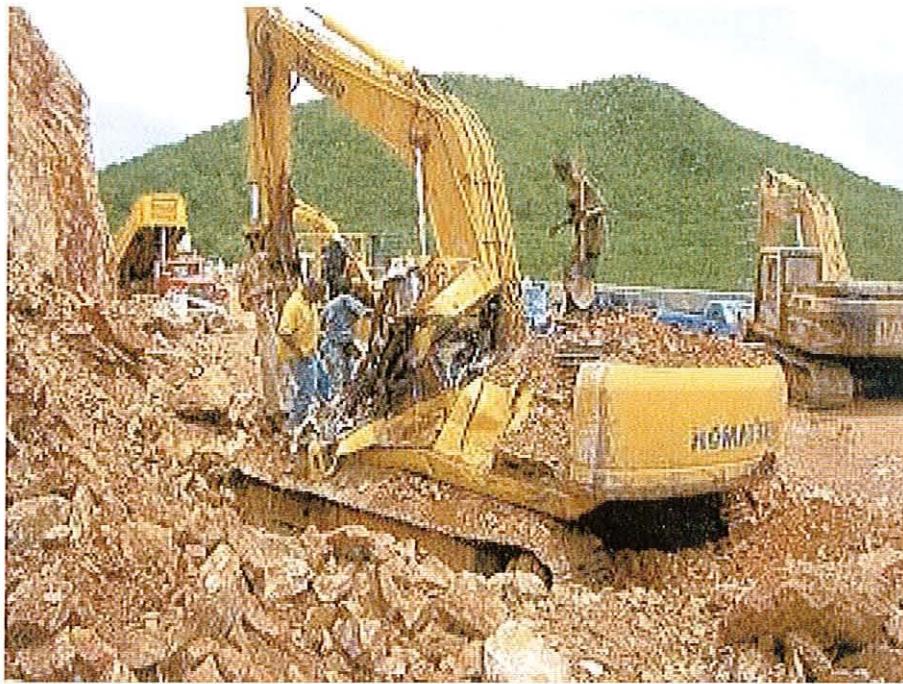
Around 11:00 a.m., the over 40 foot high, steep excavated slope suddenly collapsed. The collapsed earth crushed the cab side of the excavator and then buried it entirely (Figures 5 and 6). As a result of the collapse, the employee inside the cab was killed. At the time of the incident, the excavator was breaking the base of the excavated slope.

Figure 5. Location of the Komatsu PC 220 Excavator during the Rescue Operation, Looking Toward North (Provided by GEC, LLC.).

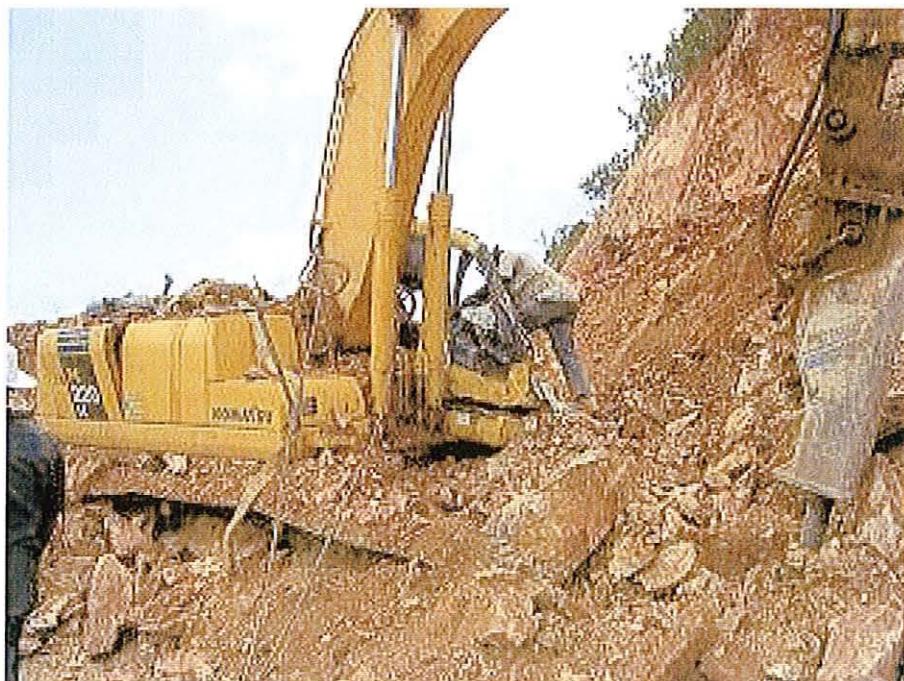
Figure 6. Location of the Komatsu PC 220 Excavator during the Rescue Operation, Looking Toward South (Provided by GEC, LLC.).

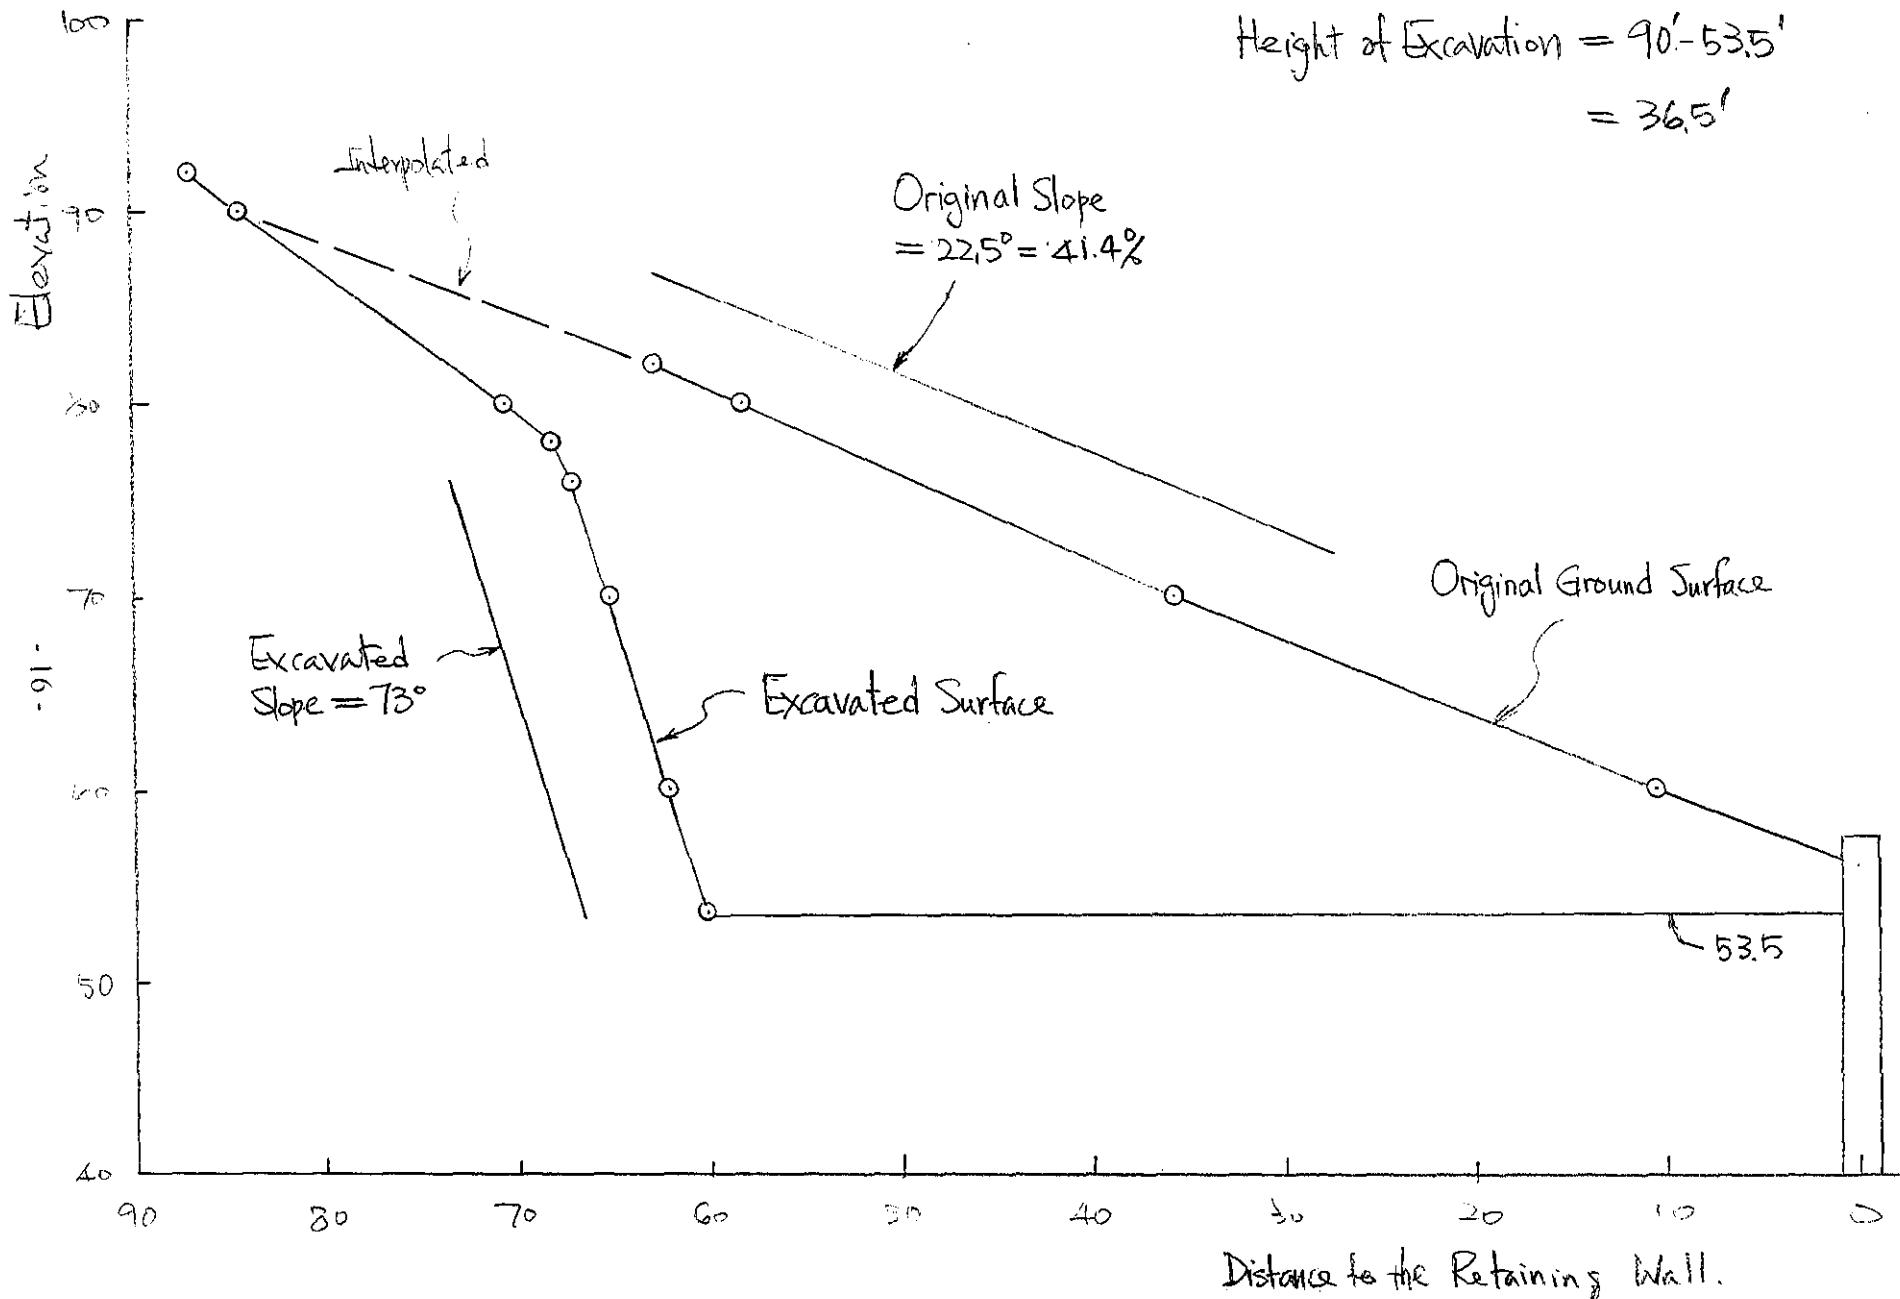
Based on the original topography of the site before the excavation (Figure 3) and the corresponding configuration after the collapse (Figure 4), six cross sections around the collapsed area were developed. The location of the sections is shown in Figure 4. The first two sections (Figures 7 and 8) were to the north of the collapsed area. From these two figures, the following information was identified:

- The original ground slope varied from 41 to 45%.
- The cut slope averaged 76 degrees, approximately $\frac{1}{4}$ (horizontal) to 1(vertical).
- The excavated elevation of the parking level 2 was about the same as the pavement elevation as indicated in Figures 1 and 2.

Figure 7. Cross Section of the Original Ground Surface and the Excavated Surface, North of the Collapsed Area (73 feet from the North End of the Retaining Wall).

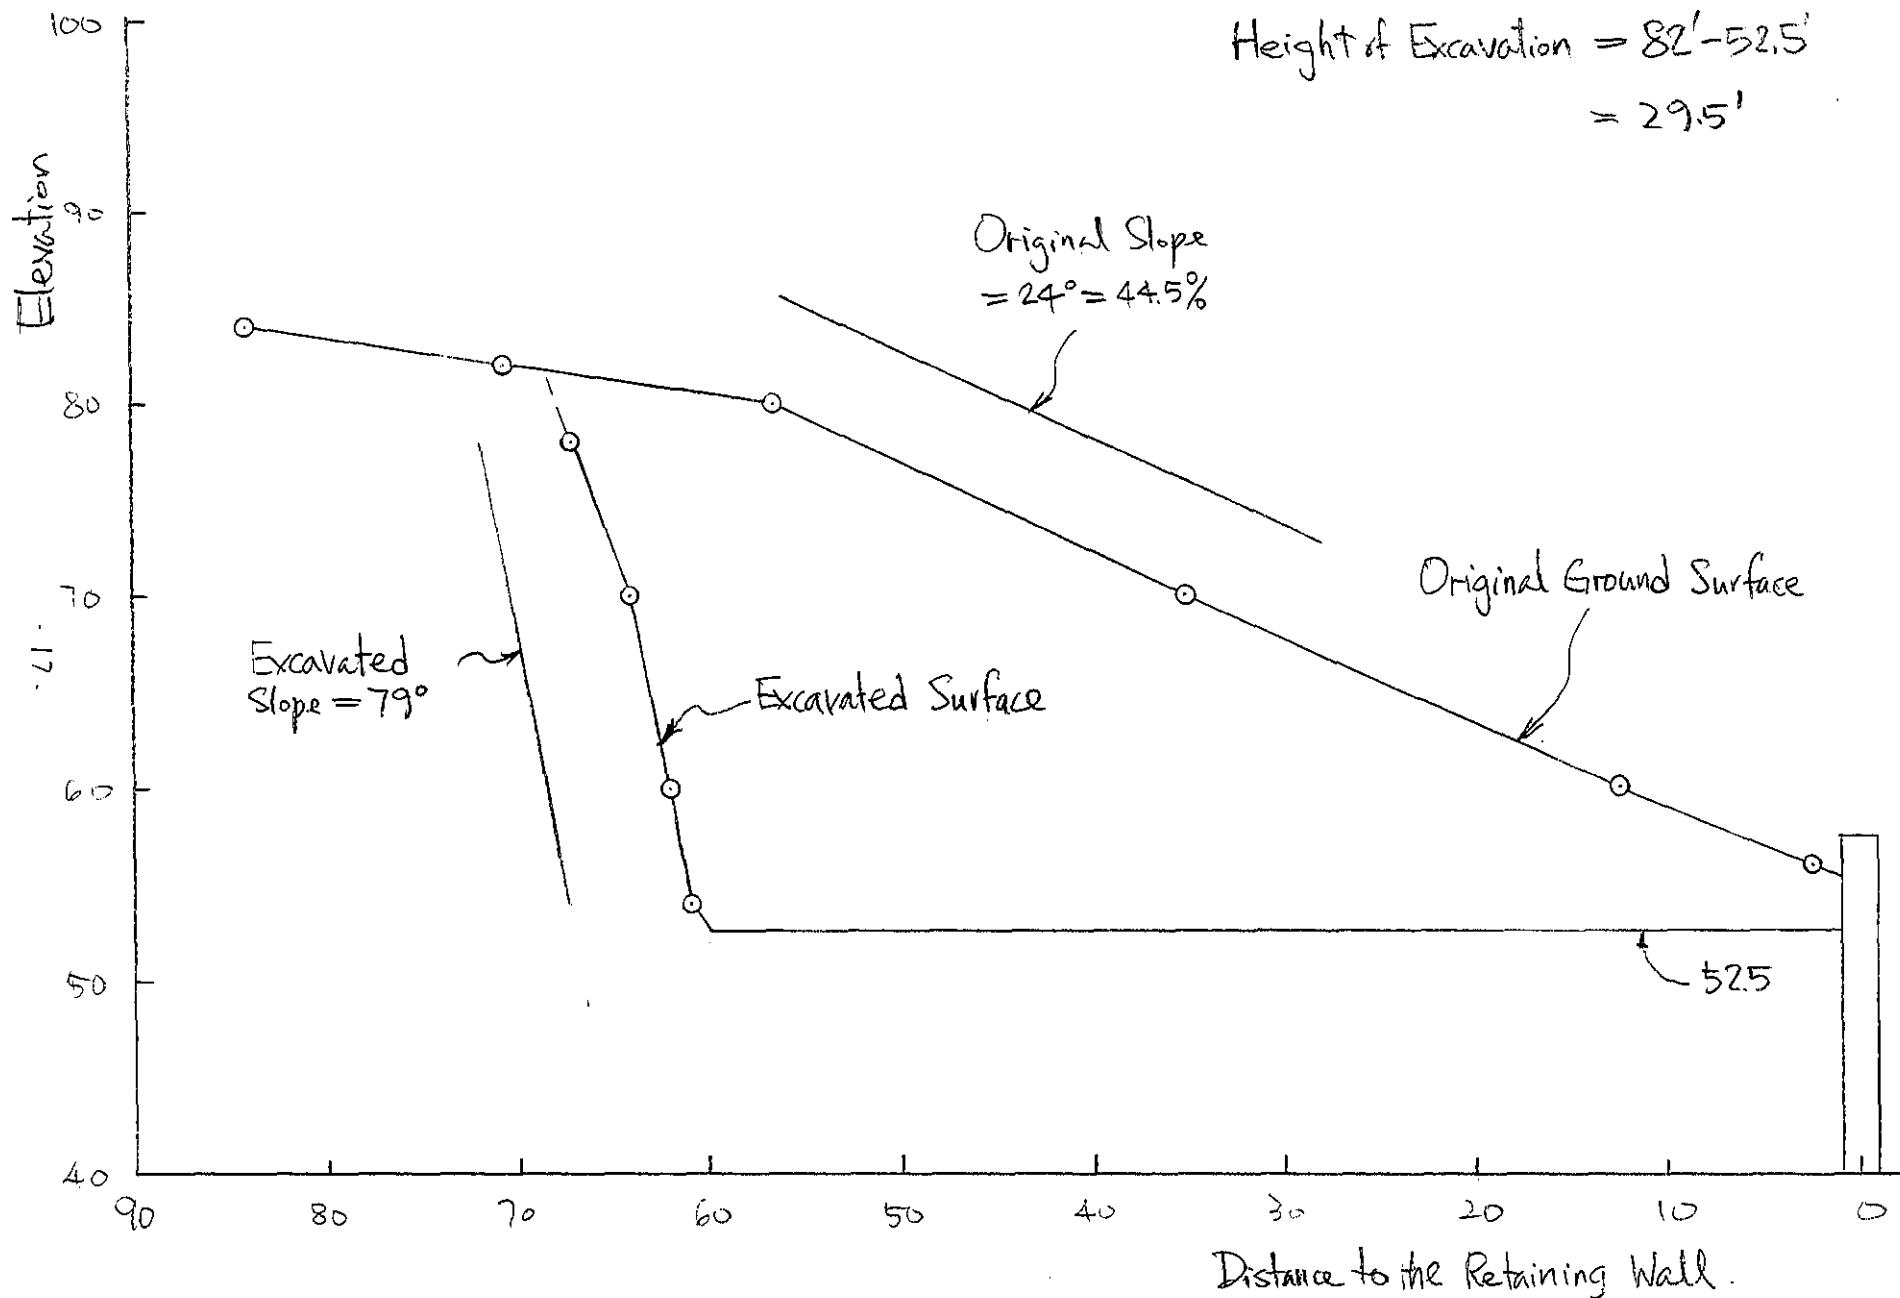
Figure 8. Cross Section of the Original Ground Surface and the Excavated Surface, North of the Collapsed Area (168 feet from the North End of the Retaining Wall).

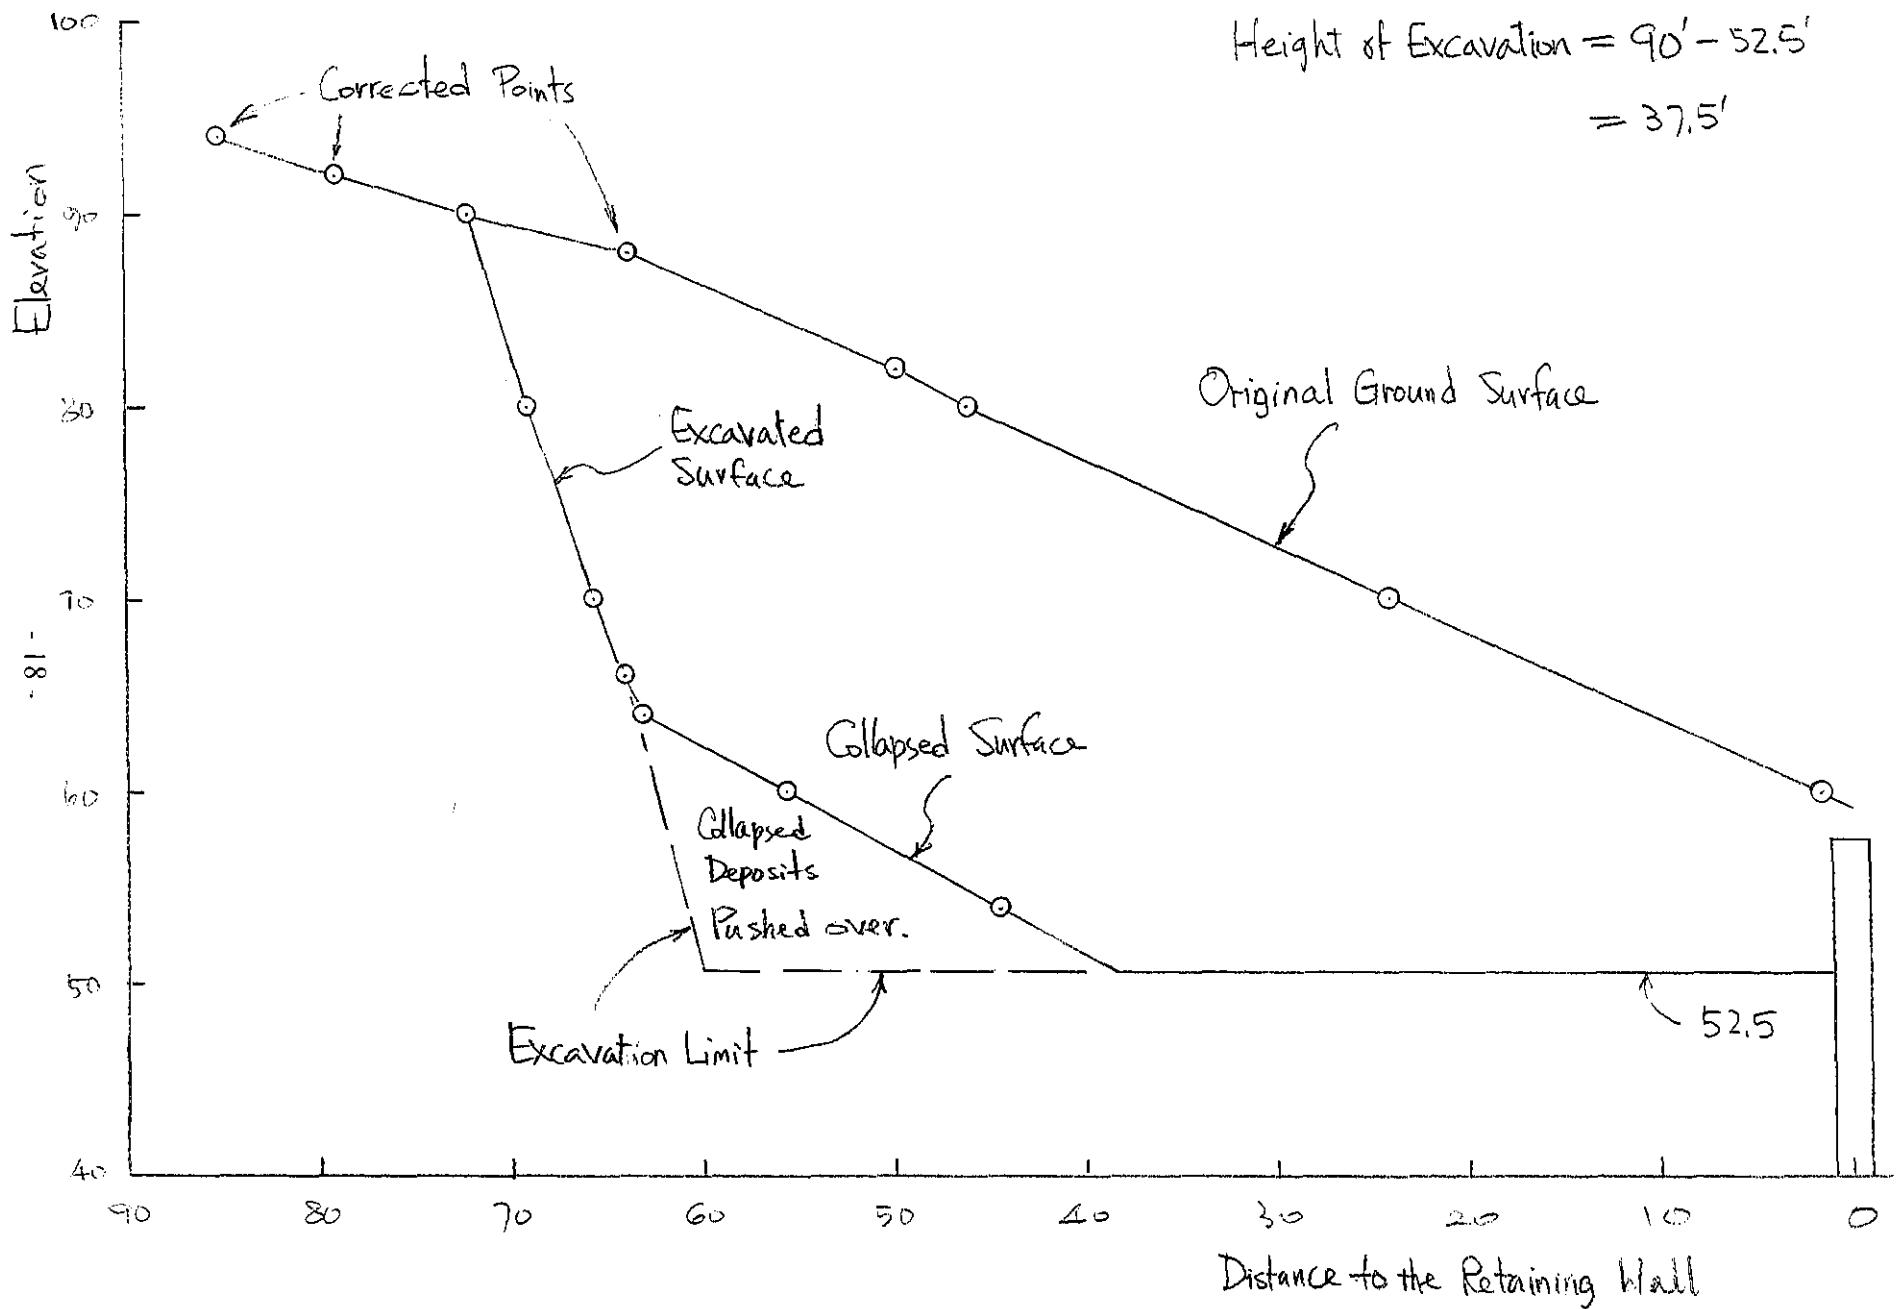
Figures 9 through 12 were developed using the above information. The upper portion of the cut slope in Figure 9 appeared to be intact. The earth deposits on the base of the slope appeared to be pushed over from the south during the rescue operation. This section could represent the north end of the collapse. Figures 10 and 11 were sections in the middle of the collapse. As indicated, the average thickness of the collapsed earth deposits was 8 feet.

Figure 9. Cross Section of the Original Ground Surface, the Excavated Surface and the Failure Surface in the Collapse Area (50 feet from the turning Point of the Retaining Wall).

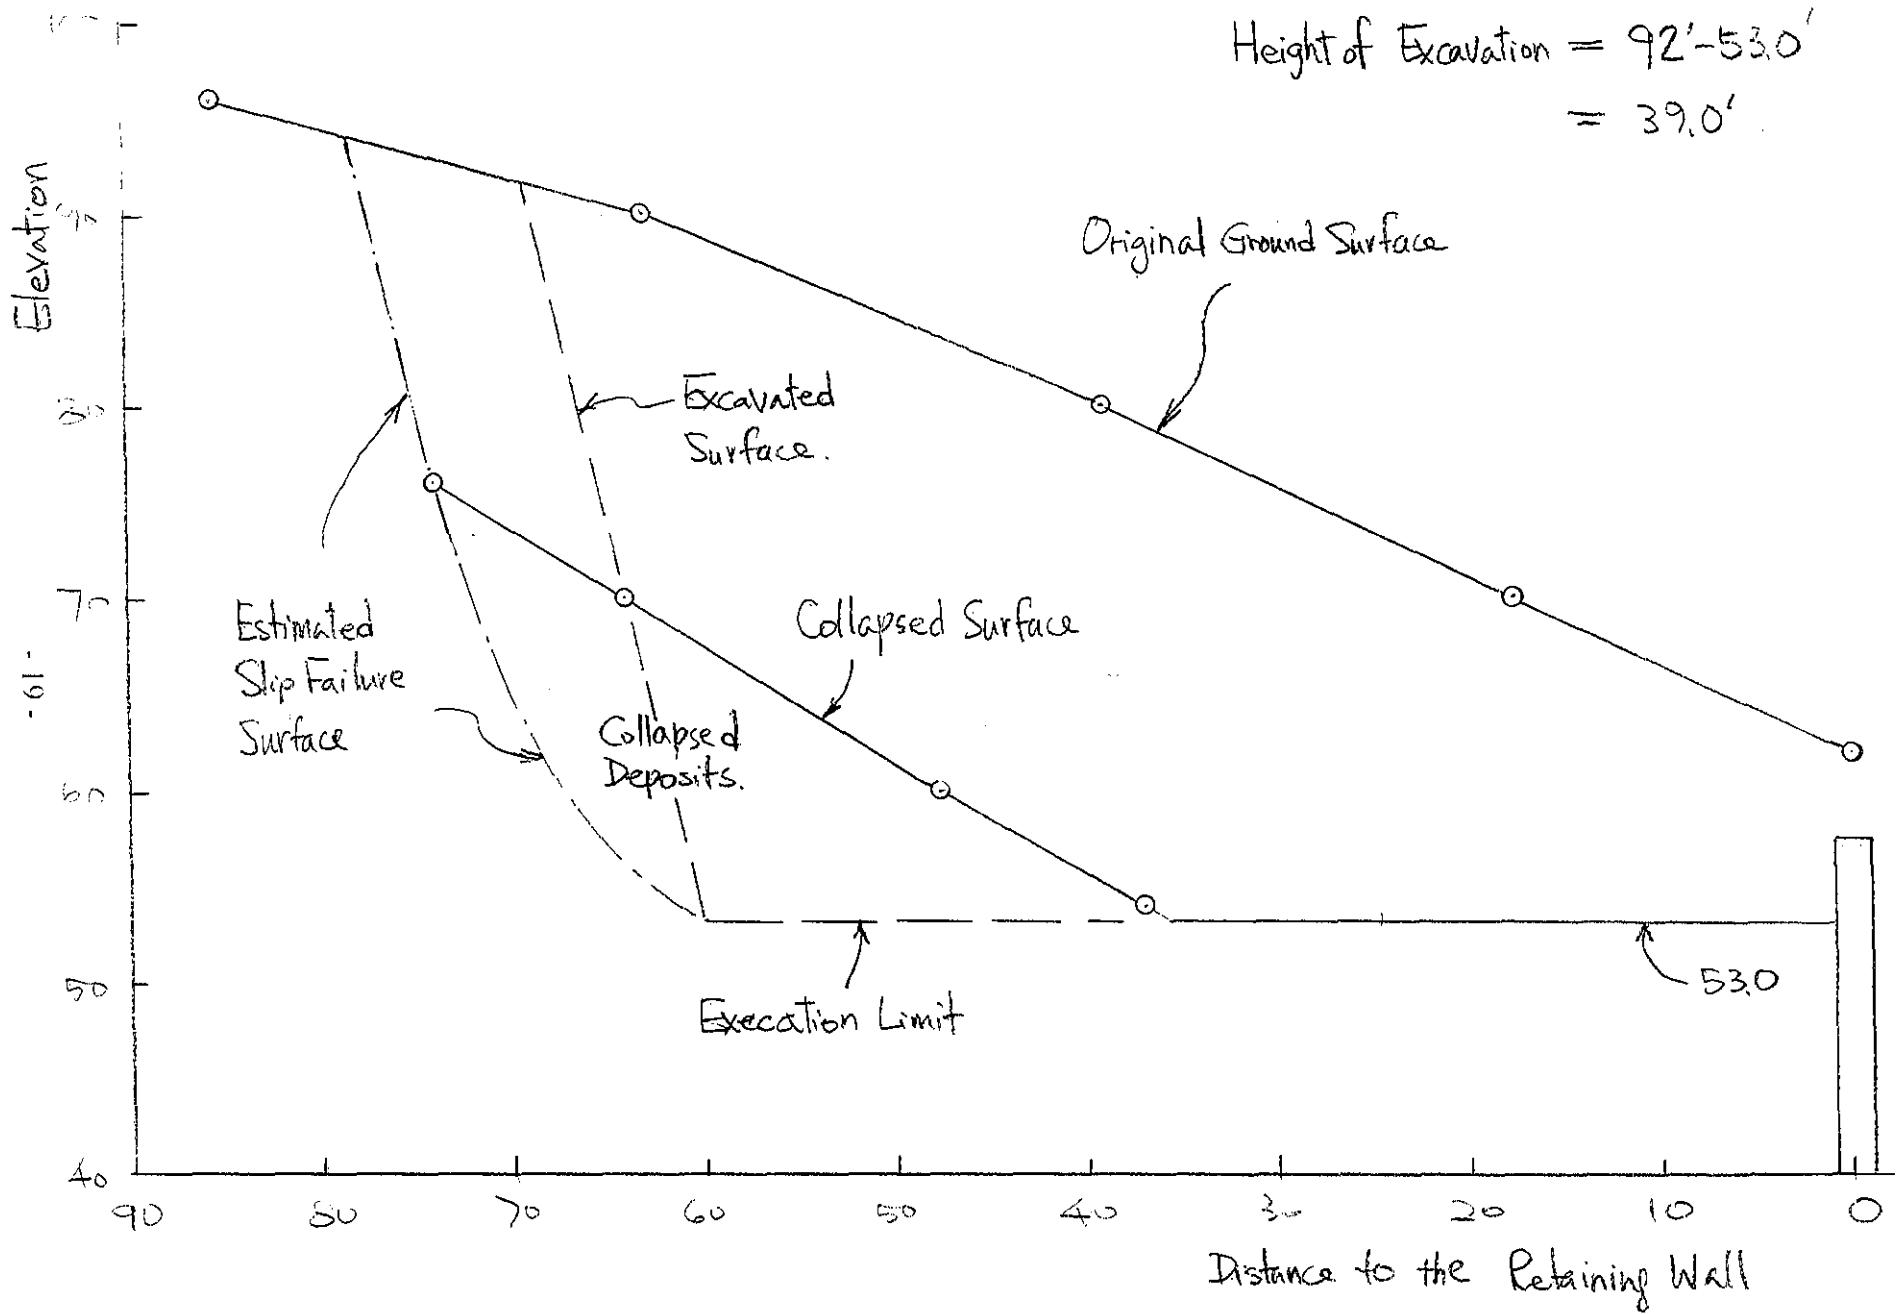
Figure 10. Cross Section of the Original Ground Surface, the Excavated Surface and the Failure Surface in the Collapse Area (70 feet from the turning Point of the Retaining Wall).

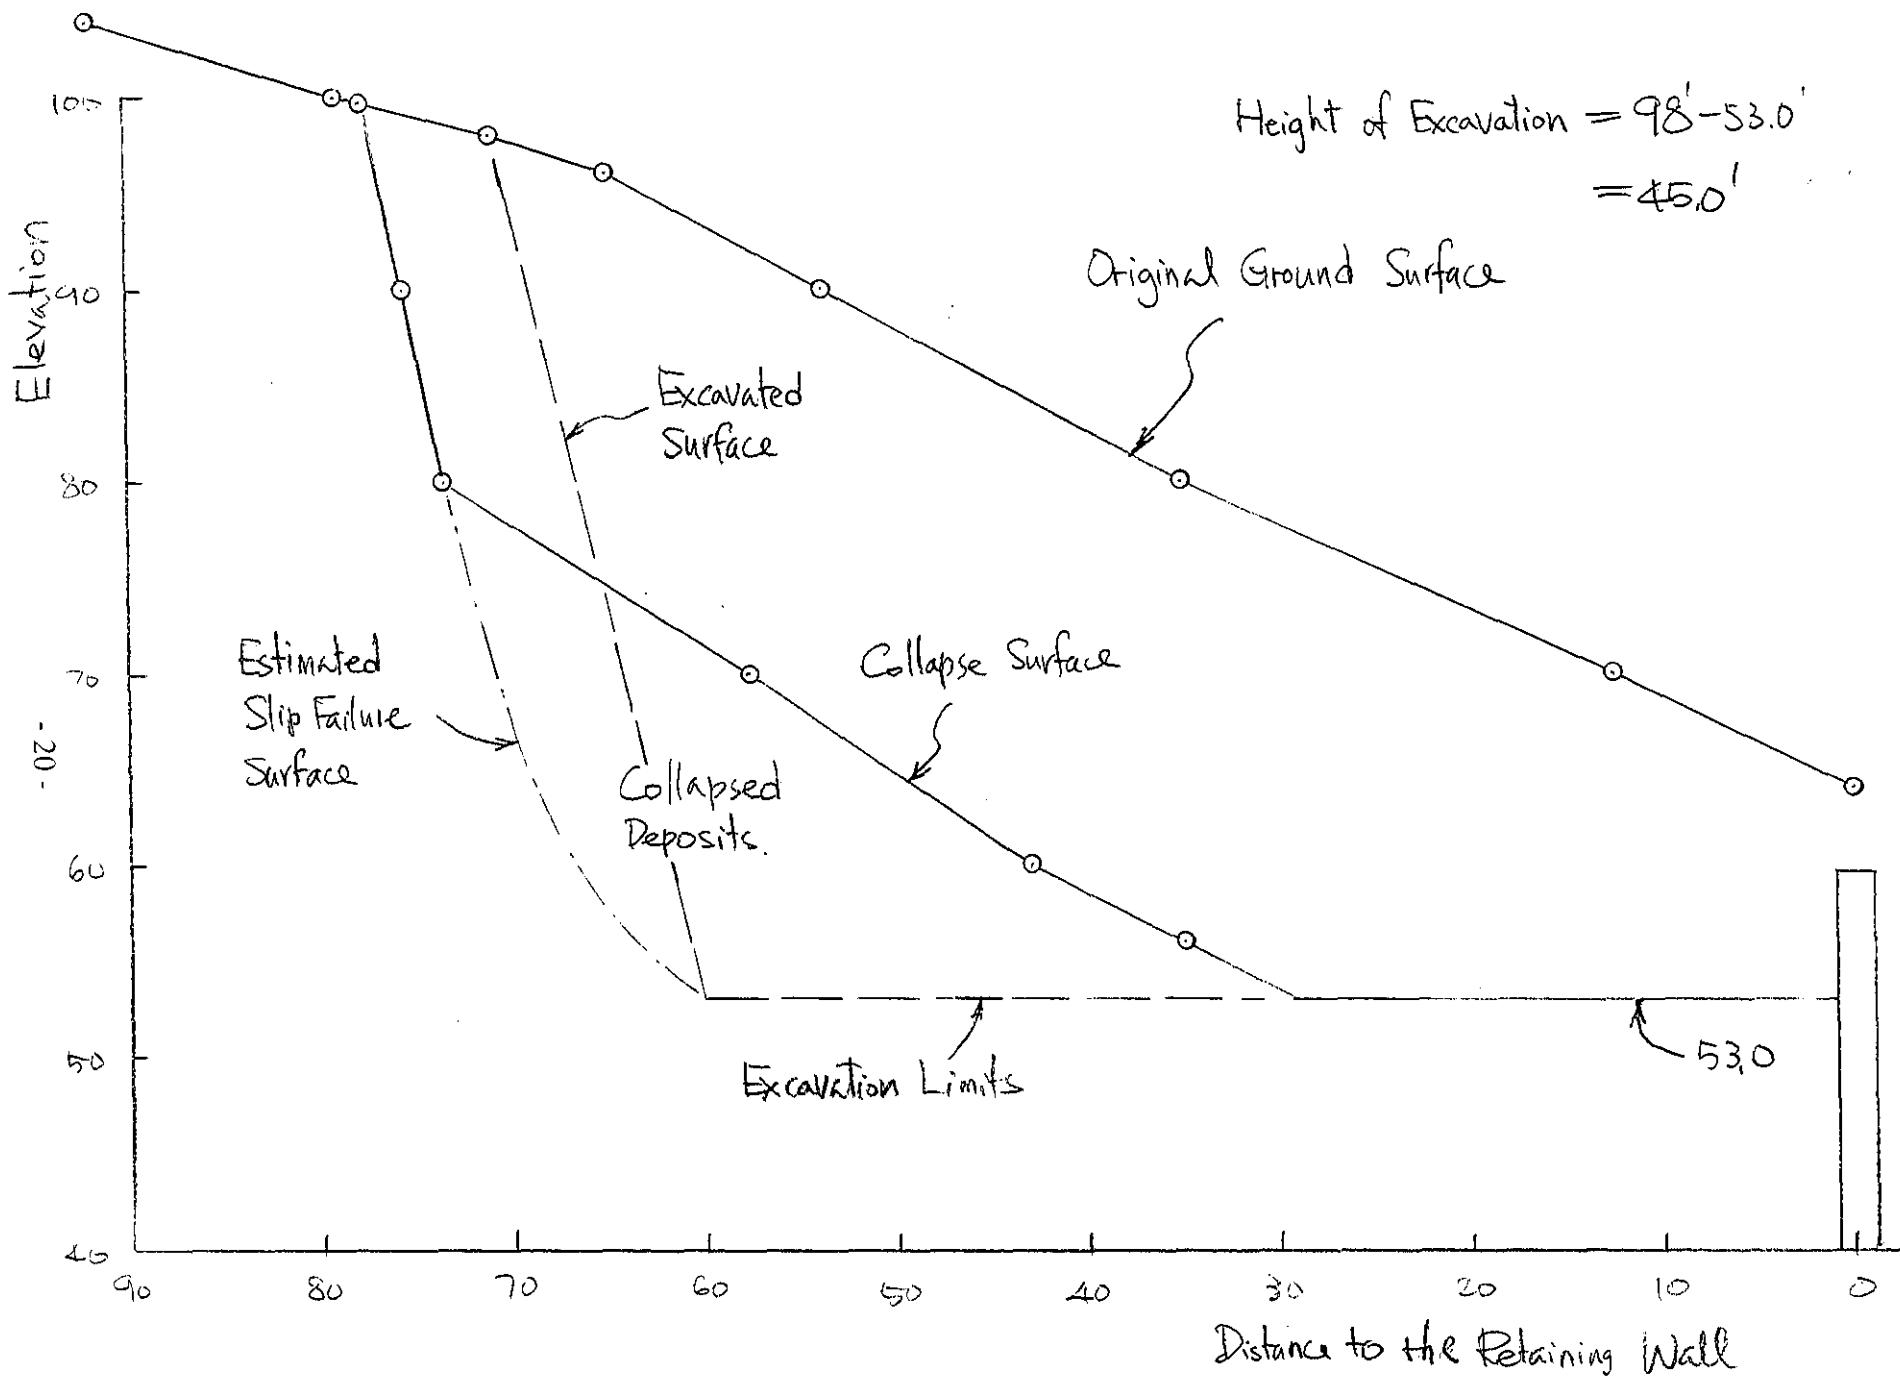
Figure 11. Cross Section of the Original Ground Surface, the Excavated Surface and the Failure Surface in the Collapse Area (90 feet from the turning Point of the Retaining Wall).

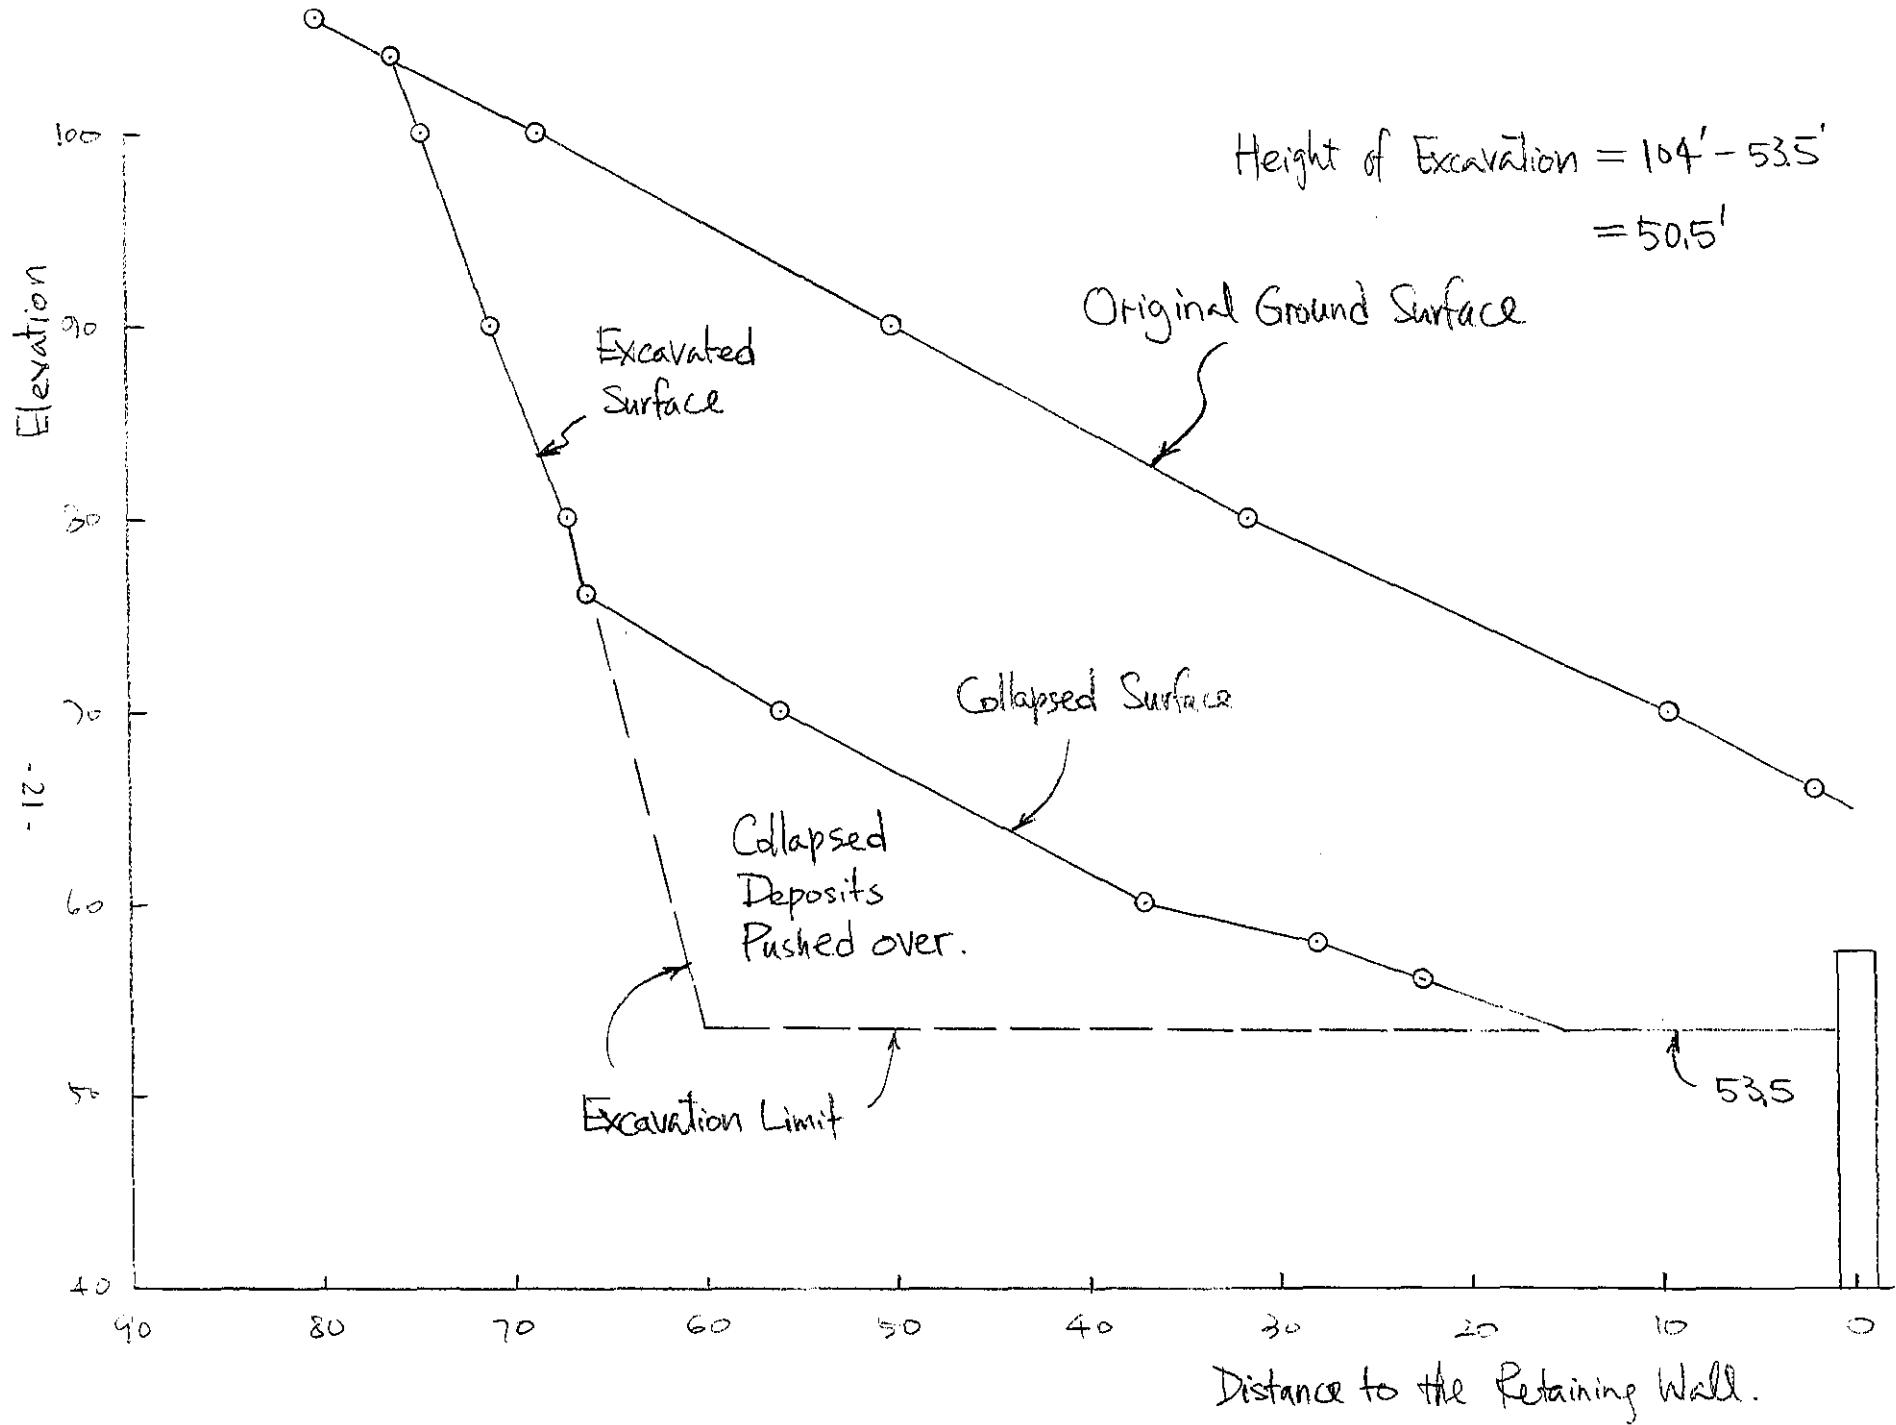
The upper portion of the cut slope in Figure 12 appeared to be intact. The earth deposits at the base of the slope appeared to be pushed over from the north. This section could represent the south end of the collapse. Based on Figures 9 through 12, the average height of the excavation was 43 feet and the width of the collapse was 60 feet. As a result, the volume of collapsed materials is estimated as:

Figure 12. Cross Section of the Original Ground Surface, the Excavated Surface and the Failure Surface in the Collapse Area (110 feet from the turning Point of the Retaining Wall).

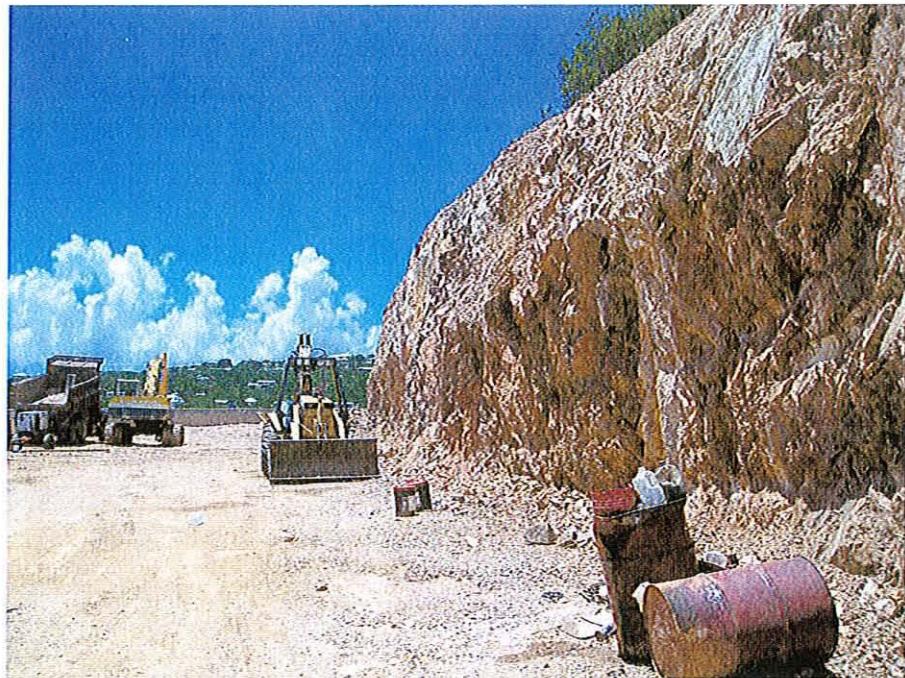
Photographs of the excavated and collapsed surfaces were examined from north to south. Figure 13 represents the excavated surface north of the collapse. As discussed, the exposed surface appeared to be heavily fractured rocks with indentations and over breaks caused by the hydraulic breaker during the excavation. Figures 14 and 15 represent the lower portion of the collapsed surface at its north end. They indicate similar heavily fractured rocks with two large cavities caused either by the excavation over breaks or the collapse.

Figure 13. Excavated Surface North of the Collapsed, Looking Toward South.

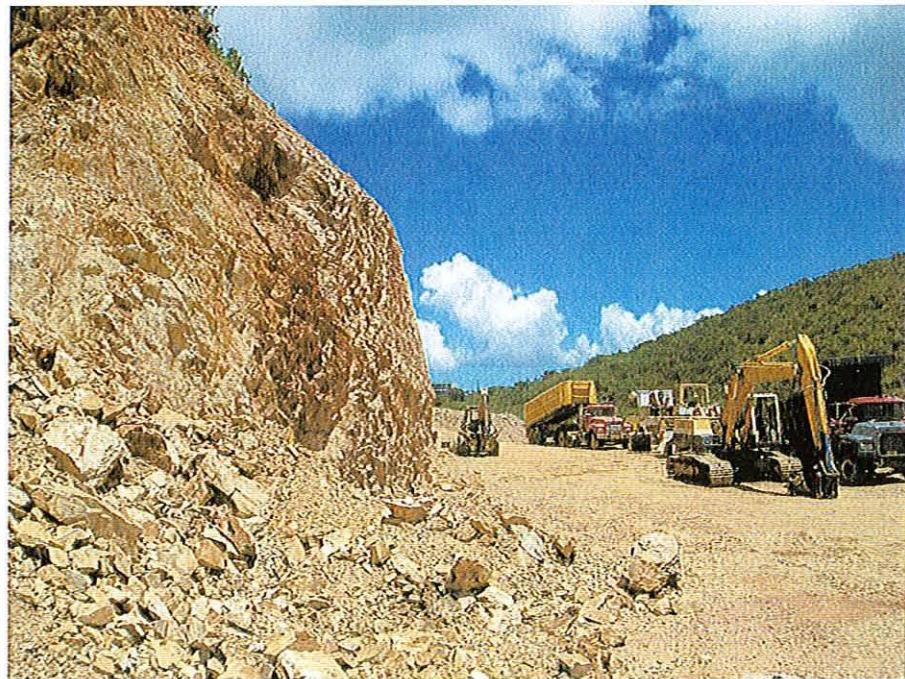
Figure 14. Lower Portion of the Collapse at its North End, Looking Toward North.

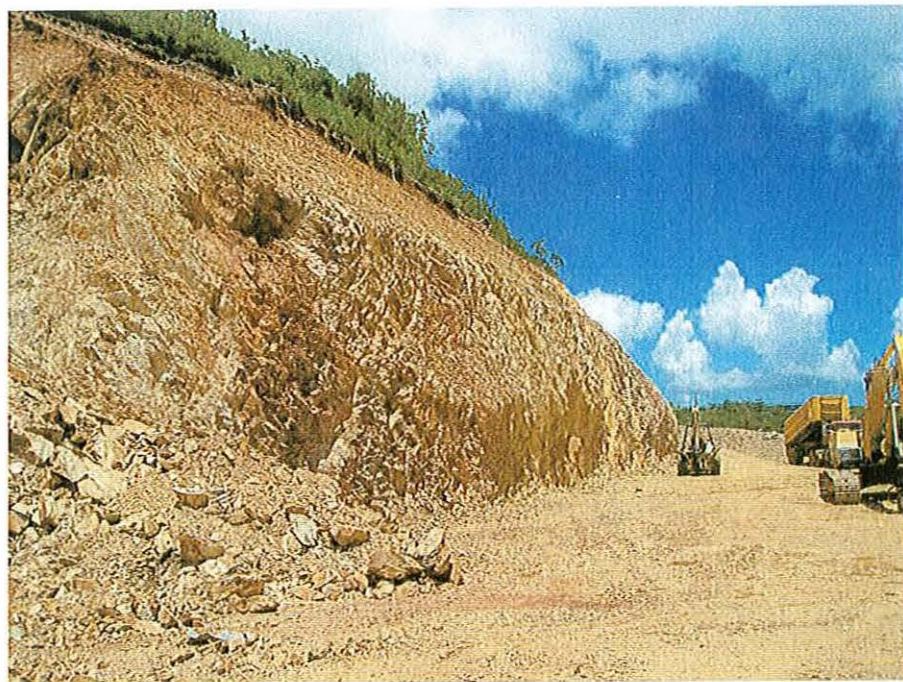
Figure 15. Another View of Figure 15, Looking Toward Northwest.

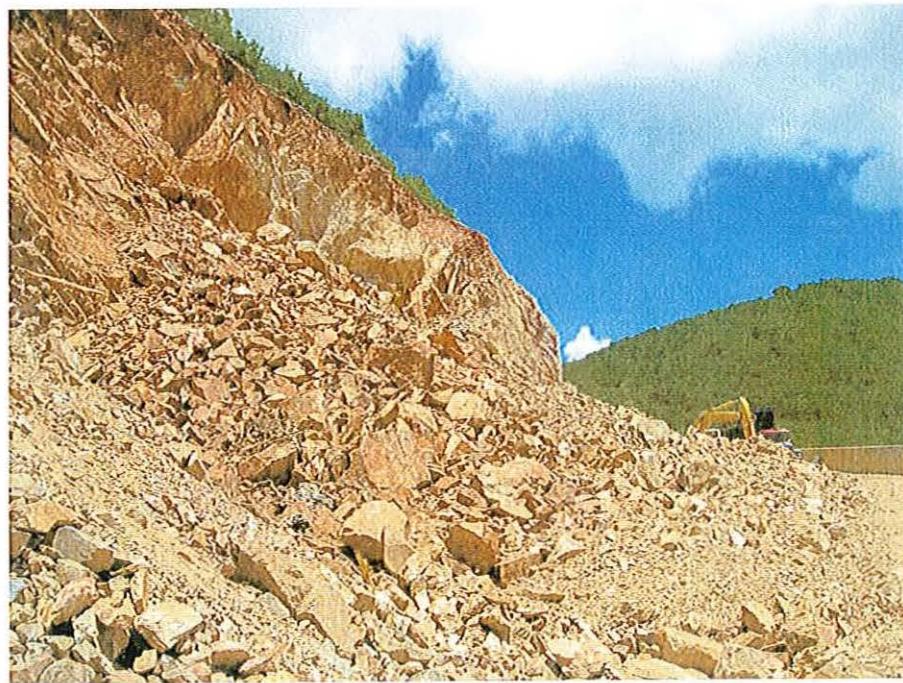
Figures 16 through 18 represent the upper portion of the collapse from north to south. The earth deposits in the upper tension zone varied from residual soil to weathered rock. Weathered rock might appear to be rock but it does not have the strength of rock, as is evident from the weathered rock being crushed to small pieces at the collapsed area.

Figure 16. Upper Portion of the Collapsed Surface (North), Looking Toward North.

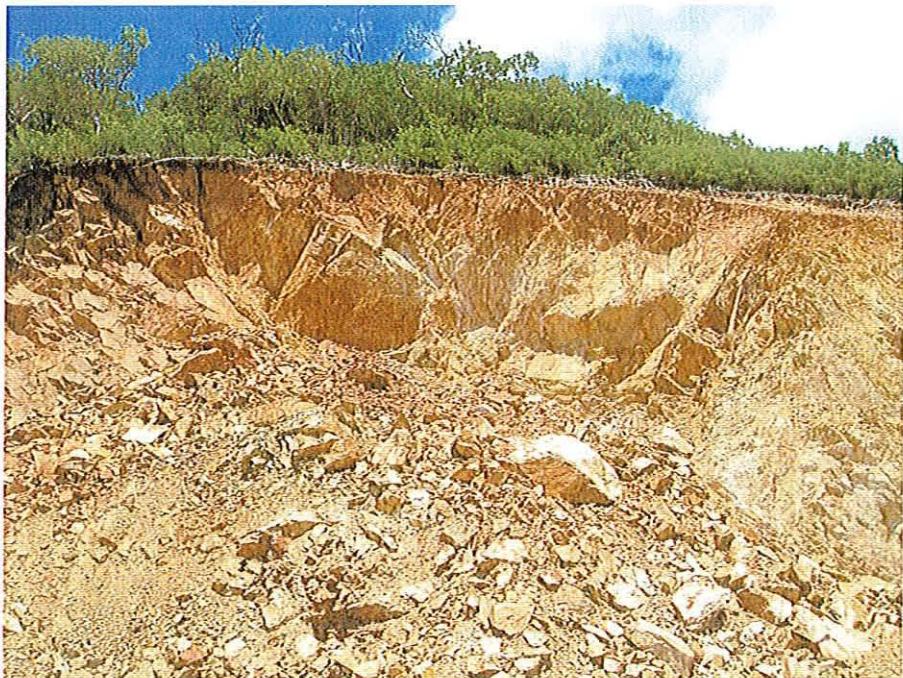
It is interesting to examine Figures 17 and 19. In Figure 17, taken on September 1, 2006, a large weathered rock block could be seen in a seemingly stable position in the upper middle portion of the figure. But Figure 19, taken 25 days later on September 26, 2006, shows that the weathered rock block had fallen, indicating its instability.

Figure 17. Upper Portion of the Collapsed Surface (Center), Looking Toward West.

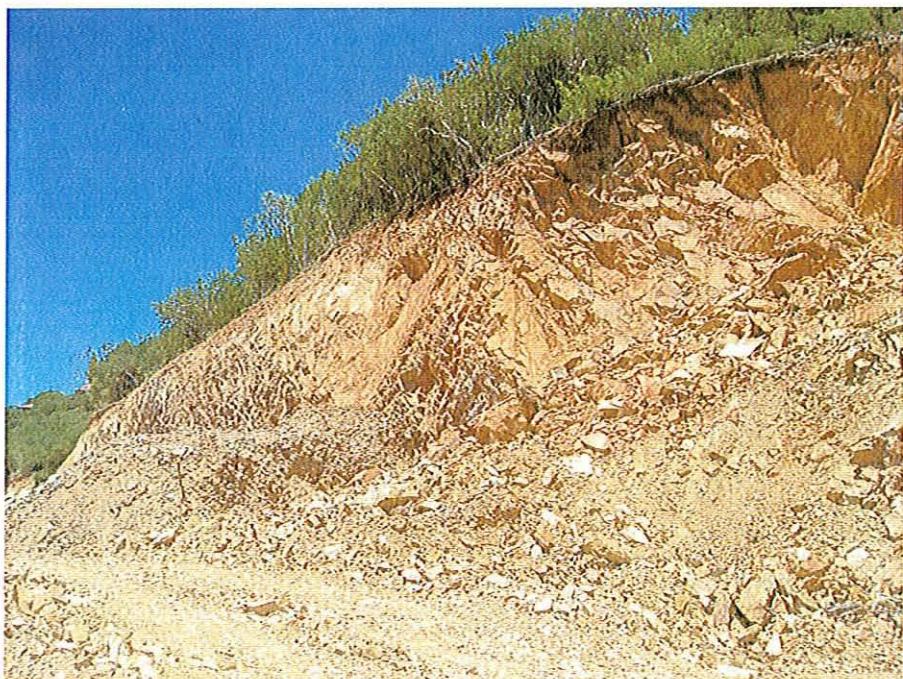
Figure 18. Upper Portion of the Collapsed Surface (South), Looking Toward South.
