INVESTIGATION OF THE AUGUST 22, 2006, FATAL EXCAVATION COLLAPSE AT RED HOOK, ST. THOMAS, U.S. VIRGIN ISLANDS

U.S. Department of Labor
Occupational Safety and Health Administration

February 2007

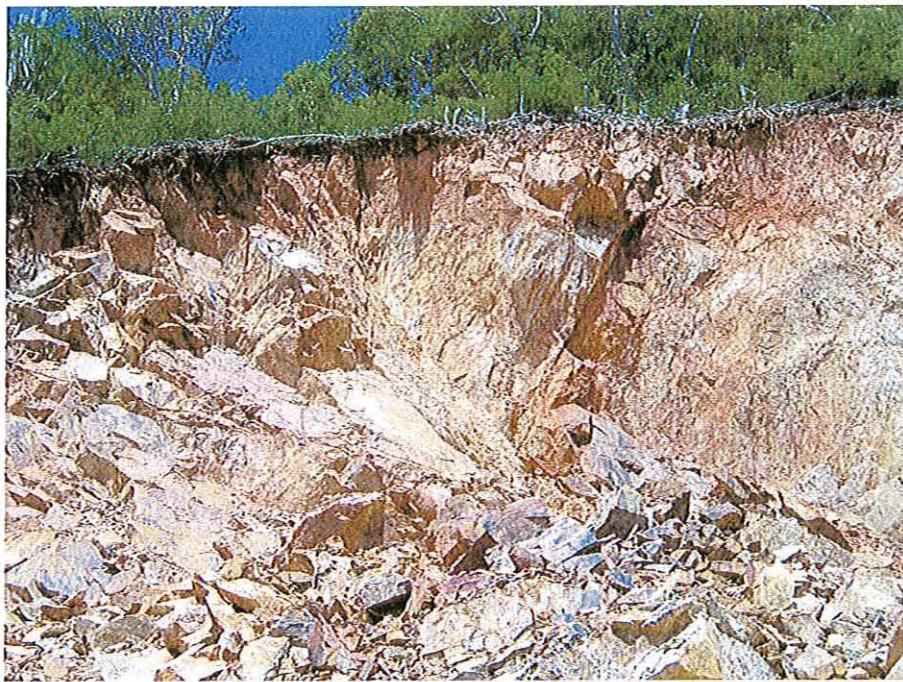
It is interesting to examine Figures 17 and 19. In Figure 17, taken on September 1, 2006, a large weathered rock block could be seen in a seemingly stable position in the upper middle portion of the figure. But Figure 19, taken 25 days later on September 26, 2006, shows that the weathered rock block had fallen, indicating its instability.

Figures 19 and 20 show numerous brightly colored fractures indicating that the rock mass was heavily weathered. Figure 20 also represents the type of rock pieces at the center of the collapse.

Figure 19. Close-up View of Figure 17 Showing a Rock Block Sled away, Looking Toward West.

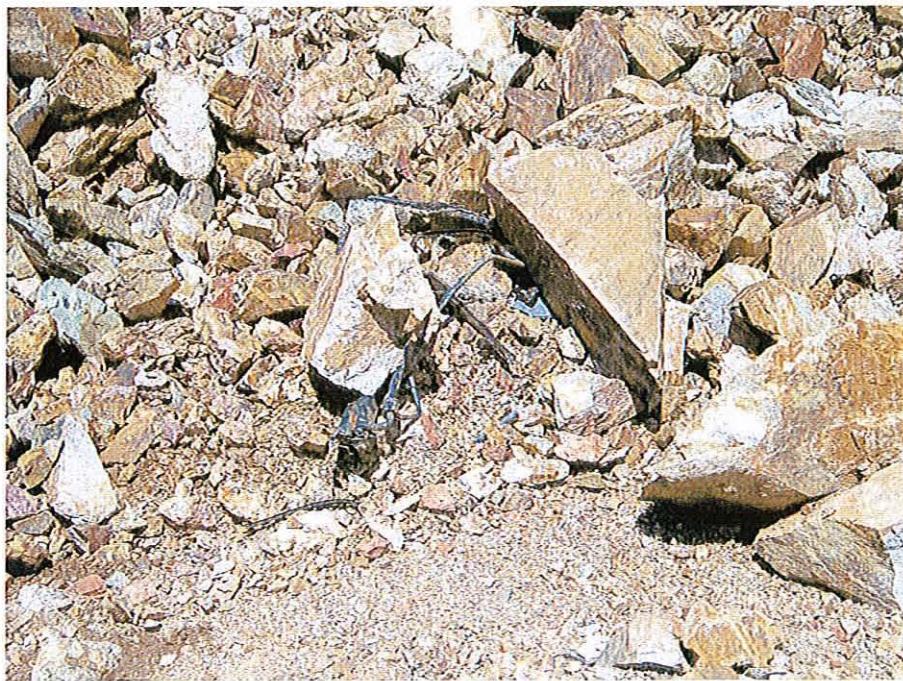
Figure 20 Type and Size of Rock Pieces at the Center of the Collapse.

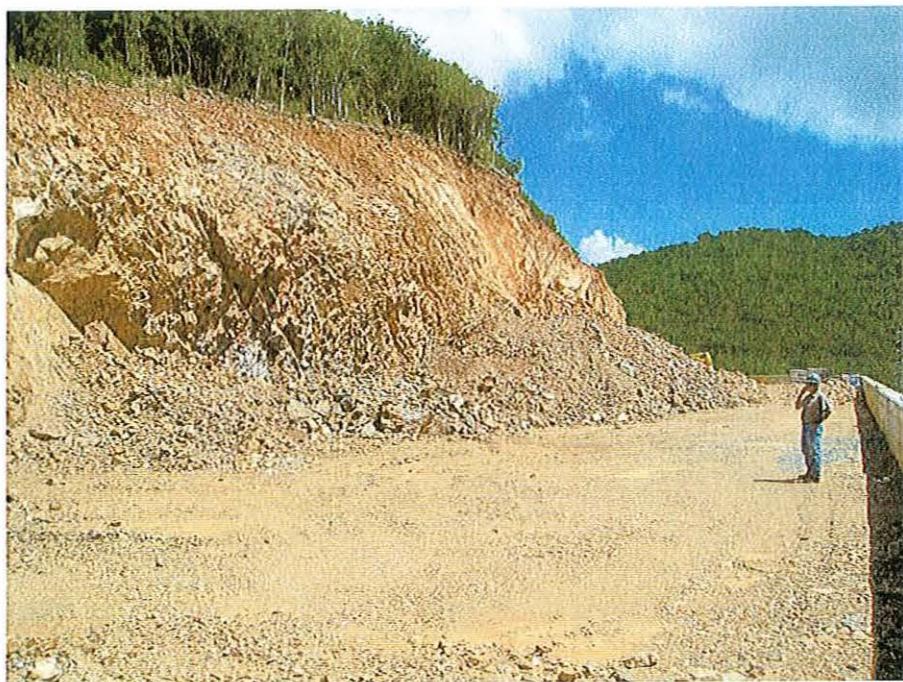
Figures 21 and 22 represent the identifiable rock slabs in the excavated surface south of the collapsed area. However, this rock structure only occurred in less than 10% of the 500 foot long excavation.

Figure 21. Identifiable Rock Slabs in the Excavation Face South of the Collapsed Area, Looking Toward Northwest.

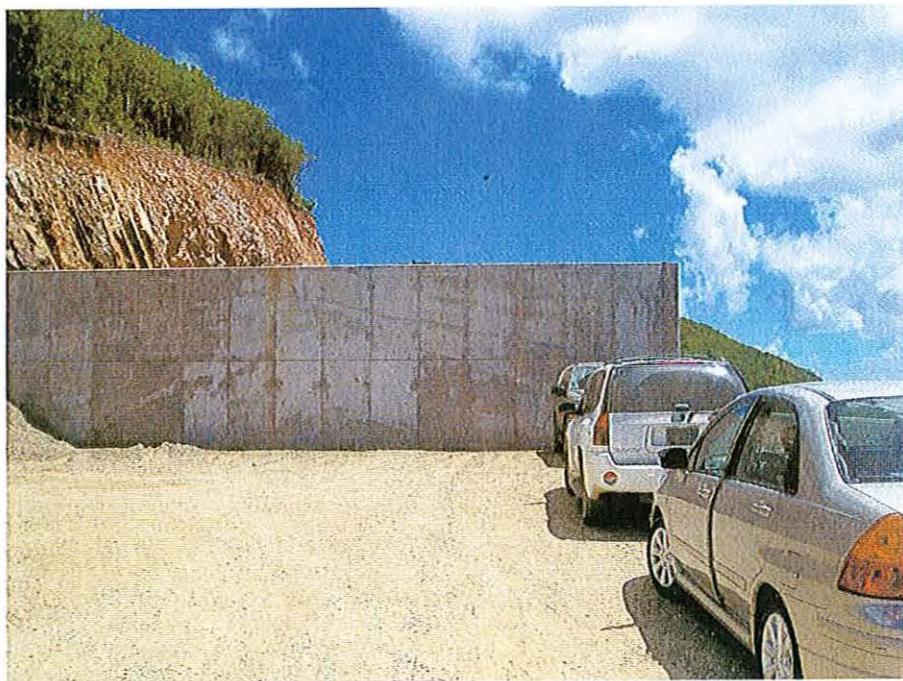
Figure 22. Another Identifiable Rock Slabs in the Excavation Face Further South of the Collapsed Area, Looking Toward North.
