Investigation of the June 14, 2007, Incident at U.S. Highway 90 across St. Louis Bay, Pass Christian, MS

U.S. Department of Labor
Occupational Safety and Health Administration
Directorate of Construction

December 2007

Report Prepared by
Mohammad Ayub, PE

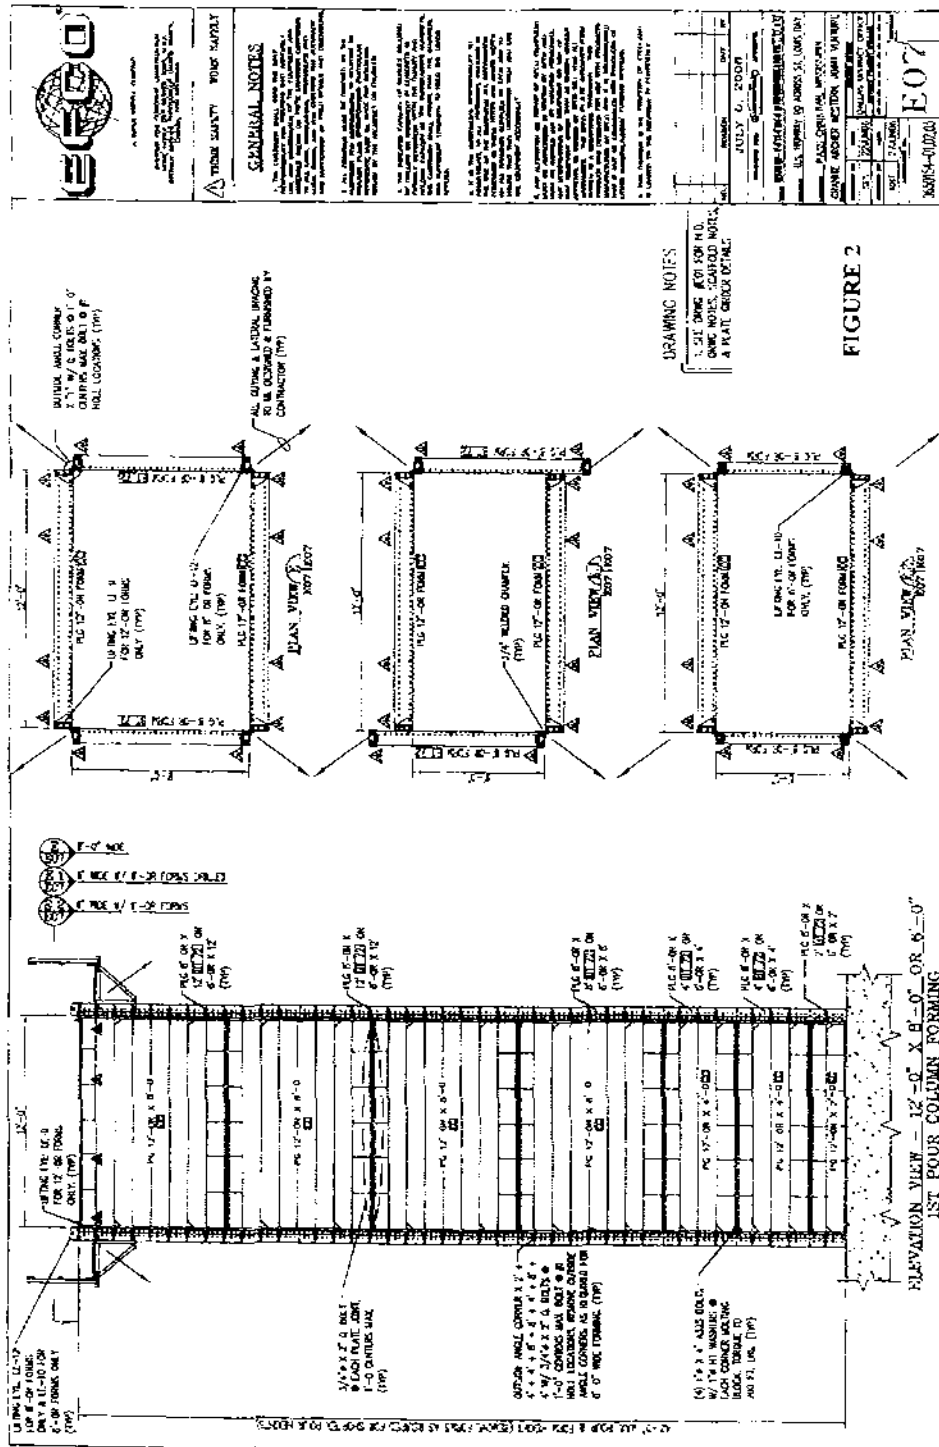
FIGURE 1

EFCO shop drawings for the column formwork provided a graph to determine the maximum rate of placement of concrete, see figure 1. The graph accounted for the use of fly ash, retarder, and ambient temperature. The graph indicated that the rate of placement of concrete should not have been greater than 2'-8" per hour. The actual rate of placement was much higher, i.e., 11'-8" per hour.

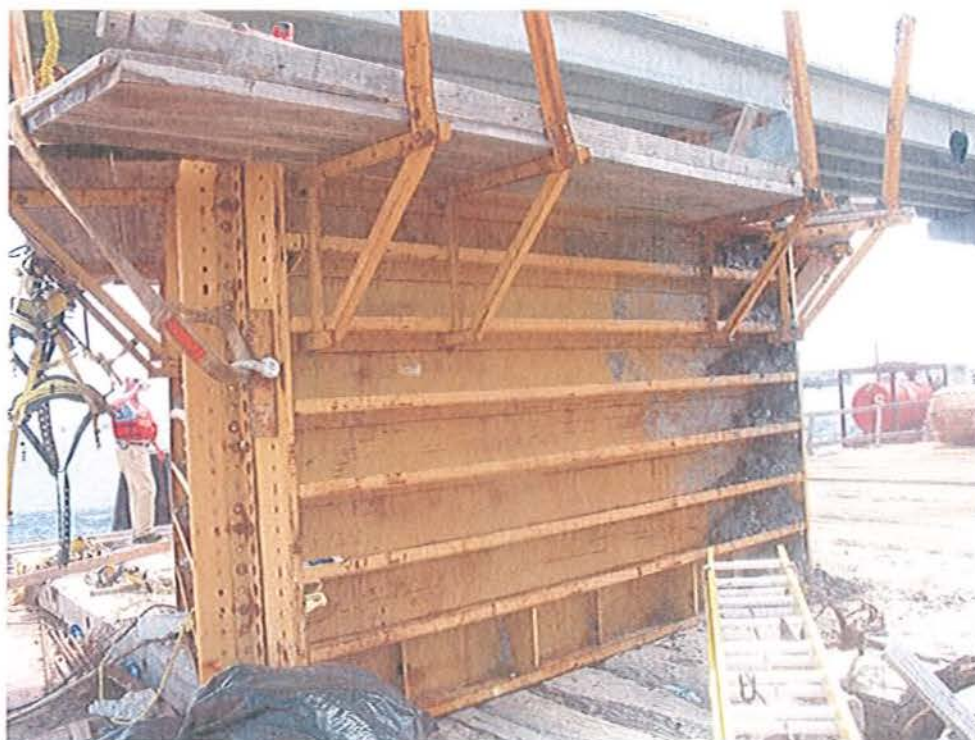
FIGURE 7

The column fell in a north-easterly direction with the reinforcing cage arching in the same direction. There was very little concrete adhering to the reinforcing bars, indicating the highly fluid state of concrete up to the time of the failure, see figures 8 thru 13. Almost all the concrete fell into the bay. The lower piece of the column form approximately 39' high fell in one piece with the bottom 9' of the north side folding approximately 180 degrees. The bottom seam of the column form at the south-west, north-east and north-west were torn apart for an approximately distance of 9'. The seam at south-east remained intact. The upper piece of the form approximately 7' high supporting the platform fell in to the bay in one piece, see figure 7.
