# Investigation of the March 15, 2008 Fatal Tower Crane Collapse at 303 East 51<sup>st</sup> Street, New York, NY

U.S. Department of Labor  
Occupational Safety and Health Administration  
Directorate of Construction

September 2008

Report Prepared by  
Mohammad Ayub, PE  
Directorate of Construction, OSHA  
Washington, DC

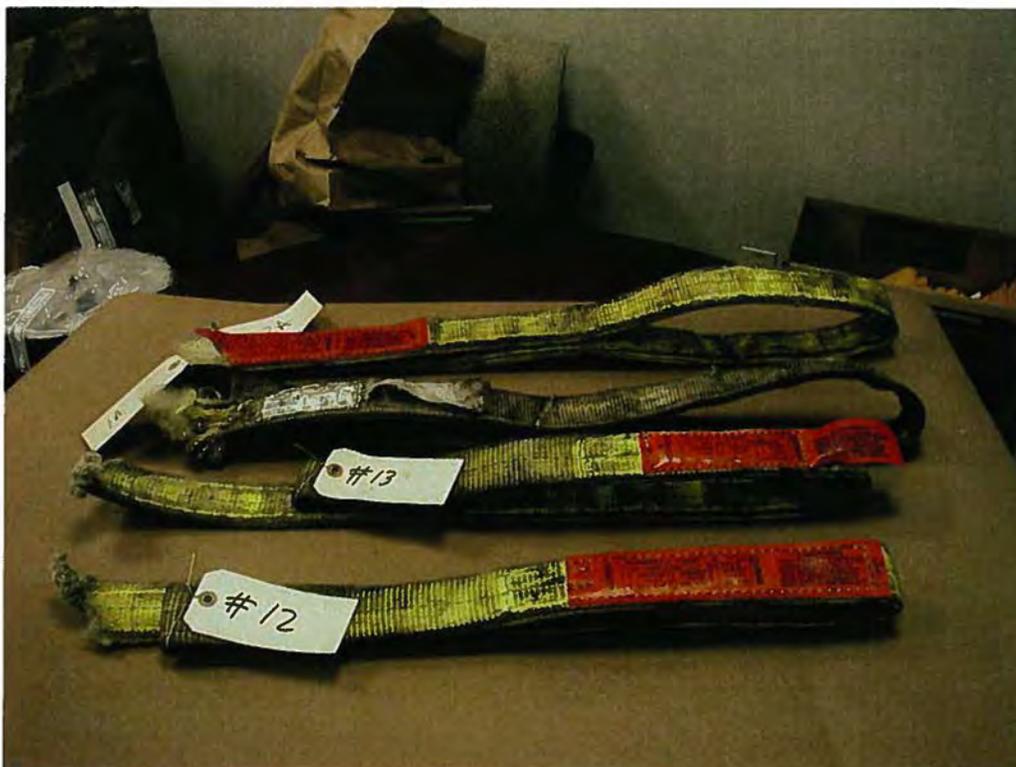
**FIGURE 25**

All four slings failed in the incident, with each sling shearing in two pieces, see Fig. 25 through 28. Out of the eight broken pieces of the slings, only seven were retrieved. Of the seven retrieved pieces, two were still attached to the top most collar lugs at points E and K along with come alongs and chain falls. It was later concluded that the missing piece was the choked portion of the Metro sling located at the southwest corner of the collar.

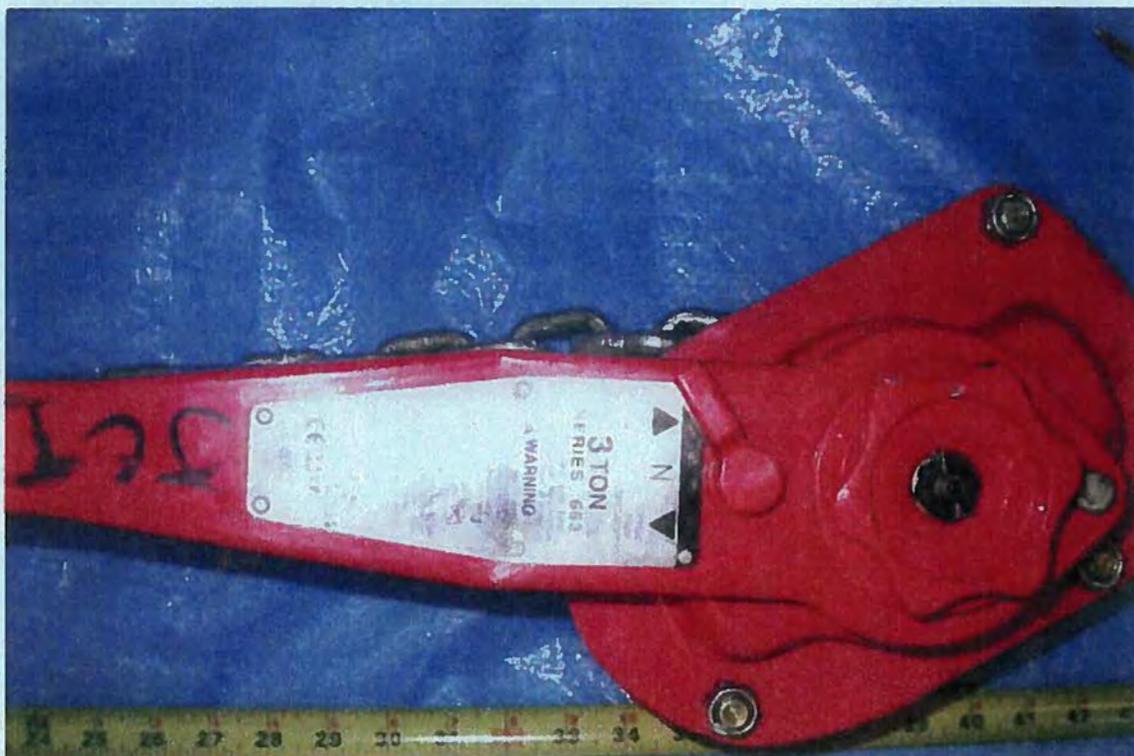
providing a total of 12 tons of lifting capacity. As noted in Photograph #2, these chain hoists have been damaged from the accident, but still appeared to be in working condition. Three of the hoists were still in a locked position, while the fourth, which was connected to sling samples #2A & 12, was in the open position. The chain was moved through the drive sprockets with ease (Photograph #3), but when the latch was moved to the locked position, the hoist did hold the chain securely. It is not believed that any slippage of the chains occurred at the time of the accident, but that the latch on one hoist was open due to the accident and subsequent recovery of evidence. A white, powdery substance was noticed on the bottom of two of the chain hoists (Photograph #4), but it is believed that this is possibly a cement residue resulting from the impact of the hoists against the ground during the crane collapse.

PHOTOGRAPH #2  
ONE OF THE FOUR CHAIN HOISTS BEING USED AT TIME OF ACCIDENT

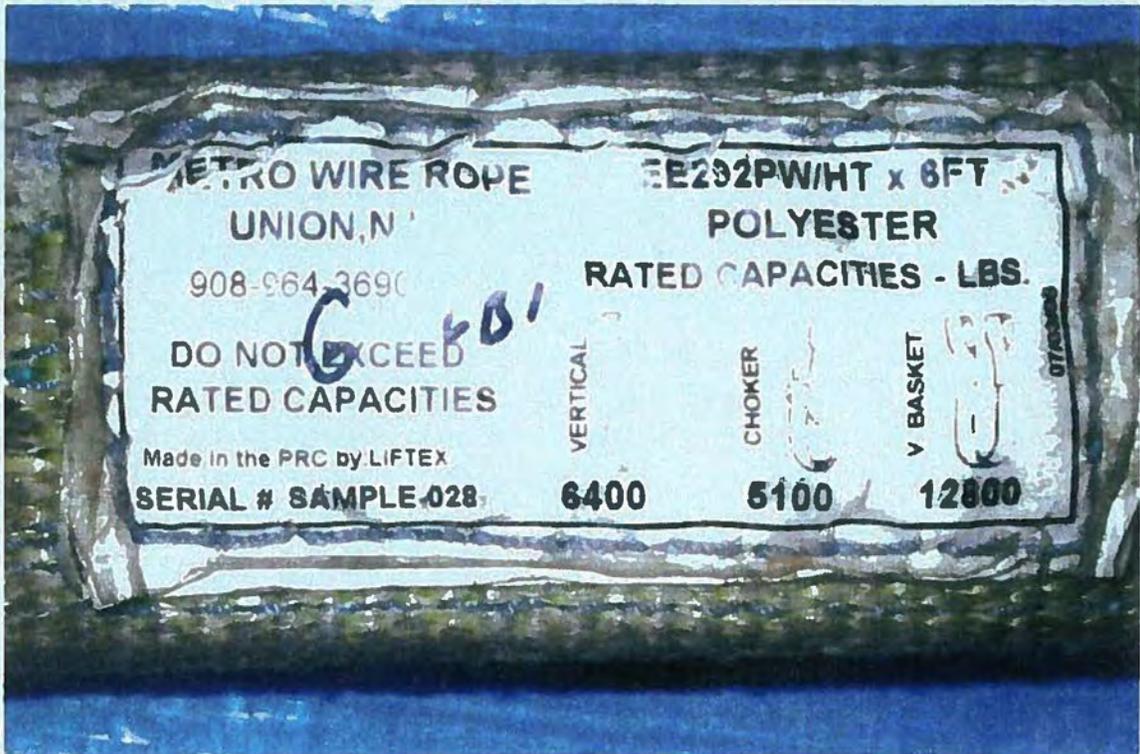
The four web slings which ruptured during the accident are 2" wide, 2-ply, polyester web slings, 6' in length. Three of the slings have tags attached that indicate they were supplied by the LiftAll Company (Photograph #5), while the fourth sling came from Metro Wire Rope Corporation (Photograph #6). The LiftAll sling tags list a rated capacity of 5000 # for a choker hitch, while the Metro sling tag lists 5100 #.

PHOTOGRAPH #6  
TAG ON THE ONLY METRO WEB SLING

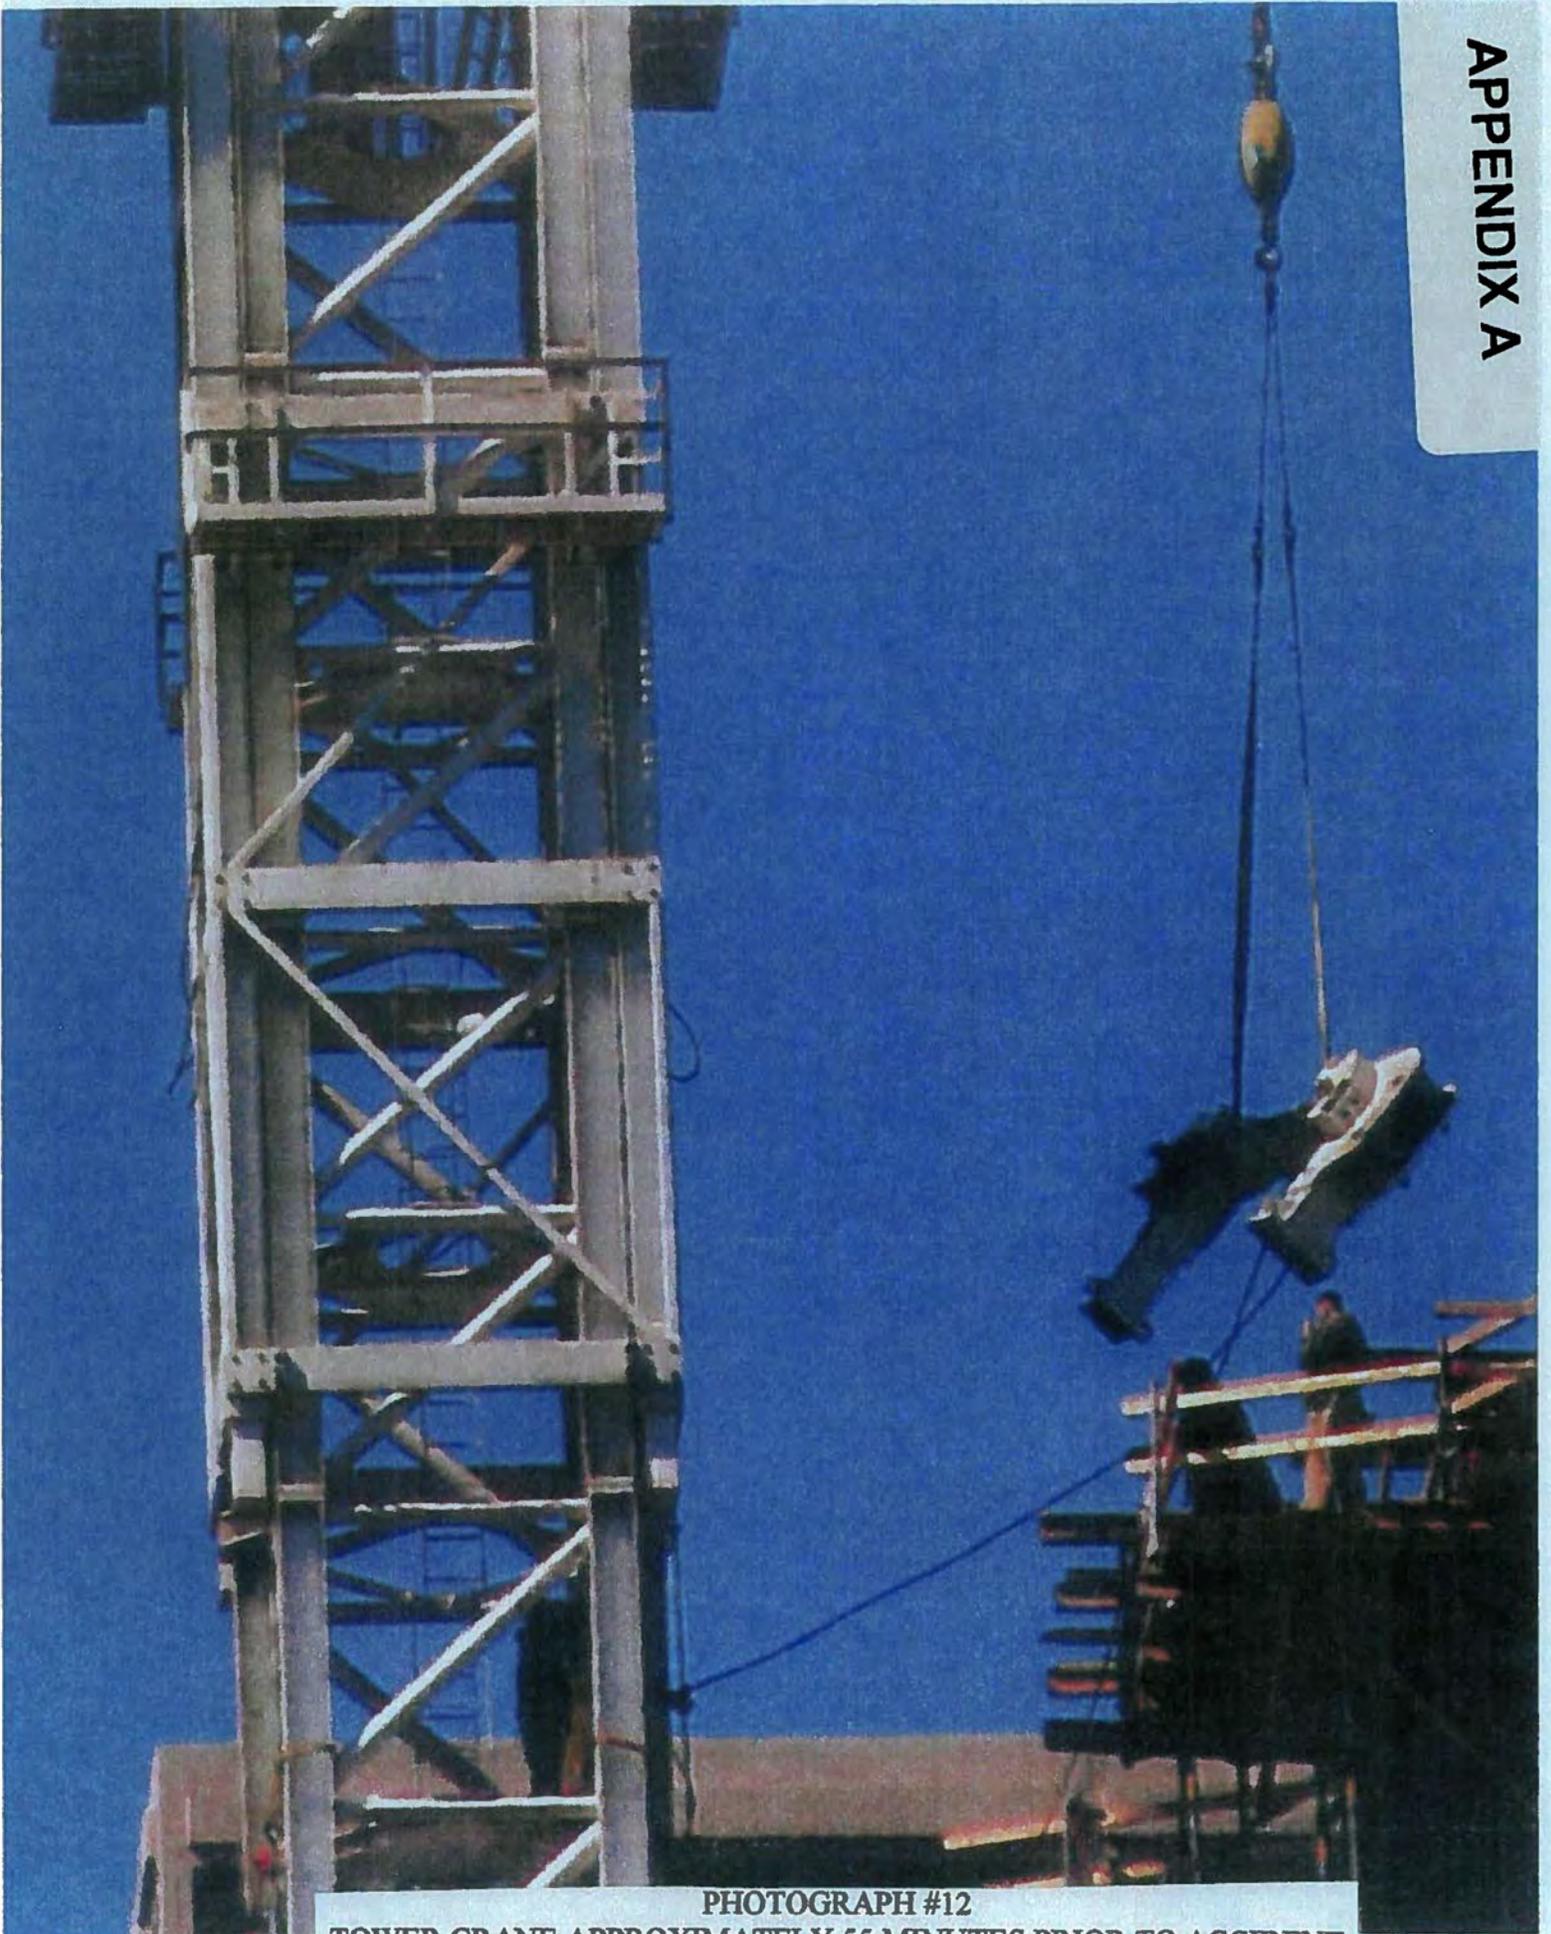
Inspection at the warehouse included inspection of a lower tower crane section along with the steel collar that was attached to the slings which failed. Photograph #11 shows a section of the crane tower on a flatbed truck. It was originally thought that the slings were choked around the 6" angular struts, but was later discovered following this inspection, that the slings were actually choked around the vertical 12" I-beams. A photograph taken by an individual of the tower crane approximately 55 minutes prior to the accident reveals that the slings were attached to the vertical I-beams (Photograph #12).

**PHOTOGRAPH #12**  
**TOWER CRANE APPROXIMATELY 55 MINUTES PRIOR TO ACCIDENT**  
**( NOTE WEB SLINGS ON LOWER TOWER SECTION )**

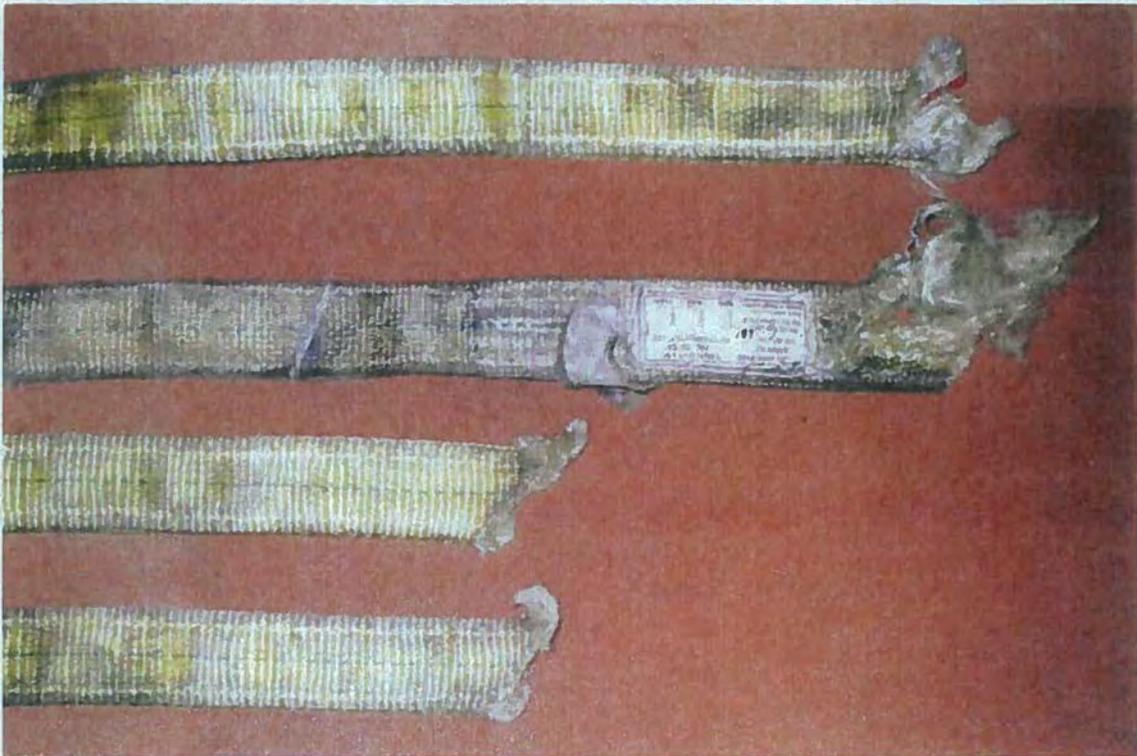
The four slings were aligned with the intact eyes together to provide an inspection of the relative locations of the field breaks (Photograph #20). Samples #1A, Metro sling, and #2A, LiftAll sling, both measure 58” from the bearing of the sling eye to the failure location. At the failure location, both of the failure edges display angular cuts through most of the 2” width of the slings, with the longer, stretched fibers parting in a tensile

mode. The shorter samples # 12 and #13, each measuring 47" in length from bearing of eyes to the break, contain diagonal cuts almost entirely across the sling widths. These differences in lengths provide evidence that the longer sling remnants ruptured at different edges of the I-beams than did the shorter remnants.

**PHOTOGRAPH #20  
COMPARATIVE LENGTH OF SLINGS STILL ATTACHED TO COLLAR**

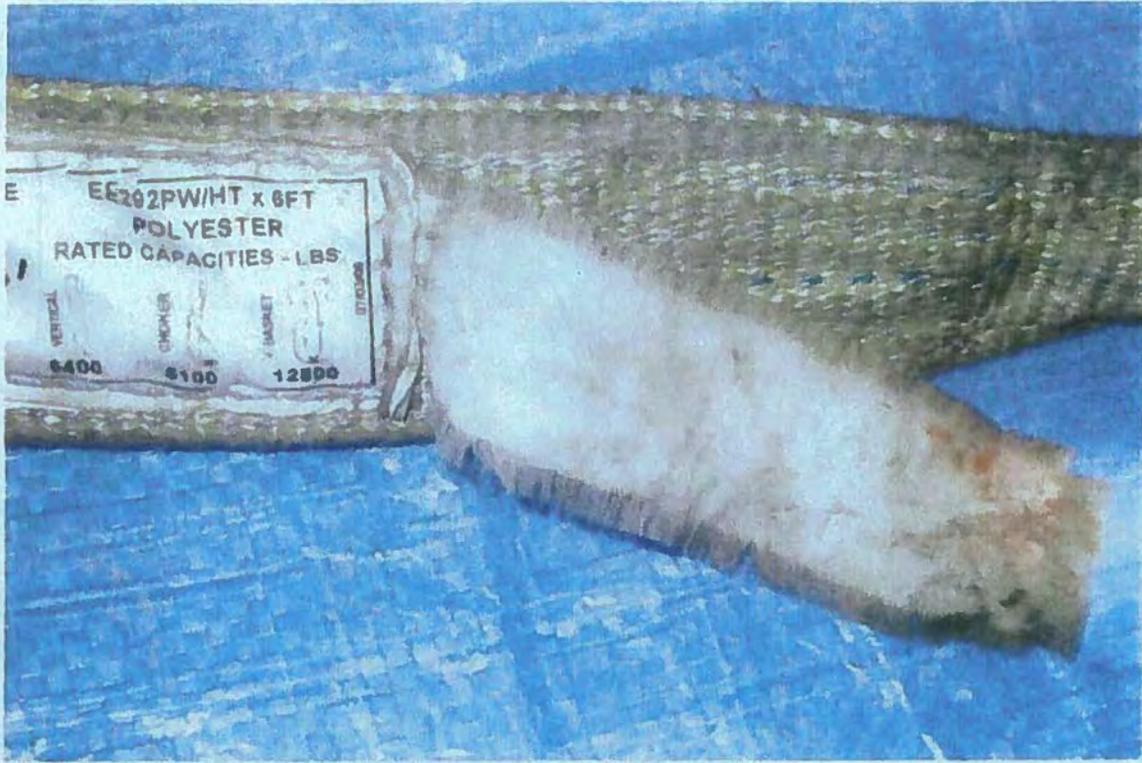
This sling is quite different in appearance than the three LiftAll slings. Not only has it experienced partial loss of the yellow coloring, an indication of Ultraviolet degradation, the sling eye is a half twist eye, whereas the three LiftAll slings have flat, fold-back eyes.

**PHOTOGRAPH #25  
FADED WARNING TAG ON METRO SLING – SAMPLE 1A**

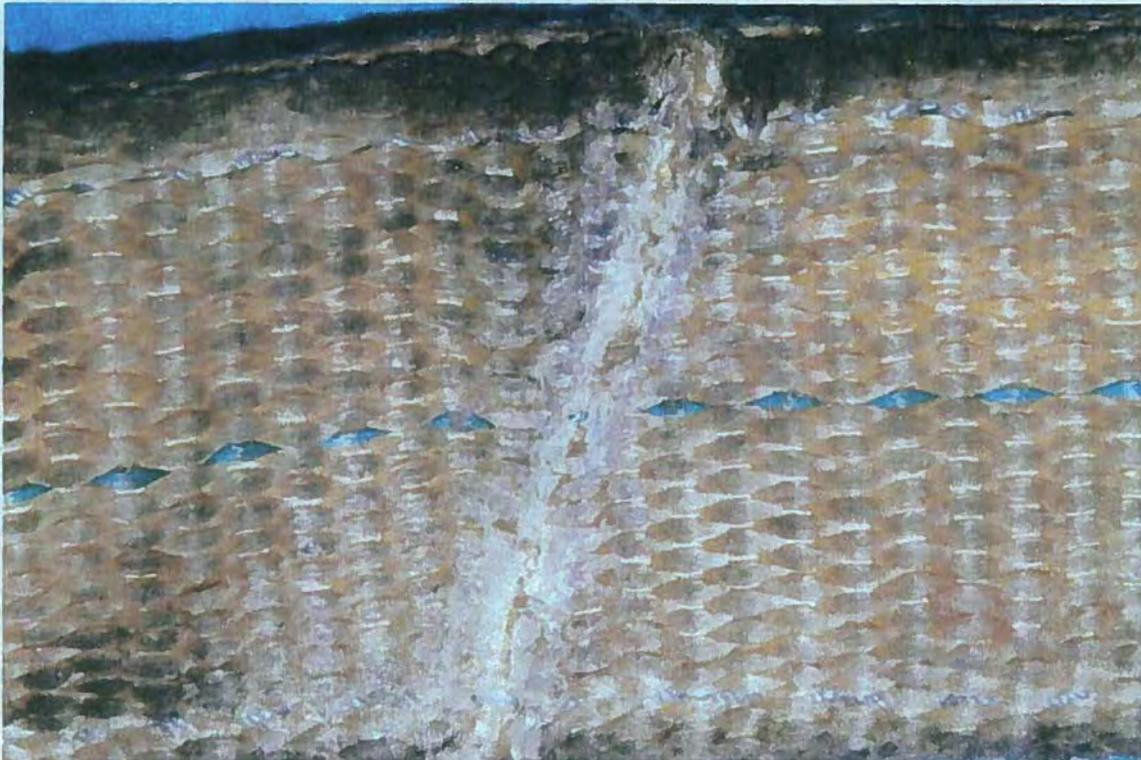
There are several locations of severe damage along this sling body that appear to have existed prior to this lift, based upon the coloring of the exposed fibers at the points of damage. For example, there are significant edge cuts (Photograph #27), crushed locations not corresponding to the angular cuts (Photograph # 28) and snags and punctures (Photograph #29). Based upon these findings, this sling should have been retired prior to this lift, and never should have been used in this damaged condition.

**PHOTOGRAPH #26  
ONE OF THREE PARTIAL CUTS ON METRO SLING – SAMPLE 1A**

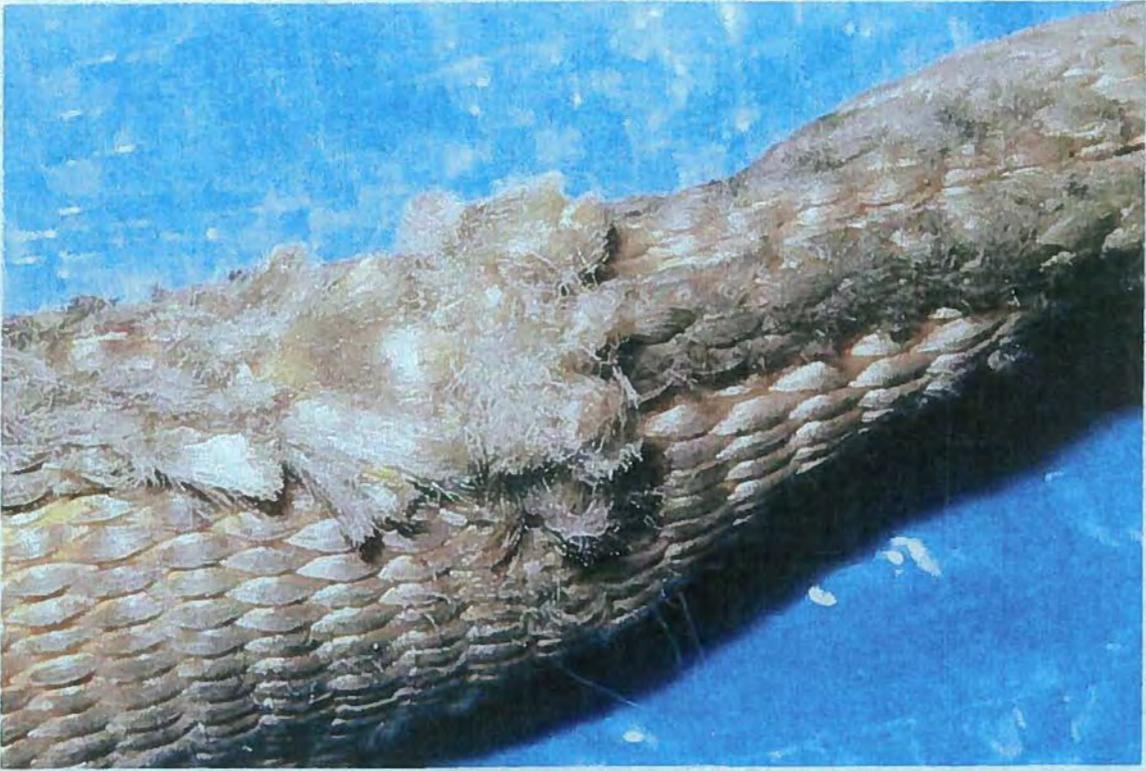
**PHOTOGRAPH #27  
EDGE CUTS ON METRO SLING – SAMPLE 1A**

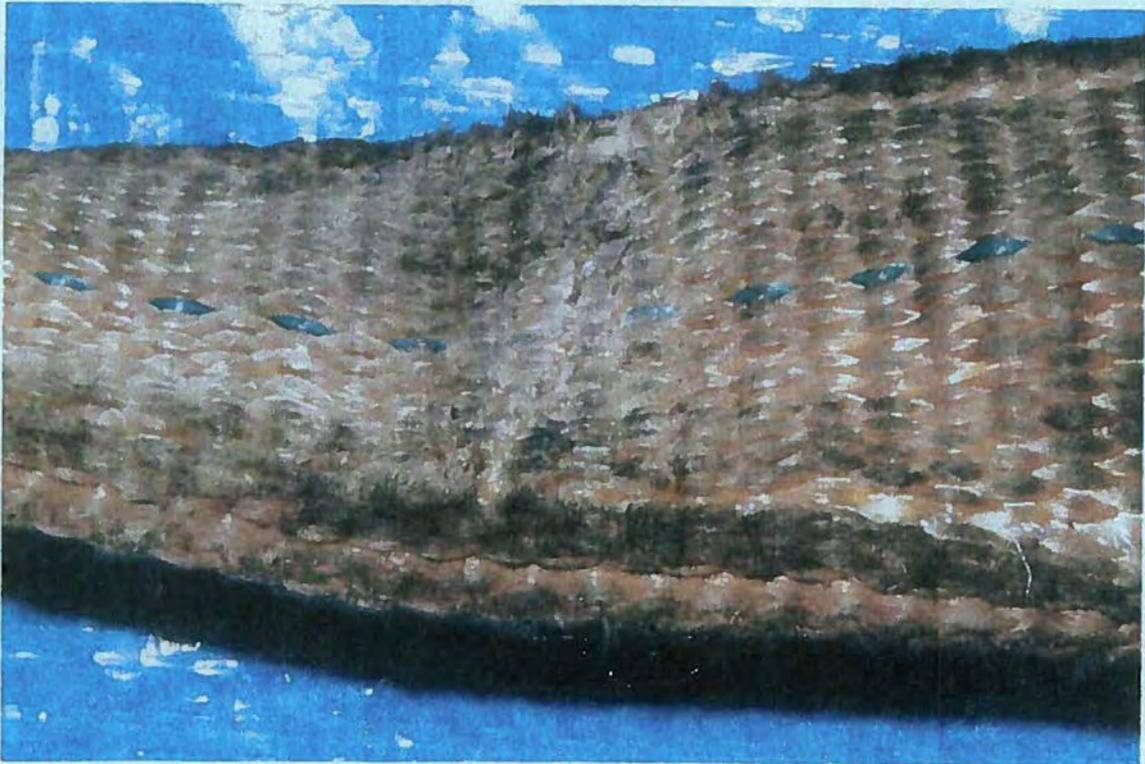
**PHOTOGRAPH #28  
SEVERE CRUSHING ON METRO SLING – SAMPLE 1A**

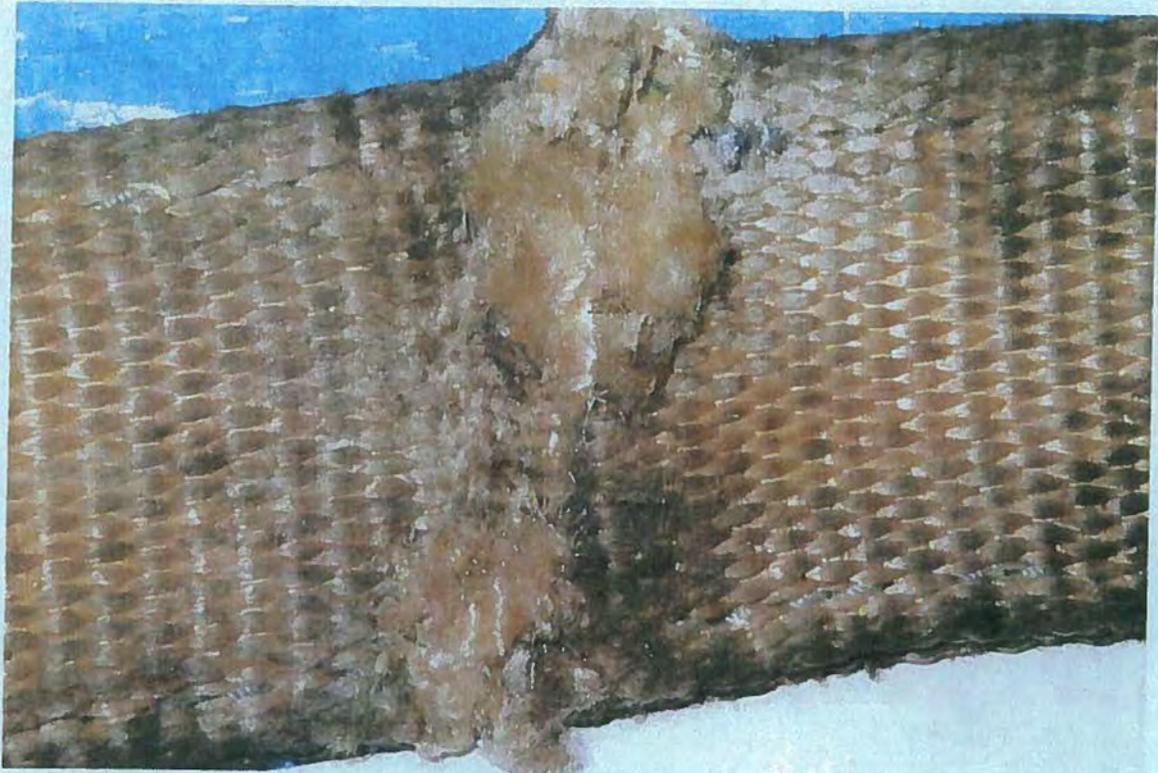
**PHOTOGRAPH #29  
SNAGS & PUNCTURES ON METRO SLING – SAMPLE 1A**

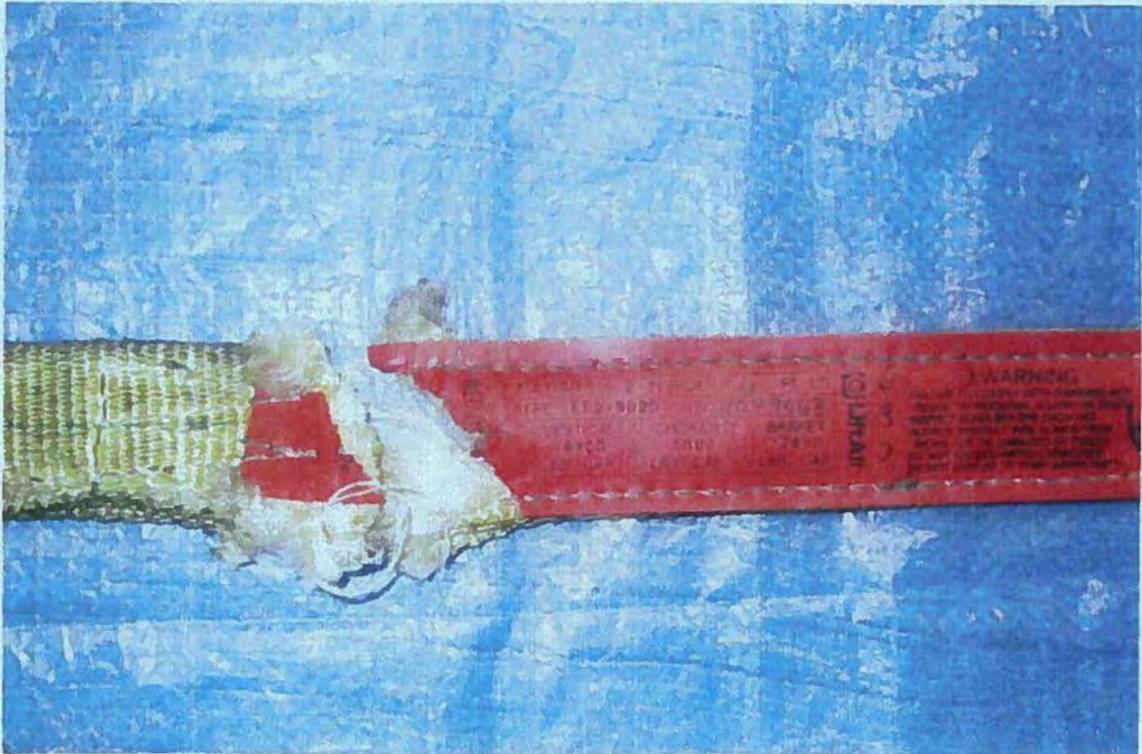
The two matched ends of this sling (Photograph #30) show that there has been an angular cut across about 1 ½” of the 2” of the sling body width at the point of failure. There are three locations, starting at 12” from the failure end and spaced about 11 ½” to 12” apart, along the length of the sling which reveal deep impressed creases. These angular deep creases have not cut through the polyester fibers, but again correlate to the position of the sling against the edges of the I-beam.

**PHOTOGRAPH #30  
MATCHED CUT ENDS OF LIFTALL SLING – SAMPLES 2A & 11**

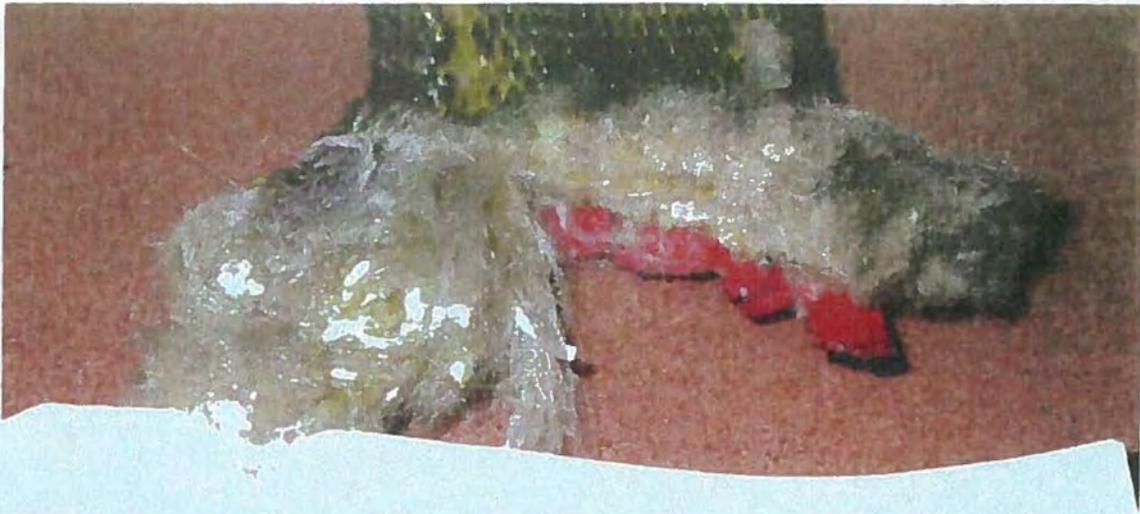
A close up view of the failure edge displays the linear configuration of the cut across the sling (Photograph #31). The elongated fibers at the left of this photograph show that the last fibers that were not cut have pulled apart in tensile. The highly magnified views of the two sides of this cut confirm that the fibers have been cut, and many of the fibers have fused together from the frictional heat developed from the sling sliding against the edge of a hard surface (Photographs #32 & #33).

PHOTOGRAPH #31  
CLOSE UP OF FAILURE END OF LIFTALL SLING - SAMPLE 2A

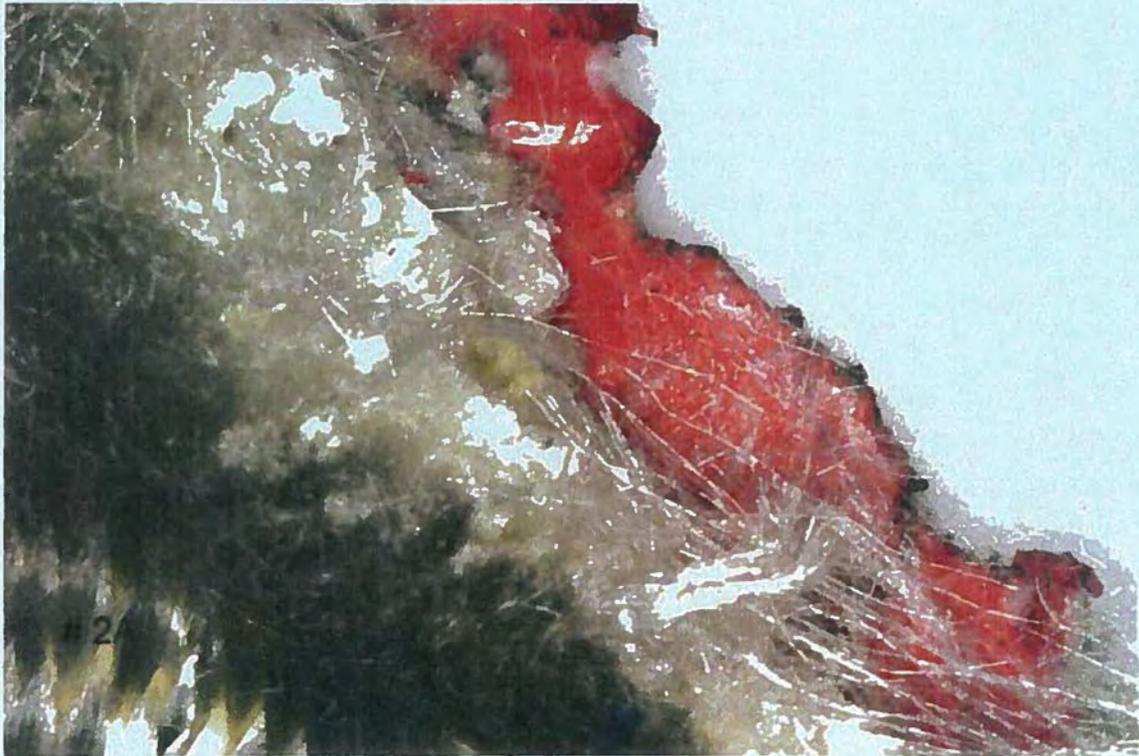
PHOTOGRAPH #32  
MAGNIFIED VIEW OF FAILURE END OF LIFTALL SLING - SAMPLE 2A

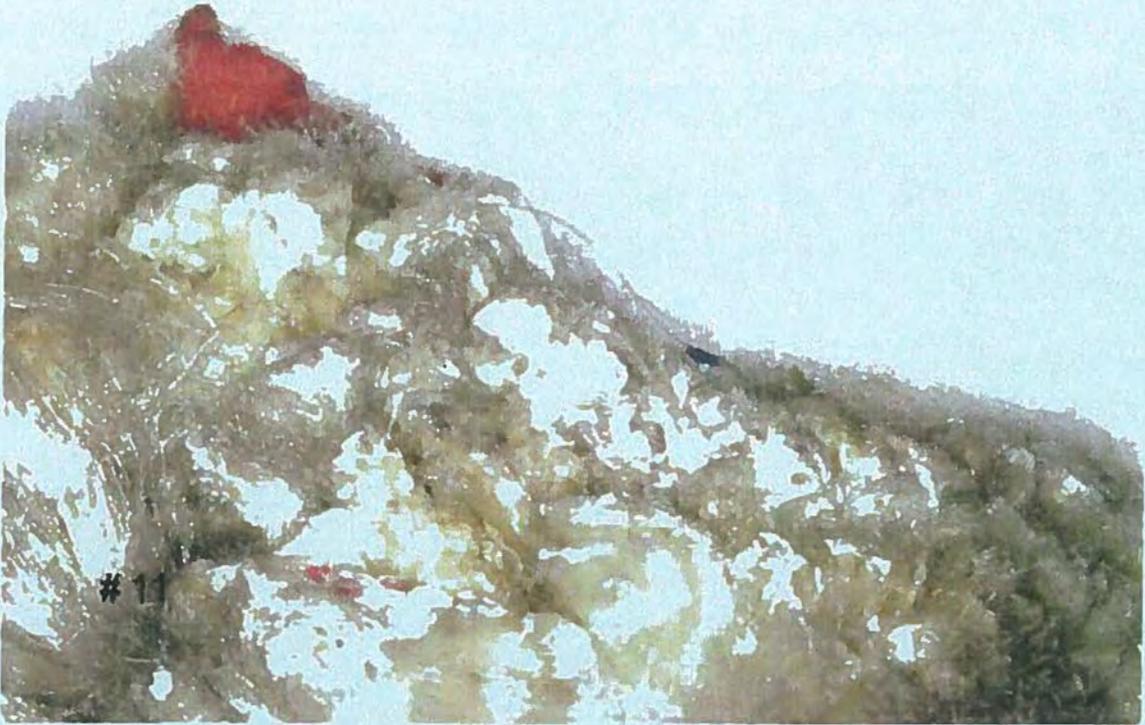
PHOTOGRAPH #33  
HIGHLY MAGNIFIED VIEW FAILURE END OF LIFTALL SLING – SAMPLE 11

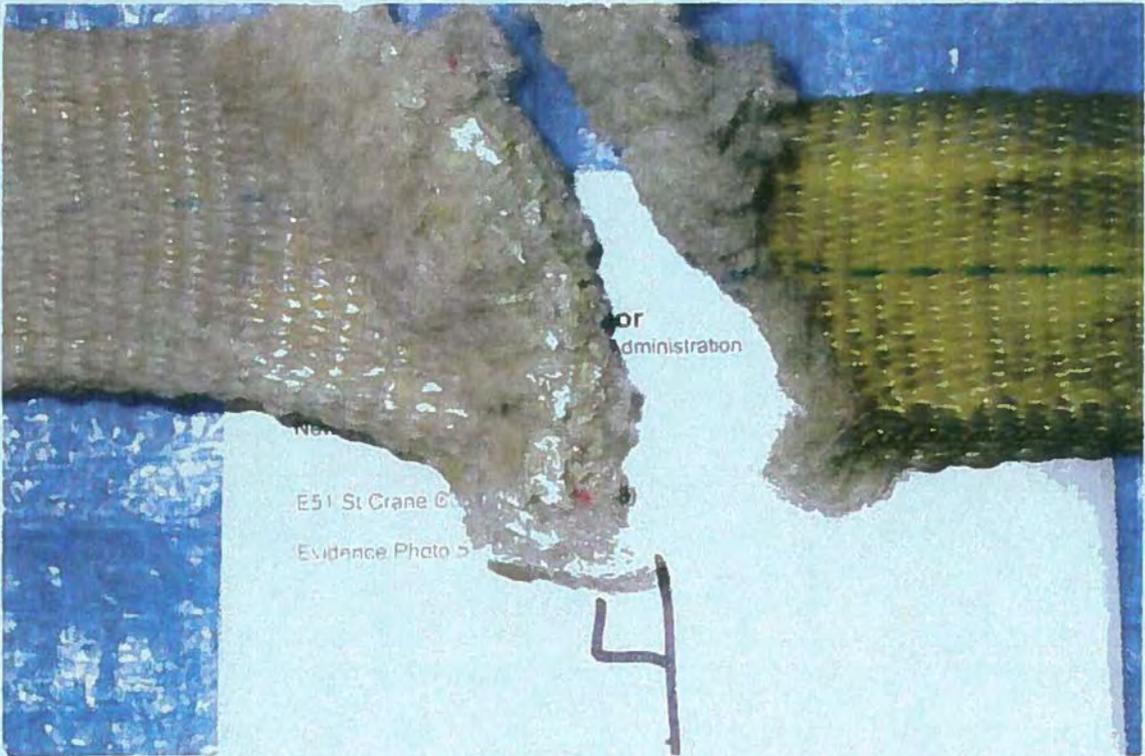
Photograph #34 depicts the ends of the break with samples 4A and 12. This angular cut has extended across almost the entire width of the sling body. The straight line cut is depicted on the left side of Photograph #35, while the elongated fibers on the right side show the last fibers to pull apart in tensile. A magnified view of the cut on sample #12 is shown in Photograph #36, which also reveals the melting and fusing of the fibers along the cut edge from the heat developed during the movement and rupture of the sling against a the edge of hard surface.

PHOTOGRAPH #34  
MATCHED FAILURE ENDS OF LIFTALL SLING – SAMPLES 4A & 12

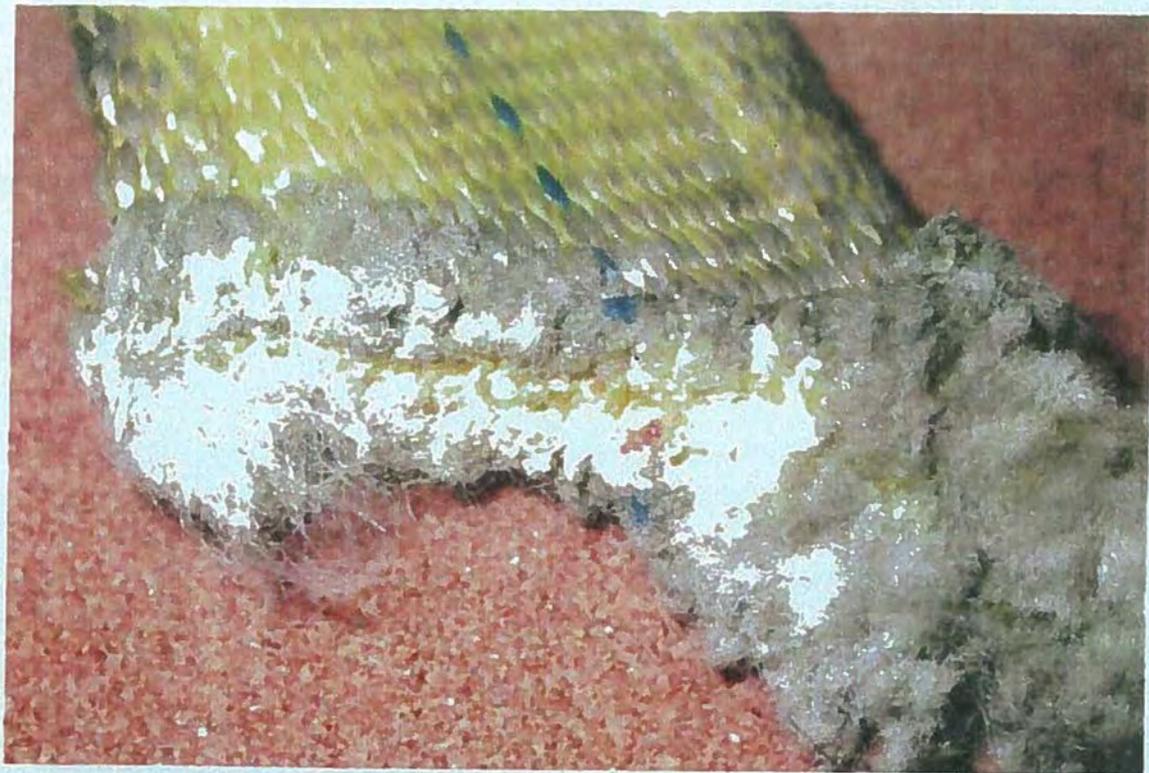
**PHOTOGRAPH #35  
CLOSE UP OF FAILURE END OF LIFTALL SLING – SAMPLE 12**

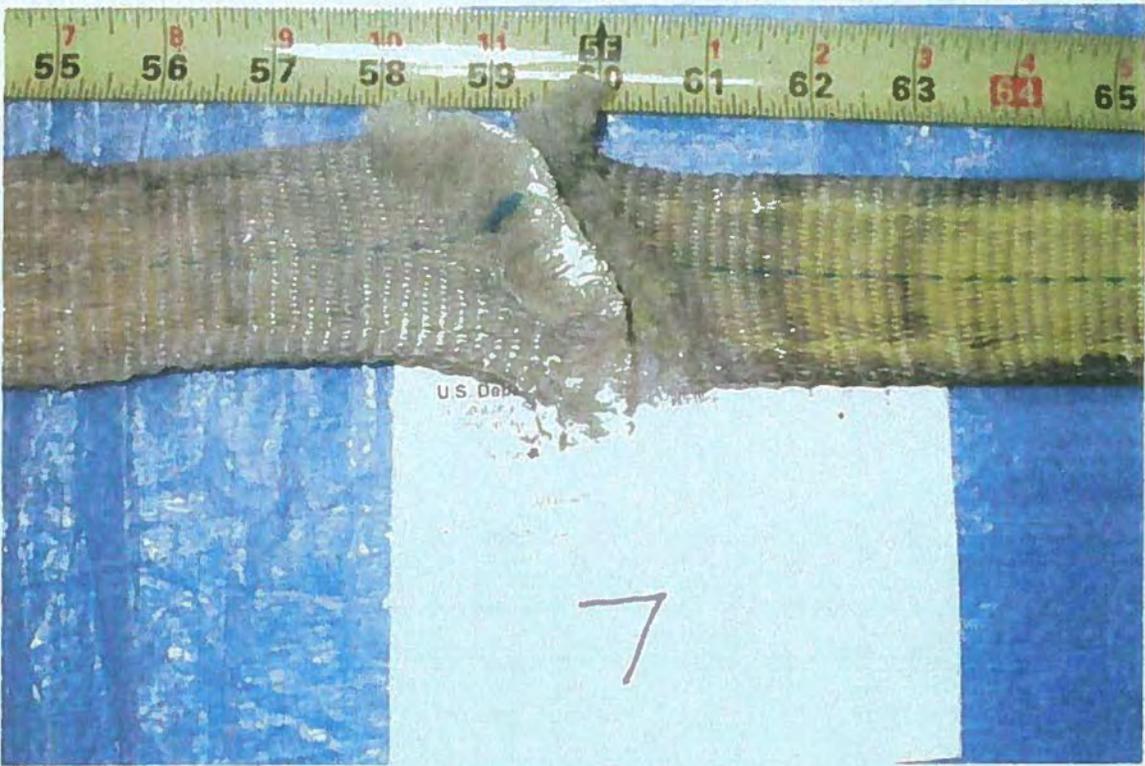
Photograph #37 show the matched failure ends of samples 7A and 13. The linear, angular cut across most of the width of the sling is depicted in Photograph #38. The few fibers at the edge of this rupture are the last fibers to pull apart in tensile after the cut has occurred. A highly magnified view of sample #7A shows the directionality of the cut and the fusion of many of the fibers at the point of failure (Photograph #39)

PHOTOGRAPH #37  
MATCHED FAILURE ENDS OF LIFTALL SLING – SAMPLES 7A & 13

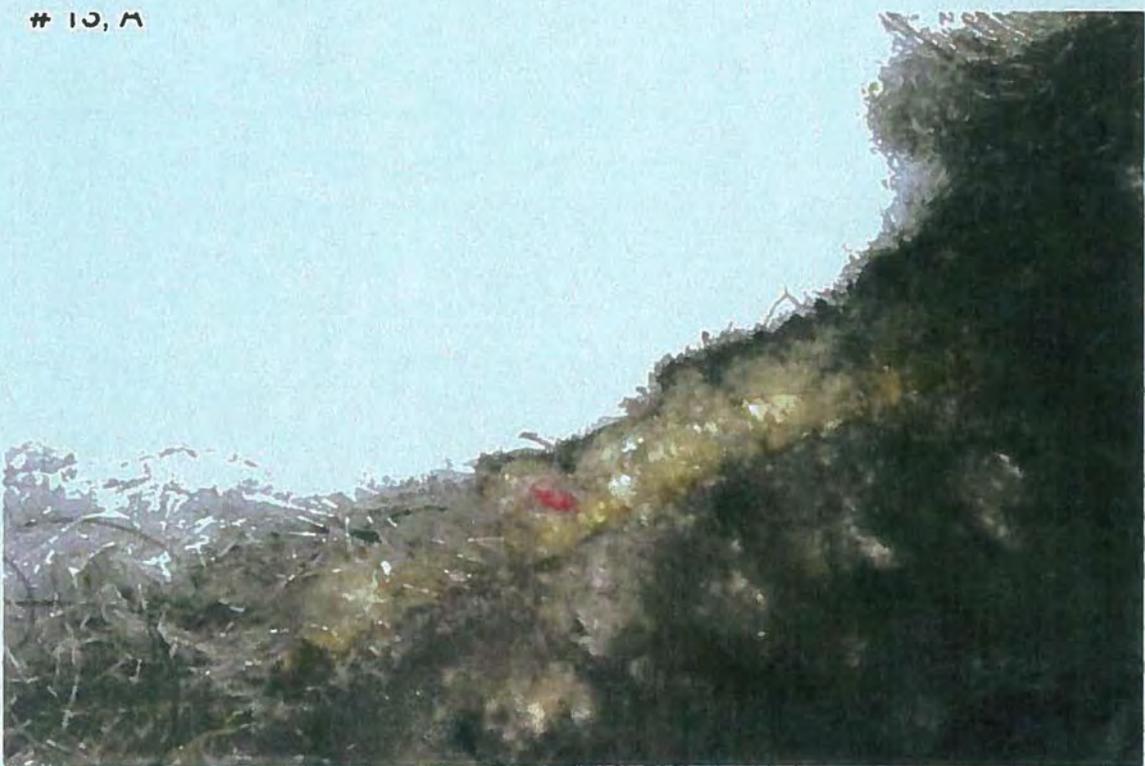
PHOTOGRAPH #38  
MAGNIFIED VIEW OF FAILURE END OF LIFTALL SLING – SAMPLE 13

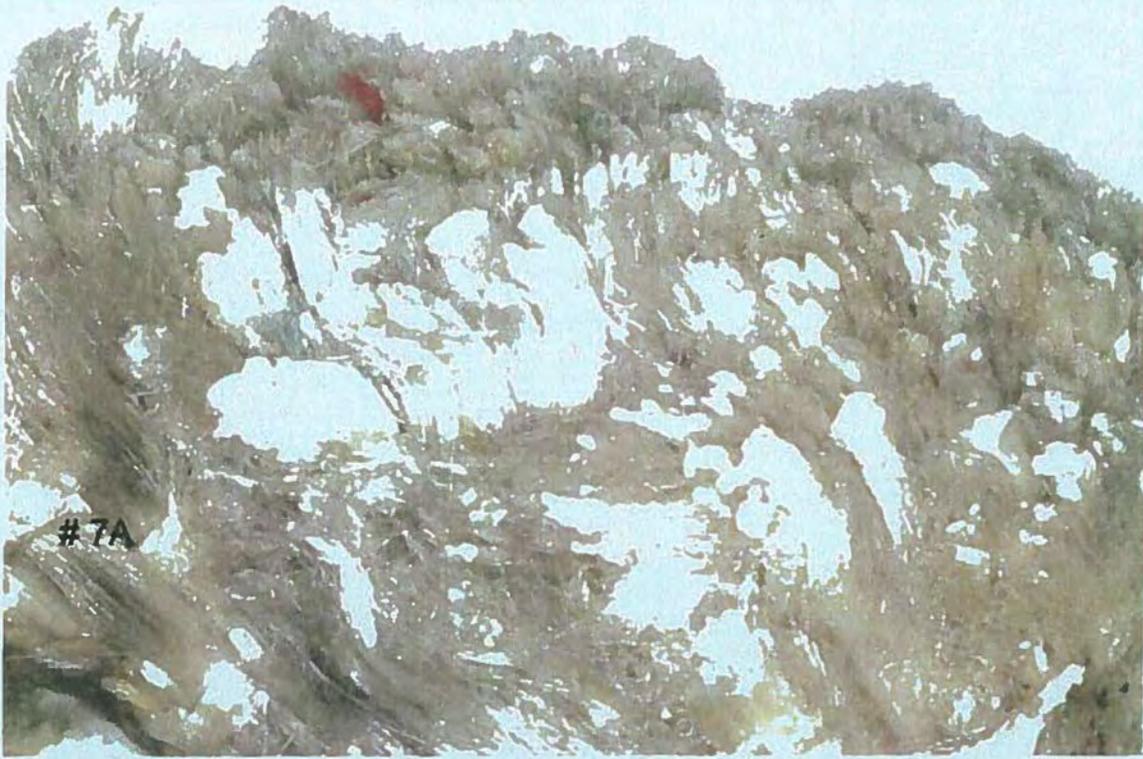
**PHOTOGRAPH #39  
HIGHLY MAGNIFIED VIEW OF FAILURE END OF LIFTALL SLING – SAMPLE 7A**

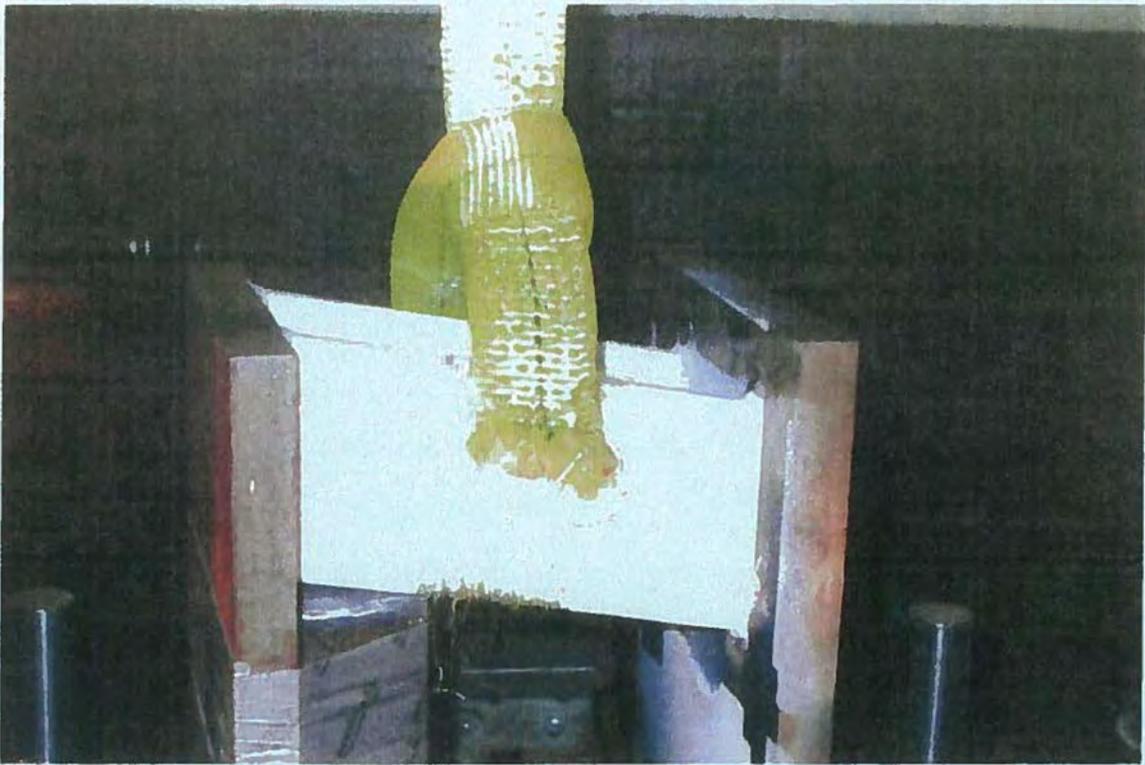
**PHOTOGRAPH #45  
FAILED SLING AT EDGE OF I-BEAM - SWRI TESTING**

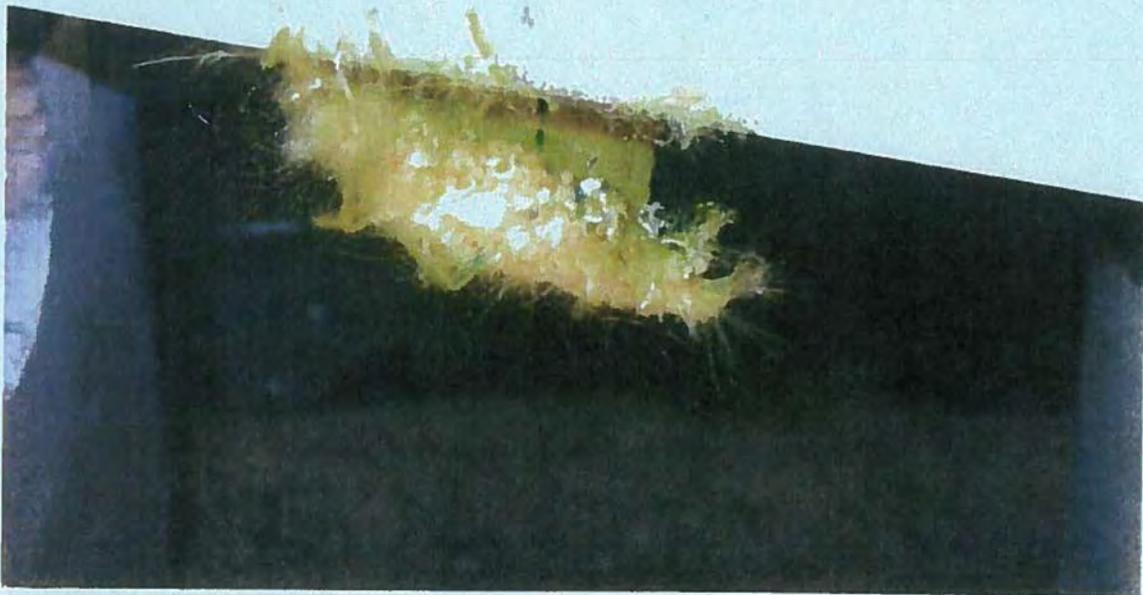
**PHOTOGRAPH #46  
CLOSE UP OF FAILED SLING AT EDGE OF I-BEAM**

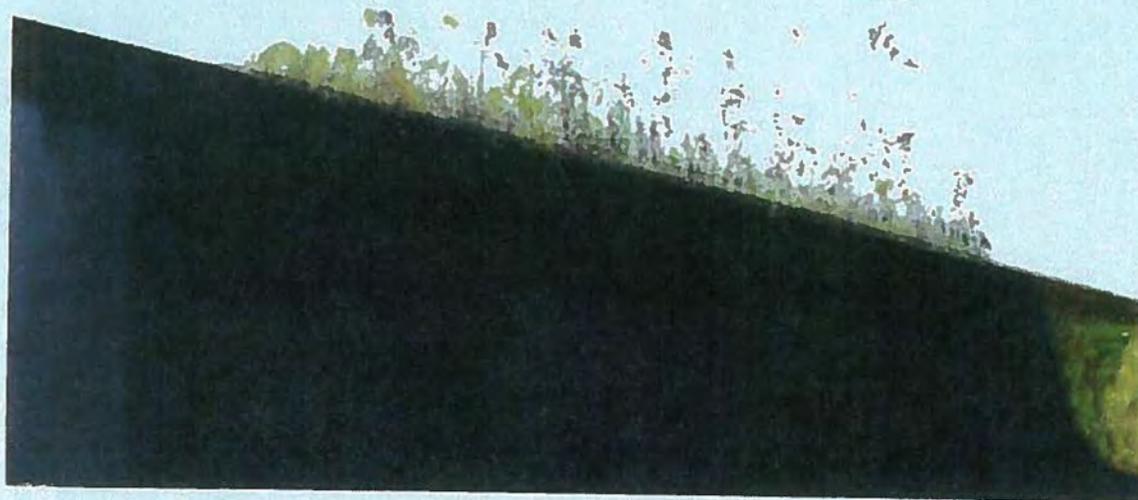
**PHOTOGRAPH #48  
MELTED WEB FIBERS REMAINING ON EDGE OF I-BEAM**
