# Investigation of the March 15, 2008 Fatal Tower Crane Collapse at 303 East 51<sup>st</sup> Street, New York, NY

U.S. Department of Labor  
Occupational Safety and Health Administration  
Directorate of Construction

September 2008

Report Prepared by  
Mohammad Ayub, PE  
Directorate of Construction, OSHA  
Washington, DC

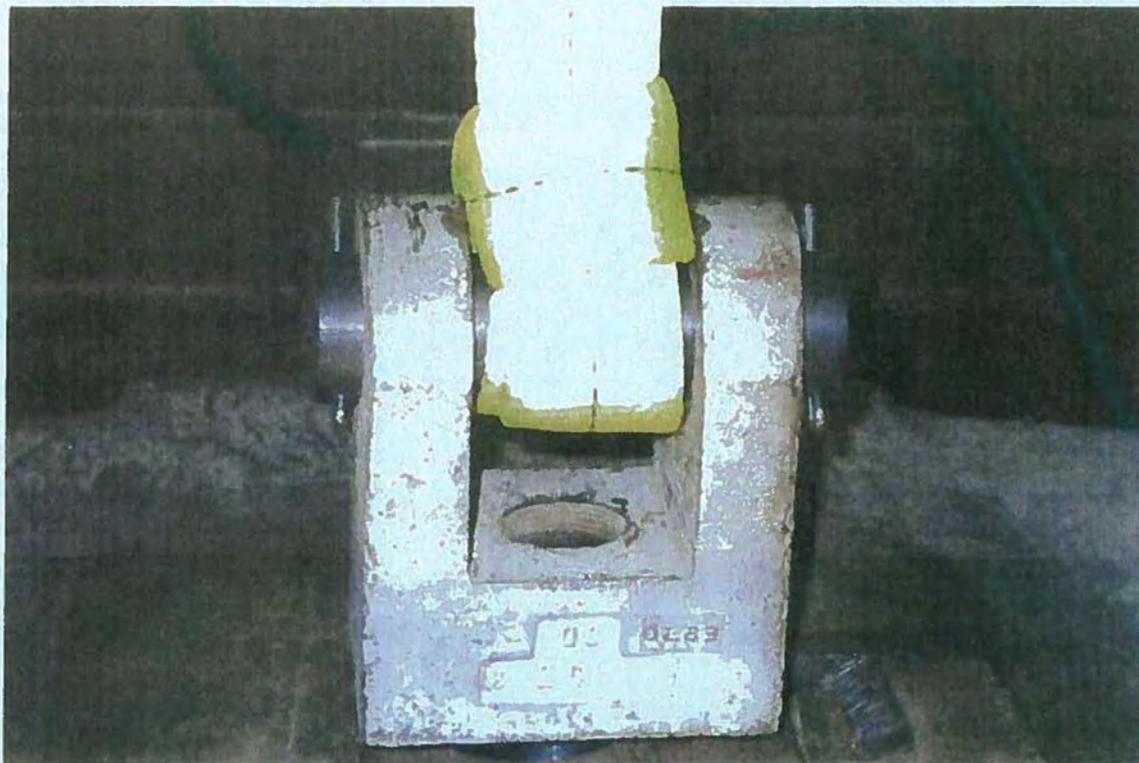
The second series of tests consists of choking the lower eyes around a 1 3/4" diameter pin (Photograph #49). As expected, the slings failed at the choked location on the pin. The LiftAll sling broke at 21,410 # and the unidentified sling broke at 20,102 # (Photograph #50). After removal from the pin, the sling break show that the fibers have parted in a tensile and shearing (Photograph #51) and there is no sign of cut fibers.

**PHOTOGRAPH #49  
SETUP OF SLING TEST CHOKED AROUND A PIN**

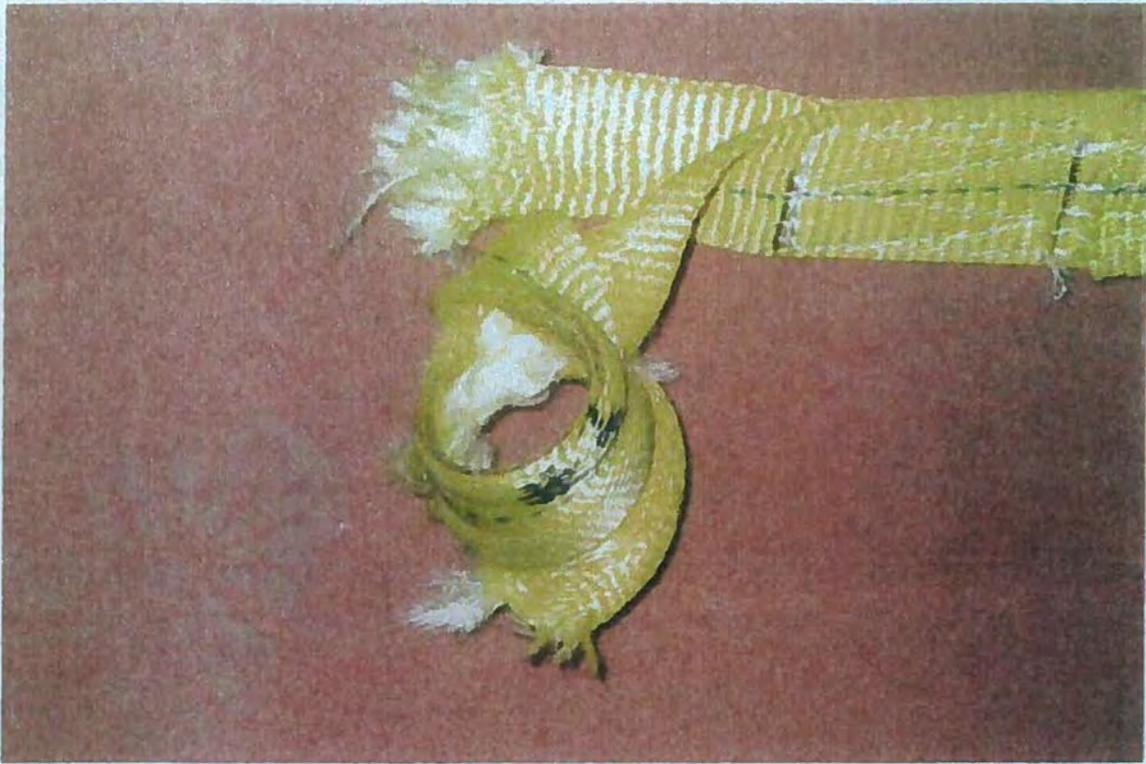
**PHOTOGRAPH #51  
FAILURE ENDS OF SLING BEING CHOKED AROUND A PIN**
