January 13, 2009

Memorandum For: Dean McDaniel, Regional Administrator
Region VI, Dallas, TX

Subject: Investigation of the July 18, 2008 Fatal Collapse of a Deep South
Crane at Lyondell Basell Houston Refinery in Pasadena, TX

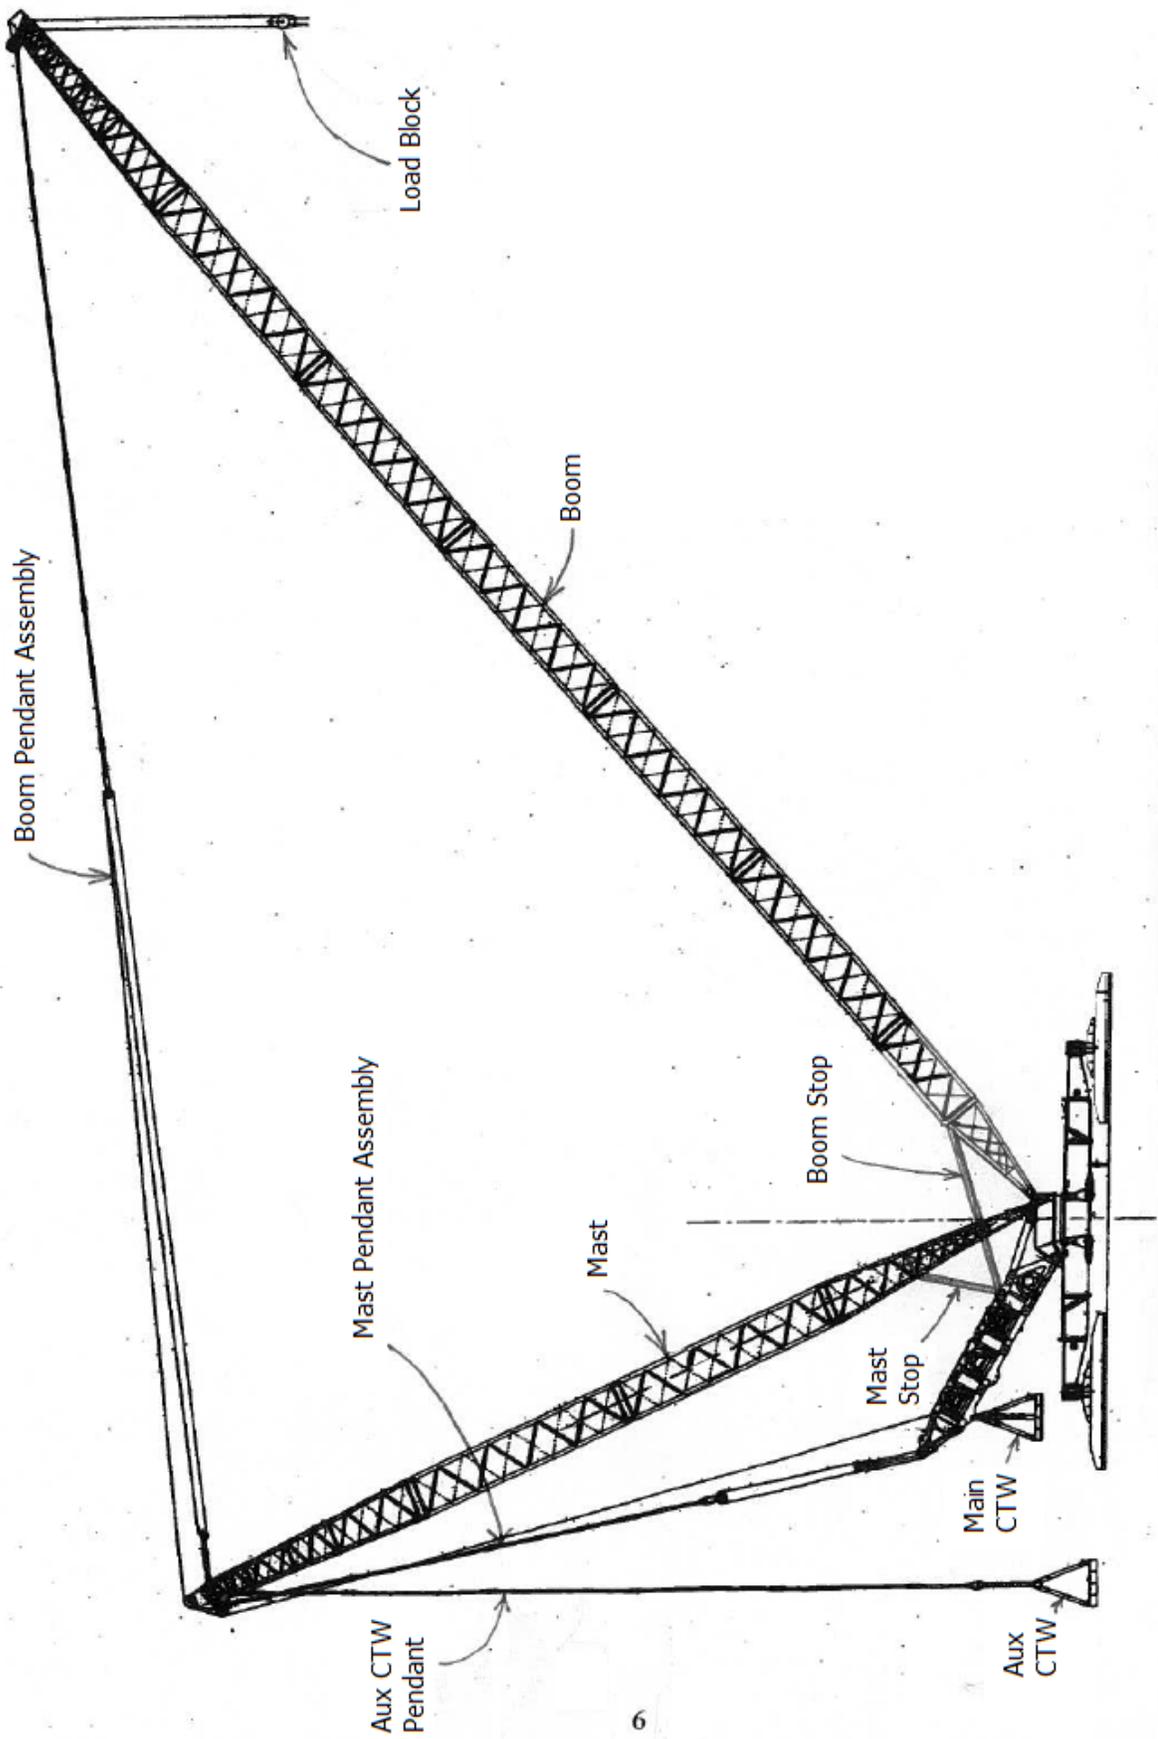
Figure 1. Configuration of the Versa Crane TC36000 Involved in the July 18, 2008 Incident (Modified from DSC, 2008).

The Versa crane TC36000, involved in the incident, was designed and built by DSC in 1998 in accord with ASTM B-30.5-1994. The crane was assembled at the Lyondell Basell site with a 420' boom, 240' mast, 61' spar and 836,000 pounds of main counterweight attached to the spar (Figures 1 and 2). An additional 836,000 pounds of auxiliary counterweight was to be attached to its pendants suspended from the mast tip at 105' from the axis of the crane. With this configuration, the crane would have a one million pound lifting capacity at a maximum boom radius of 160'. The incident occurred during the installation of the auxiliary counterweight.
