# Investigation of the December 19, 2008 Collapse of Atlanta Botanical Garden Canopy Walkway during Construction in Atlanta, GA

U.S. Department of Labor  
Occupational Safety and Health Administration  
Directorate of Construction

June 2009

Report Prepared by  
Mohammad Ayub, PE

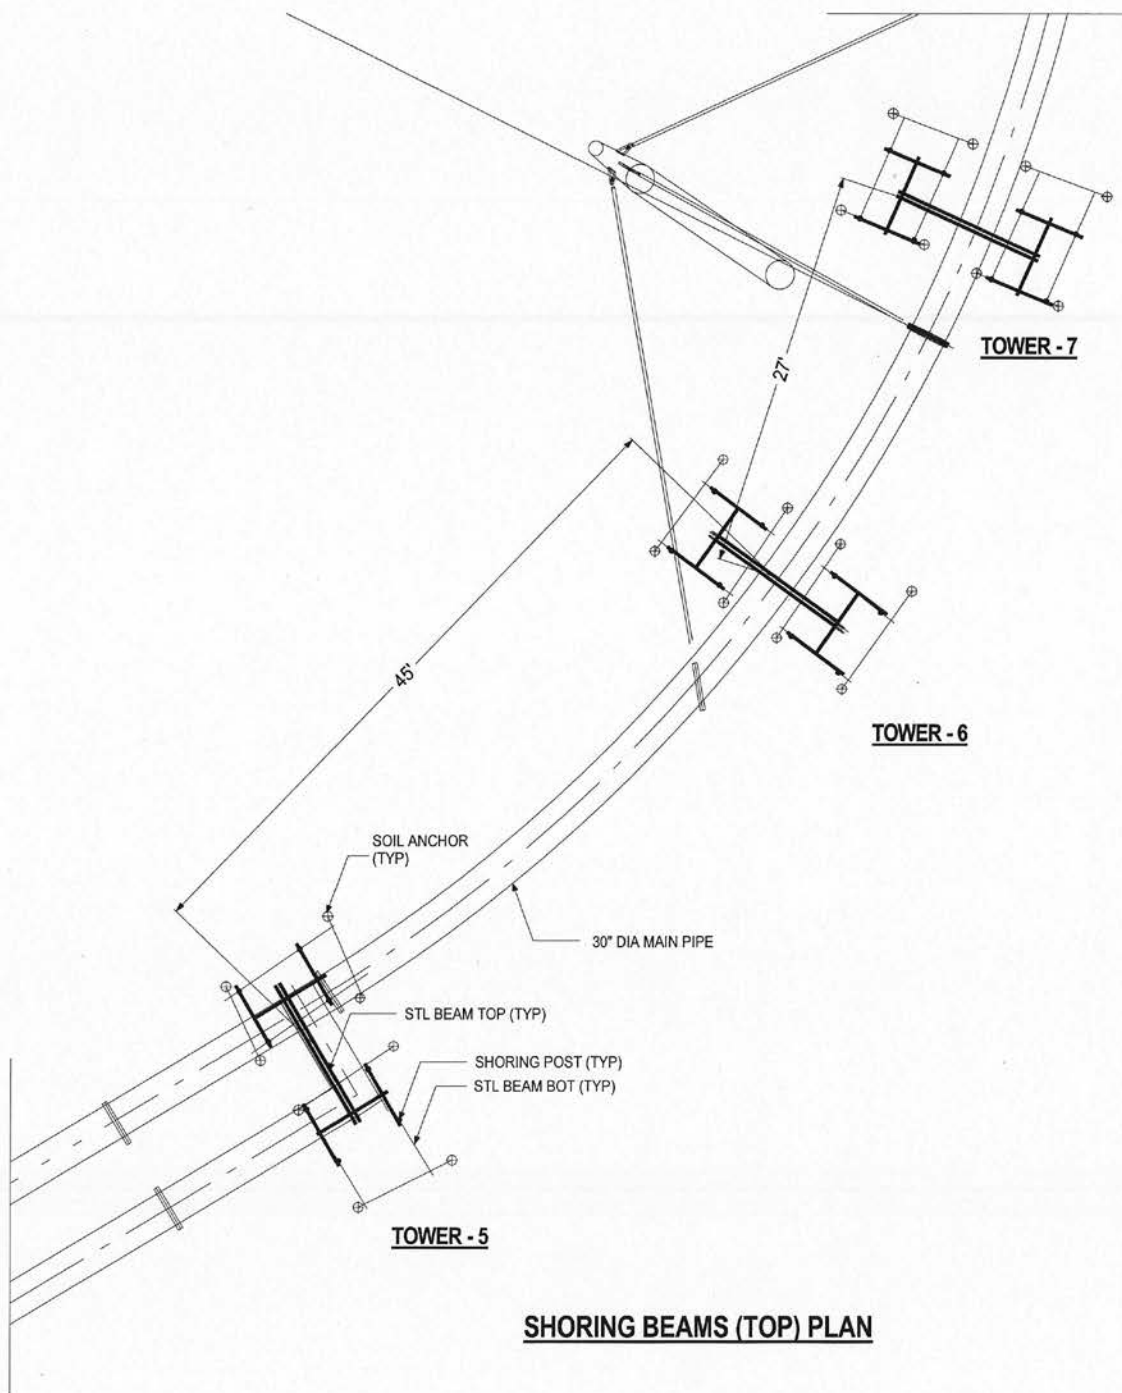
**Figure 18**

The shoring tower at grid D.1 (tower #5) was relocated to grid D, see Fig. 16, by Williams and this increased the spacing between tower #5 and tower #6 to 45', see Fig. 18. The original distance between tower #6 and tower #7 was 27'. The distance between tower #5 and tower #7 thus became 72'. This resulted in an average effective span of 36' for tower #6. Assuming that concrete was placed only between tower #5 and tower #8 and the construction live load could be reduced to 19 psf, the loads on the shoring towers # 6, 7, 8 and 9 were approximately 56, 42, 34 and 16 kips, respectively, at the time of the incident.

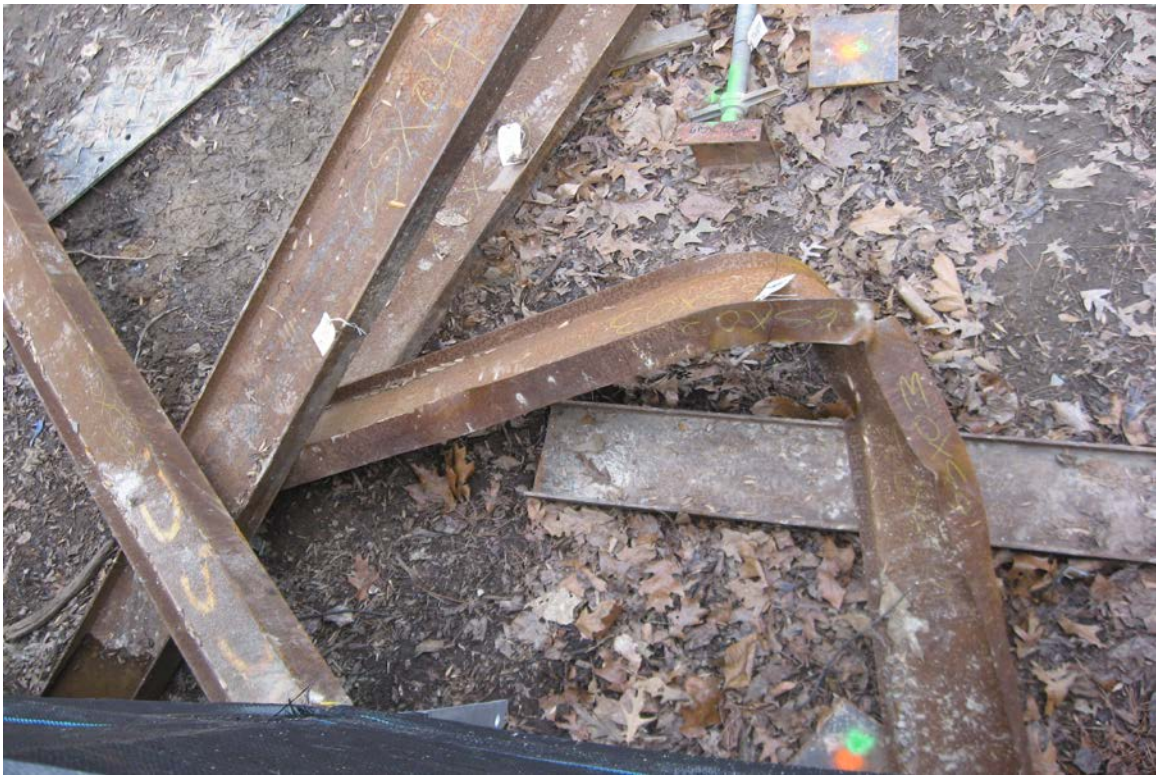
We will first examine tower #6. As a result of the collapse, two steel beams, W10x12 and W10x19, were observed trapped under the bridge's main pipe, at tower #6. If Williams placed these two beams under the pipe, in the worst-case scenario, the two beams must have then jointly supported a load of 56 kips. Assuming that the load would have been shared by the two beams in the ratio of their stiffness, W10x12 and W10x19 would have been subjected to loads of 19.6 and 36.4 kips, respectively. Given the higher yield stresses of the beams as determined by the laboratory testing, the beams would have just been able to support the loads. If Williams did not place these two beams under the pipe, but rather placed 2-W10x19 under the pipe, the 2-W10x19 beams would have had enough strength to support the loads. W10x12s, if placed anywhere else would also have had enough strength to support the load. Post-collapse observations indicated that the W10x12 and W10x19 beams were placed by Williams under the pipe. The other W10x12 beam is believed to have been placed either over the scaffolding tower or across the scaffolding towers, was ejected during the collapse, and was found lying some 30' away from tower #6. Further, all eight soil anchors under 6A and 6B had adequate embedment depths. If it is assumed that tower #6 had, in fact, failed, triggering the collapse, then the load would have been instantly transferred to towers #7 and #5. Tower #7 would then have been subjected to an increased load of 98 kips, much greater than the combined strength of 2-W10x19 beams and subjecting them to failure in a flexural mode. Interestingly, post-collapse observations did not indicate such deformations in the beams. In fact, the beams remained practically undeformed. The failure of tower #6 can, therefore, be eliminated as a triggering cause.

**Figure 23 Tower #6A Shoring beams after collapse**

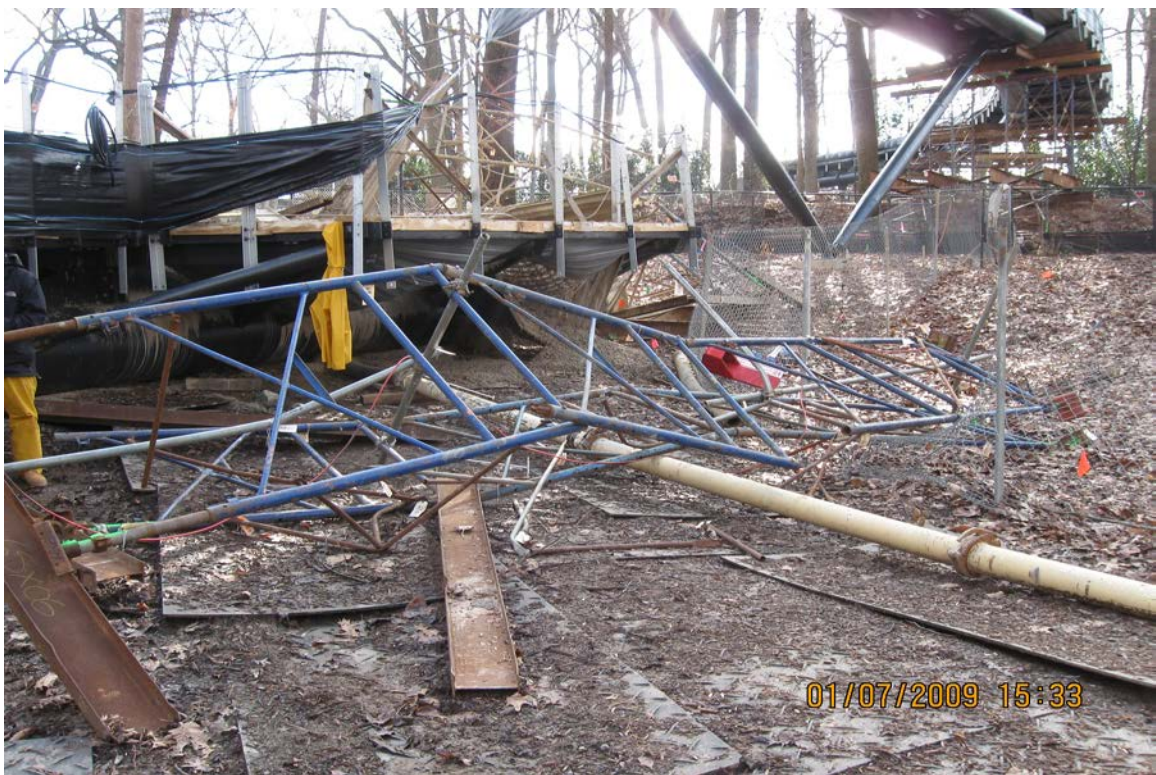
**Figure 24 Tower #6B after collapse, No deformation**

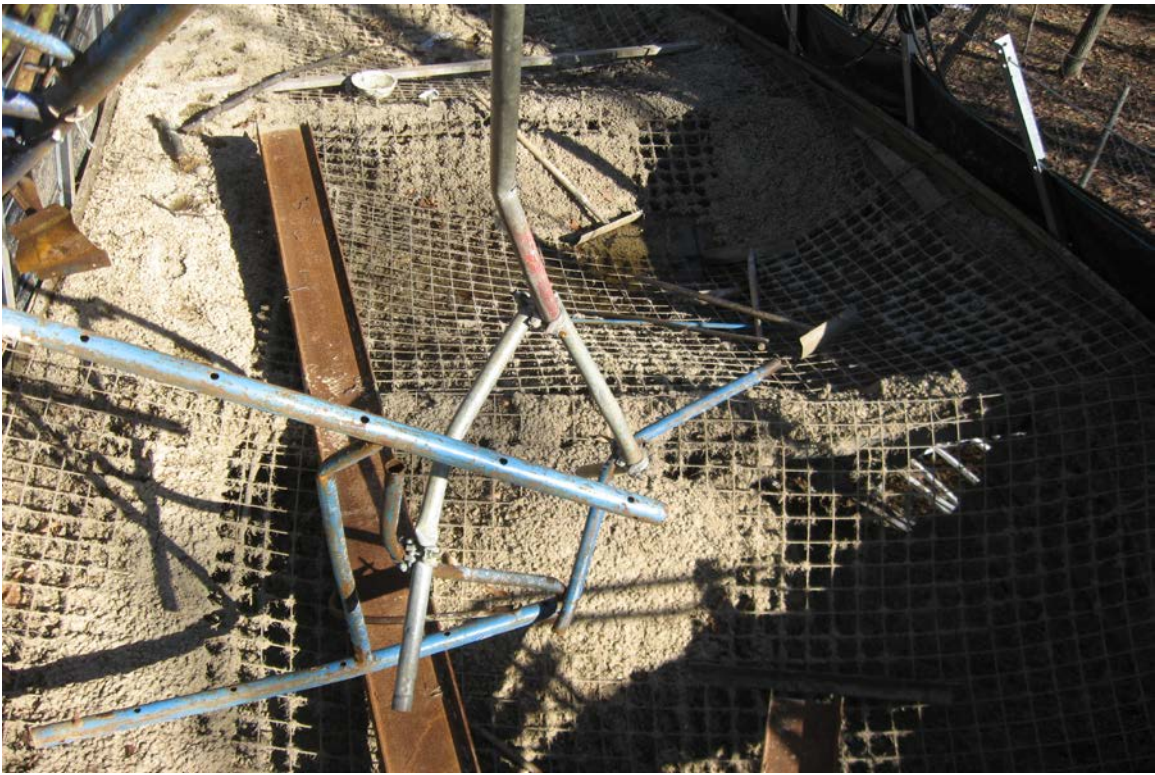
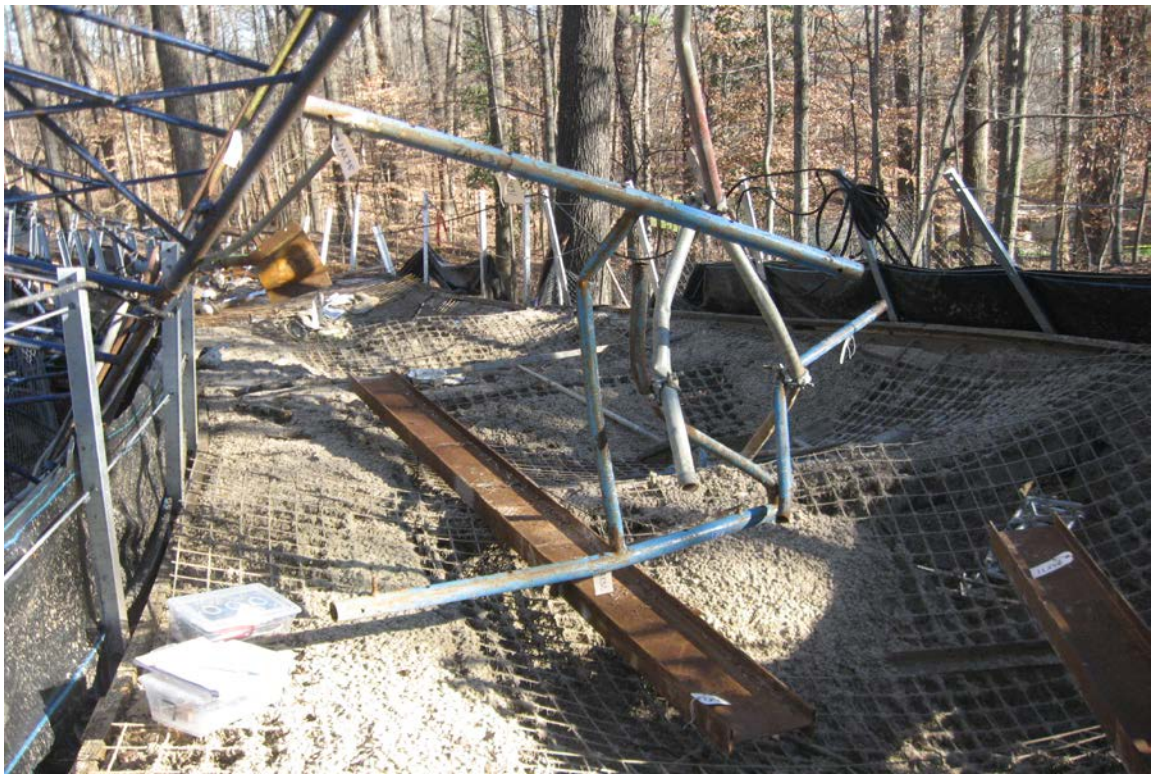
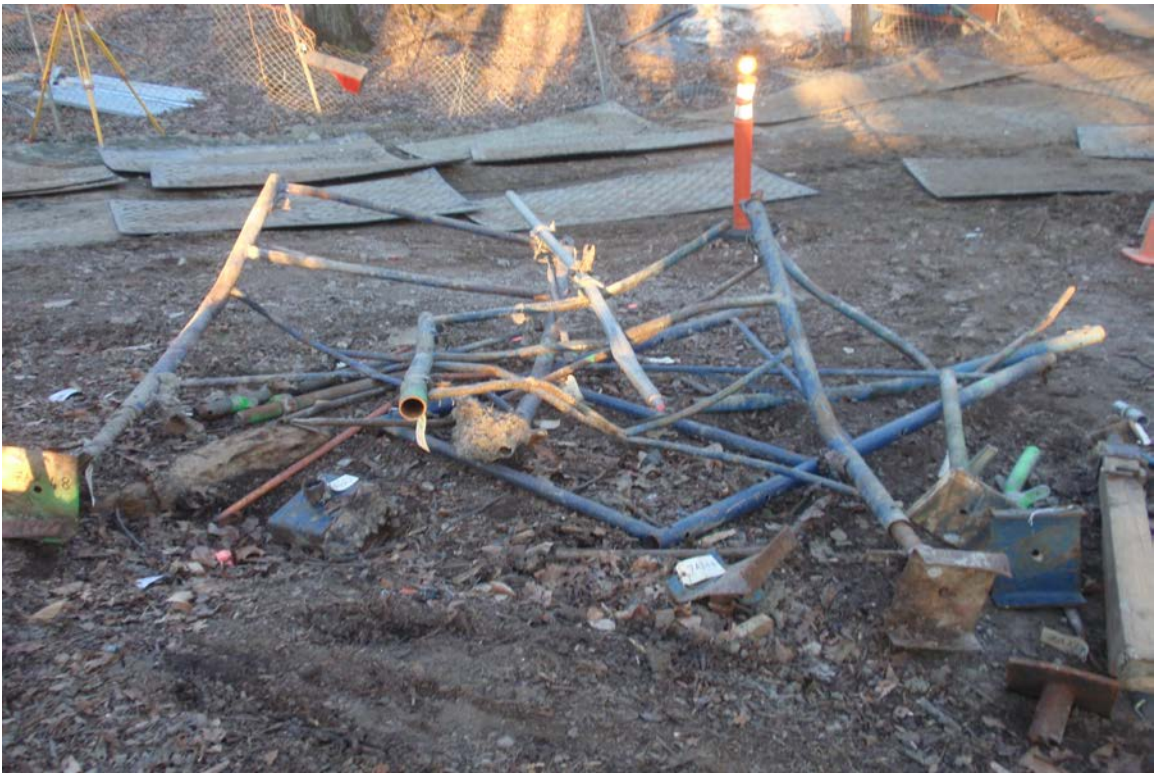
We next examined tower #7. During post-collapse inspection, scaffolding tower #7A was observed to be severely deformed and damaged, while scaffolding tower #7B remained relatively intact and leaned over to one side. Besides, a substantial quantity of fresh concrete was observed to have fallen over #7A. Scaffolding tower #7A was observed to have sustained the most damage among scaffolding towers, #6A, 6B, 7A and 7B. Under scaffolding tower #7A, two of the four soil anchors on the west side had inadequate embedment lengths of 29" and 35" in the soil. If the top 12" of the soil is disregarded, the effective embedment depths of the anchors on

the west side were only 17” and 23”. The anchors on the east side of the scaffolding tower #7A were anchored 80” deep. The distance between the east and the west anchors was approximately 8’. The difference in the relative elevations of the bottom of the anchors between the east and the west were 51” and 45”. A review of the bottom elevations of the soil anchors of the towers indicated that it was highly unlikely that the west soil anchors of tower #7A with shallow embedment had hit a bedrock formation and that the anchors were resting on a sound rock stratum. Based on the micropile drilling records of the area by Hayward Baker Inc, dated June 20 through 26, 2008, a silty sand layer was first encountered with an average thickness of 24’. The average depth of bedrock was 45’. Thus, the anchors had hit some boulders below which could have been soft or loose soil subject to gradual settlement. If, in fact, there was a differential settlement between the east and the west anchors of scaffolding tower # 7A, the tower would have been subjected to eccentric loading, resulting in its collapse. Since the towers were not supported at a uniform reinforced foundation with slabs or similar systems which are effective in resisting differential settlements, the tower’s structural integrity could have been seriously jeopardized in the event of settlement of an individual anchor. It is suspected that the differential settlement of the soil anchors resulted in overloading of scaffolding tower #7A, thus causing the failure. The observation of the post-collapse failure supports this scenario, as explained above. With the failure of scaffolding tower #7A, tower # 7B failed, and subsequently, towers #6 and #8 failed due to increased loading. With the elimination of towers #6, #7 and #8, the bridge’s pipe was overstressed at the splices near tower #9 and #5, leading to the resulting total failure.

**Figure 25 Tower #7A after collapse**

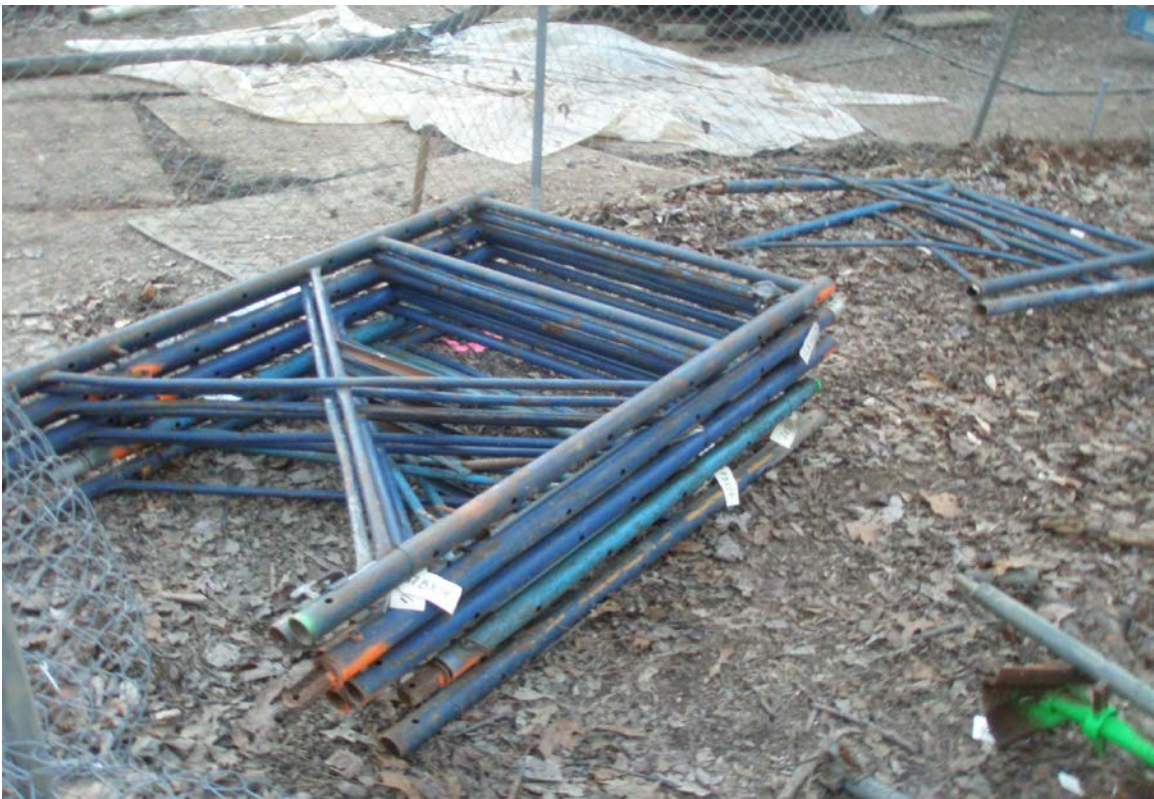
**Figure 28    Tower #7B after collapse, No deformation**

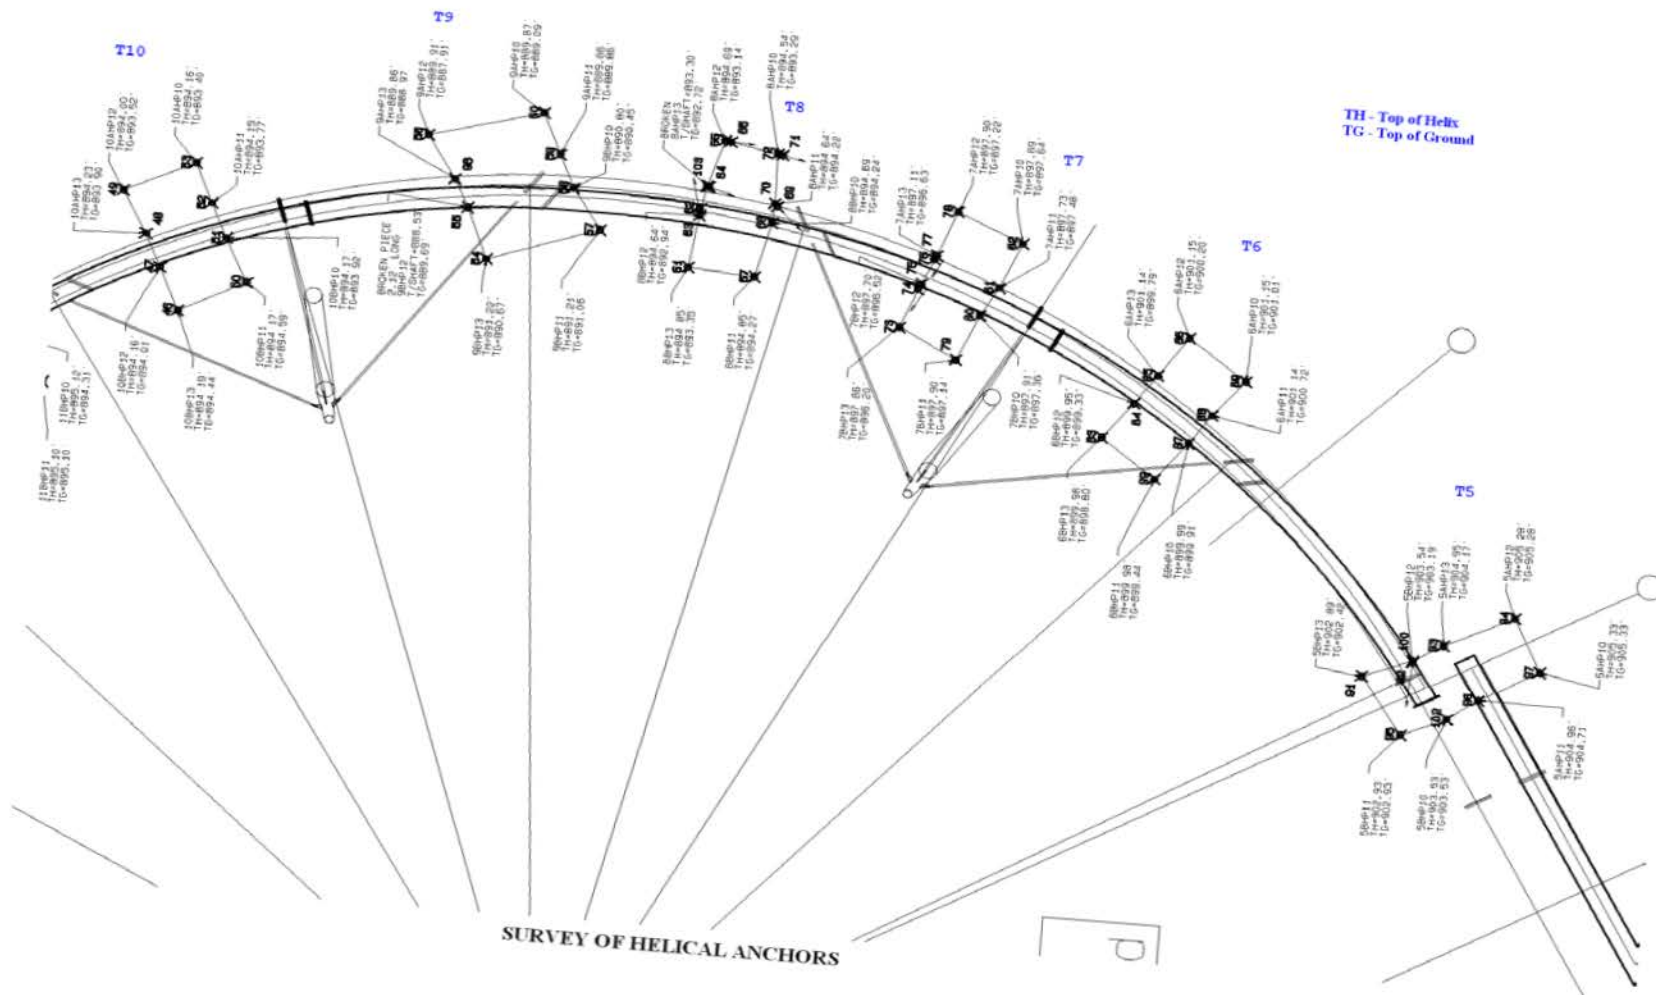
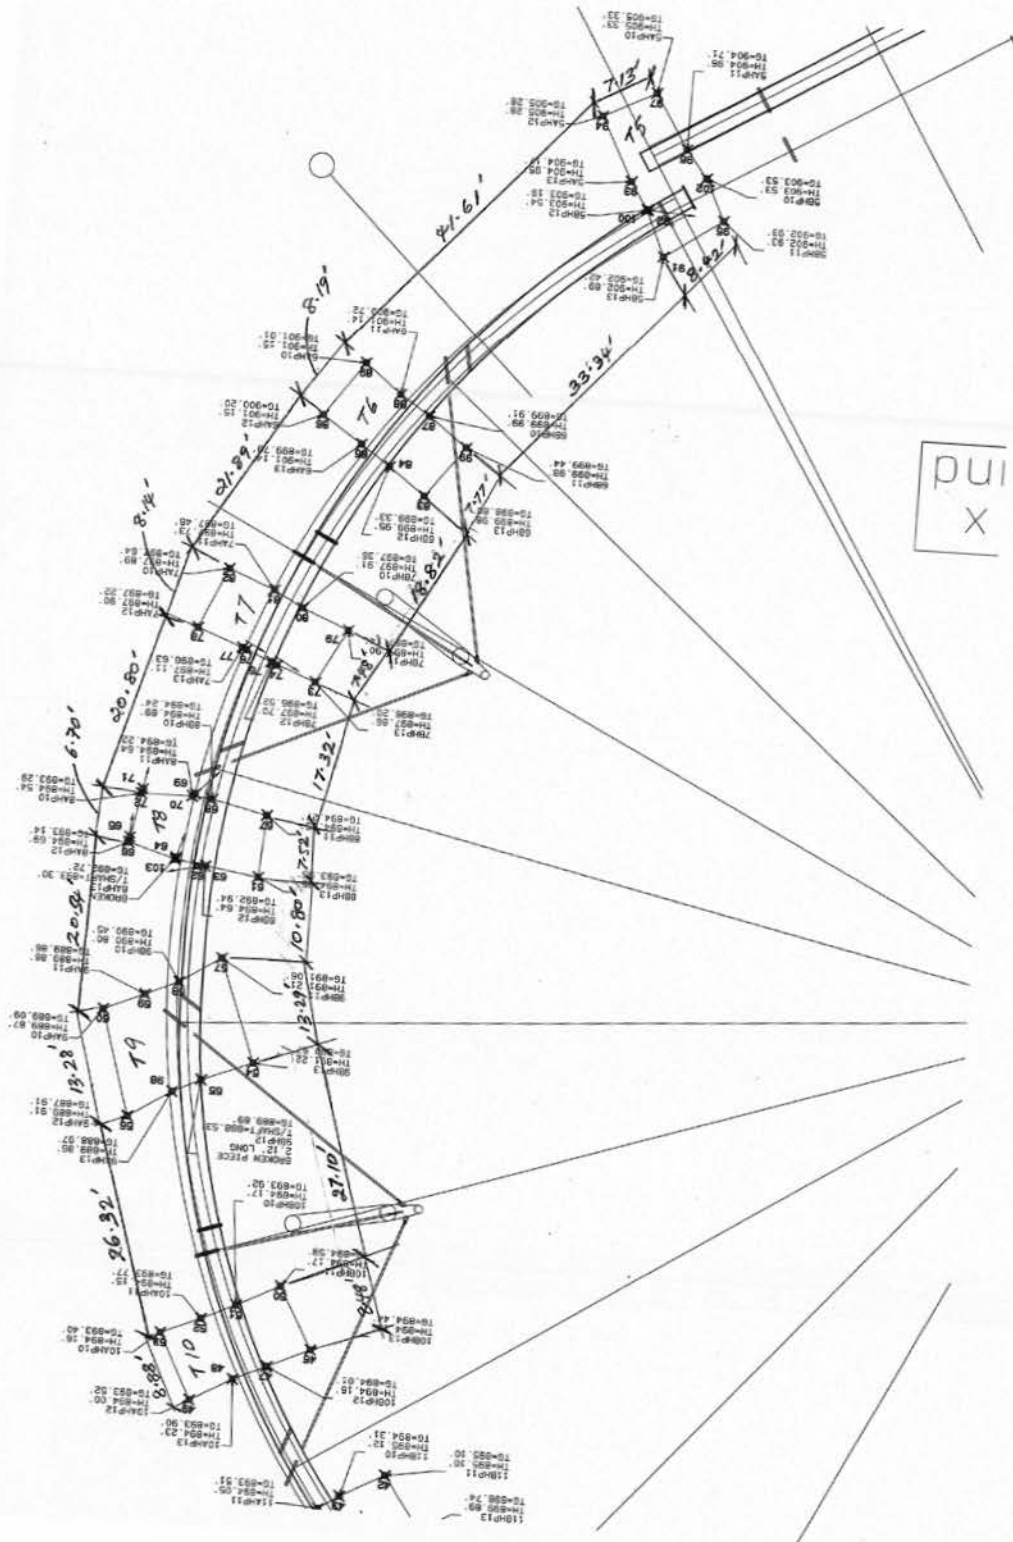
**Figure 31 Helical Anchor Embedment**

Fig. 31 indicates the anchors for towers No. 5 thru 10 with the depths of the embedment and the exposed height of the anchors above the grade. All anchors appeared to have adequate embedment. However, two anchors under Tower #7, and five under tower #8 had variable embedment depths ranging from 17" to 43". The following illustrates the depth of embedment for anchors under towers #7 and #8:

While the axial gravity capacity of the anchors might not have been impaired due to shallow embedment, the lateral load capacity was certainly questionable. We have determined that the maximum lateral load capacity of such anchors could vary from zero to a maximum of 500 pounds. Anchors having effective embedment depths of 5" to 23" can not be relied upon to support the load, particularly because there was no sub-surface investigation performed at the site. Unequal depths of anchors supporting a scaffolding tower could result in differential settlements of the anchors.

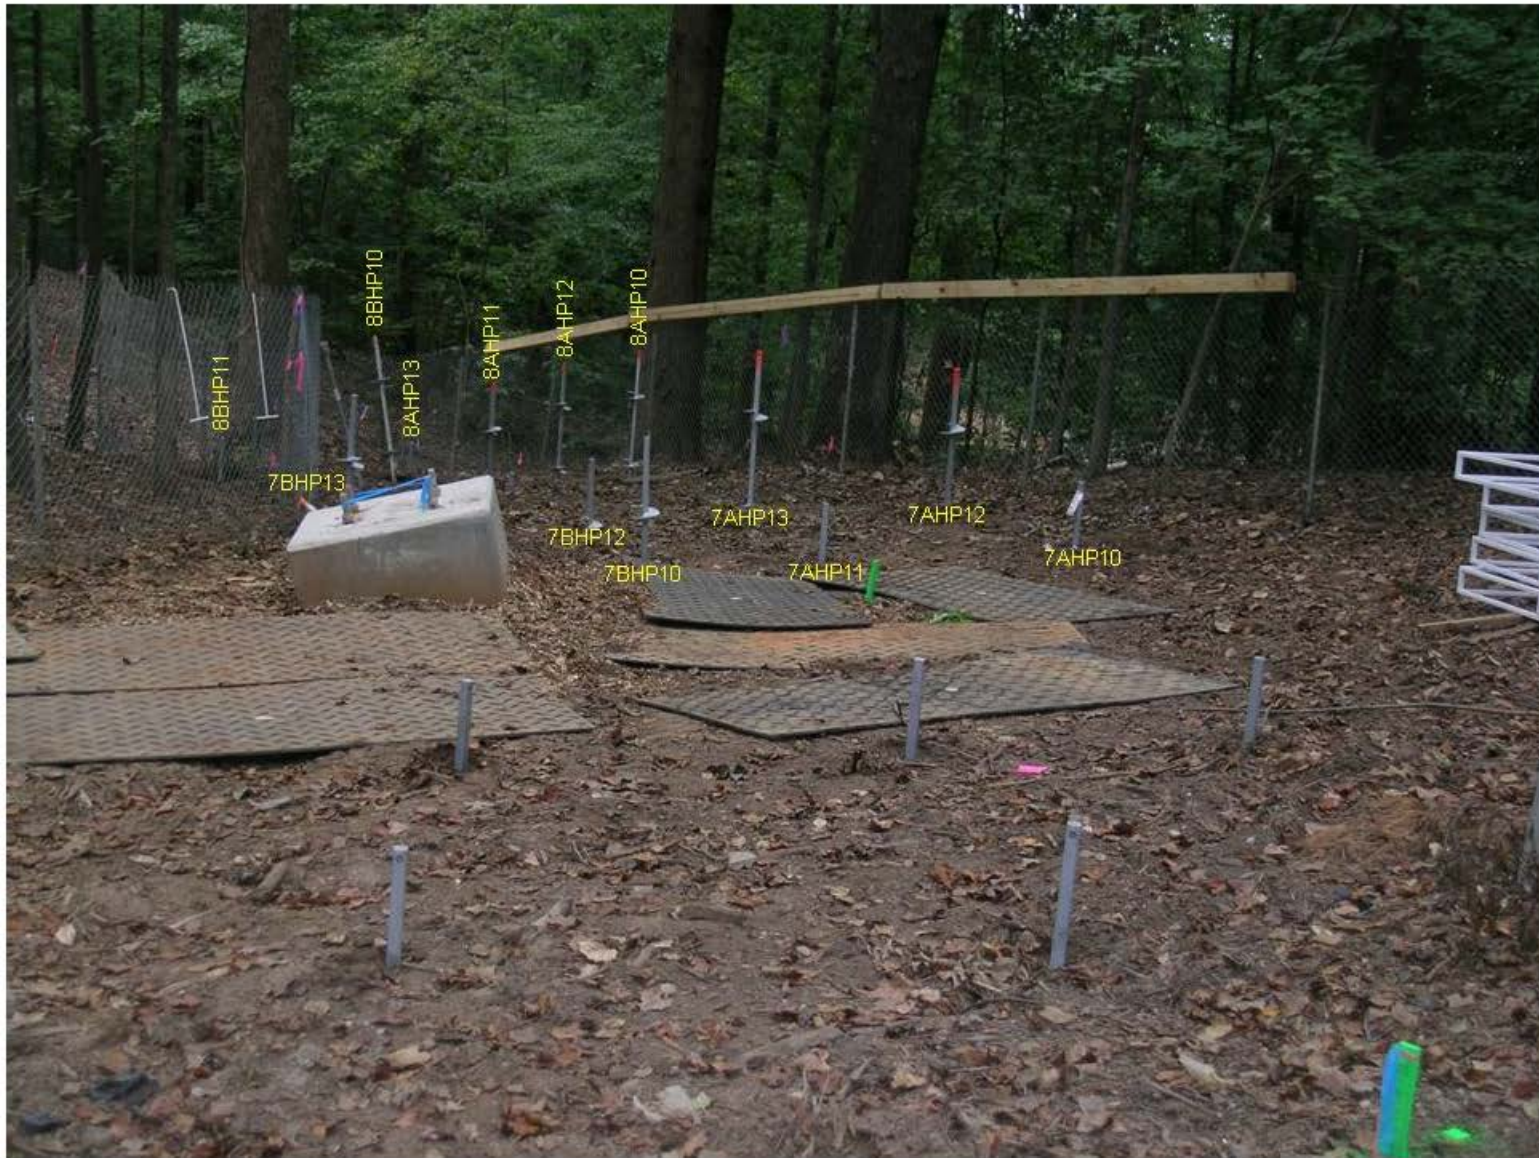
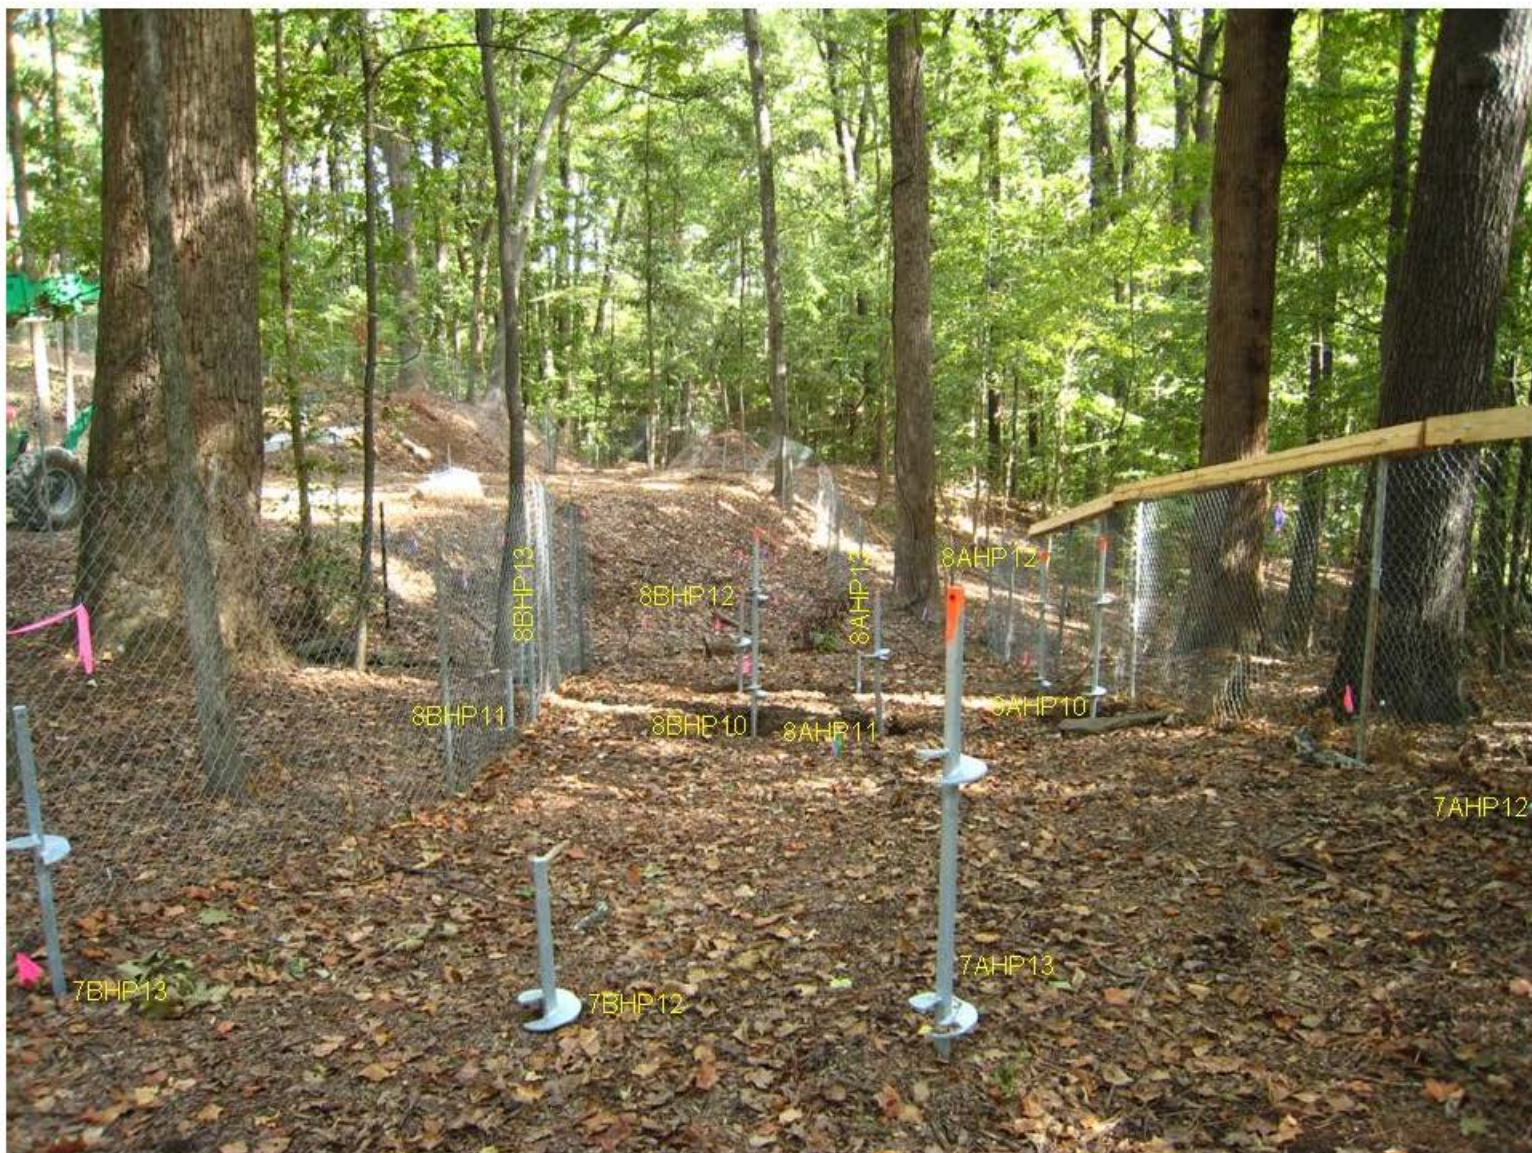
LBYD was informed that some anchors had insufficient embedment depths of approximately 3'. LBYD then prepared sketches for Williams to provide diagonal bracings between those anchors, and between the adjoining shoring towers in case even one anchor had insufficient embedment depth. LBYD was not informed of the anchor depths as low as 17". Nevertheless, Williams did not provide the diagonal cable bracings between the anchors to resist the lateral loads as required by LBYD, see Figs. 11 and 12. Williams however installed L3x3x1/4" horizontal bracings between anchors at tower #8A. Bracing were not provided at tower #7A. Therefore, these anchors were highly susceptible to lateral movement, jeopardizing the stability of the shoring

**Figure 32 Helical Anchors at T7 and T8 before cutting**

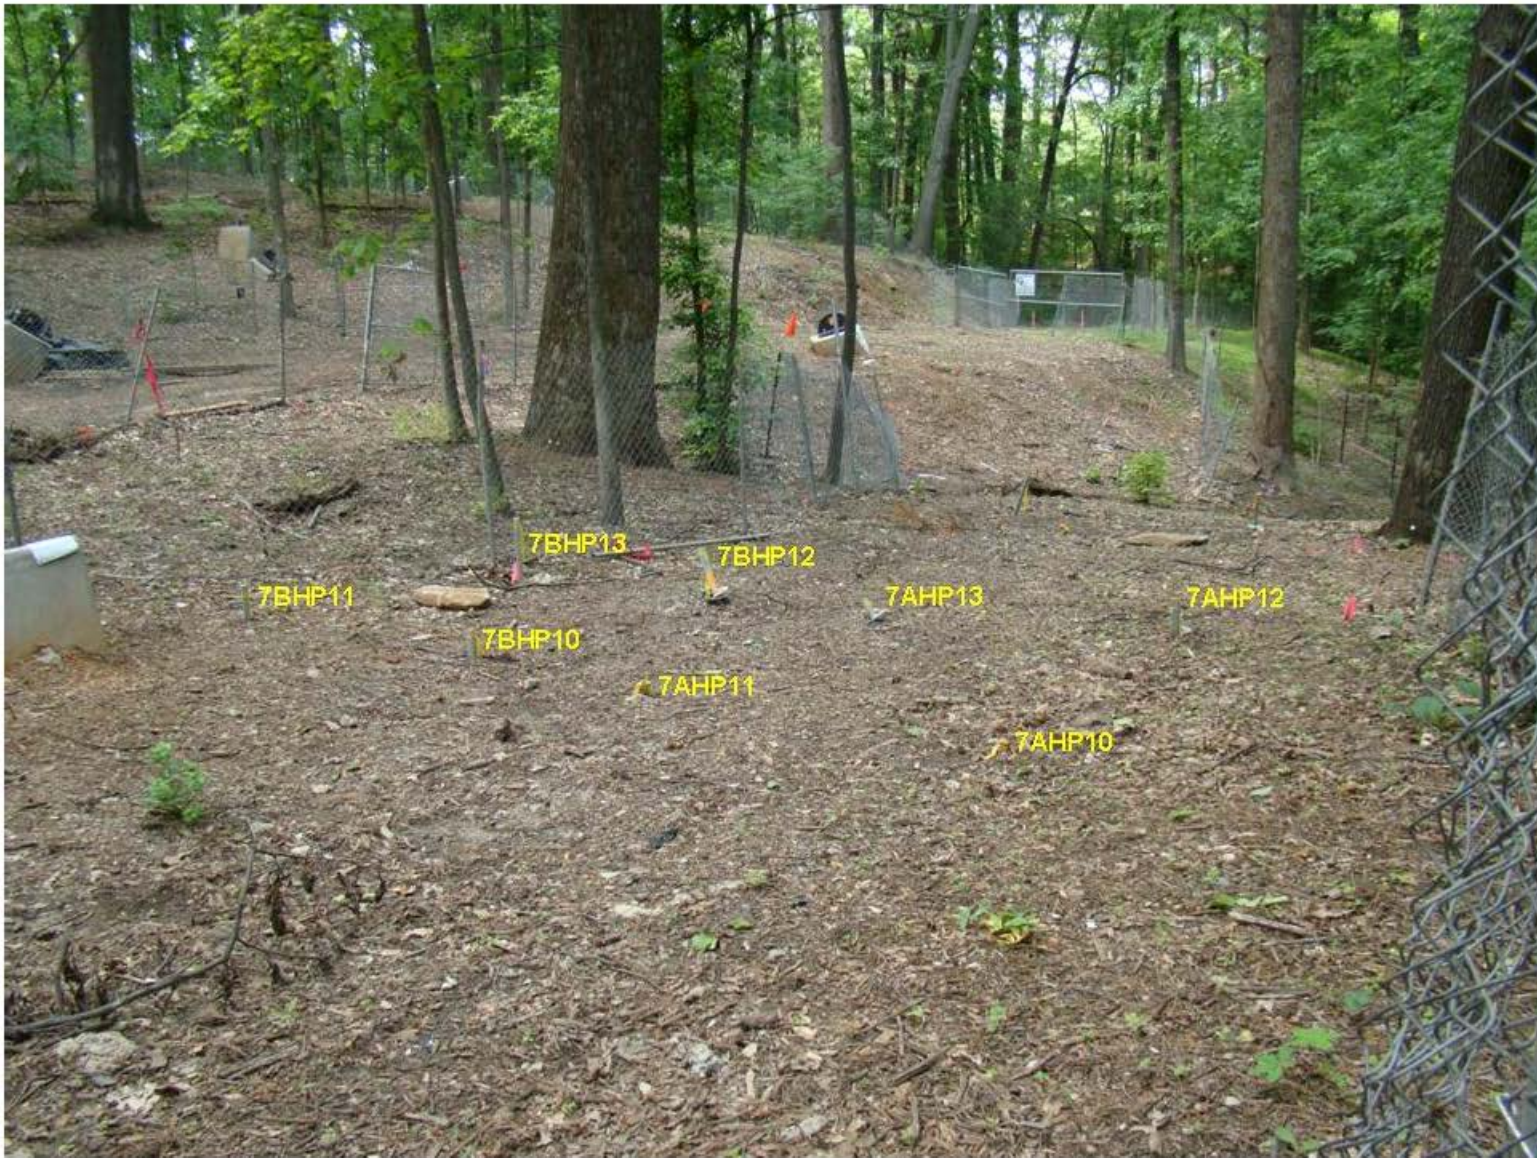
3. The shoring contractor did not provide the required diagonal cable bracings between the anchors which had insufficient embedment depths, as required by the shoring tower engineer. Anchors with shallow depths are highly susceptible to differential settlement and lateral movements. This created a serious hazard. The shoring contractor had received instructions to provide lateral bracings. Seven anchors under tower #7 and #8 had embedment depths that varied from 43" to 17". This omission contributed to the collapse.

**Figure 34 Helical Anchors at T7 taken after collapse**

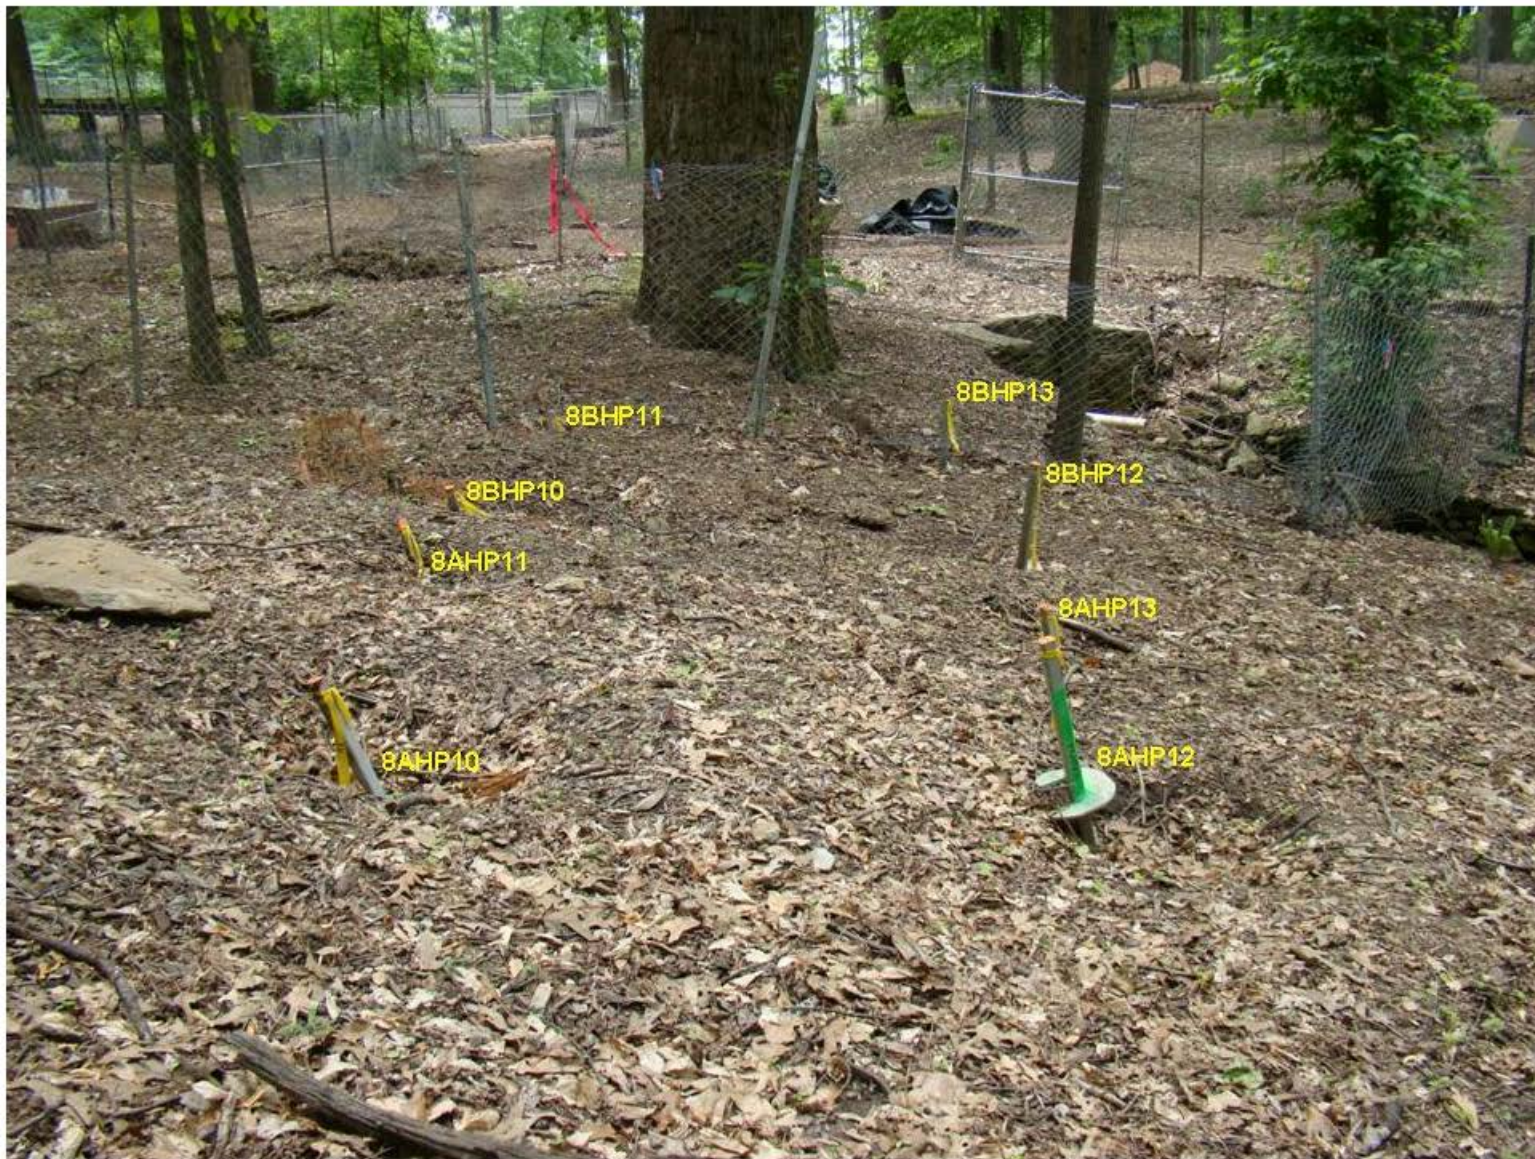
**Figure 35 Helical Anchors at T8 taken after collapse**
