INVESTIGATION OF THE SEPTEMBER 7, 2011 COLLAPSE OF A MOBILE CRANE AT THE NATIONAL CATHEDRAL SITE IN NORTHWEST WASHINGTON, DC

U. S. Department of Labor
Occupational Safety and Health Administration
Directorate of Construction

March 2012

This report was prepared by
Scott Jin, Ph.D., P.E.
Mohammad Ayub, P.E., S.E.
Directorate of Construction
Occupational Safety and Health Administration

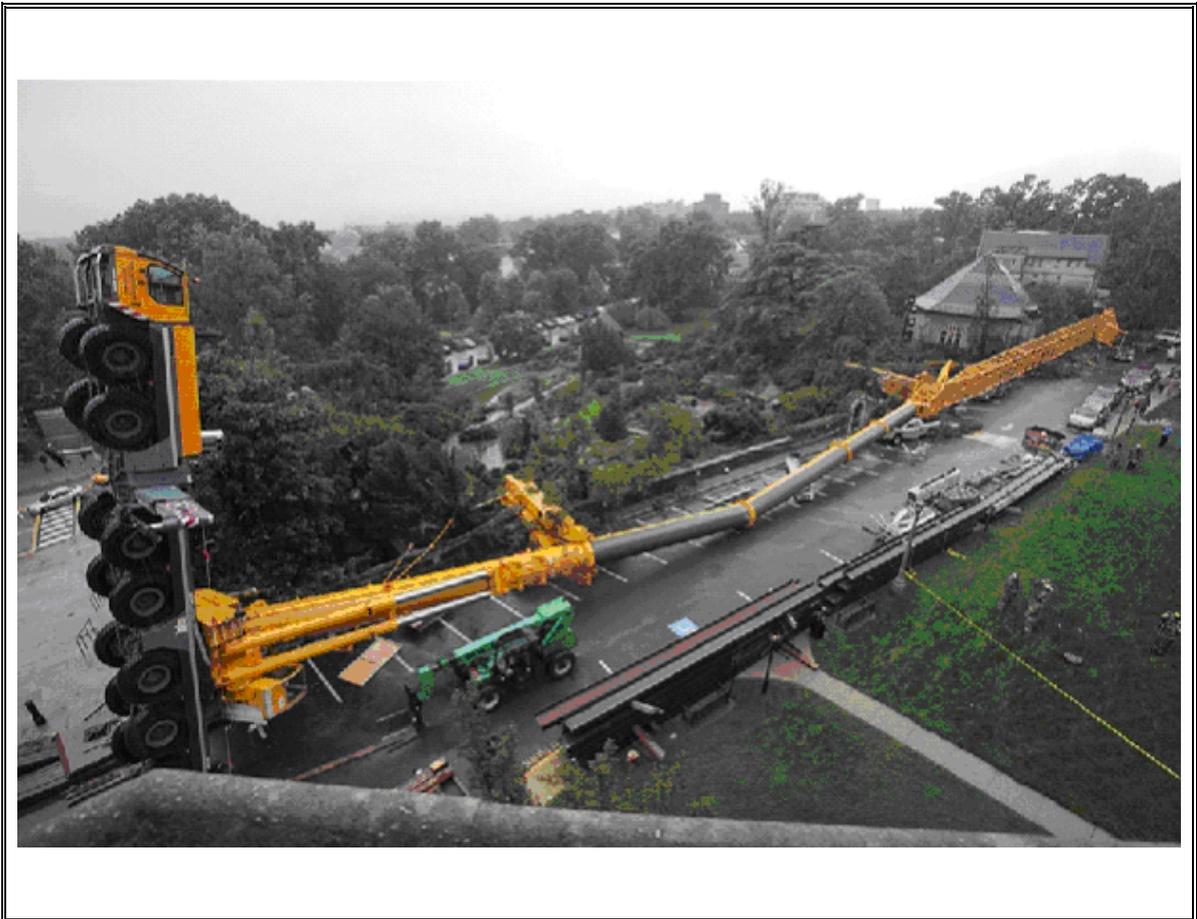
This photograph was taken from the top of the cathedral building about 4 hours after the collapse (Taken from National Cathedral Twitter).

- The main body of the boom landed on the pavement surface (See the photograph on the cover of this report).
- Due to the overturning energy, the carrier and the attached superstructure tilted upward to a near vertical position with the rear side of the carrier supported on the pavement surface (Figure 14).

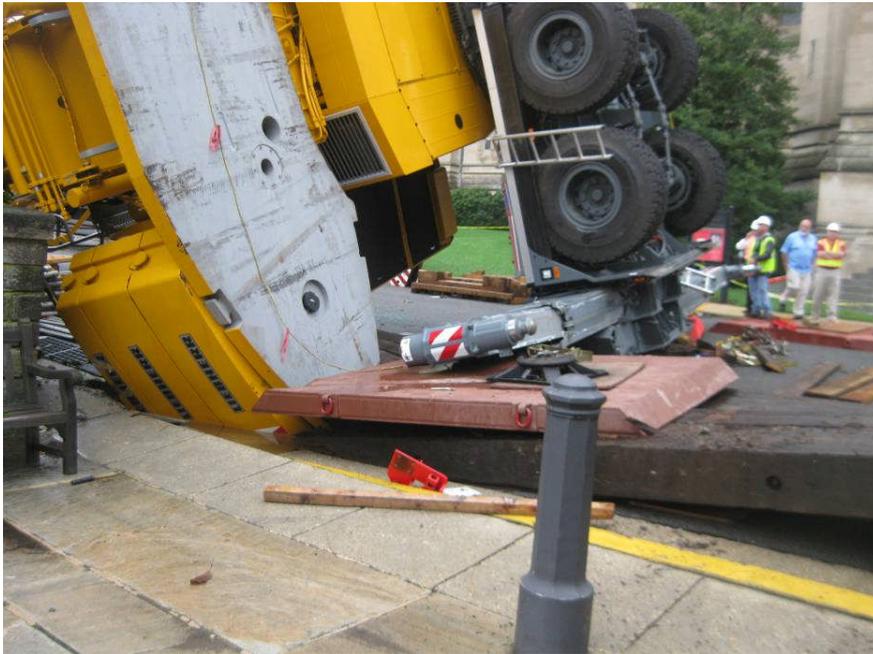
The crane was put to work on Monday, September 5. It made a few lifts mostly in the 3,200 pounds range. In the afternoon, the crane operator and others observed a crack on the asphalt pavement at the rear right outrigger pad.

The next day, September 6, the cracking of the asphalt continued and caused a ¼ inch settlement of the rear right outrigger pad. CSC placed two 32 ft. long, 4 ft. wide and 12 in. thick timber mats side by side on the asphalt; and added an 8 ft. by 9 ft. steel pad between the mats and the rear right outrigger pad (Figures 6 and 7 indicate the pad after the collapse). The purpose of the mats and the steel pad was to uniformly spread the load over a larger area and to minimize any additional settlement. Later in the afternoon, when the wind subsided, the crane successfully made one lift of scaffold cross braces. No other activity took place and the crane was set for the night.

Figure 6. The Rear Right Outrigger Pad after the Collapse. Note the steel plates and the timber mats (Taken from KCE Structural Engineers, PC).

- There was no payload attached to the hook (load block) at the time of the collapse.
- The settlement of the rear right outrigger pad was approximately 6 inches.

3. The right rear support of the pad settled approximately 6 inches before the incident but did not cause the collapse. Its contribution to the collapse was minimal, approximately 1.5%. If the crane had been operated within the load chart, the collapse would not have occurred despite the settlement.

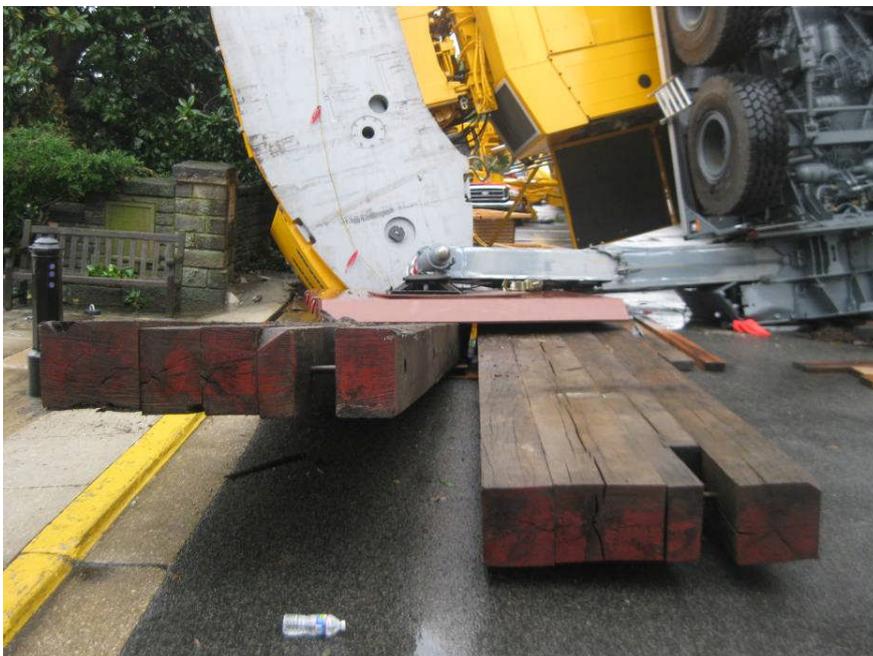
Figure 7. Same as Figure 6, but Viewed in a Different Direction (Taken from KCE Structural Engineers, PC).

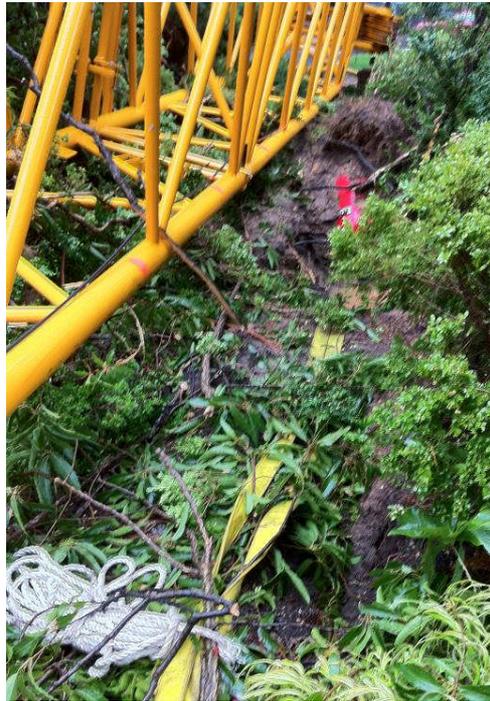
- The tipping axis during the collapse was the rear outrigger pads of the crane (Figure 5).
- During the collapse, the load block (headache ball) hit the ground first. The load block dragged over the grass surface more than 50 ft. until the tip of the jib hit the ground on the front yard of the Episcopal Church House (Figures 8 and 9).

Figure 8. Load Block, Synthetic Web Slings and Nylon Ropes (Taken from KCE Structural Engineers, PC).

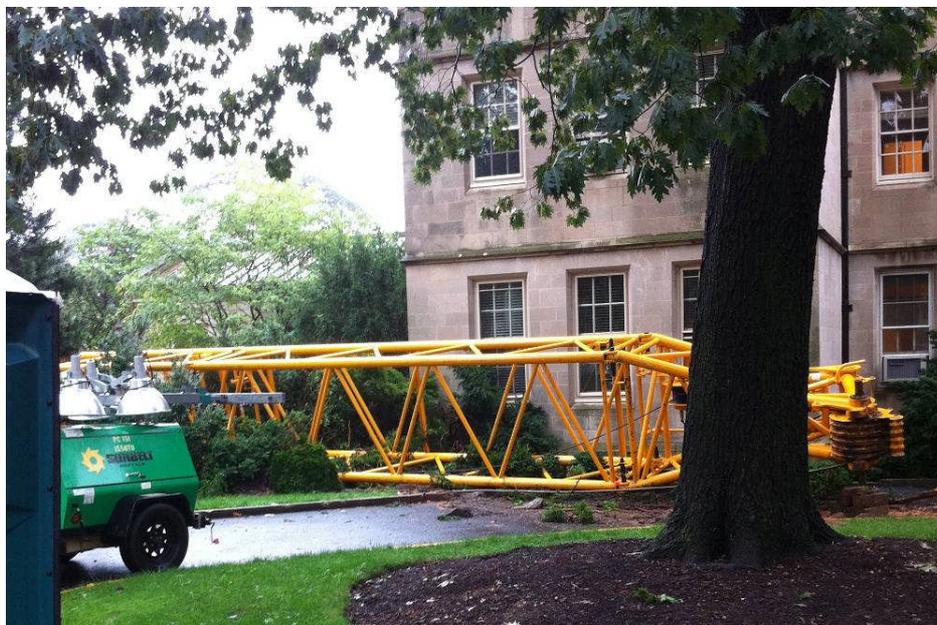
Figure 9. Tip of the Lattice Jib Landed on the Front Yard of the Episcopal Church House (Taken from KCE Structural Engineers, PC).

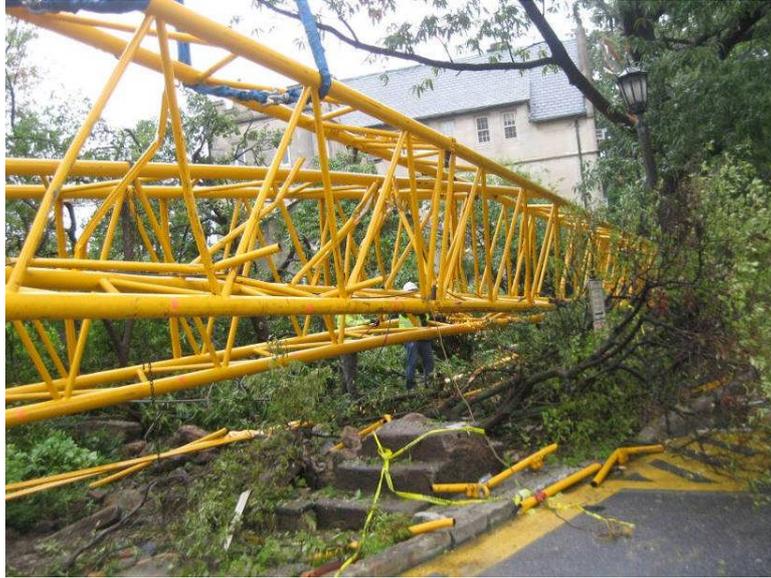
- The lattice jib broke at the mid transition point (between the smaller and bigger sections) when the tip hit the ground (Figure 10).

Figure 10. Broken Lattice Jib Pieces after the Collapse (Taken from KCE Structural Engineers, PC).

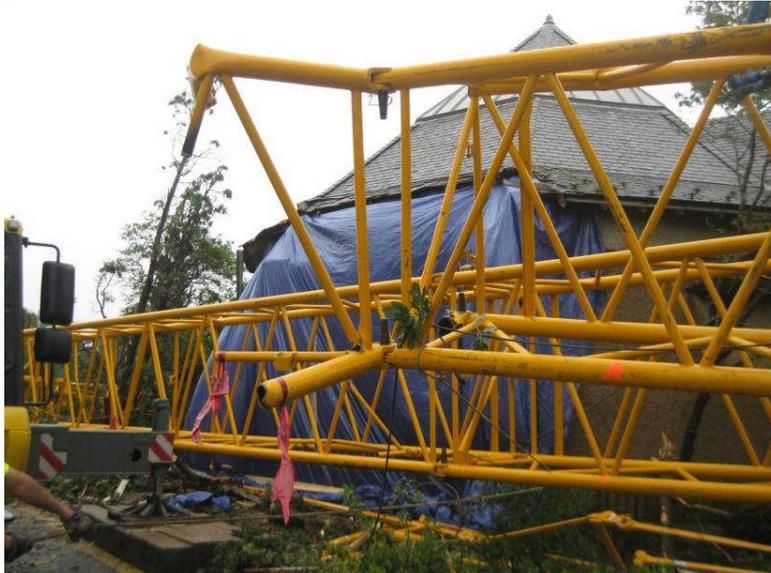
- The rear portion of the jib hit the roof of the Herb Cottage (Figure 11) and crushed a parked truck (Figure 12).

Figure 11. Herb Cottage Damaged by the Lattice Jib (Taken from KCE Structural Engineers, PC).

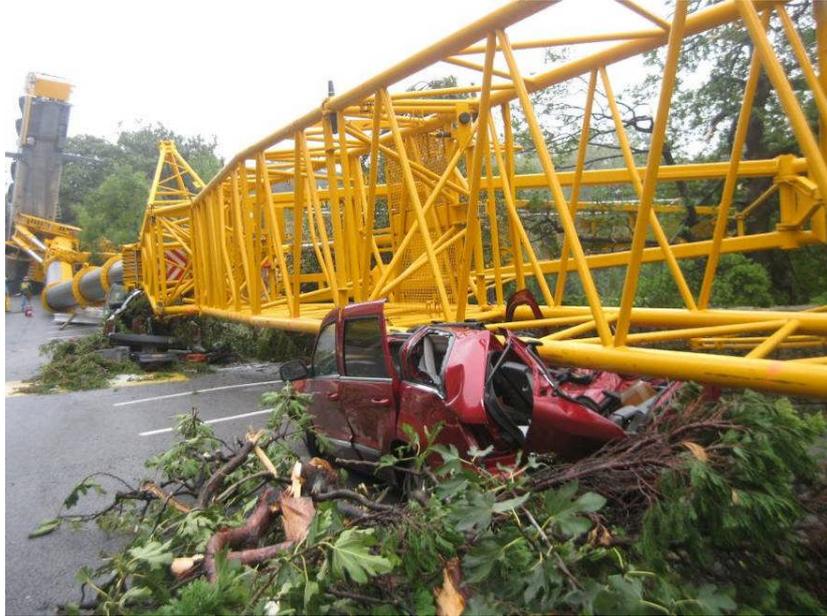
Figure 12. A Parked Red Truck Crushed by the Lattice Jib (Taken from KCE Structural Engineers, PC).

- The tip of the telescopic boom fell over a second parked truck (Figure 12) and the TY guys of the boom landed on a third truck (Figure 13).

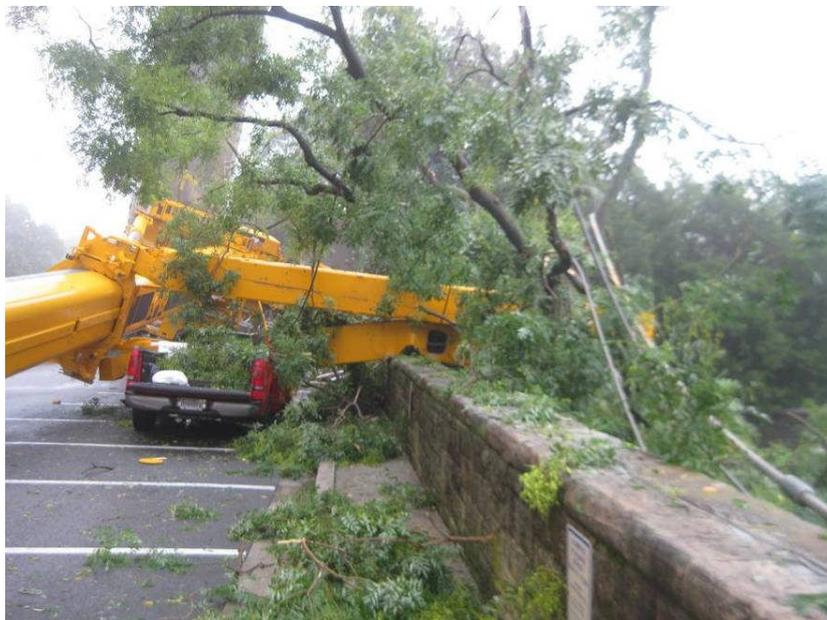
Figure 13. Another Parked Red Truck Damaged by the TY Guys of the Telescopic Boom (Taken from KCE Structural Engineers, PC).

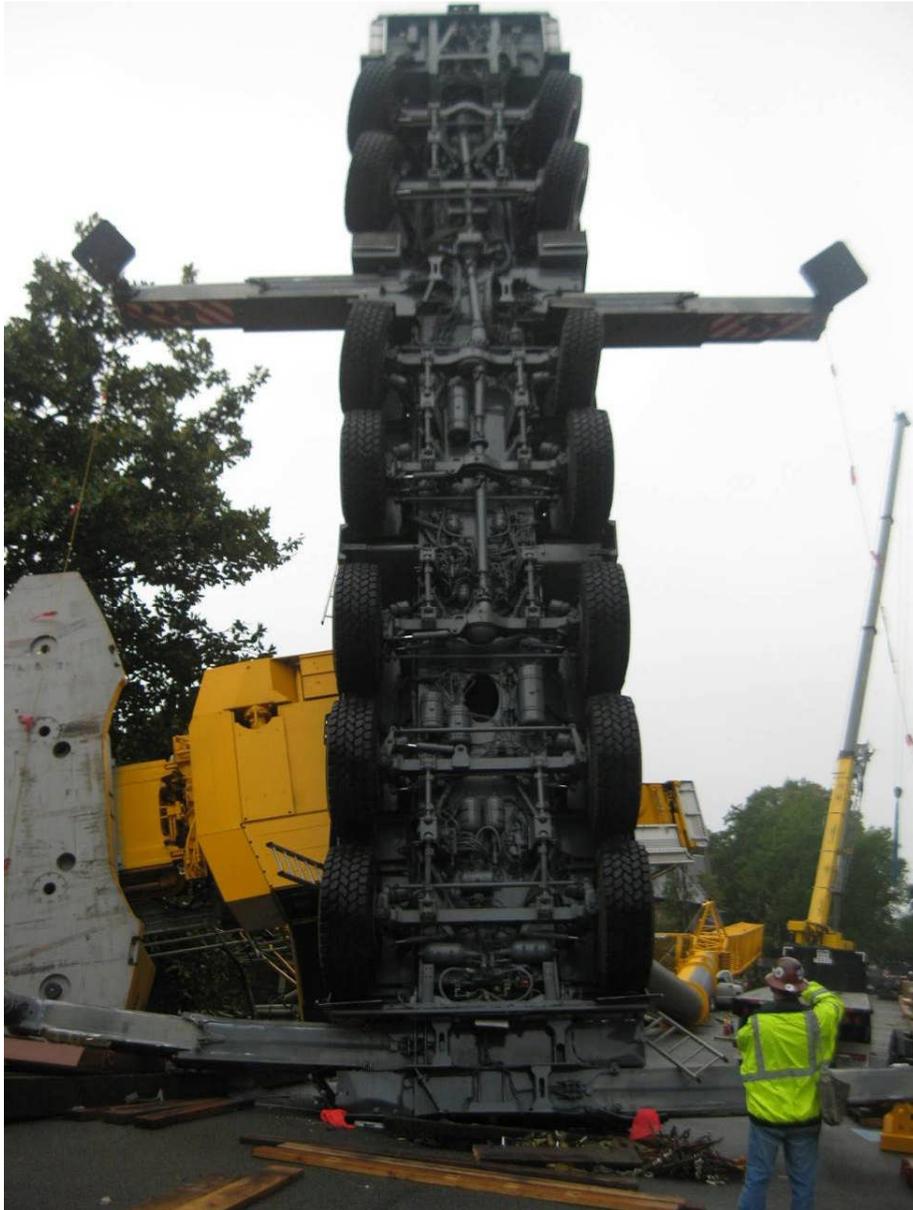
Figure 14. A Near Vertical Position of the Carrier and the Superstructure after the Collapse (Modified from KCE Structural Engineers, PC).

- At the initial stage of the tipping, the counterweight became unbalanced. It rotated southward along with the superstructure. They both rotated about 90 degrees counterclockwise (Figure 14). As a result of the rotation, the north half of the counterweights fell off of its frame and landed on the earth slope below. The south half remained connected.

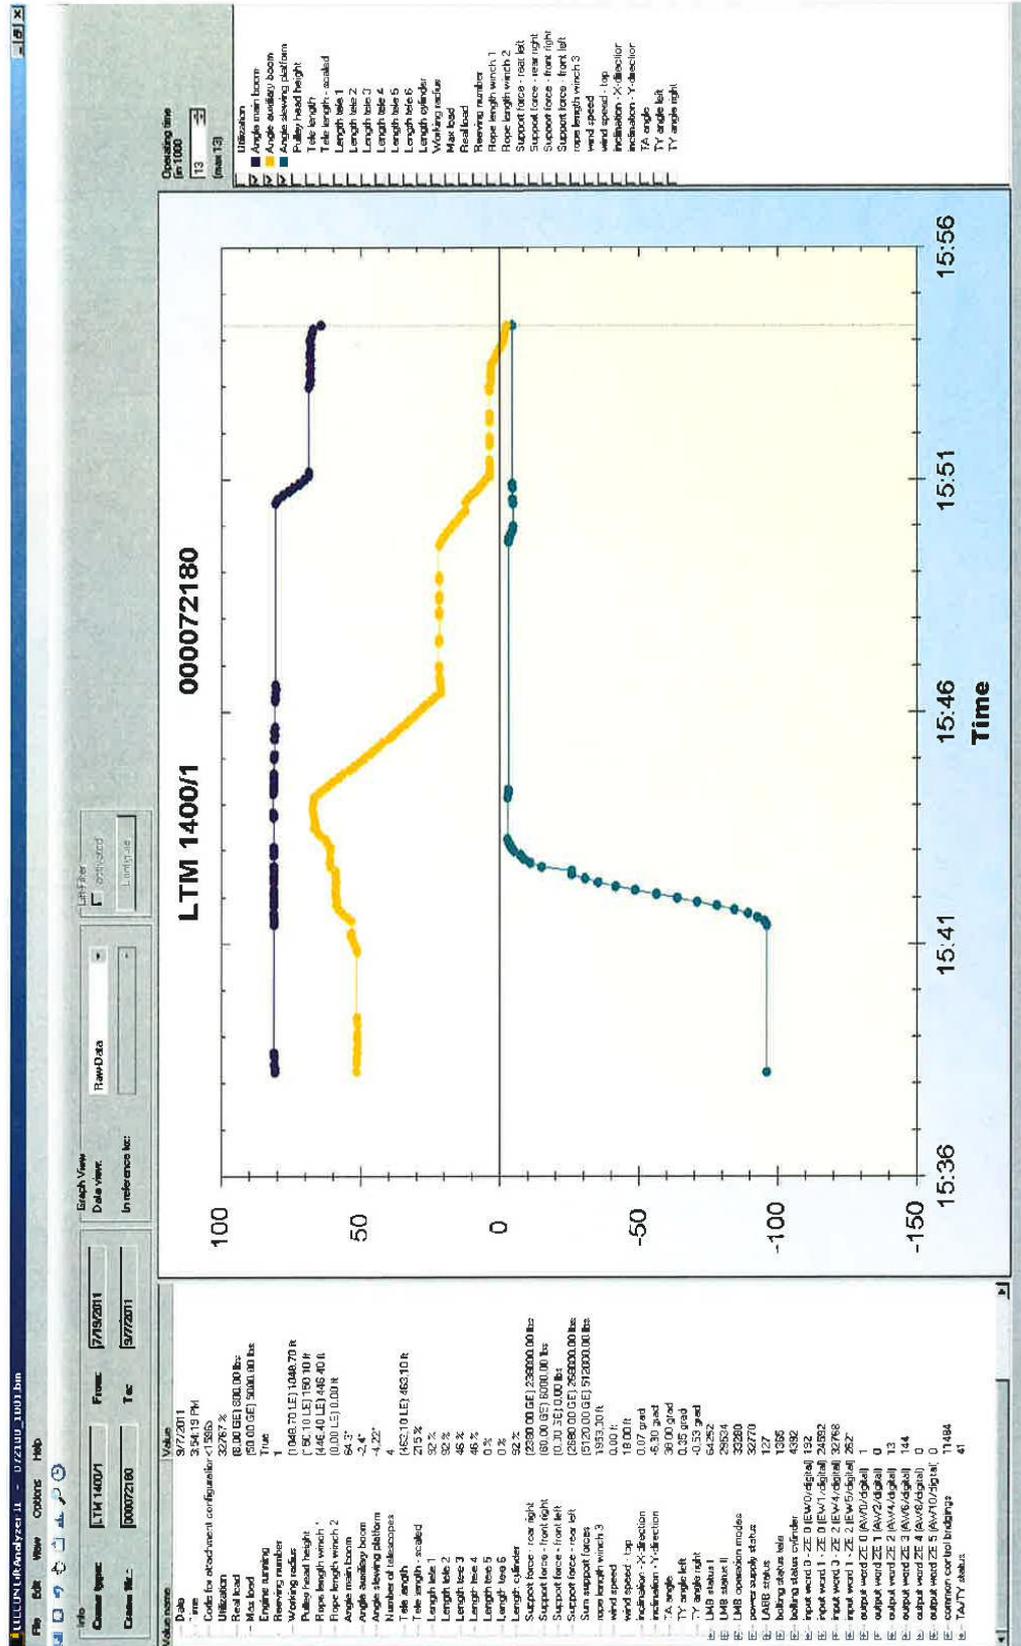
Figure 19. Recorded angular positions of the Telescopic Boom and the Lattice Jib for the Last 16 Minutes before the Collapse (Taken from Data Logger by Crane Service Company).

For the next three minutes, no movement was recorded either in the boom angle or the jib angle, which would indicate that the computer had actually shut off the operation. But, at 10:56 a.m., the operation started again. Is it possible that in the last three minutes, the bypass switch was activated? We do not know because the crane operator denies engaging the bypass switch. At 10:56 a.m., the jib was recorded to be lowered to 16 degrees, while the boom was maintained at approximately 81 degrees. At 10:58 a.m., the boom was lowered to approximately 70 degrees, and the jib was further lowered to 4 degrees. At 11:00 a.m., the boom was recorded to be at approximately 64 degrees with the jib at nearly horizontal. In fact, the recorded support reactions from the data-logger

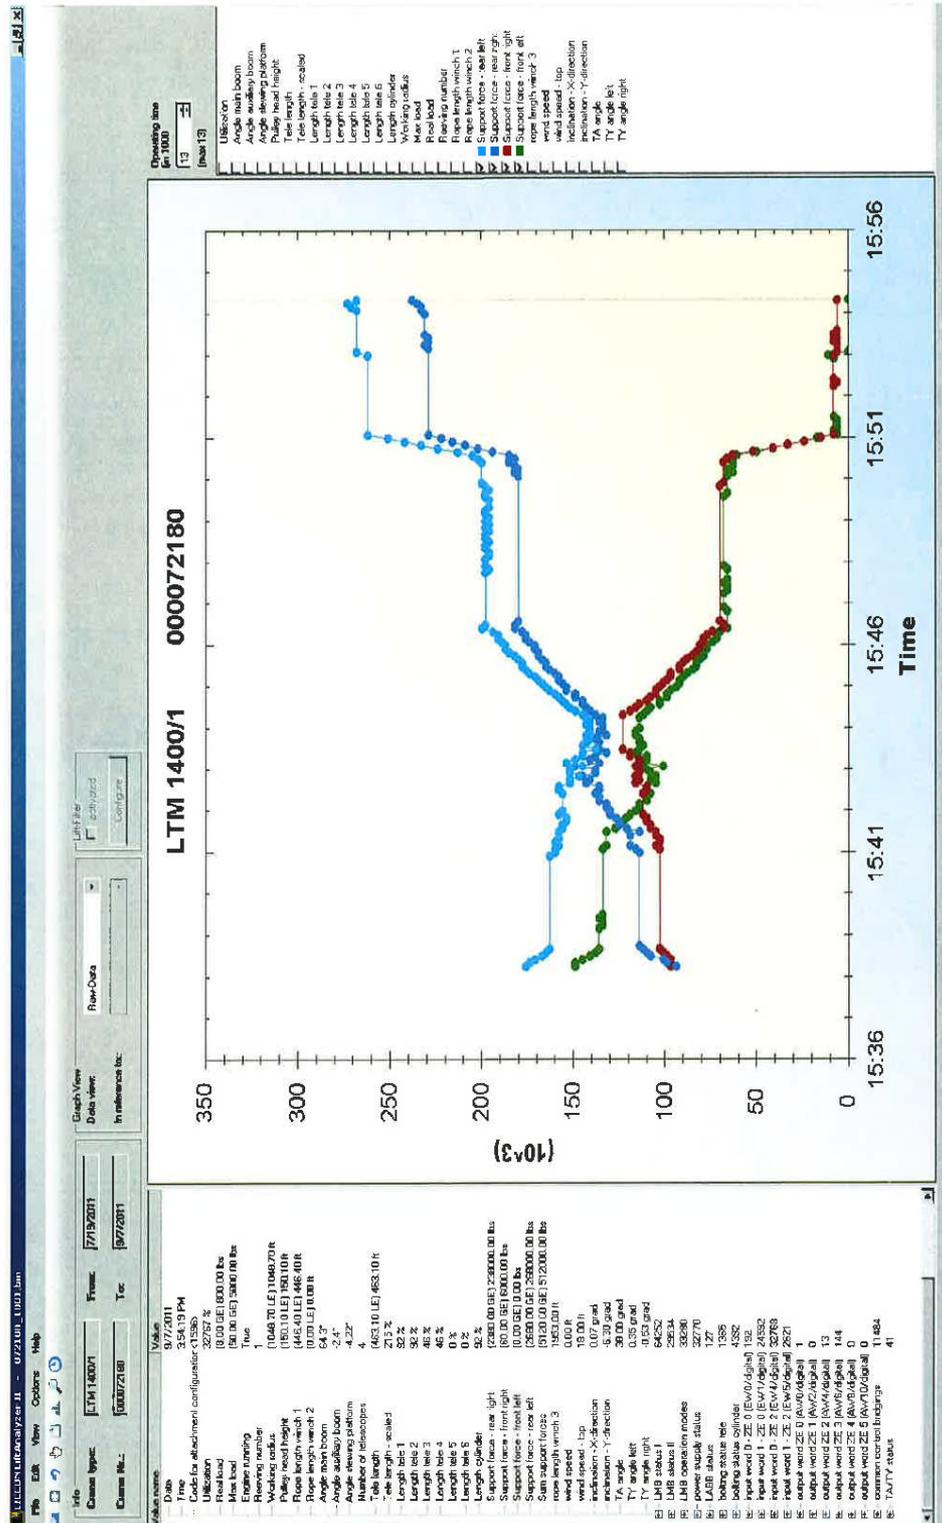
show that the front left pad had just separated (See Figure 20). The collapse followed immediately.

Figure 20. Recorded Reactions at Four Outrigger Pads for the Last 16 Minutes before the Crane Collapse (Taken from Data Logger by Crane Service Company).

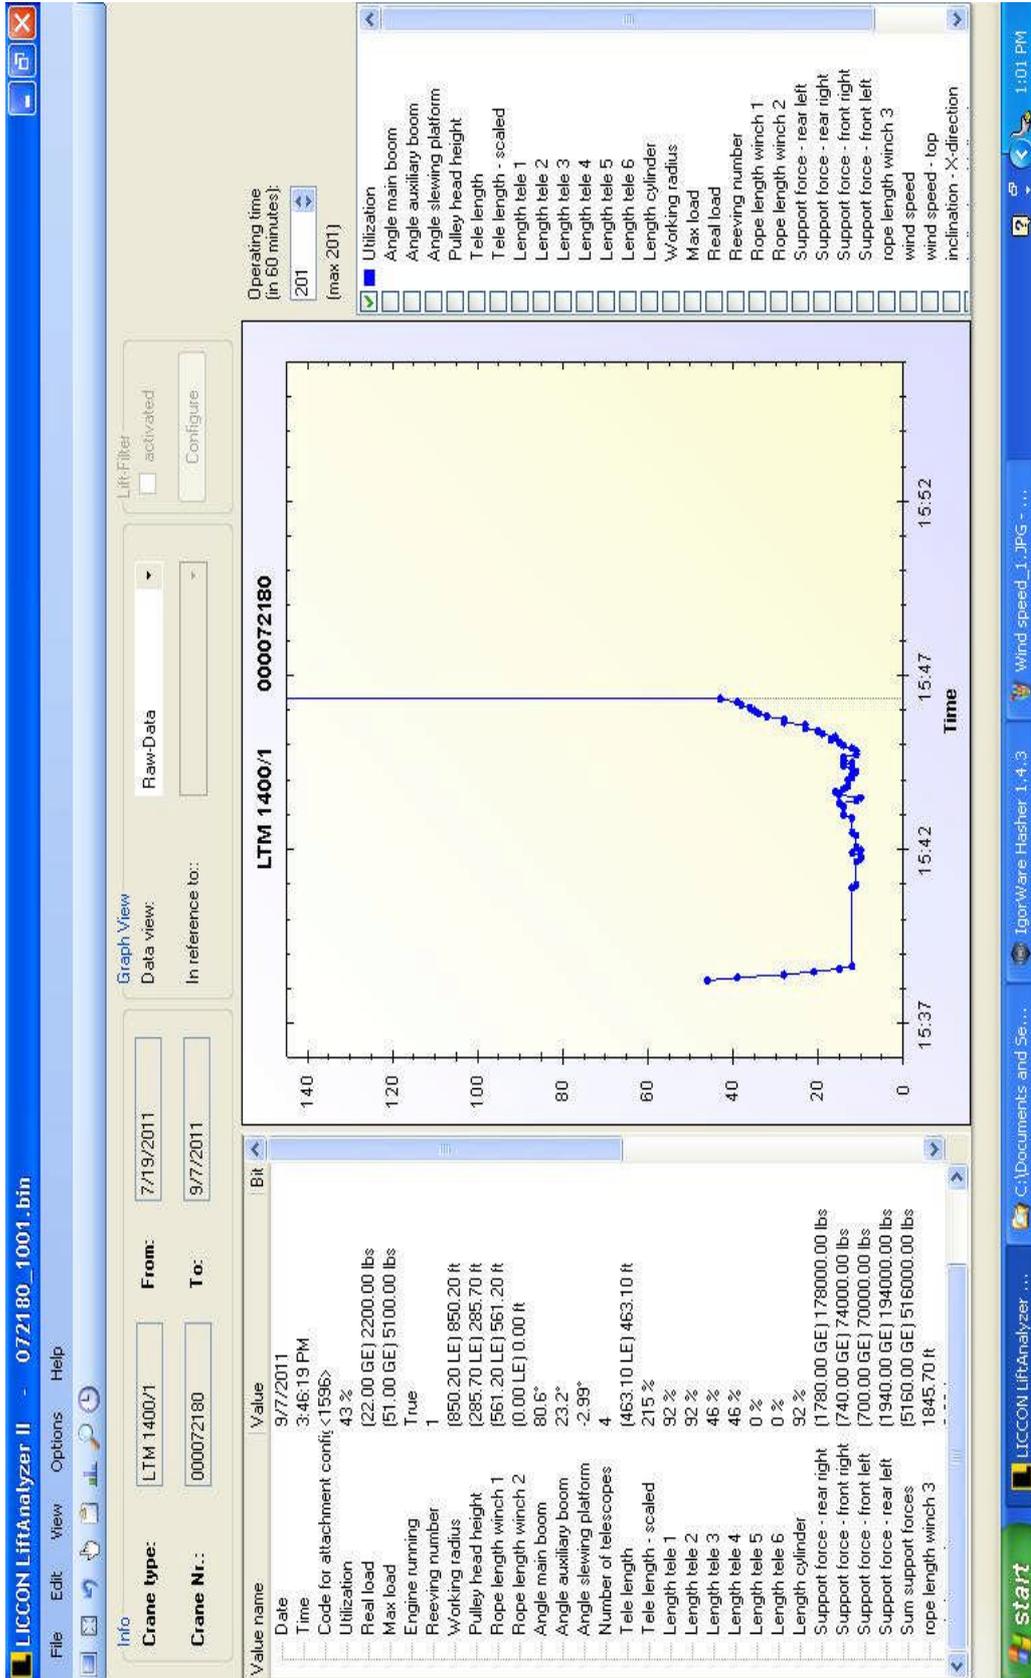
Figure 21. Recorded Utilization Values for the Last 16 Minutes before the Collapse (Taken from Data Logger by Liebherr-Werk Ehingen GmbH).

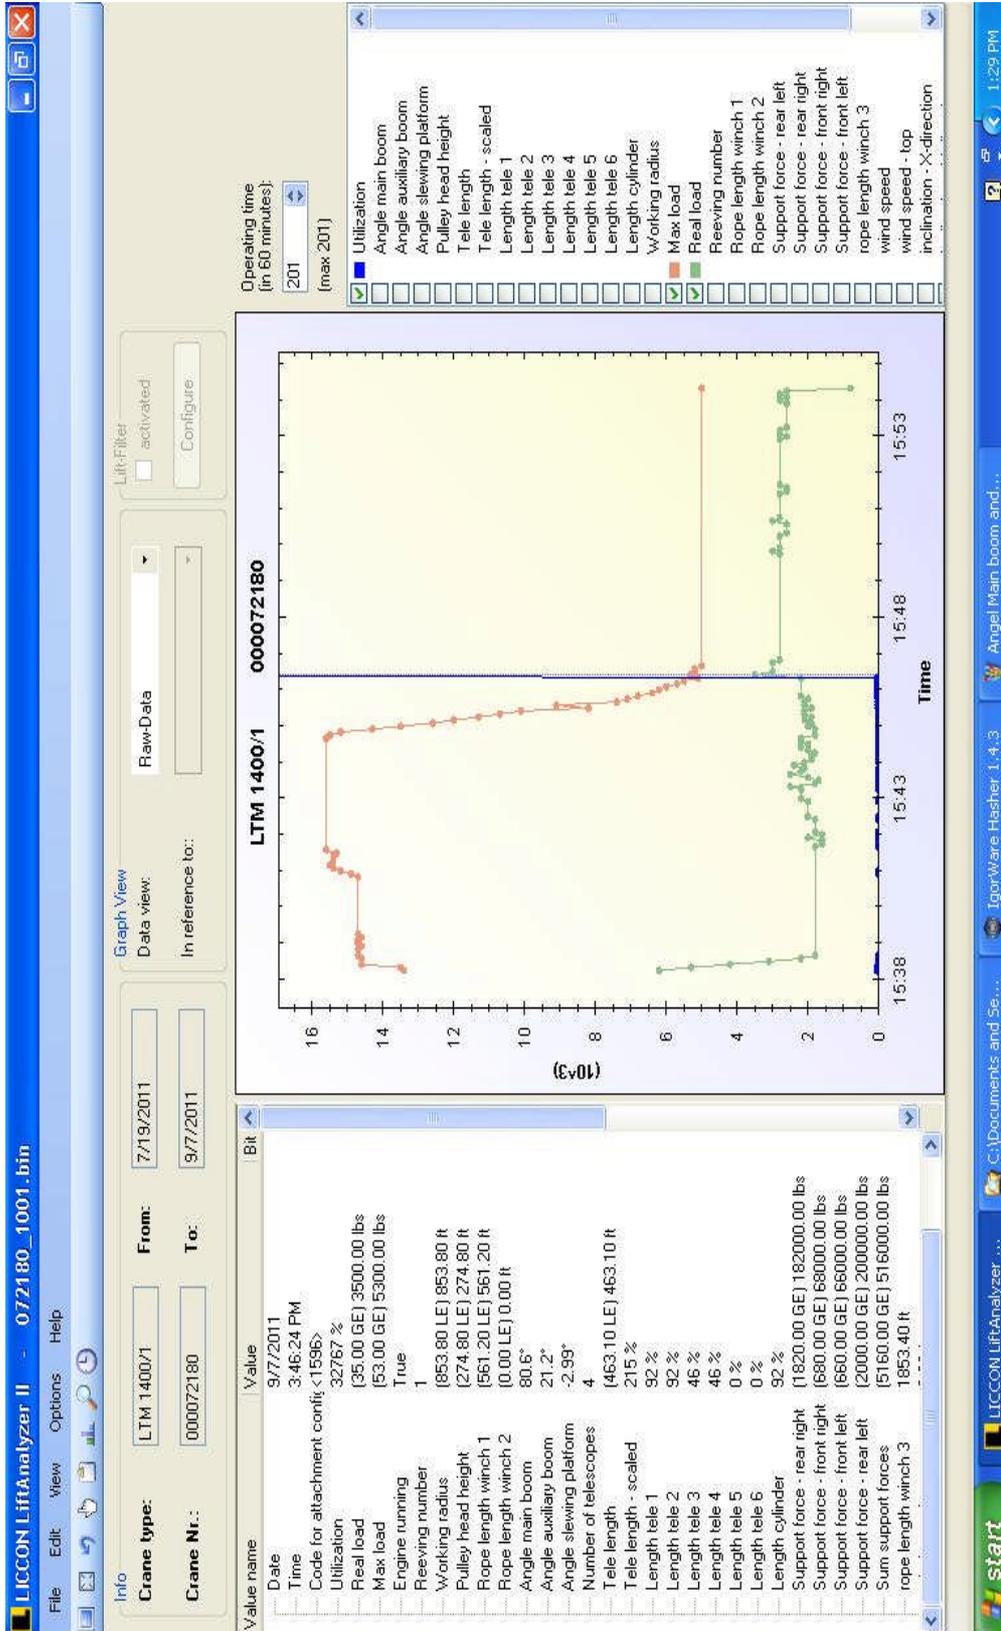
Figure 22. Recorded Real (Actual) Load and the Maximum Permissible Load for the Last 16 Minutes before the Collapse (Taken from Data Logger by Liebherr-Werk Ehingen GmbH).
