Investigation of the April 18, 2013 Partial Collapse of a Masonry Wall during construction of the Goodwill Retail Store in Hendersonville, TN

U.S. Department of Labor
Occupational Safety and Health Administration
Directorate of Construction

July 2013

Report Prepared by
Mohammad Ayub, P.E., S.E.
Dinesh Shah, P.E.
Office of Engineering Services
Directorate of Construction

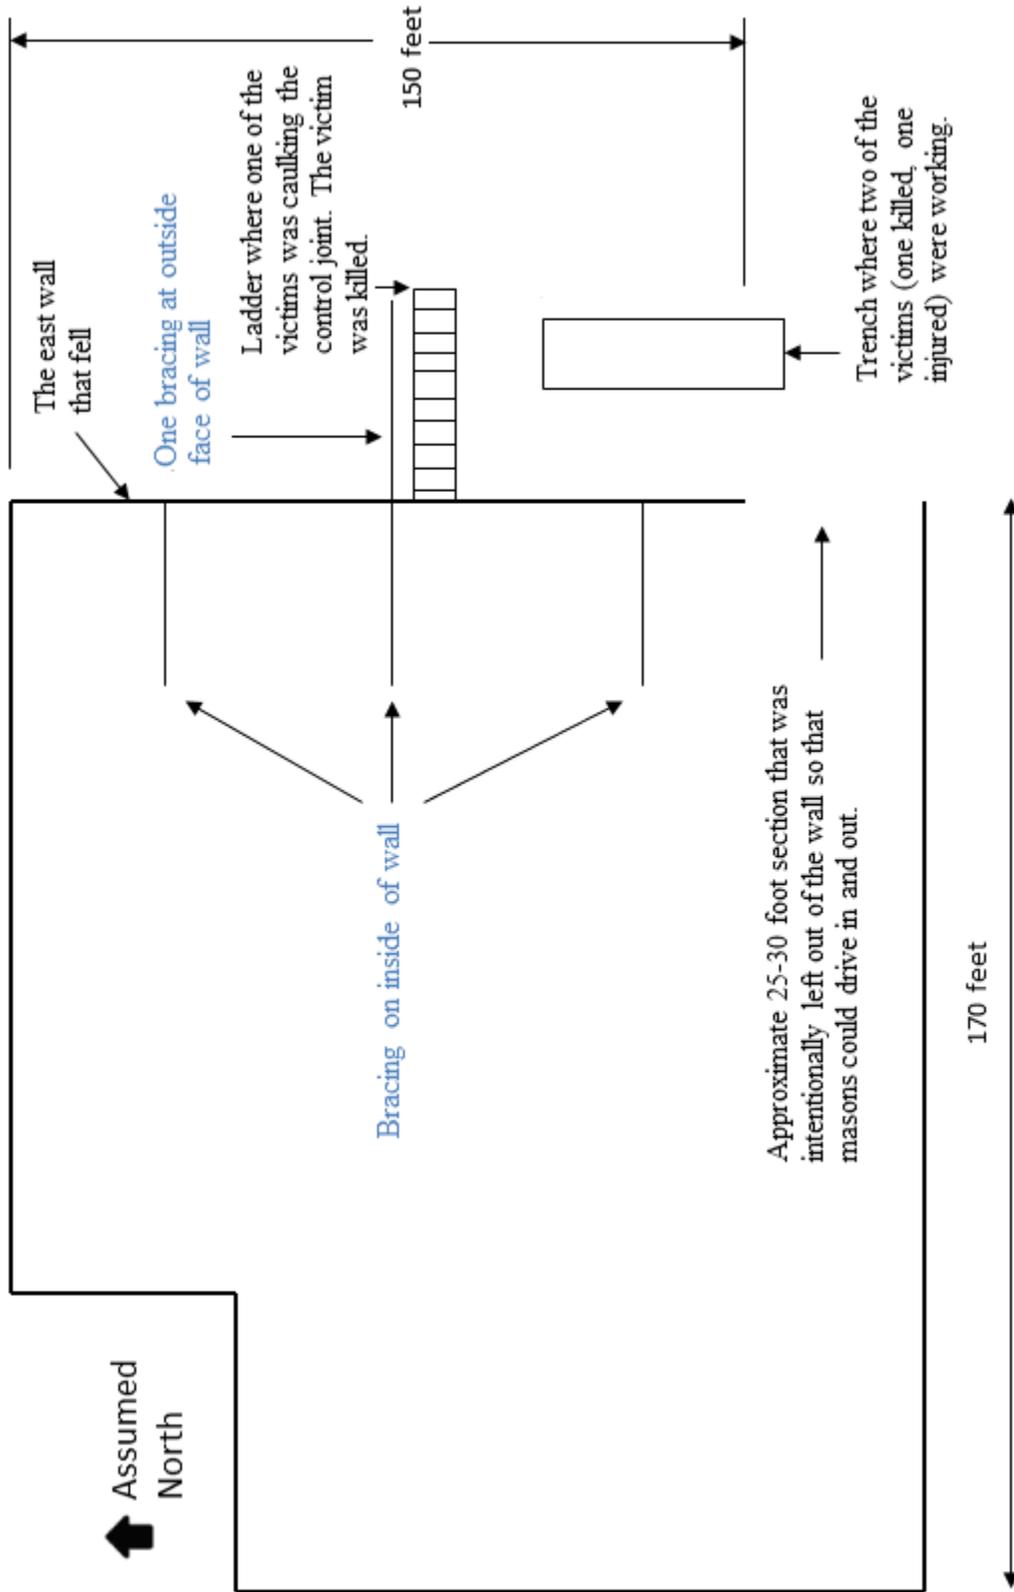
Figure 7 – Schematic CMU wall plan showing bracing location at east wall

A few days prior to the collapse, all three exterior braces on the north, south and west walls were removed but on the east wall only two exterior braces were removed. The middle exterior brace was left intact on the east wall that fell (see figure 7).

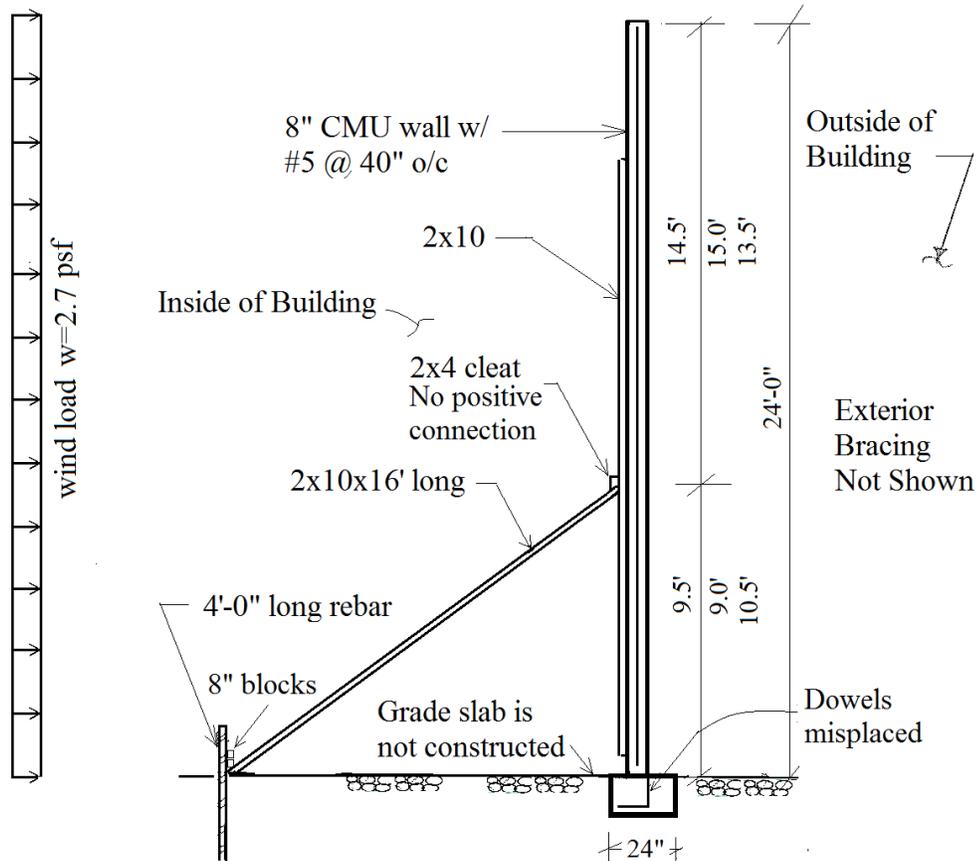
Figure 8 – Section showing interior as-built bracing at east wall

For the installation of the bracing, the contractor installed 2x10 vertical members abutting to the face of the walls (see Figure 8).

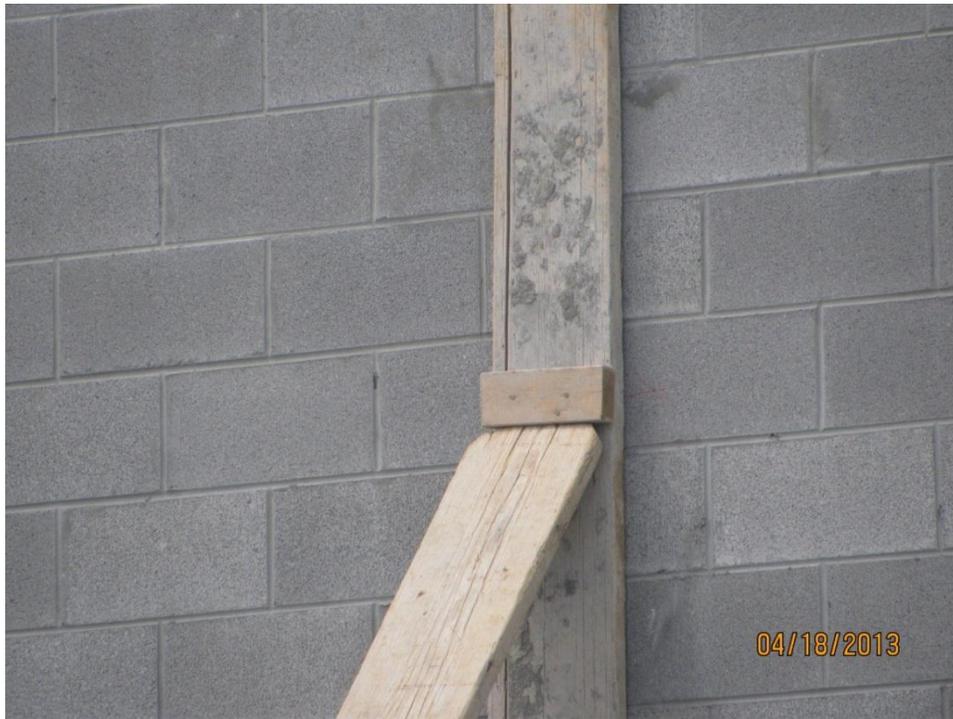
At mid-height of the vertical member, approximately 10' above, 2x4 horizontal cleats were provided. The 2x4 cleats were nailed to vertical members (see Figure 9). The diagonal bracing member consisted of 2x10 Southern Yellow Pine (SYP) OSHA scaffold plank, the top end of which was held underneath the cleats while the opposite end was held against 4' (\pm) long rebar. The rebar was embedded into the soil for a depth of approximately 2'-6" and projecting out around 1'-6". On top of the plank near the rebar, two CMU blocks were placed (see Figure 10).

Figure 9 - Top end of brace without positive connection

Even the few braces that were provided did not meet the industry standards because they were not anchored to the wall either by bolts or screws. They were susceptible to sliding and falling off the walls. The wall could maintain its capability to prevent overturning either by the presence of an adequate number of braces properly fastened to the wall or by the internal strength derived from the flexural capacity due to rebars. In this case, neither was provided.

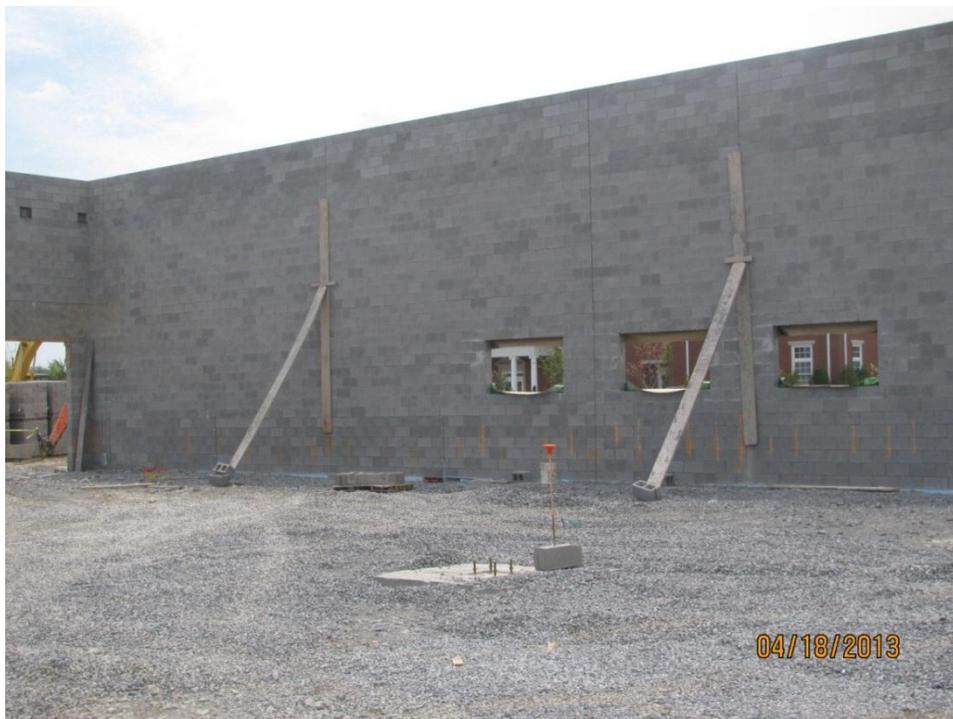
Figure 10 - Two CMU blocks on top of plank near rebar

7. The length of the brace was considered to be 16'. Bracing member used was 2x10 SYP OSHA plank.
8. The brace was considered to be pinned at both ends. The top of the brace was snugly fitted underneath the cleats (see Figure 9) while the bottom of the brace was held against the rebar embedded into the ground (see Figure 10). There was no positive connection between bracing members.

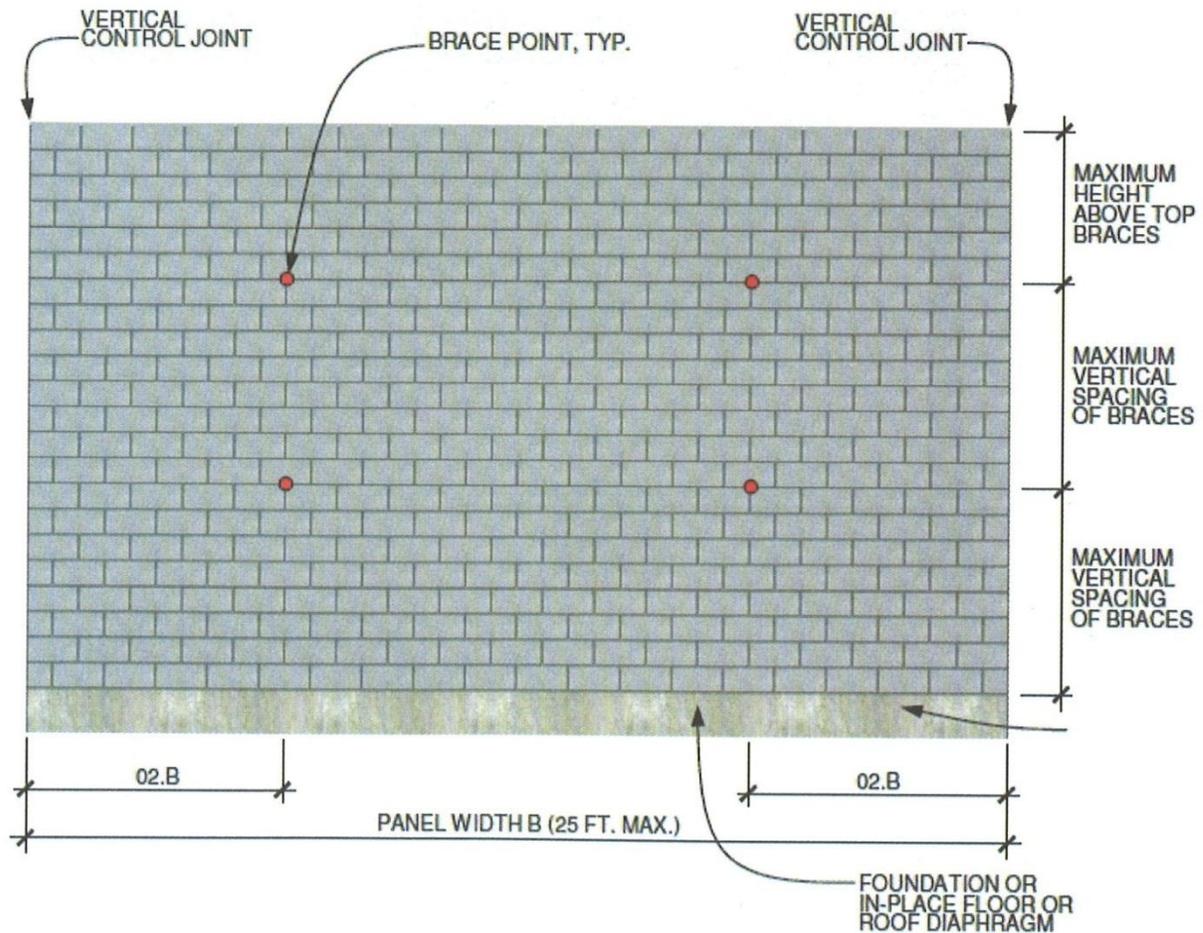
The design of the bracing members was not performed by any contractor or by an engineer. Bracings were installed randomly based on the contractor's judgment. "Standard practice for Bracing Masonry Walls under construction," developed by the Council for Masonry Wall Bracing, was not followed (see Figure 11).

Note: Industry practice required two braces between control joints

Figure 11 - Brace spacing requirement for masonry wall between control joints

The masonry contractor provided too few braces between the control joints of the 150'-long masonry wall that fell. In this project, the control joints in the masonry wall were designed and detailed as a complete separation (see Figure 5) similar to an expansion joint which necessitated a minimum of two braces for the masonry walls between the control joints (see Figure 11). Only three interior and three exterior braces for the entire wall were provided instead of the twelve specified in the industry standard, "Standard practice for Bracing Masonry Walls under construction" developed by the

Council for Masonry Wall Bracing. Two exterior braces of the east wall were removed a few days prior to the collapse. All required braces should have been left in place until permanent supporting elements were constructed, e.g., the roof deck and its attachments to the bond beam at the top of the wall. If the masonry contractor had provided an adequate number of braces as per the industry standard, this incident could have been avoided.

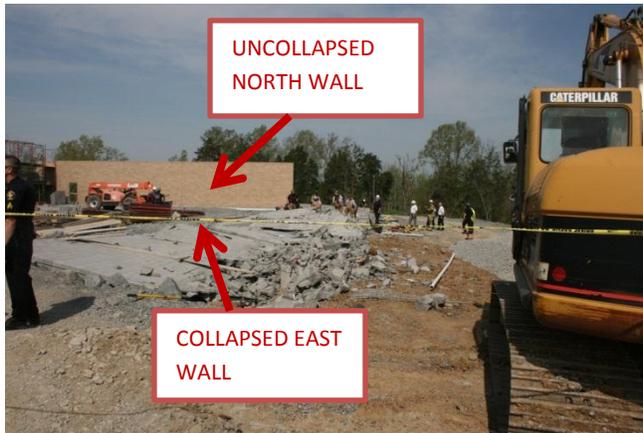
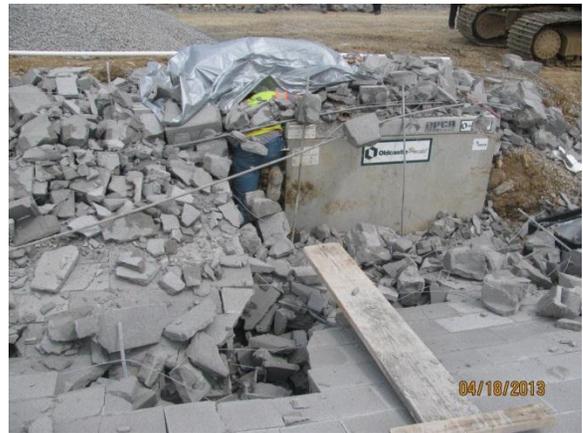
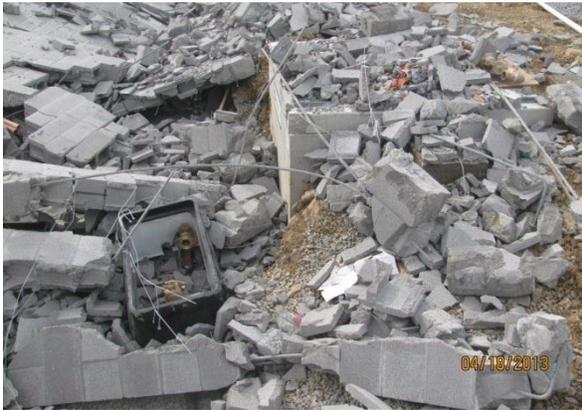
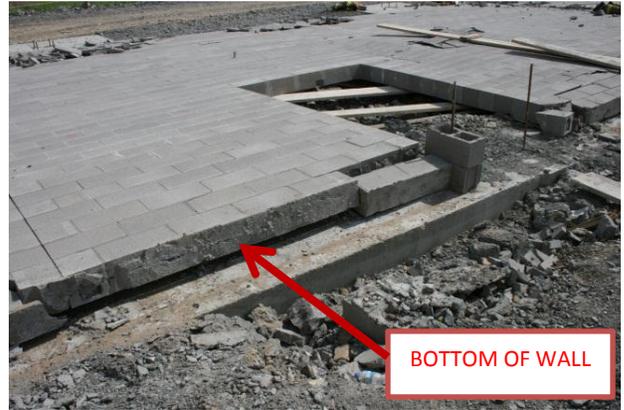
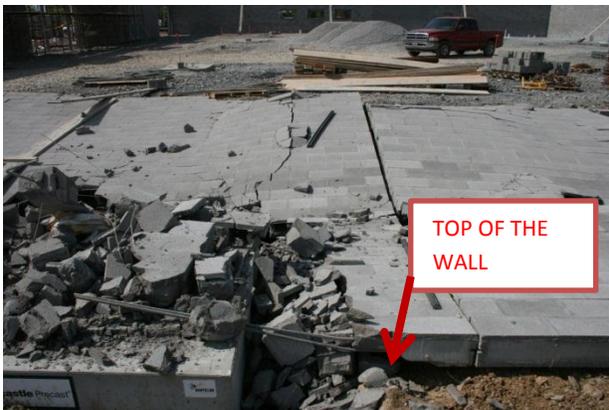
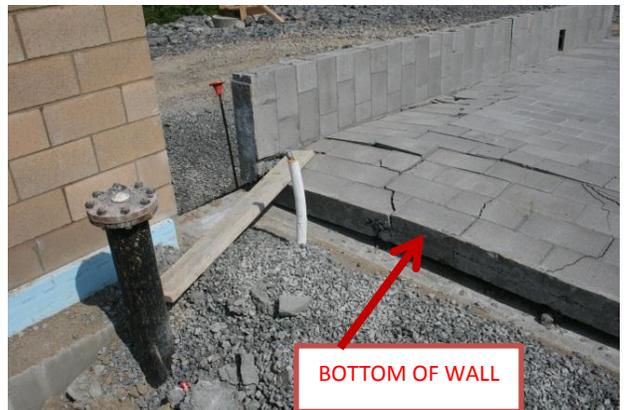
- Three interior braces and one exterior brace on the east wall fell along with the wall.
- The base of the entire east wall overturned outward and was completely separated from the top of the footing with no bent rebar dowels either coming out from the footing or from the wall.

- Some of the wall dowels from the footing to the wall were observed to have fractured at the base of the wall.
- Parts of the masonry blocks were disintegrated and turned into rubble.
- At certain areas of the fallen wall, cracks were visible.
- Parts of the bond beams were completely disintegrated and rebars from the bond beams were exposed, visible and were bent.
- At certain locations, the marks of the fractured rebars were visible either at the center of the CMU wall or at the edge of the CMU wall.

The above statement indicated that the contractor had placed wall dowels at the required locations (i.e., at the center of the CMU wall) but that is not supported by the photographs taken after the incident, and in statements made by the masonry contractor. When the masonry contractor began to build the wall, he noticed that the wall dowels (rebars) of the east wall at many locations (at north and south of the 6'-0" wide door opening) were offset from the correct location. He notified the general contractor of the misplacement of the dowels. Rather than stopping the work and getting guidance from the structural engineer of record, the general contractor advised the masonry contractor to bend the rebars and maneuver them in the block cells. Since the rebars were bent and placed near the inside edge of the CMU wall rather than being at the center of the CMU wall, rebars were not effective in resisting lateral loads arising out of the westerly wind. If the general contractor or inspector had promptly reported the misplacement of the rebars to the structural engineer of record, the structural engineer would have recommended corrective measures and the incident could have been prevented. One of the corrective measures was to drill new holes for the rebars in the footing at the center of the masonry wall and epoxy grout to meet the design intent.
