INVESTIGATION OF THE MAY 23, 2013 PARTIAL COLLAPSE OF A PRESTRESSED CONCRETE DOUBLE TEE AT MONTGOMERY MALL IN BETHESDA, MD

U.S. Department of Labor
Occupational Safety and Health Administration
Directorate of Construction

October 2013

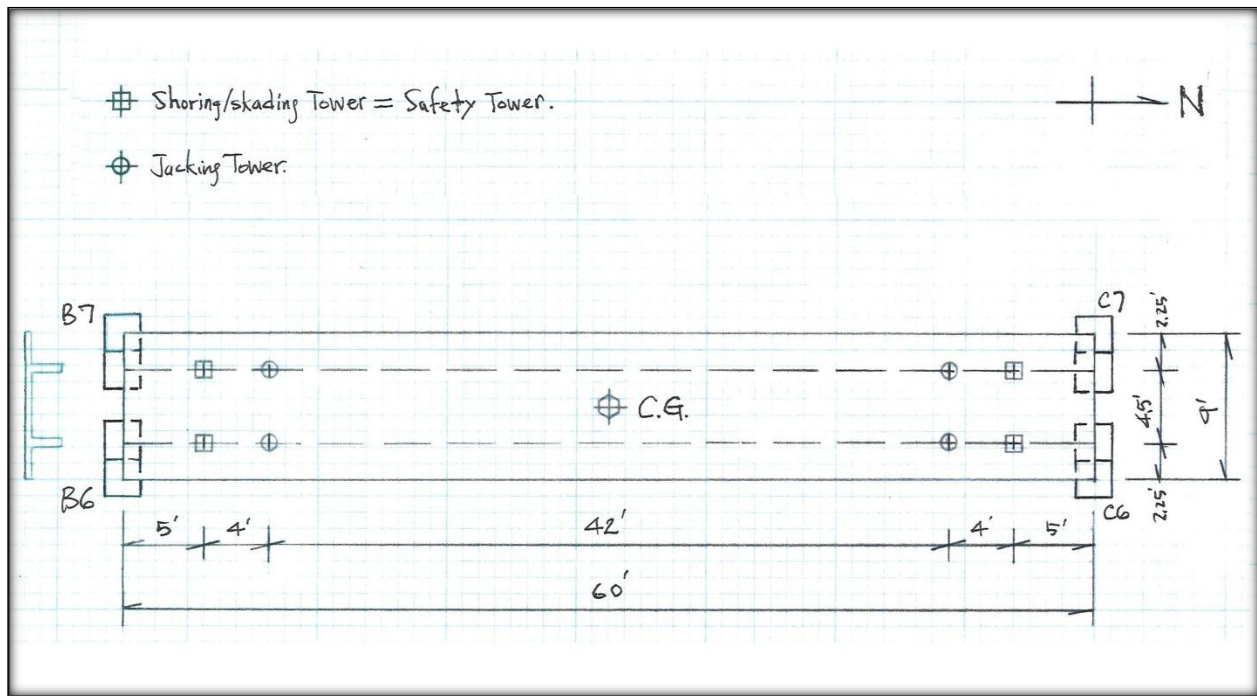
Figure 1. Locations of the Supporting Towers under the Sterns of the Double Tee.

1. Eight independent shoring towers, four for jacking and four for shoring/skating, were used to raise the double tee. The locations of these towers under the bottom of the double tee stems are shown in Figure 1.

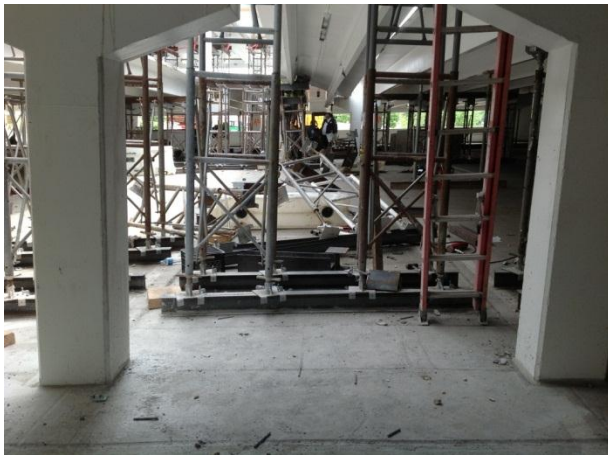
2. All eight towers were 2' by 2' in size and were seated over W6x9 floor beams (Figures 2 and 3) at the ground level. For the jacking tower, the upper support system for the hydraulic jack consisted of four 36" long W8x31 steel beams and a 10" long W8x31 spacer (spreader). They were installed on the U-heads of the tower (Figures 4 and 5). For the shoring/skating towers (hereafter referred to as "safety towers"), two levels of three 36" long W8x10 beams and a 10" long W8x31 spacer (spreader) were installed on the U-heads of the tower to support the double tee at the bottom of its stems (Figures 6 and 7).

Figure 2. Bottom Support of the Towers at the Ground Level
(Looking from the North End of the Double Tee toward South).

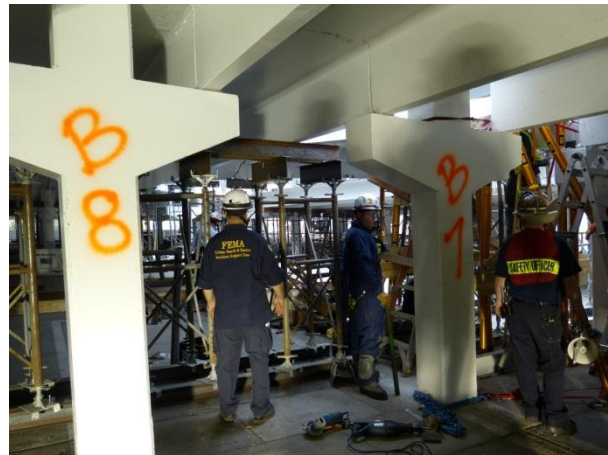
Figure 3. Bottom Support of the Towers at the Ground Level
(Looking from the South End of the Double Tee toward Northwest).

The minimum vertical clearance of the parking garage was marked at its entrance as 6'-7". However, from Figure 3, the actual vertical clearance or the height of the safety tower in the vicinity of the incident area from the ground level to the bottom of the second floor was estimated to be:

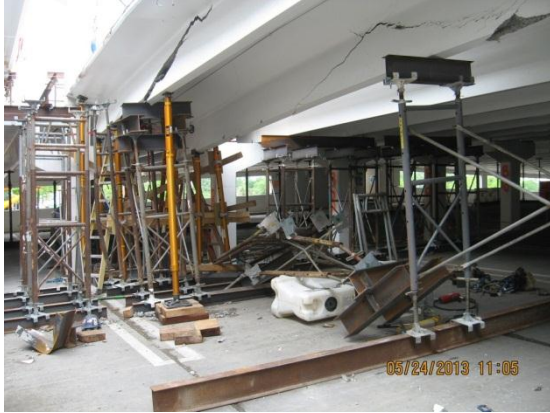
14. After the collapse, the SE corner of the double tee dropped about 2'-4" and landed on the upper W8x31 beam of the jacking tower (Figures 4 and 5). The NW corner dropped about 12" and landed on the flattened upper W8x10 beam (Figure 6). The NE corner dropped about 8" and landed on the upper W8x10 beam (Figure 7). The SW corner dropped more than 4' and was suspended in the air.

Figure 4. Final Conditions of the SE Jacking Tower and its Upper Support System.

From Figure 4, the height of the four jacking towers before the collapse was estimated to be:

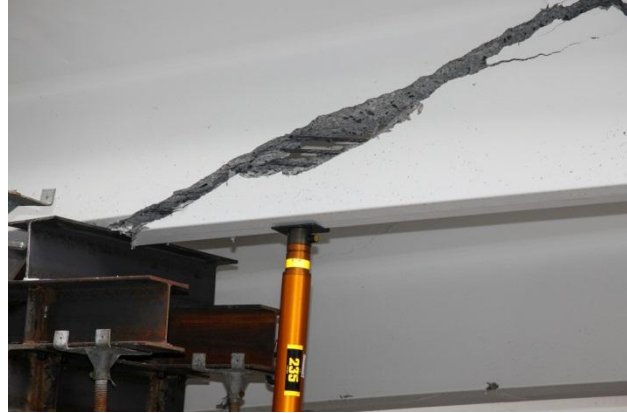
Figure 5. Close-up of the Upper Support System of the SE Jacking Tower.

Note that the most damaged area of the east stem occurred at the SE jacking tower.

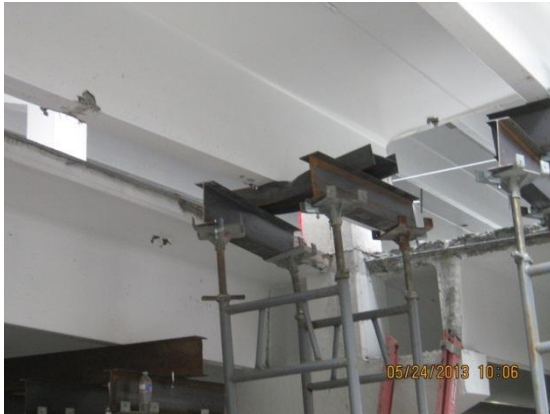
Figure 6. Final Conditions of the NW Safety Tower and its Upper Support System.

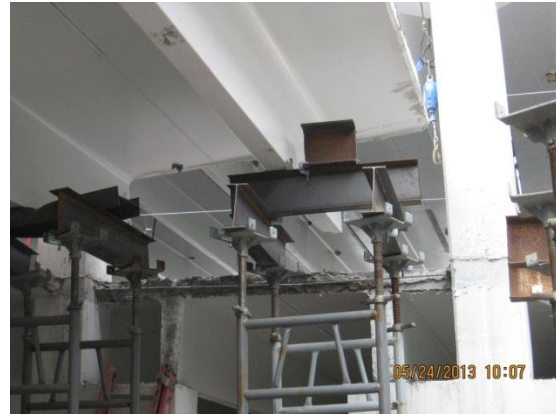
Figure 7. Final Conditions of the NE Safety Tower and its Upper Support System.

Note that the tower and its upper support system remained intact after the collapse.

Based on the undamaged NE safety tower (Figure 7), the height of the four safety towers at the time of the collapse was estimated to be:

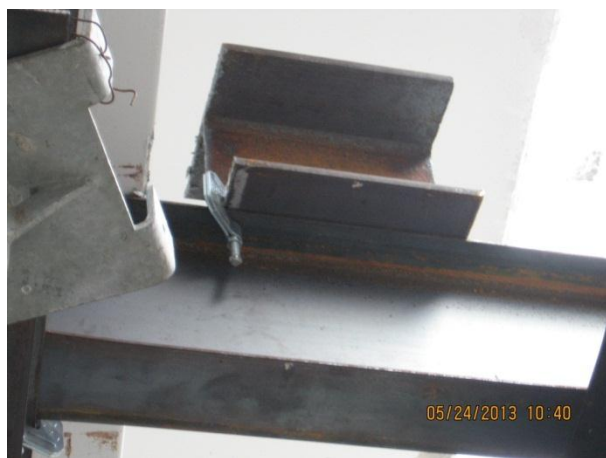
Figure 8. Close-up View of Figure 7 at the Connection of the W8x10 beam and the W8x31 Spacer. Note that the bottom flange of the spacer was cantilever over the upper flange of the W8x10 beam.

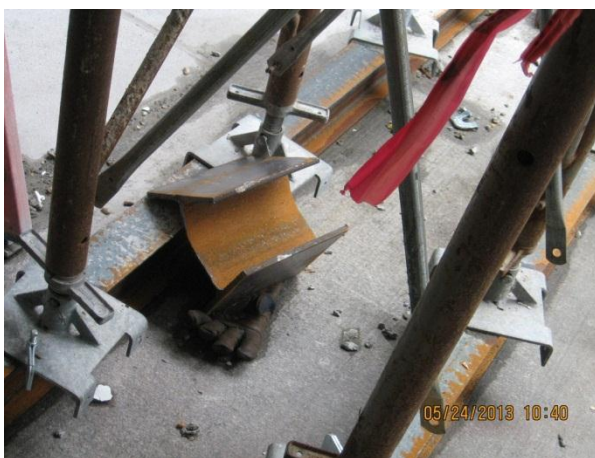
We identified at least four deformed spacers at the incident site. The basic pattern of the failures was the deformation along the depth of the web. Figure 9 presents the first deformed spacer that fell from the top of the NW safety tower. Figure 10 shows an intact spacer and the badly buckled W8x10 beam near the SE safety tower. It is believed that this beam came from the SE safety tower after it experienced the collapse. Figure 11 indicates the second deformed spacer near the SE corner of the double tee. Figure 12 presents the same second deformed spacer and the third deformed spacer away from the NE corner of the double tee. Figure 13 shows the fourth deformed spacer with a length of only 6" near the SW corner of the double tee.

Figure 9. The First Deformed Spacer Fell from the Top of the NW safety Tower.

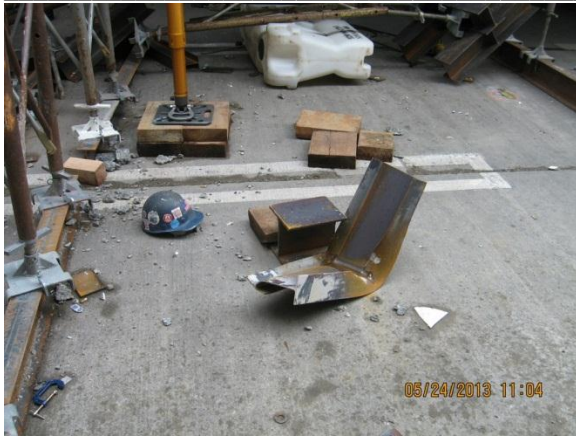
Figure 10. An Intact Spacer and the Badly Buckled Upper W8x10 Beam near the SE Safety Tower.

The failure could have been avoided if a bigger beam, W8x31, rather than a W8x10 beam was used or if stiffener plates had been welded to the flanges and web at the loading locations.

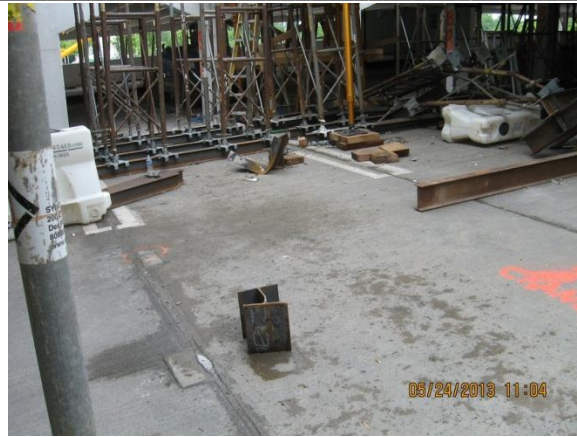
Figure 11. The Second Deformed Spacer near the SE Corner of the Double Tee.

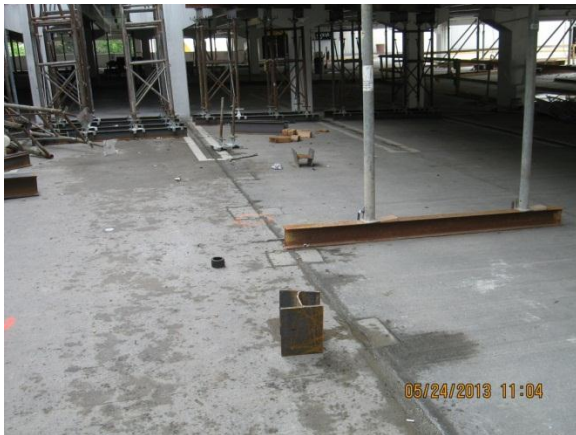
Figure 12. The Same Second Deformed Spacer and the Third Deformed Spacer away from the NE Corner of the Double Tee.

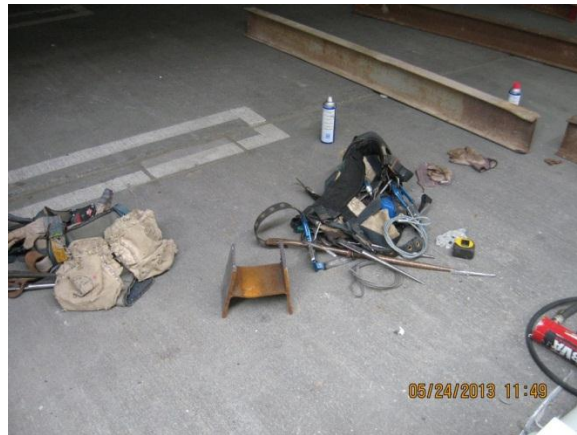
Figure 13. The Fourth Deformed Spacer with a length of only 6" near the SW Corner of the Double Tee.

We located a short deformed spacer 6" in length instead of the normal 10" at the incident site (Figure 13). If this particular spacer was installed on top of the SE safety tower, it could explain the cause of the initial failure of the upper W8x10 beam at the SE safety tower at approximately 1:30 p.m.

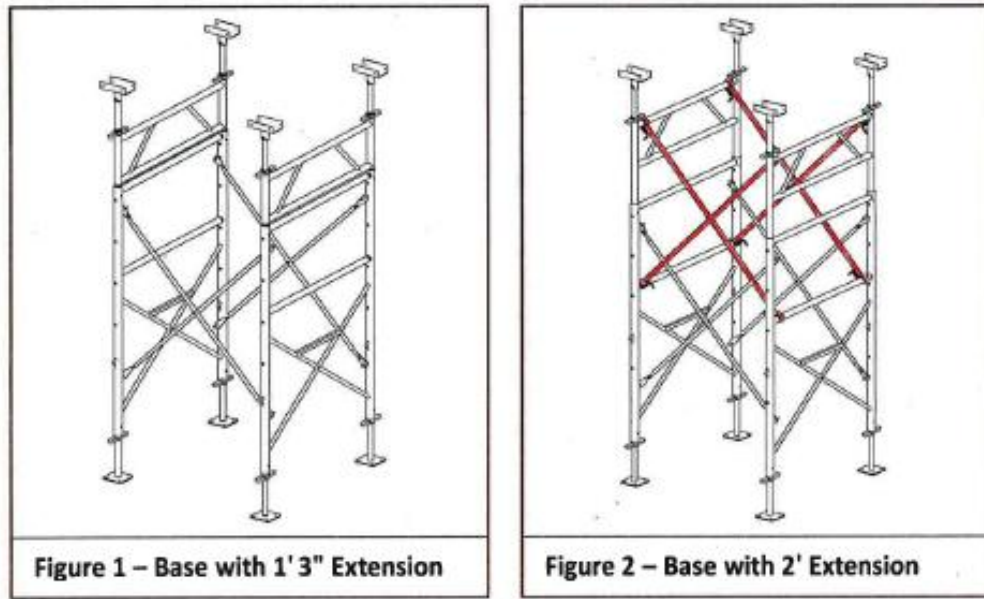
When the extension frame was installed, with its post inside the post of the base frame, and the extension frame was raised 2' or more above the base frame (Figure 14), the diagonal goosener braces must be installed as per the instructions of the manufacturer of the shoring tower. The purpose of the braces was to ensure the rigidity of the shoring tower and the stability of its upper support system. Figure 15 shows that the extension frames were raised 2' above the top of the base frame at all four safety towers, but without the required diagonal goosener braces.

Note that this requirement is from SAFWAY Adjust-a-Shore System, Product Selection Guide, Page 4.

Figure 14. The Diagonal Goosers Braces (marked in red) Are Required When the Extension Frame Has a 2' or More Extension.

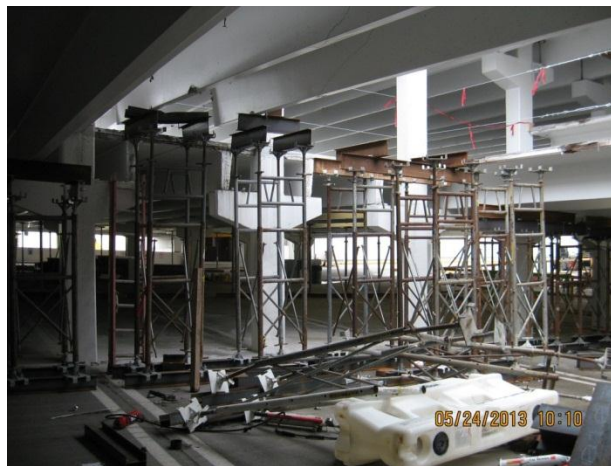
It should be noted here that the minor axis (the axis of the braces) of the safety towers was in the north-south direction. Lack of diagonal goosener braces would decrease the rigidity and impair the

stability of the safety tower in the north-south direction. Thus, due to the flexibility of the safety tower and the weakness of the spacer beam in the north-south direction, the upper W8x10 beam of the safety tower was not only subject to the vertical load from the double tee, but also subject to the bending moment across the width of its flanges. Therefore, the cantilever flexural resistance of the compression flange of the upper W8x10 beam must be considered in assessing the as-built stability of this beam.

Figure 15. The Diagonal Goosers Braces Were Not Installed for All Four Safety Towers When the Extension in These Towers Was Set at 2'.
