# Investigation of the November 13, 2013 collapse of precast walls at a garage construction site, Ft. Lauderdale, FL

U.S. Department of Labor  
Occupational Safety and Health Administration  
Directorate of Construction

March 2014

Report Prepared by  
Mohammad Ayub, P.E., S.E.  
Office of Engineering Services  
Directorate of Construction

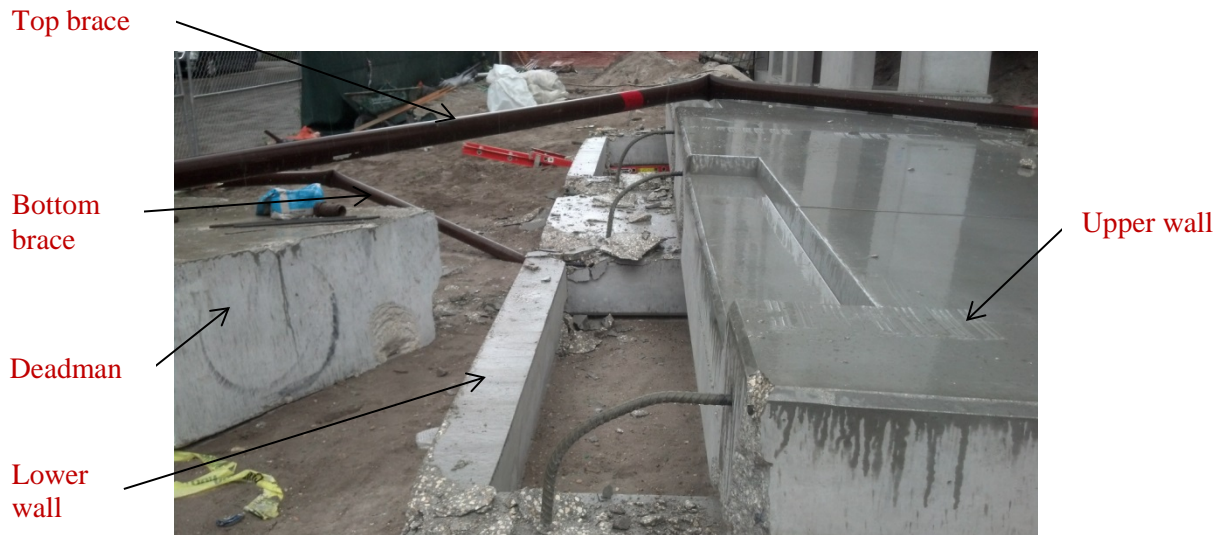
**Fig. 10** Failed walls and deadman

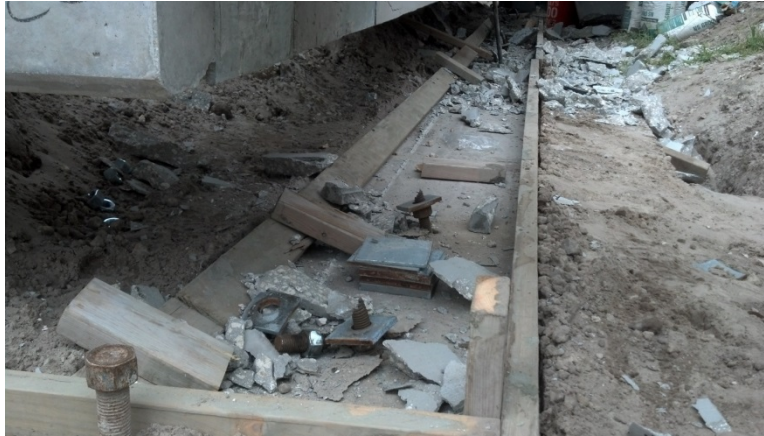
**Fig. 14** Lumber as a formwork for the grout

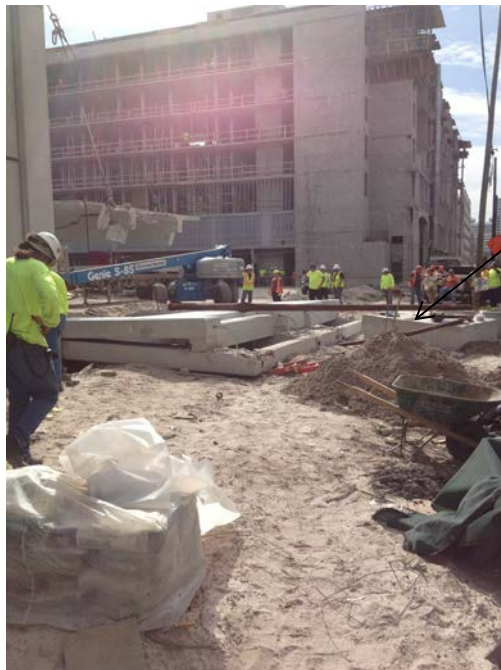
Immediately thereafter, a pipe brace, approximately 3 1/2" in diameter was placed about three feet from the top of the wall, with a drilled red head anchor. The bottom of the brace was anchored with a bolt to a concrete deadman, 5' x 5' x 2' deep located about 12 to 13 feet away from the bottom of the wall. It is believed that the deadman was located off the center of the wall, thereby rendering the brace skewed; see Fig. 15 and 26.

**Fig. 15** Deadmen offset to pipe braces and walls

4. The deadman concrete blocks where the braces were anchored were considerably off-set from the center of the braces, thus increasing the forces on the braces, and reducing their effectiveness. The deadman block for the top brace was offset by as much as fifteen feet.

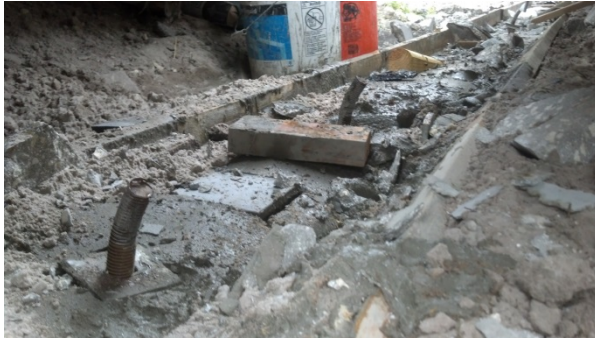
The foreman then ordered the second tee, marked T-504, to be brought in. As the crane brought in the double tee, T-504, and as it was very near its final position but still held by the crane, the upper wall and the lower wall folded, and fell towards the west, see Fig.s 24 to 26. The upper wall fell over the fallen lower wall. The double tee, T-511, dropped over to the ground. The crane continued to hold the other double tee, see Fig. 3.

**Fig. 24** Failed anchor bolts at the foundation

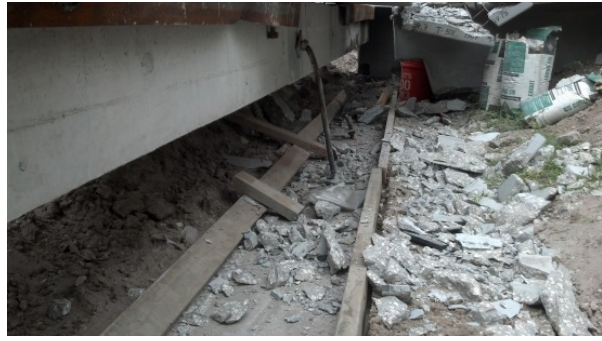
**Fig. 25** Wall collapse (looking west)

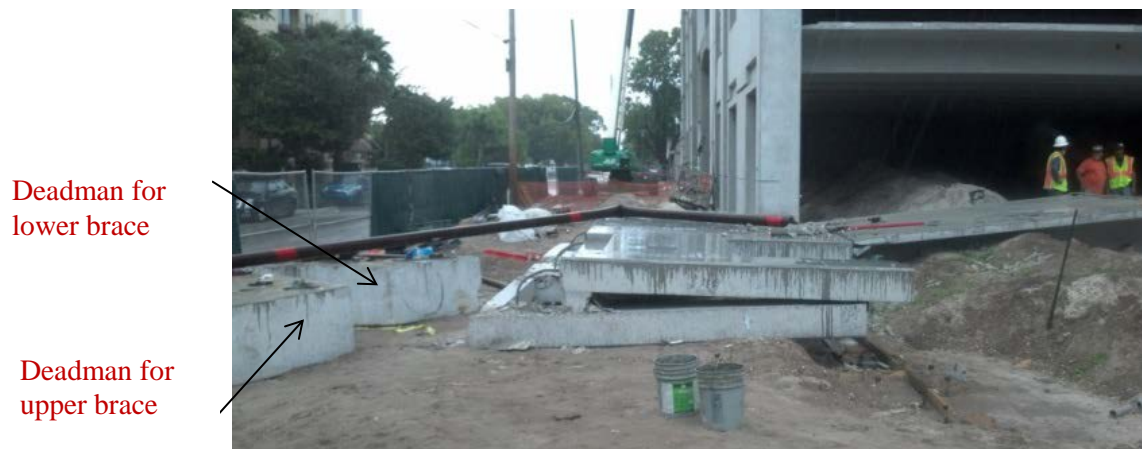
Deadman for  
lower brace

Deadman for  
upper brace

Note deadmen extent of offset

**Fig. 26** Wall collapse (looking north)

The most glaring flaws in the erection of the two walls were the use of only one brace to support each wall, and the off-set location of the two deadmen where the braces were anchored by foot plates. The braces were, therefore, inclined in two directions, as shown in Fig. 34 and 26, thereby increasing the force on the braces and foot plates. The normal practice in the industry is to provide two braces normal to each wall, and to center the deadman on the braces, see Fig. 35 (being practiced after the incident).

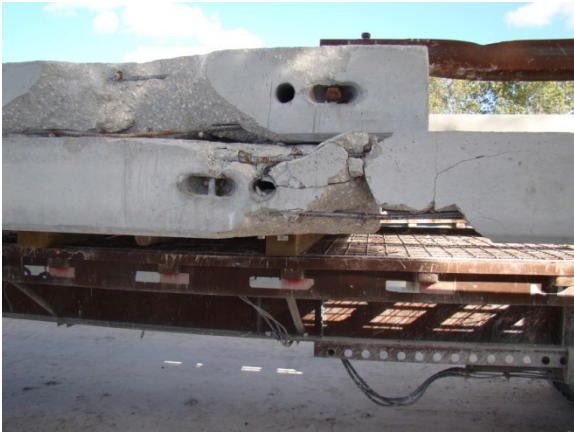
**Fig. 29** Damaged wall at Coreslab yard

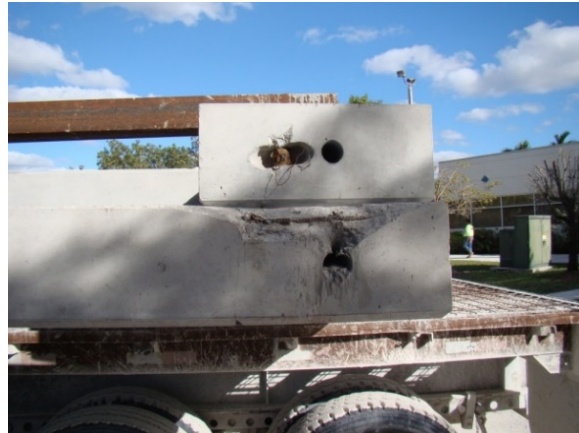
**Fig. 30** Damaged wall at Coreslab yard

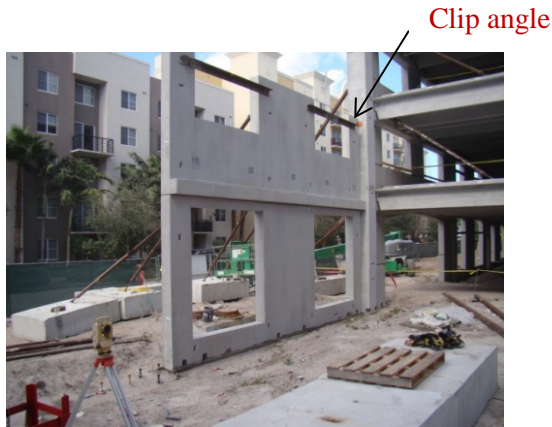
**Fig. 32** Wall panel connected by clip angle to column (post-incident)

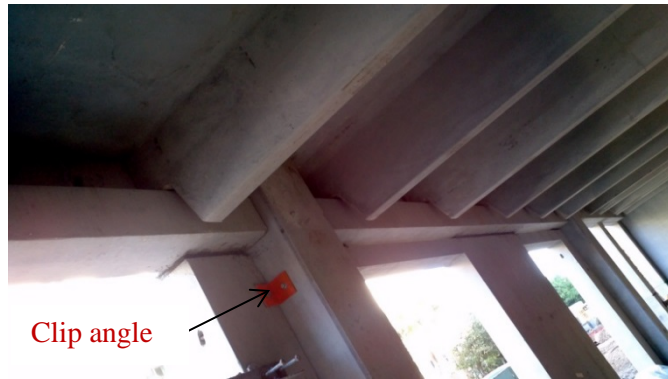
**Fig. 33** Wall panel connected by clip angle to column (post-incident)

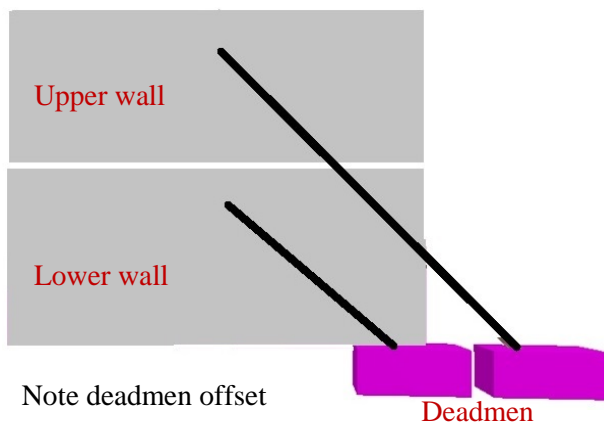
**Fig. 34** Schematic elevation of bracings provided at time of incident

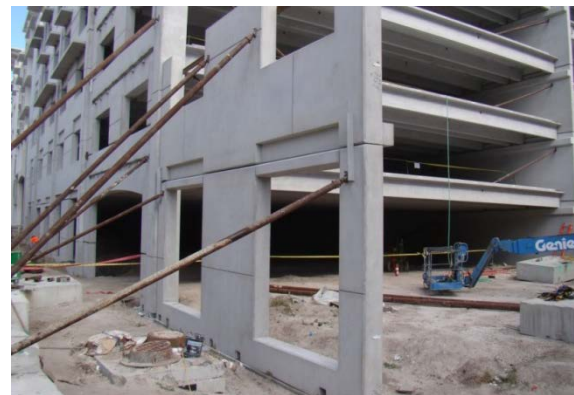
**Fig. 35** Two Bracings per wall (post-incident)

It is believed that if two braces for each wall were provided and if the deadmen were centered on the braces as is now practice after the incident (see Fig 35), the incident would not have occurred since the forces in the “foot plate” would have been below their failure load, even if the tees were not welded to the wall and the adjoining tee flanges. If due diligence had been applied as could be expected from the Solar Erectors manager and superintendent, they would have immediately realized that this was an incident waiting to happen.
