# Investigation of the November 2, 2013 collapse of concrete beams at Fort Lauderdale-Hollywood Airport runway project

U.S. Department of Labor  
Occupational Safety and Health Administration  
Directorate of Construction

April 2014

Report Prepared by  
Mohammad Ayub, P.E., S.E.  
Office of Engineering Services  
Directorate of Construction

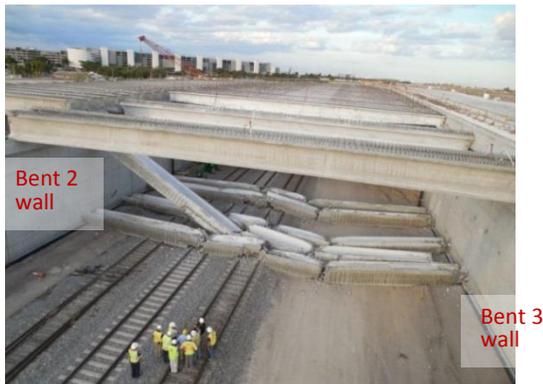
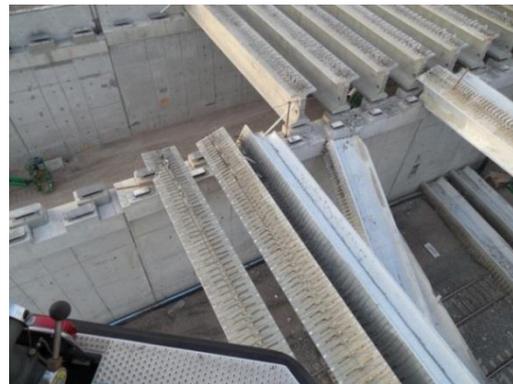
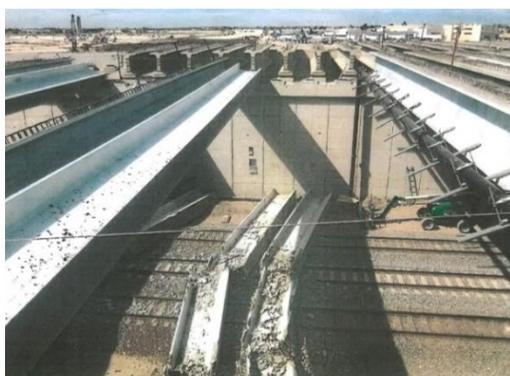
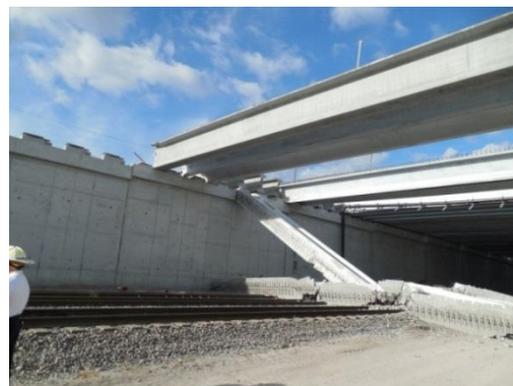
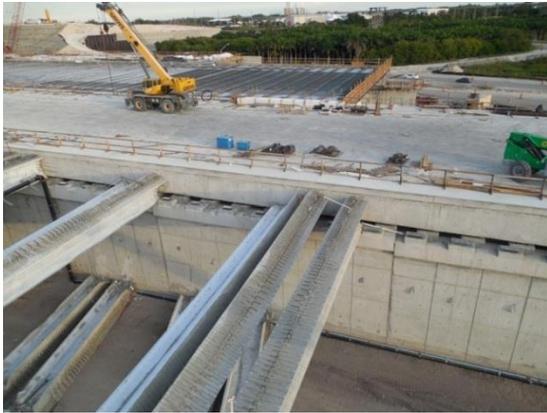
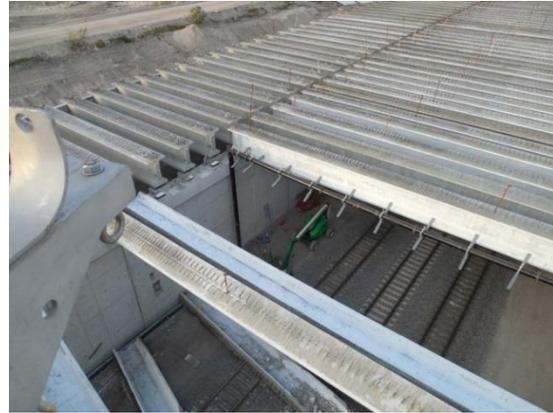
At approximately 1:30 p.m. on November 2, 2013, five concrete beams (84, 85 and 88 thru 90) suddenly fell to the ground over the railroad tracks. Another set of five beams (86, 87, and 91 thru 93) shifted and overturned but remained on the bents. The fall of the concrete beams created havoc, but due to lack of activity in cell # 2, there were no injuries, see Figs 7 thru 12.

**Fig. 7** Fallen beams

**Fig. 8** Fallen and displaced beams

**Fig. 9** Fallen beams

**Fig. 10** Fallen beams

**Fig. 11** Displaced beams

**Fig. 12** Displaced beams

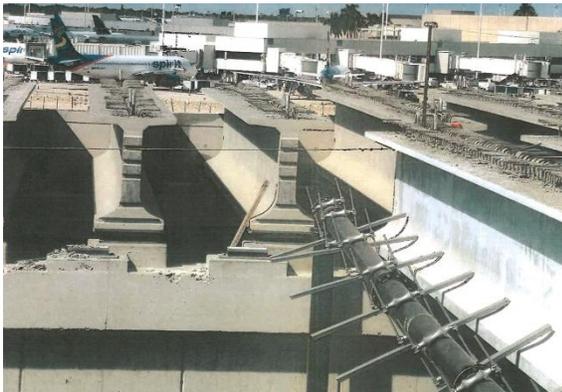
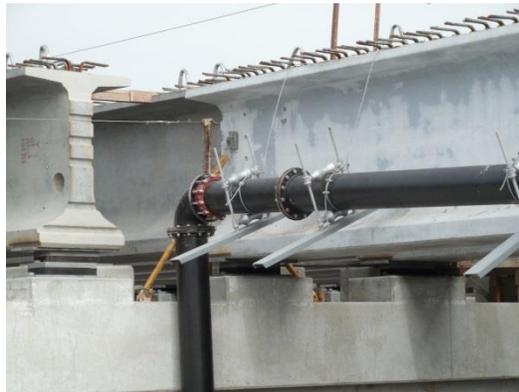
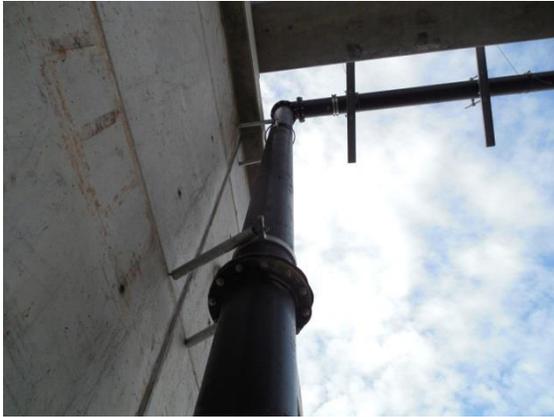
As beam 84 fell off the bearing, the channels supporting the pipe lost their support but were hanging in an inclined manner, still connected to the pipe. The pipe lost its support as the channels were no longer supported at both ends. The pipe did not fall off as it gained support by the risers placed over the grade, see Fig.s 13 thru 17, below. The pipe was anchored to the bent walls with U straps which also failed, see Fig.s 16 and 17. The pipe running on grade at the foot of the east and west bents were loosely anchored to the bent walls and fractured at multiple locations, see Fig.s 18, 19 and 20.

**Fig. 13** Water pipe and steel channels support

**Fig. 14** Water pipe and steel channels support

**Fig. 15** Water pipe and steel channels support

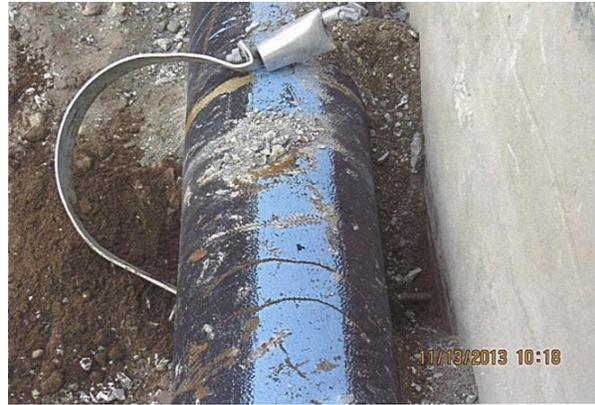
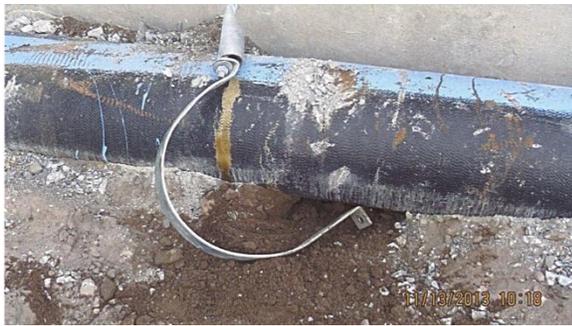
**Fig. 16** Failed clamp for water pipe

**Fig. 17** Failed clamp for water pipe

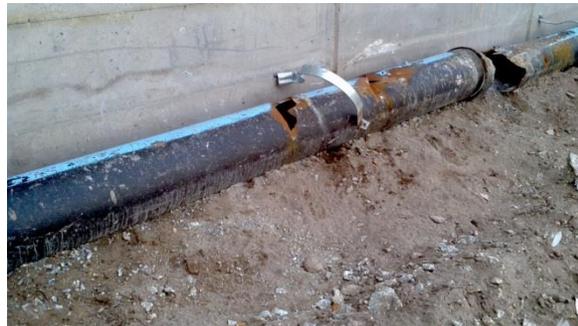
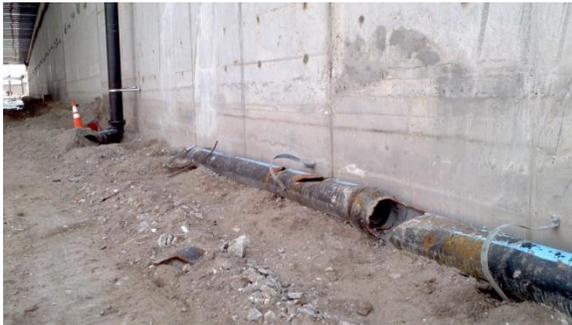
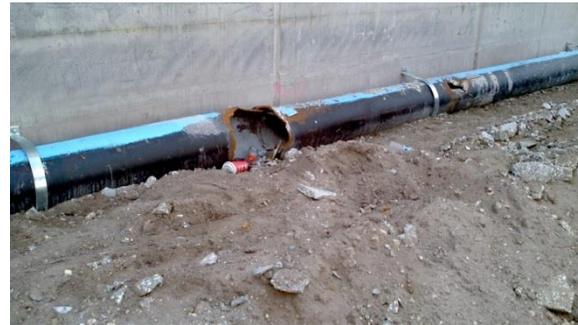
**Fig. 18** Fractured 12" Water pipe

**Fig. 19** Fractured 12" Water pipe

**Fig. 20** Fractured 12" Water pipe

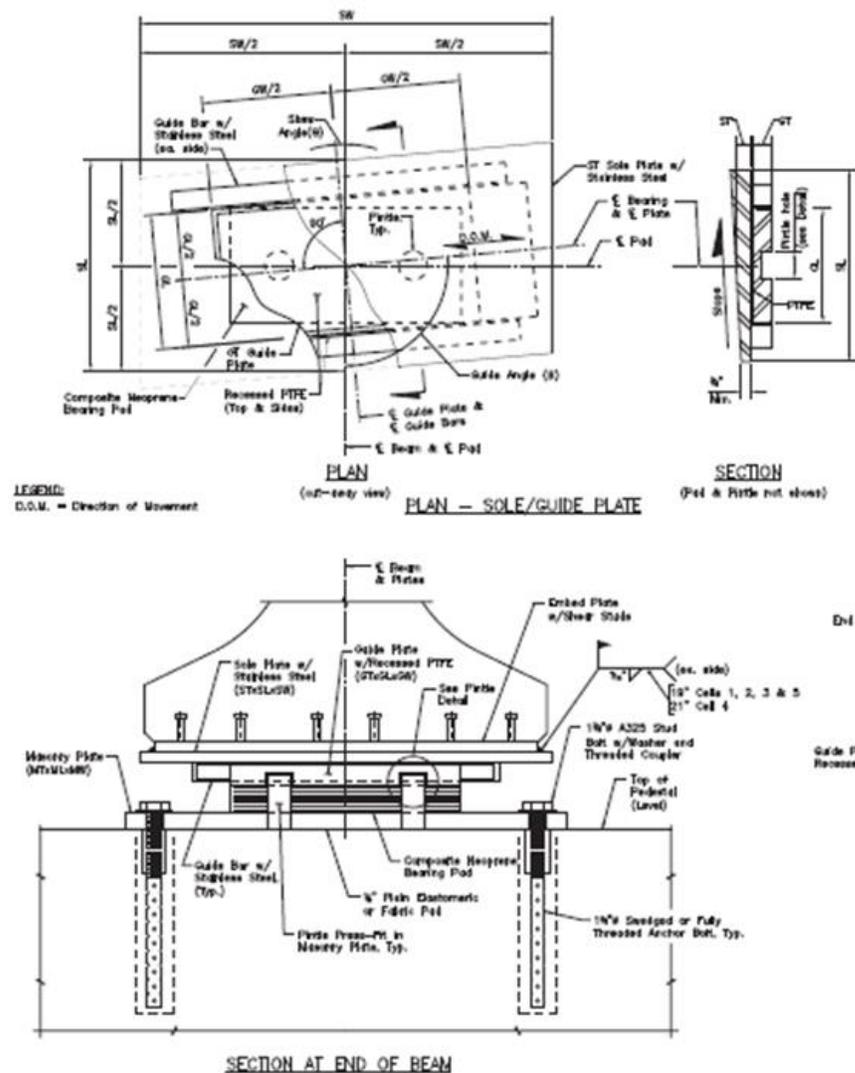
Fig. 22 Typical detail of bearing type III

Type IV bearings provide movement in multiple directions. Type III bearings are restricted to transverse movements only. The longitudinal movements are contained by welding guide bars to the sole plate, see Fig. 22 above.

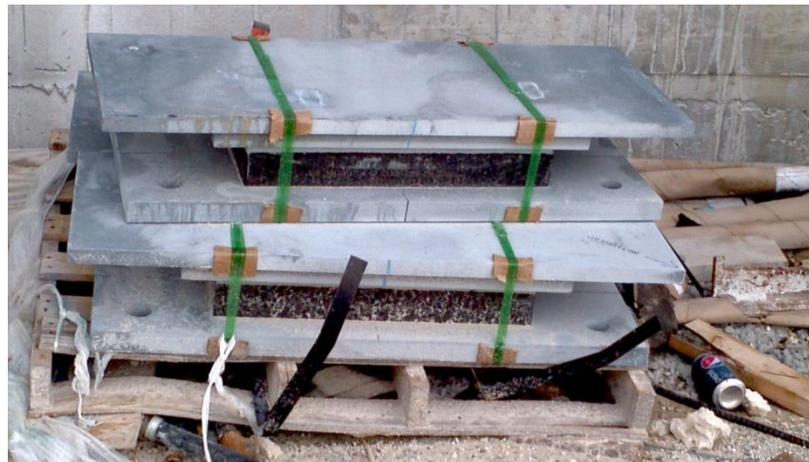
**Fig. 24** Typical bundled bearings

The use of PTFE and a mating stainless steel with a mirror finish are well recognized and accepted in bridge construction where longitudinal or transverse movements are desired. All bearings were manufactured by D S Brown Company of Ohio, and were individually shipped with all five pieces of the bearings bundled together. The bearings were not opened until they were placed when the sole plate was ready to be welded to the embedded plate of the concrete beams, see Fig. 24.

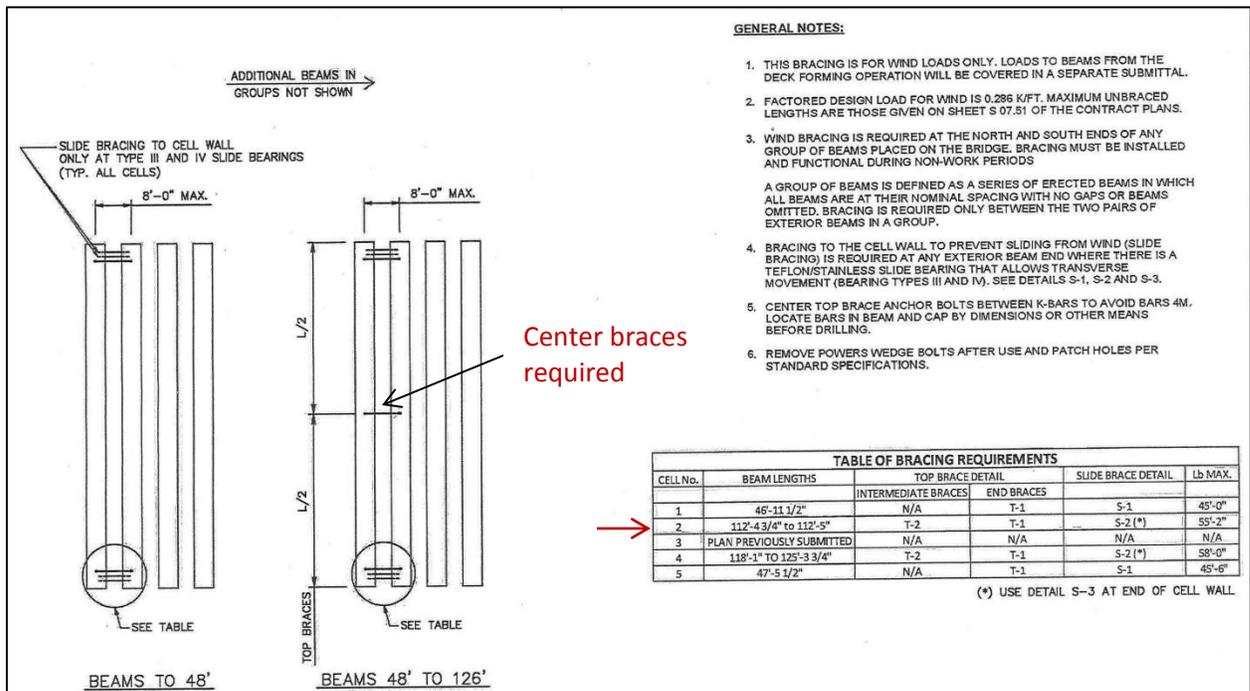
Fig. 26 Temporary bracing prepared by consultant for the beams erector

2. Contex retained a specialty engineer, Construction Engineering Consultants (CEC), to design temporary bracings for the precast concrete beams. CEC produced three drawings with varying dates, the original date being July 29, 2013. A table of bracing requirements was prepared, see Fig. 26, below. For cell No. 2, braces were required for the end locations and at the center of the span for the exterior pair of beams only. Interior beams were exempted by CEC from having any temporary bracings on the premise that they would be shielded by adjoining beams, and would not be subjected to any appreciable wind loads. These beams were 6 ft. deep, spaced at 8 ft. on center with a top flange 4'-4" wide. CEC's drawings called for a pair of horizontal bracings at the center of the two exterior beams see Fig. 26 and 27. These bracings were not installed by Contex. CEC also called for horizontal braces between the two exterior beams at their ends. These braces were also not installed. The lack of braces mentioned above is significant, but this is not believed to have contributed to the incident of November 2, 2013. However, it would have prevented beams 92 and 93 from sliding and overturning.

3. The precast erector did not follow the drawings produced by his consultant to provide horizontal braces between the exterior beams at the center of the span and at the ends. This nonconformance and deficiency, although significant, would not have prevented the incident of November 2, 2013.

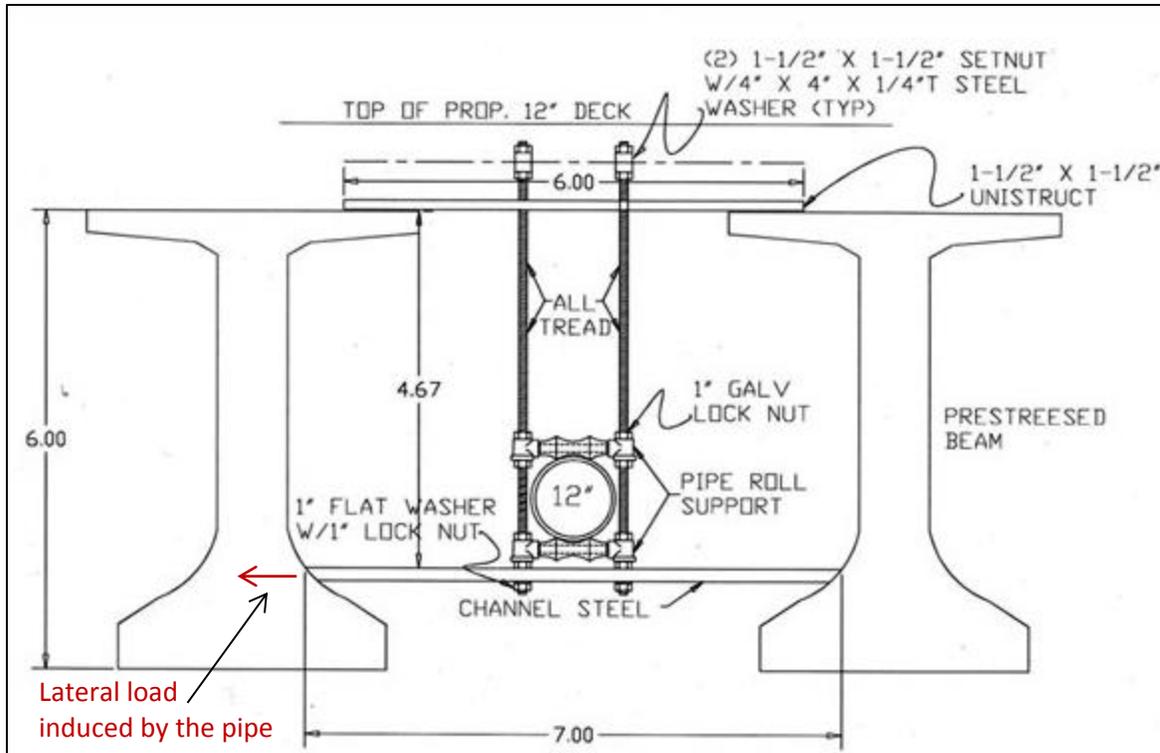
**Fig. 29** Drawing prepared by the consultant of Florida Paving Group after the incident

4. Florida Paving Group retained a specialty engineer, Gator, to design the support system of the 12" water main to be placed between beams 83 and 84. Gator designed the support for the pipe over steel channels spanning between the sloping bottom flanges, see Fig. 29. Gator had no knowledge of the sliding bearings over which the concrete beams were

seated because Gator was not provided with construction drawings. The steel channel with bottom roller was assembled on the ground, and then placed between the concrete beams. A crane dropped the black pipe over the steel channel and connections were made. Then pipe risers were brought in and fastened to the horizontal pipe. The dead load of the pipe was transferred to the sloping bottom flanges of concrete beams through steel channels. Our calculations indicated that a horizontal thrust would be created which could slide the beam horizontally if the coefficient of friction is at the bearing in the low range of 1 to 1.5%. It must be noted here that the bottom horizontal run of the pipe was placed just over the uncompacted grade, and the risers were not supported over concrete pads. Therefore, it is believed that the risers could be hanging from the horizontal pipe, thus adding more loads to the pipe supports.

Gator did not consider the lateral thrust of the pipe support on the concrete beams. It is understood that Gator was not provided any information about the bearings. If the bearing information was provided or if Gator had asked for the information, it is believed that Gator would have designed it differently or would have highlighted the need to restrain the bearings against movement.

It is not certain whether HNTB reviewed the design of the pipe support system prior to the incident. The inspector for the construction manager saw the drawing and informed her supervisor about the existence of such a drawing, but no follow-up action was taken by the construction manager. It was certainly known to both, the JV and the construction manager how the pipe was being supported. Neither performed any inquiry to determine if the design had undergone proper review. If that had been done, this incident could have been avoided.
