# Investigation of the January 19, 2015 collapse of bridge onto southbound interstate I-75 during demolition in Cincinnati, OH

U.S. Department of Labor  
Occupational Safety and Health Administration  
Directorate of Construction

May 2015

Report Prepared by  
Mohammad Ayub, P.E., S.E.  
Office of Engineering Services  
Directorate of Construction

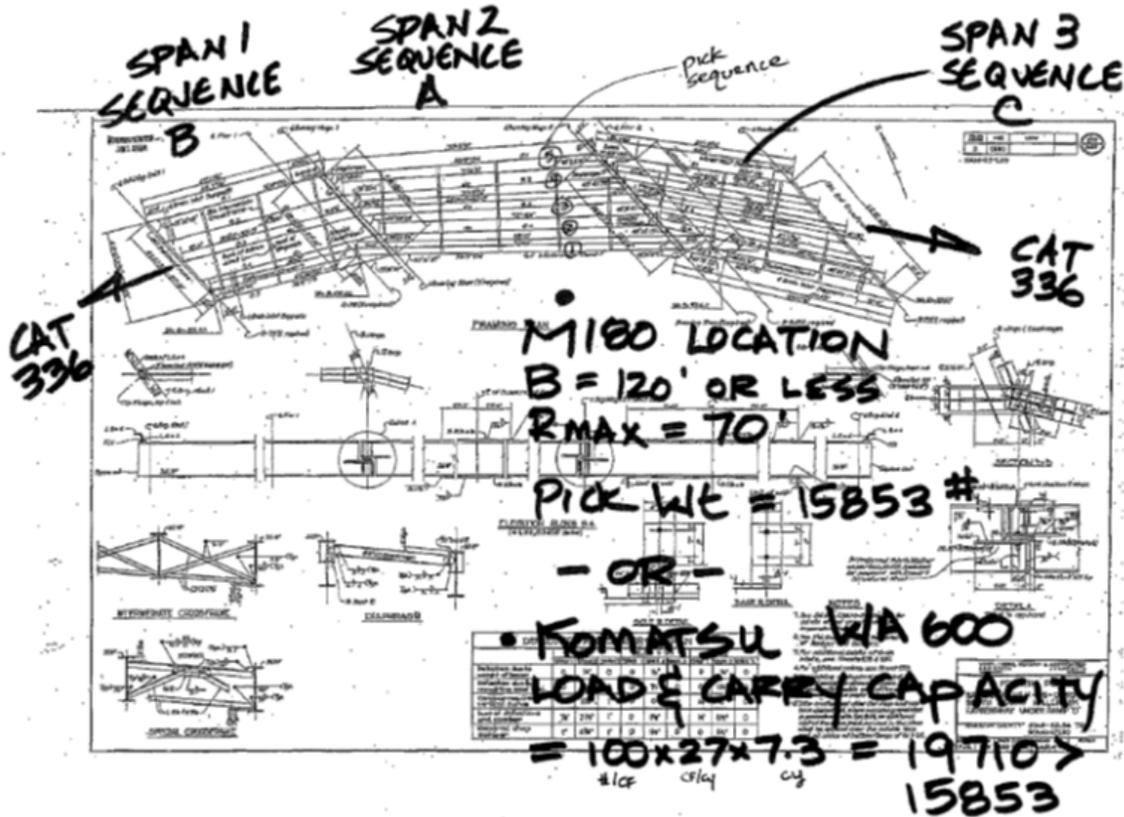
Figure 7 – Plan showing sequence of removal of girders (page 26 of demo plan dated 12-16-14)

Kokosing decided to demolish the concrete deck beginning from the east abutment, and gradually proceeding towards the west. Steel beams along with diaphragm members were to be left intact until it was time to remove the steel girders. Steel girders were to be removed first from the center span followed by removing the steel girders from the east and west spans as shown in demo plan. The demo plan did not specify the sequence and direction of removal of the concrete deck. However, it was in the knowledge of the Kokosing engineers that the field personnel were removing the concrete deck from east to west.

Kokosing engineers were fully aware of the sequence of concrete removal by Kokosing field personnel and did not raise any concern. The proper way would have been to remove the

concrete deck from the center span either by saw-cutting or crunching, thus relieving load on the cantilevered segments. This would have precluded any uplift of the girders at the abutment.

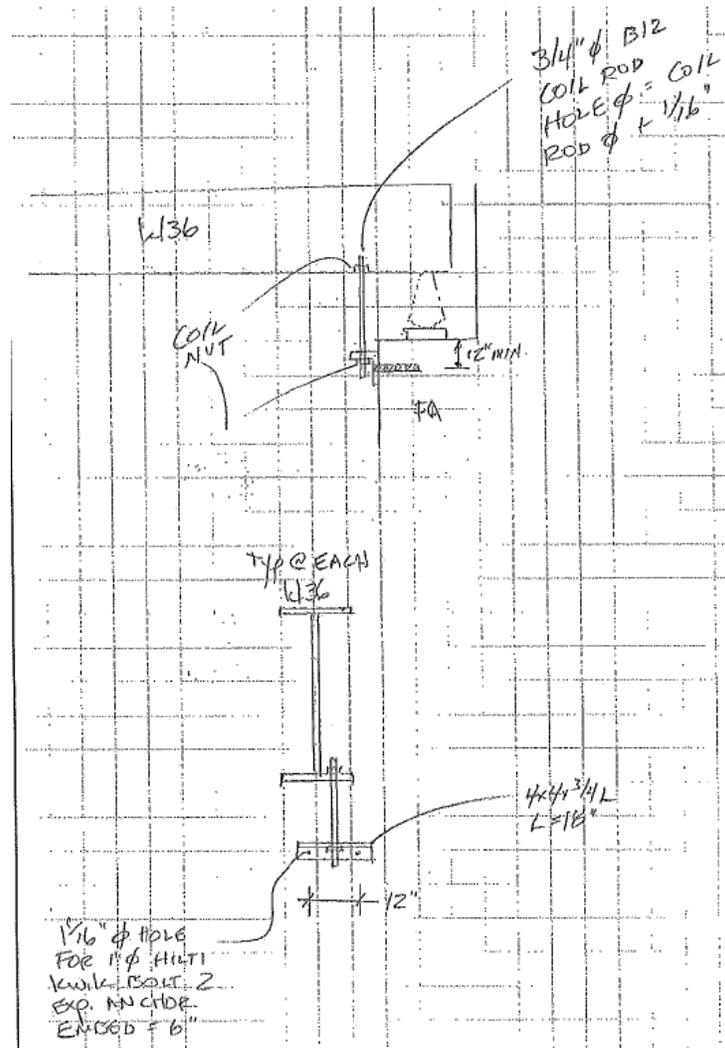
Figure 8 – Details of how girders to be tied down to the abutment

The next morning, Mr. Brett Murray, PE, proposed that the girders be tied down to the abutment at the east end (Abutment #2) with Hilti anchors. Mr. Murray prepared a sketch showing a 3/4" coil rod through the bottom flange of the steel girder with a 4x4x3/4" angle anchored to the abutment wall with two 1" dia. Hilti anchors, see figure 8 below.

Sketch prepared by Kokosing engineer

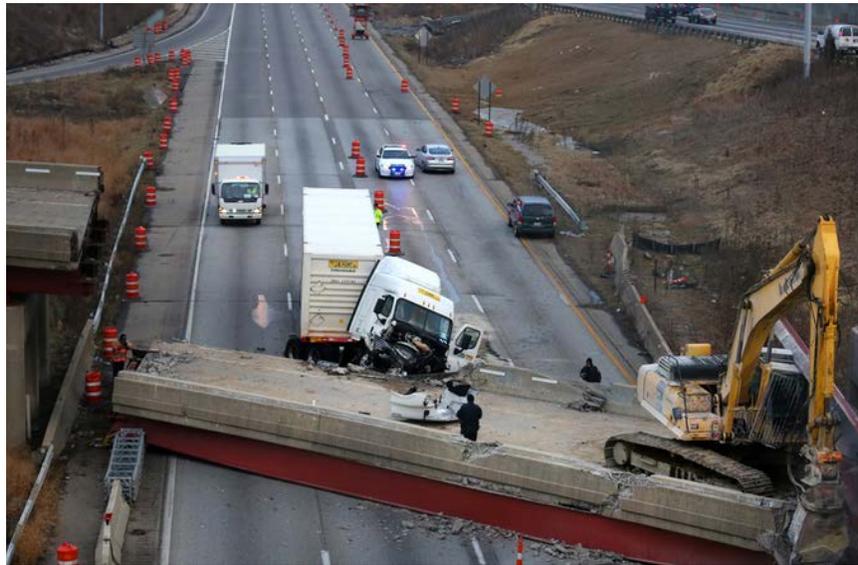
Figure 9 – Bridge center span with excavator collapsed onto I-75S (taken from the web)

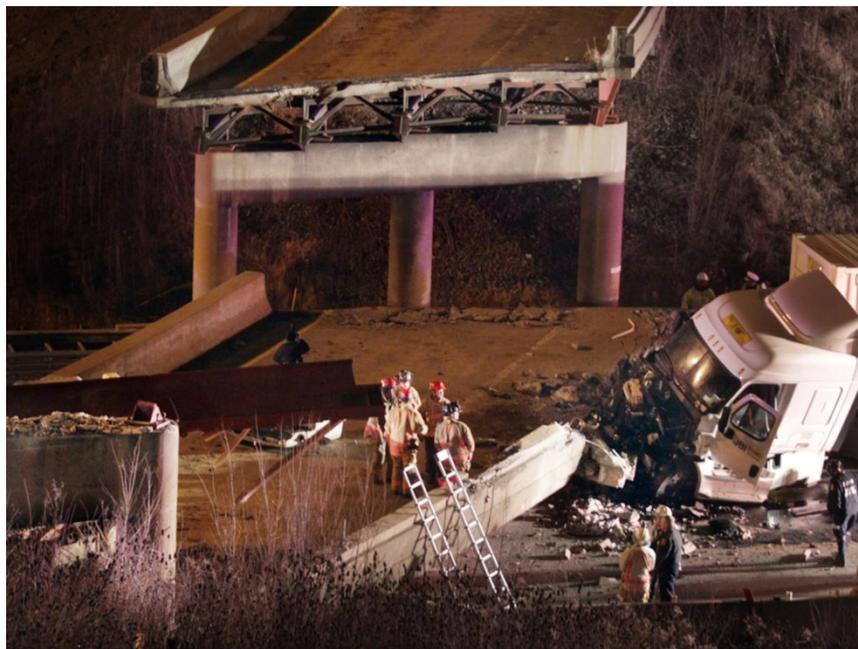
Figure 10 – I-75S after the incident (taken from the web)

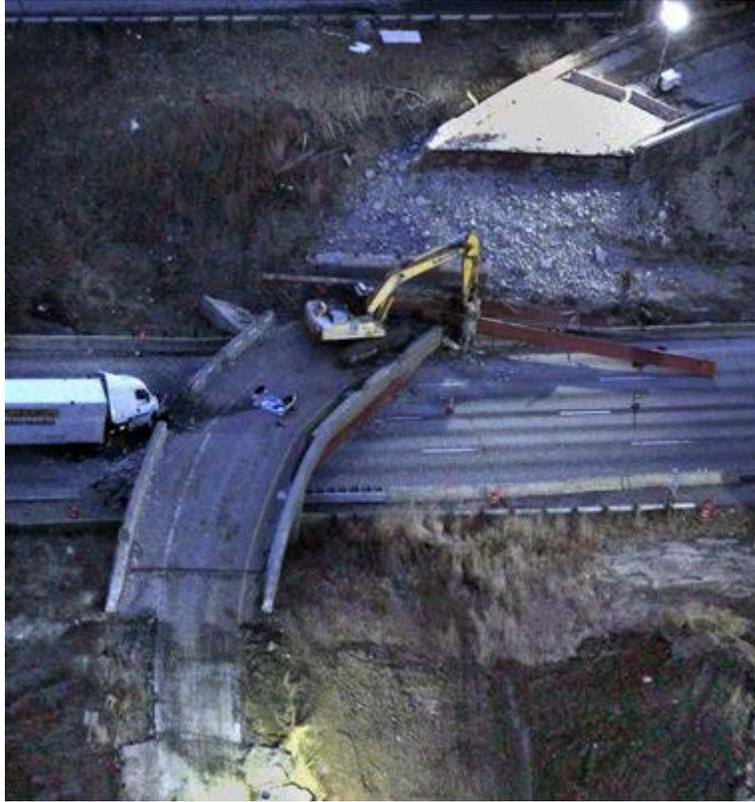
Figure 11 – Collapsed bridge with excavator, abutments and I-75S (taken from the web)

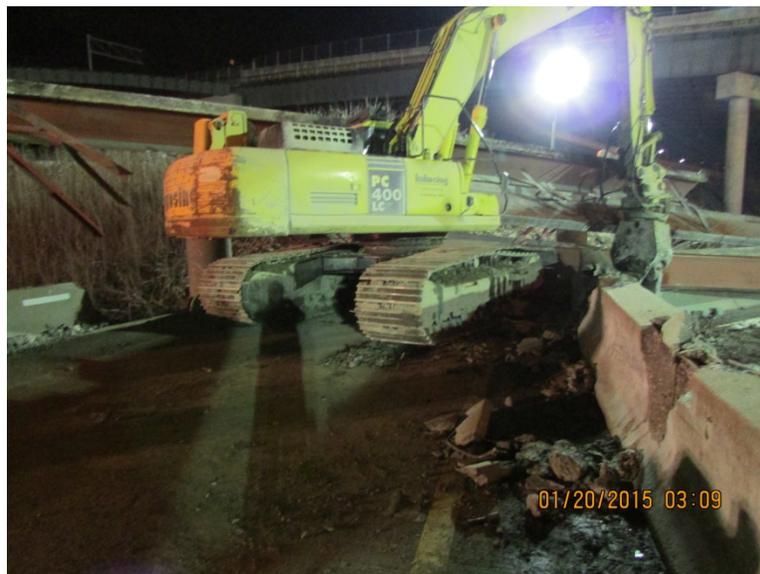
Figure 12 – Excavator after the collapse

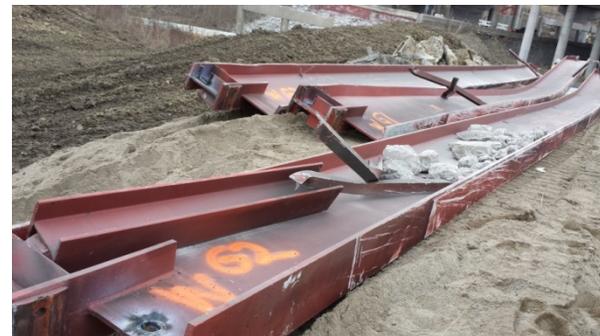
Figure 16 – Failed girders after collapse

Each of the five girders of the center span was bolted with two bolts to each of the five cantilevered east and west girders. As the east span tilted up, exerting undue force on five girders of the center span, the bolts failed. As all five girders, interconnected with the diaphragms and the concrete deck, began to fall down they exerted tension on the bolts on the west side which also failed, prompting the entire center span to fall in one piece to the ground.

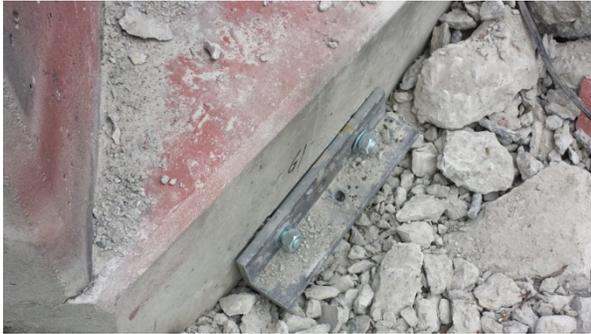
Post-incident inspection revealed that the Hilti anchors which secured the bottom flange of the girders from lifting failed either by pulling out of the concrete or by failing in shear. All five girder hold-down measures failed.

Figure 19 – 4x4x3/4" angle anchored to abutment #2 with Hilti anchors to prevent uplift of the girders

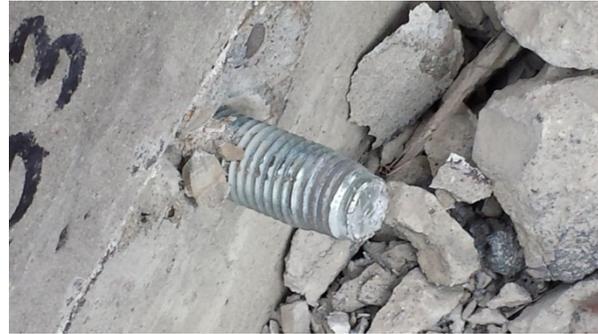
Figure 20 – Failed Hilti anchor

OSHA conducted an independent structural analysis of the girders. The excavator was placed on the cantilevered portion close to hinge #2. The weight of the excavator with the genesis was assumed to be spread over 2 girders. This analysis indicated that the entire procedure for removing concrete from the east abutment and proceeding towards the west was flawed. The computations indicated that each of the two girders were subjected to an uplift force of 18,000 pounds at abutment #2, when the entire concrete between the abutment #2 and pier #2 is removed. The analysis confirmed that as the east span was being relieved of the dead load of concrete by crunching the deck, the steel girders would rise from the abutment. The original design did not call for any positive tie-down of the girders at the abutments. The physical tie-down of the girders installed on the day of the incident on the recommendation of the engineer was poorly designed and did not meet industry design standards. The Hilti anchors were subjected to a combination of axial tension and shear in excess of their capacity, and this caused the failure. It is unfortunate that although the remedial measures were designed and reviewed by two professional engineers, neither of them gave due regard to the design that they proposed. The remedy was proposed in haste and ignored basic engineering considerations. The design called for three Hilti anchors with an embedment of 6 inches for each girder. The Hilti anchor provided in the field had an embedment of only 4.5 inches. Even with an embedment of 6 inches, the design would not satisfy industry standards.

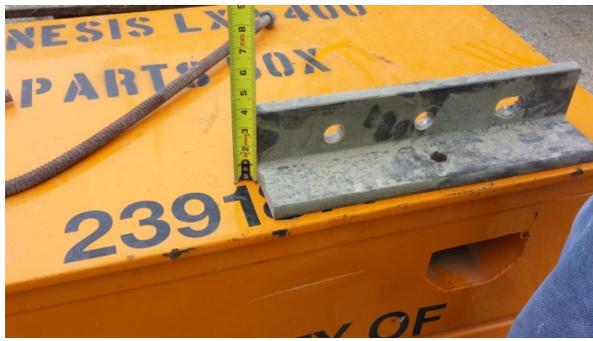
Figure 21 – 4x4x3/4" angle used at abutment #2

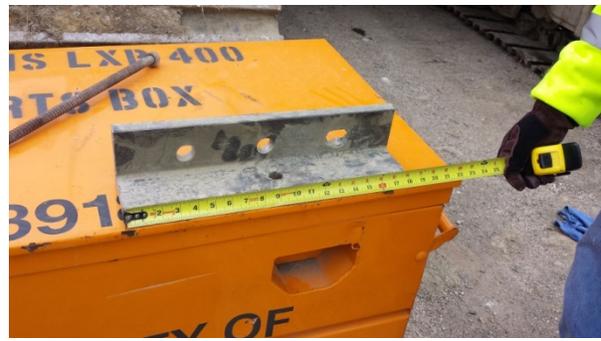
Figure 22 – Another view of 4x4x3/4" angle used at abutment #2

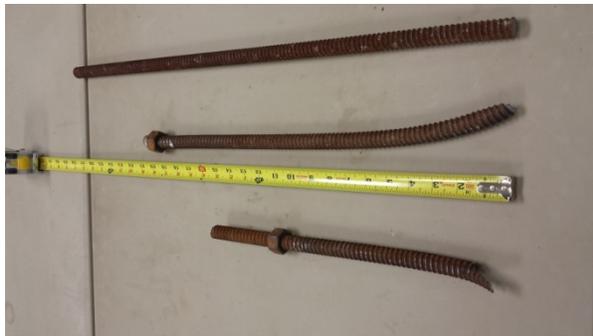
Figure 23 – 3/4" coil rod that was used at abutment #2 to hold down the girder

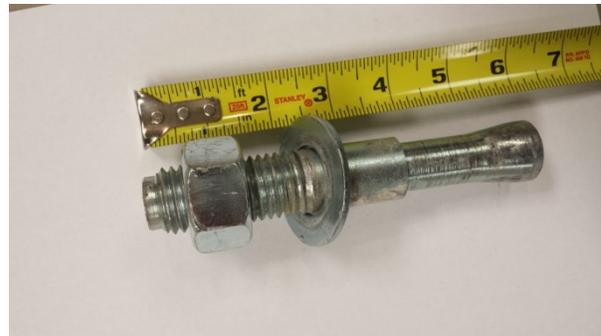
Figure 24 – Hilti anchor used at abutment #2
