Investigation of the March 23, 2015 Mast Climbing Scaffold Collapse during Dismantling at Raleigh, NC

U.S. Department of Labor
Occupational Safety and Health Administration
Directorate of Construction

August 2015

Report Prepared by
Mohammad Ayub, P.E., S.E.
Office of Engineering Services
Directorate of Construction

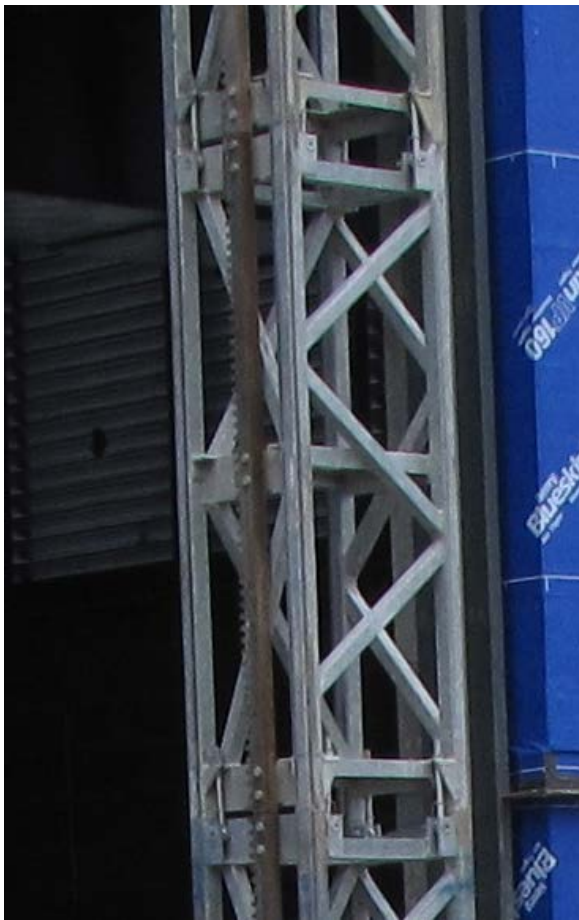
Fig. 1 – Mast sections bolted with swing bolts

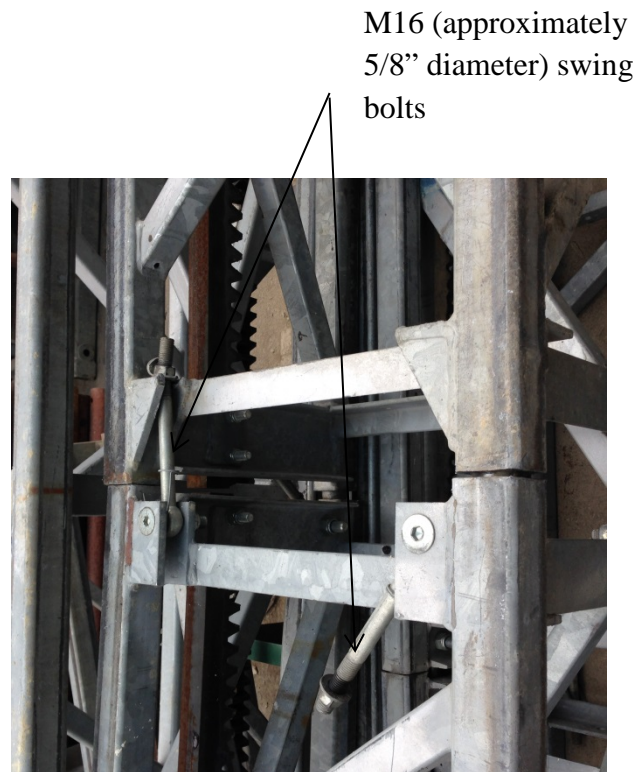
Fig. 2 – Mast sections bolted with swing bolts

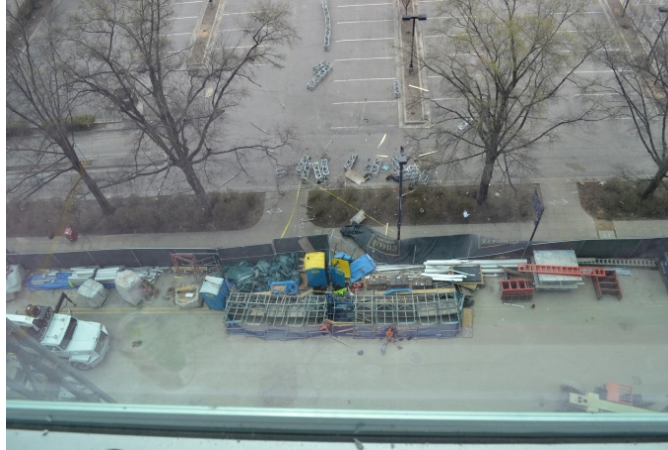
Three employees were thrown to the ground and were killed. The fourth employee, Elmer, fell over the roof of a portable toilet and was saved. The standing mast from the 6th to the 9th floor fractured five feet above the 6th level, and five feet below the 6th floor, and fell to the ground in three parts. One part contained five sections (5x5=25 ft.) still connected to each other. The second part consisted of two sections (5x2=10 ft.) and the third part was a solitary section (5 ft.). These parts fell farthest from the building. The 13 sections and the 6 ties, which were placed over the deck, fell in a scattered manner to the ground; see Fig. 11, 12 and 13. The 45 ft. long deck fell almost intact, lying closest to the building, see Fig. 11 and 14.

Fig. 11 – Mast sections and platform on the ground after collapse

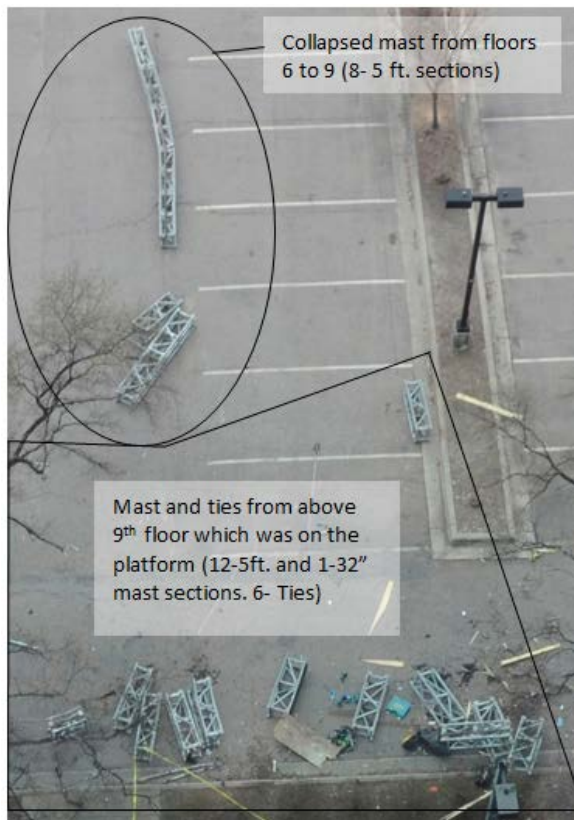
Fig. 12 – Mast sections on the ground after collapse

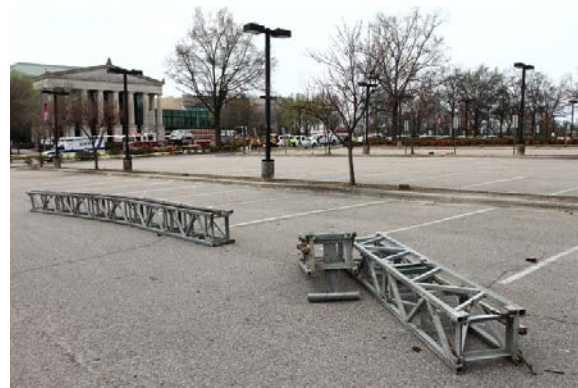
Fig. 13 – Mast sections from floors 6 to 9 after collapse

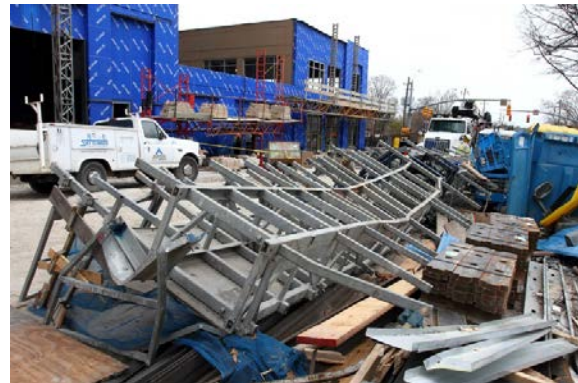
Fig. 14 – Collapsed platform deck lying upside down

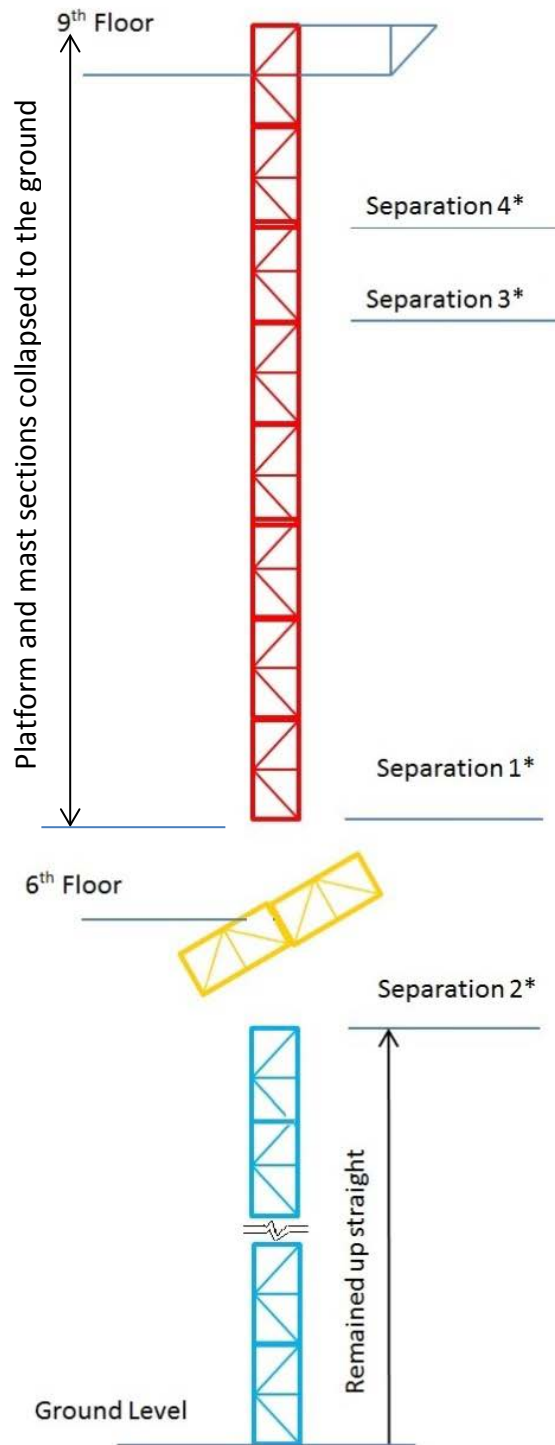
The two sections, one above the 6th floor and the other below the 6th floor, were still connected to each other but were leaning approximately 45 degrees. These two sections remained connected to the 6th floor ties, see Fig. 15 thru 23.

Fig. 15 – Location of separation of mast sections

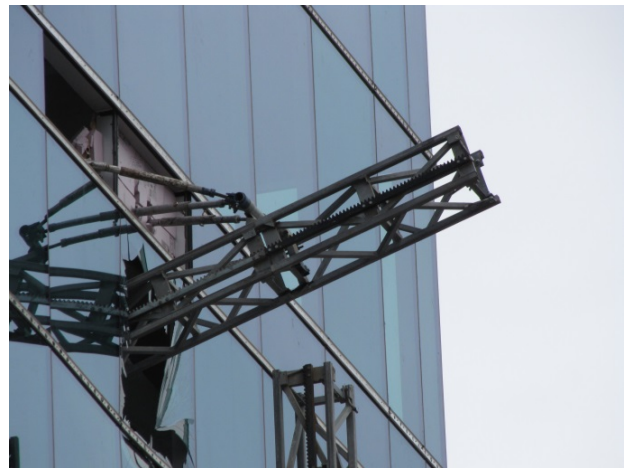
Fig. 16 – Mast sections at 6th floor rotated

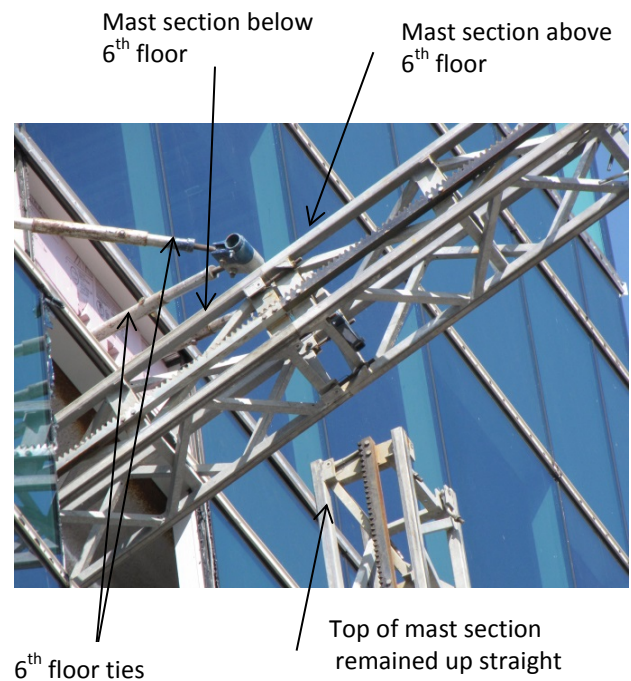
Fig. 17 – Mast sections at 6th floor rotated

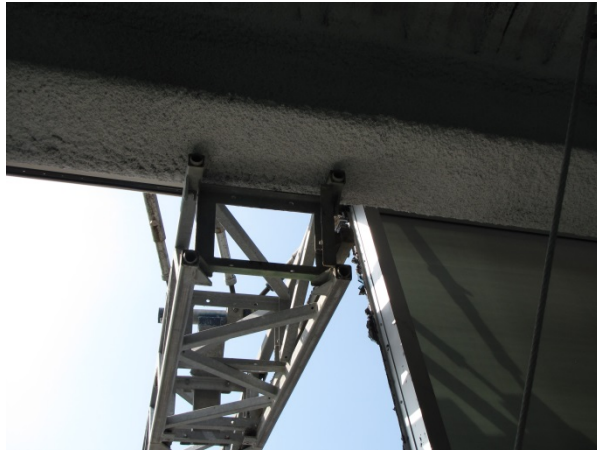
Fig. 18 – Mast sections at 6th floor after collapse

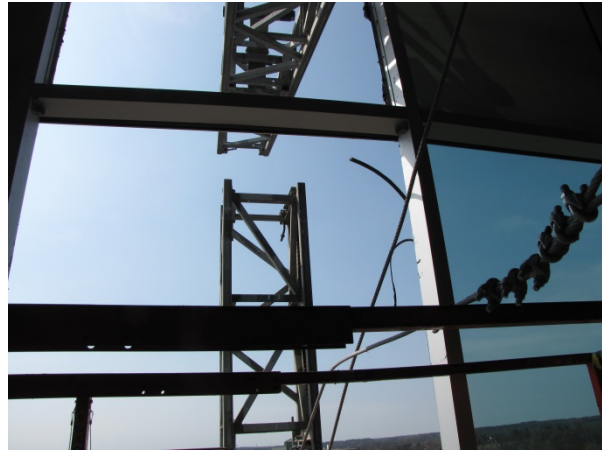
Fig. 19 – Mast sections at 6th floor after collapse

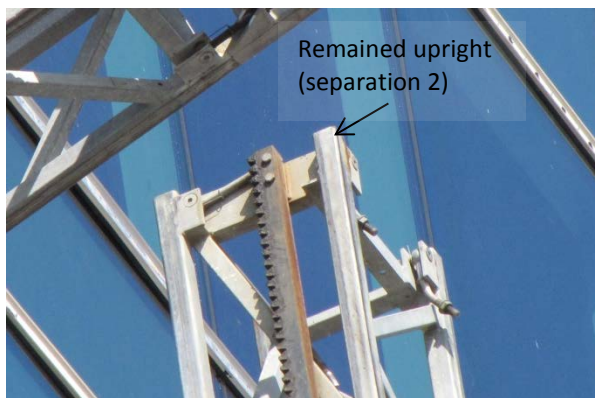
Fig. 20 – Mast sections at 6th floor after collapse

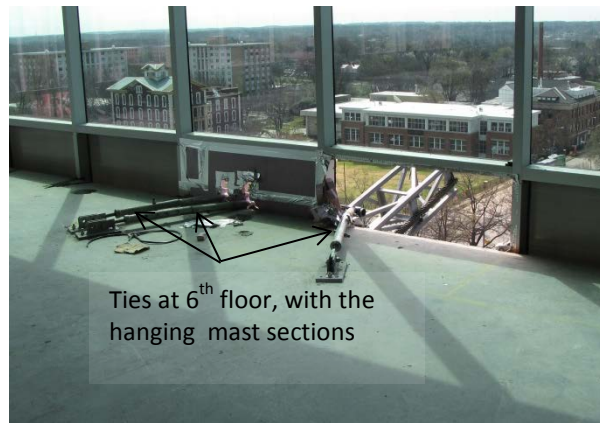
Fig. 21 – 6th floor ties

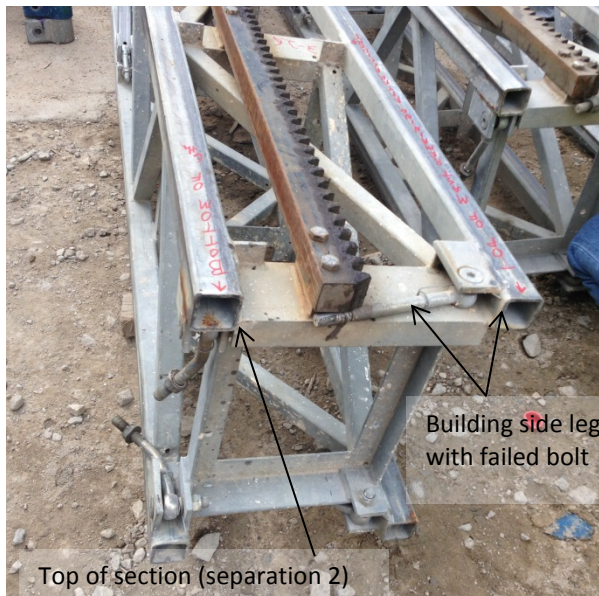
Fig. 22 – Top of section that remained up straight

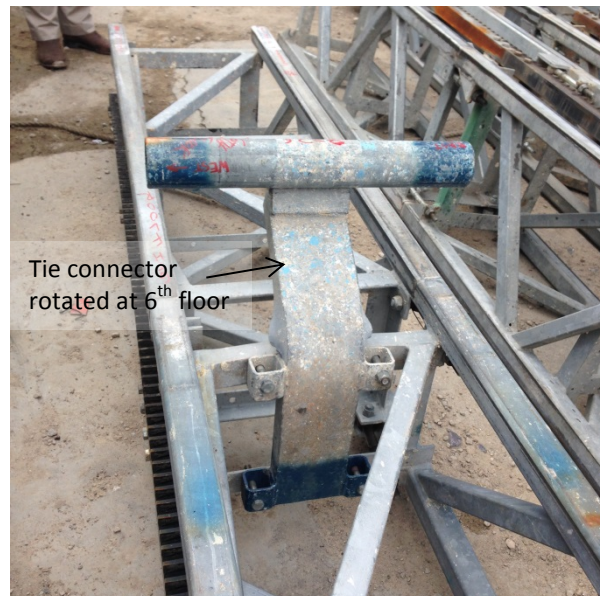
Fig. 23 – Mast section that was hanging at 6th floor

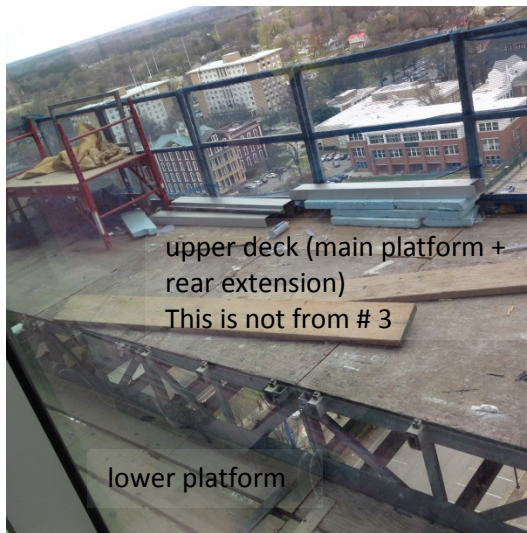
The failed mast climbing scaffold had a front lower extension of 24" and a rear upper extension of 24", see Fig. 26, 27 and 28. The dead weight of the rear extension (extension steel tubes and deck) itself is approximately 500 lbs. The deck with an upper extension is not a standard configuration and is not commonly used in the industry. All manufacturers generally do not provide the safe capacity of the deck configuration with the upper rear deck, and ask that the user contact them to determine the safe load capacity. In this instance, the manufacturer was not contacted to determine the safe load carrying capacity of the deck configured with an upper rear deck. The safe load carrying capacity will be lower than 3,000 pounds and if the load is placed on the rear extension, the allowable load capacity will be further reduced due to the greater eccentricity of the loading. It is not known whether the contractor was using the rear extension as a part of the main platform during dismantling and whether the dis-assembled mast sections were actually placed on the rear extension area.

Fig. 26 – Mast scaffold nearby showing the extended upper deck and lower deck

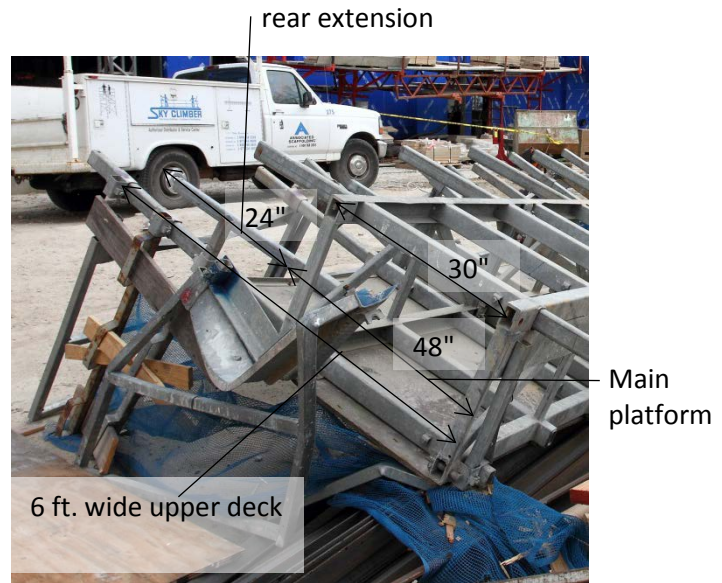
Fig. 27 – Collapsed Mast scaffold deck lying on the ground upside down

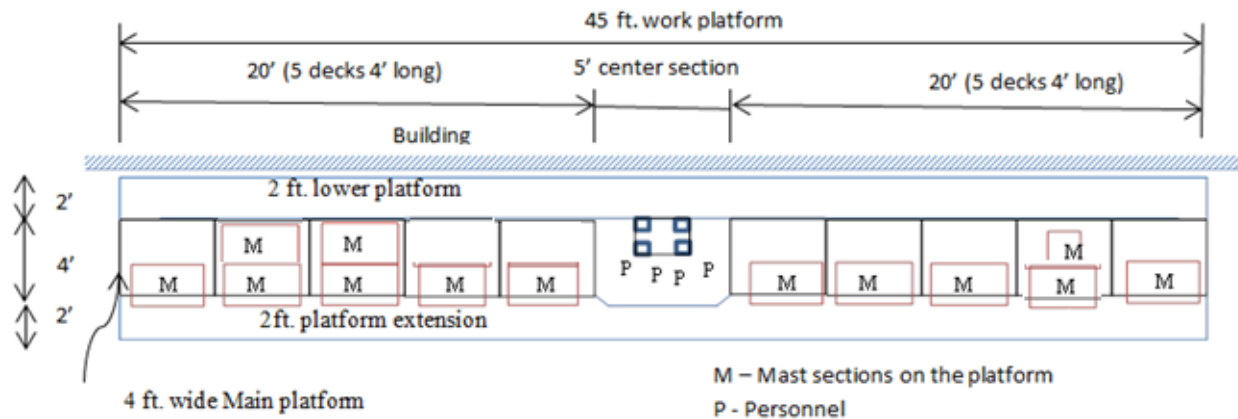
Fig. 30 – Placement of removed mast sections on the platform for analysis

For Case IV, which was identical to Case III except for the fact that the superimposed load on the platform was not uniformly distributed, but as shown in Fig. 30, the tension in the bolts significantly increased to 8 kips. Again with due consideration of the P-delta effect, and the reduced spacing between the bolts and pre-tension in the bolts, the tension in the bolts was 26 kips, well above the failure load, and this caused the failure.

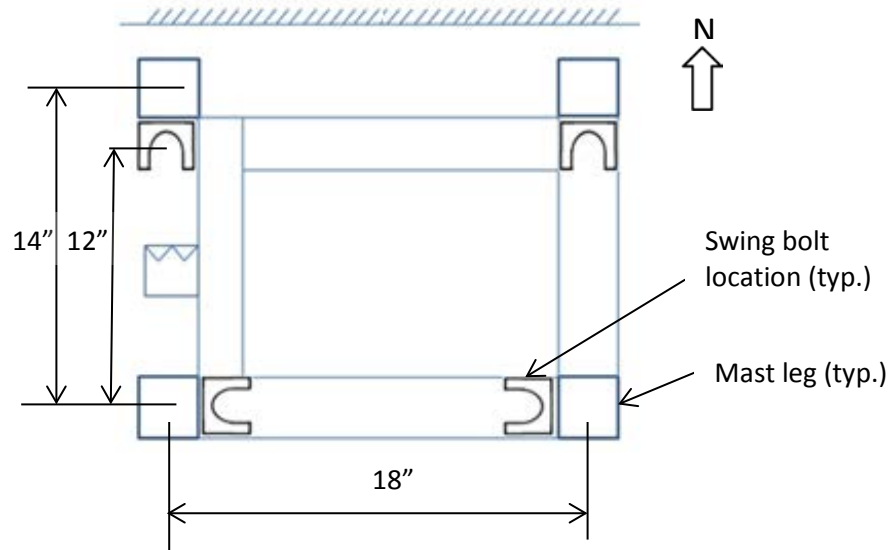
In the computer model, the distance between bolts were 14" in the N-S direction and 18" in the E-W direction. The actual distance, however, between the bolts in the N-S direction was approximately 12", see Fig. 31, which will increase the tension in the bolt by 17%.

Fig. 31 – Plan showing swing bolt location

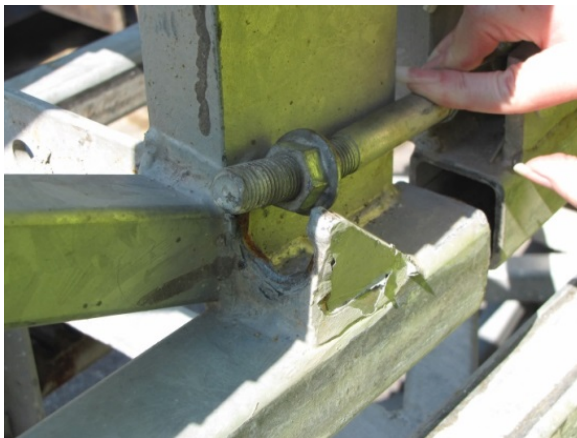
It is interesting to note that in the remnants of the mast stored in the yard of Associated Scaffolding Inc., a swing bolt was discovered to have punched through the 1/4" outstanding flange of the steel angle, see Fig. 33 thru 36. Our calculations indicated that the punching shear capacity of the leg of the angle was approximately 25 kips, though it is not certain whether that was the triggering mechanism or it happened during the collapse.

Fig. 33 – Bolt punched through 1/4" plate

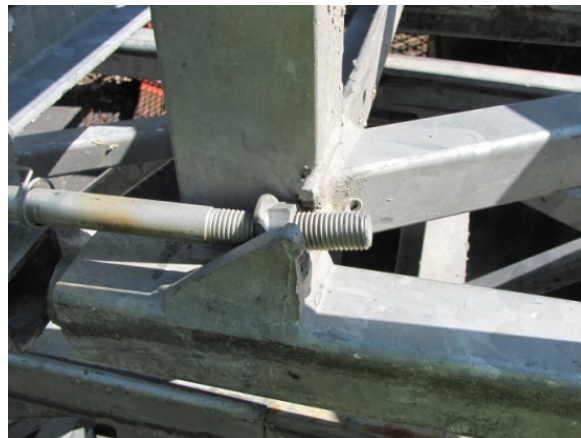
Fig. 34 – Bolt punched through 1/4" plate, another view

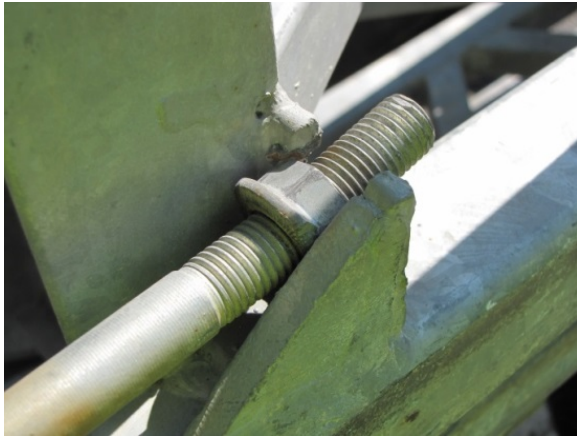
Fig. 35 – Bolt punched through ¼” plate

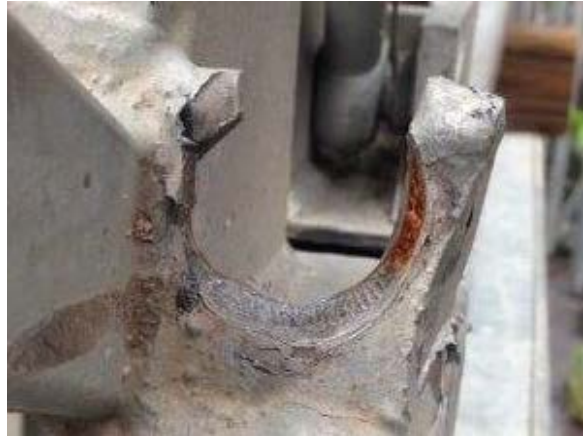
Fig. 36 – Bolt punched through ¼” plate
