# Investigation of the February 5, 2016 Crane Collapse at 40 Worth Street, New York, NY

U.S. Department of Labor  
Occupational Safety and Health Administration  
Directorate of Construction

July 2016

Report Prepared by  
Mohammad Ayub, P.E., S.E.  
Office of Engineering Services  
Directorate of Construction

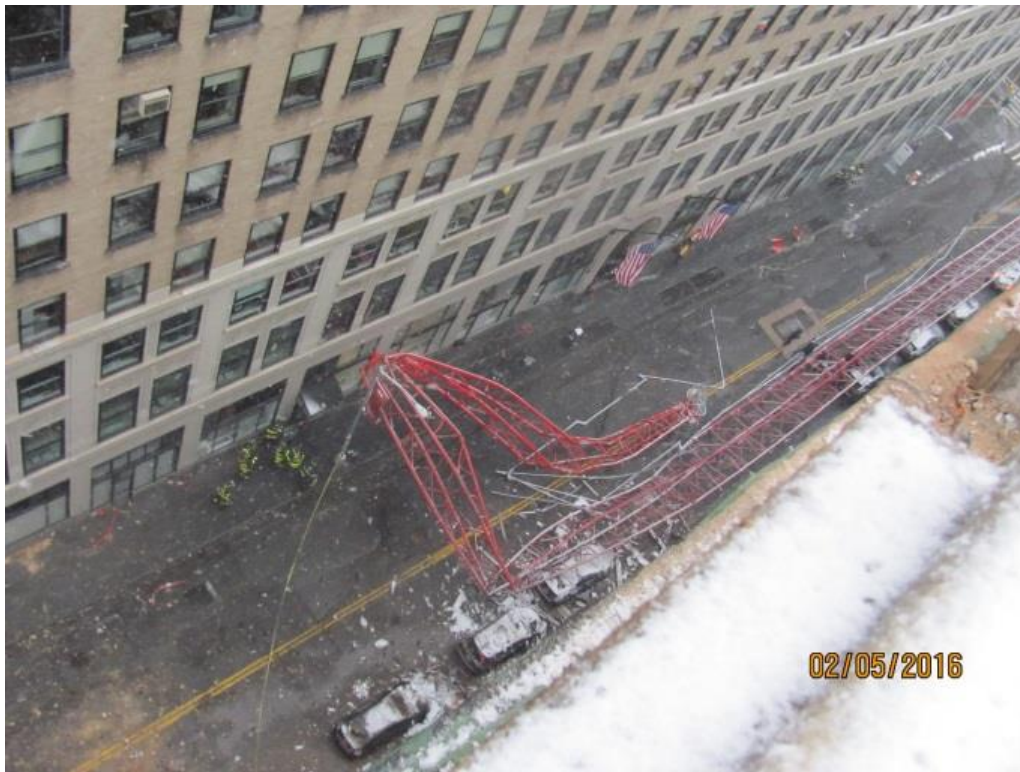
**Figure 2** Jib head section after the incident – aerial view.

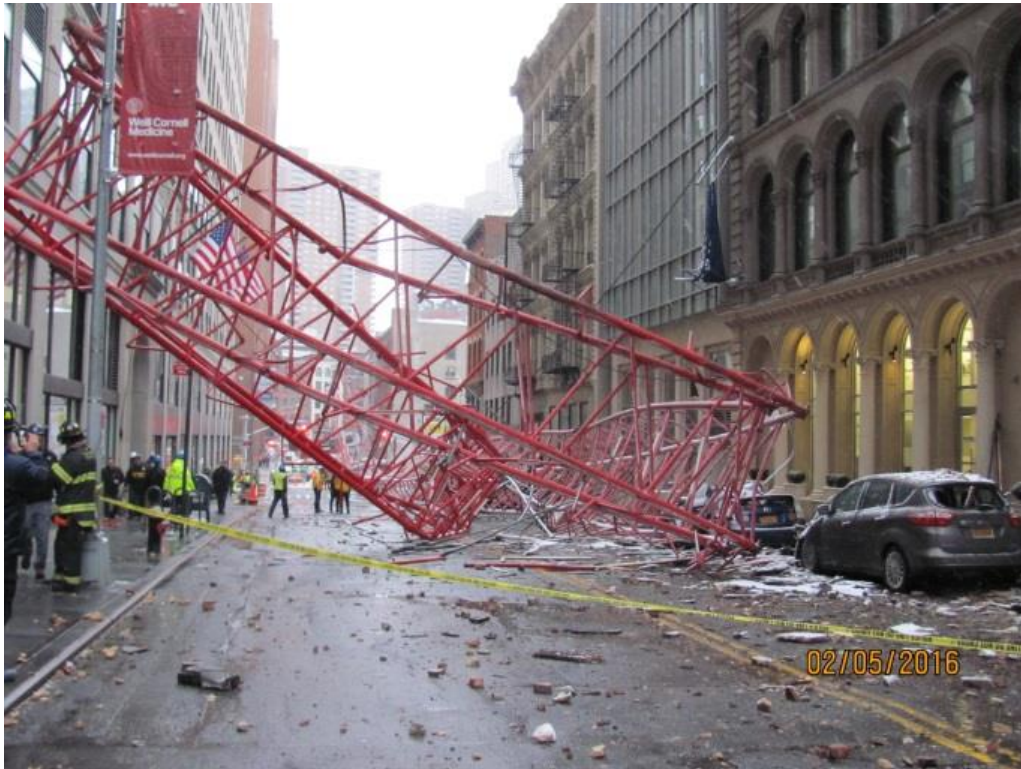
**Figure 3** Jib head section after the incident – street view 1.

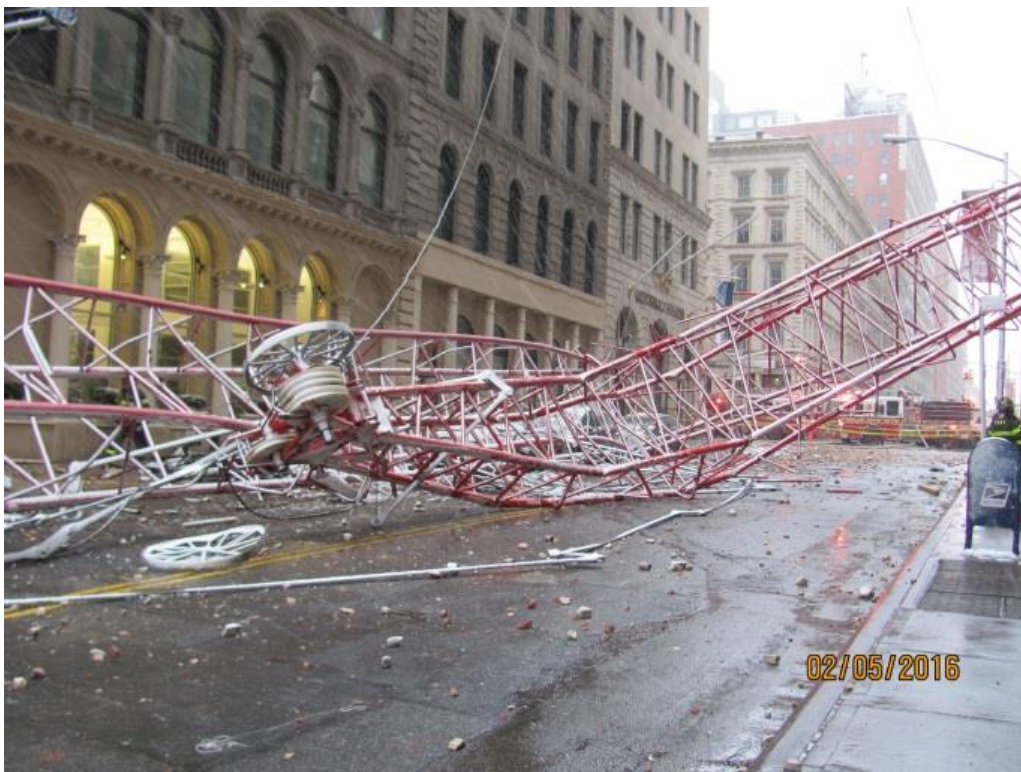
**Figure 4** Jib head section after the incident – street view 2.

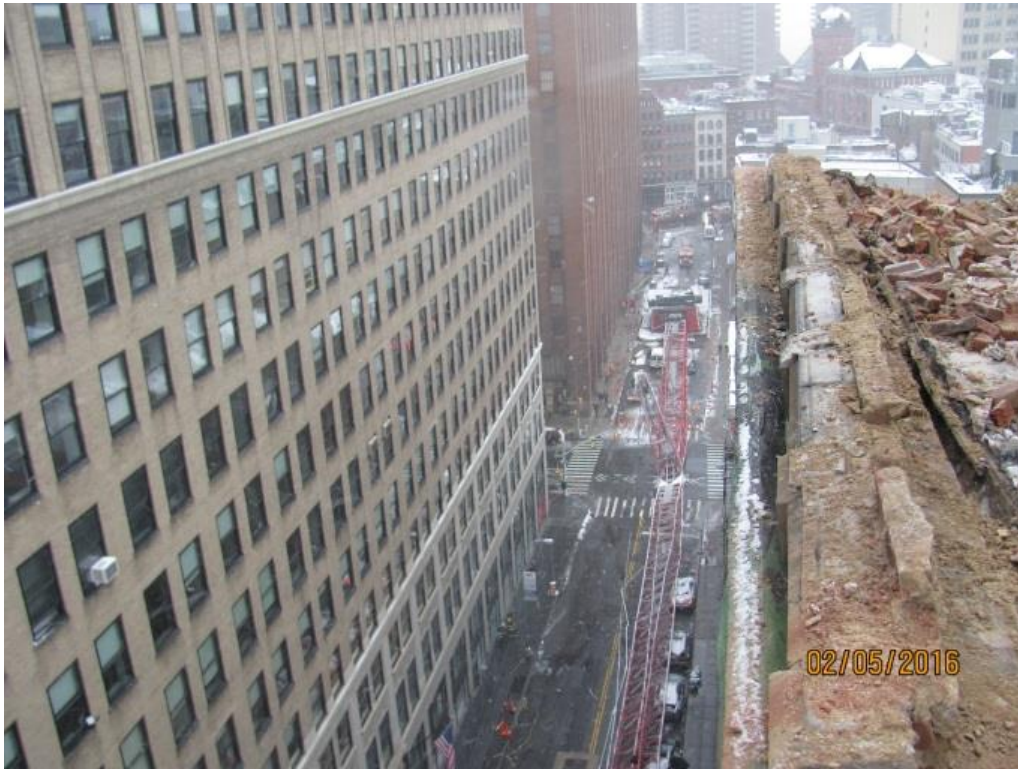
**Figure 5** Boom and jib on the ground after the incident – aerial view.

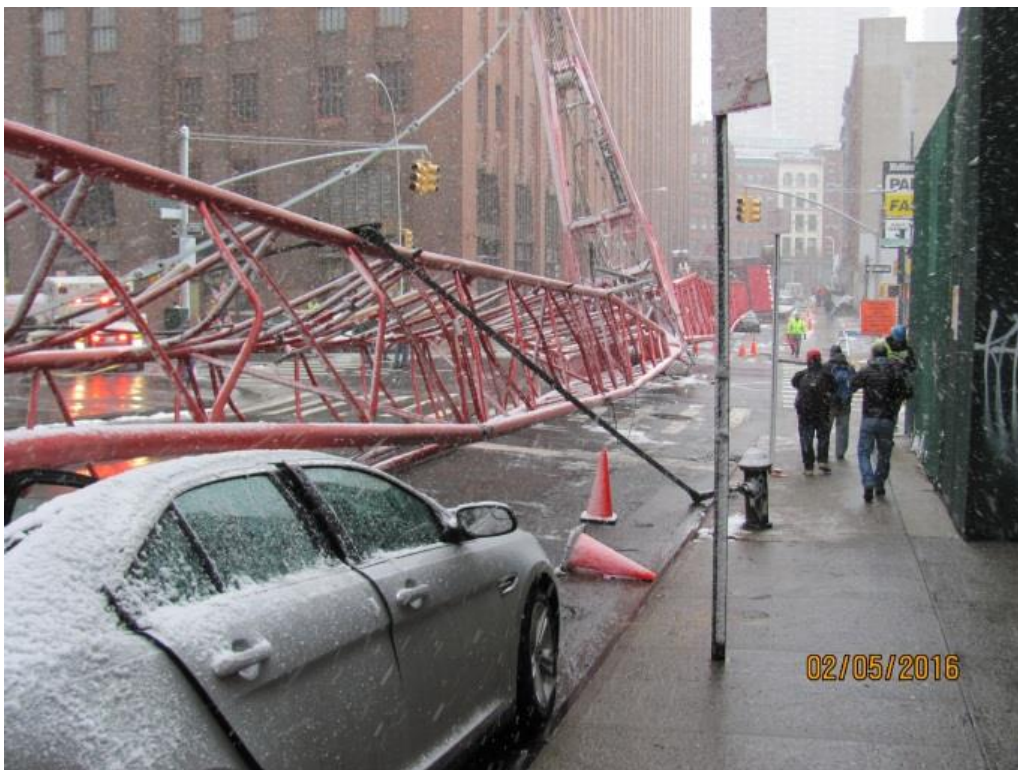
**Figure 6** Boom and jib on the ground after the incident – street view.

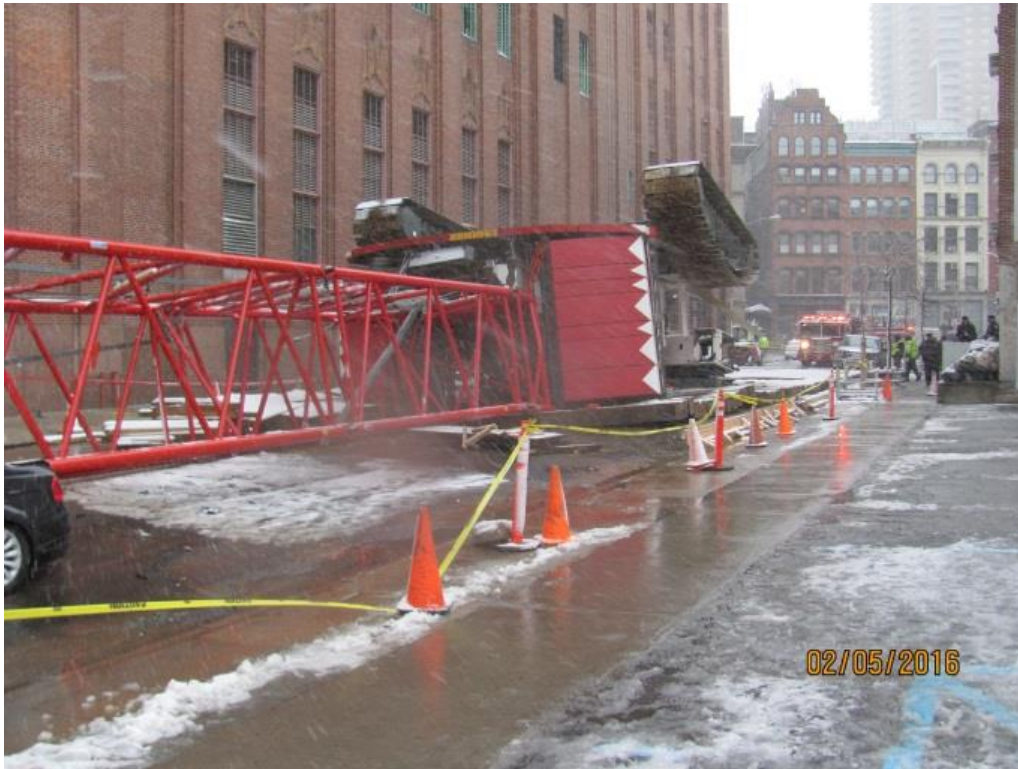
**Figure 7** Crane and counterweights after the incident.

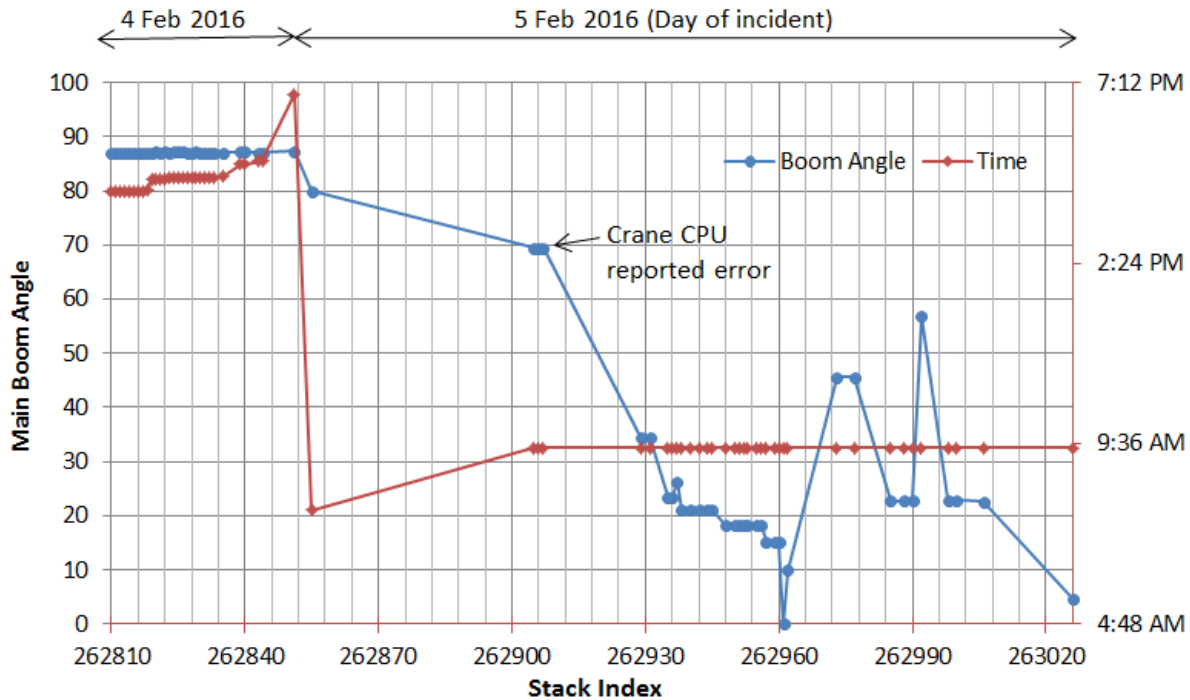
**Figure 13** Plot of boom angle and computer time (data taken from Crane CPU output).

The Table 1 and the graph (fig. 13) show the boom angle on the day of the incident and the previous evening. The table shows that the boom angle was approximately 87° on the evening of February 4, 2016. The last recorded boom angle on February 4 was 87.4° at 6:53 p.m. computer time. On the morning of the day of the incident, the first recorded boom angle was 80°, an unexplained variation of 7° from the previous evening. The top ten lines of the following figure indicating the boom angles suddenly reversed upwards after being on the ground (stack index 262962 to 263026), are not considered reliable. This could have been the result of the overturning of the base of the crane including the operator's cabin.

*Note: The boom angle when the system was shut down on 4-Feb-16 was 87.4°. On Feb. 5th, the day of the incident, the main boom angle was at 80° at 7:49 AM and then it became 0° at 9:29 AM.*

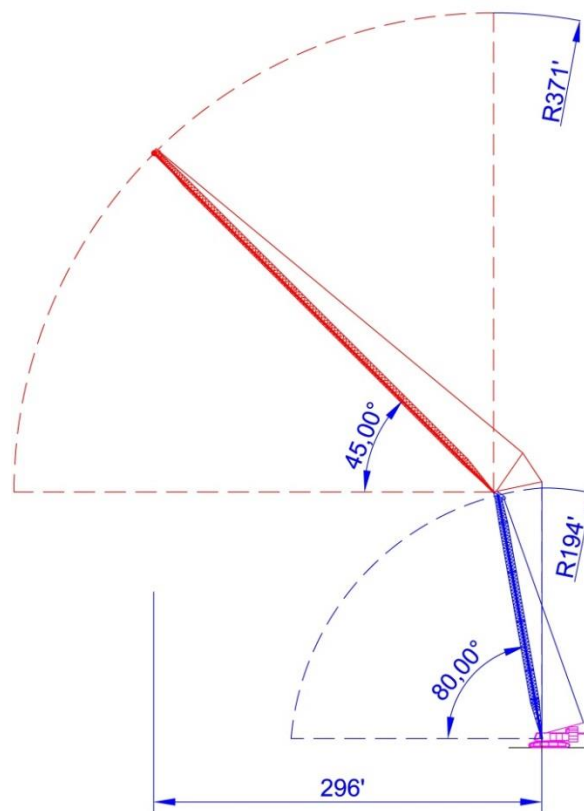
**Figure 16** Case I - Crane vertical profile.

The crane boom is considered at an angle of 80° with the luffing jib at 45°.

For condition w/o wind  
SF = 1.789

Wind speed, mph	20	22	25	26	30
SF =	1.380	1.315	1.222	1.190	1.073

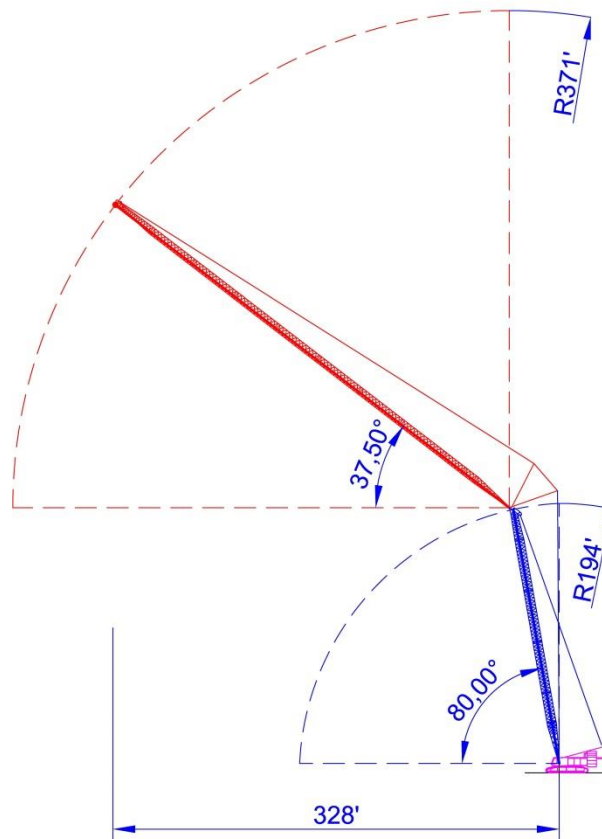
**Figure 17** Case II - Crane vertical profile.

The crane boom is considered at an angle of  $80^\circ$  with the luffing jib at  $37.5^\circ$ .

For condition w/o wind  
SF = 1.627

Wind speed, mph	20	22	25	26	30
SF =	1.341	1.292	1.220	1.194	1.099

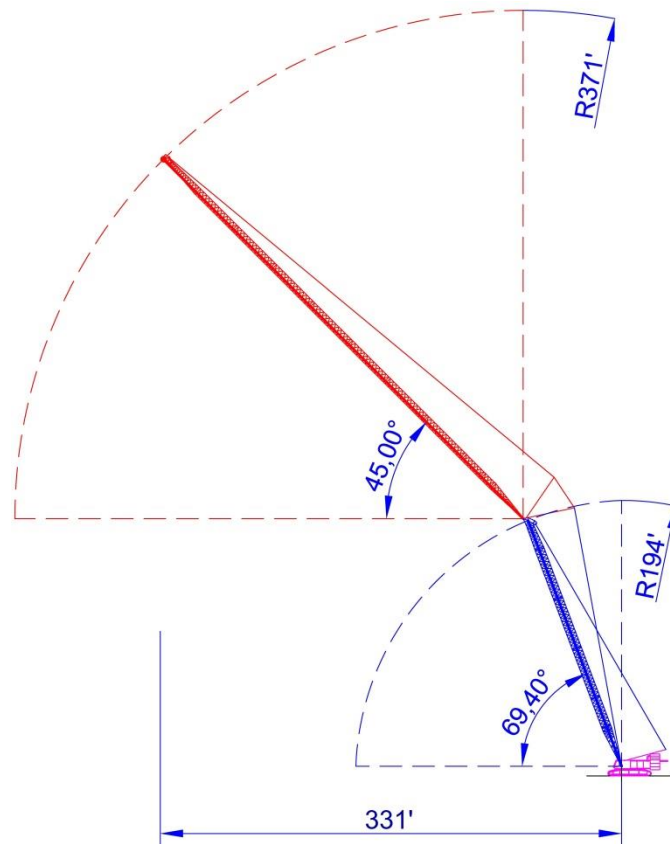
**Figure 18** Case III - Crane vertical profile.

The crane boom is considered at an angle of  $69.4^\circ$  with the luffing jib at  $45^\circ$ .

For condition w/o wind  
SF = 1.276

Wind speed, mph	20	22	25	26	30
SF =	1.061	1.024	0.969	0.950	0.877

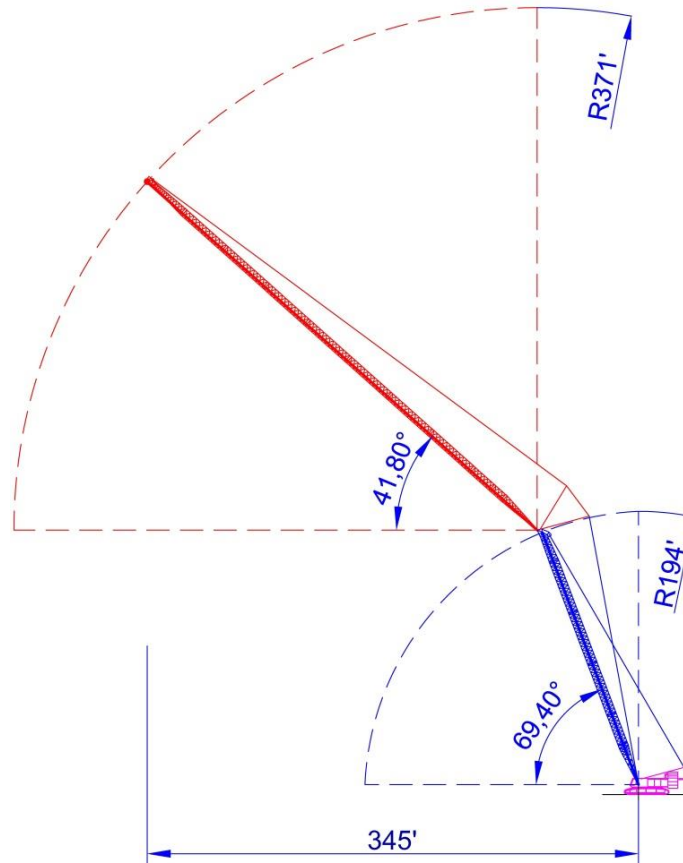
**Figure 19** Case IV - Crane vertical profile.

The crane boom is considered at an angle of  $69.4^\circ$  with the luffing jib at  $41.8^\circ$ .

For condition w/o wind  
SF = 1.237

Wind speed, mph	20	22	25	26	30
SF =	1.050	1.017	0.968	0.950	0.884

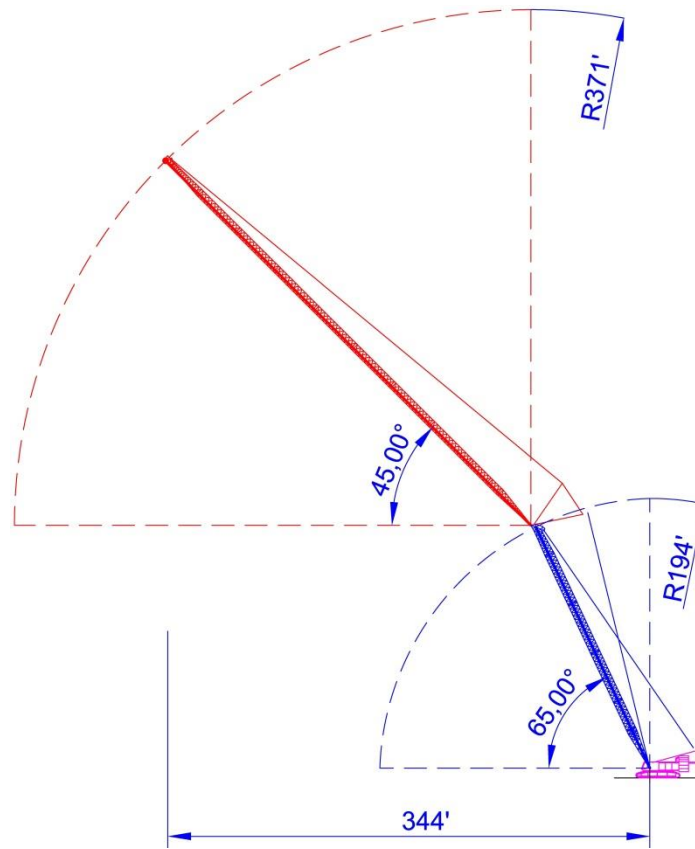
**Figure 20** Case V - Crane vertical profile.

The crane boom is considered at an angle of  $65^\circ$  with the luffing jib at  $45^\circ$ .

$$SF = 1.145$$

Wind speed, mph	20	22	25	26	30
SF =	0.974	0.943	0.898	0.882	0.821

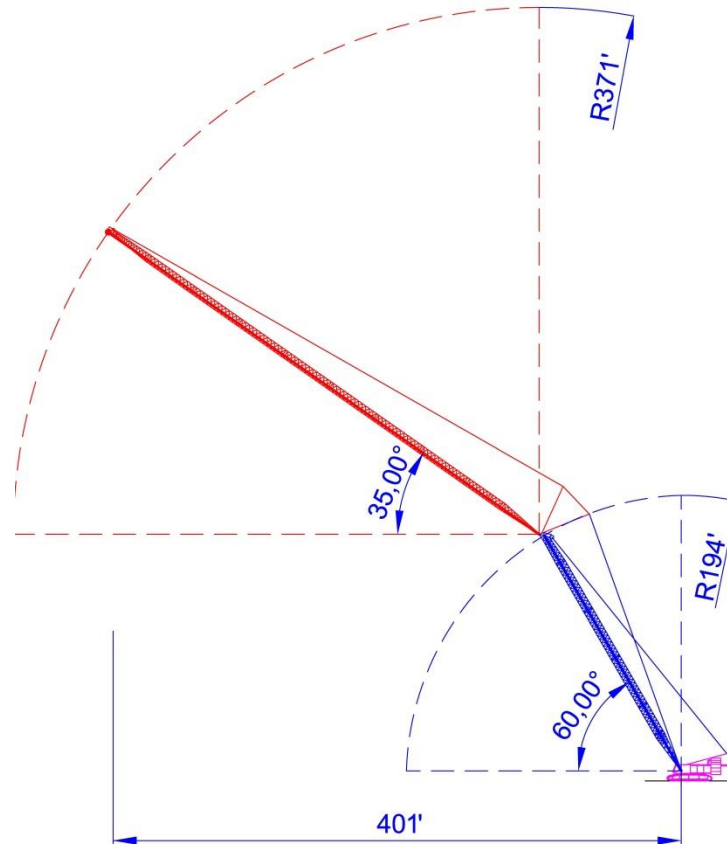
**Figure 21** Case VI - Crane vertical profile.

The crane boom is considered at an angle of  $60^\circ$  with the luffing jib at  $35^\circ$ .

$$SF = 0.958$$

Wind speed, mph	20	22	25	26	30
SF =	0.870	0.853	0.827	0.818	0.780

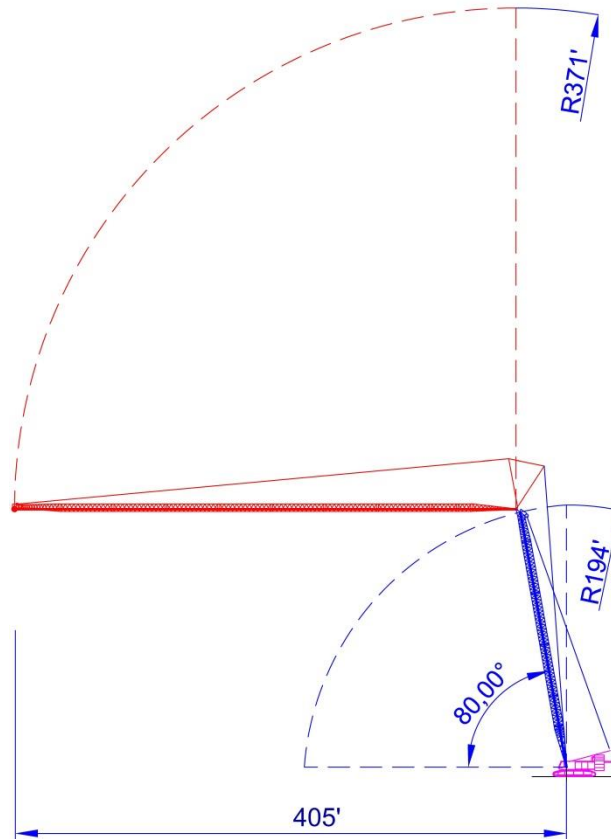
**Figure 22** Case VII - Crane vertical profile.

The crane boom is considered at an angle of  $80^\circ$  with the luffing jib at  $0^\circ$ .

$$SF = 1.317$$

Wind speed, mph	20	22	25	26	30
SF =	1.243	1.228	1.205	1.196	1.162

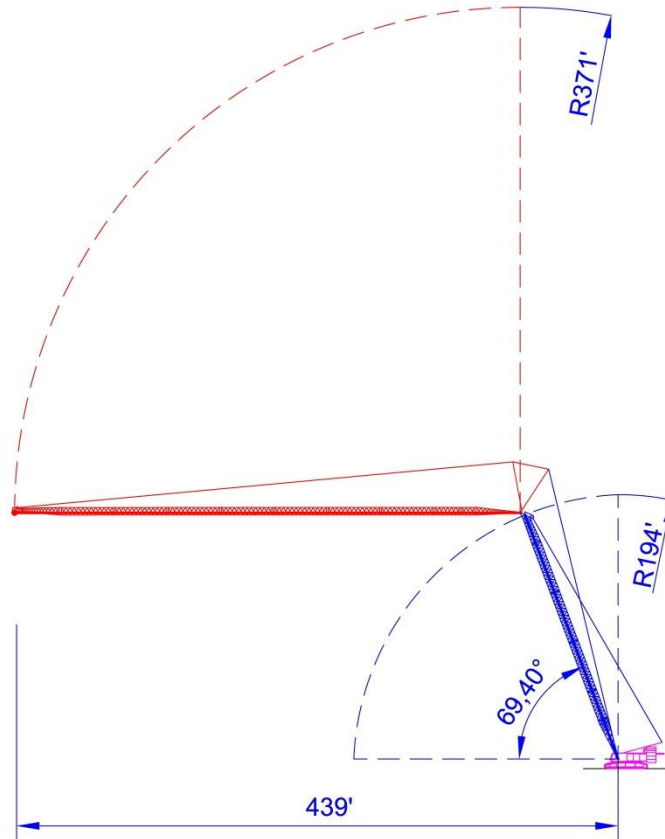
**Figure 23** Case VIII - Crane vertical profile.

The crane boom is considered at an angle of  $69.4^\circ$  with the luffing jib at  $0^\circ$ .

For condition w/o wind  
SF = 1.016

Wind speed, mph	20	22	25	26	30
SF =	0.974	0.966	0.953	0.948	0.927

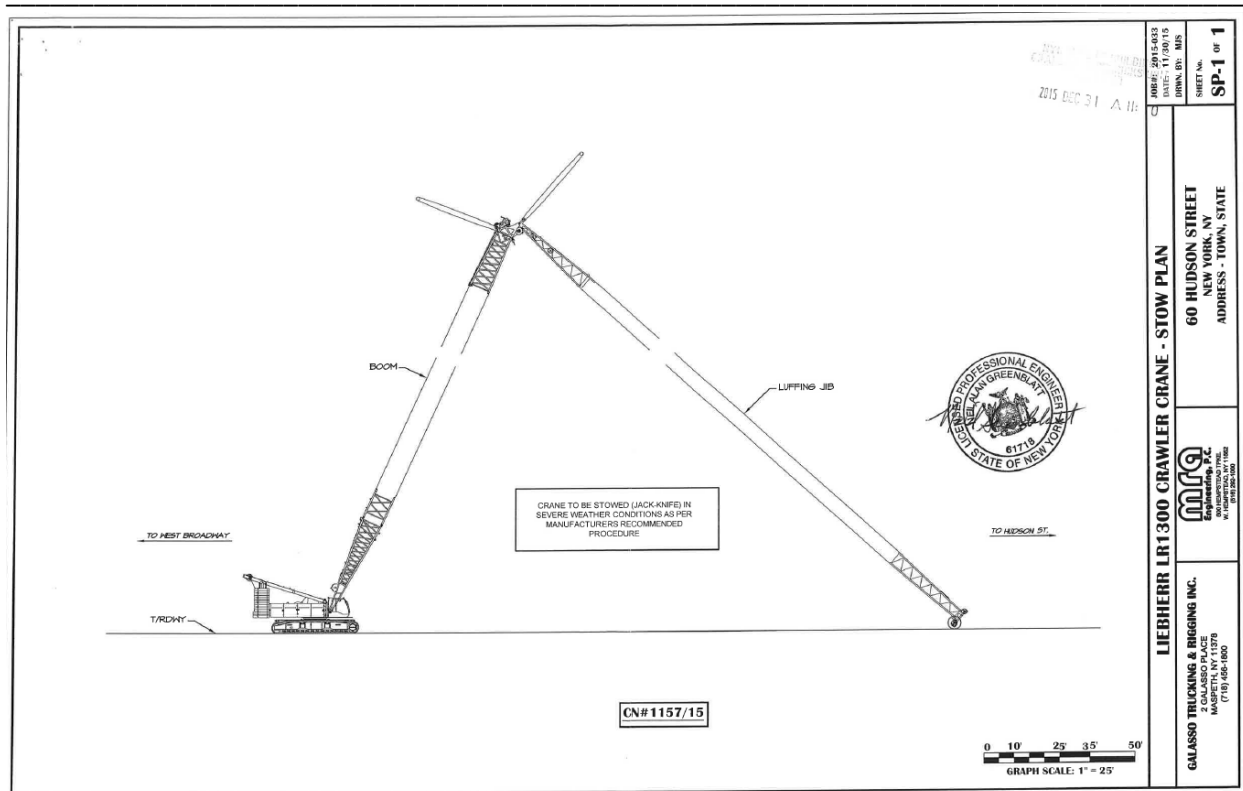
**Figure 28** Stow Plan from the consultant

*“Cranes to be stowed overnight or in severe weather conditions as per manufacturer’s recommended procedures found in the operator’s crane manual.”* MRA also provided a sketch showing the manner in which the crane needed to be stowed, although a few details like the angle of the boom and the jib are lacking. The sketch, however, provides an overall arrangement for stowing the crane overnight and during severe weather conditions. MRA’s above instruction contained a directive “as per manufacturer’s recommended procedures found in the operator’s crane manual”. However, Liebherr in its manual did not recommend that the crane be stowed or parked in the manner suggested by MRA, but rather they instructed the user of the crane, due to the long length of the jib, to lay down the crane instead of jack knifing it, in the event the wind speed is anticipated to be in excess of 20 mph. Bay Crane, which owned the crane, requested Liebherr, after the incident, to determine whether the subject crane could be jack knifed under severe weather conditions instead of laying it down on the ground. Liebherr stated in its email of February 5, 2016, the day of the incident, that Liebherr could make such a determination if asked by the “customer” with the specific configurations of the boom and the jib. In an email of February 5, 2016, after the incident, Liebherr stated that the subject crane could be parked in a jack knife position up to a maximum wind speed of 67 mph provided certain conditions were met. This determination by Liebherr overrides the instructions provided in the Liebherr manual and provides alternate options to the user and is in general agreement with MRA’s instructions to Galasso, although MRA’s instructions lacked information about the angle of the boom and the maximum wind speed.

At the end of the day on February 4, 2016, the weather forecast for the wind for the night and the next morning were reportedly known to Galasso Trucking & Rigging Inc. but no decision was taken to lay down the crane. That proved to be a grievous error.
