April 15, 2016 Double Tee Collapse at the Miami-Dade College West Campus Parking Garage, Doral, FL

U.S. Department of Labor
Occupational Safety and Health Administration
Directorate of Construction

August 2016

Report prepared by:
Mohammad Ayub, P.E., S.E.
Office of Engineering Services
Directorate of Construction

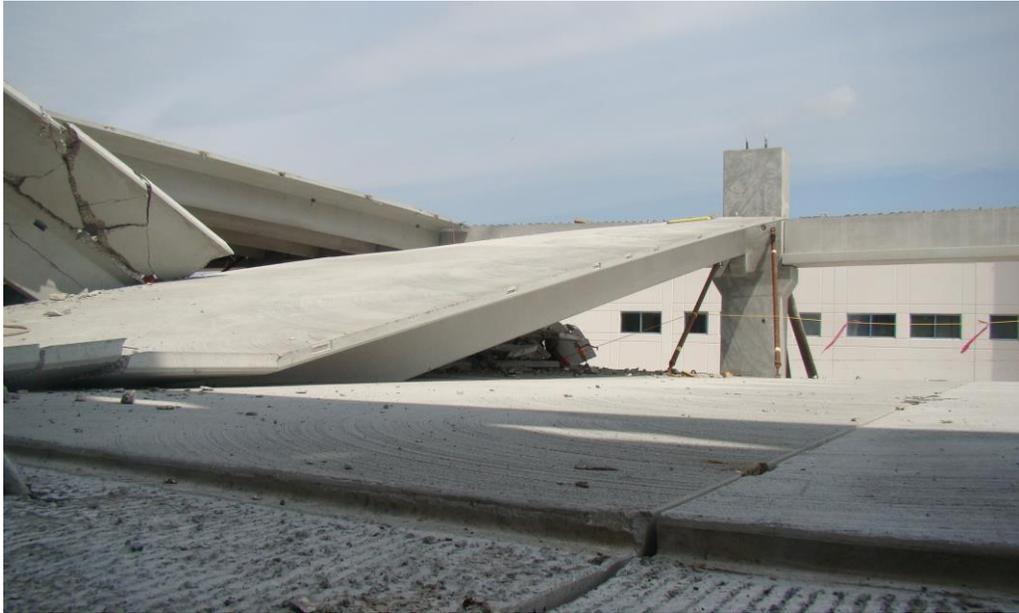
Figure 2. Collapsed Precast Double Tee Beams

1. The cause of the collapse of the double tees was the lack of adequate support during erection until permanent corrections were made.

5. If the double tees had been properly secured, it is unlikely that multiple double tee members would have collapsed while shimming adjustments were being made to an adjacent member.

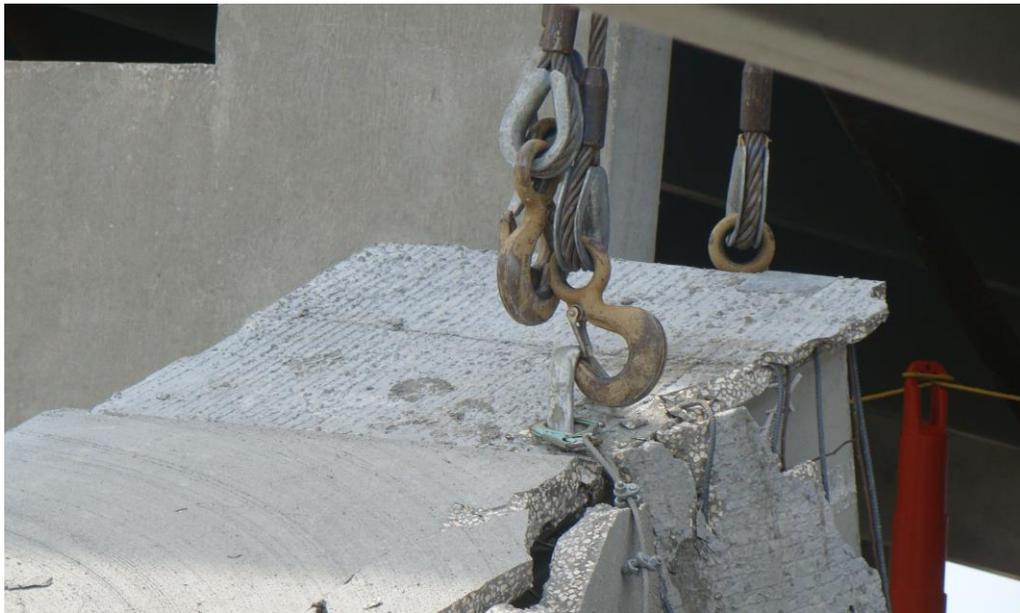
On April 15, 2016, Pre-Con completed the third level between bays N and Q by erecting the three remaining double tees, and then proceeded to work on the fourth level. First, inverted tee beams were placed between column lines 6 through 14 with all connections completely welded to the column inserts. Second, double tees were placed by supporting them on inverted tee beams on the north end and on wall panels on the south end. The direction of erection for the double tees was from west to east. Three double tees marked 387, 388, and 389 were placed between column lines 6 and 8. Then, four tees marked 390 through 393 were placed sequentially between column lines 8 and 10. When the double tee marked 393 was placed, it was observed that the southeast flange of the double tee marked 392 was slightly lower than the corresponding flange of the double tee marked 393. The need, therefore, arose to place a shim under the southeast stem of the tee marked 392 to align it with the flange of 393. The crane was already released from the double tee marked 393. The connector asked the crane operator to lower the hooks near the southeast corner of the tee marked 392 to make the necessary adjustments. The crane operator lowered all four hooks near the southeast corner. Then the connector placed one of the four hooks into the lifting insert. The connector instructed the crane operator to raise the stem no more than $\frac{1}{2}$ to $\frac{3}{4}$ inch, just enough to place a shim under the southeast stem of the double tee marked 392. The shim was installed and the double tee was lowered into place. The connector removed the hook from the insert and instructed the crane operator to “boom up, load up.” As stated earlier, there were four hooks hanging loose in the immediate vicinity of the insert. Suddenly, as the crane began to raise the hooks, one of

the hooks caught the insert, as shown in Figure 5, and the double tee began to rise along with the hooks. To the horror of the welder and the connector, who screamed on the radio to the crane operator to lower the hooks, the crane operator continued to raise the hooks, causing double tees 392 and 393 to collapse. The welder and the connector were injured in the collapse of the double tees.

Figure 5. Hoisting Hook Inadvertently Caught on Insert

The erector, Pre-Con Construction, failed to properly weld the double tee ends and flange connections before releasing the crane, deviated from a safer method of shimming the double tees by using floor jacks instead of the crane, and neglected to follow standard procedures to ensure that the hoisting hooks were clear of the lifting inserts embedded into the double tees before booming up on the crane.

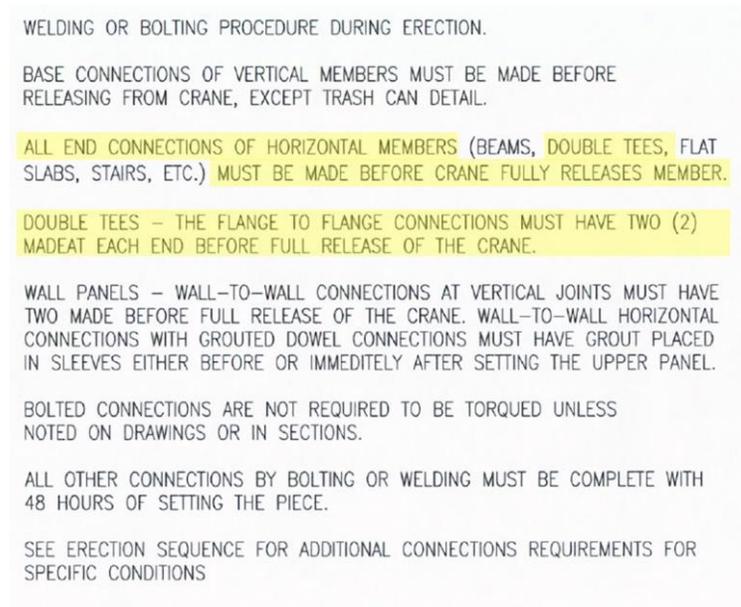
Another contribution to the April 15, 2016 incident was the fact that the contractor did not provide welds in accordance with the instructions in the general notes. If the double tee had been properly welded at each end as required by the construction documents, then the crane operator might have noticed the tension developing in the hoisting hooks and stopped the crane's operation before the beams collapsed. The erection instructions are listed on Sheet E0.12 of the BRD drawing package prepared for Metromont. The relevant section of the erection instructions is shown in Figure 6 and the instructions pertaining to the double tees are highlighted. The erection notes clearly required that **all** end connections and a minimum of two flange connections on each end be made before the release of the crane.

Figure 6. Erection Instructions, Sheet E0.12, Welding Procedure During Erection

The erector, Pre-Con, neither followed the welding procedure provided in the erection instructions nor the diagram shown in Detail A on Sheet E0.12. Field observations following the incident indicated that none of the double tees placed on the day of the incident on the fourth floor complied with the erection instructions on Sheet E0.12. Additionally, only two of the seven double tees placed on the day of the incident on the fourth floor agreed with the required end connections shown in Detail A. Furthermore, four of the double tees had either only 1 or none of the 4 required welded end connections, including the two members involved in the incident. Compliance with either the written erection instructions or Detail A could have reduced the likelihood of the incident.

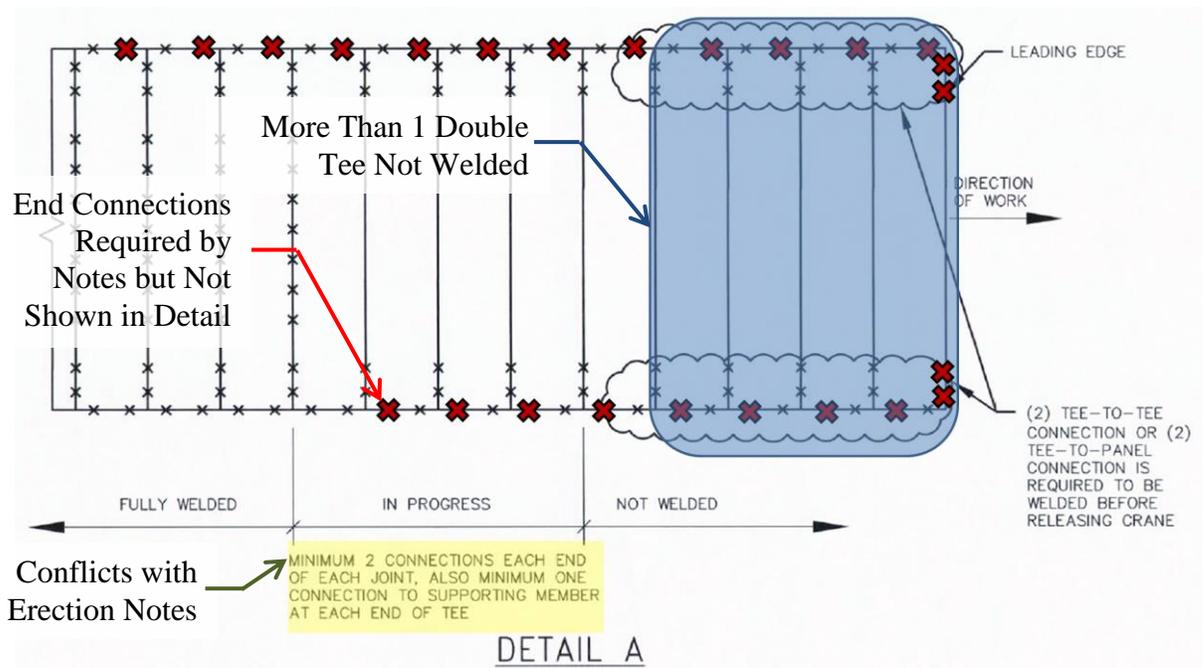
However, Detail A on the same sheet conflicts with the erection instructions. Detail A is shown in Figure 7 and conflicts with the erection instructions in the following ways:

1. End connections are missing in the “Fully Welded” zone. According to the erection notes all end connections must be made before the member is released from the crane.

2. End connections are missing in the “In Progress” zone. Again, according to the erection notes all end connections must be made before the member is released from the crane.

3. More than one double tee is shown in the “Not Welded” zone. The erection notes stipulate that the end and two flange connections at each end must be made before the crane releases the member. Therefore, only 1 double tee can be in the “Not Welded” zone at a time. Once the required welded connections are made to release the crane, the double tee is then classified within the “In Progress” zone.

4. The highlighted text in Detail A contradicts the welding instructions described in the general notes. The highlighted text requires a minimum of one connection to a supporting member at each end of the tee while the erection procedure instructions require two connections. Furthermore, the highlighted text reference to joint connections is vague and unclear.

Figure 7. Sheet E0.12, Detail A Differences with Erection Instructions

4. The structural engineer, Blue Ridge Design, produced a conflicting and confusing welding procedure for the erection of the double tees. The number of end connections that had to be in place before the crane released the member was unclear. In the erection notes, two end connections were required. However, a diagram showed that only one end connection was required. Furthermore, the diagram showed that multiple double tee members could be installed without proper end and flange weld connections in the “Not Welded” zone.
