Investigation of the September 27, 2017, Gin Pole Collapse at an Antenna Tower in Miami Gardens, Florida.

U.S. Department of Labor
Occupational Safety and Health Administration
Directorate of Construction

February 2018

Report Prepared by
Mohammad Ayub, P.E., S.E.
Bryan D. Ewing, Ph.D., P.E.
Office of Engineering Services
Directorate of Construction

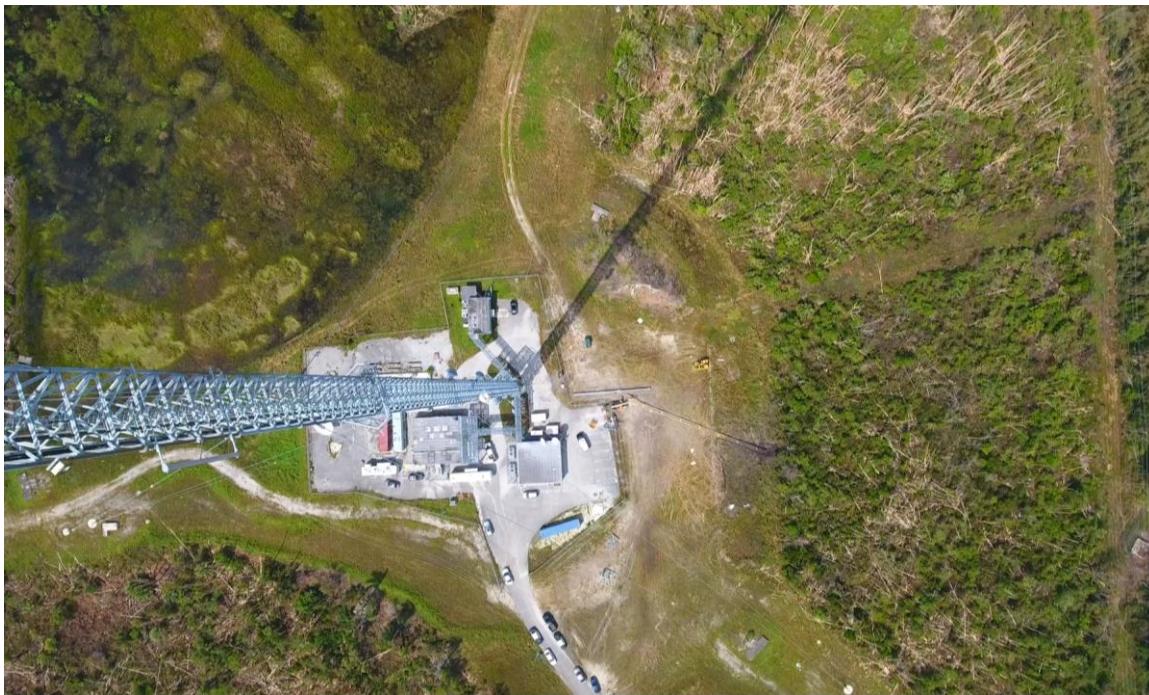
Figure 7 –Debris Field (Bird's Eye View)

The incident occurred in the late afternoon on September 27, 2017. As the Tower King crew was relocating the dummy pole pedestal, the components of the bridle connection suddenly failed. The reasons for this failure are discussed in the next section of the report (Structural Analysis and Discussion – page 17). The 160-foot-long gin pole began to freely rotate away from the tower about the base of the arbor. Next the basket slings frayed and ruptured from its contact with the base of the arbor. Finally, the gin pole fell freely approximately 1,000 feet and impacted the ground. The force from the impact buried the rooster head nearly 10 feet into the ground. Additionally, the impact of the gin pole with the

ground resulted in axial deformations consistent with large compressive forces. Finally, the weight of the remaining length of the gin pole above the ground combined with the weakened state of the gin pole from its impact with the ground caused the gin pole to snap into two separate pieces. One section of the gin pole was buried in a crater approximately 10 feet deep and the second section fell backwards onto the ground. Images of the debris field are shown in Figure 7 and Figure 8. The remaining pieces of the gin pole track and its attachment to the arbor are shown in Figure 9. Three Tower King employees' fall arrest protection systems were tied off to the gin pole at the time of the collapse. According to CSI photographs provided by Miami Gardens Police Department, the employees were tied off near the base of the cantilevered section of the gin pole.

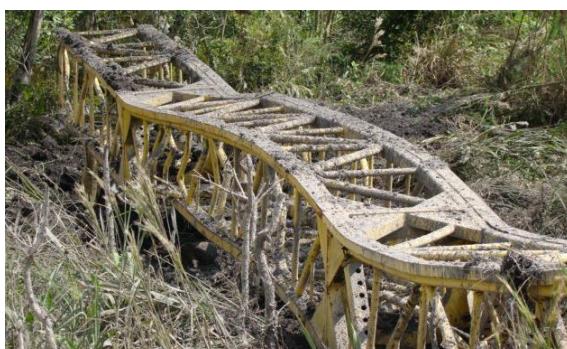
Figure 14 – Gin Pole Section Break

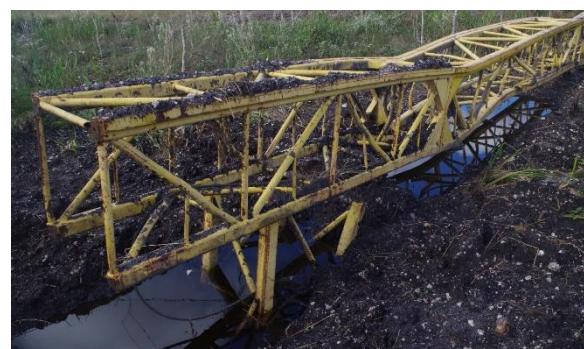
Figure 15 – Rooster Head Section Buried

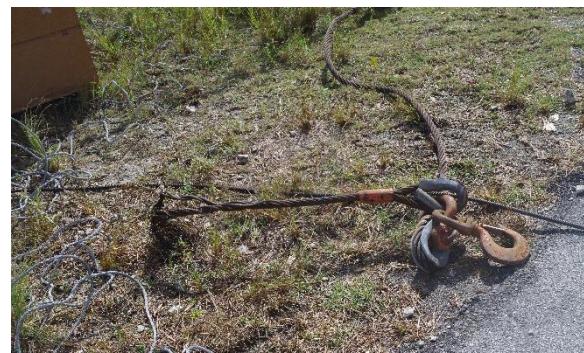
hundreds of feet of wire rope (jump, tag and load lines – see Figure 22) and their associated blocks and assemblies. The fractured basket sling is shown in Figure 23. To the extent possible, these items were stored in a secure, fenced-in area for specimen preservation and for further testing and examination as needed.

Figure 23 – Fracture in Basket Sling

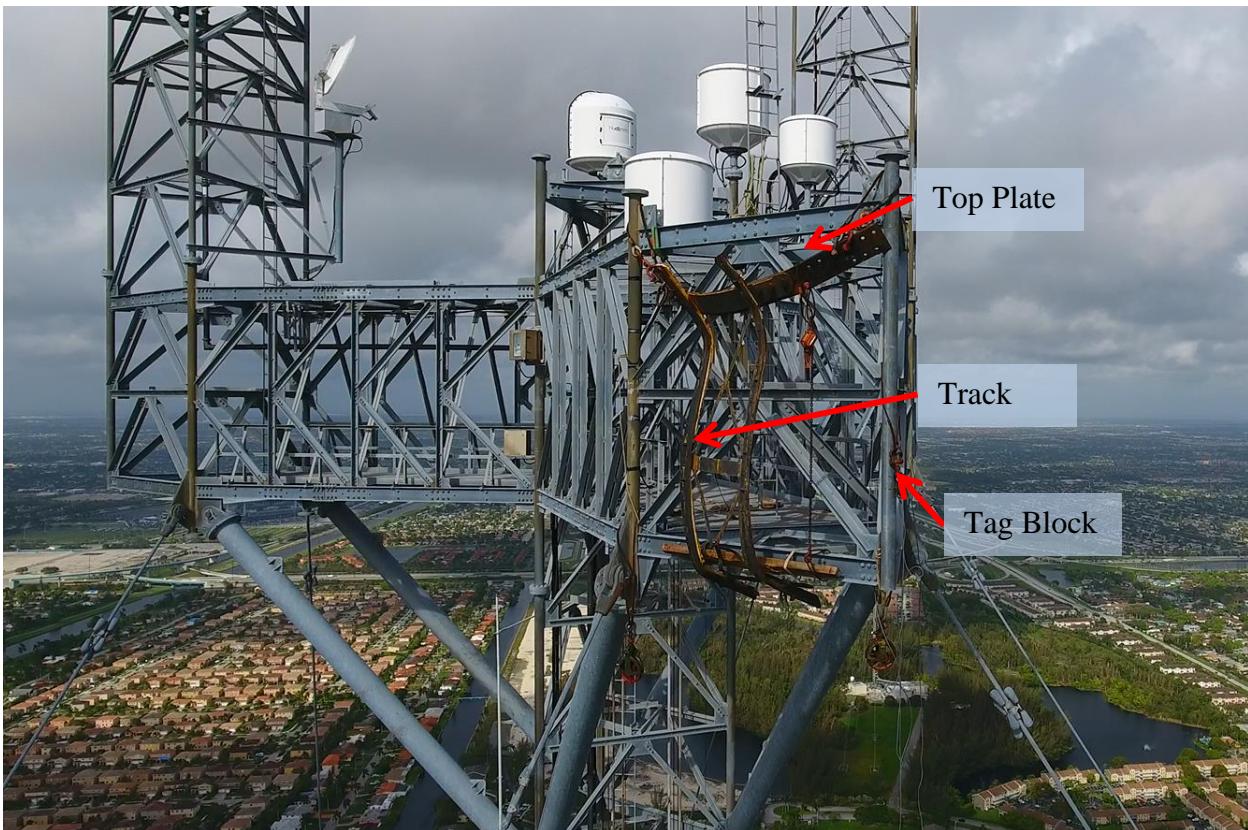
Some parts of the gin pole assembly remained fastened to the arbor of the tower. These items included the track and its attachment slings, jump blocks, bridle connection components (come-alongs, slings etc.) and tag block. These items are shown in Figure 24.

Figure 24 – Damaged Track Components

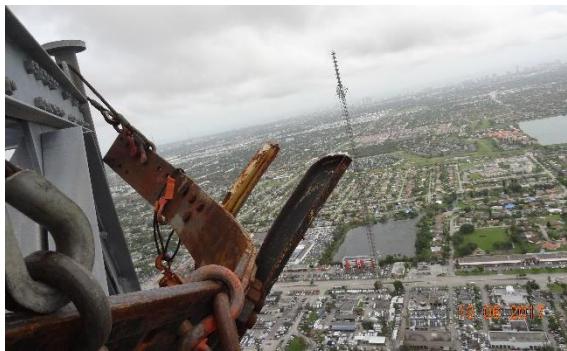
Figure 25 – Bent Top Track Plate (provided by Stainless)

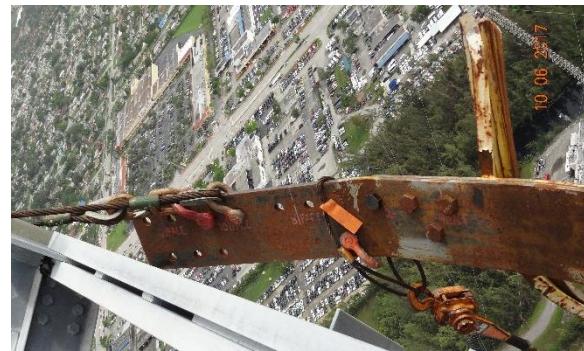
Figure 26 – Close-up of Plastic Hinge in Top Track Plate (provided by Stainless)

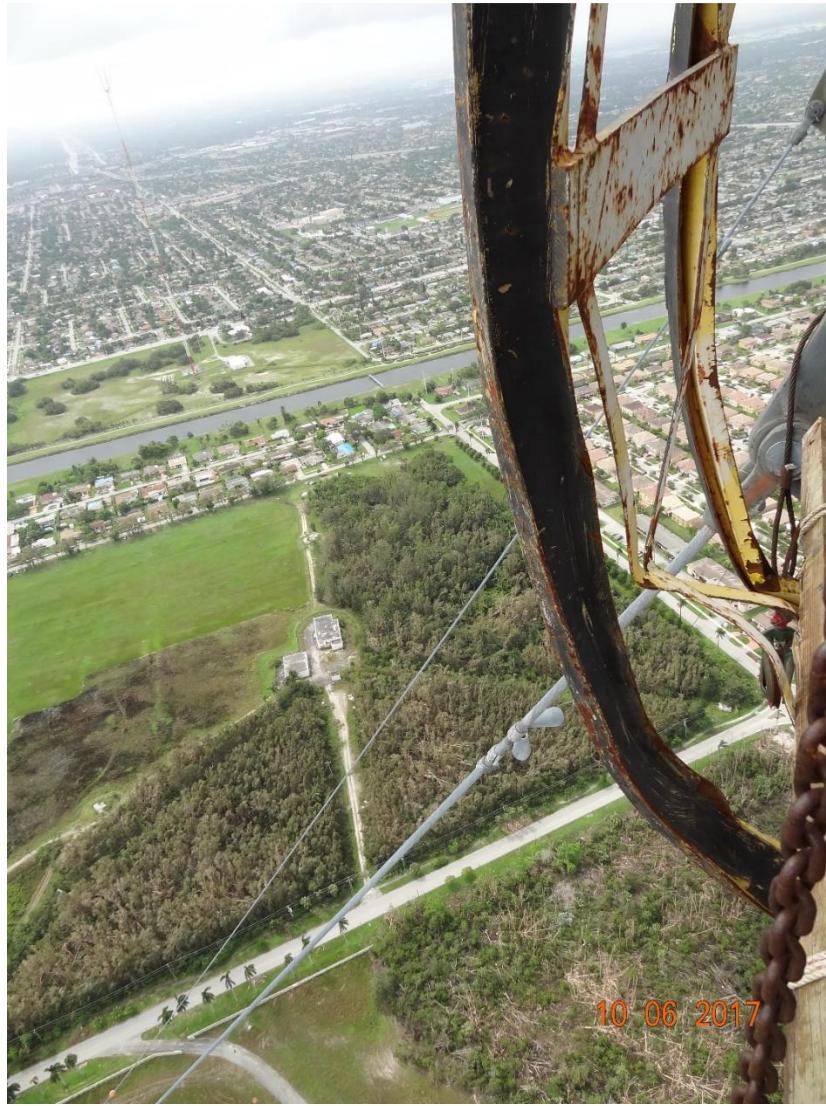
Figure 27 – Buckled Gin Pole Track (provided by Stainless)

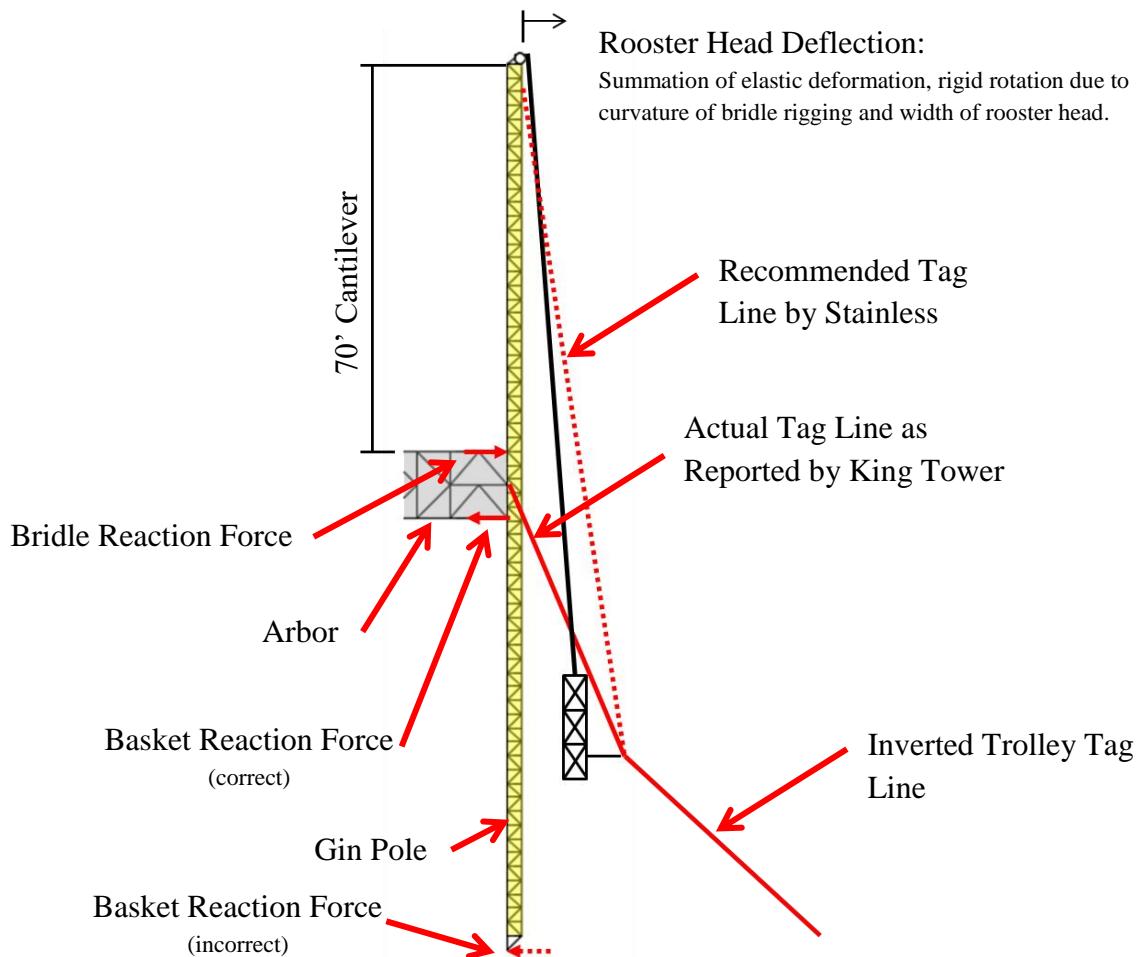
Figure 28 –Tag Line Rigging and Reaction Forces

A few days before the completion of this report, Tower King stated during the interview with OSHA personnel that the tag line was attached directly to the arbor, and not to the gin pole. Stainless had asked that the tag line be attached to the gin pole three feet below the rooster head. Stainless was not aware of this change. This deviation, which should have been done with the consent of Stainless, reduced the tensile forces at the bridle connection of the gin pole to the arbor to Tower King's advantage. The deviation in the configuration of the tag line is shown in Figure 28. The solid red line is the layout of the tag line on the day of the incident and the dashed red line is the layout used by Stainless to calculate the reaction forces. The force was reduced to approximately 13,000 pounds from 15,000 pounds. Nevertheless, the rigging was inadequate even for the reduced forces, and did not meet the required factor of safety of 5.0

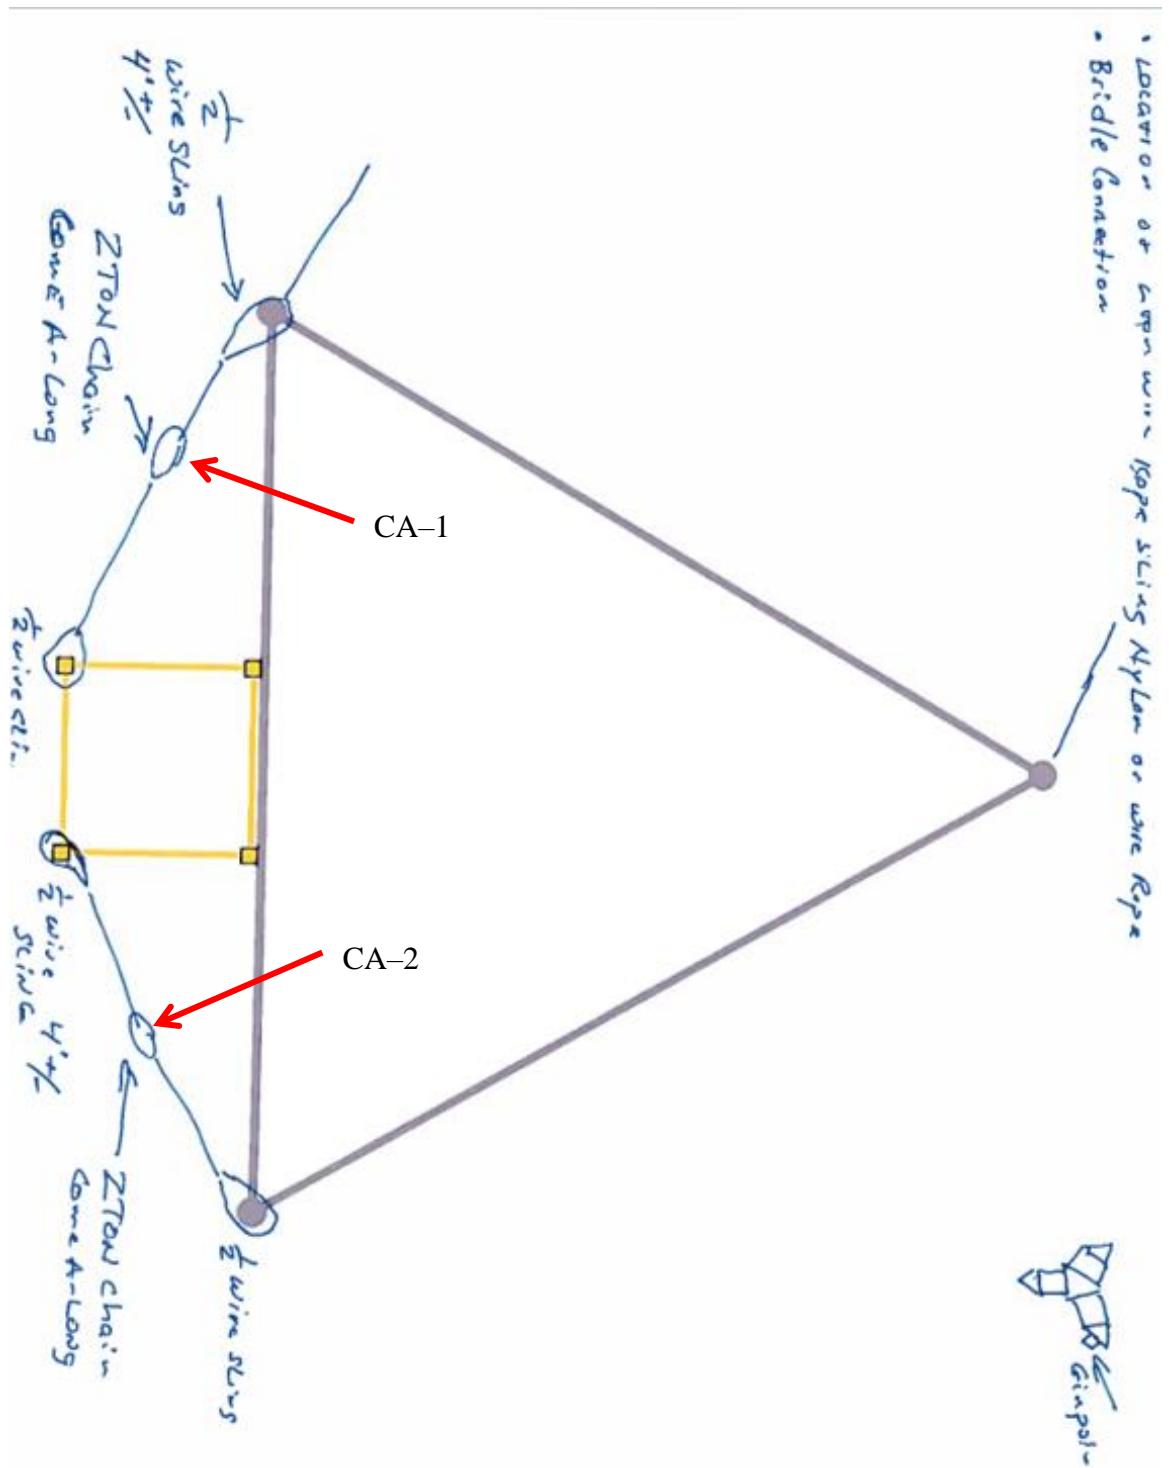
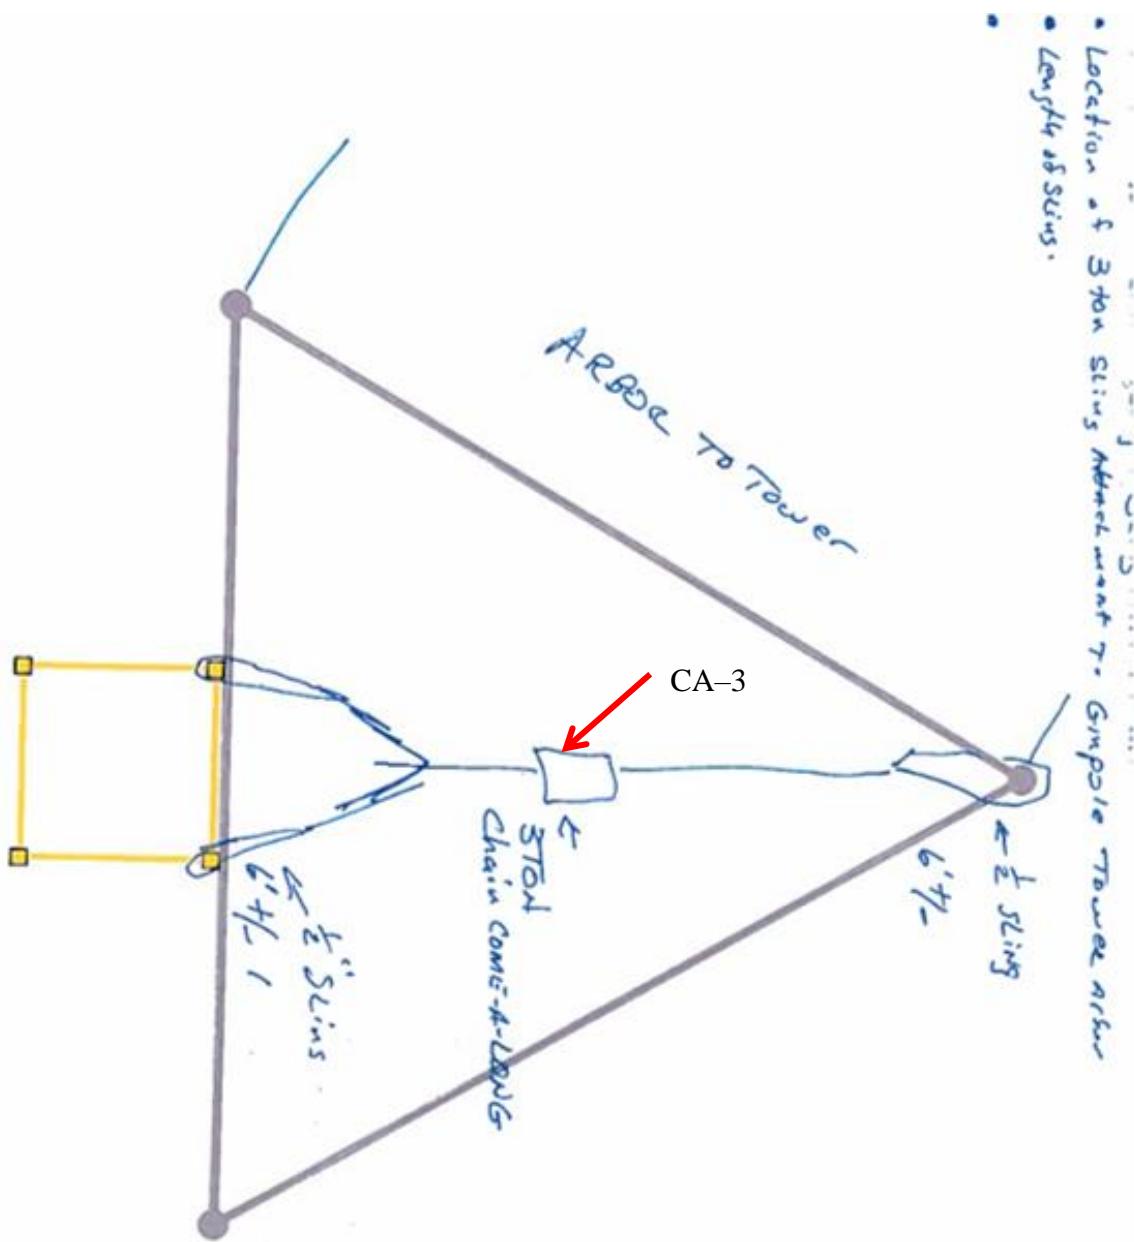
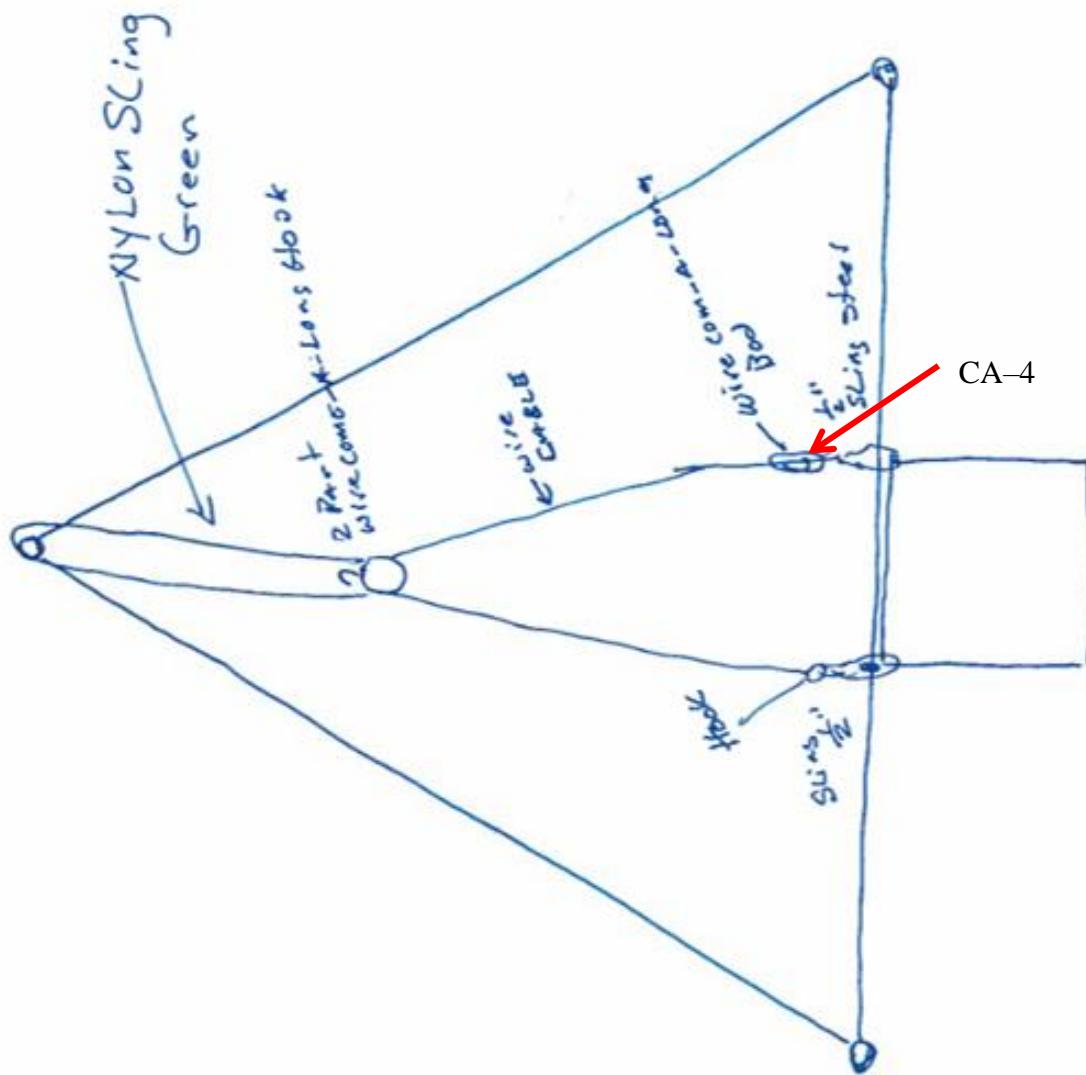
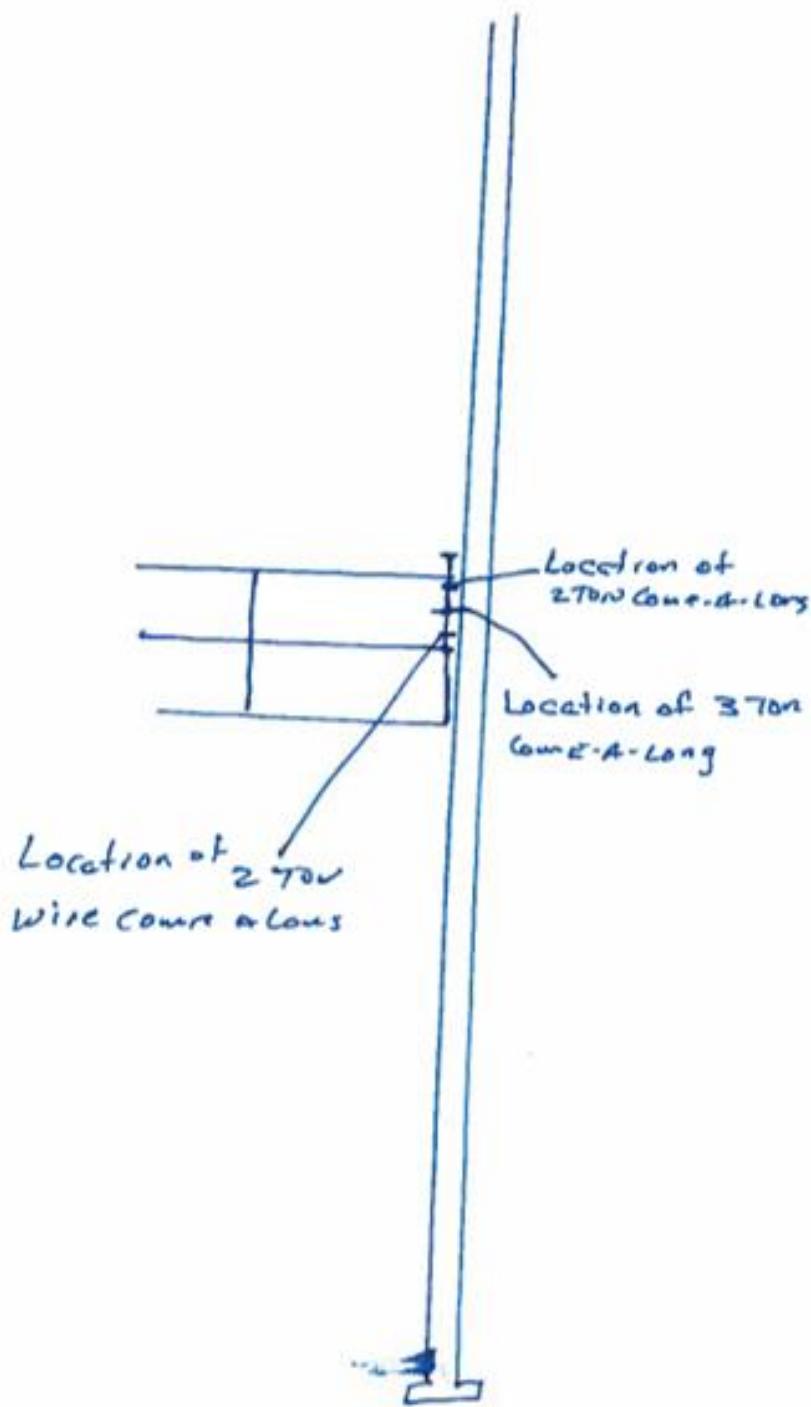
Bridle connections are identified for this report as CA-1, CA-2, CA-3 and CA-4. Sketches of the bridle connection, as drawn by Tower King, are provided in Appendix A. CA-1 and CA-2 consisted of chain links with $\frac{1}{2}$ " wire rope slings at each end with a 2-ton come-along. The wire rope slings engaged the vertical legs of the arbor and the gin pole. According to Tower King, the attachments were made at the top most horizontal plane of the arbor. $2\frac{1}{2}$ ft. below was the next attachment identified as CA-3 that consisted of chain link with a 3-ton come-along and $\frac{1}{2}$ " wire rope slings at each end. $2\frac{1}{2}$ ft. below the CA-3 rigging, was another attachment identified as CA-4 that consisted of wire rope with wire rope slings and a 2-ton come-along. The following is a table showing the sizes and the manner of failure:

Slings	Tension Member	Come-along	Length	Failure
CA-1	Wire rope	7.2 mm chain	2-ton	5'-6"	Chain
CA-2	Wire rope	7.2 mm chain	2-ton	5'-6"	Sling
CA-3	Wire rope	8.4 mm chain	3-ton	10'-6"	Chain
CA-4	Wire rope	Wire rope [2-part]	2-ton	10'-6"	Wire rope

CA-1 and CA-2 will be the first to take up the tension as per the sketch drawn by Tower King. A tensile force of 15,000 pounds would translate into a force of 16,100 pounds in each of the chain links because of the angle each chain link makes with the direction of the tensile force. This force is close to the failure load of the chain link. With the failure of CA-1 and CA-2, CA-3 located $2\frac{1}{2}$ ft. below will be called upon to take up the load. Unfortunately, the magnitude of tension will be increased as the lever arm will be shortened to $9\frac{1}{2}$ ft. from 12 ft., increasing the tension to an approximate ratio of 12/9. It is estimated that the tension will be approximately 20,000 pounds. However, this force would be further magnified due to removal of slack inherent in the 10-ft. long rigging at CA-3. The additional movement of the rooster head due to magnified deflection at the top of the gin pole because of slack removal would further increase the tension. The P-delta phenomena would occur with increasing deflection with increasing tension. CA-3 is expected to fail with increasing tension. Next is the rigging of CA-4 $2\frac{1}{2}$ ft. below CA-3. The tension would be increased due to a much shorter lever arm by an approximate ratio of 12/7. Therefore, the tension would be approximately 30,000 pounds without considering the deflection of the gin pole. If the deflection of the gin pole is considered, the tension would be further magnified, and failure would be imminent.
