# Investigation of the April 19, 2018, Communication Tower Collapse in Fordland, Missouri.

U.S. Department of Labor Occupational Safety and Health Administration Directorate of Construction

October 2018

Report Prepared by Bryan D. Ewing, Ph.D., P.E. Mohammad Ayub, P.E., S.E. Office of Engineering Services Directorate of Construction

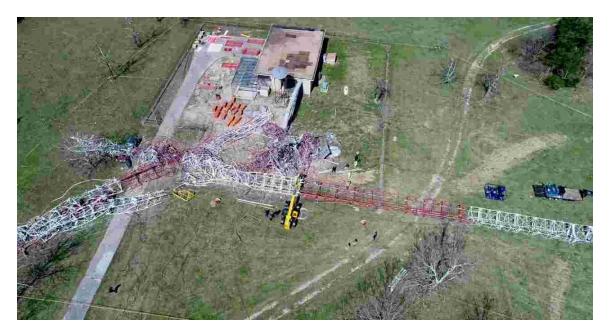
Figure 5. Collapsed Communication Tower (Google Image Search)

As shown in Figure 5, it appears that as the tower began to collapse onto itself, the tower initially fell in the southern direction. Then the tower tilted and fell over itself back in a northern direction. As the top tiers of the tower fell, they remained essentially intact. As shown in Figure

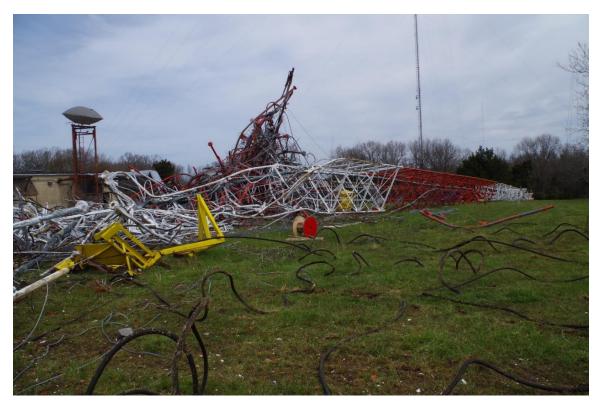
Figure 6 Top Section of Collapsed Communication Tower

6, all the guy wires disengaged from their anchor points and whipped about slashing through tree limbs and fencing. The man-basket, original and new diagonals and tools, including two comea-longs were buried under the wreckage. The tower section from 90' to 120' was recovered and stored on-site for further observation. This tower section is shown in Figures 7 to 10. The slings and diagonals were found at the 105' tower elevation as shown in Figure 11. Several wires of the sling used for the come-a-long attachment to the tower panel point was severed and others were bird-nesting. A total of six bolted connections were missing. Two bolts were missing at the connection point between the two diagonals and the redundant horizontal bar. Two more bolts were missing from each gusset plate at the connection between the tower legs at the 100' elevation of the diagonals (see Figure 11). This was consistent with witness statements that the crew was working on the final third bay of diagonals at the 105' elevation at the time of the incident. The redundant bar and the tower leg appeared to have buckled.

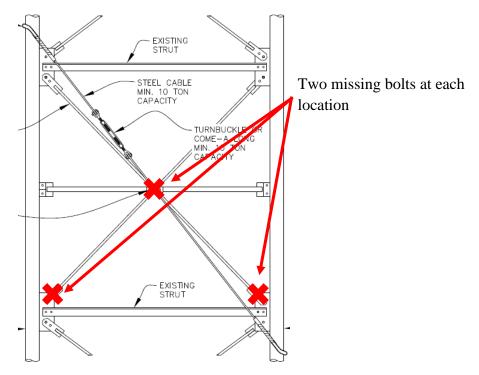
Figure 11. Missing bolts at the 105' Tower Elevation

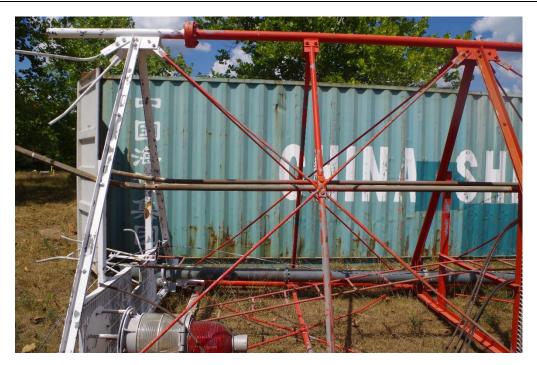
A representative section of the 105' tower elevation is shown in Figure 12. Figure 12 is a photograph of one of the tower bays of the top section of the tower that remained essentially intact after the collapse. The tower legs are braced by the diagonal rod members and the horizontal (appears vertical in the photograph as the tower is on its side) redundant. The typical tower bay is 10' wide by 10' tall. Therefore, this configuration of the bracing members creates unbraced lengths of five feet for the tower legs and redundant. The diagonals and the redundant were connected with two bolts at their mid-span as shown in Figure 13.

Figure 12. Representative Section from the Top of the Tower

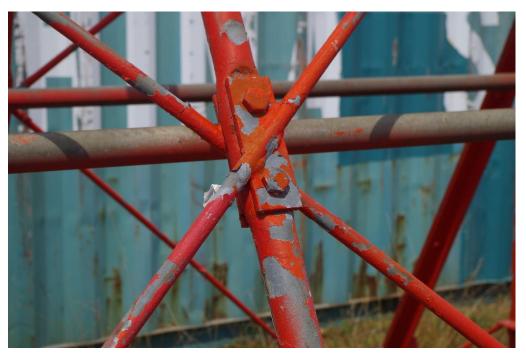
Figure 13. Bolted Connection between Diagonals and Redundant Horizontal

TCI's erection drawings states that the diagonals must be replaced one at a time. However, in order to replace a diagonal, the two bolts on each end of the diagonal and the two bolts at the diagonal's mid-span must be removed. The removal of the bolts at the mid-span, however, results in doubling the unbraced length of the tower legs and redundant from five to ten feet.

This doubling of the unbraced length creates three problems for the redundant member. First, the redundant member exceeds the allowable slenderness ratio for main compression members other than leg members and for secondary members (200 and 250 respectively) as outlined in ANSI/TIA-222-G. The resultant slenderness ratio of the redundant member without the bolted connection at its mid-span is 274. Second, the unfactored compressive resistance is reduced from 32 kips to 8 kips. This 75% reduction of compressive strength created the third problem for the redundant member. The redundant no longer satisfied the ANSI/TIA-222-G requirement for minimum bracing resistance for the tower legs. ANSI/TIA-222-G requires that the strength of the brace is at least 1.5% of the axial design compressive force of the supported member. Therefore, the unbraced length of the tower legs has doubled to ten feet.

The ANSI/TIA-222-G design strength of the tower legs was reduced by 68% due to the doubling of the unbraced length. The tower legs require a minimum bracing resistance of approximately 13 kips. However, the horizontal redundant member is only capable of providing 8 kips. The resultant unfactored design strength of the tower legs reduces from 865 kips to 279 kips. The total dead load from the guy wires and the weight of the tower above the 105-foot elevation is 316 kips. Furthermore, any incidental wind load would increase the compressive load on some of the tower legs. The overstressing of the tower legs could have been a reason for why some of the diagonals did not fit and required re-boring of the bolt holes.

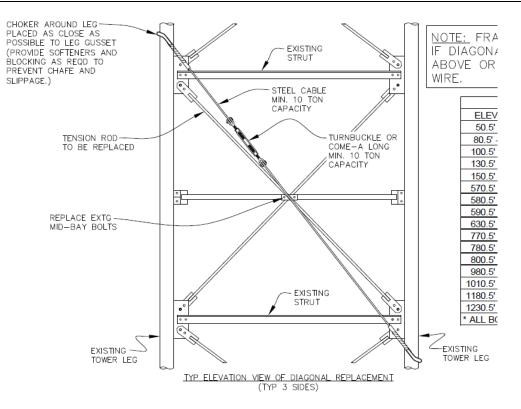
The diagonal replacement procedure is described on sheet E-5 of TCI's erection drawings document and is partially shown in Figure 14. The diagonal replacement procedure requires the use of a come-a-long to eliminate the tensile forces in the diagonal to facilitate the removal of the diagonal. TCI requires the use of a come-a-long with a ten-ton capacity. However, Lemay used a come-a-long device (Griphoist/Tirfor® T-532D) with a rated working load of 8,000 pounds (4 tons). An identical model come-a-long used on-site is shown in Figure 15. The come-a-long used on the tower is shown in Figure 16 while in the debris field and which was recovered later is shown in Figure 17.

Figure 14. TCI Diagonal Replacement (E-5)

- 1) TCI's suggested diagonal replacement procedure was flawed in that it compromised the effectiveness of the integrated surrounding braces and the load bearing capacity of the tower legs. A single diagonal brace could not be removed without affecting the integrity of the redundant brace because the braces share two common bolts at the diagonal/redundant connection.

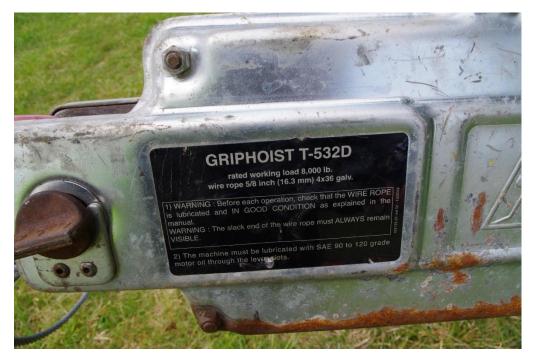
Figure 15. Lemay Come-a-long Used On-site

- 3) Lemay used an undersized come-a-long while removing the diagonal braces.
- 4) Lemay failed to provide the design of the required temporary frame for diagonal replacement above or below a guy level. TCI failed to confirm the use/design of a temporary frame as TCI is required to approve the adequacy of the temporary frame prior to diagonal replacement according to TCI's construction documentation.

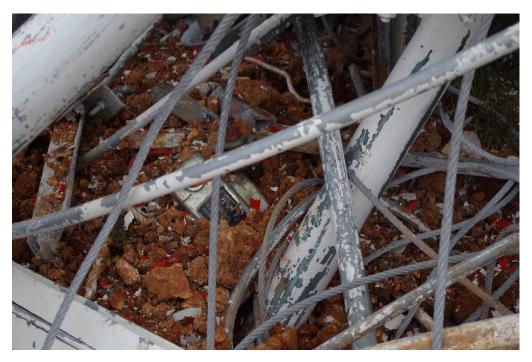
Figure 16. T-532D Come-a-long in Debris

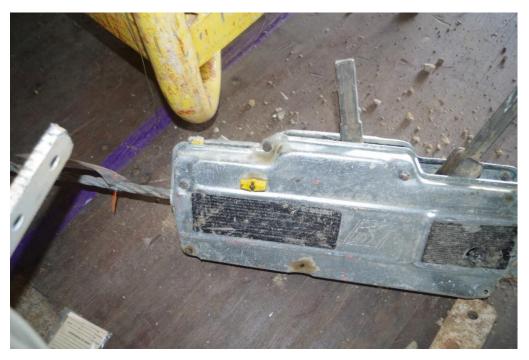
Figure 17. T-532D Come-a-long Salvage from Debris
