# Investigation of November 19, 1990 Excavation Collapse at 14th and H Streets, N.W. Washington, D.C.

U.S. Department of Labor  
Occupational Safety and Health Administration

May 1991

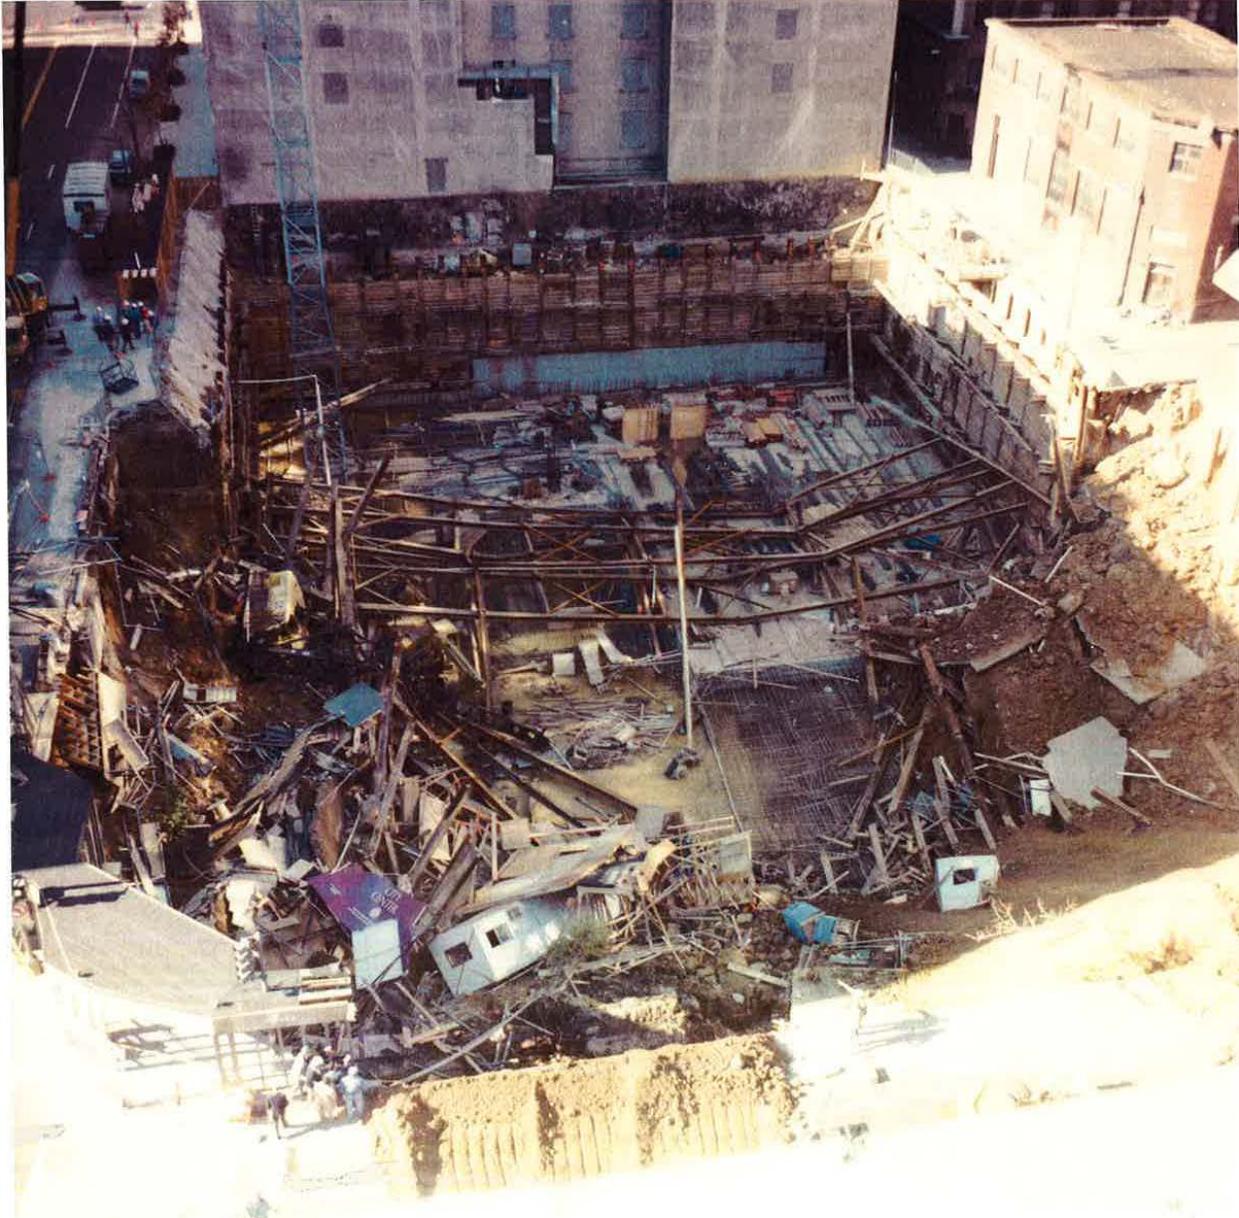
Figure 1.1. Overall View of the Collapsed Site (Looking Toward West)

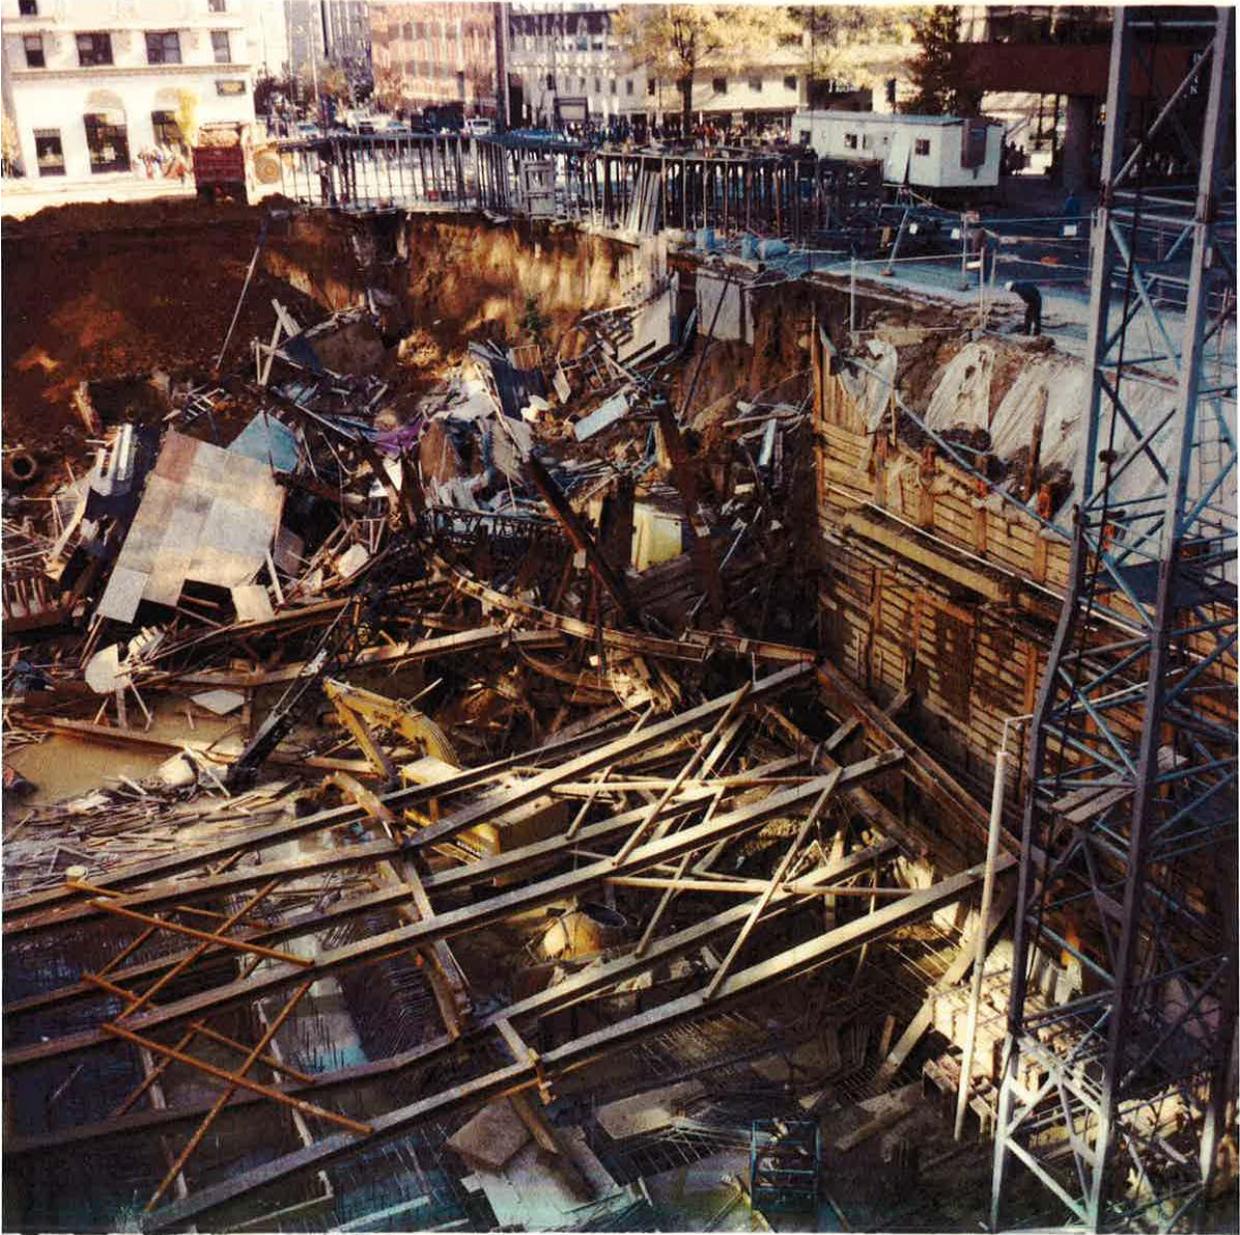
Figure 1.2. Overall View of the Collapsed Site (Looking Toward East)

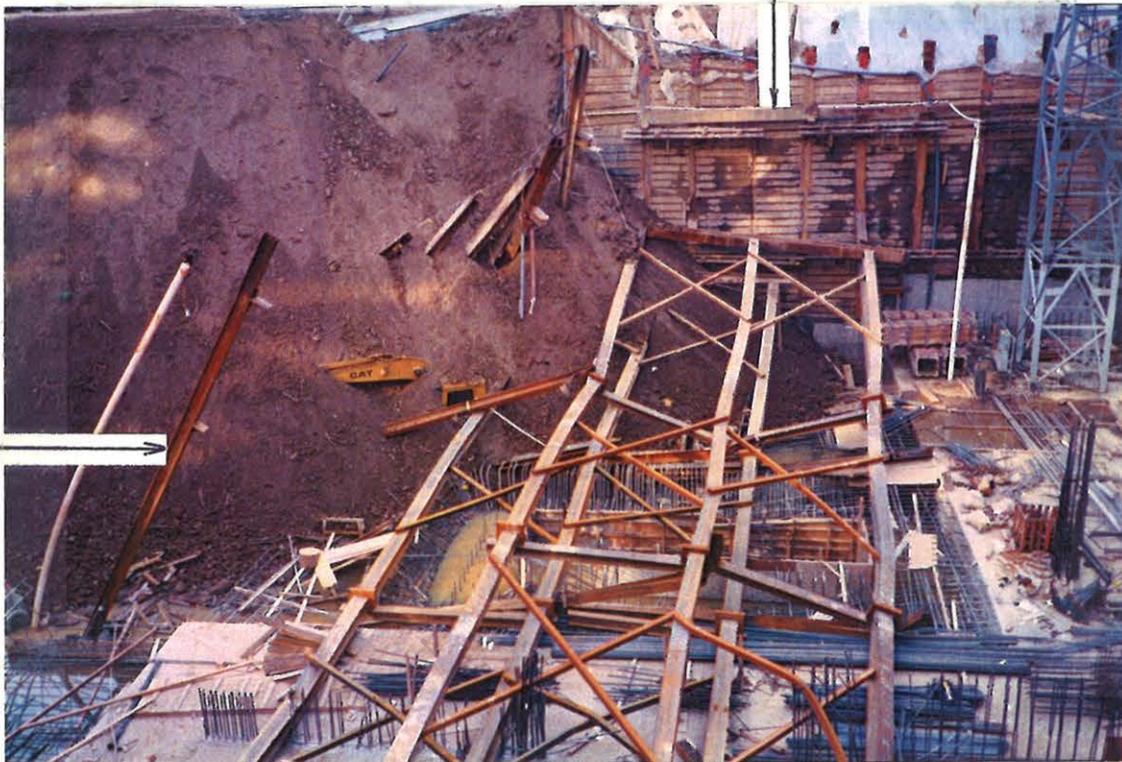
Top tier south wale, between soldier beams 64 to 71, was still attached.

Pinpile 6 separated from the main frame.

Figure 3.4 Sliding and Falling of South Wall Wale (Looking Toward South).

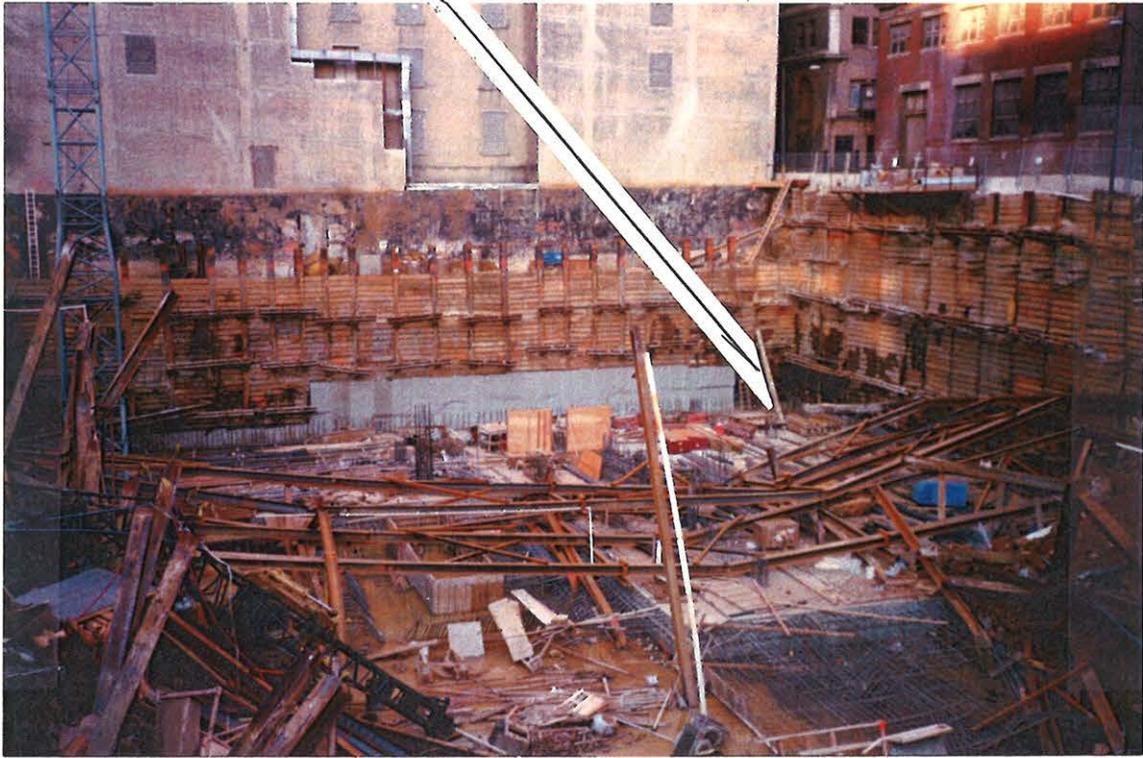
The three lines of struts in both top and middle tiers, although bent and twisted, appeared to travel with the wales due to their unbroken connections. A similar falling pattern was also observed for the pin pile frame, since most of the pin pile connections were still attached to the struts. Pin pile No. 6 was an exception, its welding connections had been broken from the main frame. The above observations were indicated in Figures 3.4 through 3.6.

Figure 3.5 Three lines of Struts Traveled with Wales (Looking Toward West).

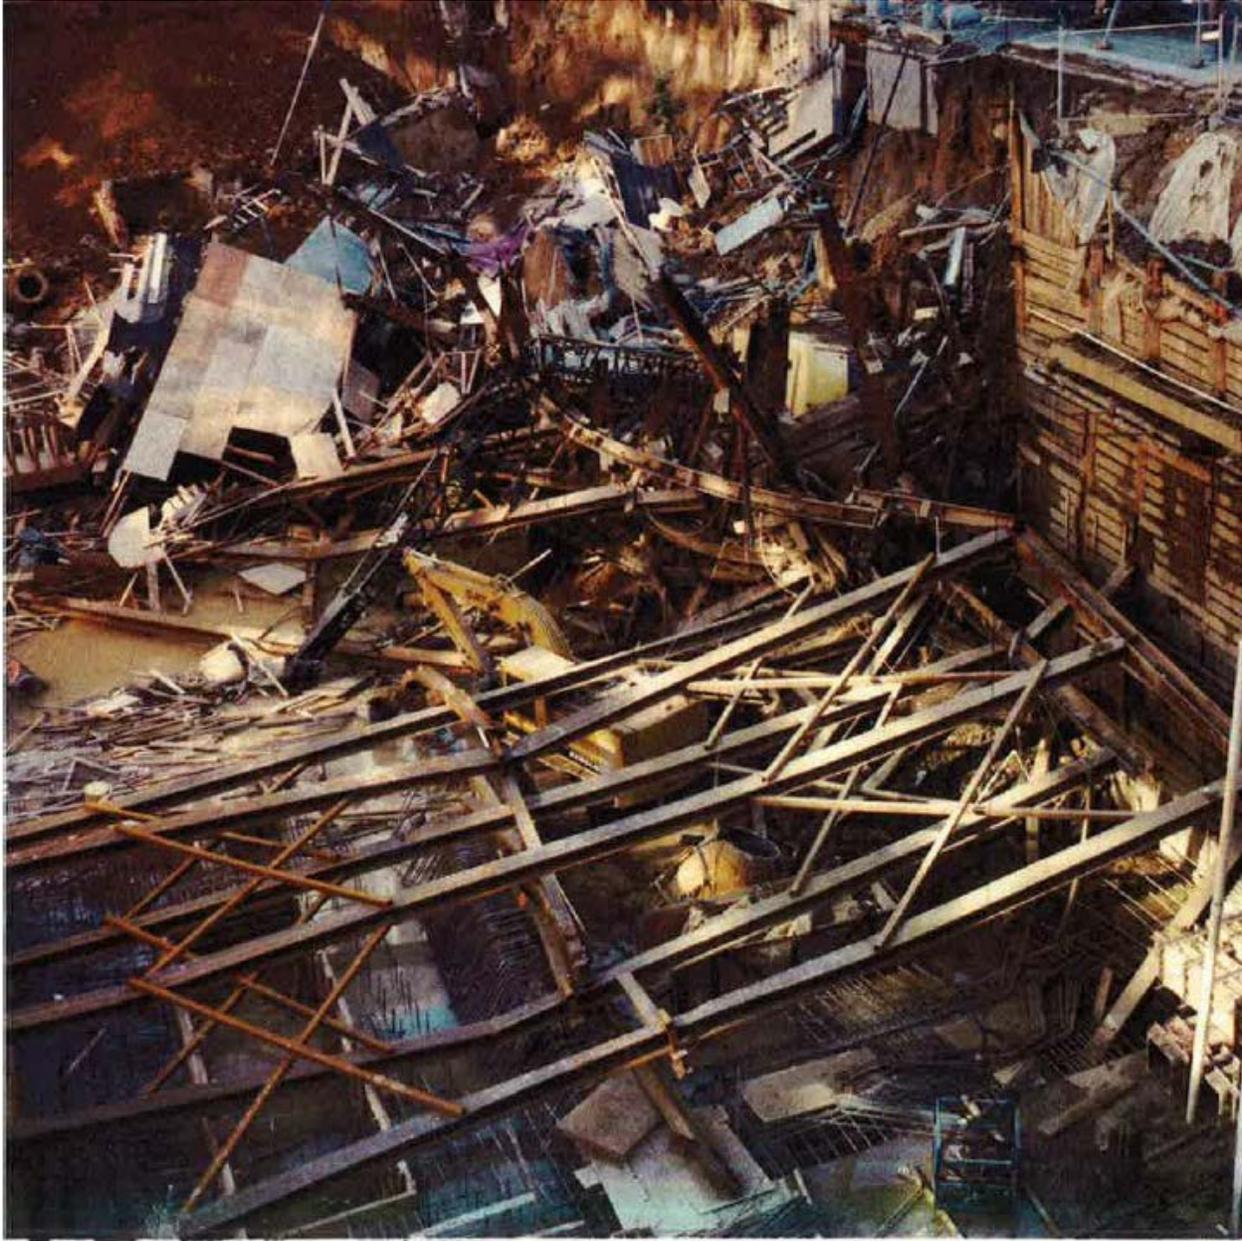
Figure 3.7 Failure Soil Surface along the East Wall after the Initial Collapse (Looking Toward East). Note: Most of the failure surface is covered by fill material for the slope stabilization.

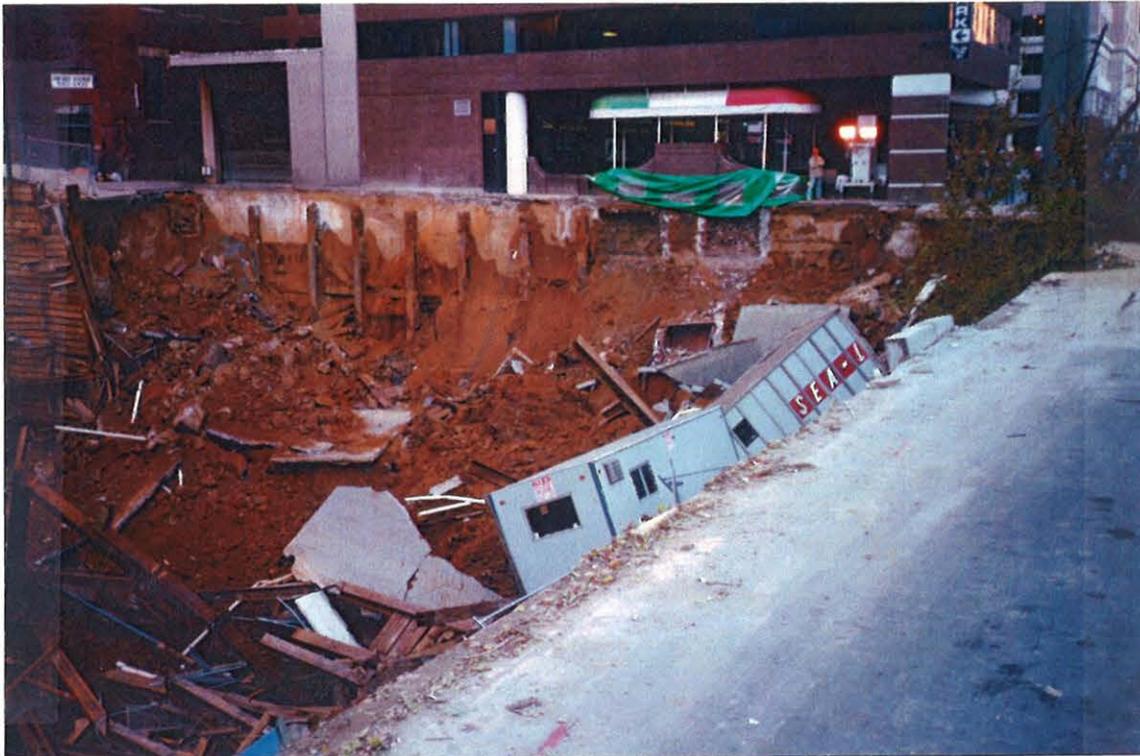
Figure 3.8 Failure Soil Surface along the North Wall after the Initial Collapse (Looking Toward Northwest).

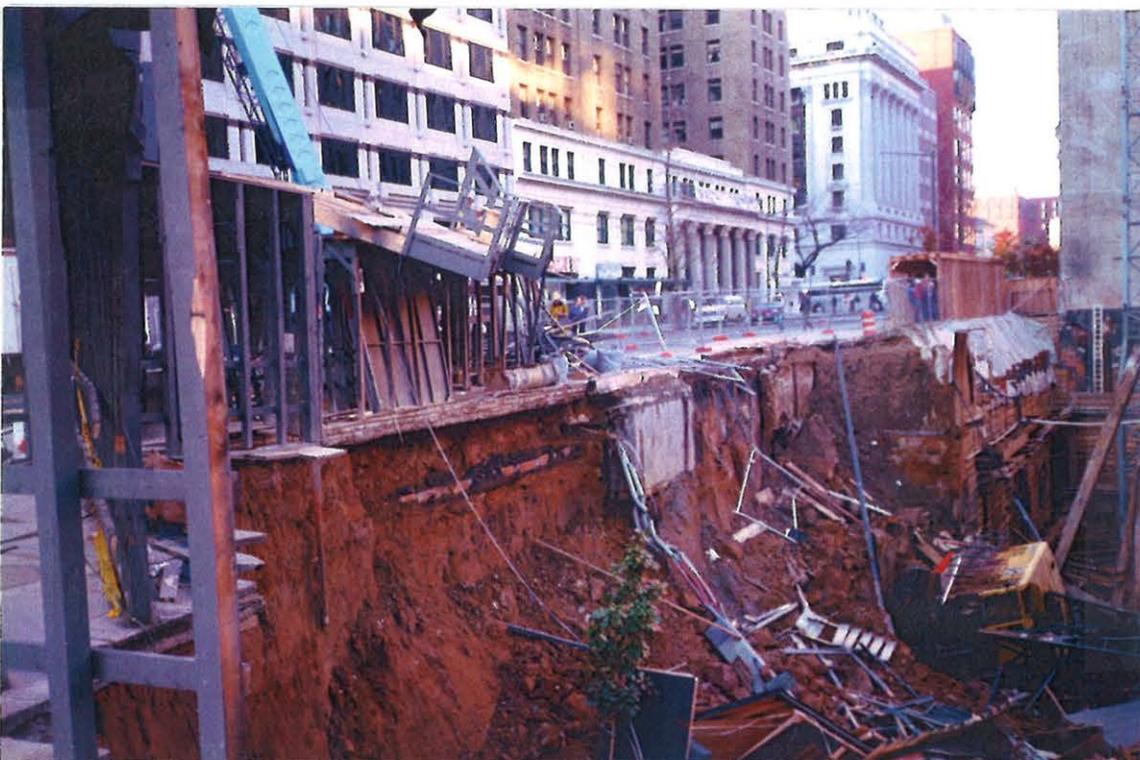
Figure 3.9 Failure Soil Surface along the South Wall after the Initial Collapse (Looking Toward Southwest).

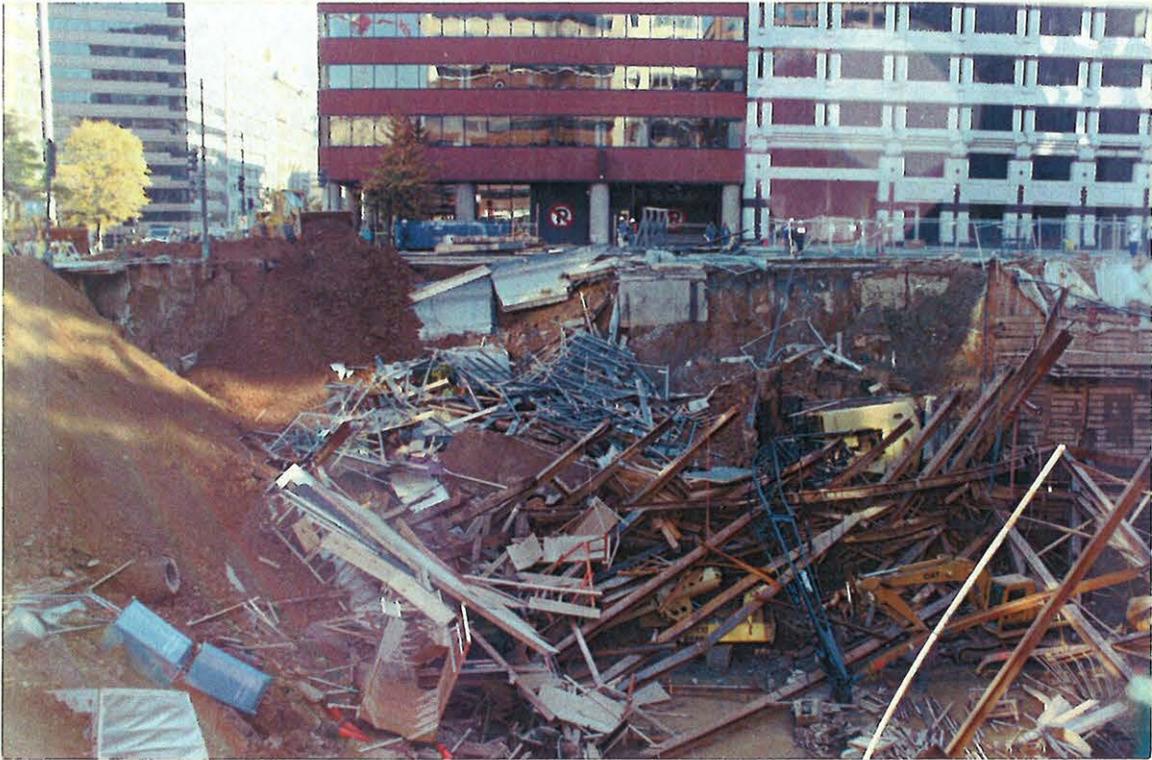
After the initial collapse, the general contractor started to refill the excavation along the 14th Street side, to stabilize the nearly vertical failure surface and to prevent further cave-in. The refilling operation was successful in preventing further cave-in along 14th Street. This operation was not sufficient along H Street. On November 20, about 1:40 p.m., 17 hours after the initial collapse, a 10 foot wide and 100 foot long section of H Street collapsed into the excavation site, along with remaining wooden sidewalk protection, as indicated in Figure 3.11.

**Figure 3.11** Failure Soil Surface along the South Wall after the Second Collapse (Looking Toward South).

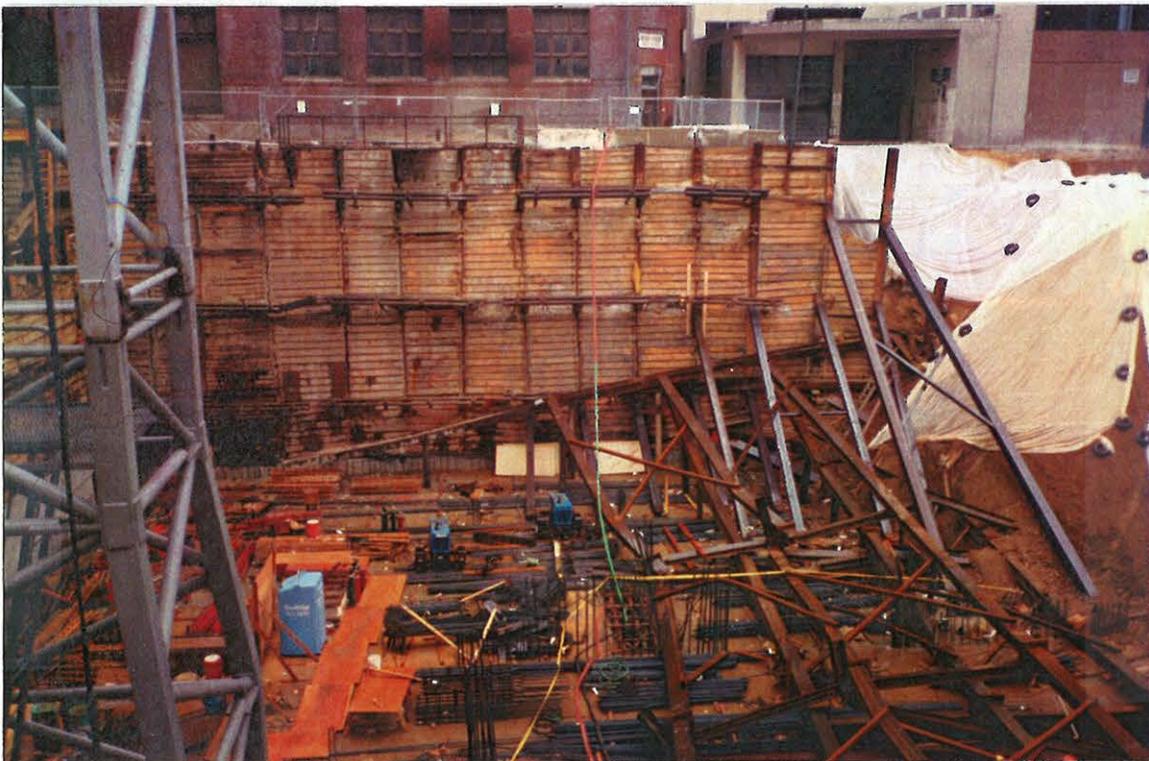
The soldier beam wall supported by the external tieback system did not fail as a result of the collapse, although a few tieback wales were damaged by the sliding and falling internal support system. Seven rakers were installed by the shoring subcontractor at the damaged tieback wale locations after the collapsed steel members of the internal support system in the excavation were secured. They were installed at the bottom tier of soldier beams 9, 10 and 11, and middle and bottom tiers of soldier beams 12 and 13, as indicated in Figure 3.12.

**Figure 3.12** Seven Rakers Installed to Secure the Damaged North Tieback Wall (Looking Toward North).

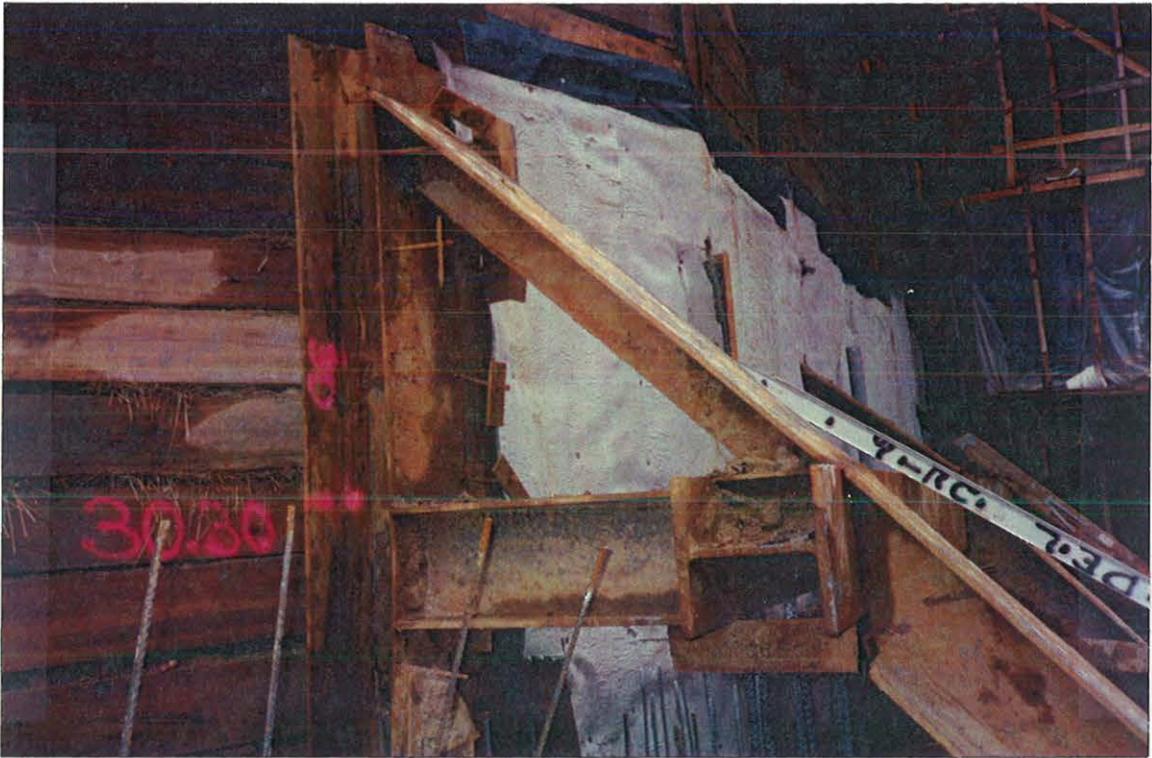
Figure 3.13 A Raker System Supporting the Bottom Portion of Soldier Beam 63 (Looking Toward West).

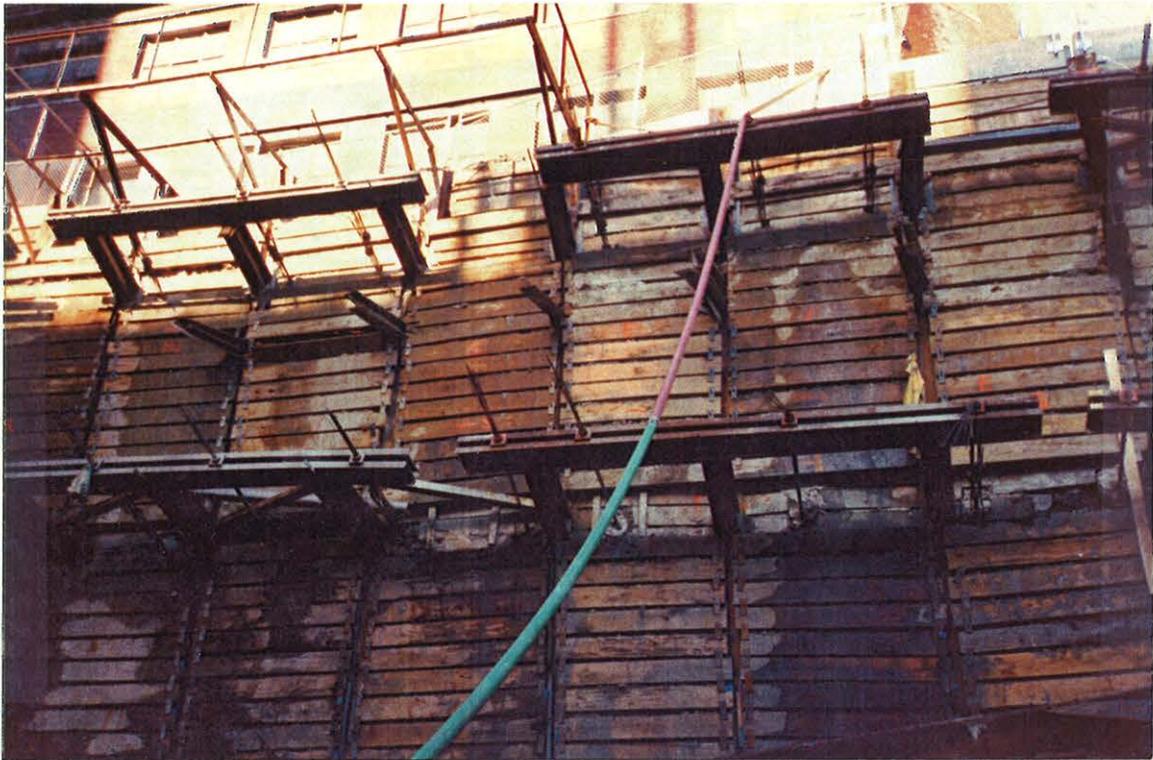
**Figure 3.15** Outlookers Still Attached to the Soldier Beam after the Initial Collapse (Looking Upward North).

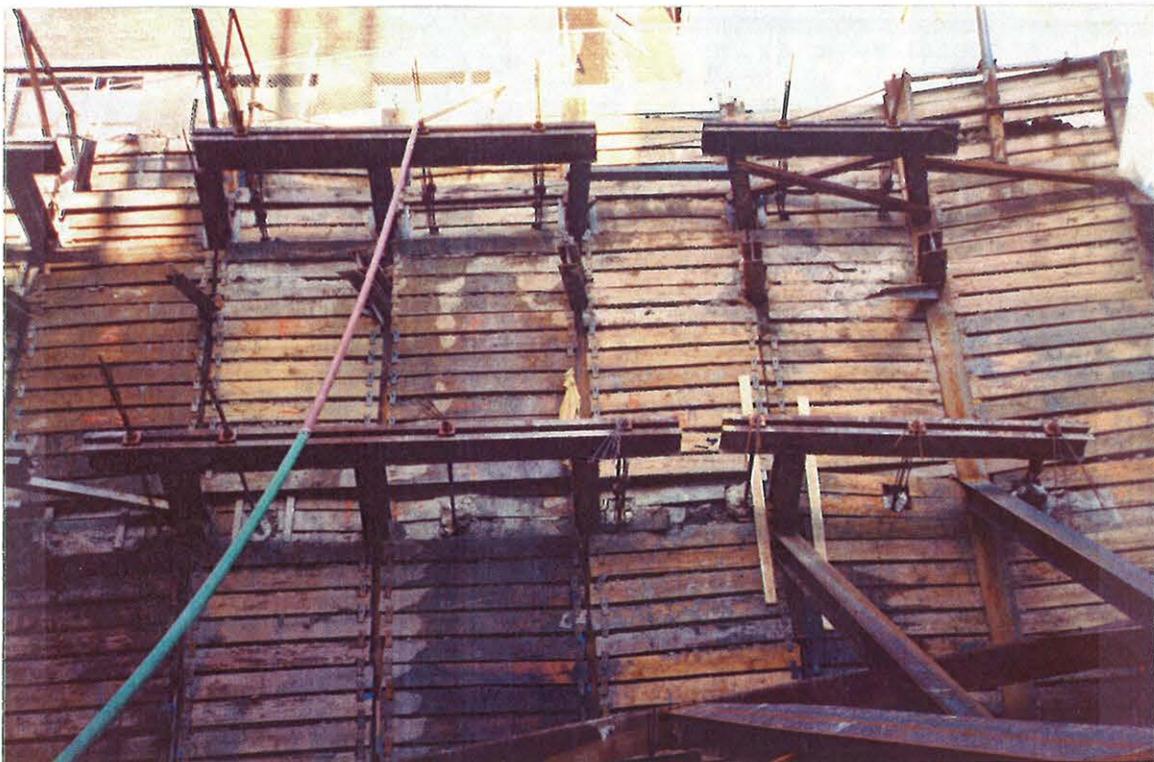
**Figure 3.16** Outlookers Still Attached to the Soldier Beam after the Initial Collapse (Looking Upward North).

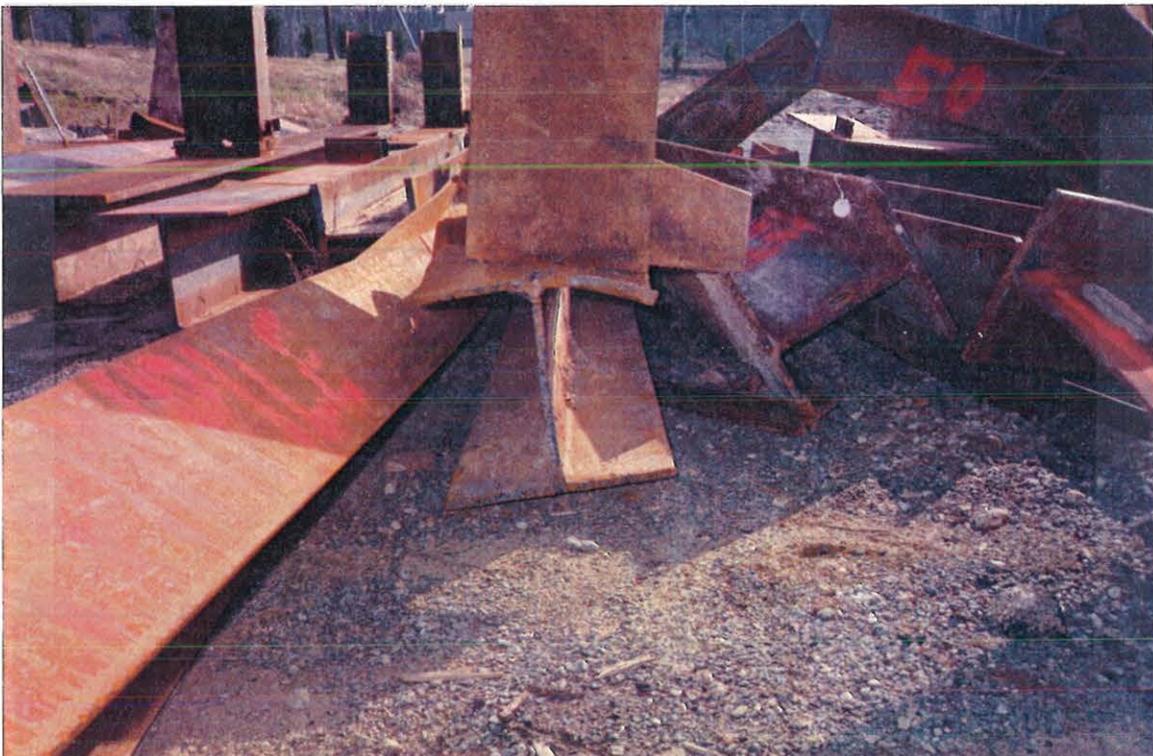
**Figure 3.18** Outlooker of Soldier Beam 60 Top Tier Showed a Westward Deformation (Looking Toward the Top of the Soldier Beam).

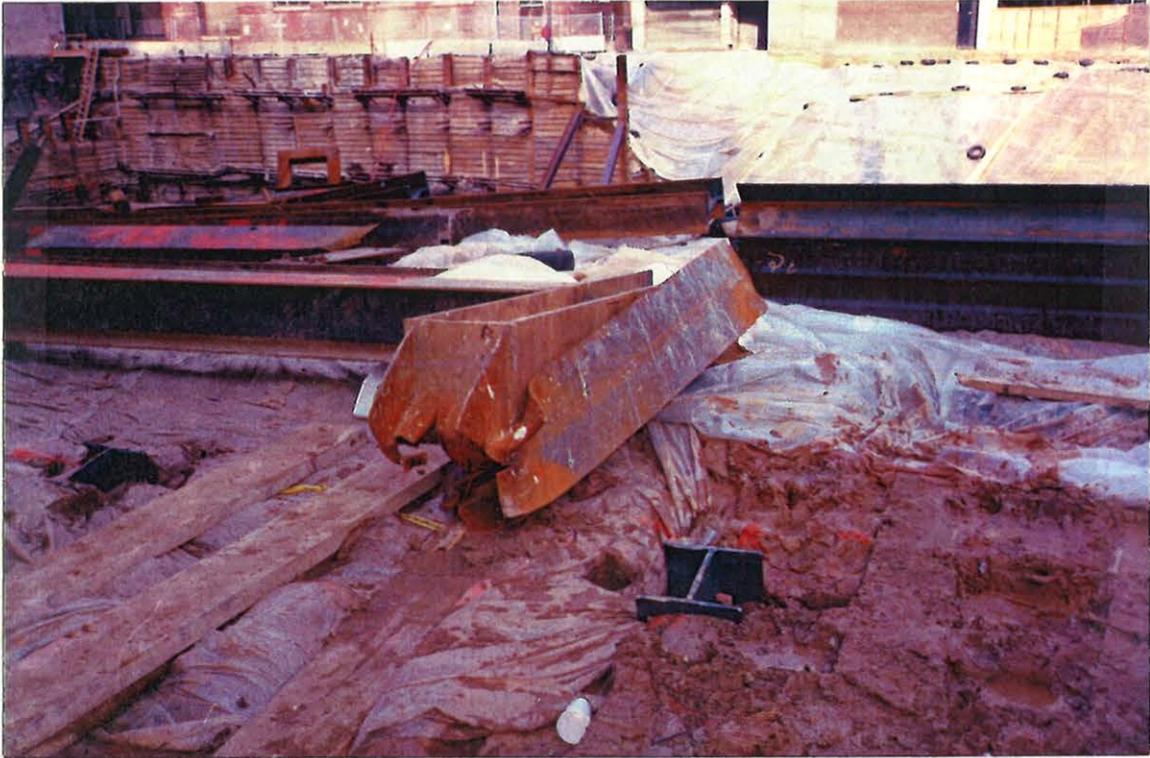
Figure 3.19 Sheared Off Section of the Sloping Wale (looking Toward East End of the Wale).

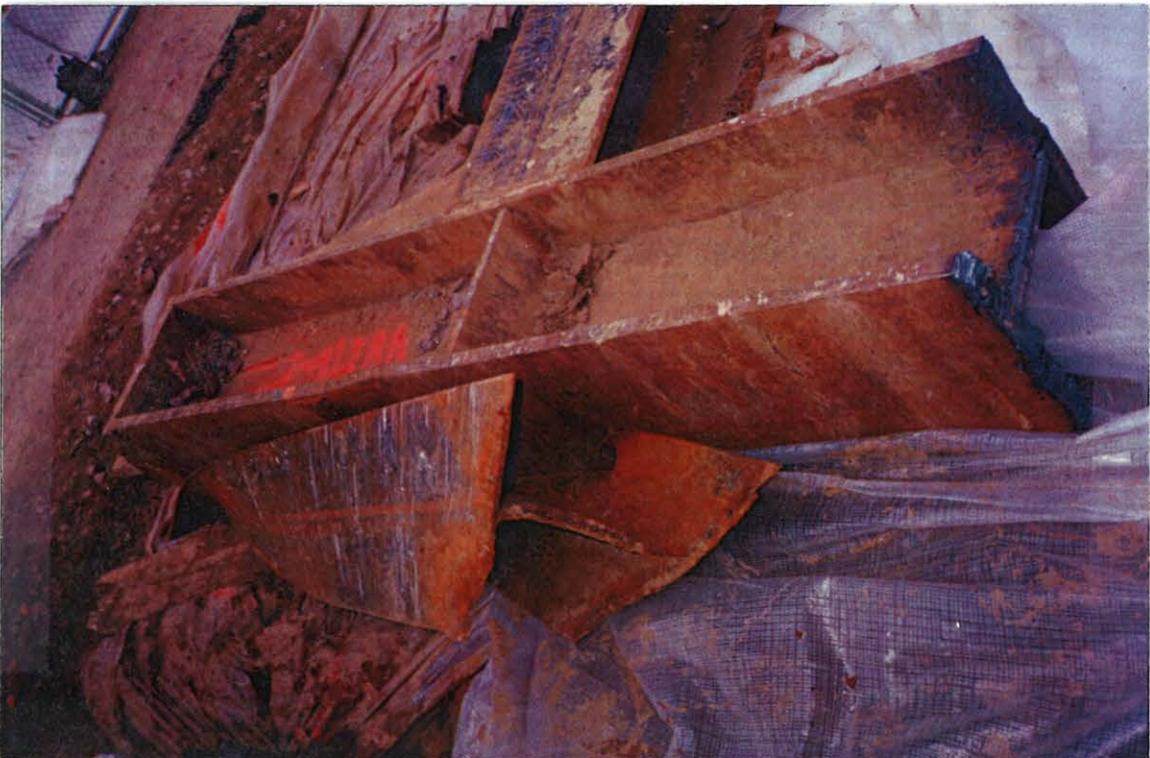
Figure 3.20 Sheared Off Section of the Sloping Wale (Looking Toward West End of the Wale).

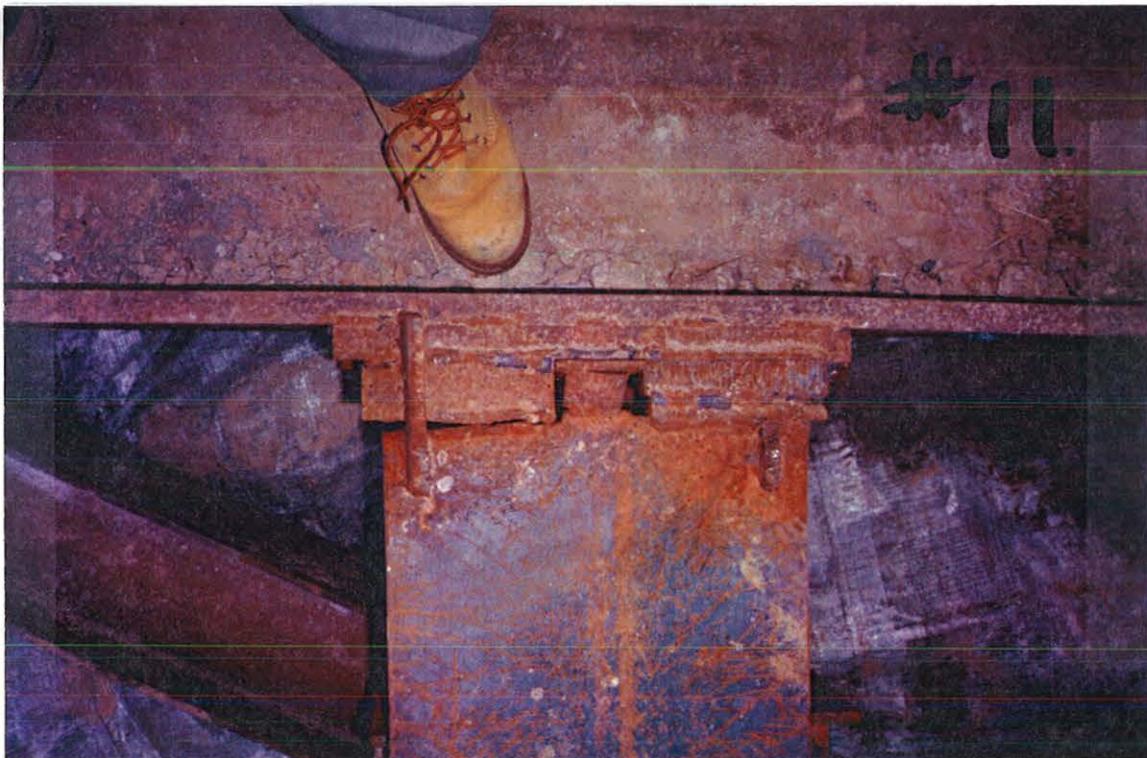
- Most of the eight uncovered wale-strut connections were still intact as indicated in Figure 3.21, for the top wale between soldier beams 14 to 16. However, the top wale-strut connection at soldier beam 18 was cracked as indicated in Figure 3.22 and the middle tier wale-strut connection at soldier beam 16 fell apart when it was moved up to the ground surface.

Figure 3.22 Cracked Top Wale-Strut Connection at Soldier Beam 18.

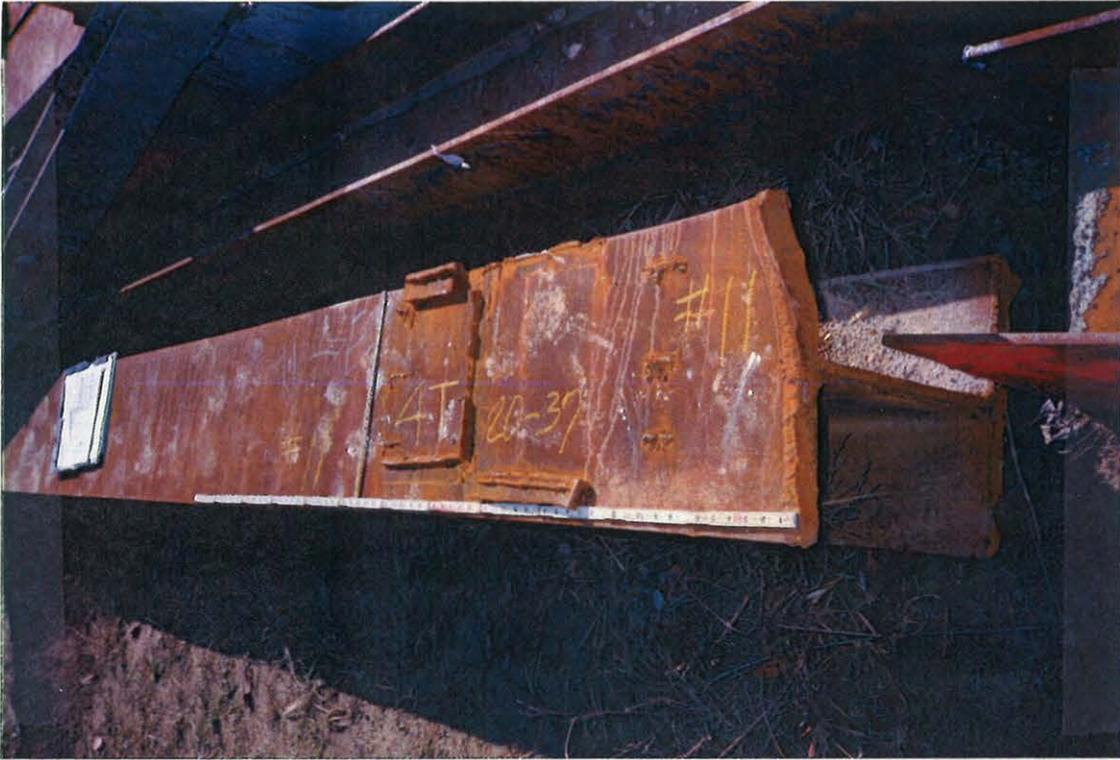
Figure 3.23 Separated Top Tier Wale-Diagonal Connection at Soldier Beam 20.

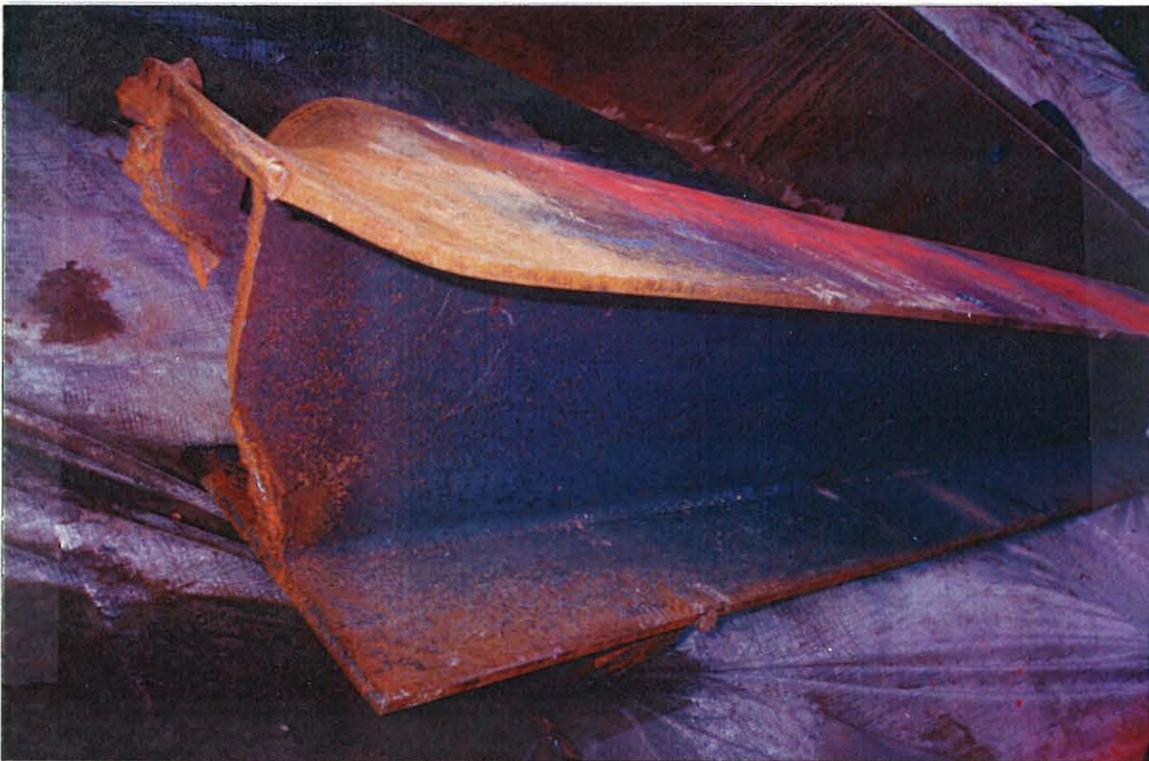
Figure 3.24 Separated Bottom Wale-Raker Connection at Soldier Beam 14.

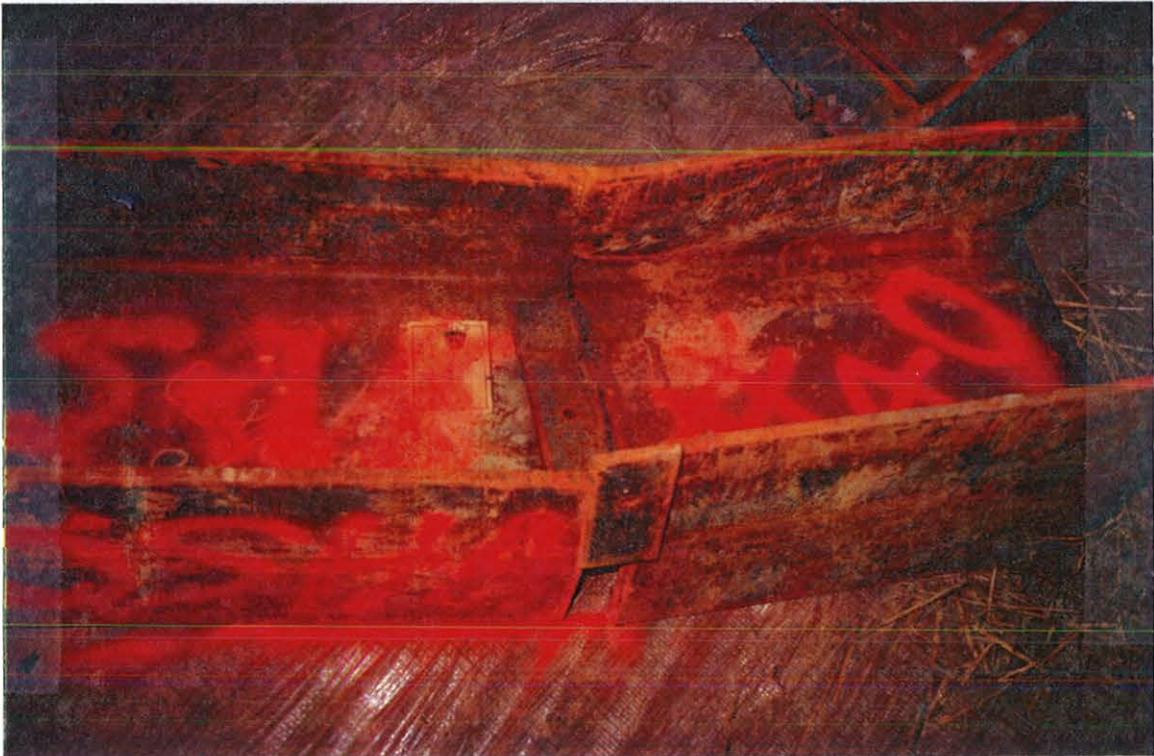
- The majority of splice joints along the six struts were in relatively good condition with only a few broken. For example, a splice joint in the middle tier strut near pinpile 7 was broken as indicated in Figure 3.26.

Figure 3.26 Splicing Joint in the Middle Strut near Pinpile 7.

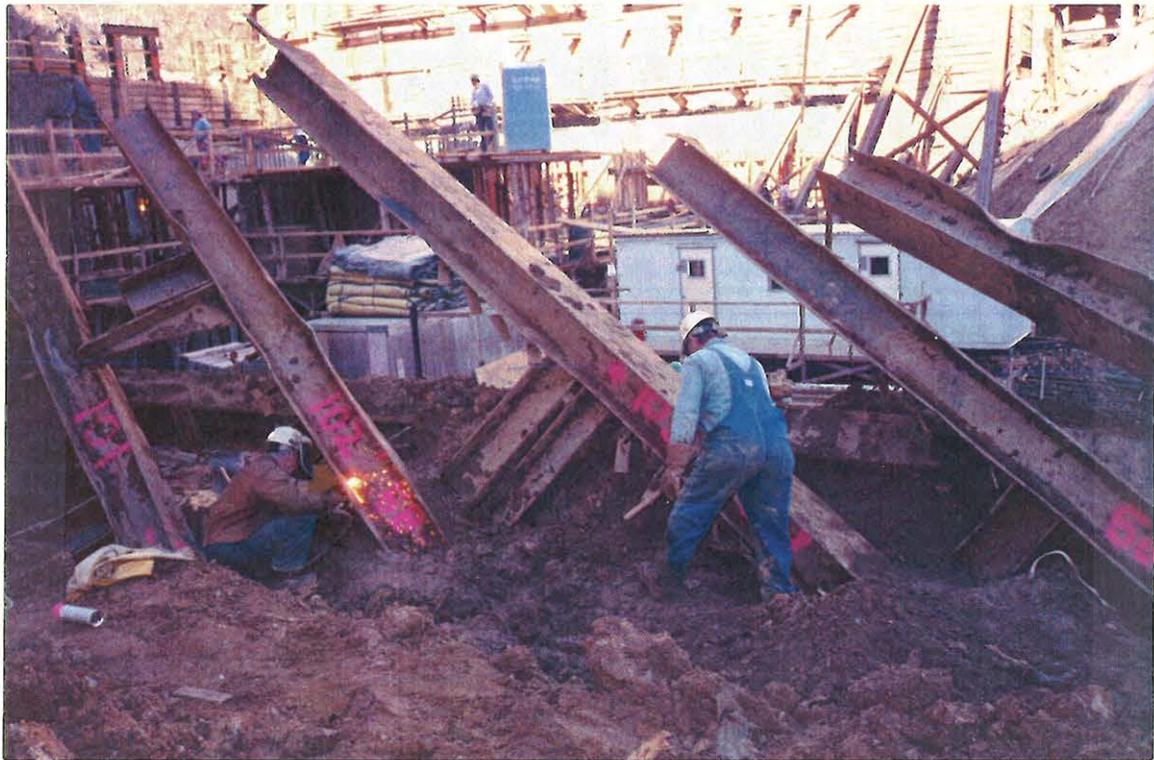
**Figure 3.27** Recovered Position of South Wall Soldier Beams 59 through 55 (Looking Toward North).

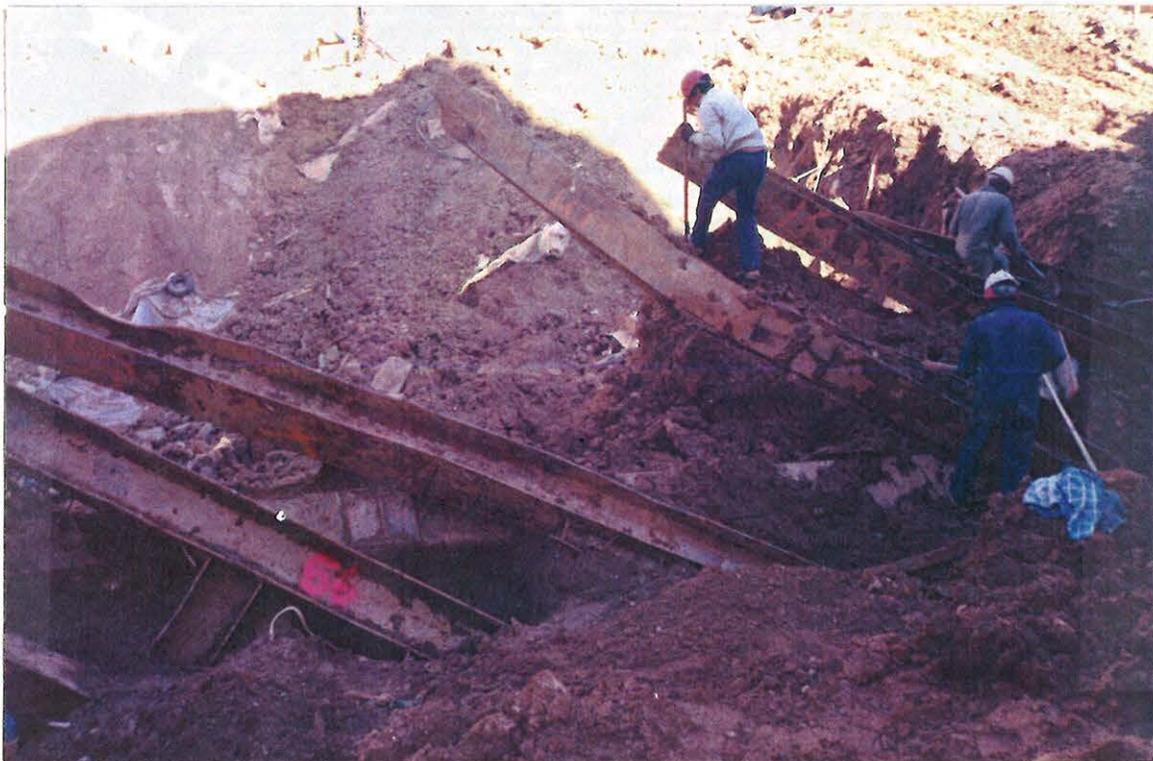
**Figure 3.28** Recovered Position of South Wall Soldier Beams 56 through 52 (Looking Toward North).

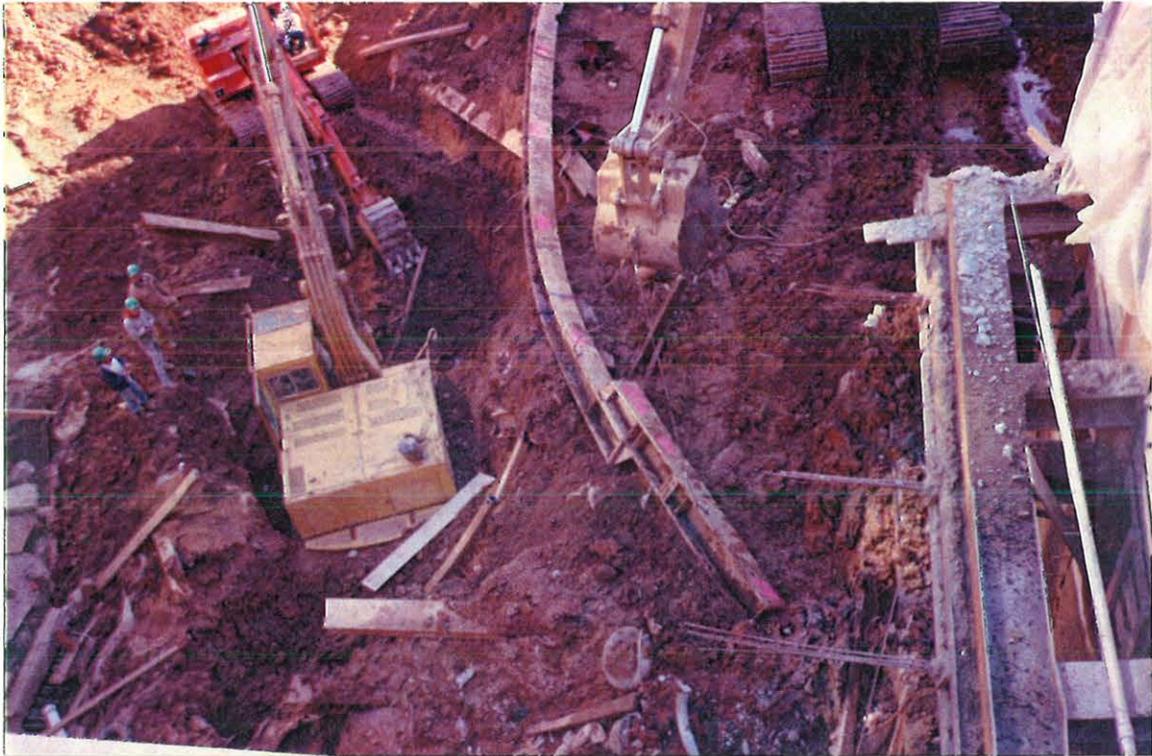
**Figure 3.29** Relative Position of the Backhoe and the South Wall Top Wale (Looking Downward). Note: No outlookers were attached to the wale.

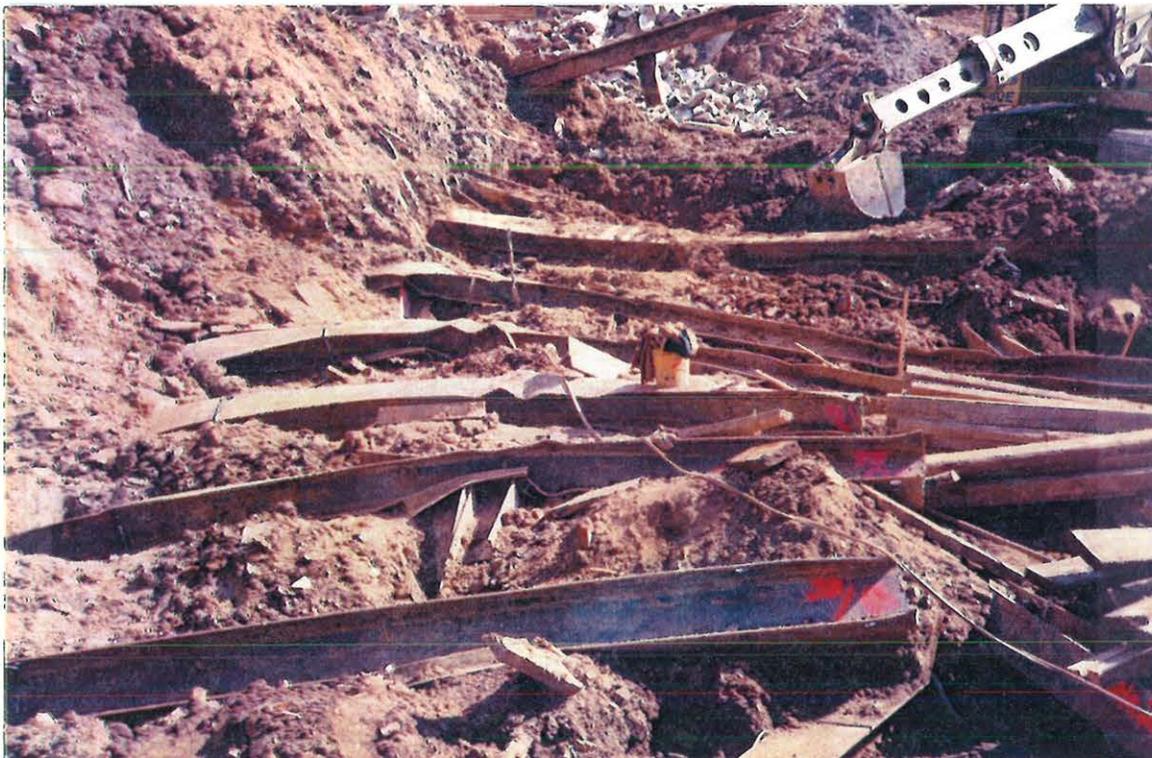
**Figure 3.30** Recovered Position of North Wall Soldier Beams 19 through 24 (Looking Toward East).
