# Investigation of November 19, 1990 Excavation Collapse at 14th and H Streets, N.W. Washington, D.C.

U.S. Department of Labor  
Occupational Safety and Health Administration

May 1991

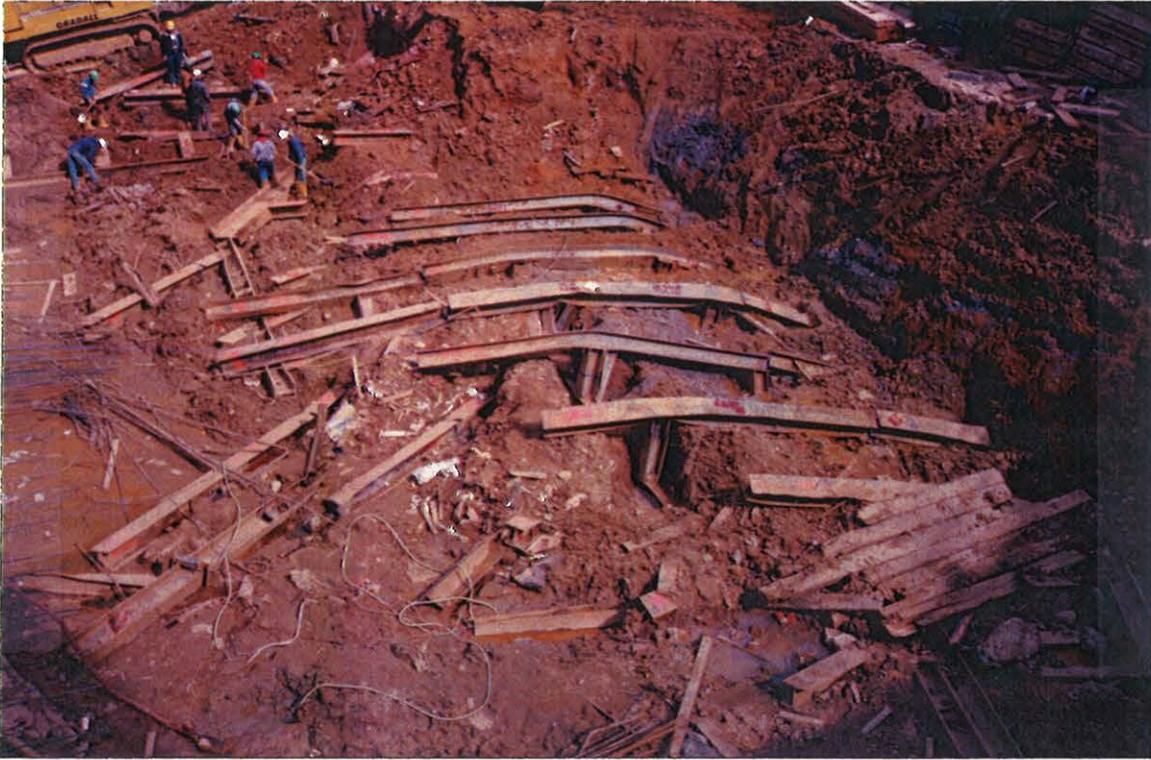
For the east wall, except for two soldier beams at each end, all remaining 16 soldier beams fell as a unit to the subgrade, as indicated in Figure 3.31. The original lagging between soldier beams probably influenced the formation of this failure pattern. Also indicated in this figure, the soldier beams experienced very little twisting when they fell.

**Figure 3.31 Recovered Position of East Wall Soldier Beams 45 through 39 (Looking Toward North).**

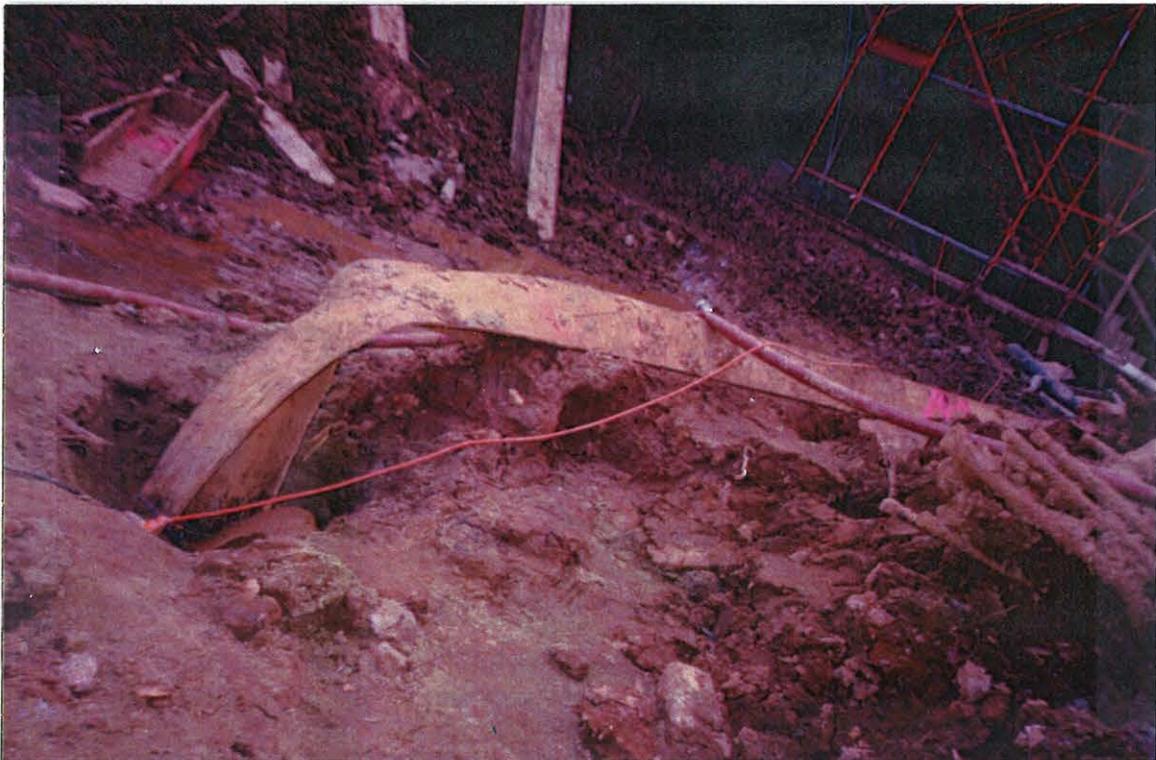
All 13 pinpiles were soundly embedded and bent near the surface of the final subgrade. Figures 3.32 and 3.33 show the embedded conditions on pinpiles 2 and 10, respectively.

**Figure 3.32 Embedment Condition of Pinpile 2 (Looking Toward South).**

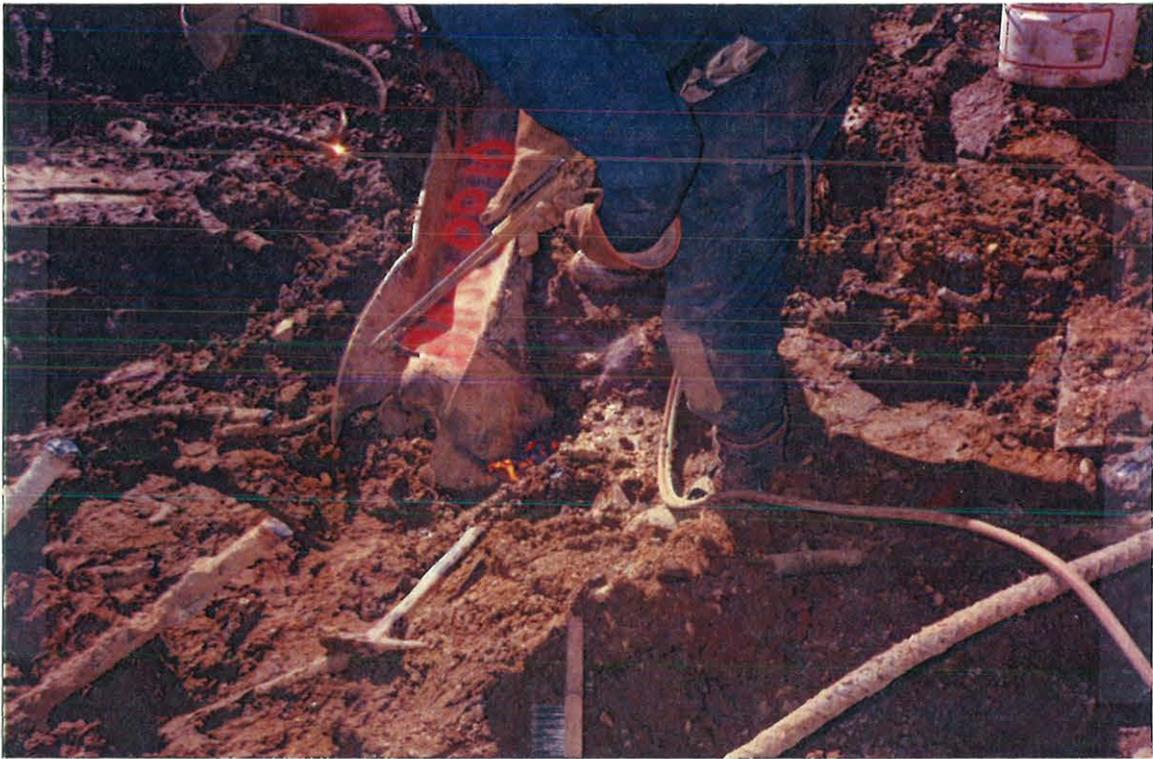
**Figure 3.33 Embedment Condition of Pinpile 10 (Looking Toward Southwest).**

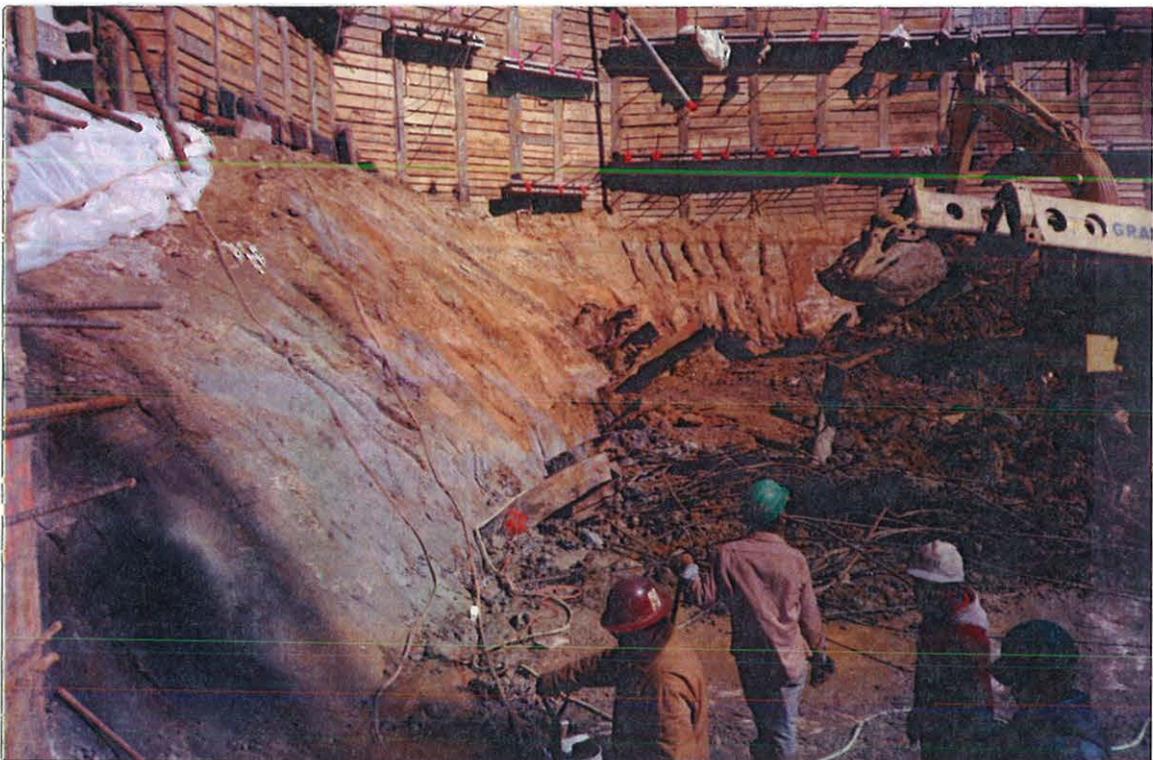
**Figure 3.34 Embedment Condition of Soldier Beams 22 through 29 (Looking Toward East).**

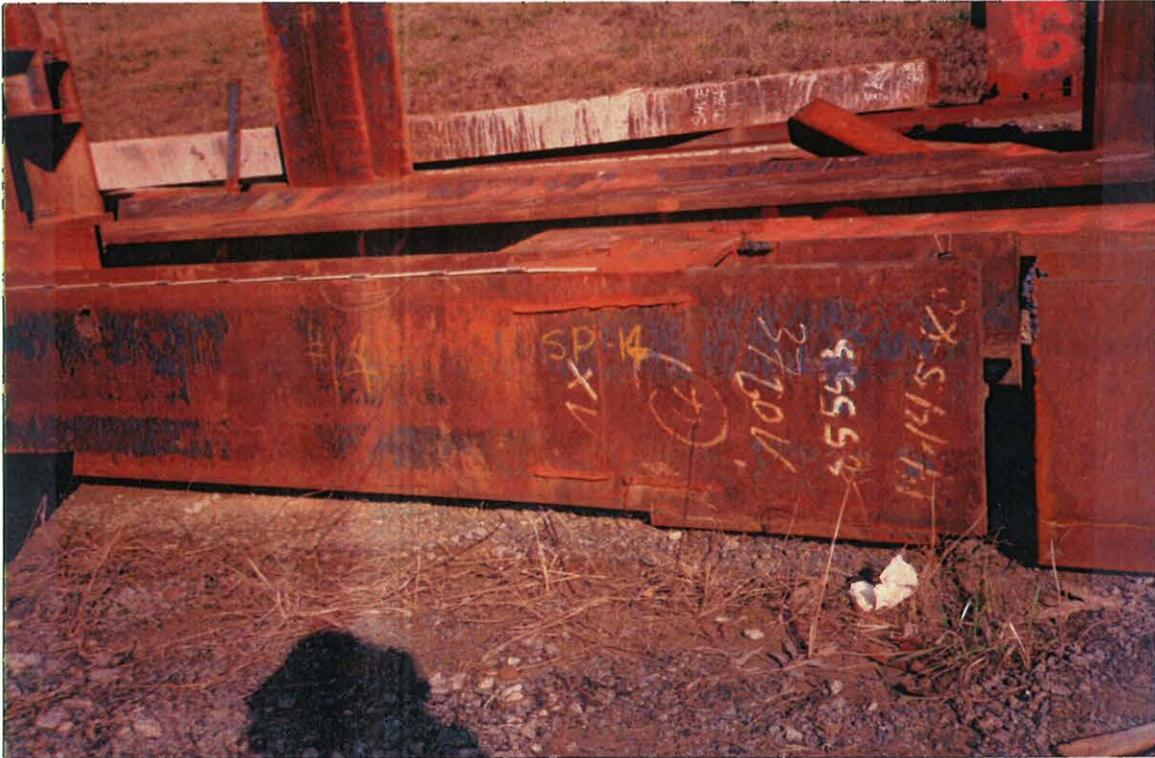
It was observed that the majority of the failures of the outlooker-wale and outlooker-soldier beam connections occurred through the fillet welds rather than in the base metal of the structural members.

**Figure 3.35** Outlooker Wale Welding Condition on the Bottom North Wale at Soldier Beam 14.

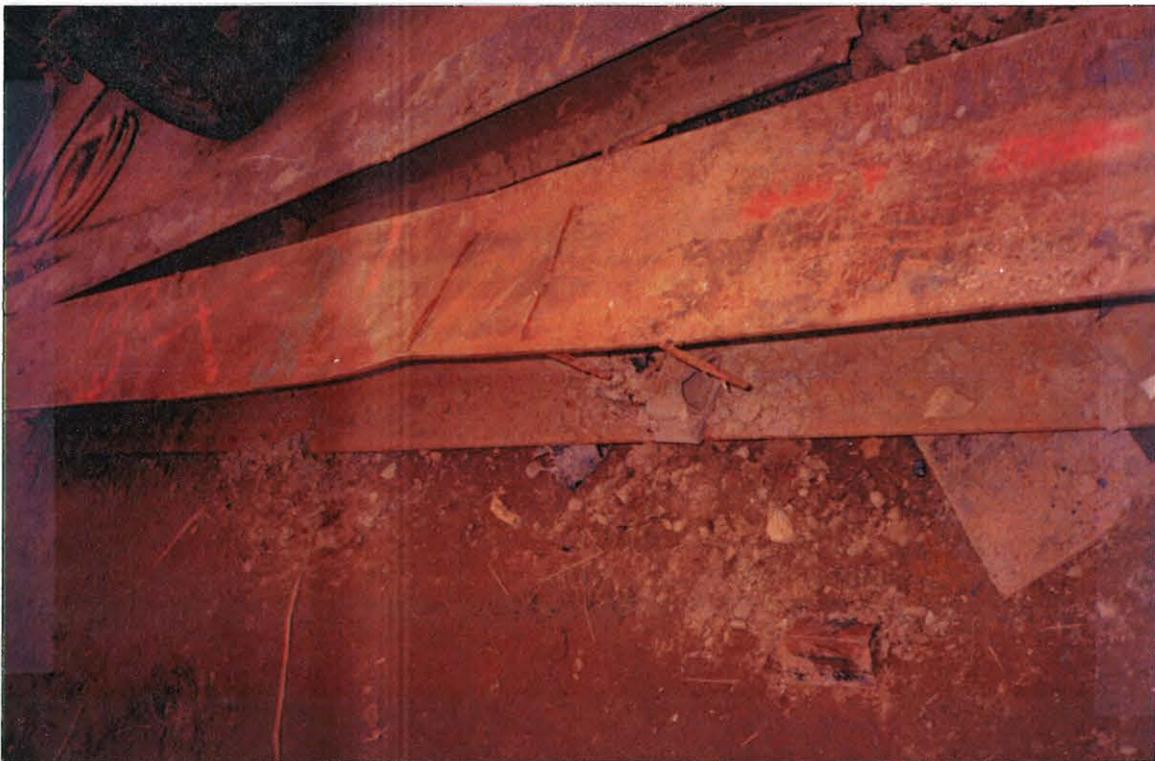
**Figure 3.36** Outlooker Soldier Beam Welding Condition on Soldier Beam 63 at the Top Tier.

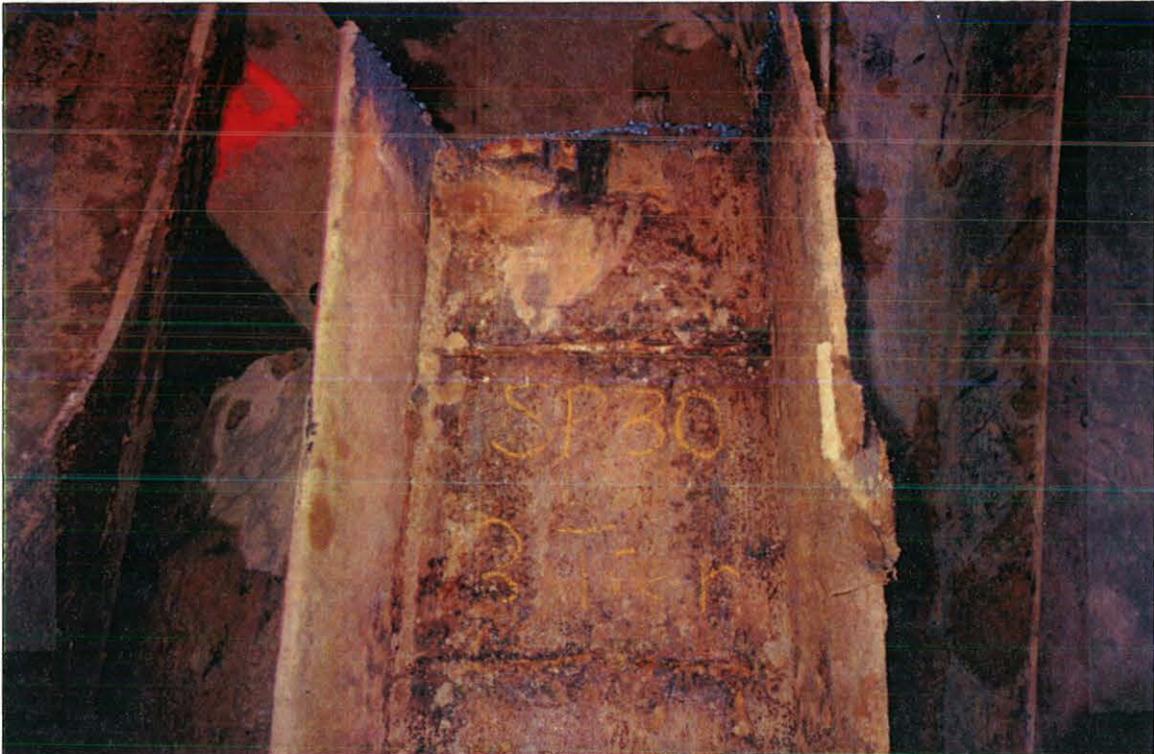
- The soldier beams were significantly twisted during driving, this condition was more pronounced in the northeast corner, where a gravel layer was encountered. Figure 3.37 shows that soldier beam 30 was twisted about 90 degrees at the third tier, so that the outlooker was welded to the web of the beam. Subsequently, a support beam was added to house the lagging. Soldier beams along the south wall were

**Figure 3.37 Bottom Outlooder Welded to the Web of Twisted Soldier Beam 30.**

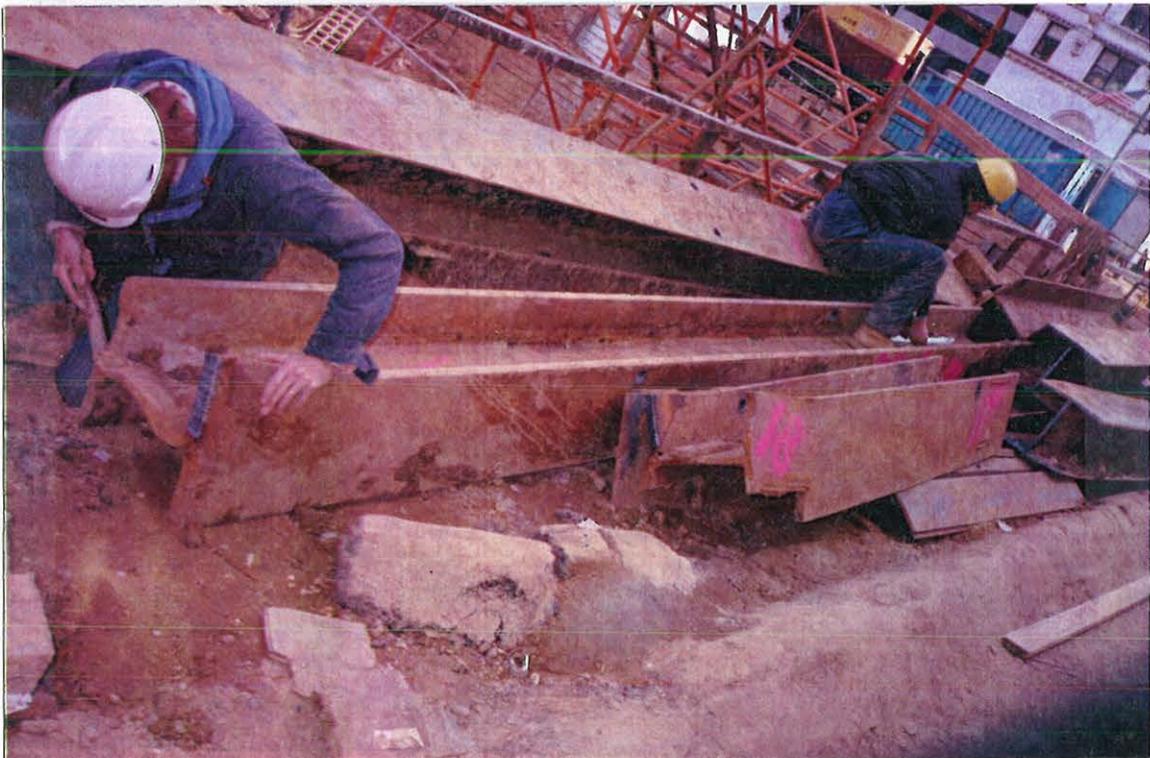
**Figure 3.38 Middle North Wale at Soldier Beam 18 Undercut in Both Flanges.**

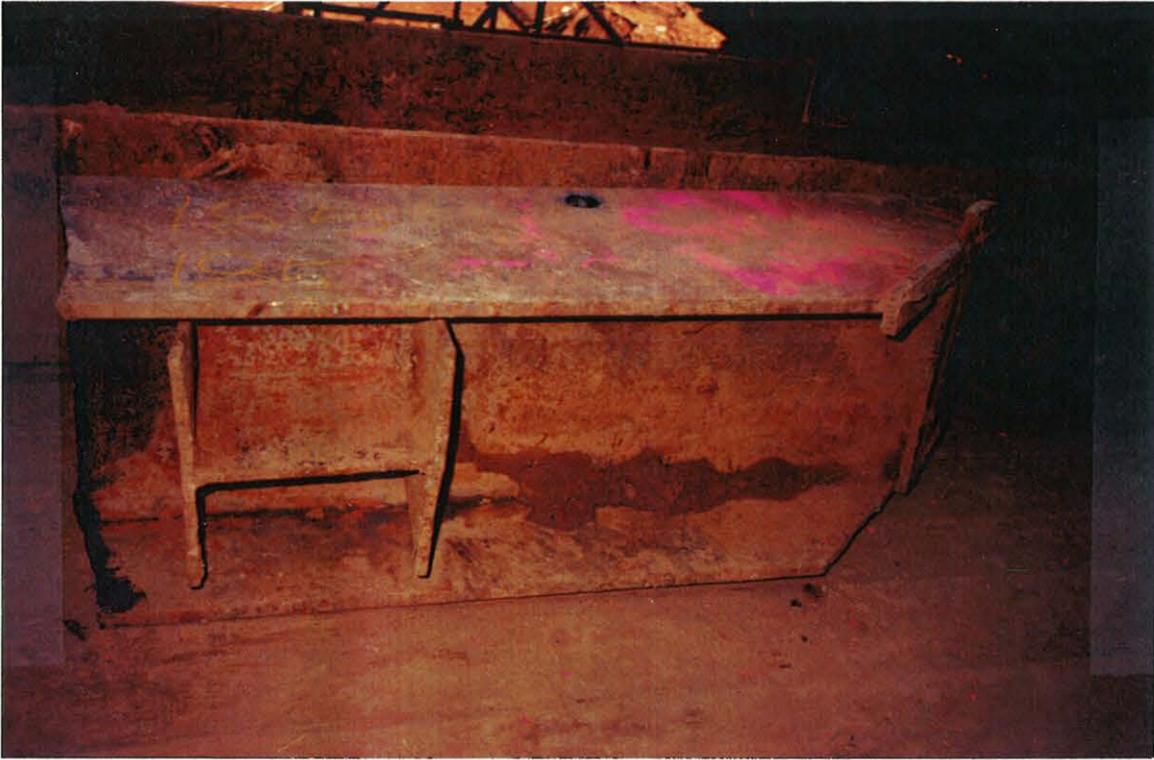
**Figure 3.39 Separated Prestressed Top Diagonal-Wale Connection at Soldier Beam 20.**

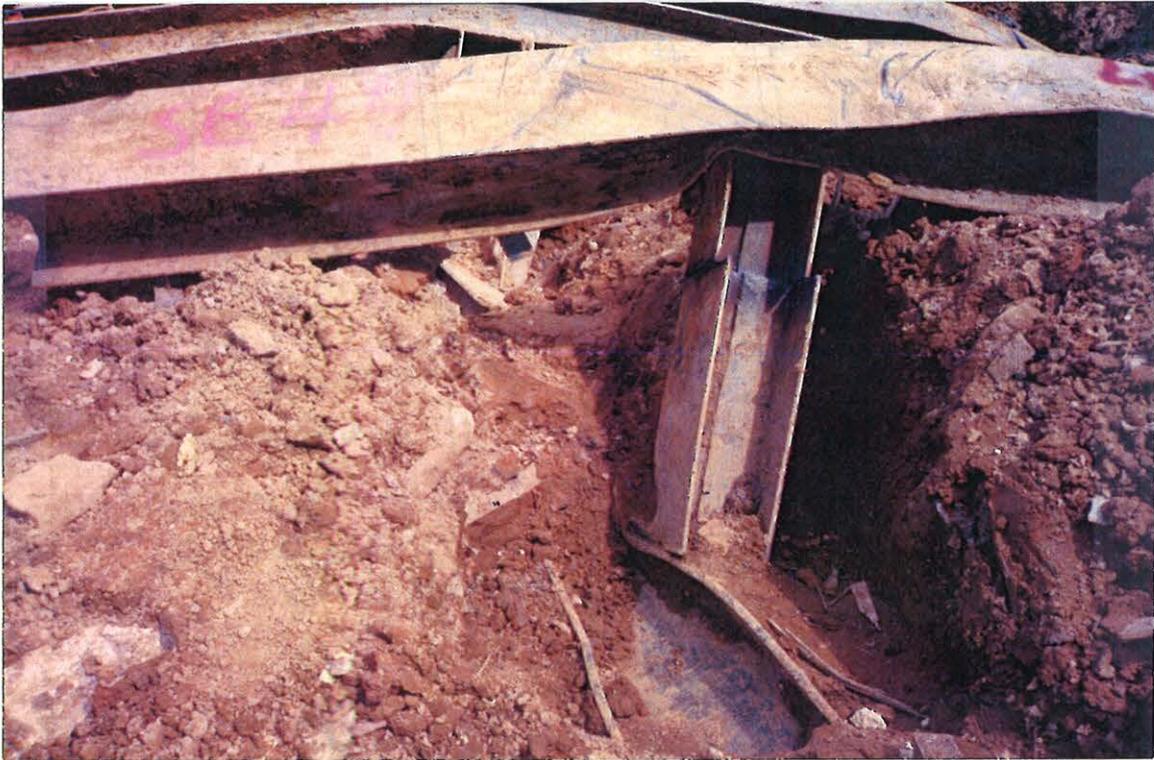
**Figure 3.40 Middle Outlooker at Soldier Beam 44 Still Attached to Both Soldier Beam and Wale (Looking Toward North).**

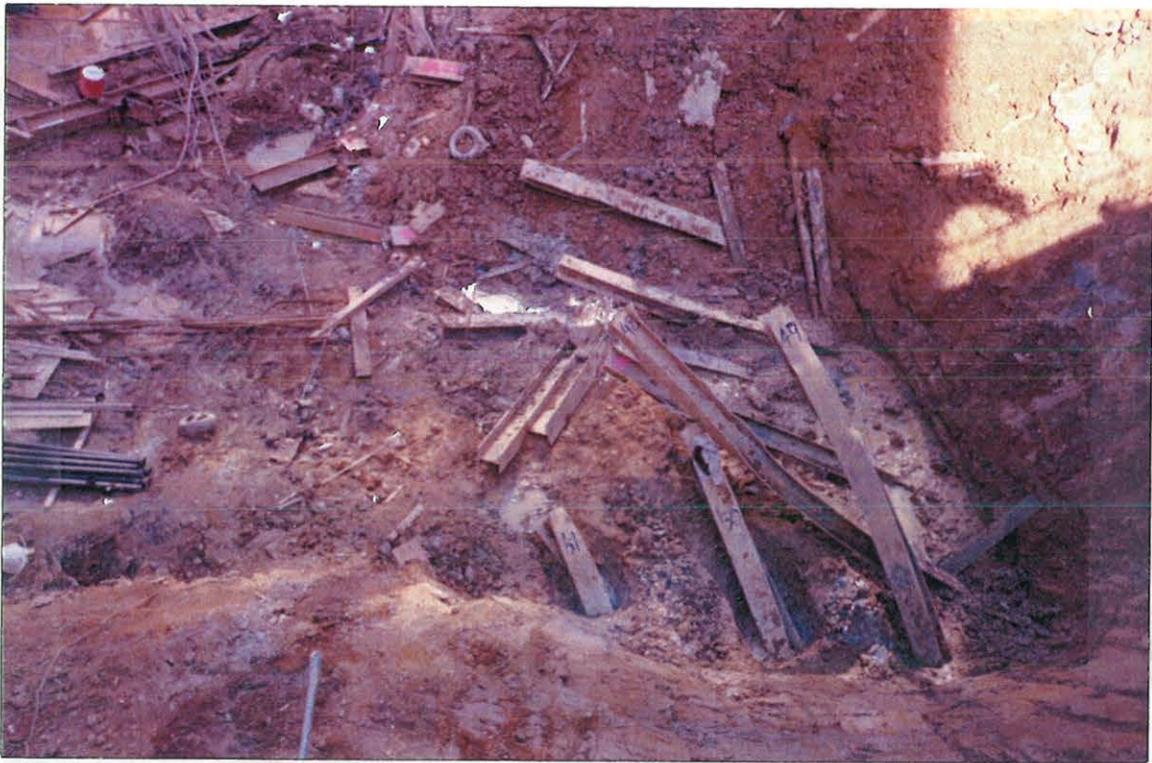
Figure 3.41 Bottom Location of Soldier Beams 46 through 51 (Looking Downward).

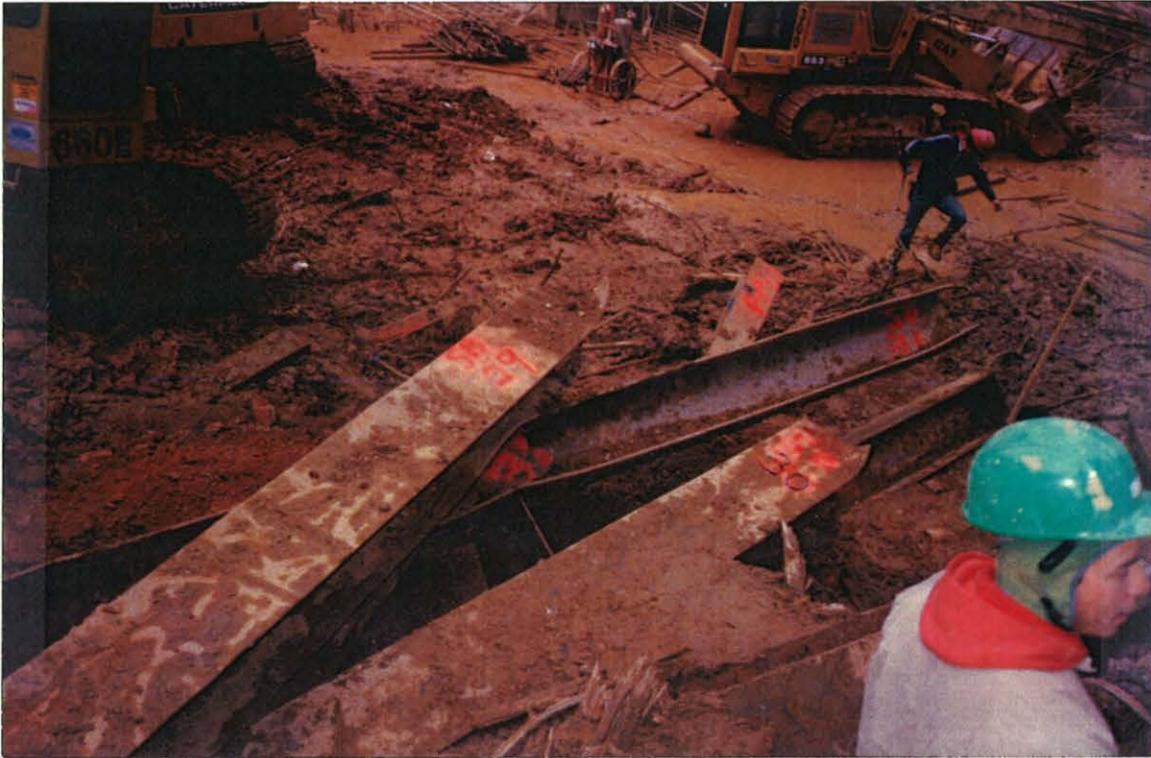
Figure 3.43 Top Location of Soldier Beams 29 through 31 (Looking Toward Southwest).

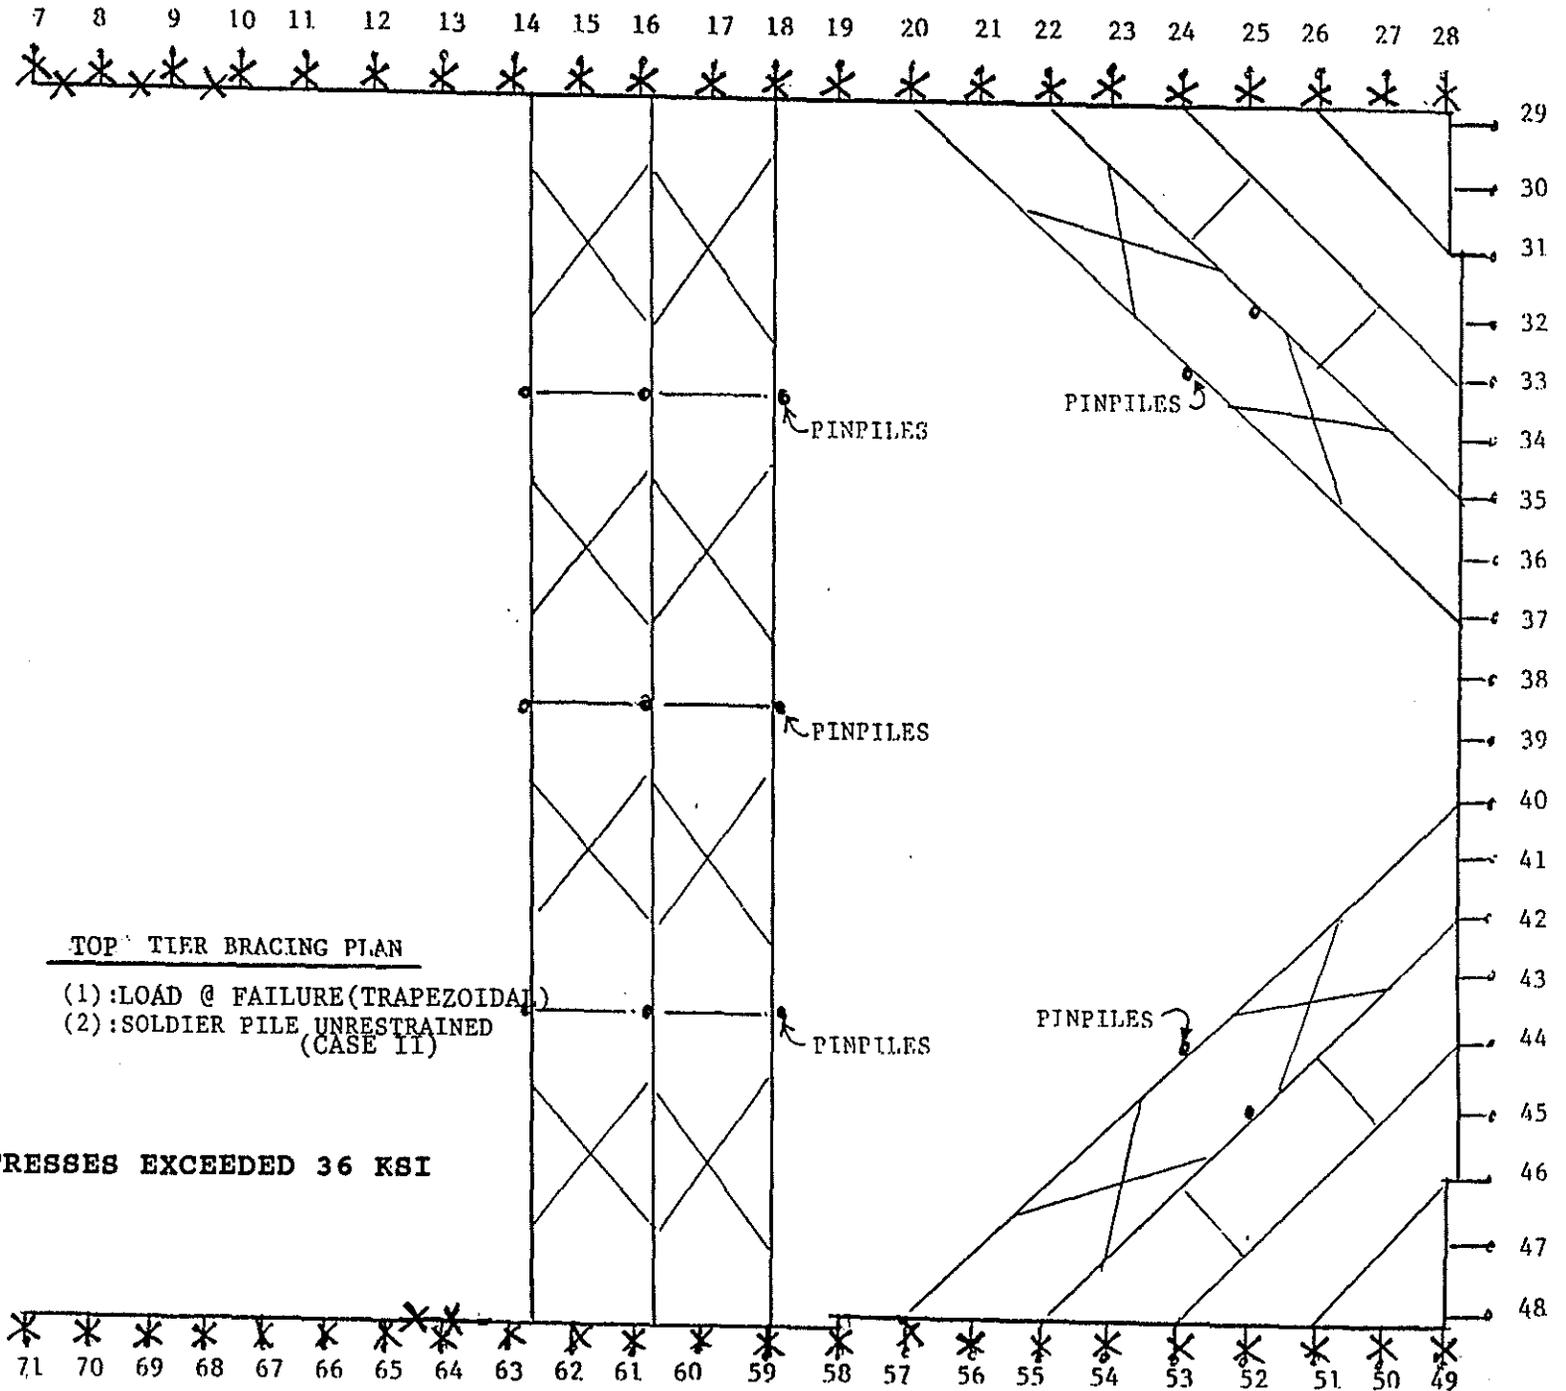
FIGURE 4.19

TOP TIER BRACING PLAN  
(1):LOAD @ FAILURE (TRAPEZOIDAL)  
(2):SOLDIER PILE UNRESTRAINED  
(CASE II)

\* COMBINED STRESSES EXCEEDED 36 KSI

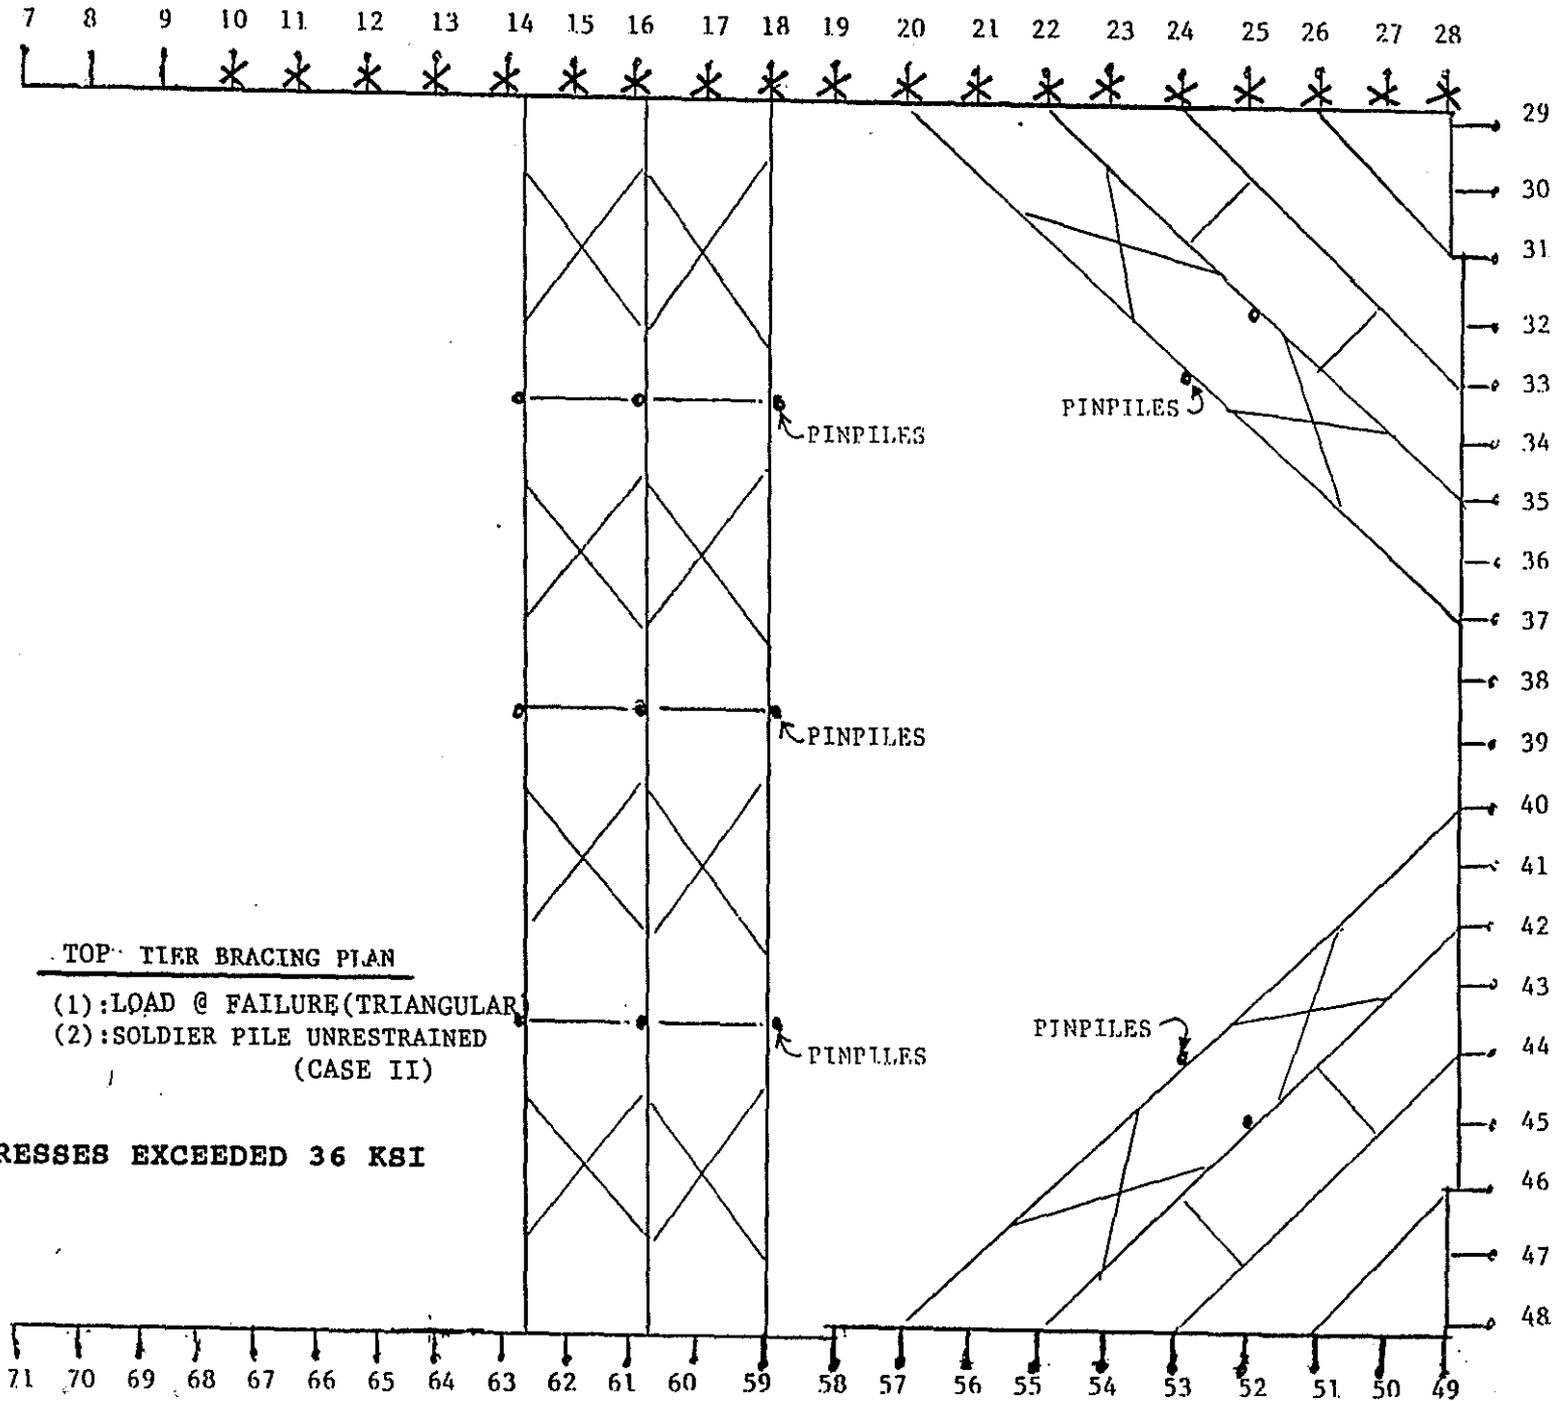
FIGURE 4.24

TOP TIER BRACING PLAN  
(1):LOAD @ FAILURE (TRIANGULAR)  
(2):SOLDIER PILE UNRESTRAINED  
(CASE II)

X COMBINED STRESSES EXCEEDED 36 KSI
