**COLLAPSE OF A MAST CLIMBING WORK  
PLATFORM (SCAFFOLD) IN MIAMI, FLORIDA  
MARCH 4, 1995**

U.S. Department of Labor  
Occupational Safety and Health Administration

June 1995

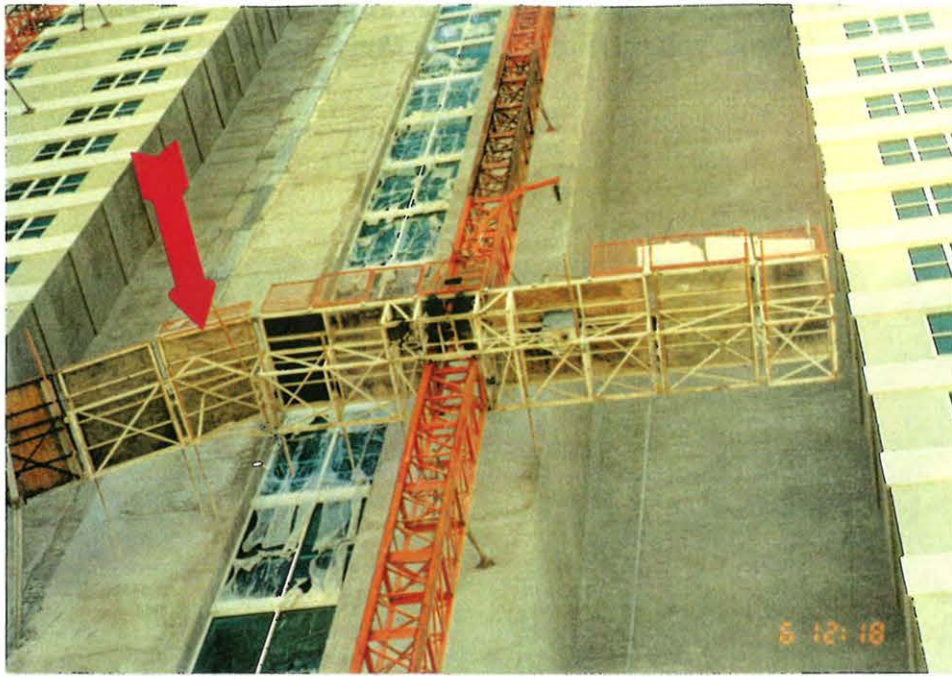
**Figure 1.6**

**Failed Platform Relative to the Building (Looking East-Northeast)  
Arrow Shows Deflection of Platform Extensions Starting at NPE1**

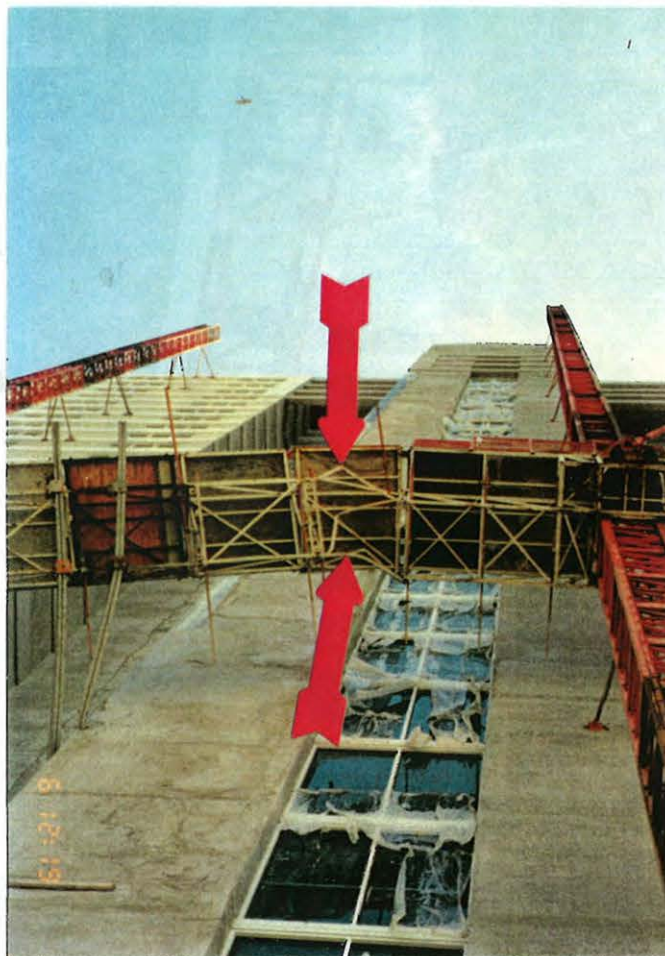
**Figure 1.7**

**Failed Platform Extensions  
Relative to the Main  
Platform (Looking Up)  
Arrow shows Buckled  
structural Members of NPE1**

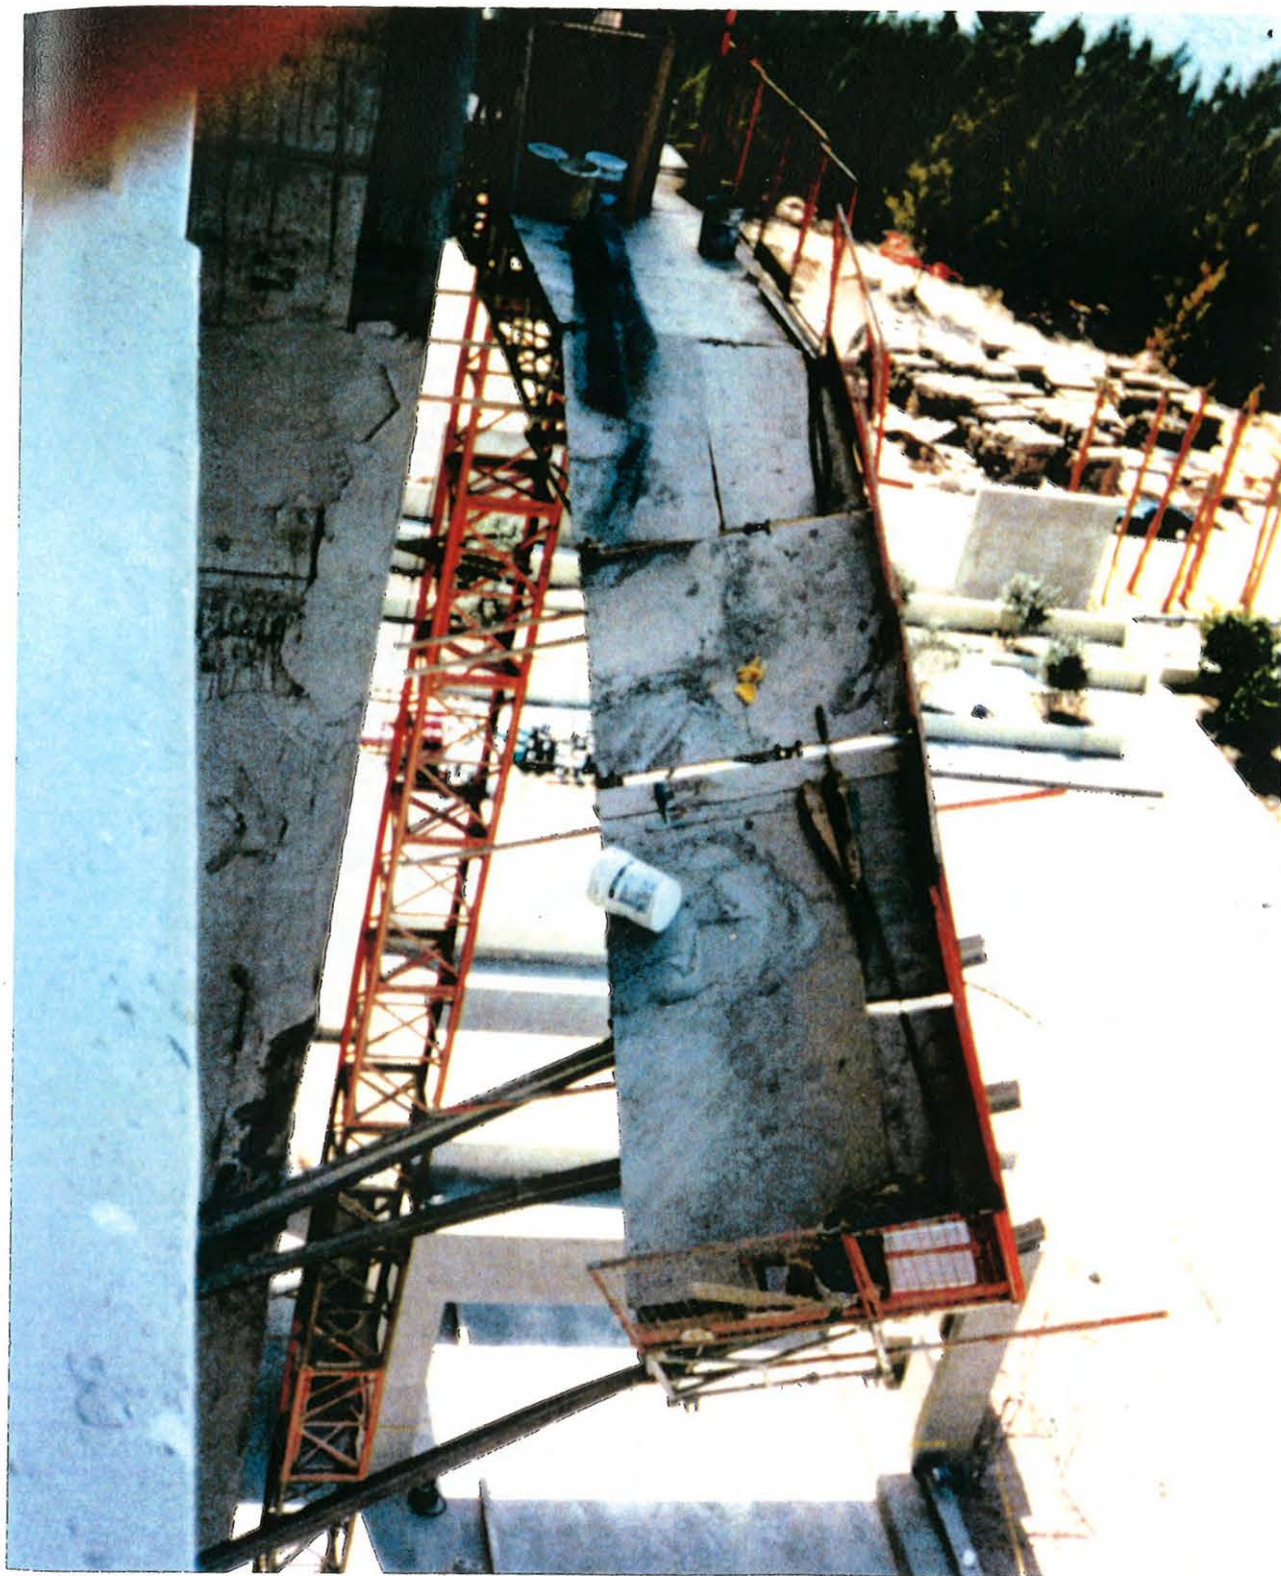
Figure 1.8

Deflection of the Platform Extensions and Cantilever Decking  
Relative to the Main Platform (Looking South)

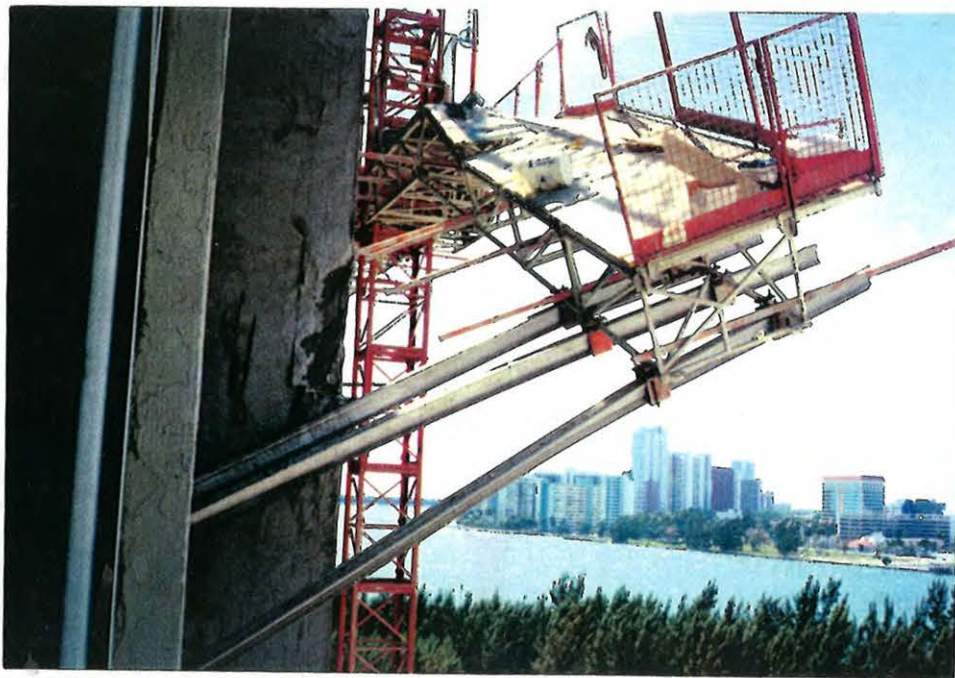
Figure 1.9

Rotation of the Platform Extension Relative to the Main Platform  
(Looking South-southwest)

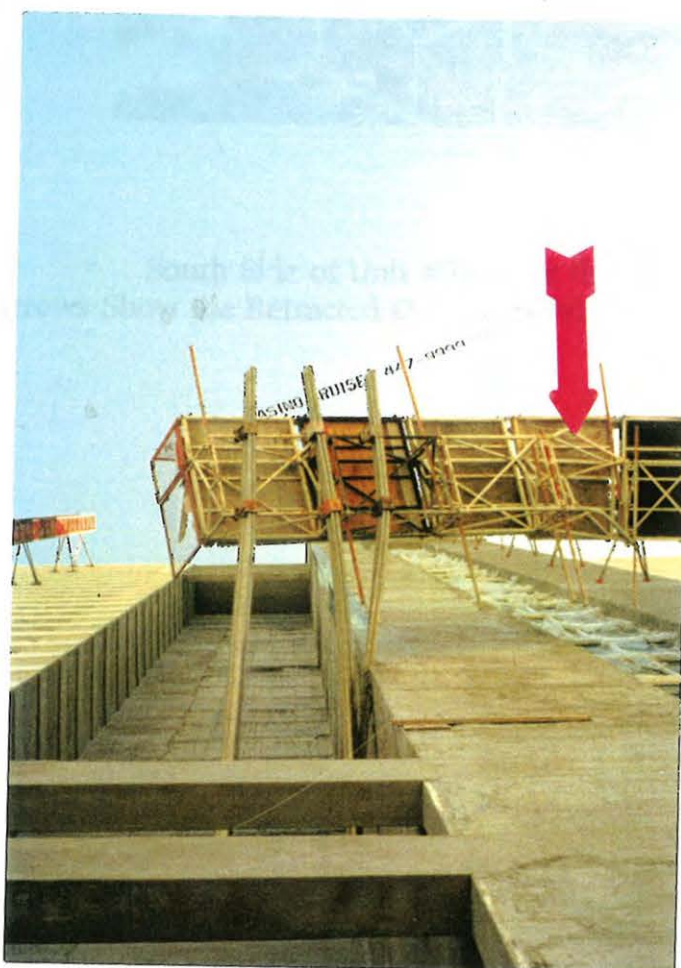
**Figure 1.11**

**Outriggers Attached to Bottom Chords of NPE3 and NPE4 (Looking Up)  
Arrow shows Buckled structural Members of NPE1**

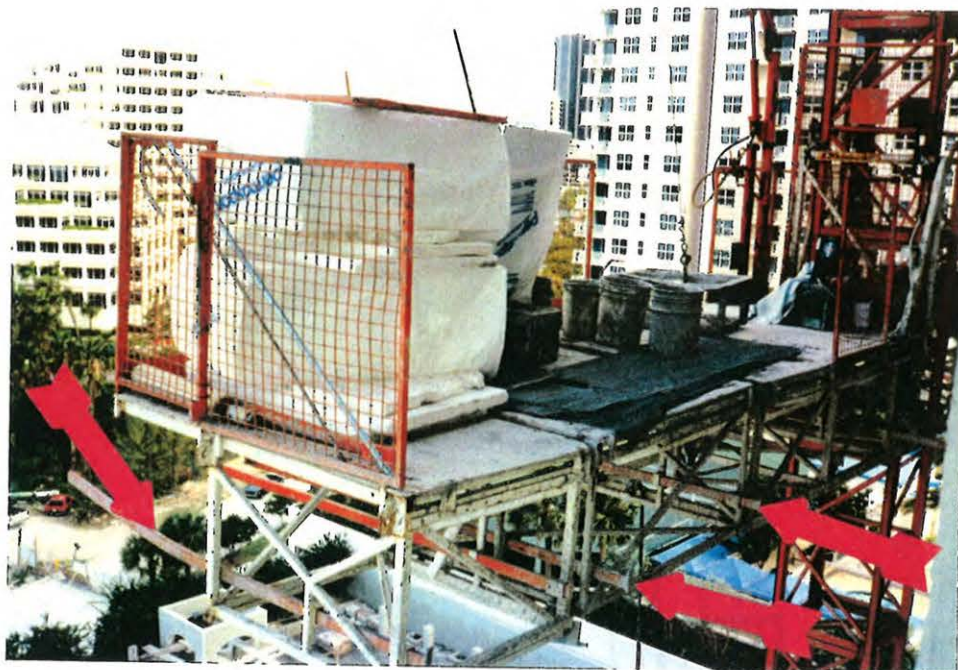
**Figure 1.12**

**South Side of Unit #78 After the Event (Looking Northwest)  
Arrows Show the Retracted Outriggers Which Support the Scaffold Plank Walkway**

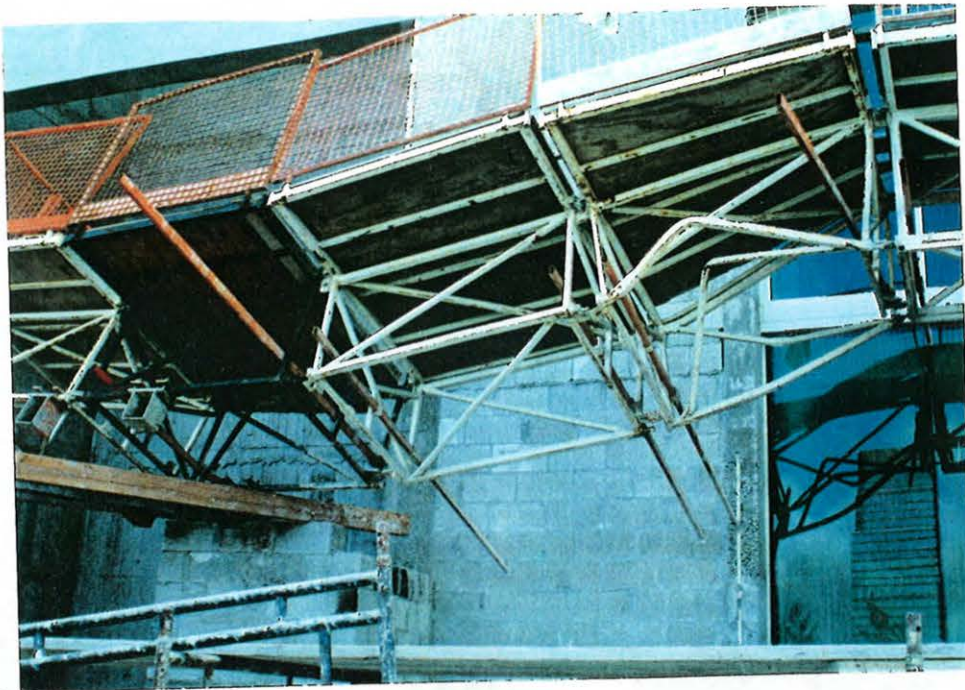
**Figure 1.14**

**Buckled Tubing Members on Bottom Side of North Platform Extension 1 (NPE1)**

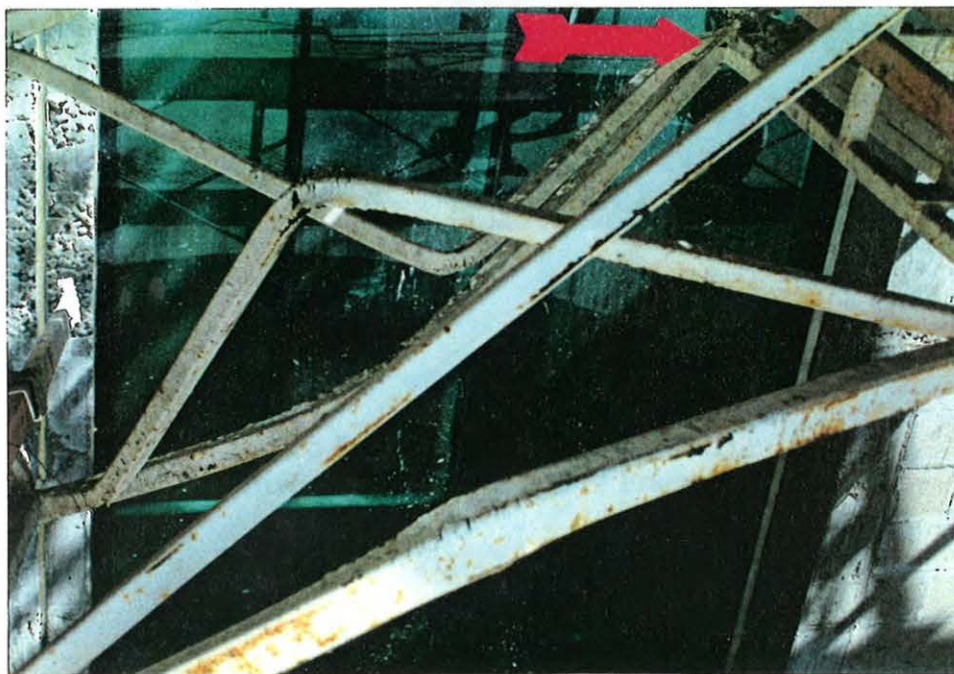
**Figure 1.15**

**Deformed Members of NPE1  
Arrow Shows Location of Fractured Members**

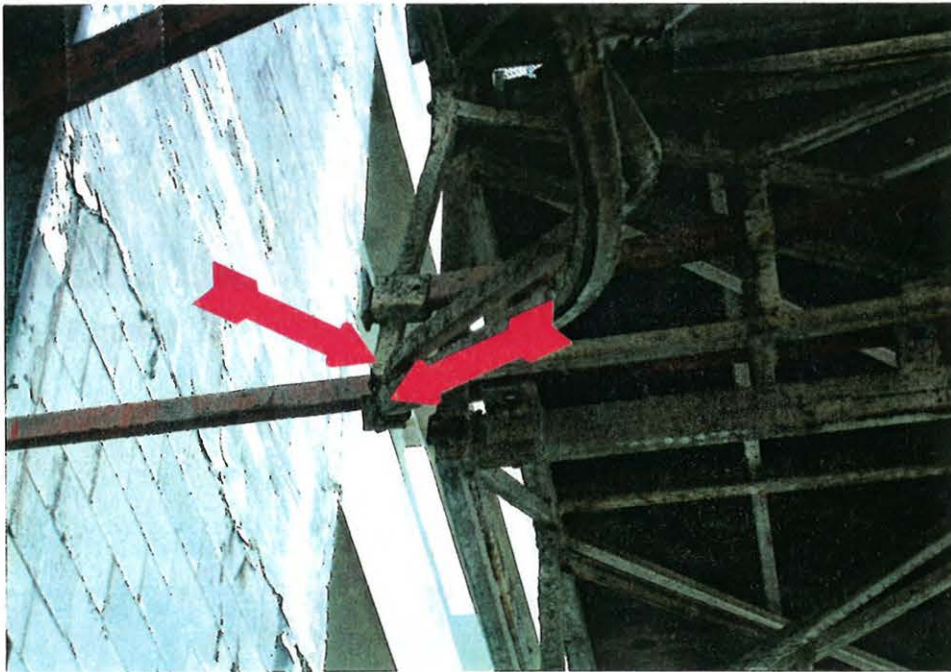
**Figure 1.16**

The first platform extension to the north of the main platform (NPE1) exhibited signs of failure. Two fractures occurred in the structural tubing of NPE1. The location of the fractures was in the bottom south corner of the east plane of the NPE1. The fractures occurred in the vertical and horizontal members close to the corner intersection. The following tubing members were buckled: 1) both bottom horizontal members running north-south buckled to the west; 2) bottom horizontal plane diagonal member buckled in upward direction; and 3) east face (plane) diagonal member running from top to bottom buckled in a westerly direction. Figures 1.14 and 1.15 are photographs showing the NPE1 structural tubing and its deformation. Figure 1.16 is a photograph of the two tube fractures described above.

**Two Fractured Members of NPE1  
Arrows Depict Location of Fractures**

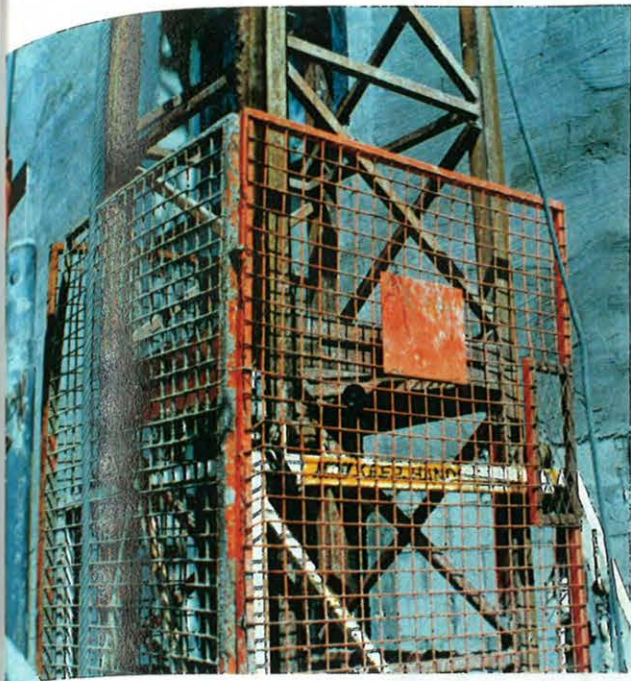
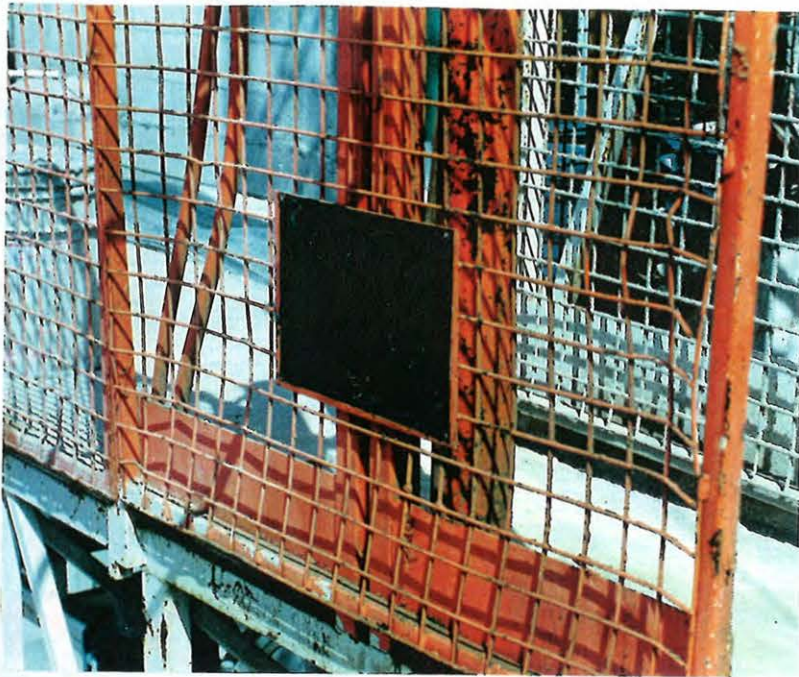
**Missing Placarding From Designated Locations**

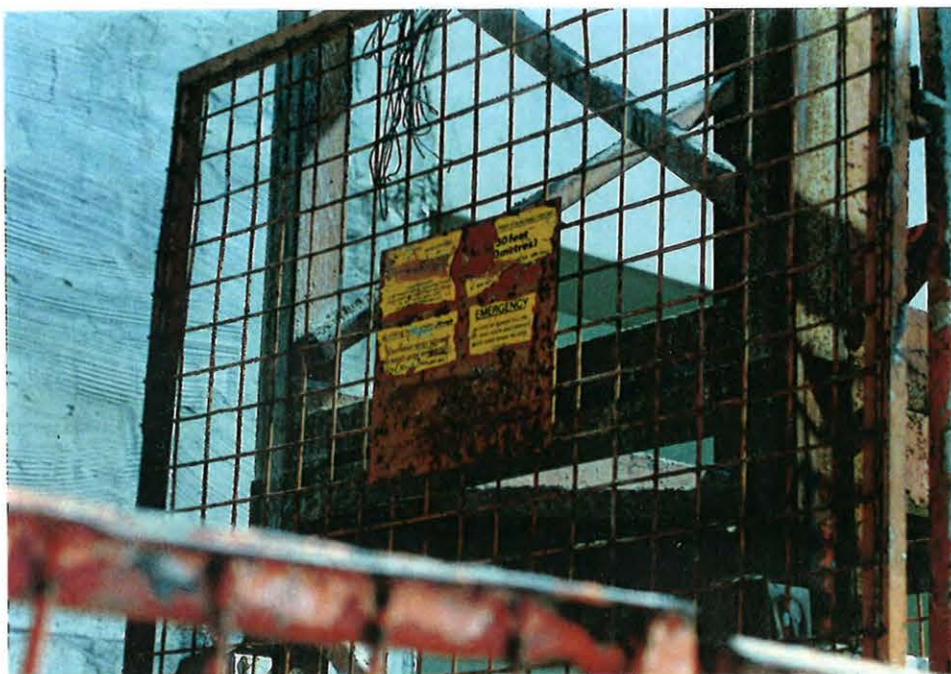
**Figure 1.19**

**Illegible Placard on North Side of Mast Unit #78**

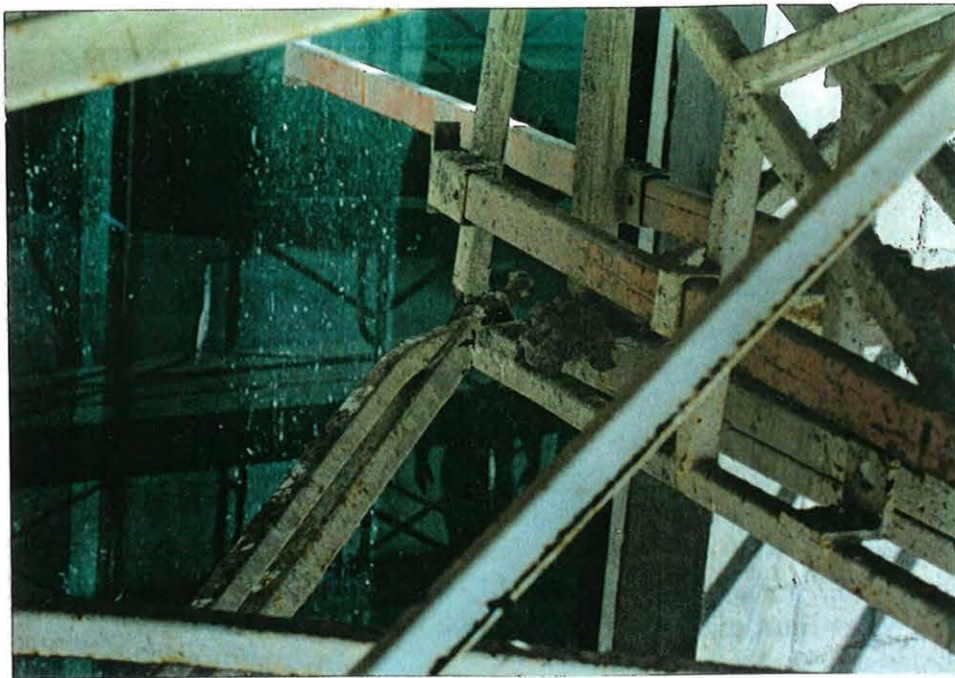
The South-East vertical member fractured at the connection.

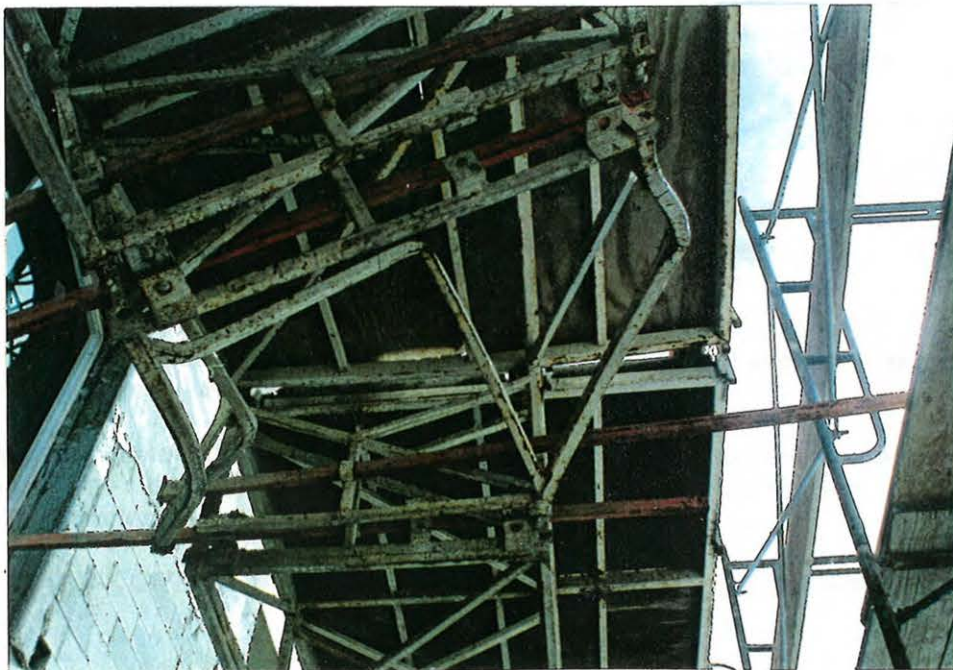
The buckled members at the first platform-extension  
Fig. 4.9

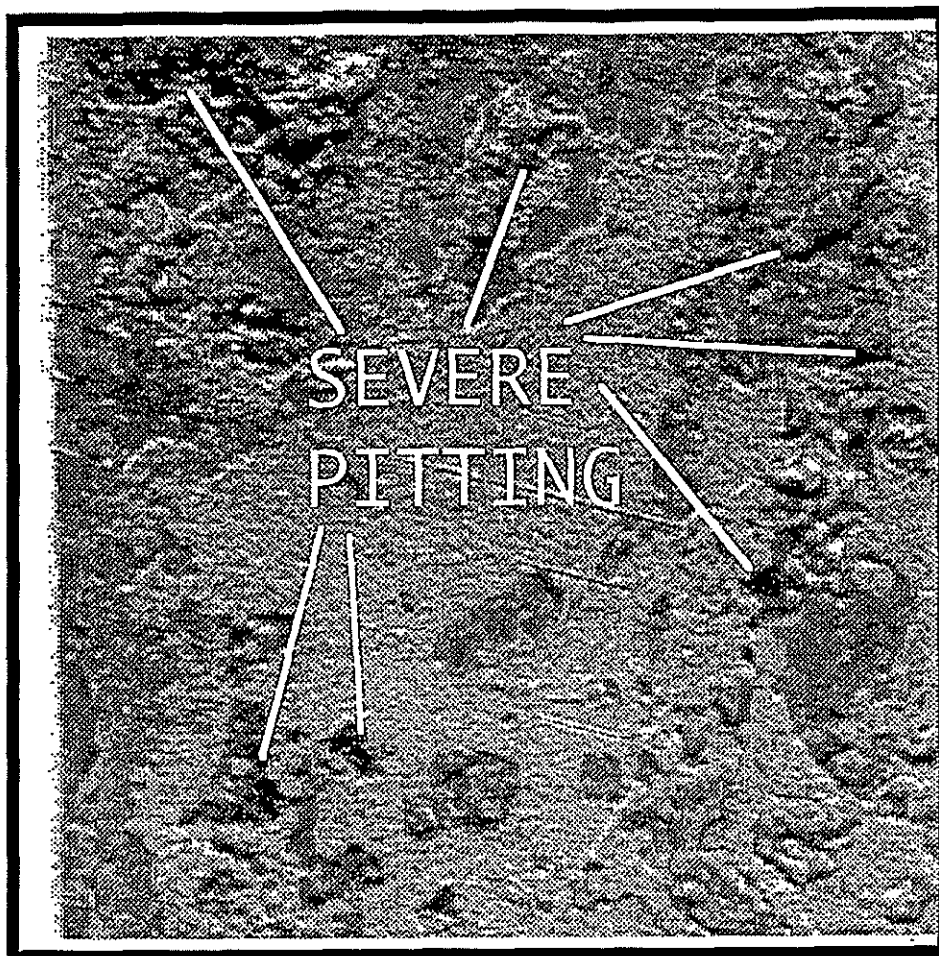
**FIGURE 4**

## **SURFACE CORROSION & PITTING**
