**Investigation of the July 31, 1997 Collapse of the Parking
Garage Steel Framing at the Portland International Airport
Portland, Oregon**

Office of Engineering
Directorate of Construction
Occupational Safety and Health Administration
US Department of Labor
Washington, D.C.

January 1998

**This report was written by
Mohammad Ayub, PE
Fragrance H. Liu, PE**

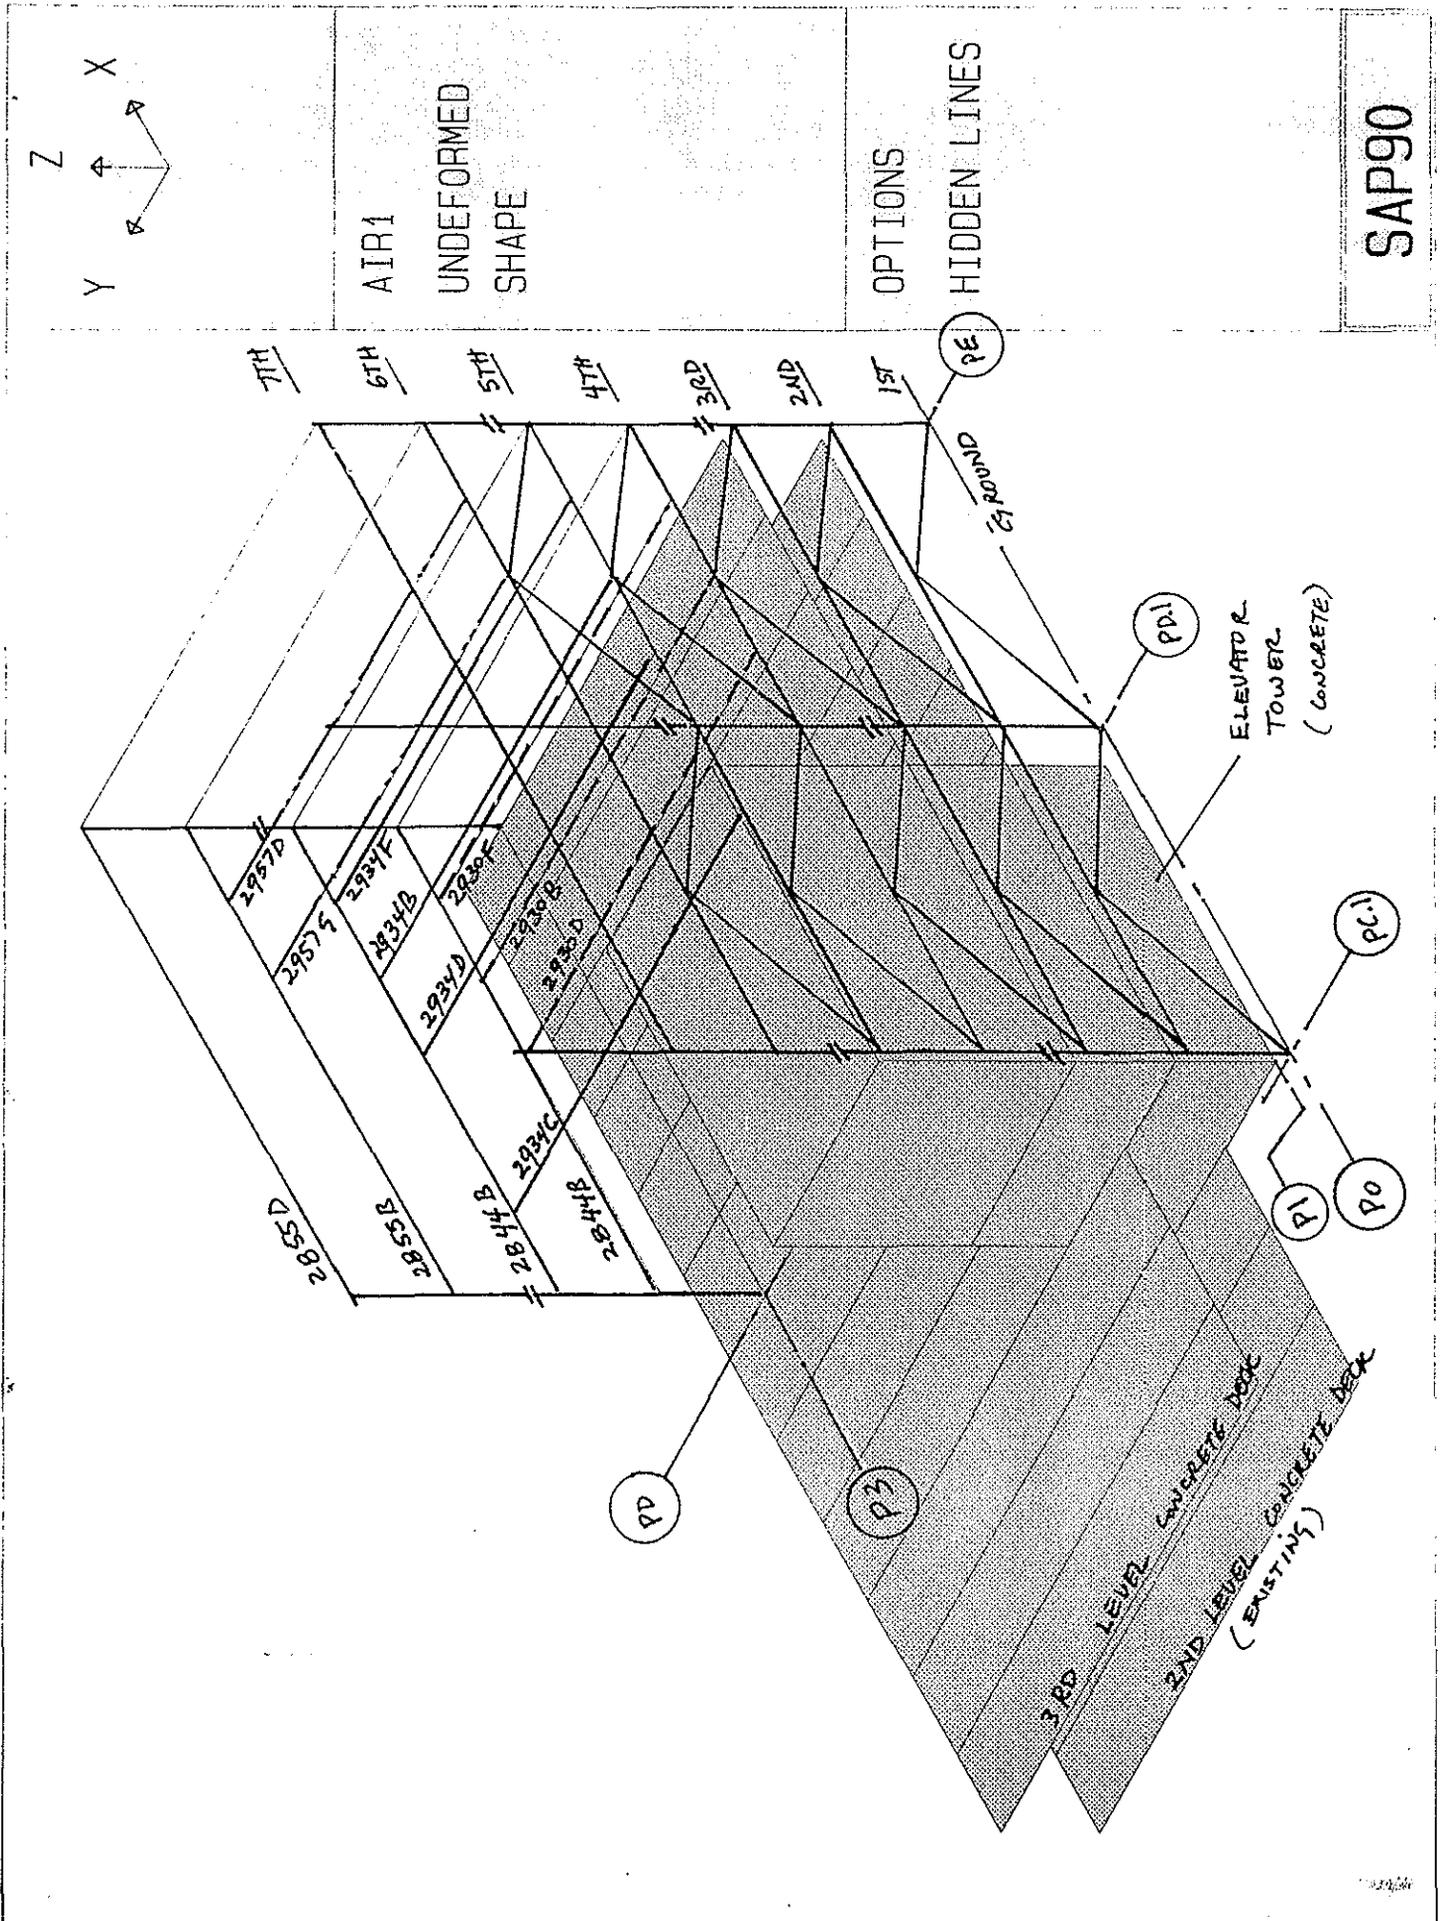
Fig. 2

and 2226B and were also of the same lengths as the previous columns mentioned. The column at P3-PD consisted of two pieces marked 2219A and 2219B, and were 19'-5" and 26'-7 5/8" long respectively. There were no beams framing in the east-west direction to the three columns. Figures 3 to 6 indicate the location of the beams framing at the time of the incident.

The above figures indicate that all three columns were unbraced in the east-west direction. For the entire length of 61'-2½" above the splice near the third level, the columns P0-PC1 and P0-PD1 were braced neither with any temporary erection bracings in the east-west direction nor with any beam framing directly to it at any level. The same was true for the column at P3-PD. The closest filler beam to column P0-PD1 and P3-PD was erected 10'-6" away at some levels.

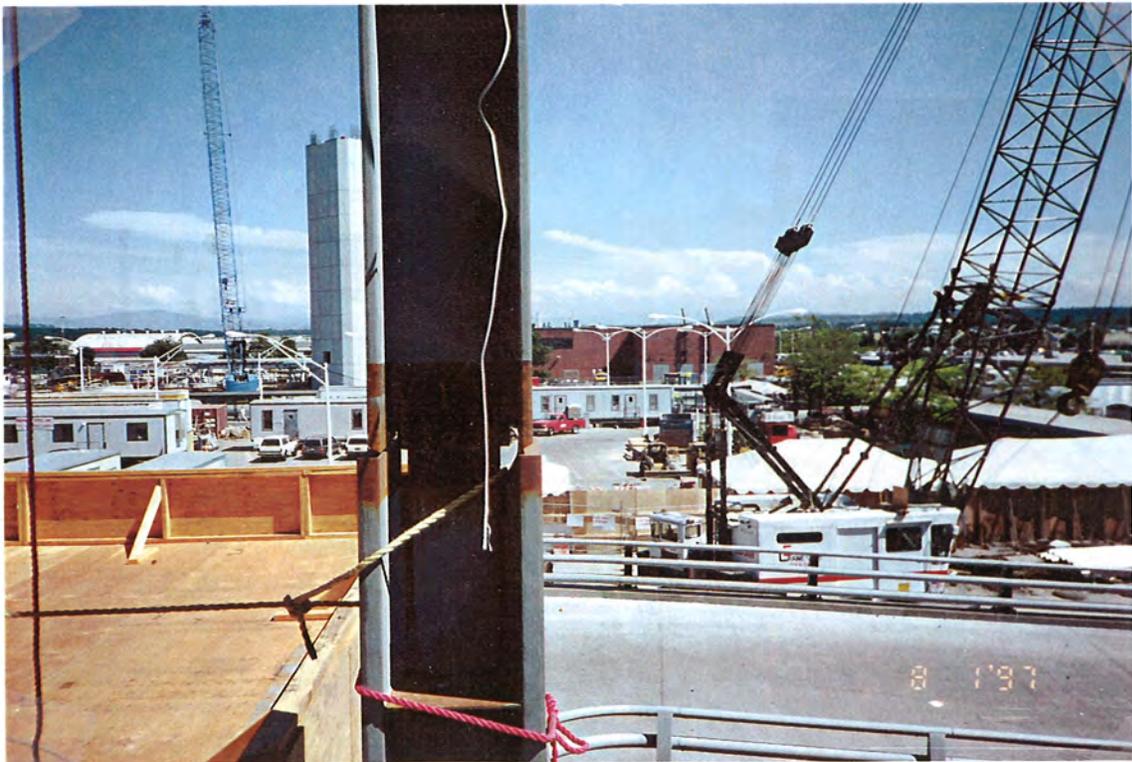
Fig. 7

At the application of the wind load of 10 mph and considering that the splice is only capable of resisting 10% of the column flexural capacity, the axial load and the bending moment at the base of the column PD-P3 about its major axis were computed to be 24 kips and 164 k" respectively resulting in a combined stress of 2.0 ksi. Under similar assumptions, the column P0-PC1 was subjected to an axial load of 30 kips and a bending moment of 110 k" about its minor axis. The column P0-PD1 was subjected to an axial load of 60 kips and a bending moment of 100 k" about its minor axis. If the effects of the column splices are ignored, the critical buckling load and the nominal flexural strength of the column PD-P3 were estimated to be higher than the imposed load. The columns at P0-PC1 and P0-PD1 were W14x90 (non-compact due to the flange criteria). The nominal flexural capacity of the columns was computed to be 3,700 k" about the minor axis against the actual imposed moment of 100 to 110 k". If the splices are ignored, the critical buckling load would be higher than the load imposed upon them. With the splices, however, the critical buckling load and the nominal flexural capacity of the columns could not be accurately determined due to lack of test data.

Column Splice Detail

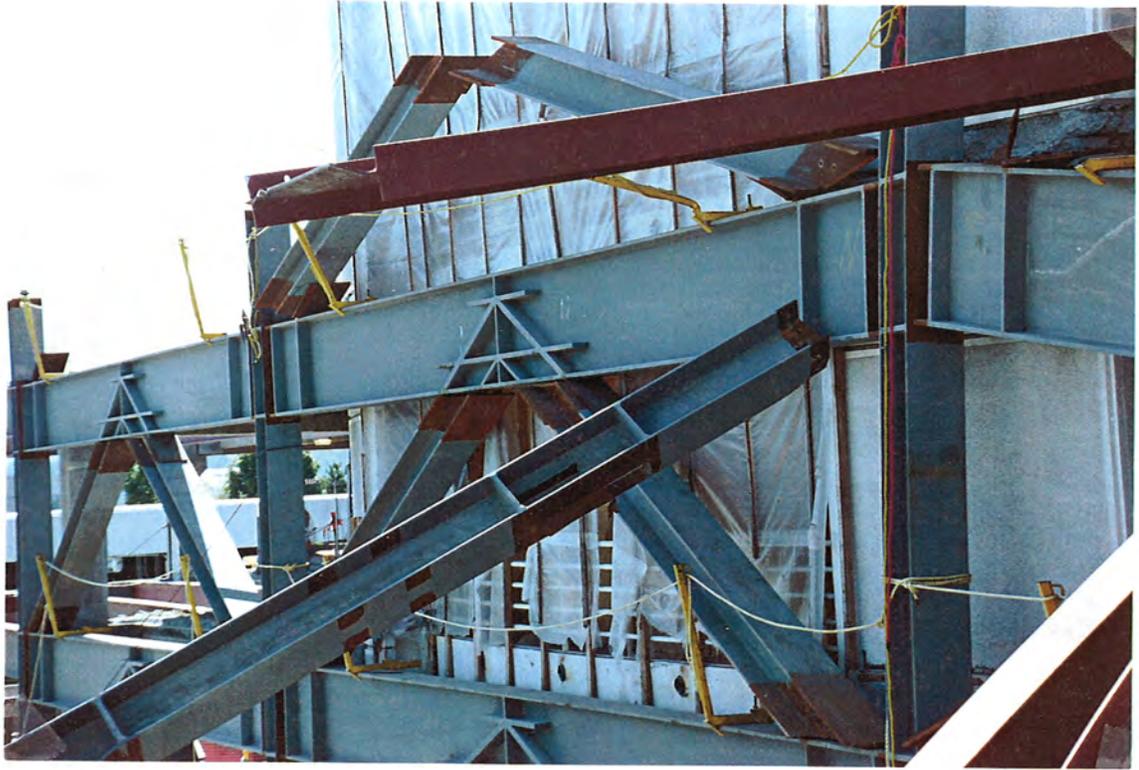
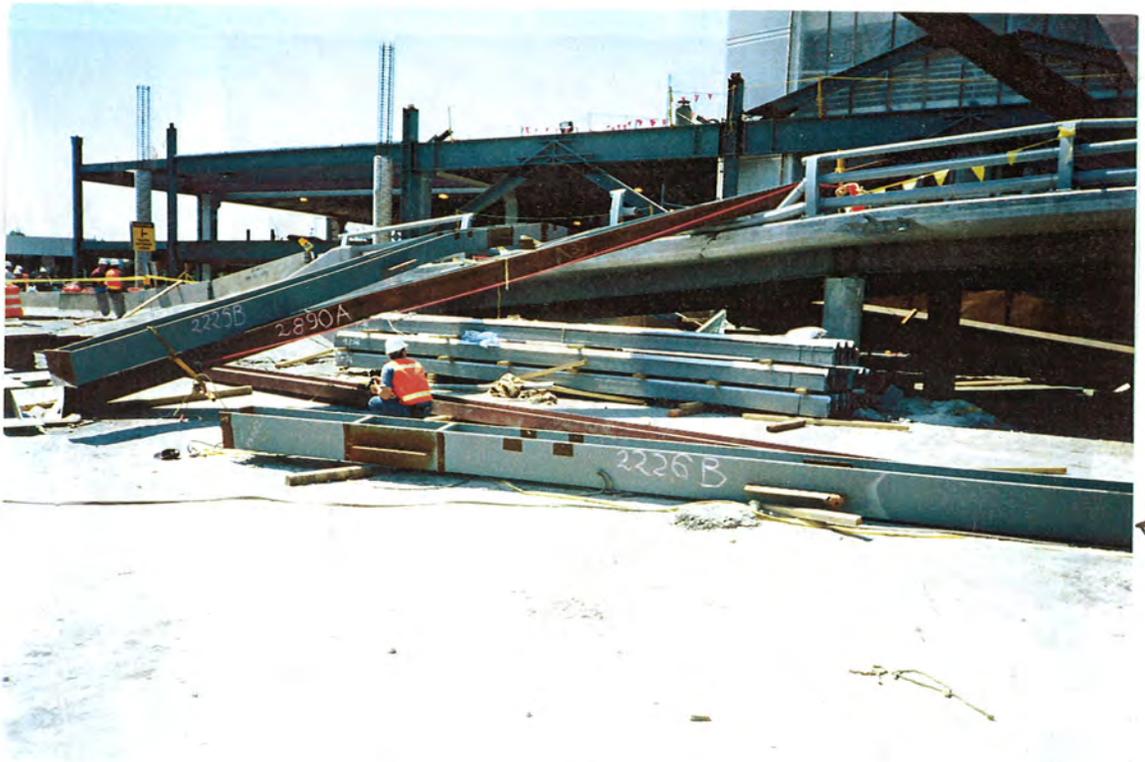
Fig. 8

All chevron bracings on the East face between P0-PC1 and P0-PE were erected up to the sixth level. The bracings between the sixth and seventh levels were to be installed when the incident occurred. As the crane hoisted one of the braces and was holding the load above the seventh floor a few feet from its final destination, the bay bounded by column lines P3 and P0 and column lines PC1 and PE collapsed in the easterly direction. All girders and filler beams above the third level fell. The columns located at P0-PC1 and P0-PD1 separated at the splice locations at the third level. The column located at P3-PD failed at its base where it was secured by anchor bolts. Three anchor bolts sheared and one was pulled out. See Figures 8 to 11.

↖ 2226A

← 2226B

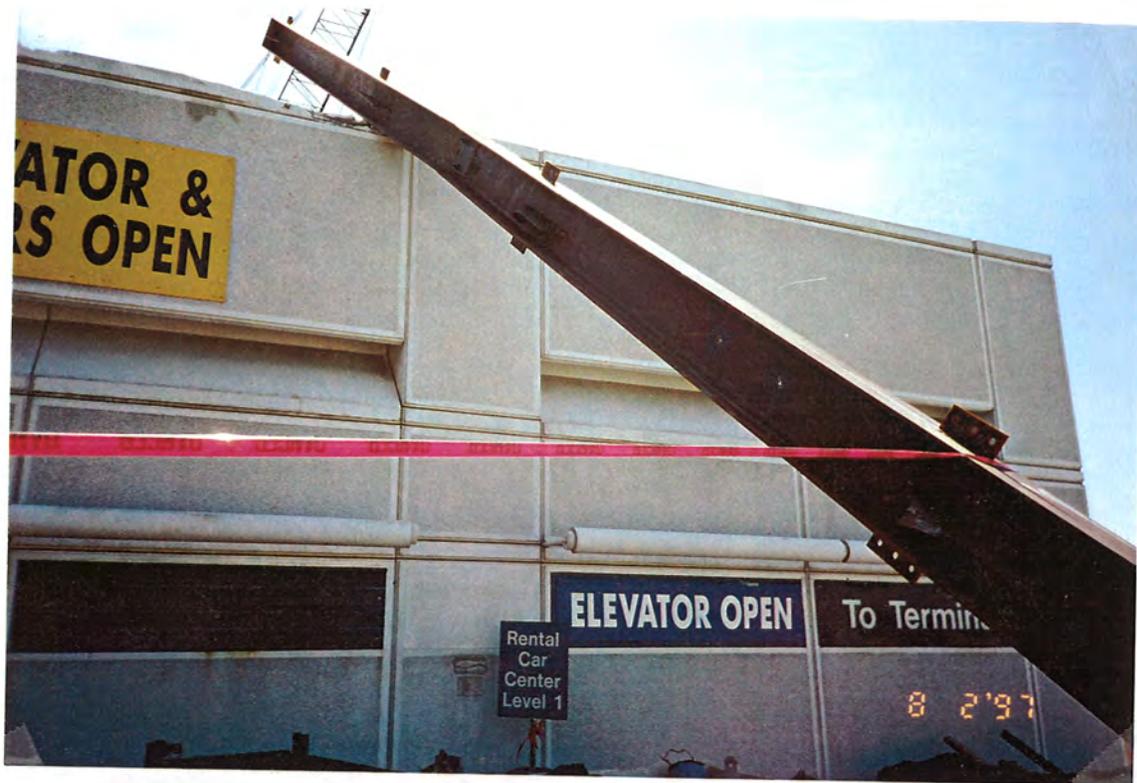
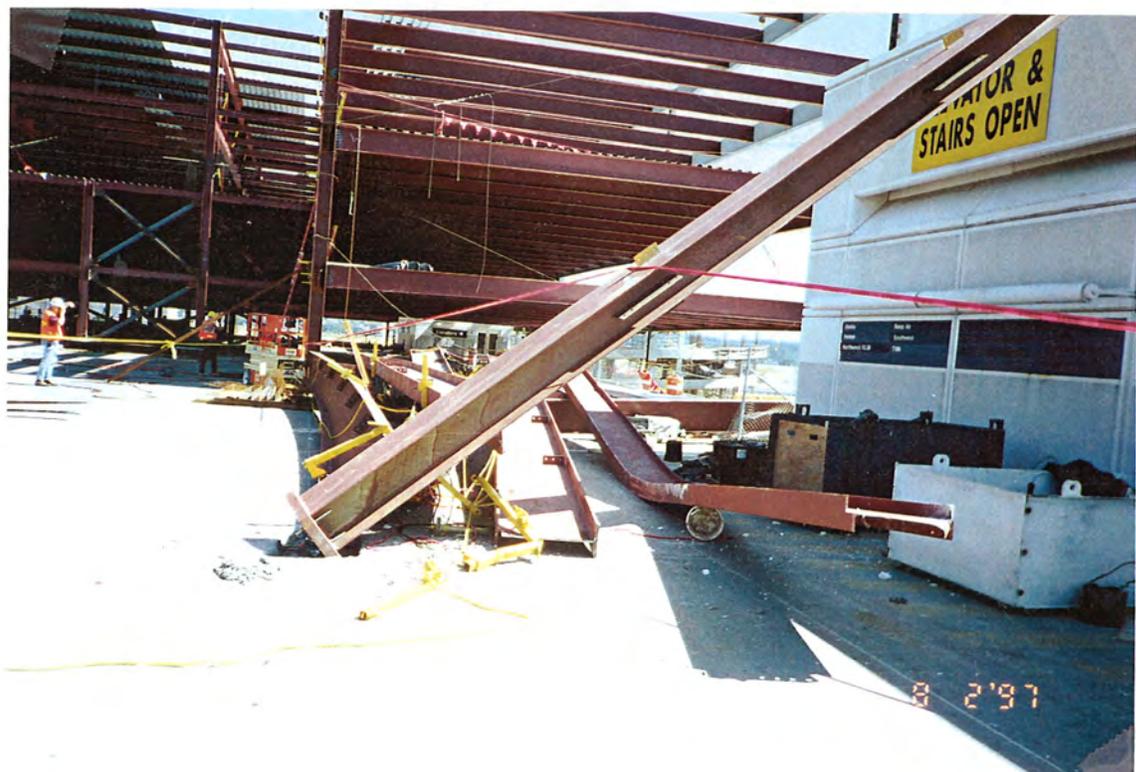
Fig. 10

←2219A&B

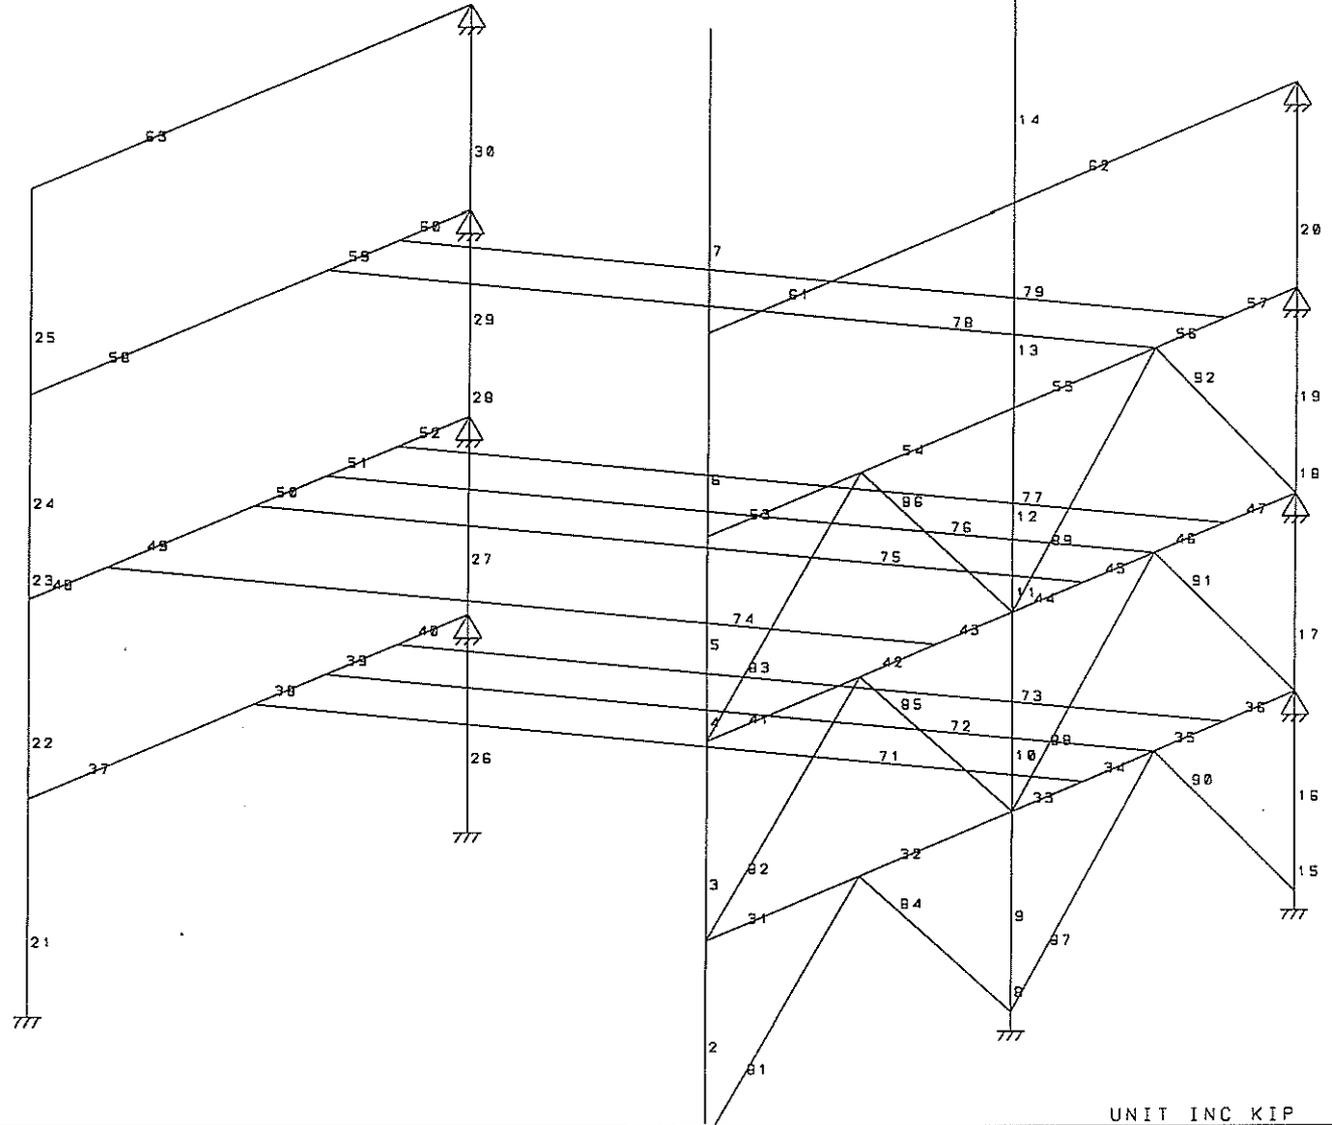
Fig. 12

Structural analyses of the steel framing bounded by columns lines PE, PC1, P0 and P3 were performed by using a finite element computer program, STAAD-III. The computer model consisted of 56 joints and 84 member elements, see Fig. 12. The bottom of the columns was assumed to be fixed at their bases at the third level. The east exterior columns were fabricated in two sections and spliced at locations of 3'-5 ½" above the 3rd and 5th floor levels as discussed earlier, and the interior column at the column line PD also was spliced at the same elevation above the 5th floor level. Since the column splices were secured by temporary measures consisting of two erection bolts, a joint was created at the splice locations capable of resisting only approximately 10% of the column flexural capacity. All beams were modeled as hinged at each end. The north columns on line PE were modeled without any translational freedom in the north-south and east-west directions.

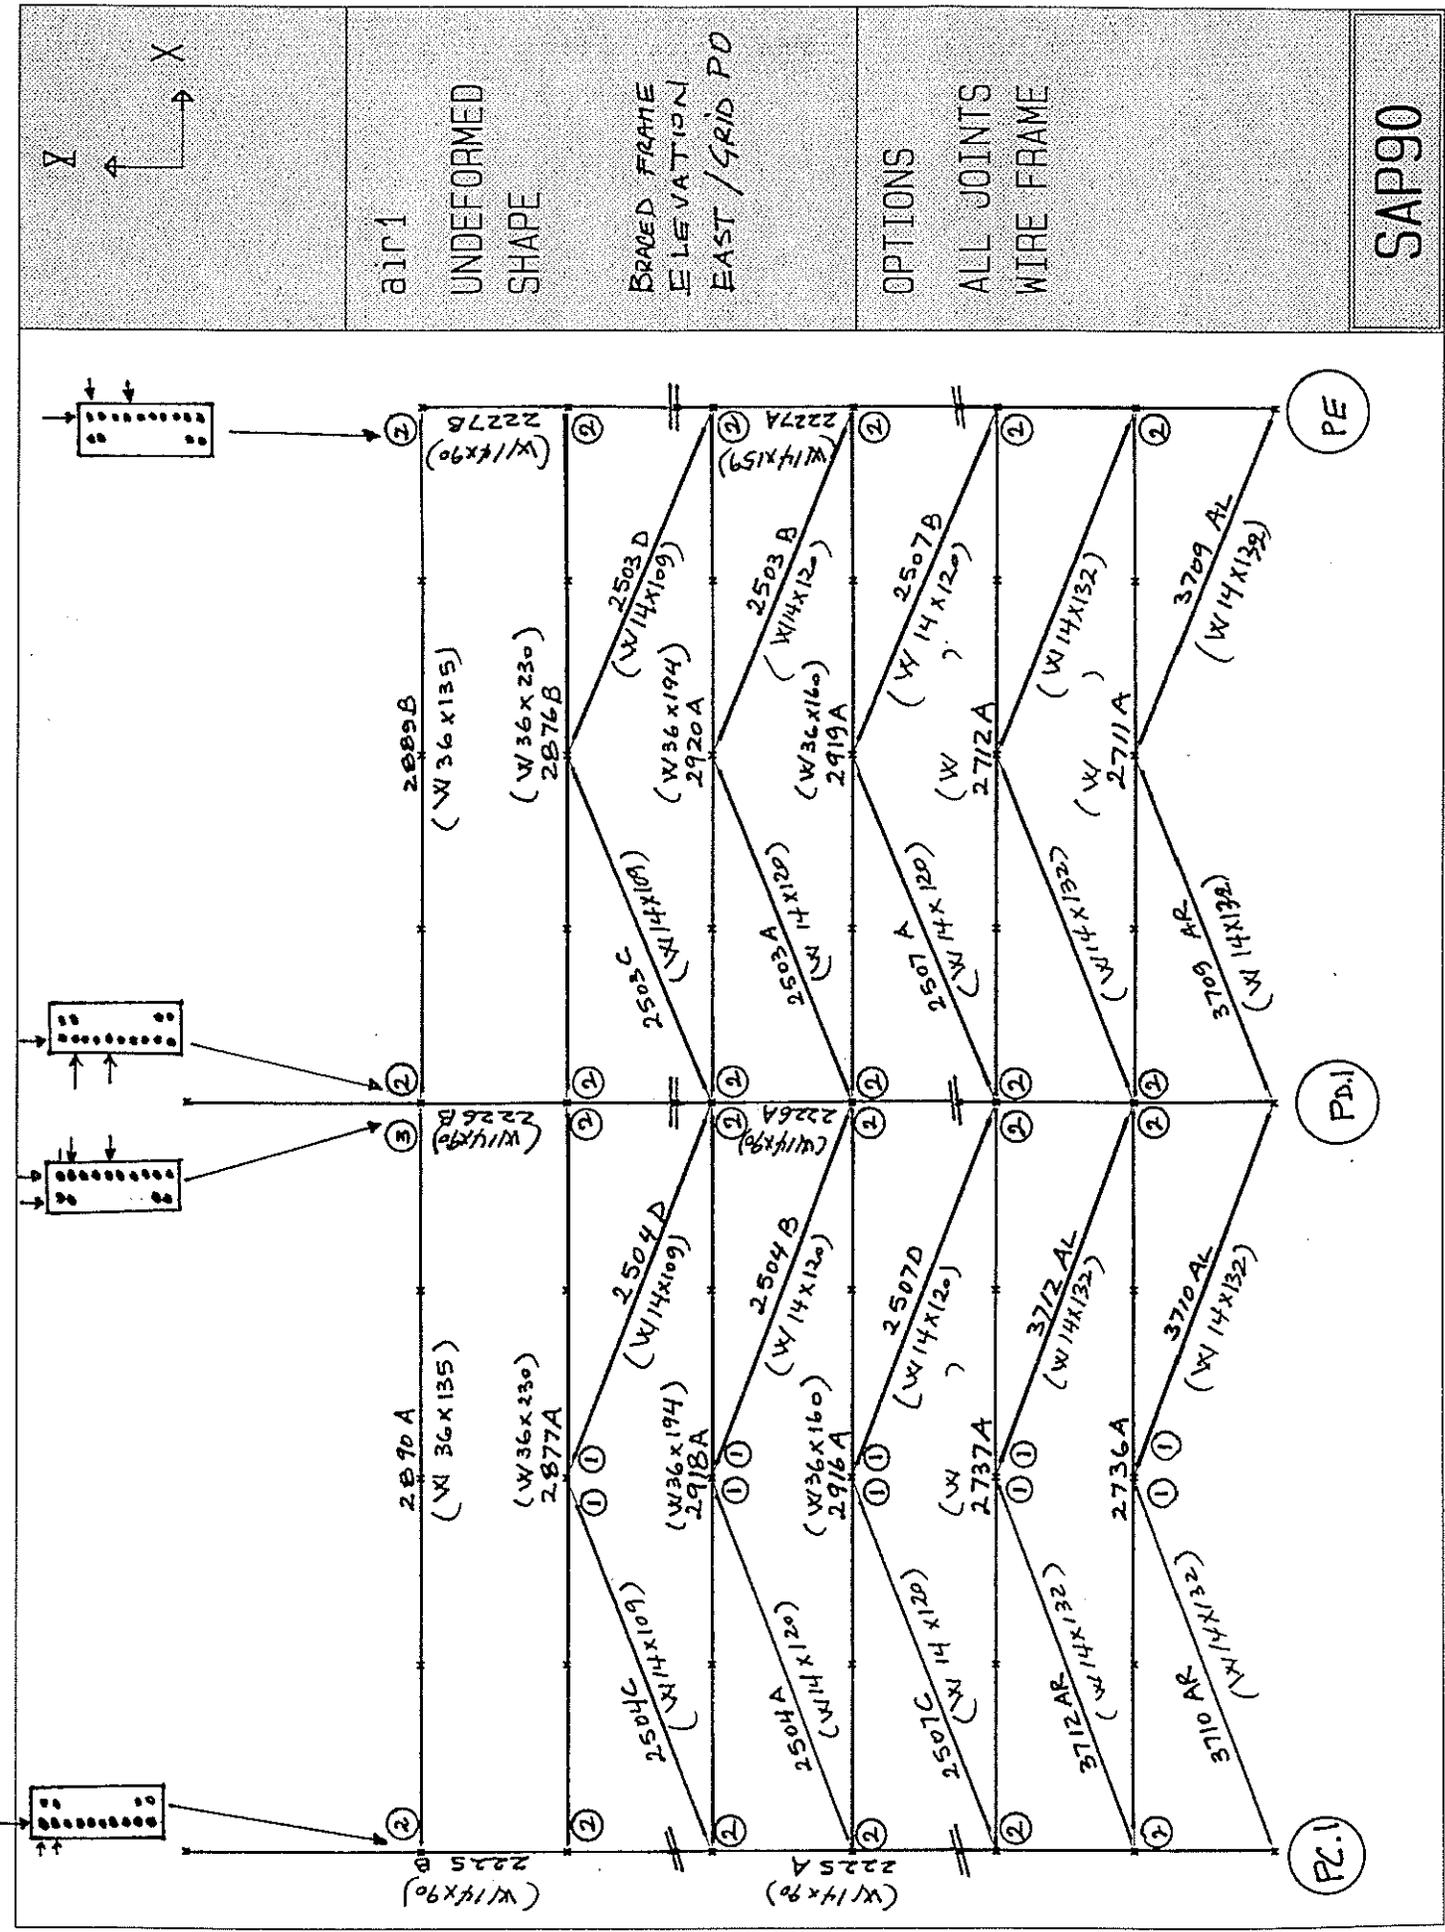
The above analysis was performed based on the assumption that the structural framing was in fact plumb and square. This assumption will be discussed later in detail. The field observation made by the OSHA's investigating team following the incident revealed that the connections of the girders to the columns were made by two bolts with the exception of the north end of the girder marked 2890A which had three bolts. The connections of the east-west filler beams to the girder were all made by one bolt only at each end and the connections of the chevron bracings to the exterior girders were made by one bolt at the

upper ends only. These connections were assumed to be pinned in the computer model and the members were also assumed to be leveled. See Fig. 13 to 18 for number of bolts at each connection.
