Investigation of the April 5, 2011 Flow Equalization Basin Wall Collapse at Wastewater Treatment Plant in Gatlinburg, TN

U.S. Department of Labor Occupational Safety and Health Administration Directorate of Construction

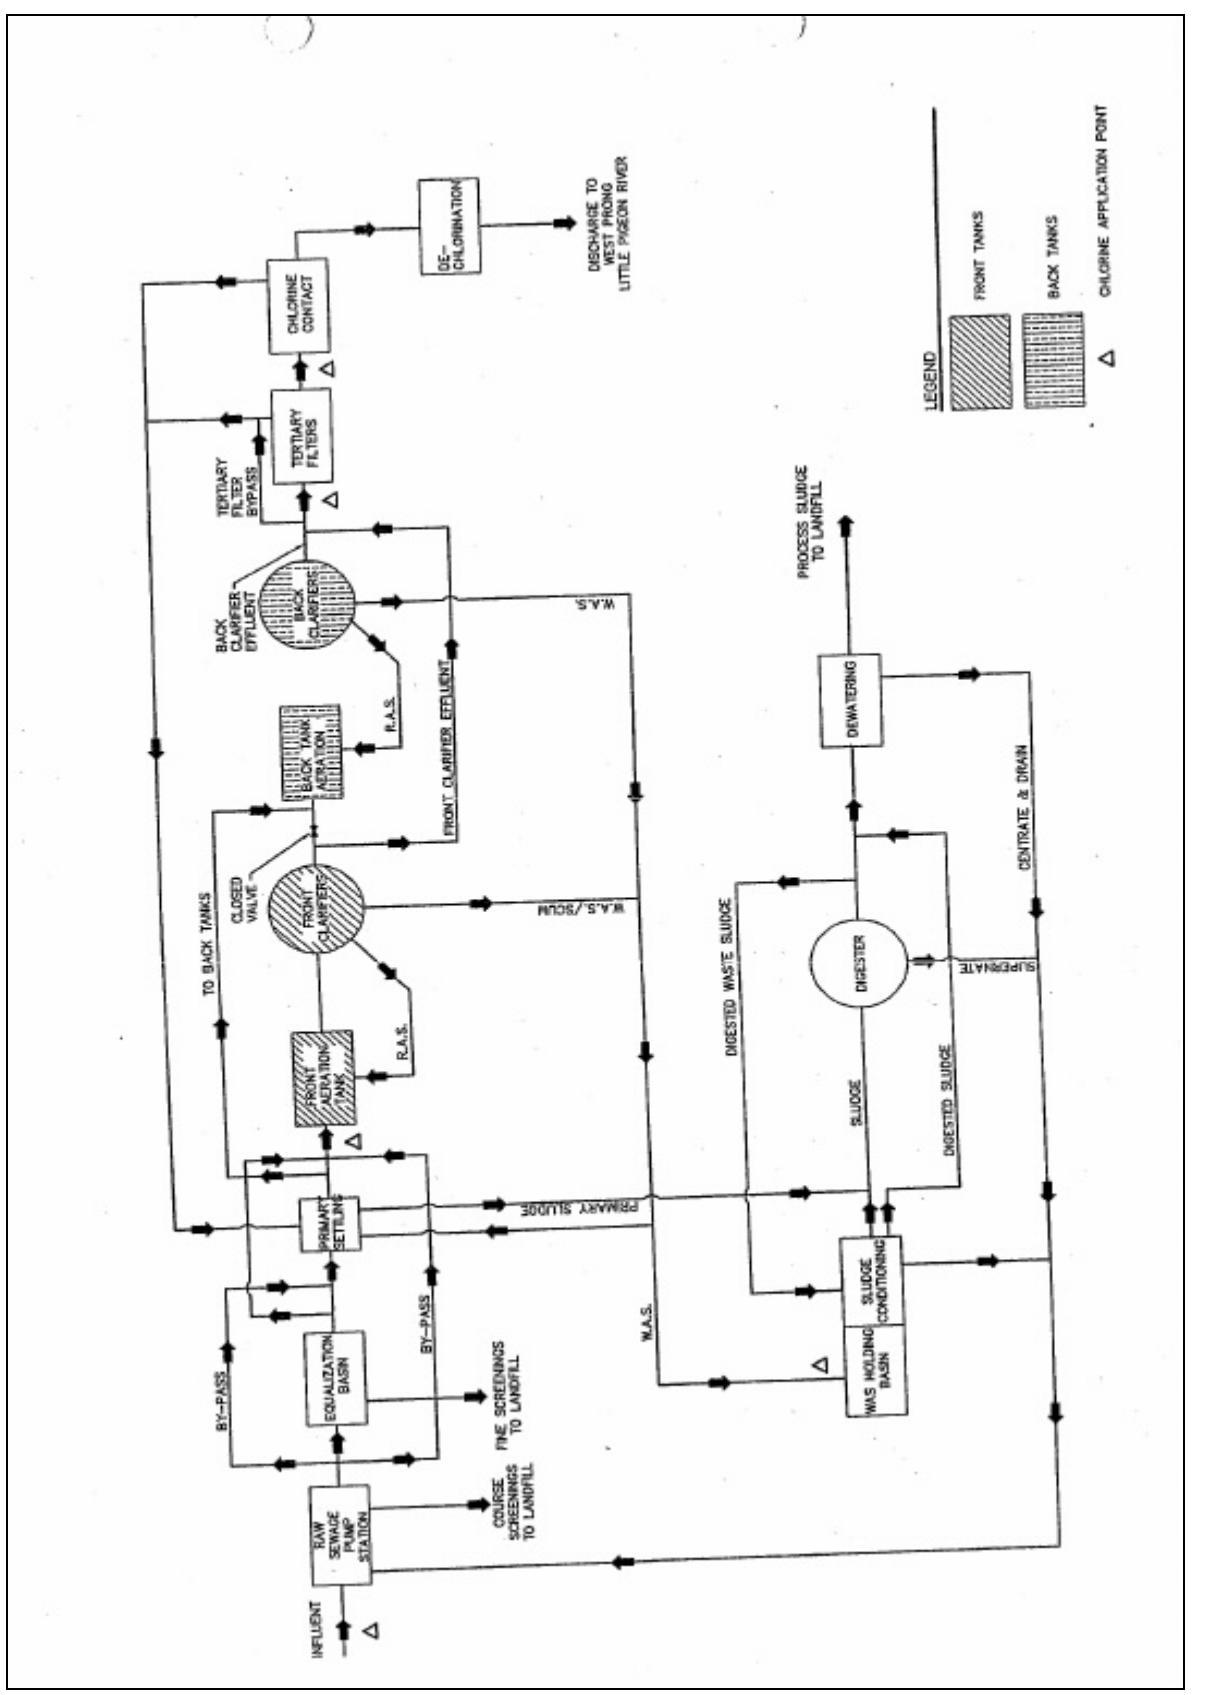
Fig. 1 Process Flow Diagram
