# INVESTIGATION OF THE DECEMBER 16, 1999 FATAL COLLAPSE OF A REINFORCING STEEL CAGE AT THE PIER WB-12 OF I-895 BRIDGE IN RICHMOND, VIRGINIA

U. S. Department of Labor  
Occupational Safety and Health Administration

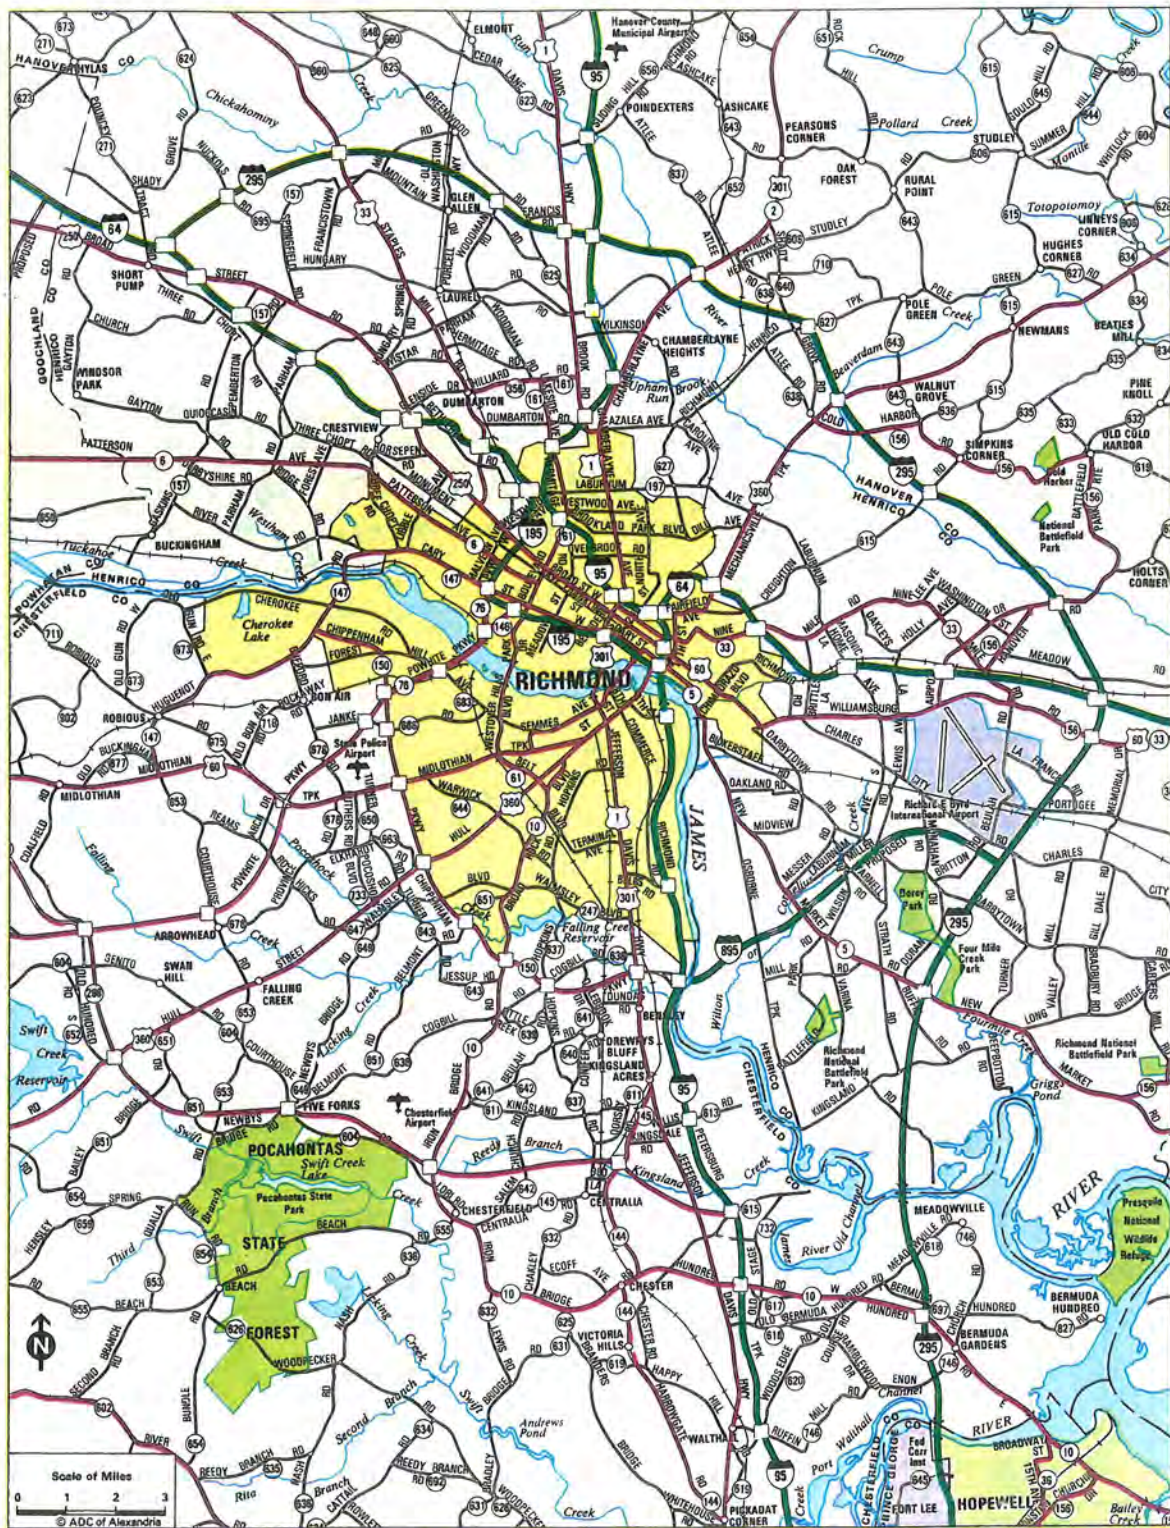
Figure 3-1 Project Location Plan in Richmond, Virginia (United States Road Atlas, by American Map Corporation, 1995).

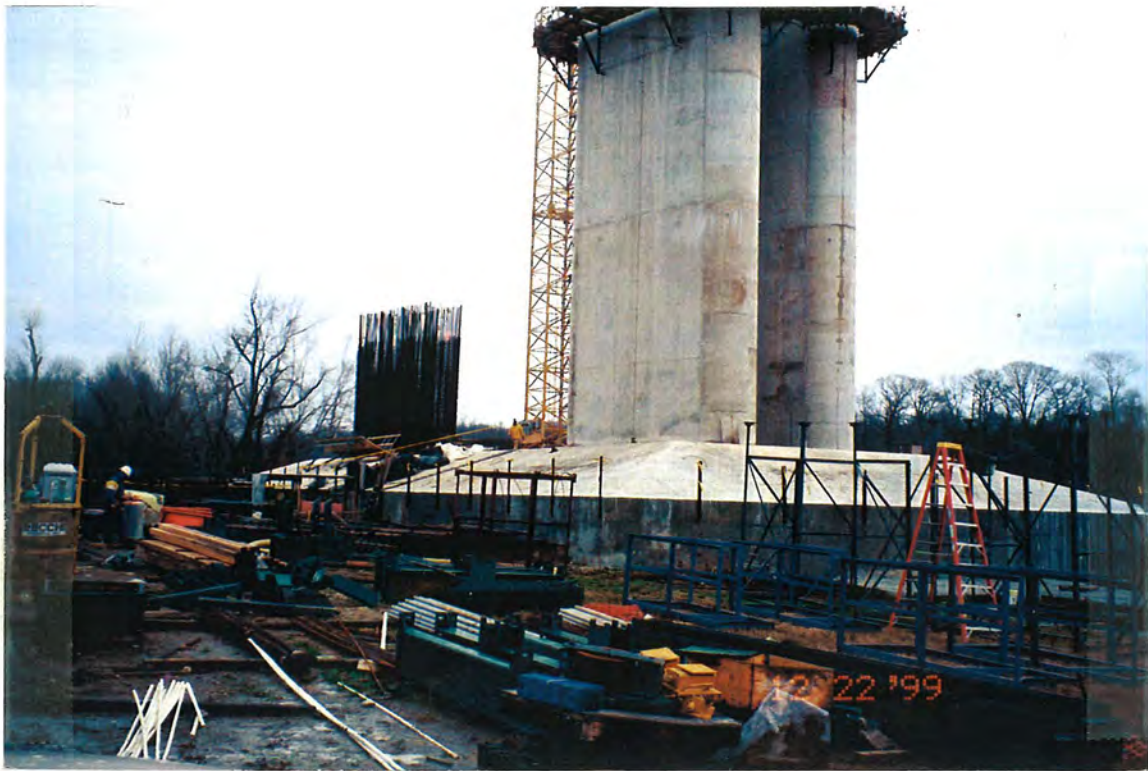
Figure 3-3 Site Condition around the Concrete Footing (Looking toward Northeast).

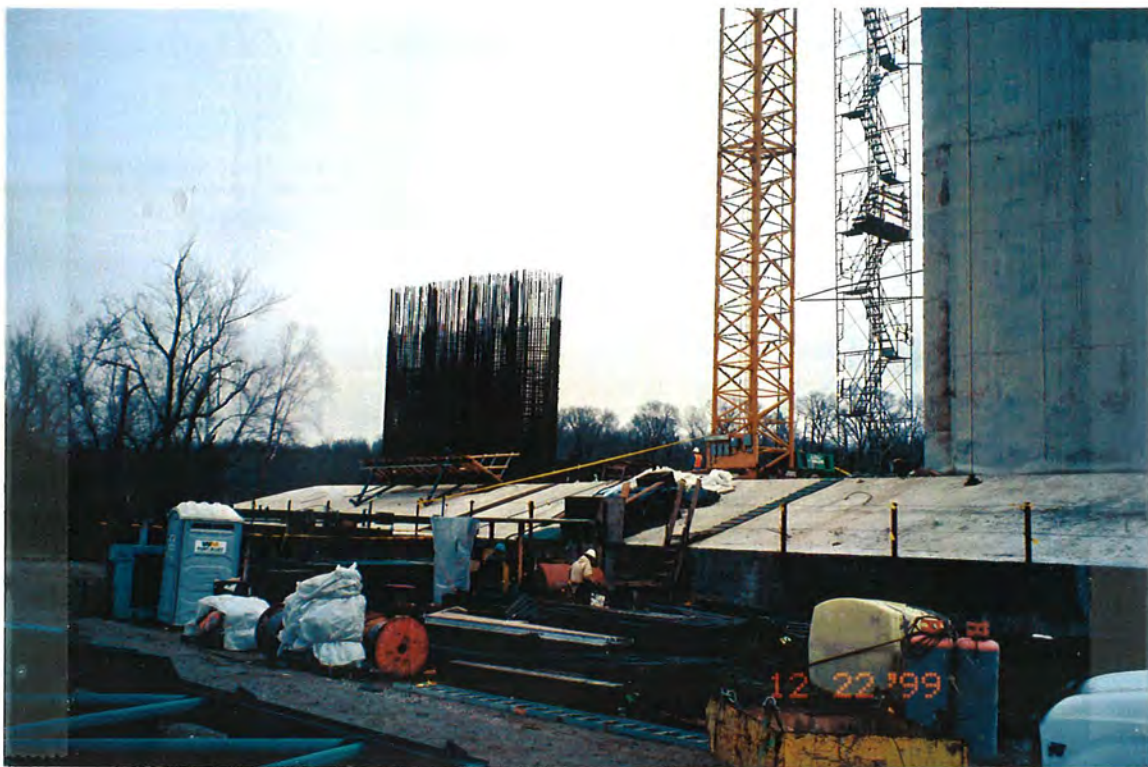
Figure 3-4 A Close-up View of Figure 3-3.

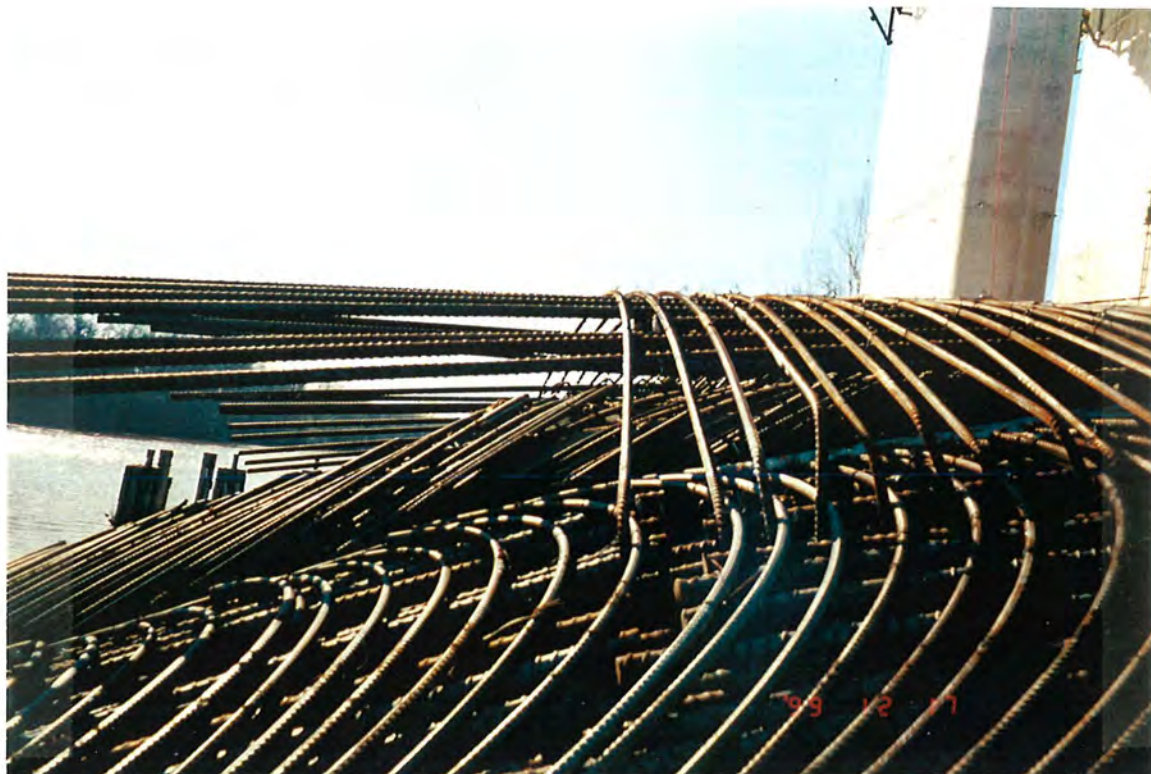
Figure 3-13 The Condition of the Collapsed Steel Cage at 23.5 Foot from the Bottom Fixed End (Looking toward South from the Concrete Footing).  
Please note the separation of the vertical reinforcements from the west face of the steel cage.

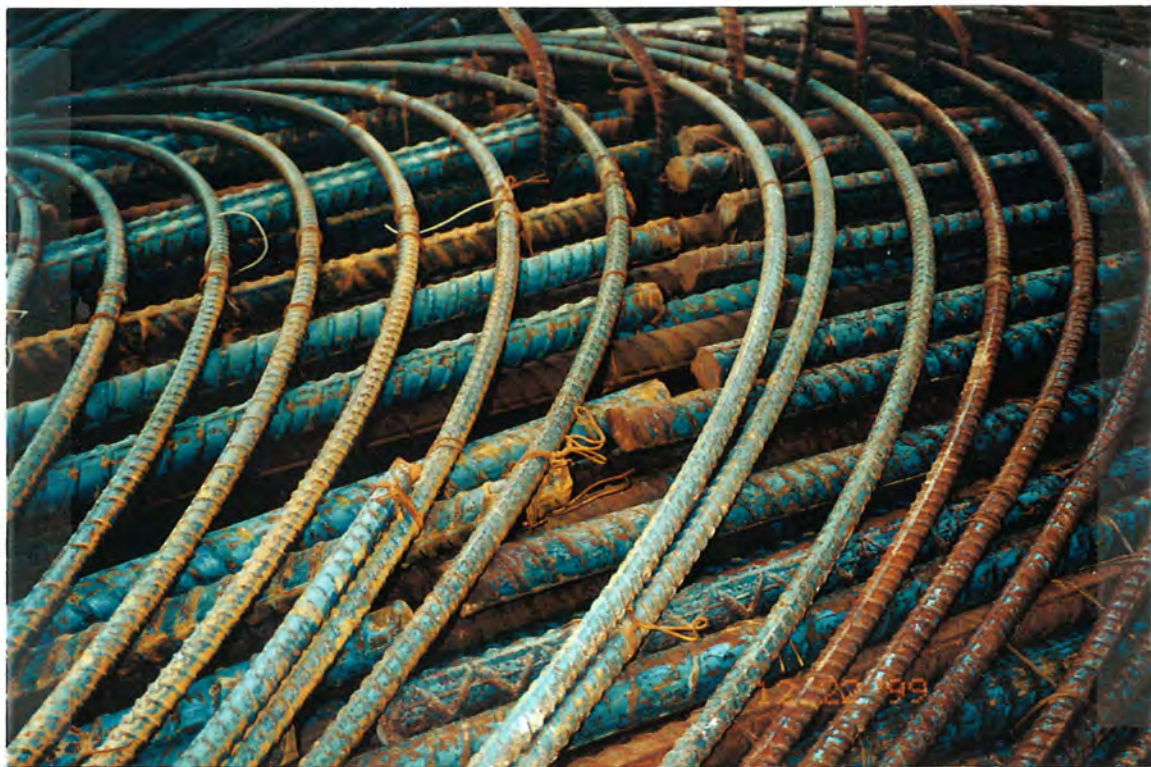
Figure 3-14 A Close-up View of Figure 3-13.

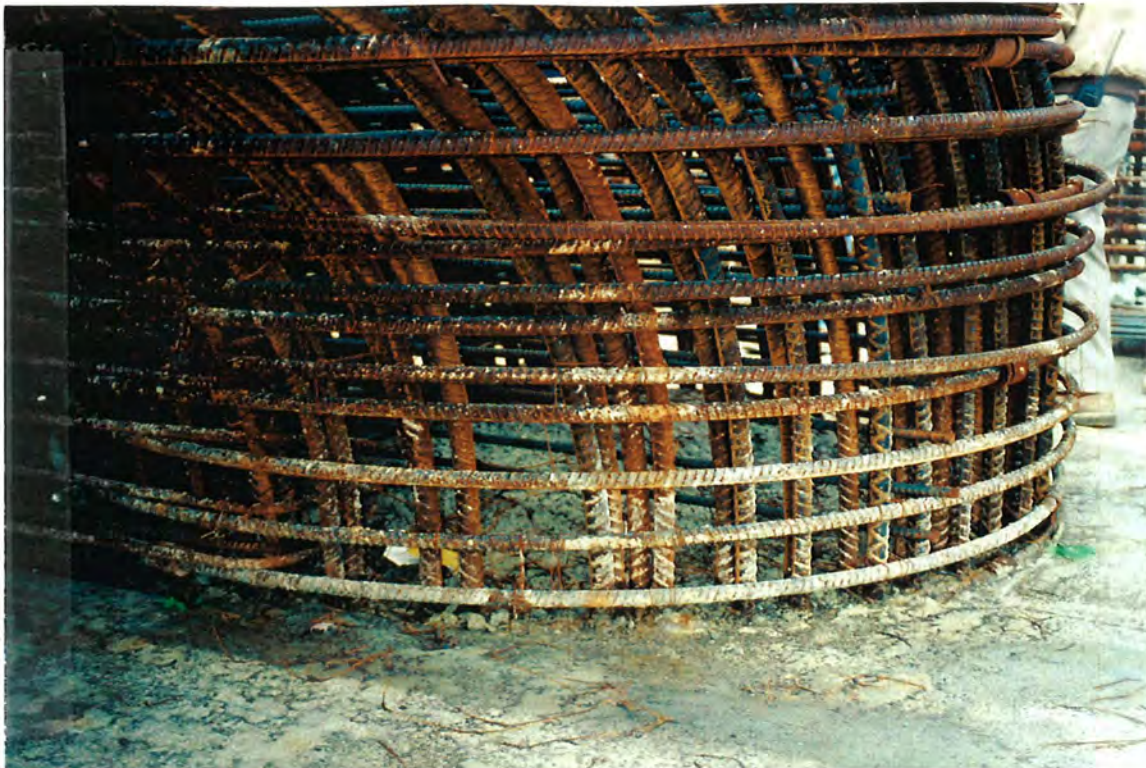
**Figure 3-15** The Condition of the Collapsed Steel Cage at its North Fixed End (Looking from the Concrete Footing).

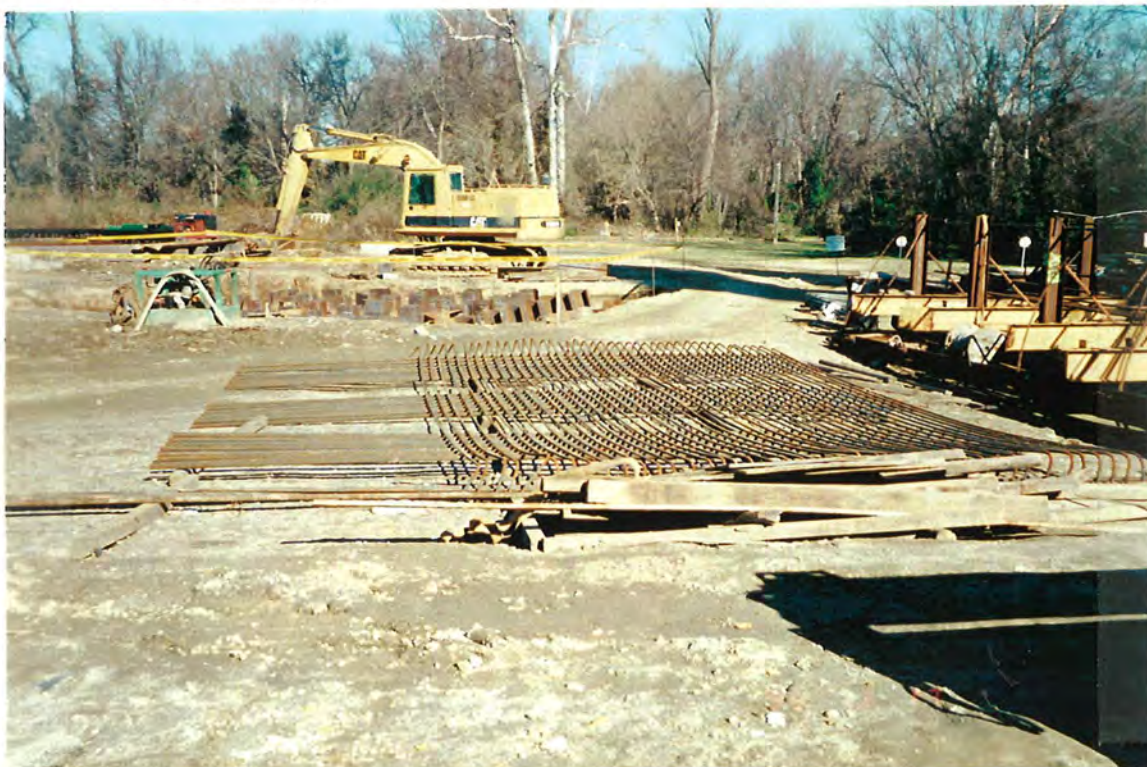
**Figure 3-16** The Last Section of West Face Extension Did Not Install to the Collapsed Steel Cage.

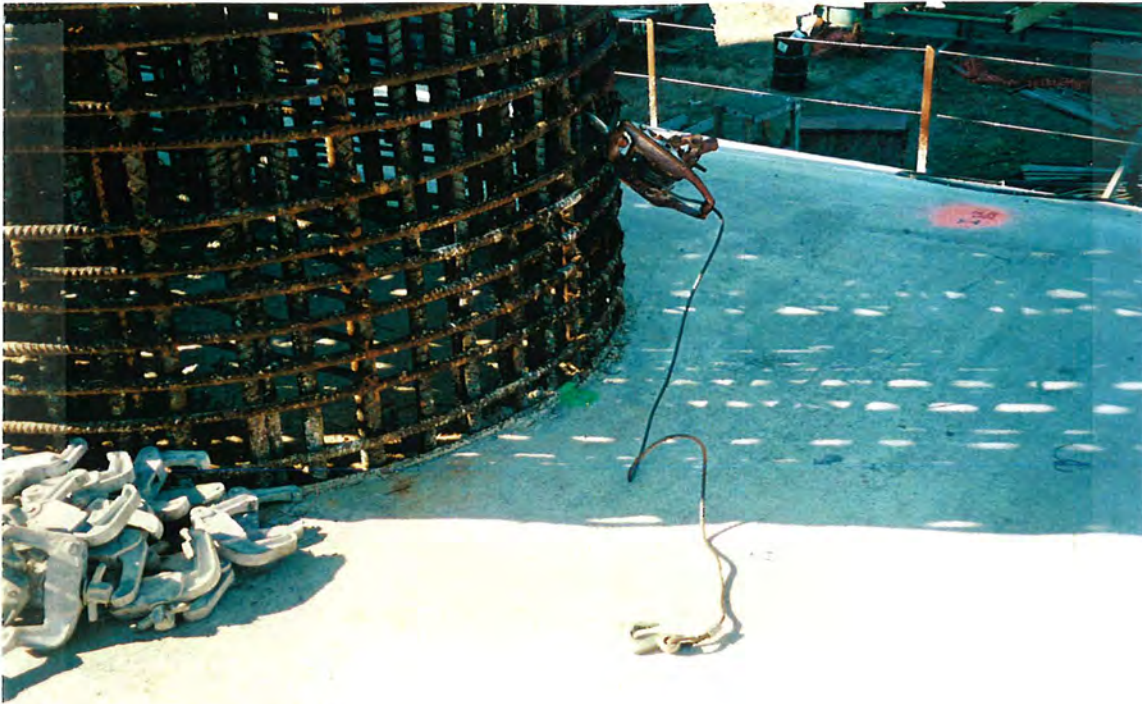
**Figure 3-17** The Lower Connection Point of the Northwest Guy Wire at the North End of the Steel Cage for Column 1 of Bridge Pier WB-12.

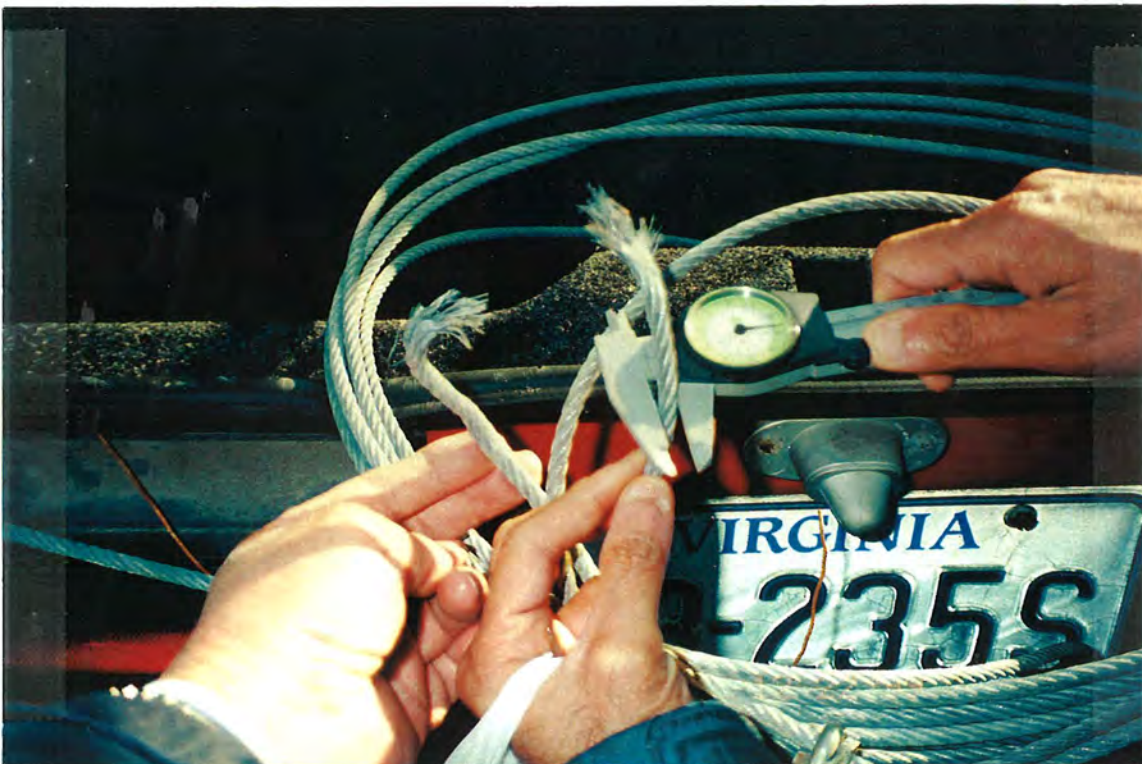
**Figure 3-18** The Damaged Northwest Guy Wire.

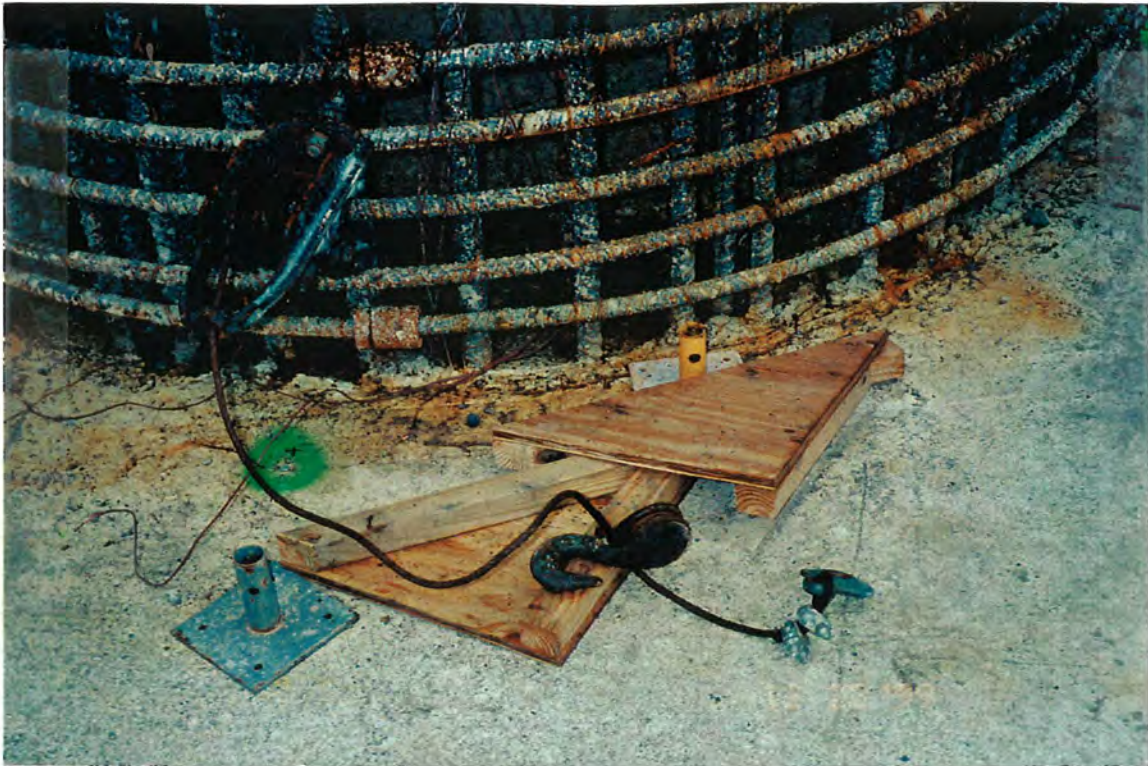
Figure 3-19 The Lower Connection Point of the Southwest Guy Wire at the South End of the Steel Cage for Column 1 of Bridge Pier WB-12.  
Please note that there were no latches on neither hooks nor any scratching marks observed on these hooks.

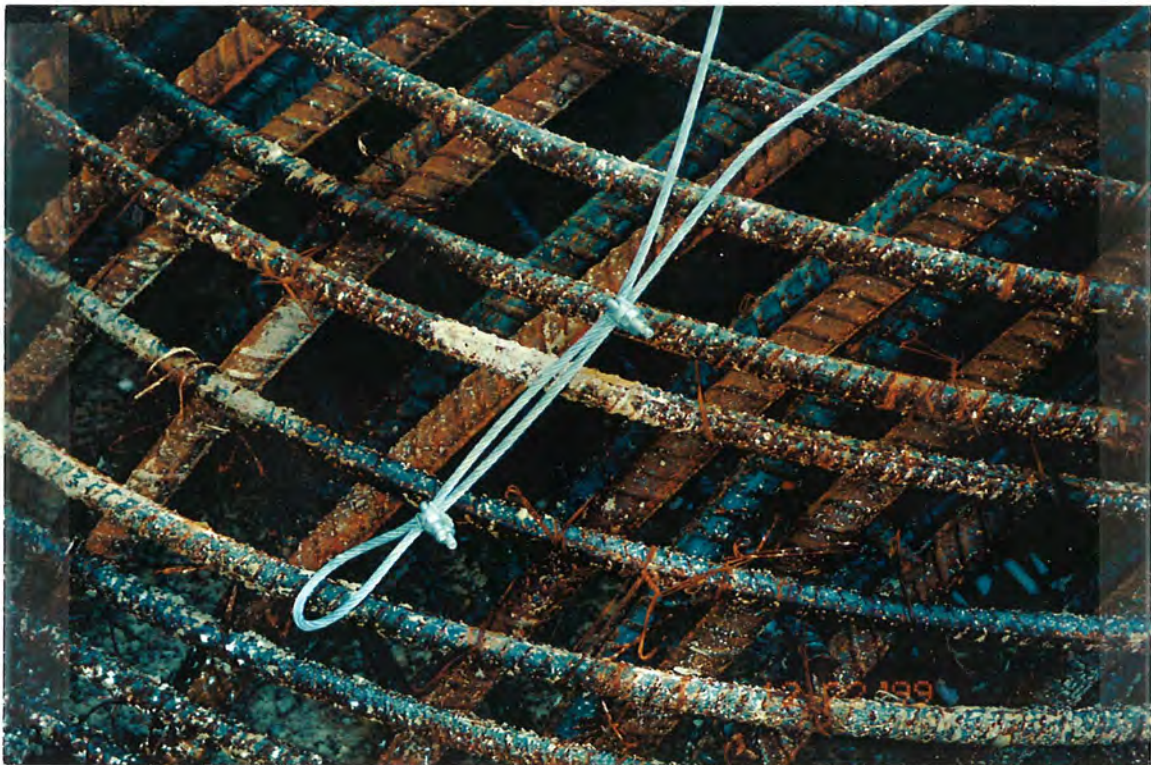
Figure 3-20 The Lower End of the Southwest Guy Wire.  
Please note that there were no damages observed on this end of the wire.

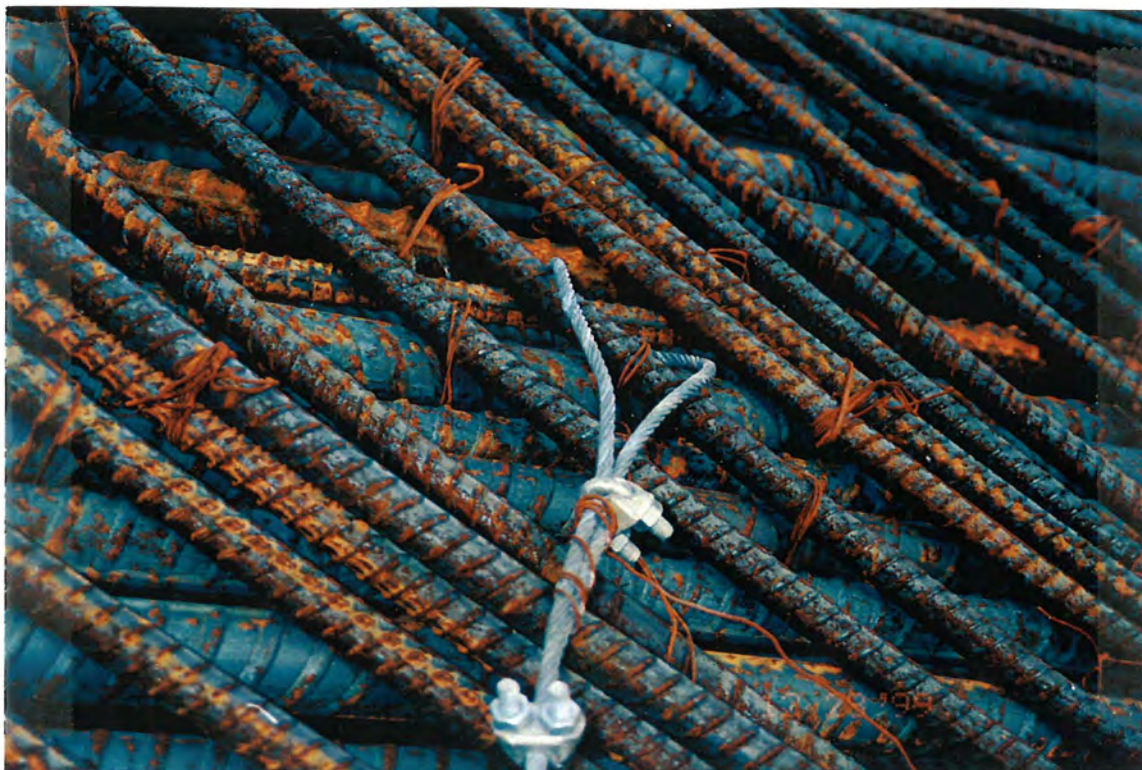
**Figure 3-21 The Upper End and Connection Point of the Southwest Guy Wire.**  
Please note that there were no damages observed on this end of the wire neither.

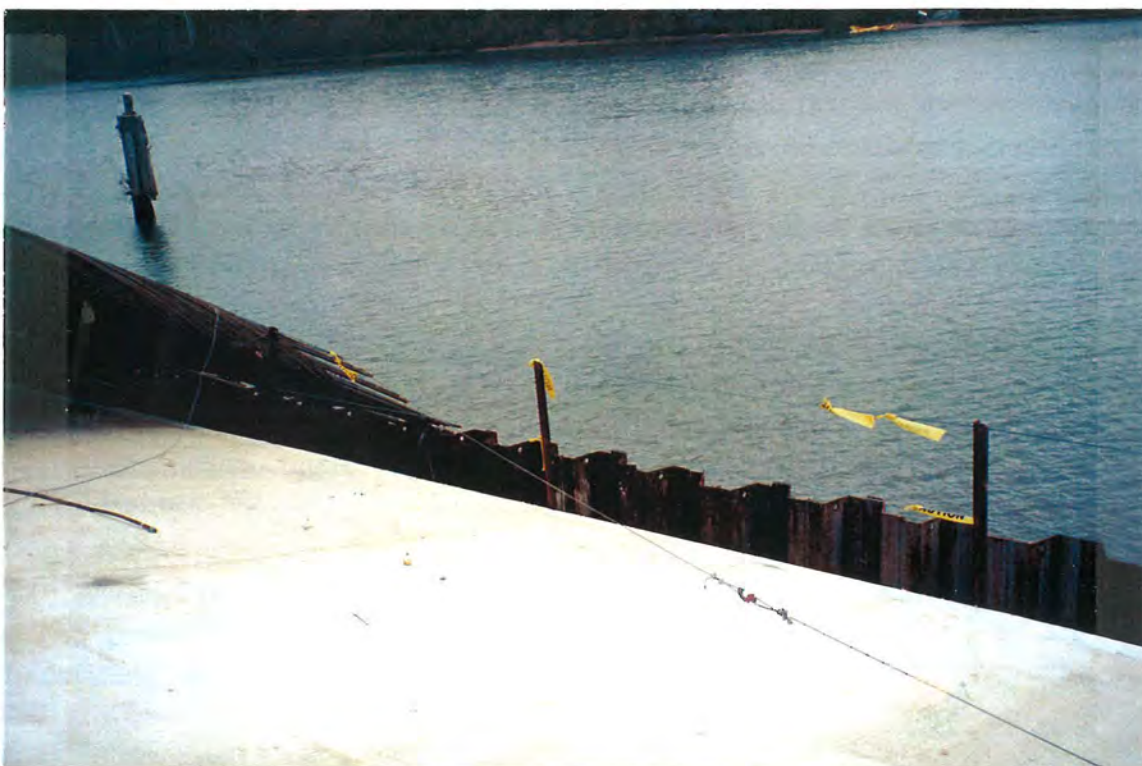
**Figure 3-22 The Middle Portion of the South Guy Wire.**  
Please note that there was no latch on the hook in this portion of the guy wire.
