Investigation of the September 24, 2002, Collapse of the 1965-foot High KDUH-TV Antenna Tower in Hemingford, Nebraska

U.S. Department of Labor Occupational Safety and Health Administration Directorate of Construction

March 2003

Report prepared by Mohammad Ayub, PE Dinesh Shah, PE

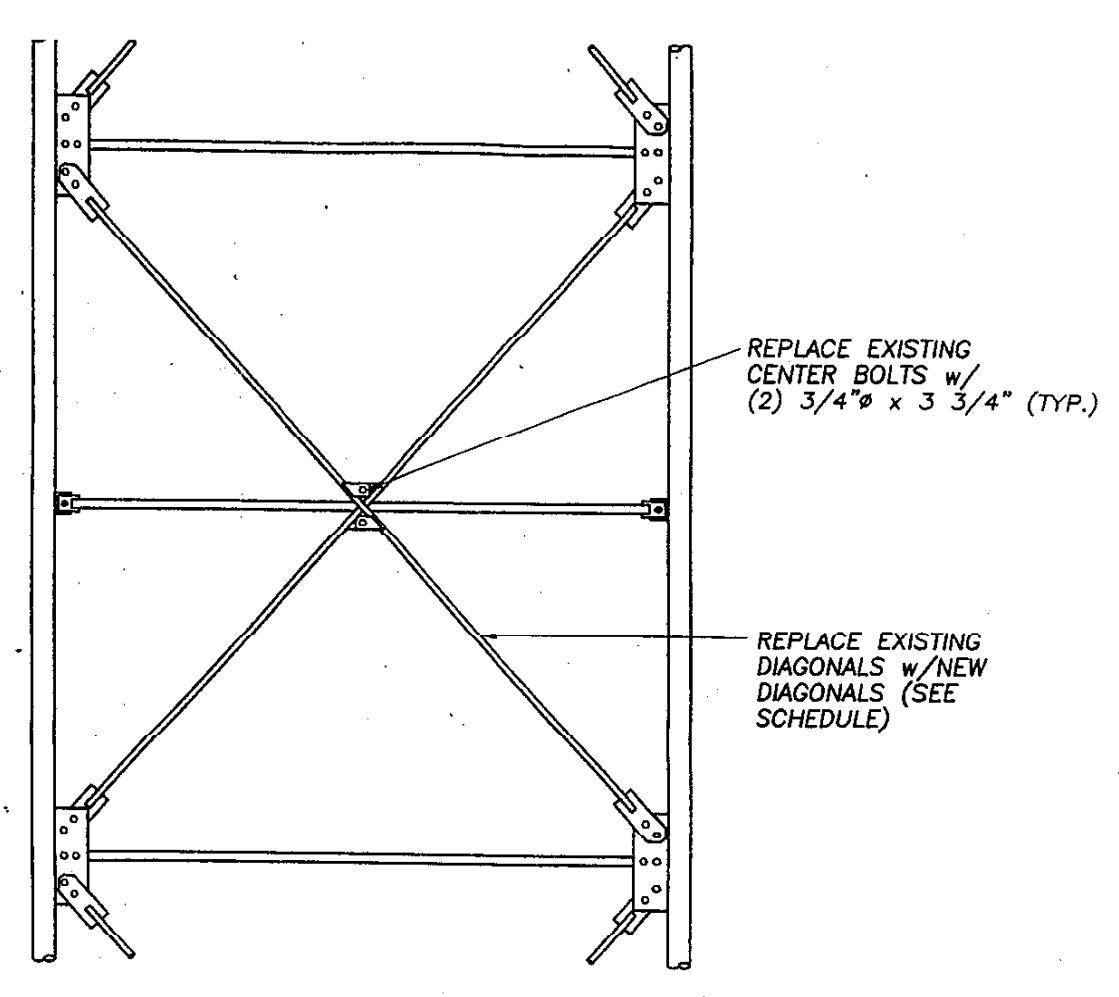
FIGURE 3

- Adding redundant members (double angles 2 x 2 x ¹/₄) to section 1, panels 2 & 3
- Replacing existing 1" diameter diagonals with new 1¹/₈" diameter diagonals in section 10, panels 1 & 2
- Replacing existing $\frac{3}{4}$ " diameter diagonals with new $\frac{7}{8}$ " diameter diagonals in section 47, panel 1

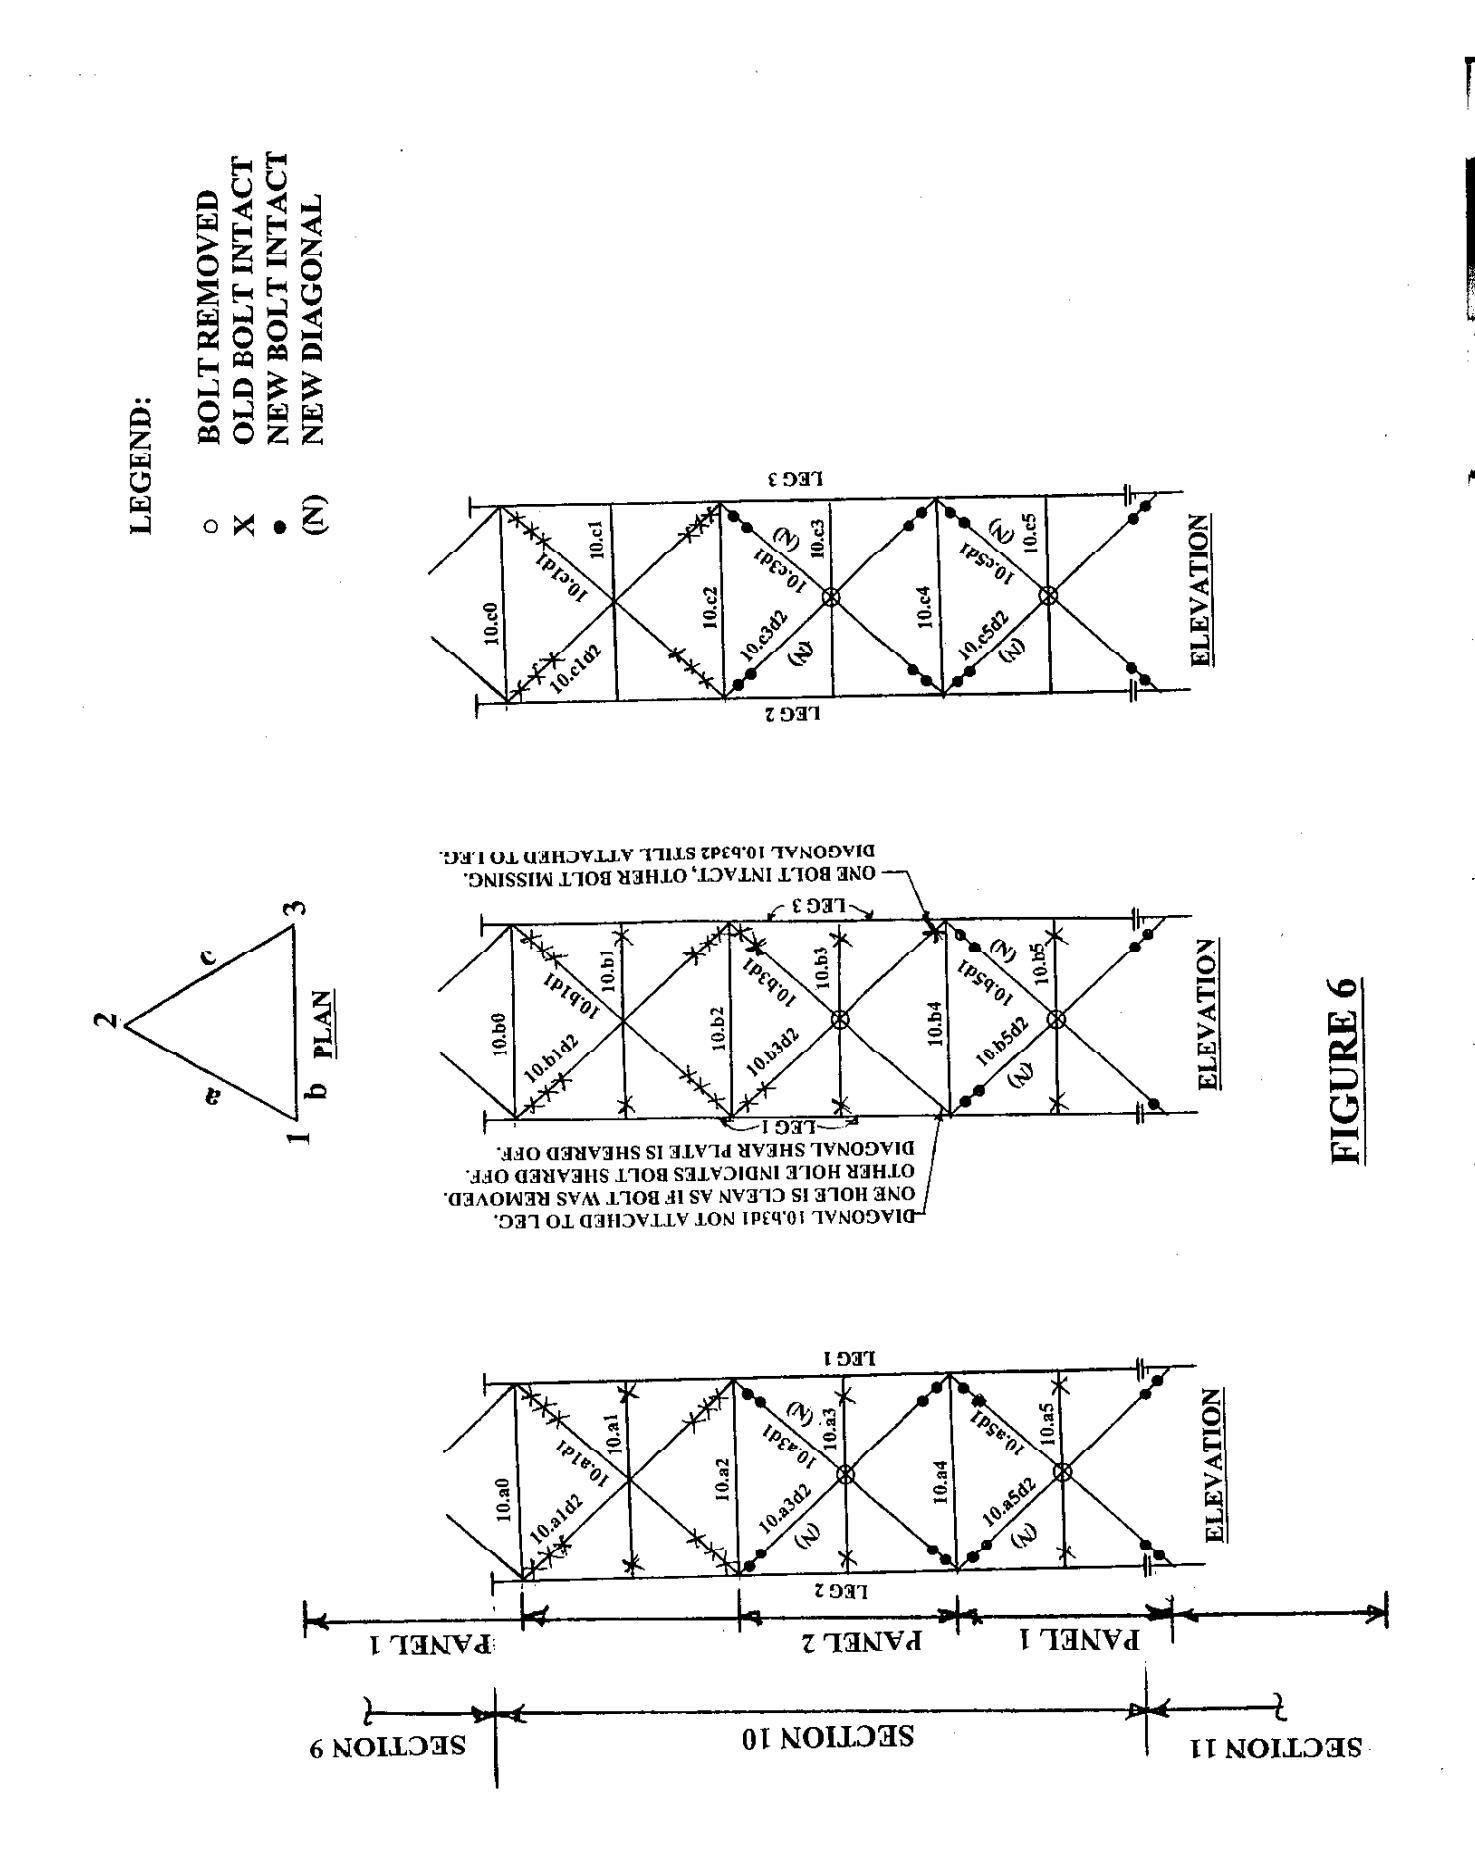
diagonals remained. A few of the bolts connecting the old diagonals sheared off during the collapse (see Figure 6). Again, the lug bolts were missing in all three faces of panel 2, including the face where the existing diagonals had not yet been replaced.

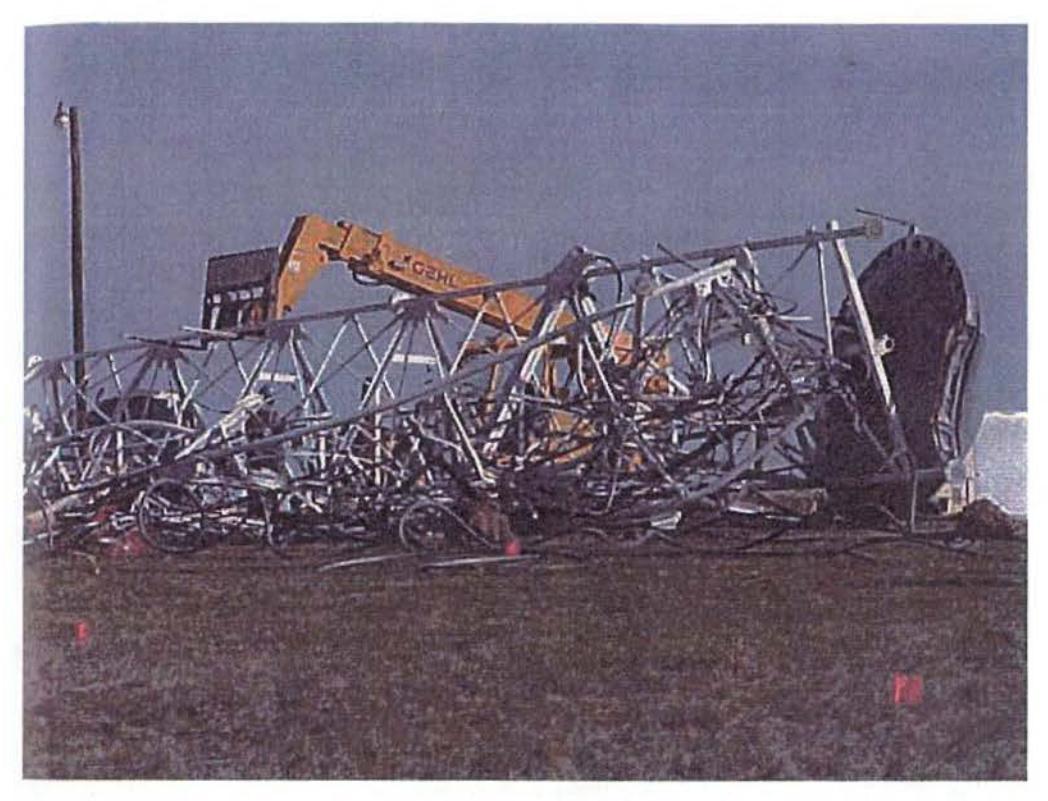
FIGURE 7 (SECTION 10)

In panel 1 of section 10, all six diagonals were replaced with new diagonals and bolted to the gusset plates at each end by high strength bolts, as required by the construction documents. However, the lug bolts were not placed in any of the three faces of panel 1. In panel 2 of section 10, four out of six diagonals were replaced with new diagonals and bolted at each end. Two old

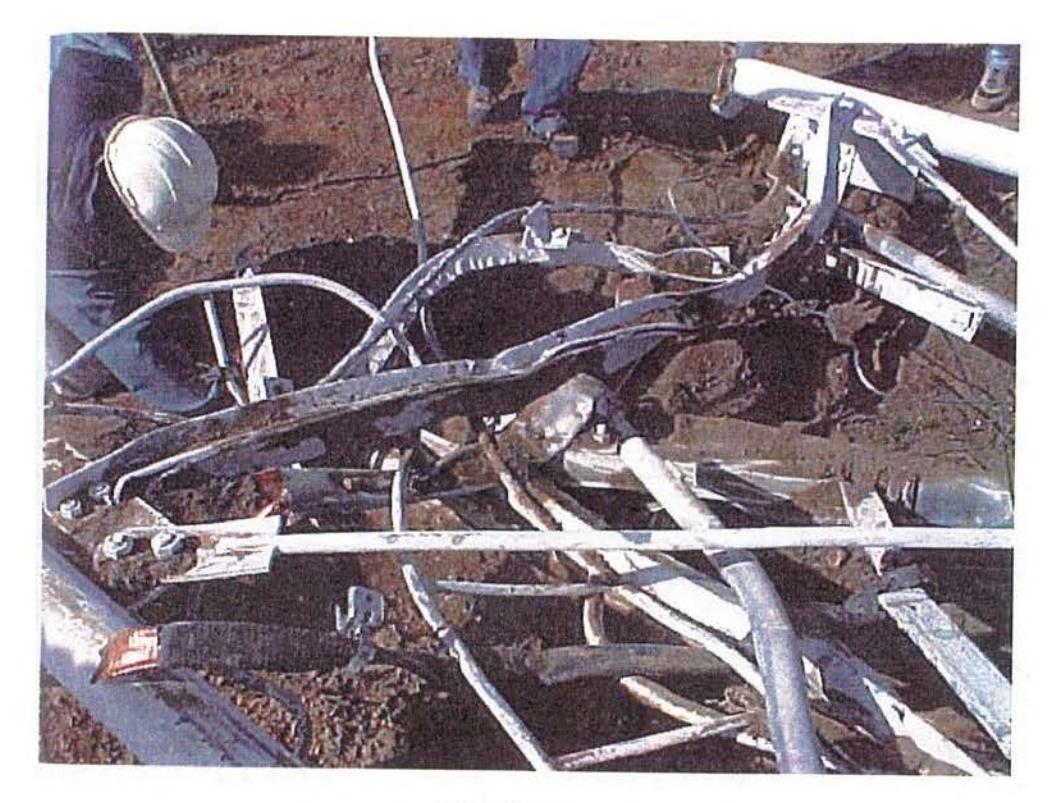
FIGURE 9 (SECTION 47)

Of all the sections of the failed tower, Section 47 was the most distorted and wrinkled, and partially buried in the ground. However, panel 1 of section 47 was examined though with difficulty due to distortions of its members. Examination at the scene revealed that the lug bolts of panel 1 were missing on all three faces as the holes were devoid of any deformations or elongations. Also, observation of section 48 in the warehouse indicated that the lug bolts were missing on two faces of panel 3 of section 48. Lug boltholes did not exhibit any sign of distortion or deformation that led to our conclusion that the bolts were missing prior to the collapse. It was also discovered that where panel 3 of section 48 joined panel I of section 47 at least one diagonal and one strut member were unbolted at the gusset plate connection of the legs of section 48. Figure 5 indicates the missing bolts and missing members. As the removal of the bolts of the diagonal and the strut was critical to the stability of the tower and this investigation, the OSHA Salt Lake Technical Center (SLTC) visually examined the holes to confirm whether the bolted connections of the diagonal and strut were removed prior to the collapse. A metallurgist from SLTC visited the warehouse and examined the holes in question of section 48 confirming that the connections of a diagonal and a strut member at section 48 were removed prior to the collapse (see appendix A for SLTC report).

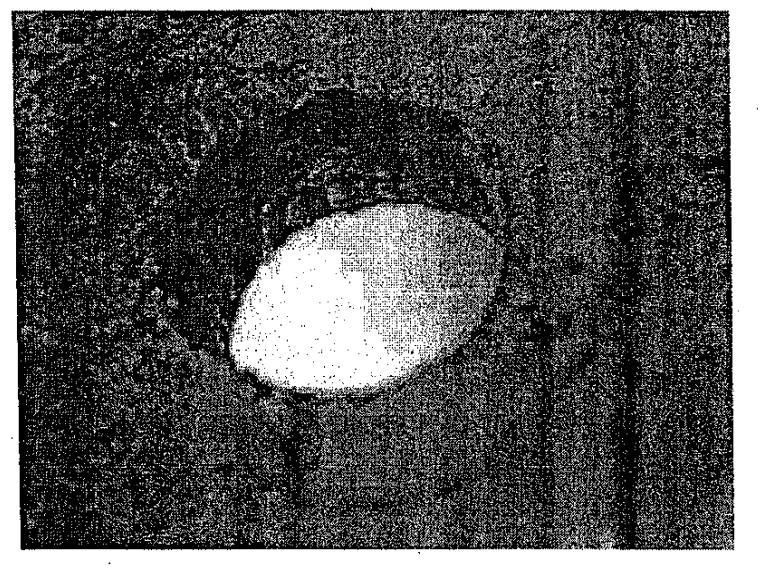
Photo 4: Hole H2, <a-c>, leg a, showing marks from bolt shank flutes

Also, as shown in photo 4, the holes had markings consistent with the flutes of the connecting bolts.

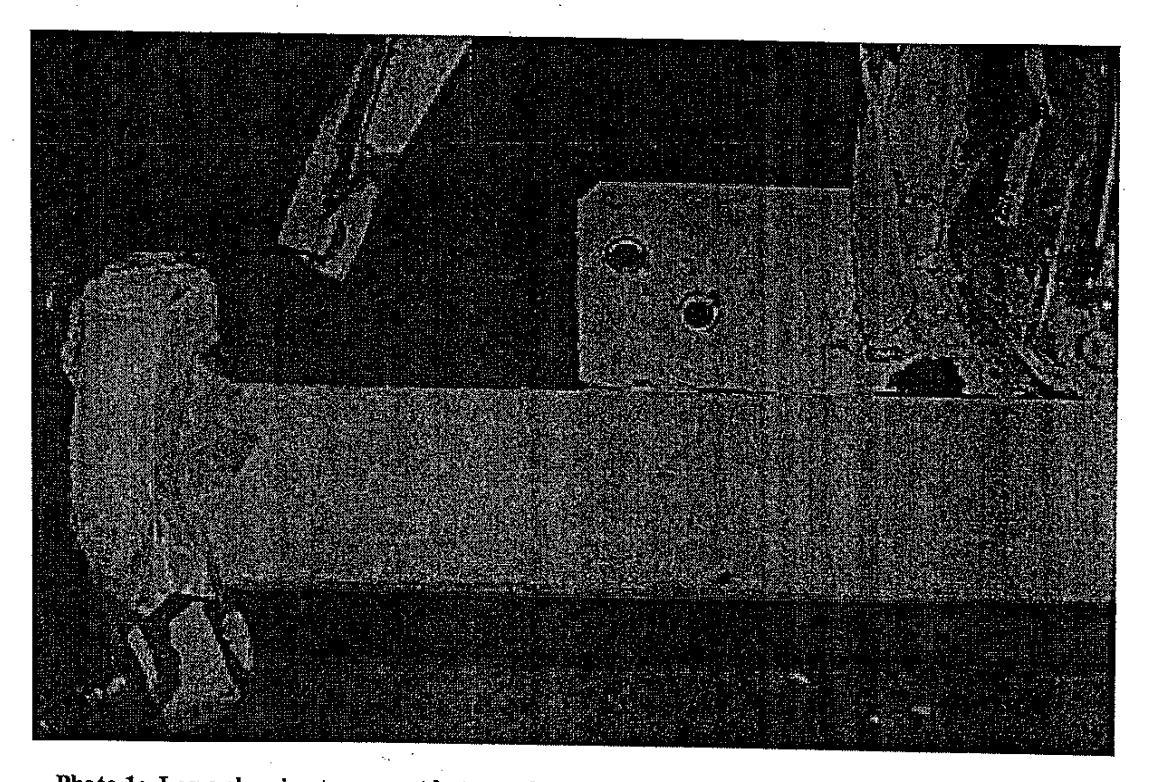
Photo 1: Leg a showing top gusset between leg a, and leg b. Note the horizontal element still in place. Bolts were removed prior to fall.

The conclusion of observations and measurements is that of the measured holes and other observed holes, only T1 and T2 of the top gusset of $\langle a-b \rangle$, leg b had bolts installed at the time of the accident.
