Investigation of the July 23, 2003, Collapse of Custom Cantilever Finishing Platform in Panama City, FL

U.S. Department of Labor Occupational Safety and Health Administration Directorate of Construction

December 2003

Report Prepared by Mohammad Ayub, PE Dinesh Shah, PE

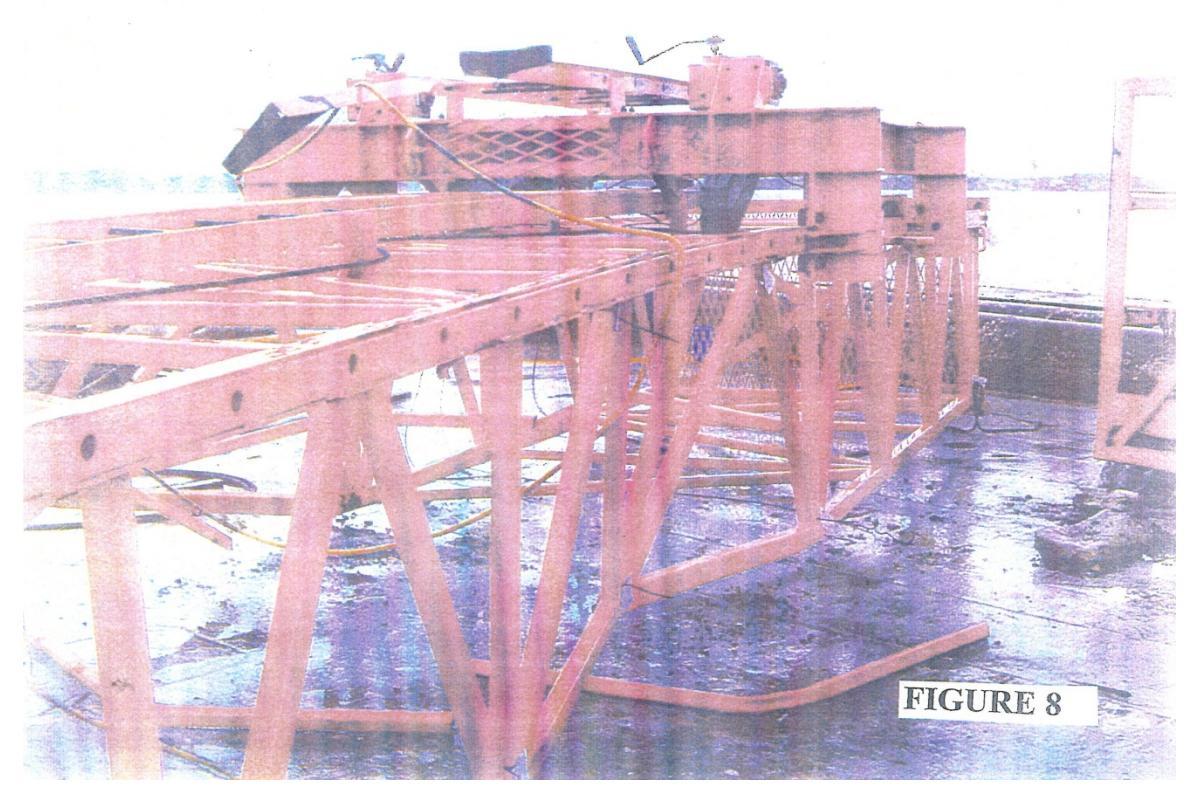
COLLAPSED STRUCTURE

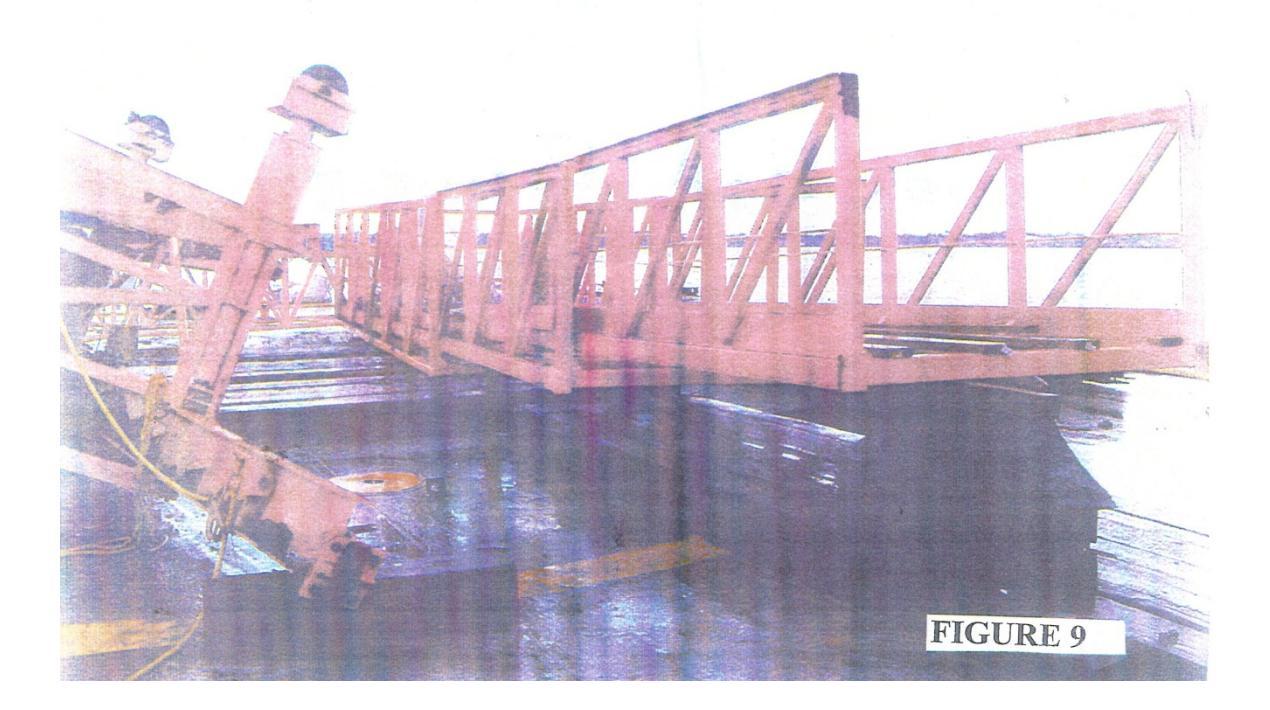
COLLAPSED STRUCTURE
