Investigation of the September 4, 2003, Collapse of the 1000-foot High TV Antenna Tower in Huntsville, Alabama

U.S. Department of Labor Occupational Safety and Health Administration Directorate of Construction

January 2004

Report Prepared by Mohammad Ayub, PE

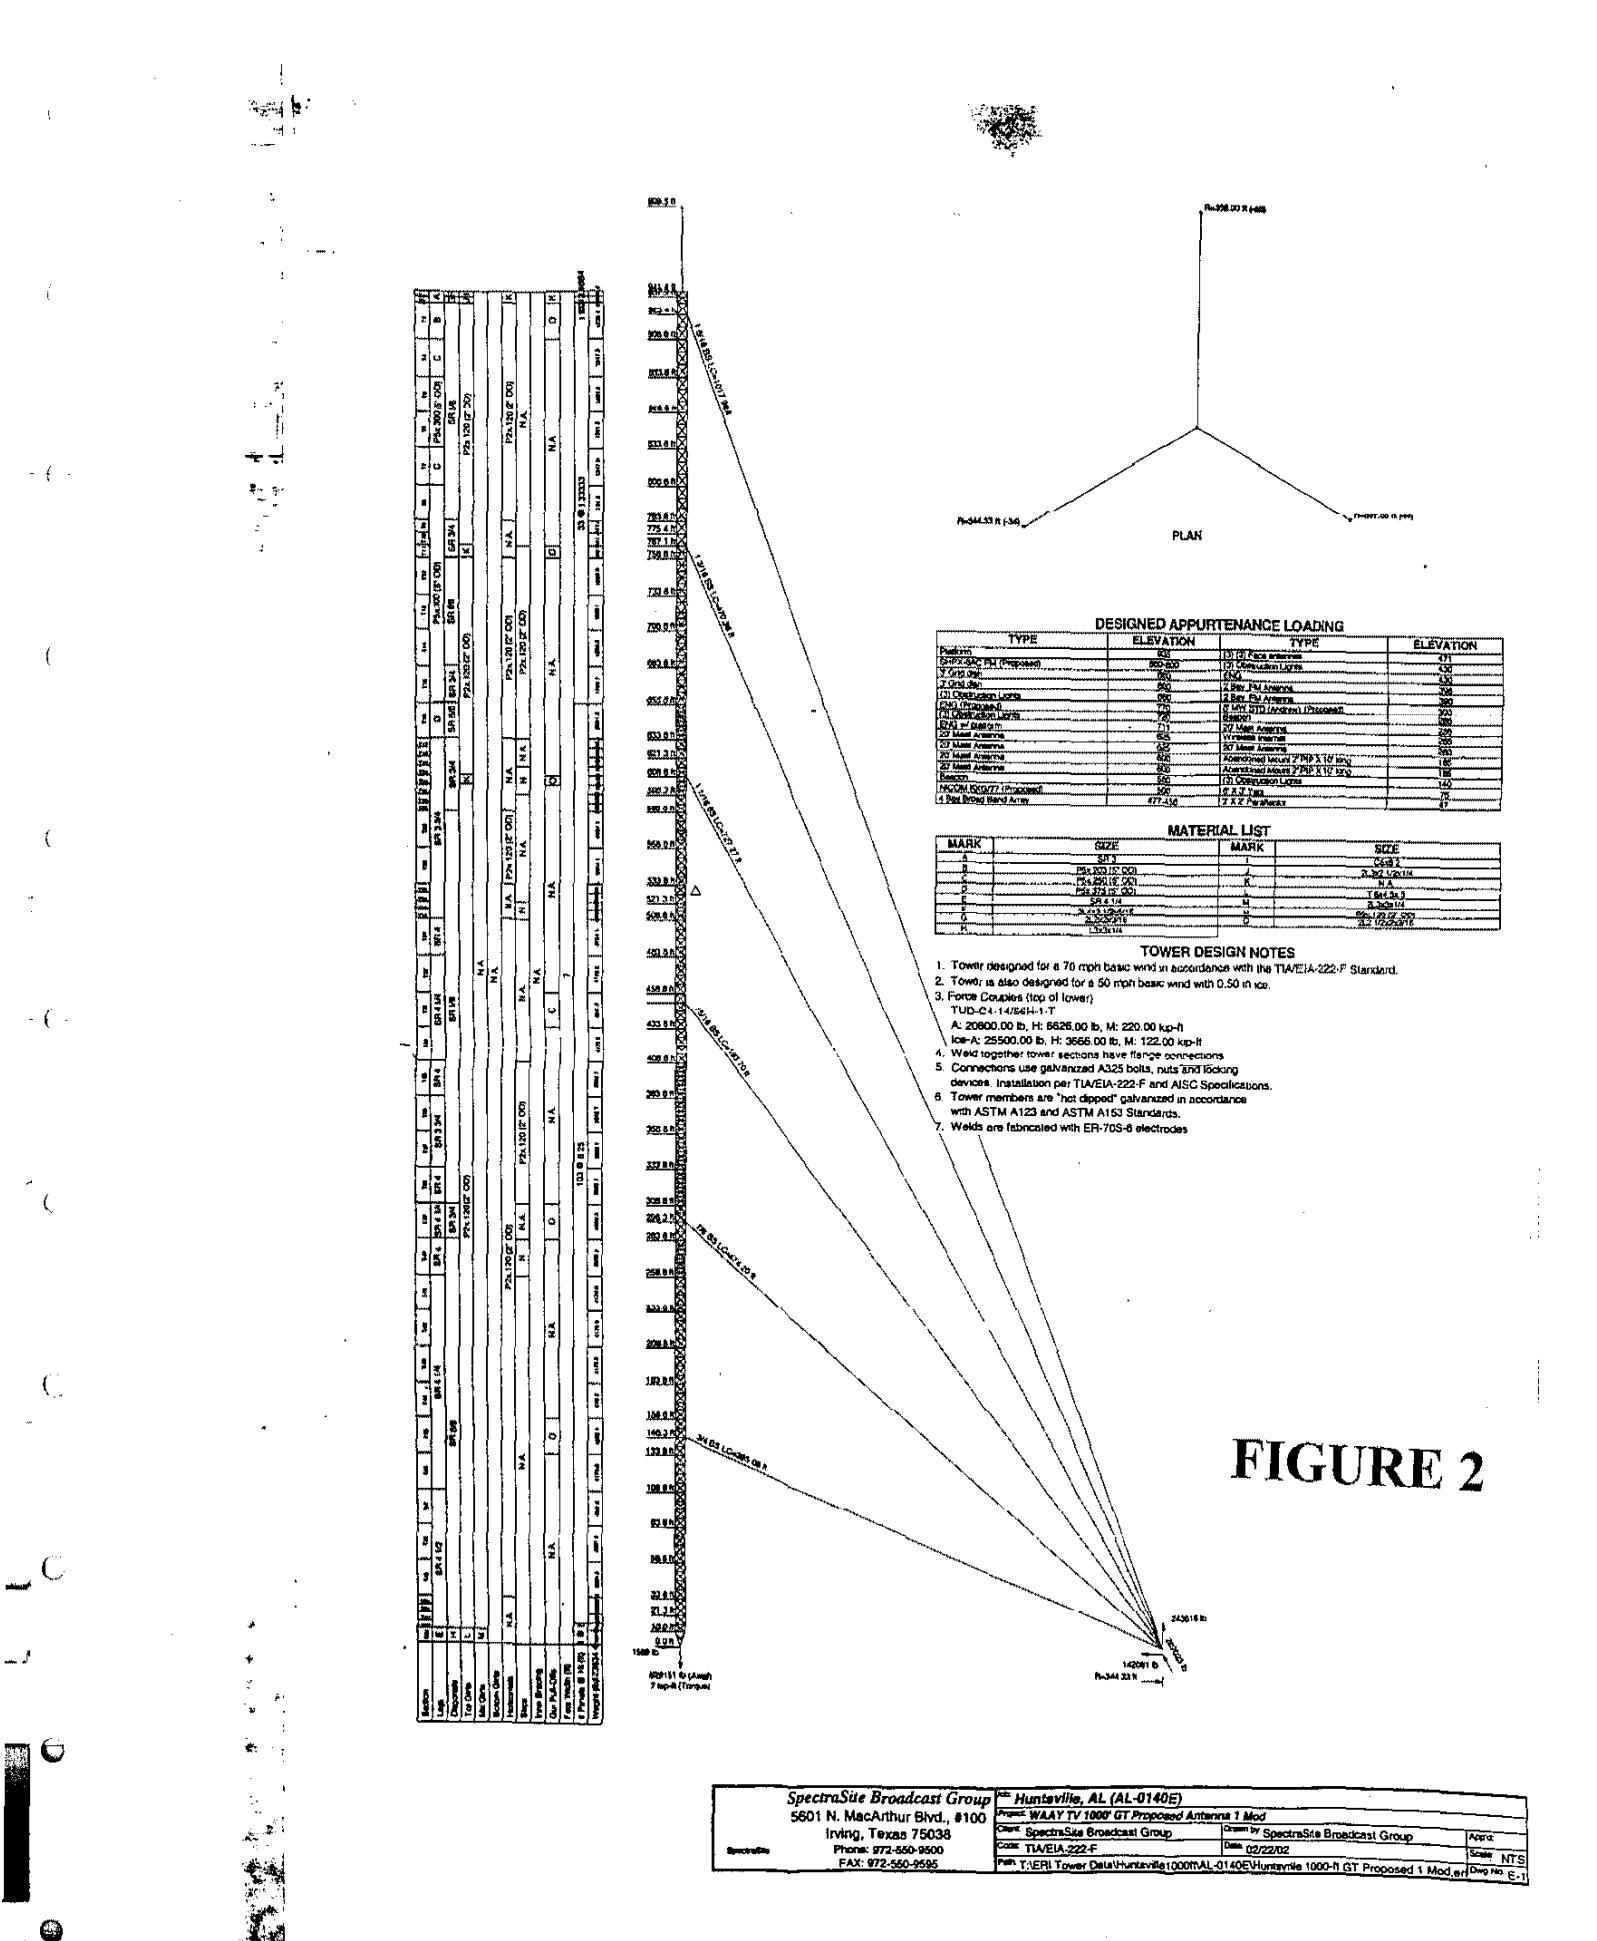
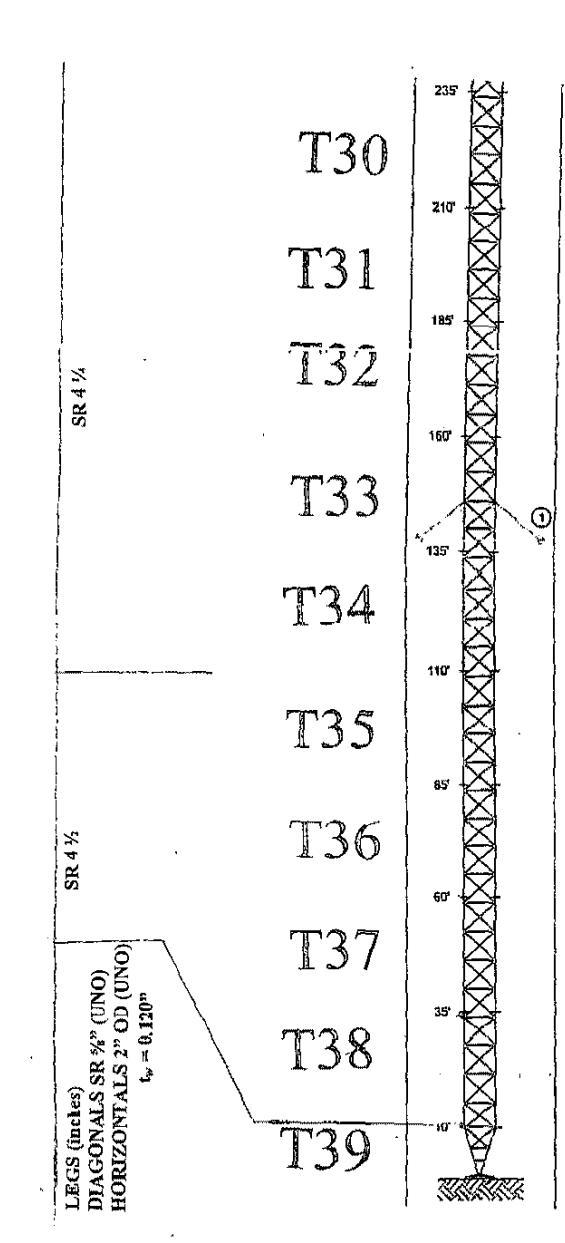
TOWER ELEVATION

The 1,000 ft. high guyed tower at Huntsville, AL was originally designed and fabricated by Stainless, Inc., and was erected in 1976. The design of the tower conformed to the then E1A/222-C standard. The tower is currently owned by SpectraSite Broadcast Group (SBG) and is leased to the TV station WAAY, Huntsville, AL. The tower, consisting of 39 sections, is triangular with each side measuring approximately 7 feet. The tower is supported by a pinned base and six levels of guy wires at equal intervals to the top of the tower, see Figures 1 & 2. Each section is 25 ft high except for the very base and top sections.

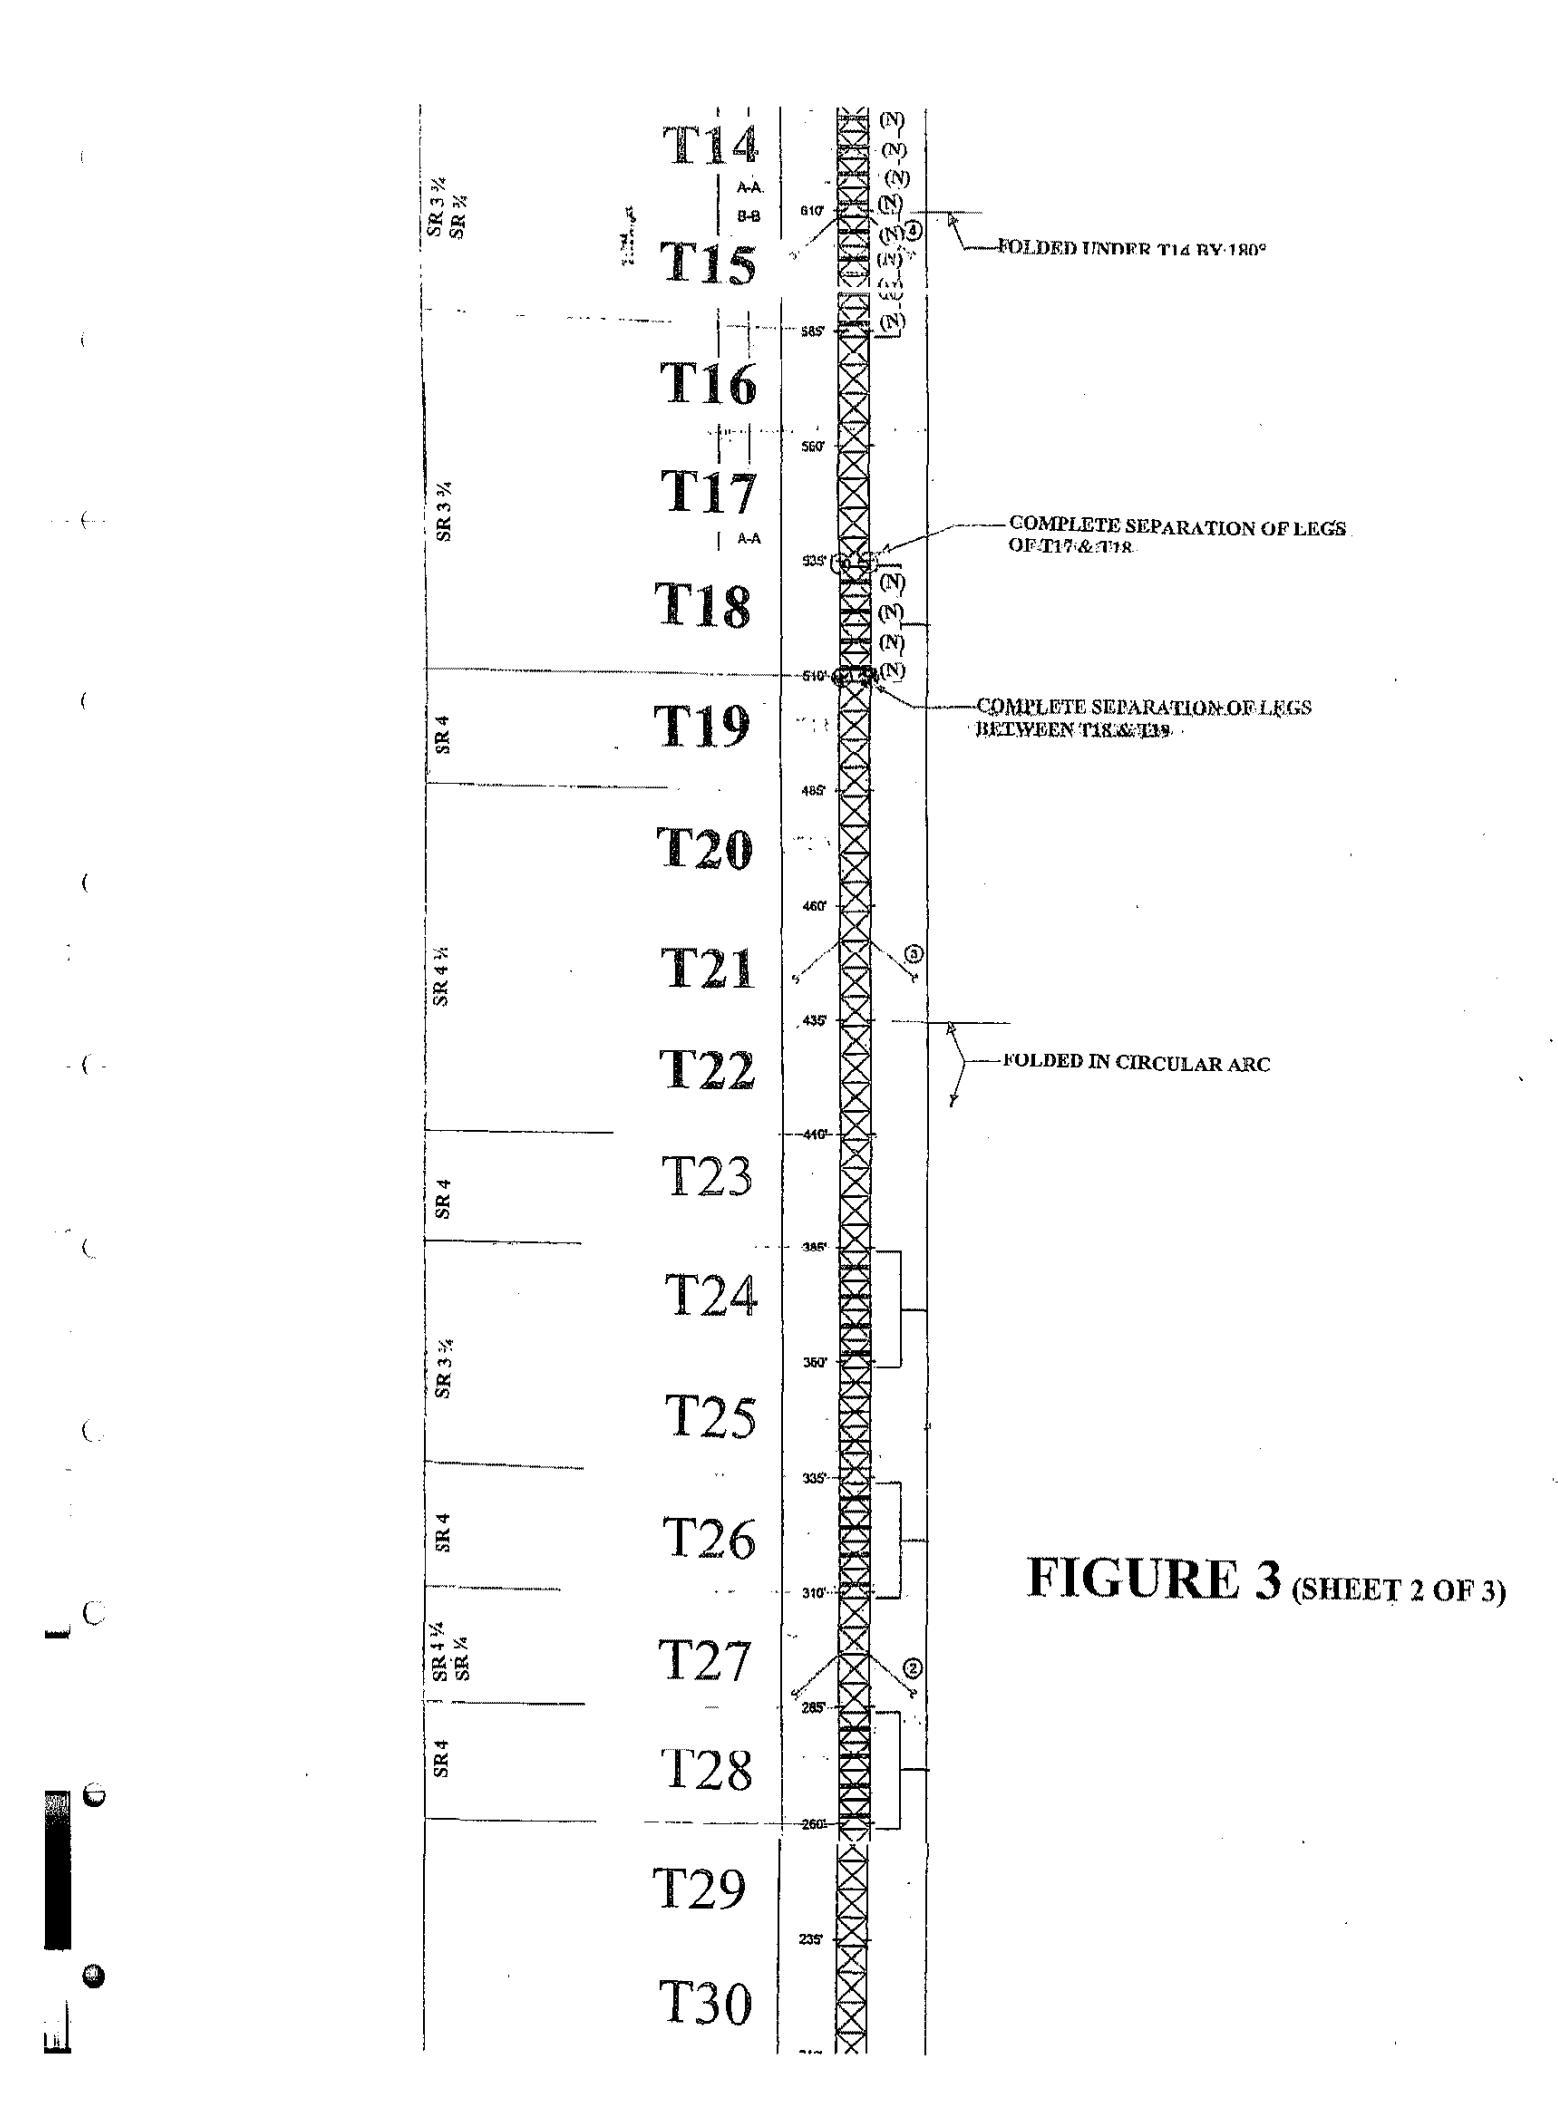
In 2002, SpectraSite Broadcast Group (SBG), the new owner of the tower, asked Stainless, a subsidiary of SBG since 1999, to re-analyze the tower for a new HDTV antenna and additional equipment. A structural analysis was performed for the new loads, identified as condition 2, to conform to EIA/TIA standard 222-F. As a result of the analysis, modifications to the tower were recommended in a report (AL-0140E). Erection drawings were prepared, detailing the extent of work to be performed. See Figure 3 for locations of new horizontal braces.

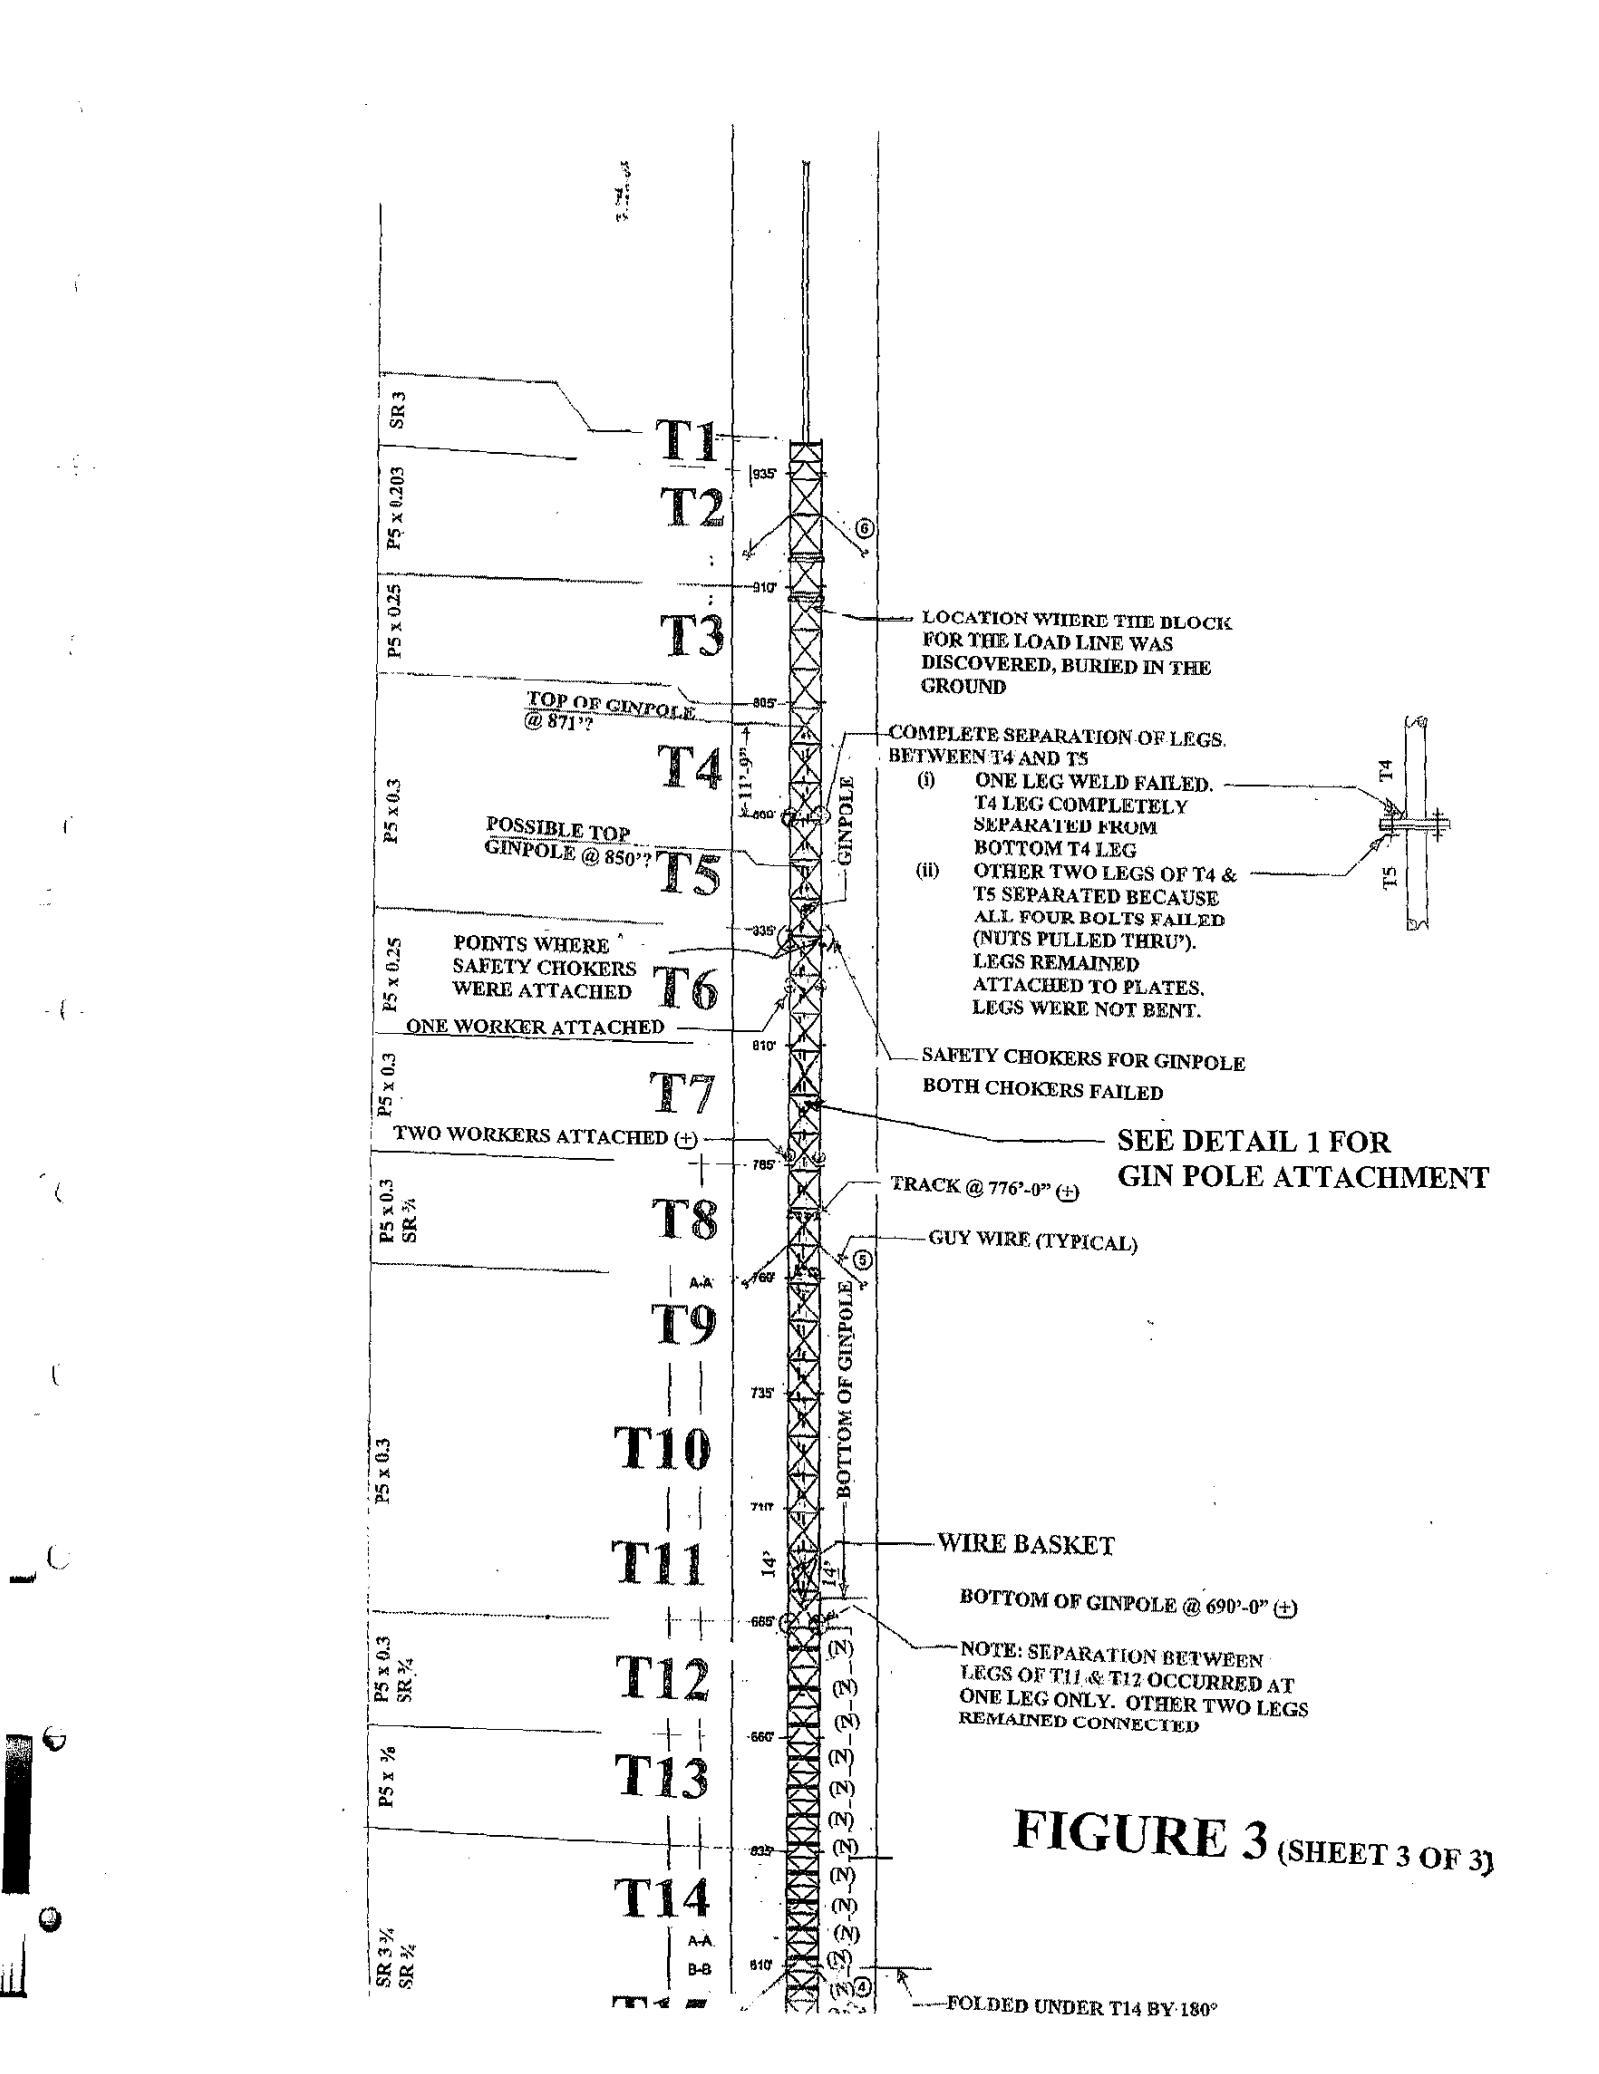
The gin pole was originally obtained by Dotty Moore Services from Kline Towers of Columbia, SC. It is believed that the track was also furnished by Kline. There were three rope lines running, known as jump line, load line and tag line see Figure 4. The purpose of the jump line (7/8" wire rope) attached to the track and the bottom of the gin pole is to raise the gin pole. The objective is to raise the gin pole well above the top of the tower so that the new antenna could be hoisted from the rooster head attached to the top of the gin pole and fastened to the top section of the tower. The purpose of the load line (7/8" wire rope) that went through a block located in the third section from the top of the tower, T3, is to slide the track upwards and to hoist miscellaneous pieces of material. A "headache" ball weighing approximately 1,500 pounds was also attached to the load line. The tag line (1/4" wire rope) going over a block near the top of the tower is meant to keep the materials being hoisted on the load line away from the face of the tower.
