Investigation of the September 4, 2003, Collapse of the 1000-foot High TV Antenna Tower in Huntsville, Alabama

U.S. Department of Labor Occupational Safety and Health Administration Directorate of Construction

January 2004

Report Prepared by Mohammad Ayub, PE

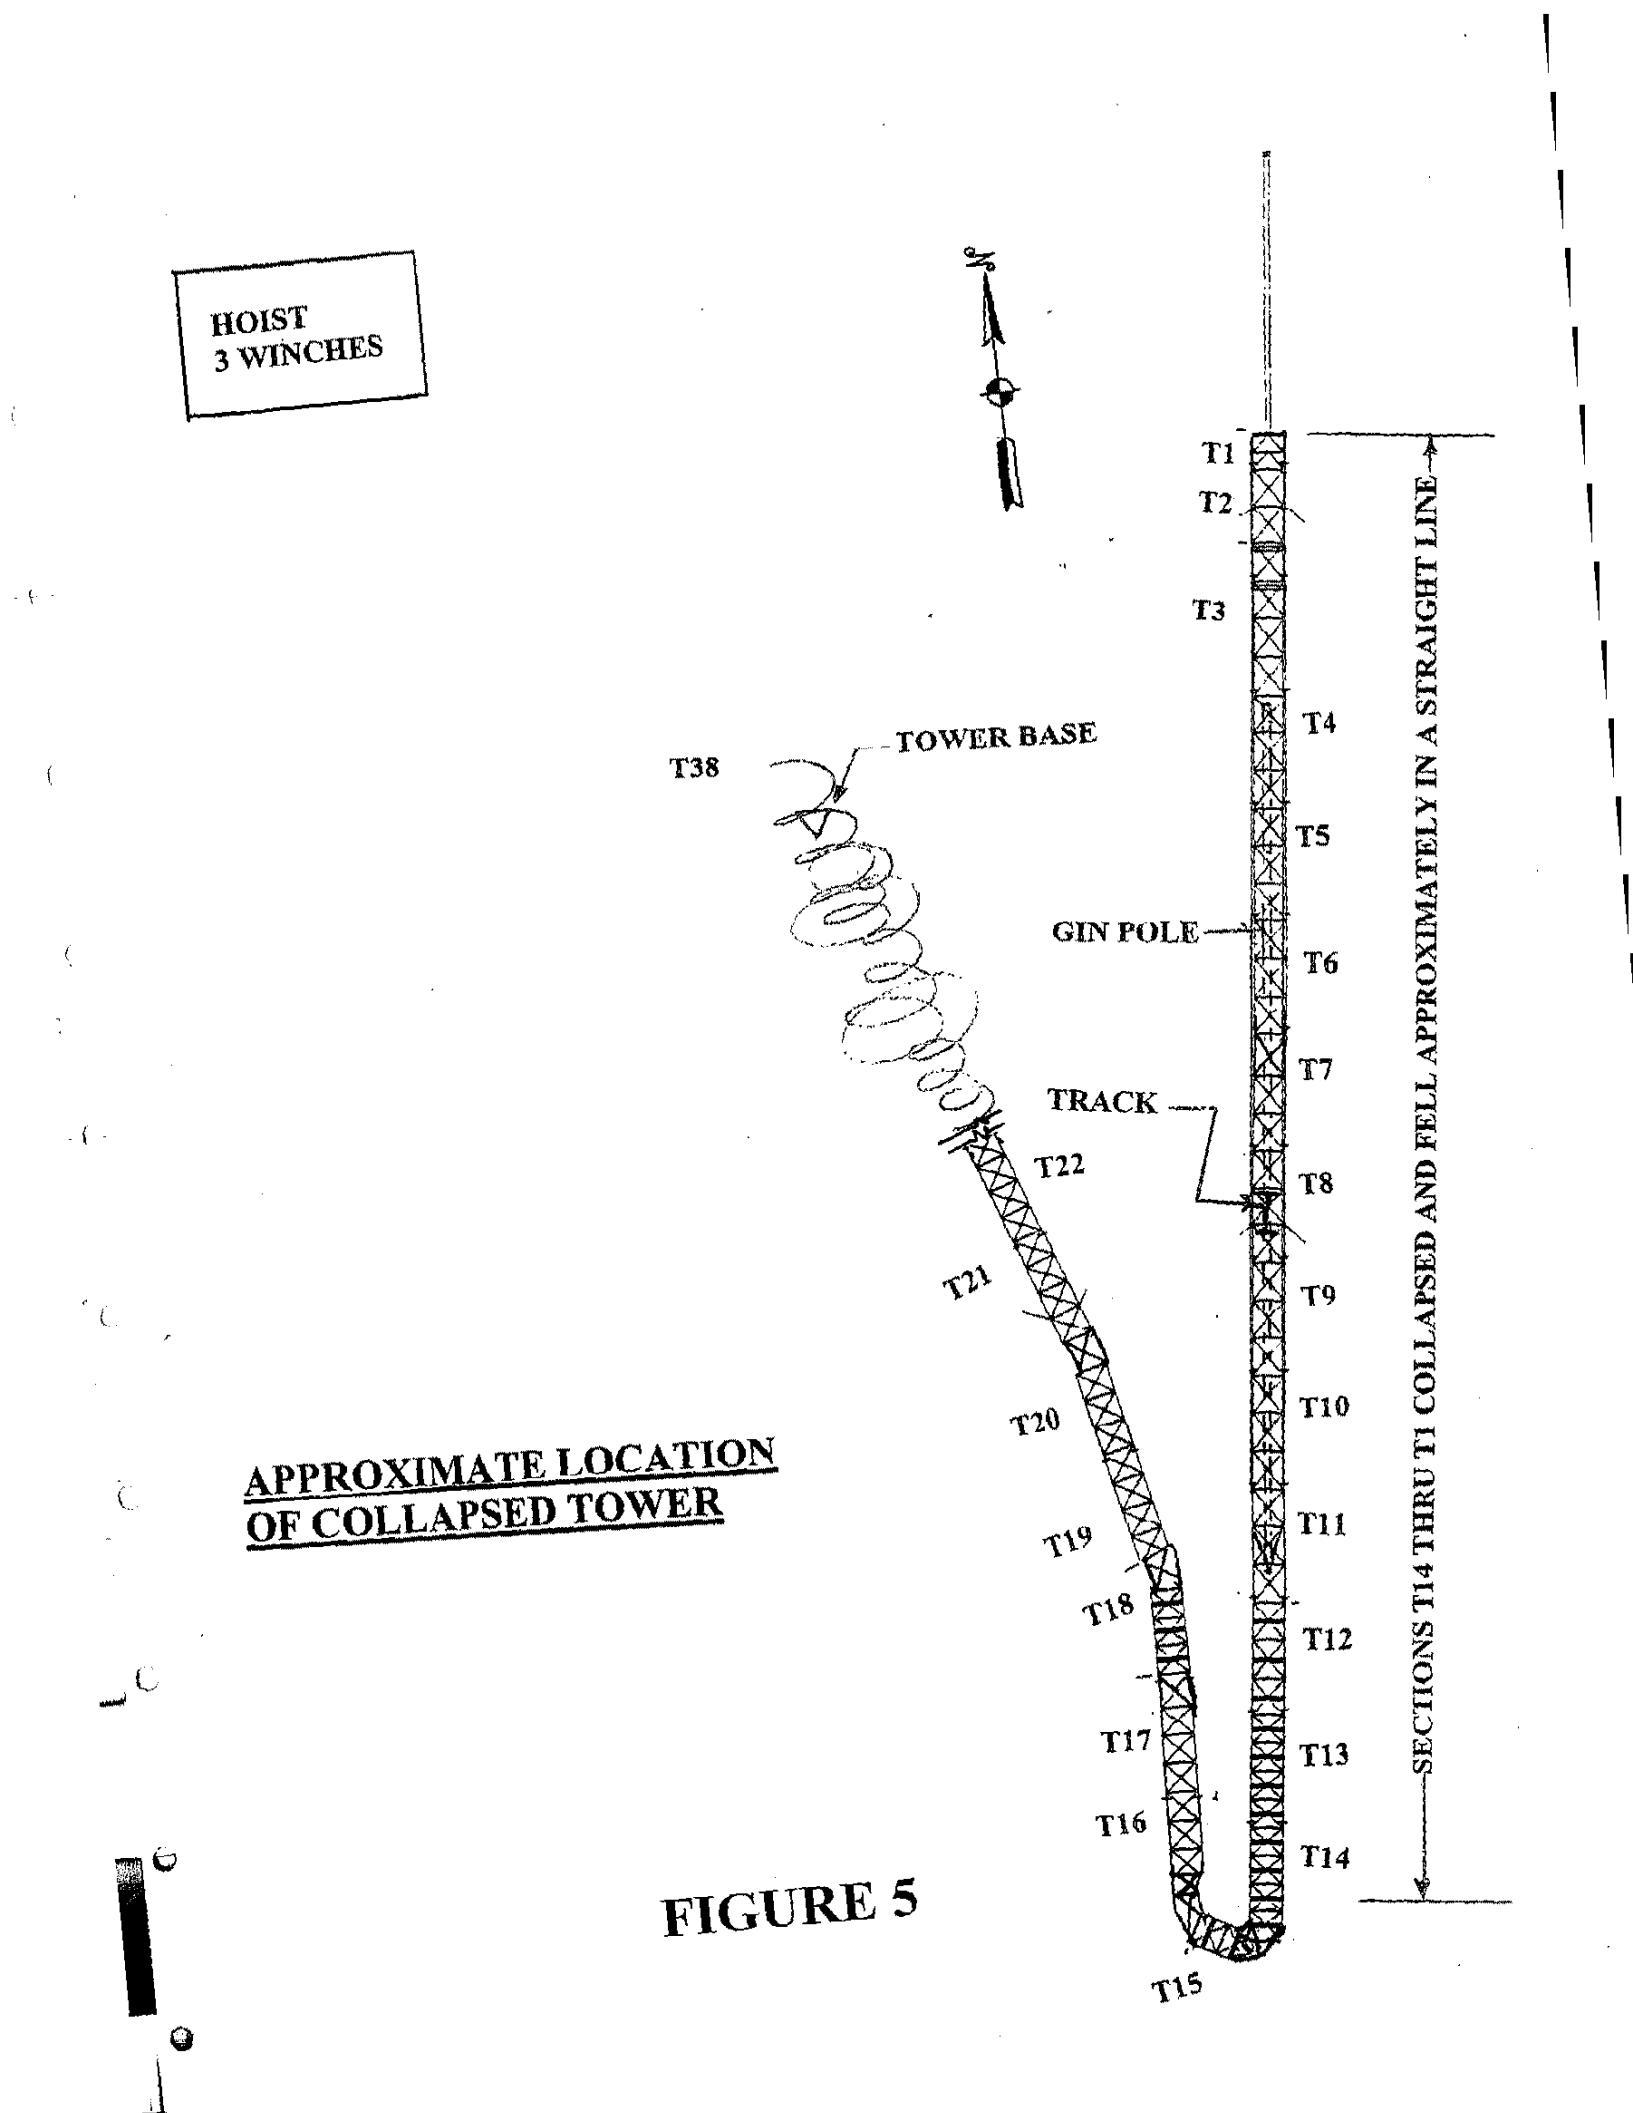
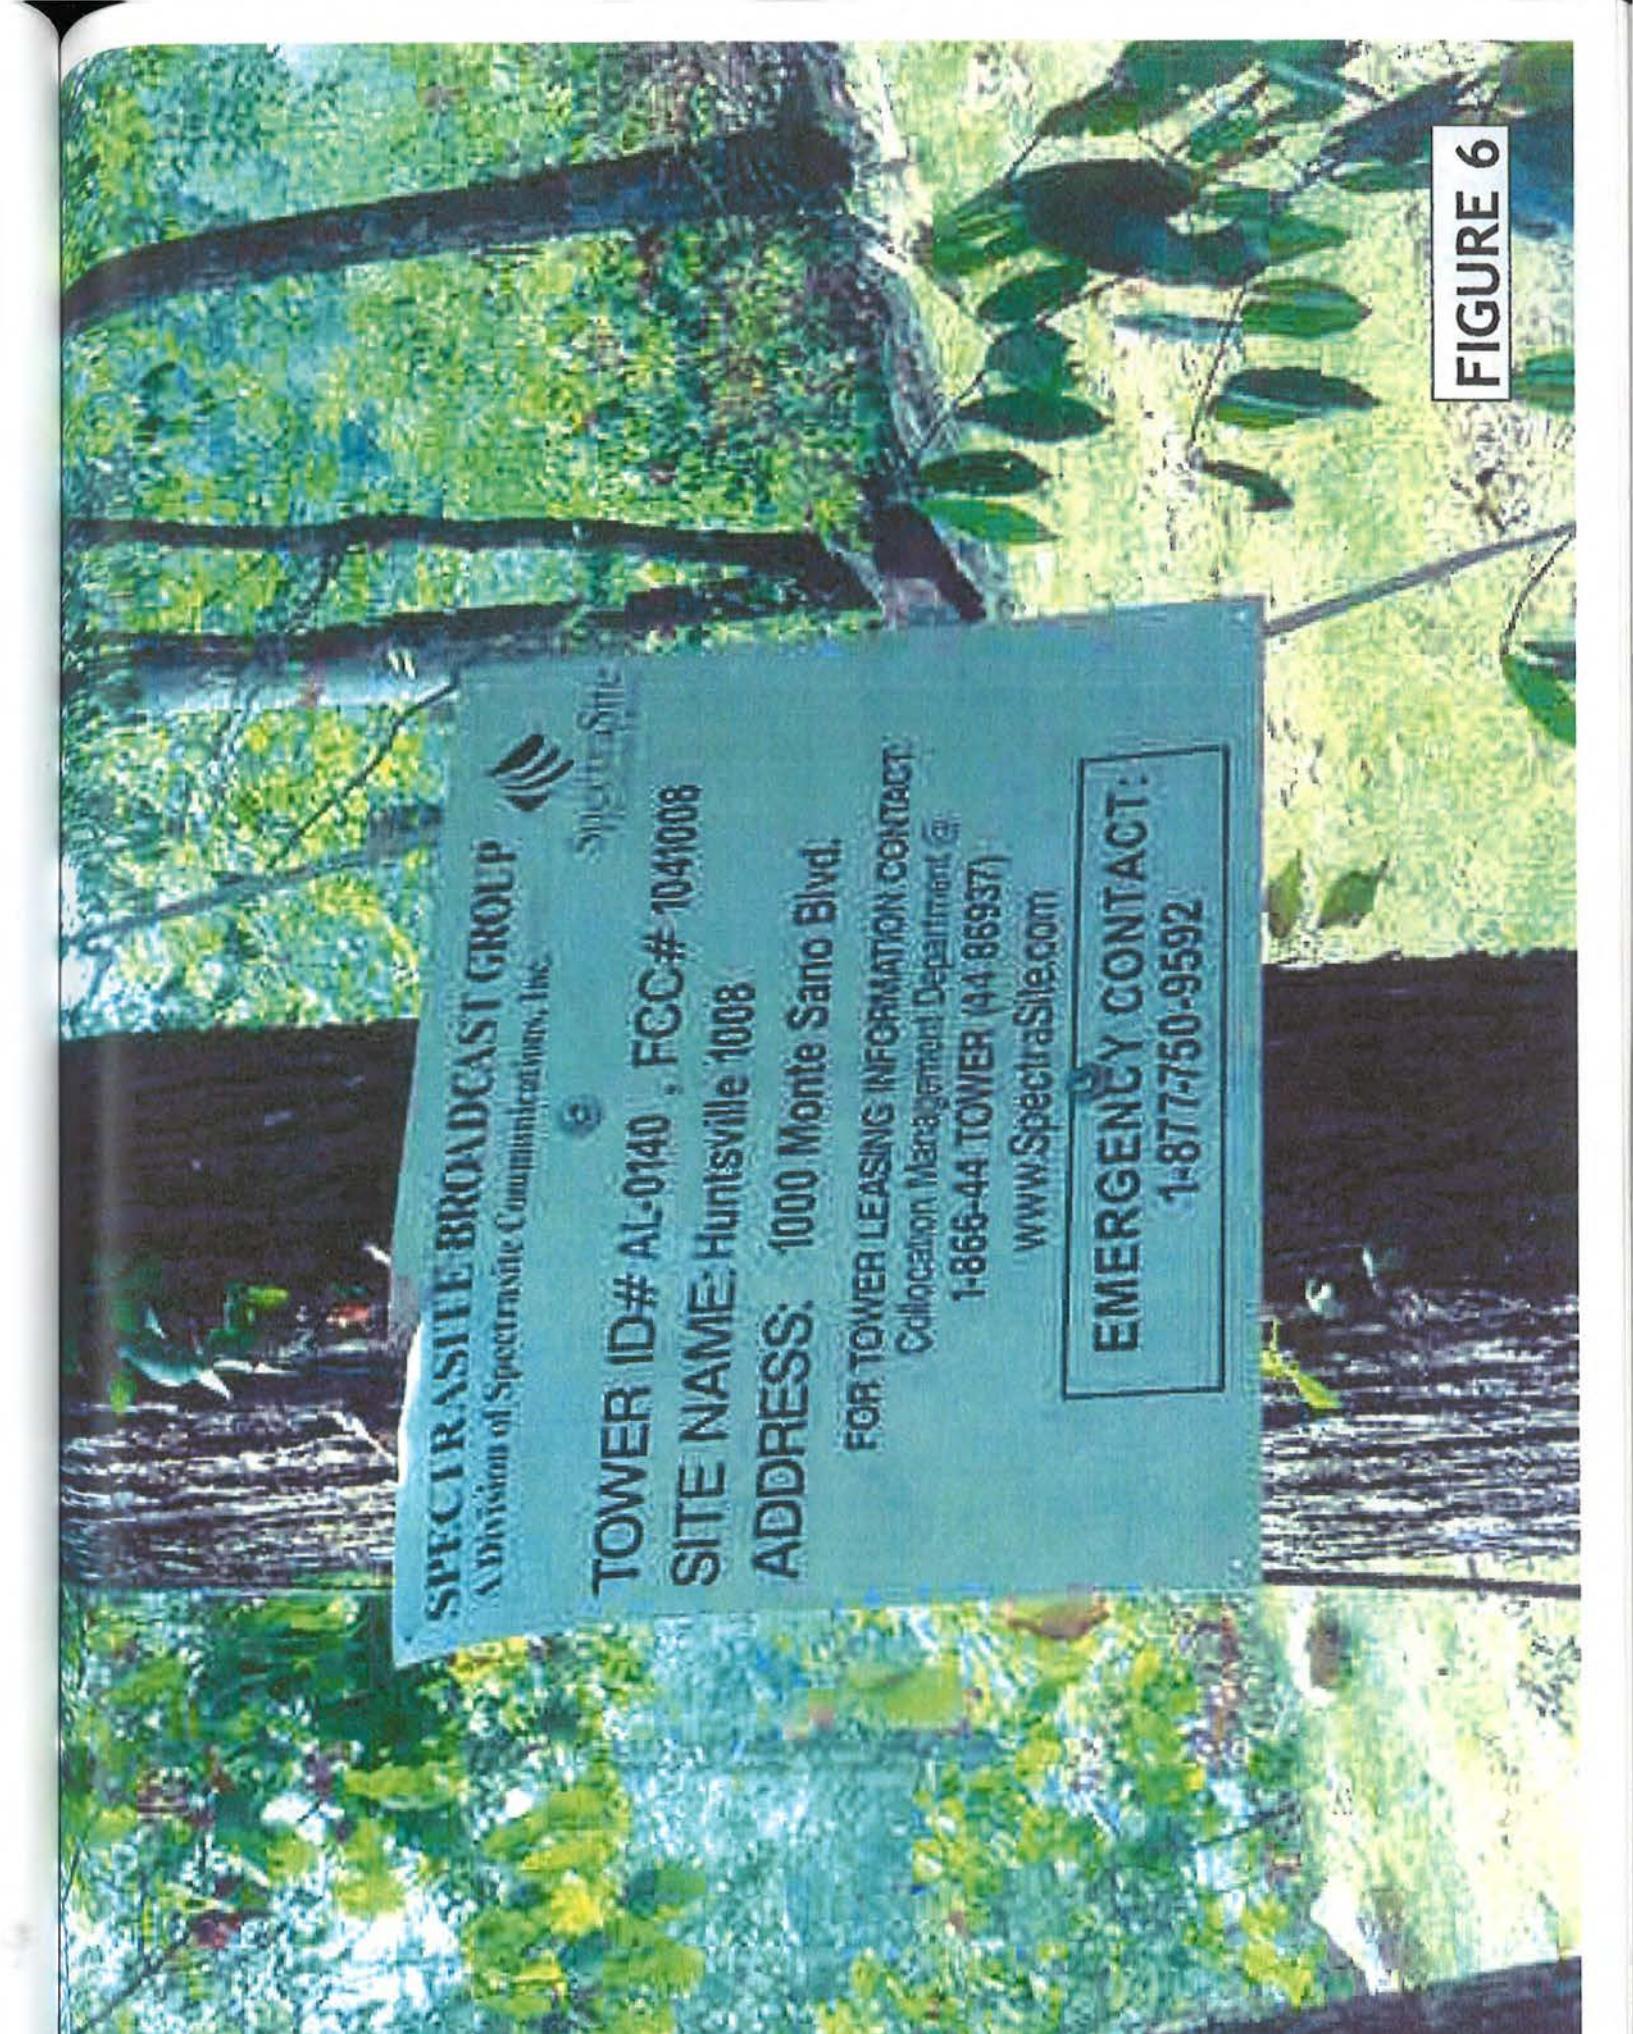
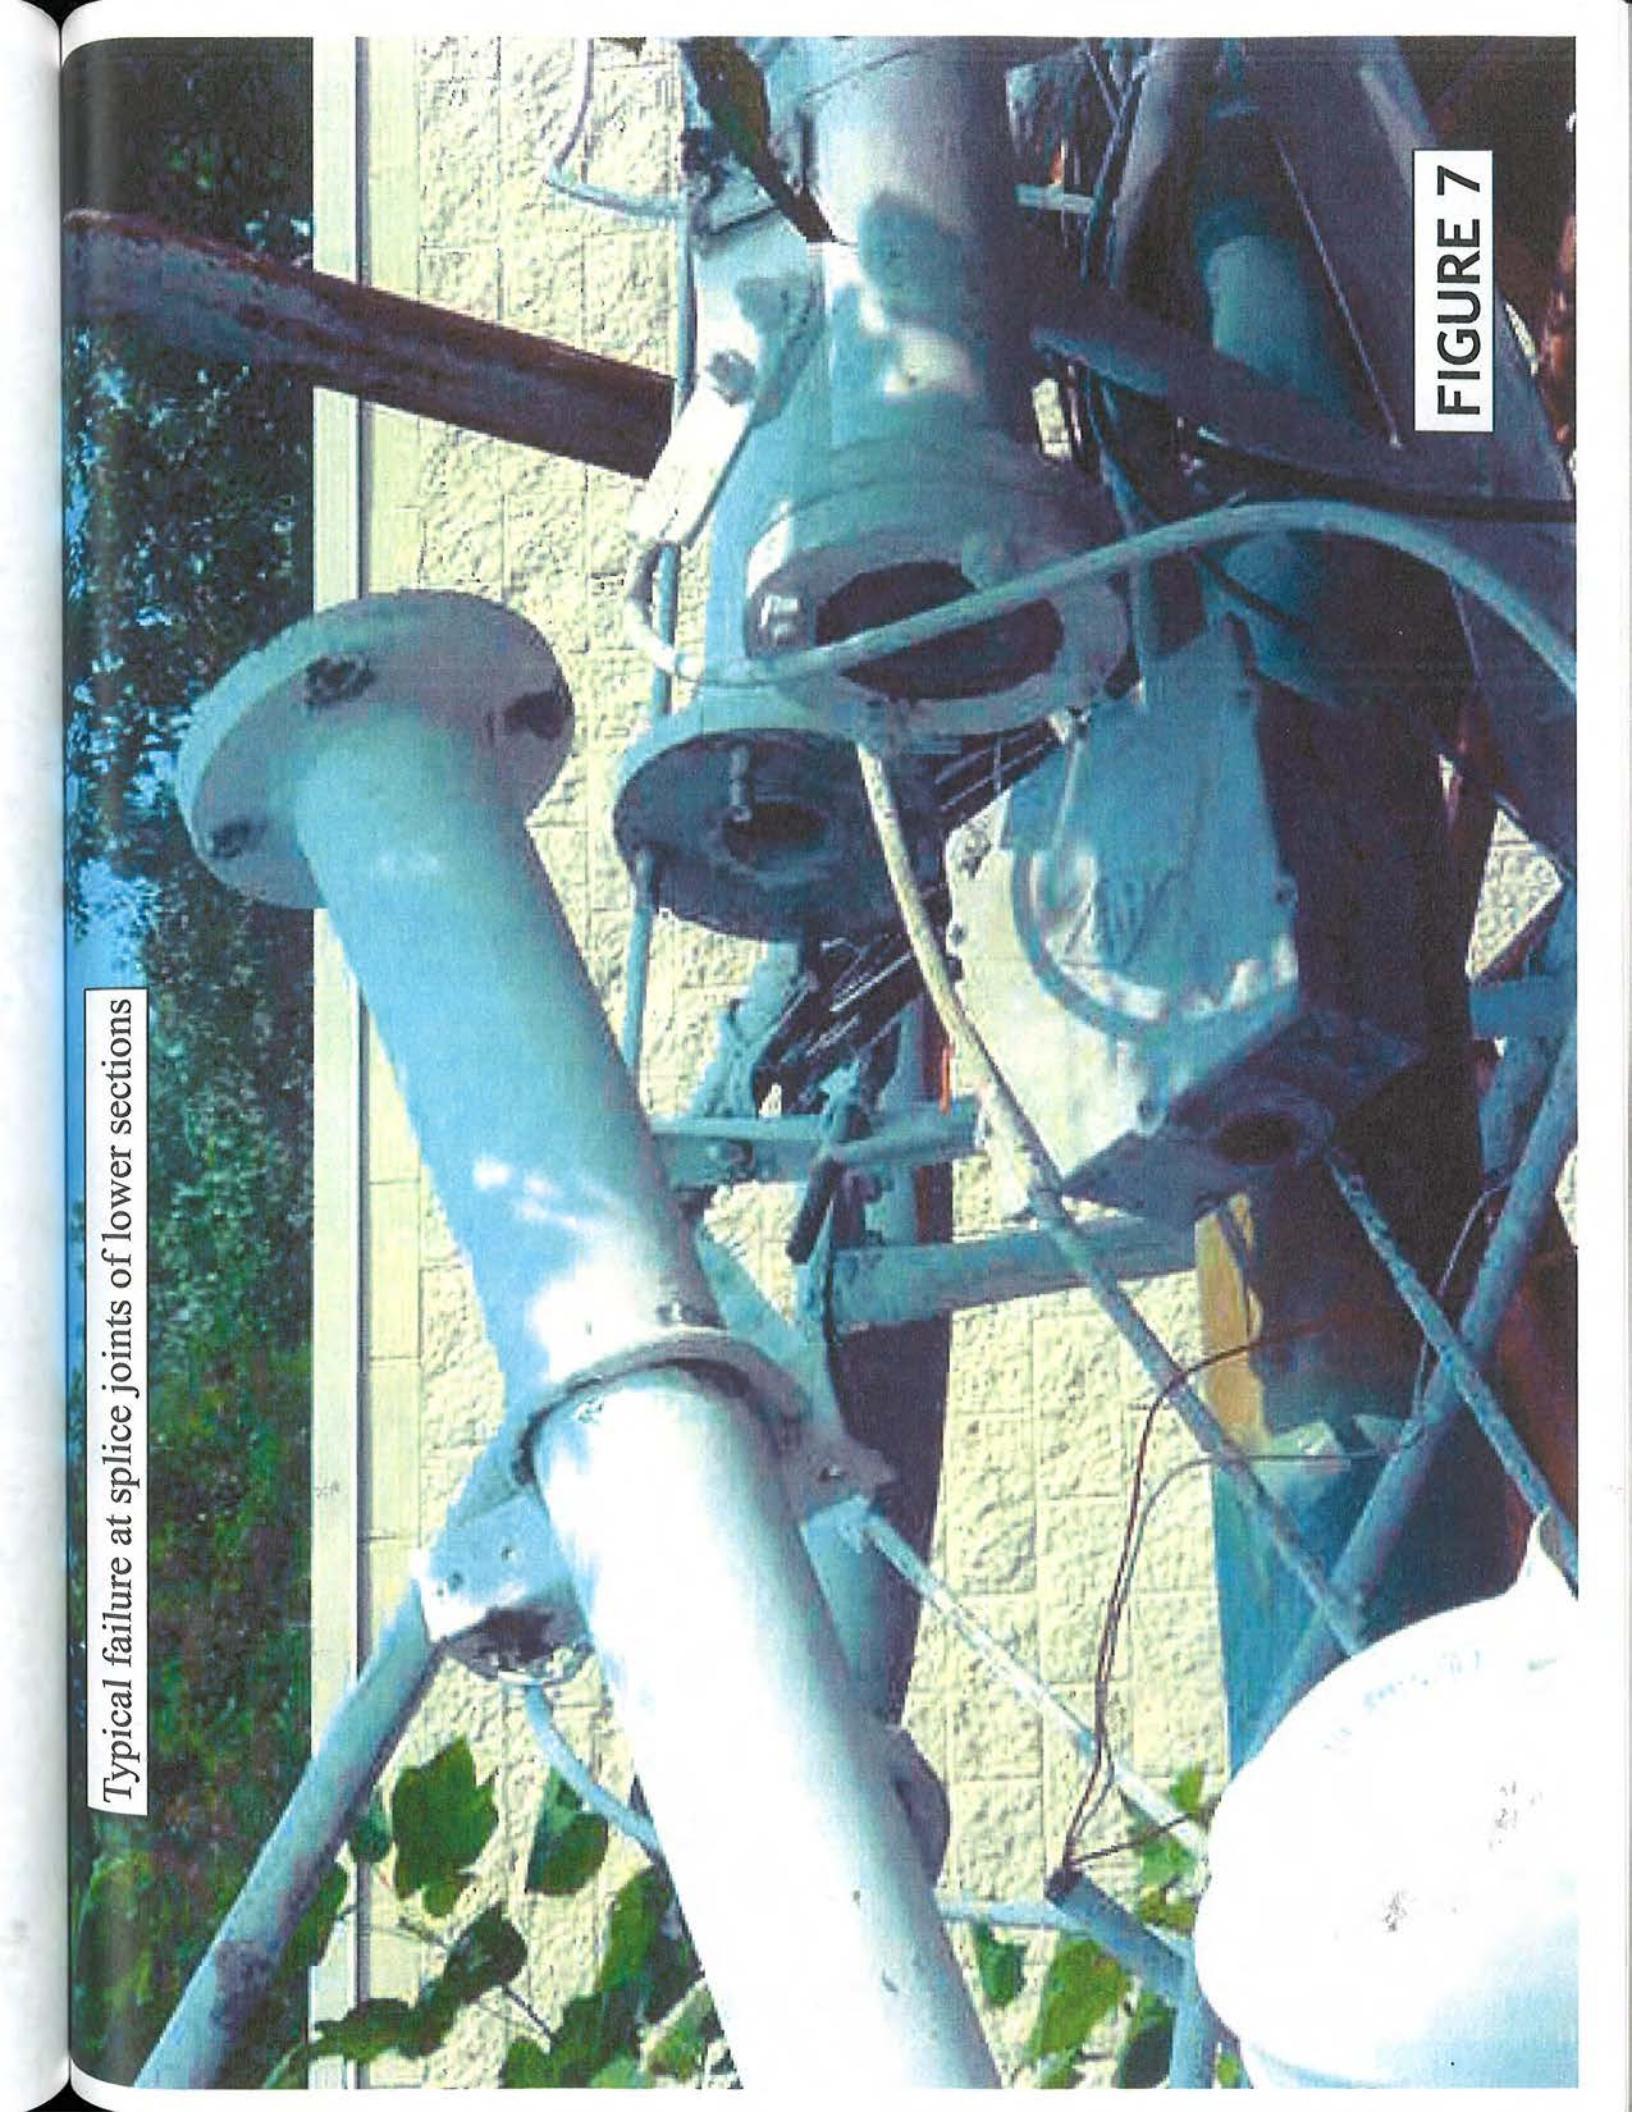
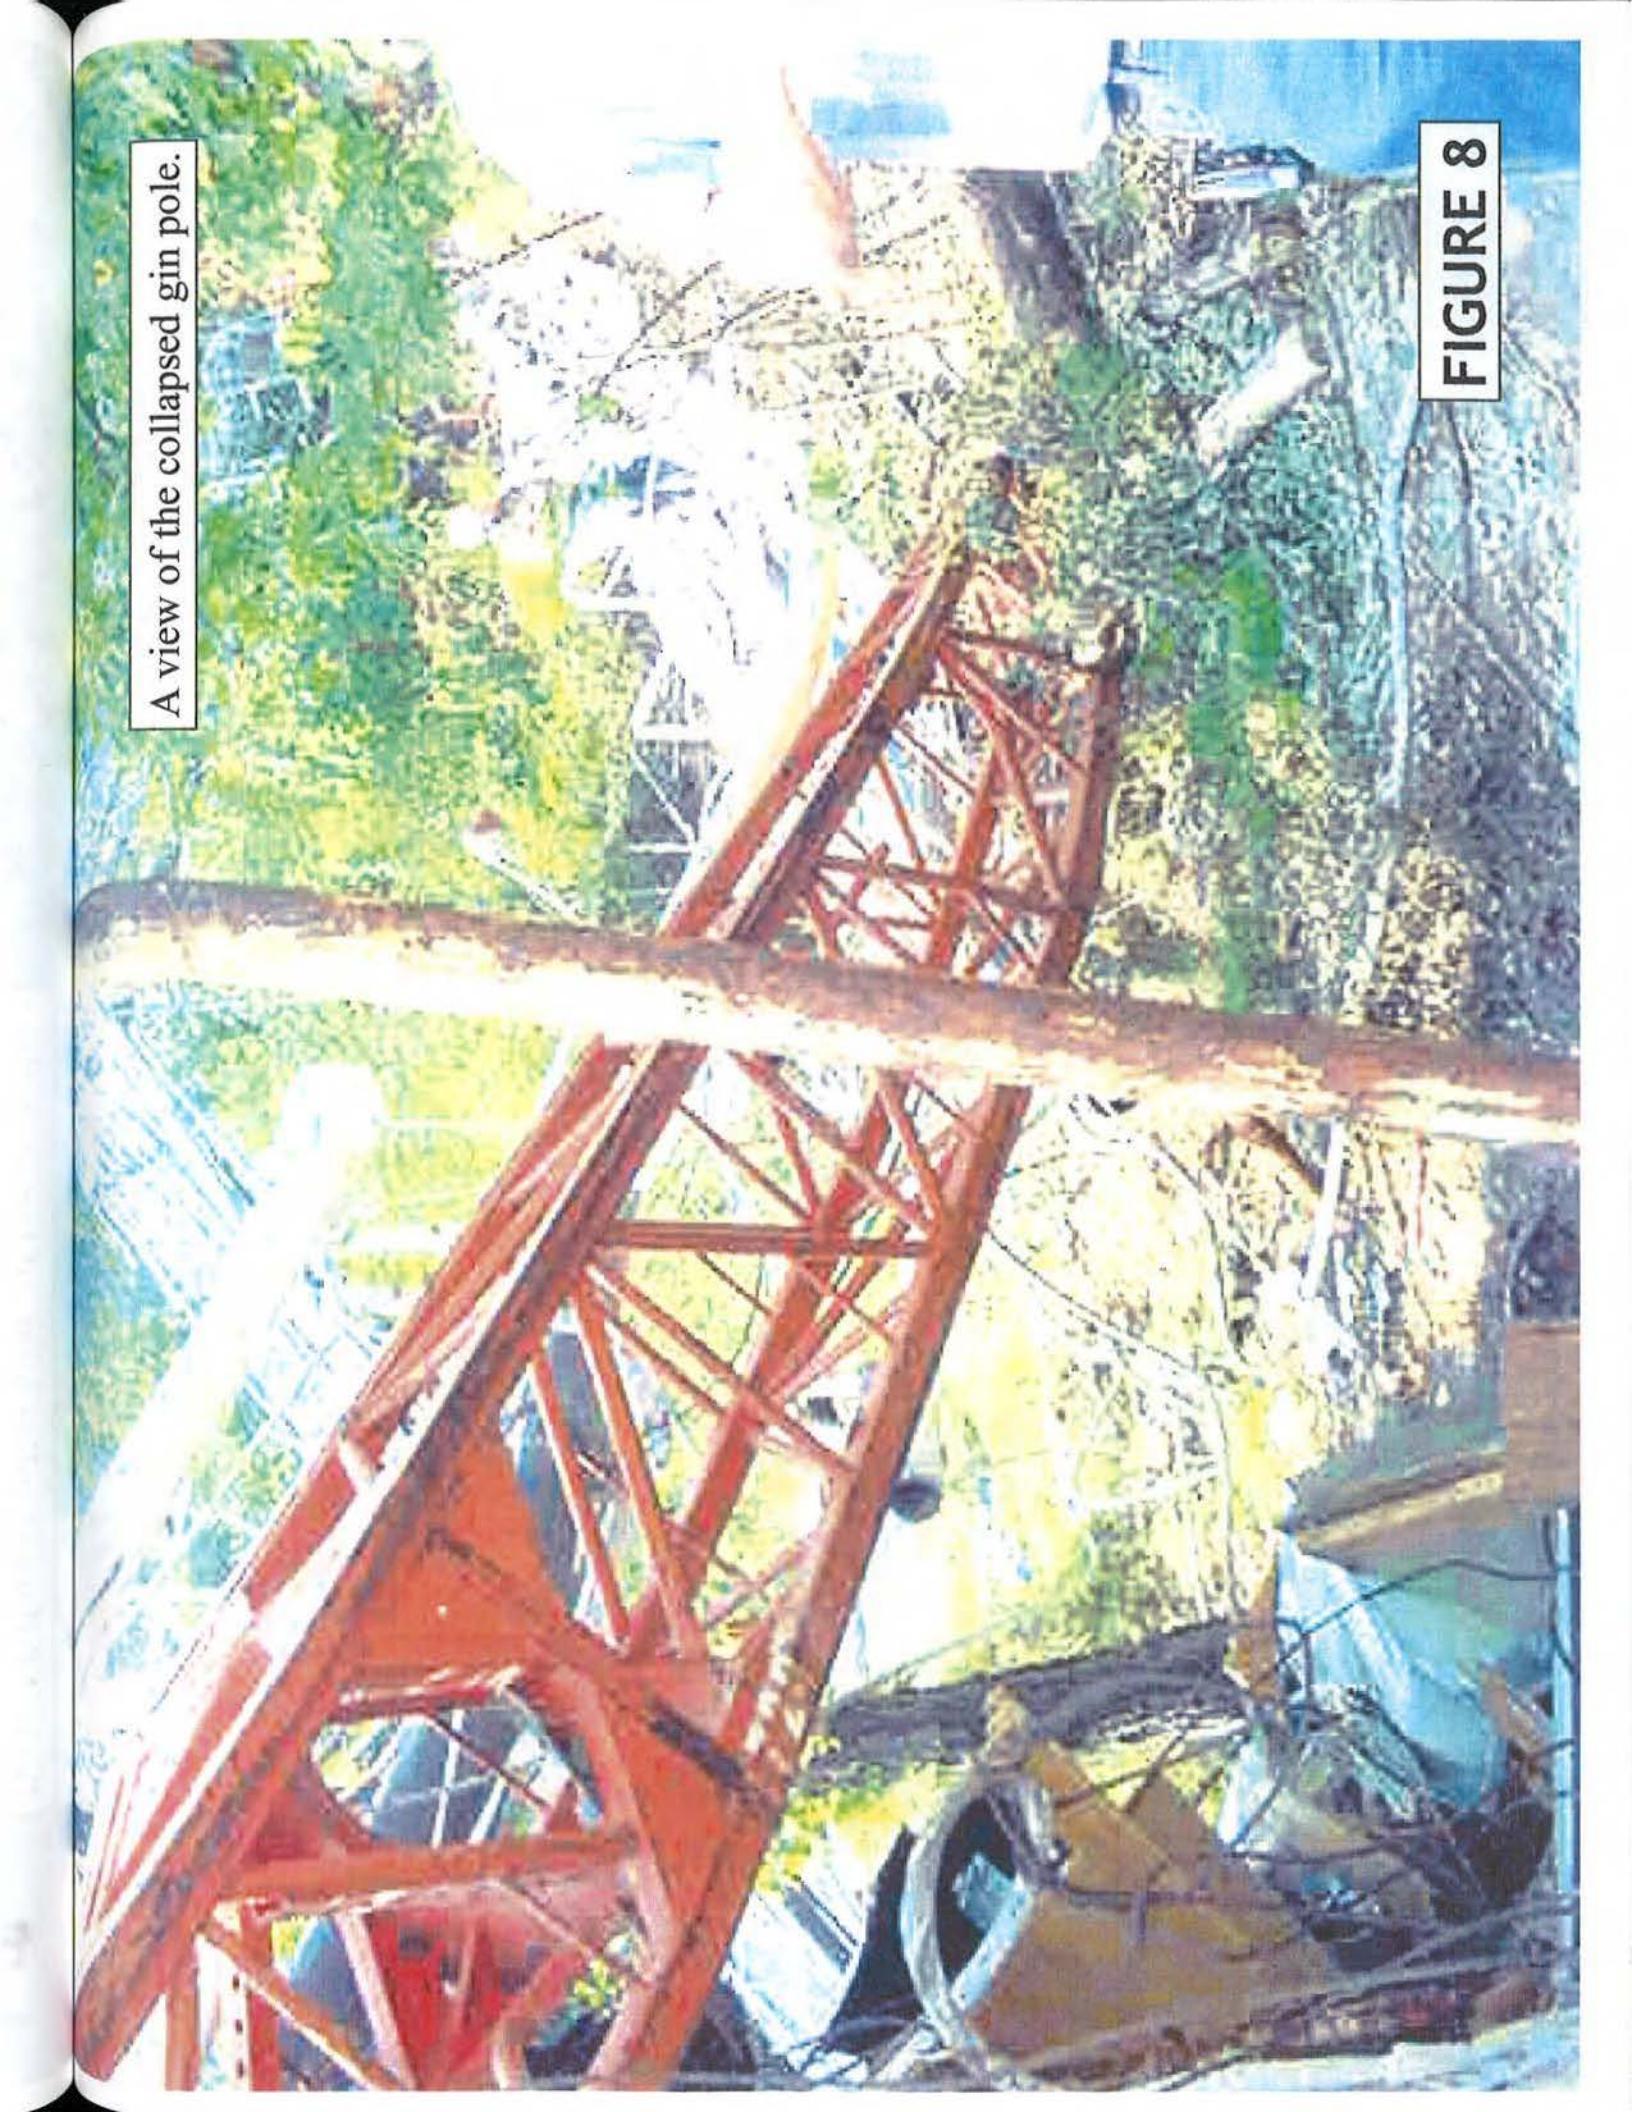
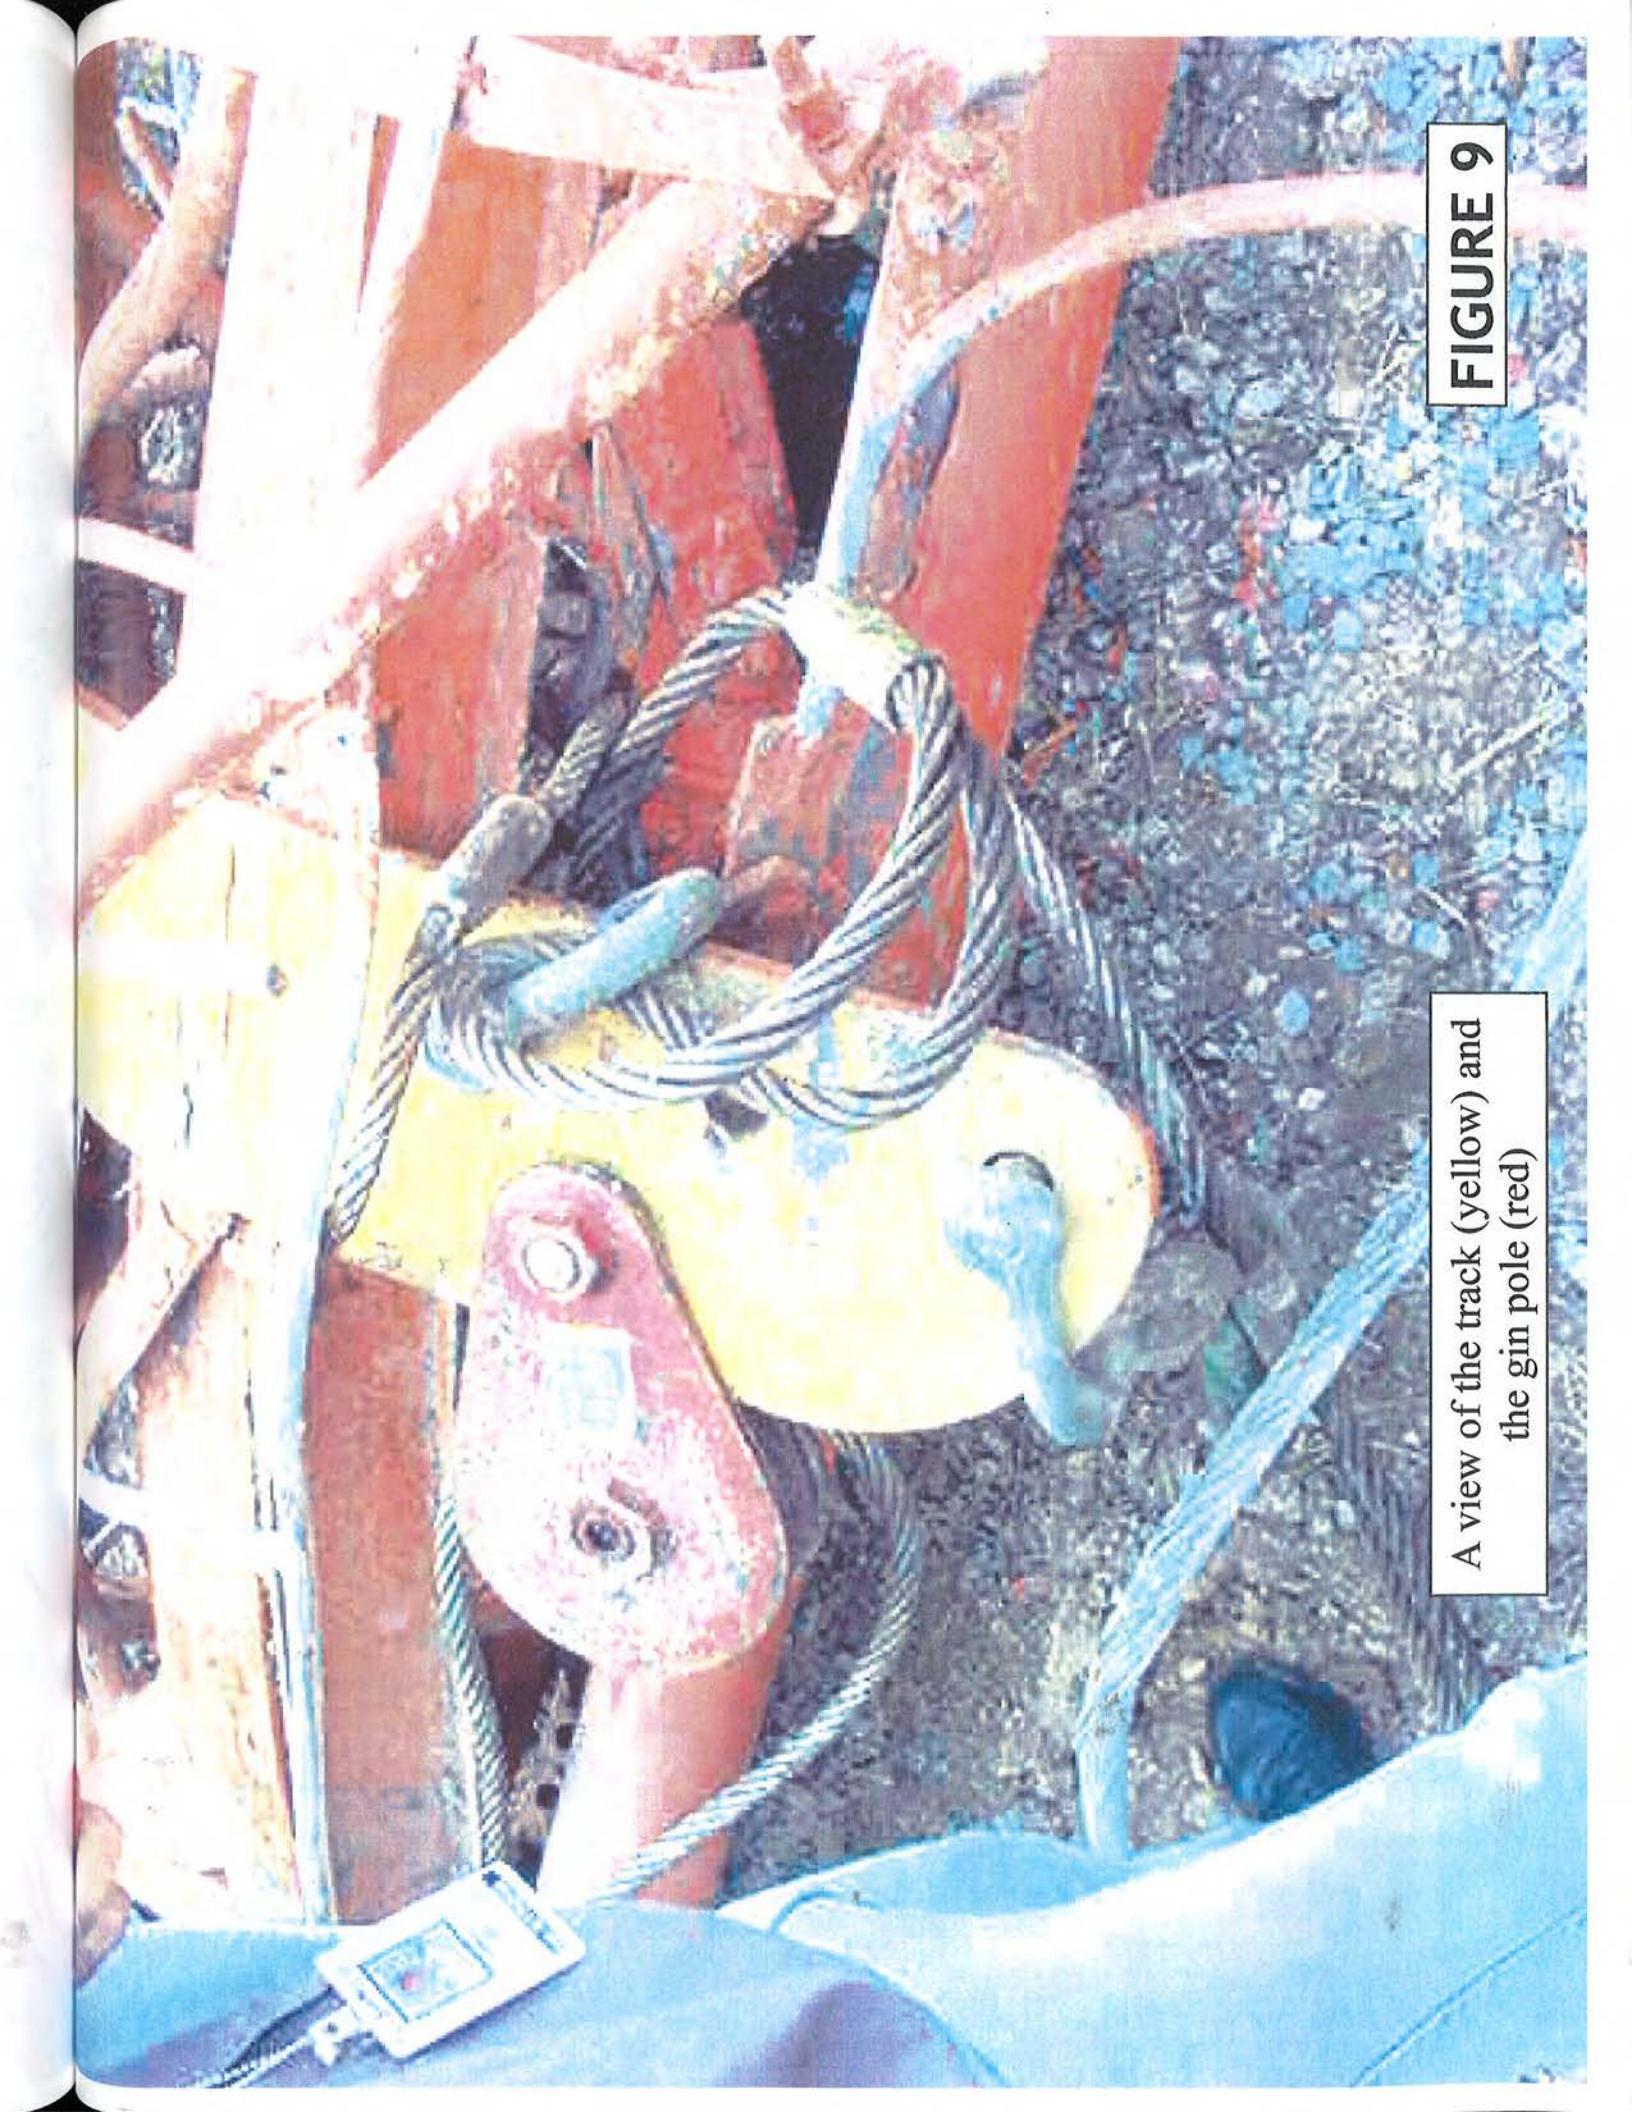
The photographs of the collapsed tower on the ground are shown in figures 6 thru 25.
