INVESTIGATION OF THE FEBRUARY 14, 2011 PARTIAL COLLAPSE OF A PARKING STRUCTURE UNDER CONSTRUCTION IN SAN ANTONIO, TX

U. S. Department of Labor Occupational Safety and Health Administration Directorate of Construction

August 2011

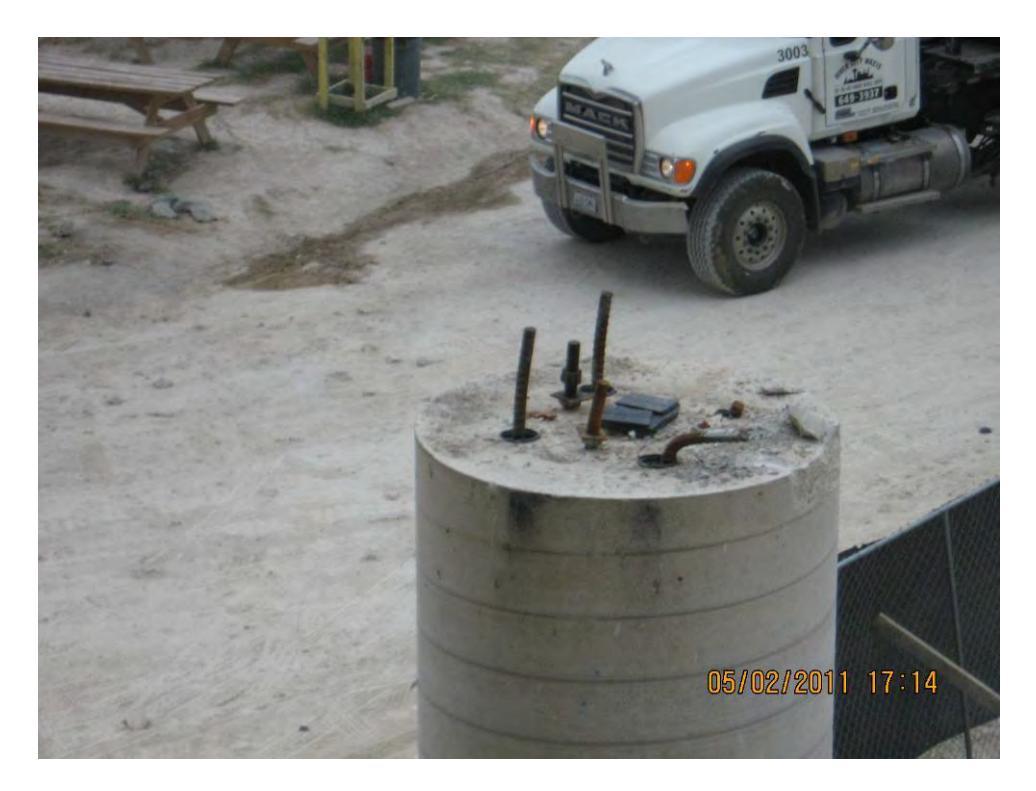
- Along Grid Line 2, for Piers P2, Q2 and R2, the six bolts in tension, the thread of the five top nuts were stripped off from their respective bolts. For the sixth bolt at Pier P2, the top nut was partially sheared off of its cross sectional area through an over-sized hole in the base plate. In regard to the three east bolts, two fractured within the threaded length of the bolt above their leveling nuts and the third bolt at Pier R2 was still attached to the Column R2.

Figure 6. Failed Conditions on Top of CIP Pier P2.

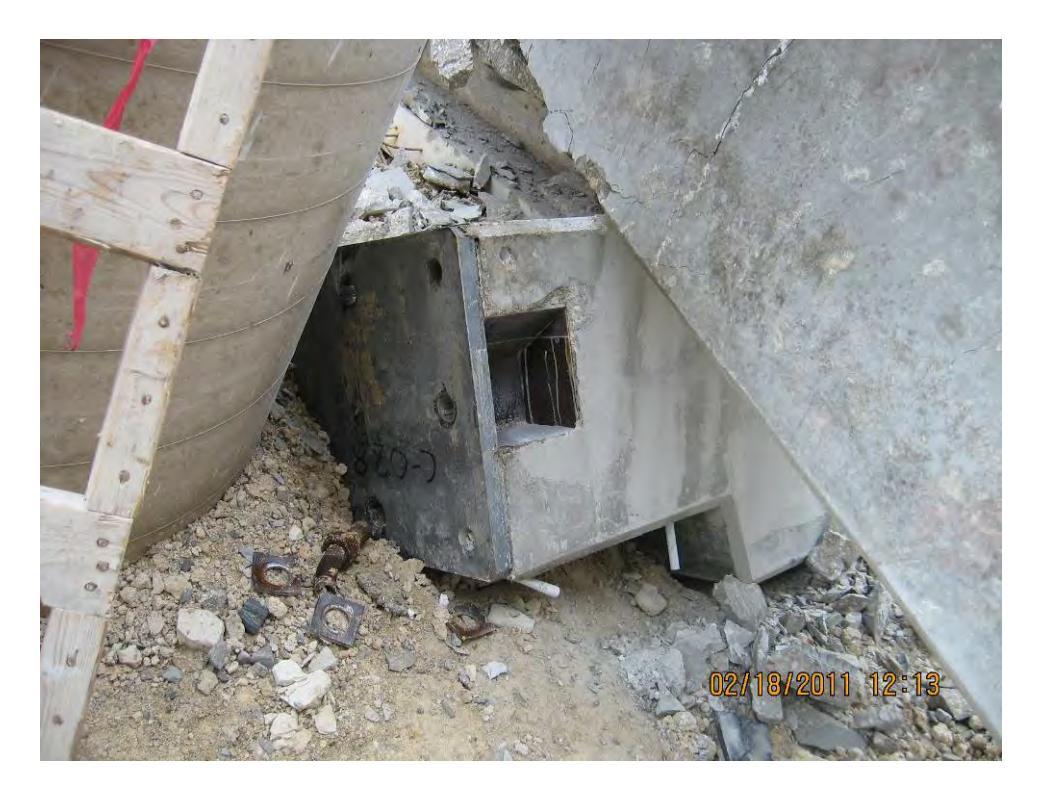
- The west anchor bolt was misaligned when Pier P2 was cast which resulted in an enlarged hole in the column base plate during the erection of the frame. As a result, during the collapse the top nut sheared off due to the oversized hole in the base plate and the anchor bolt did not provide the required strength. Similar enlarged holes were also observed in other base plates in the collapsed area.

Figure 7. Failed Conditions at the Bottom of Column P2 (Mark No. C-028).

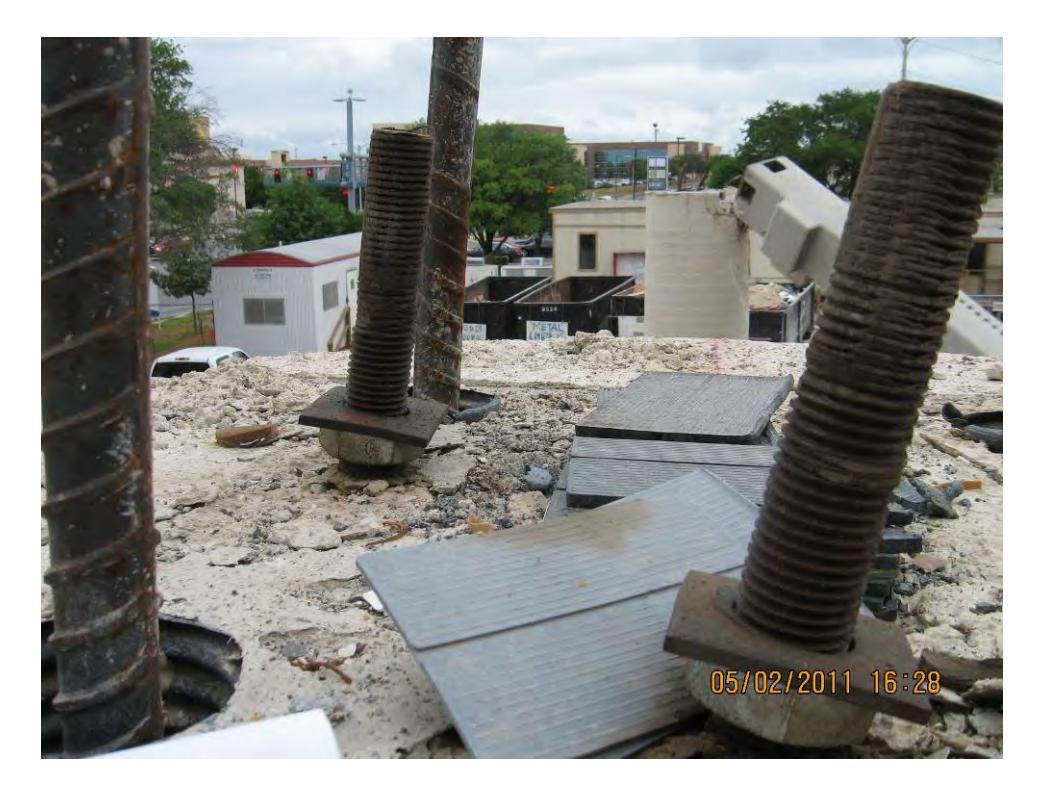
Figure 8. Failed Conditions on Top of CIP Pier Q2.

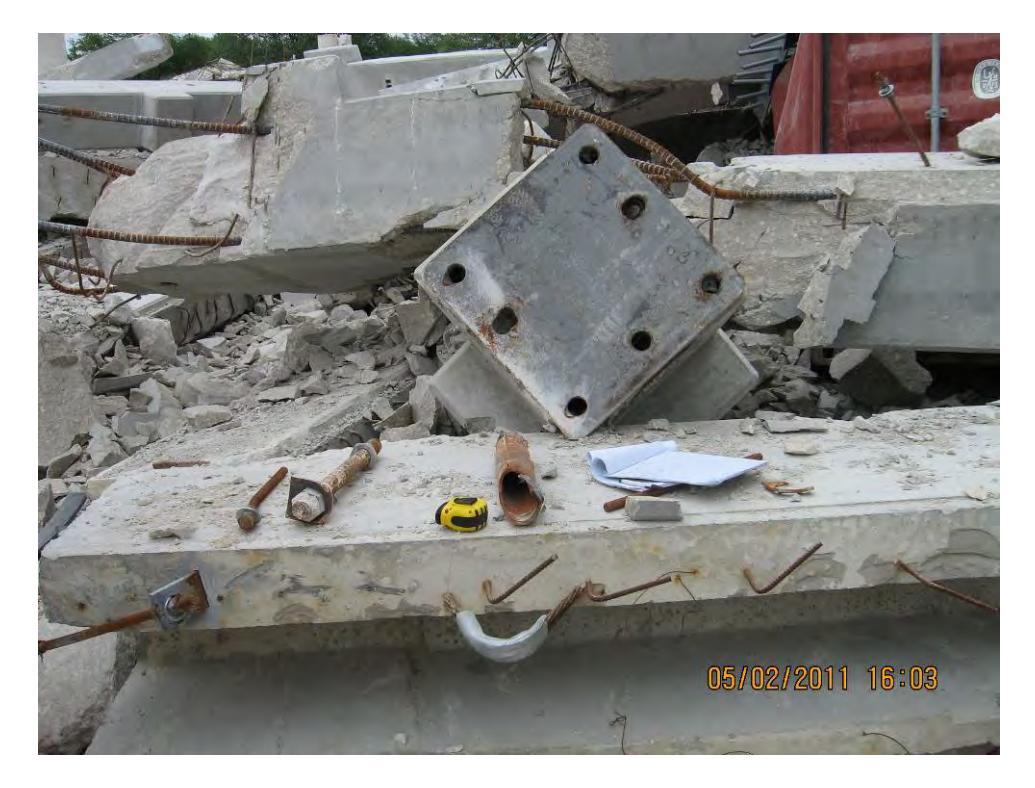
Figure 9. Failed Conditions at the Bottom of Column Q2 (Mark No. C-029).

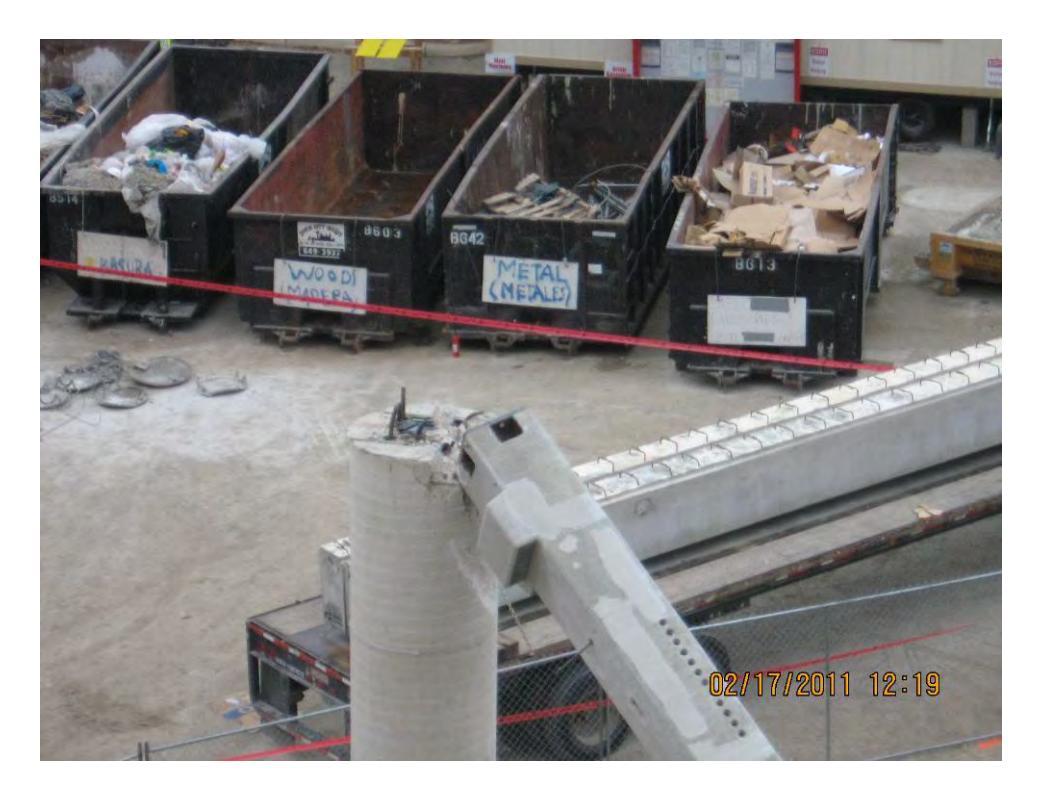
Figure 10. Failed Conditions on Top of CIP Pier R2.

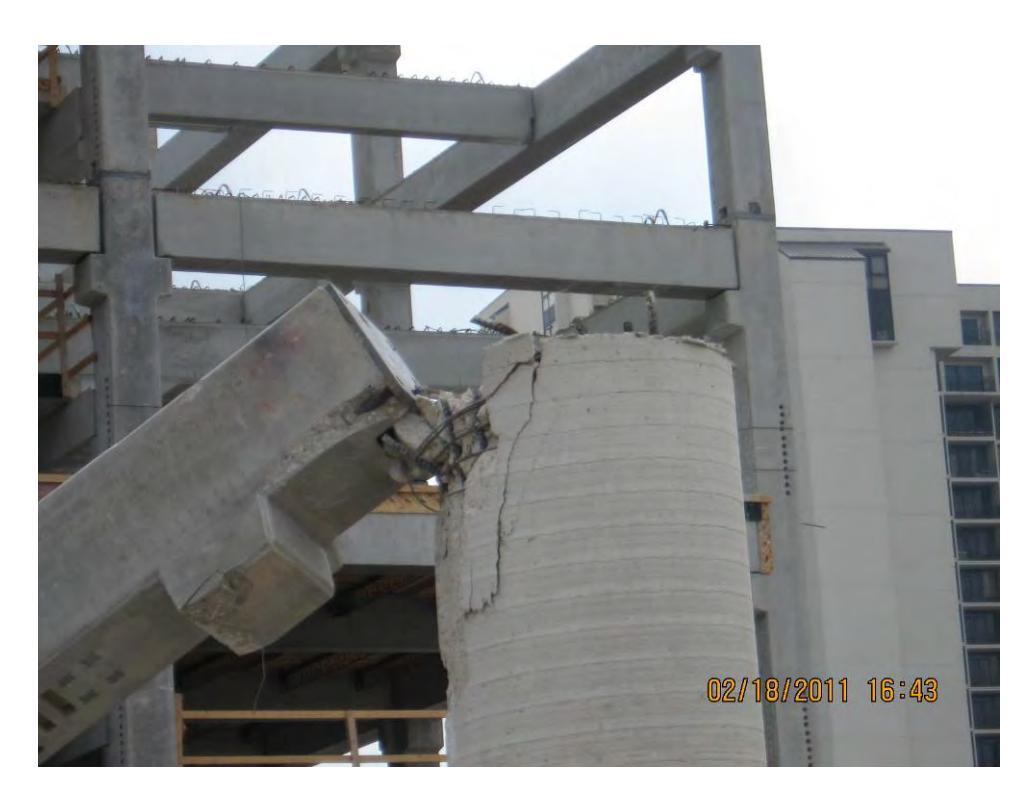
Figure 11. Failed Conditions at the Bottom of Column R2 (Mark No. C-030). Note that this is the only column that still connected to the pier.

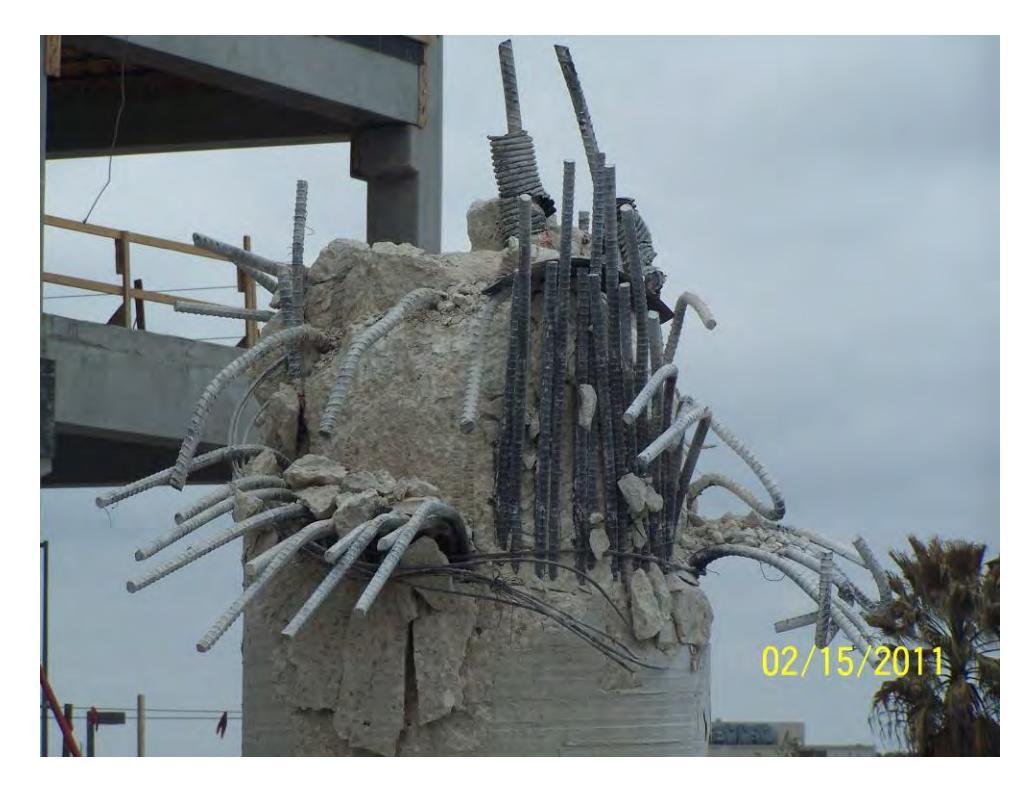
- Along Grid Line 3, for Piers P3 and Q3, the west bolts fractured above the leveling nuts; the south bolts and east bolts were pulled and compressed in the crushed concrete, respectively, and fell together with the base plate (Figures 13 and 15). For Pier R3, the thread of the top nut was stripped from the west bolt, the south bolt fractured below the leveling nut and the east bolt fractured above the leveling nut.

Figure 12. Failed Conditions on Top of CIP Pier P3.

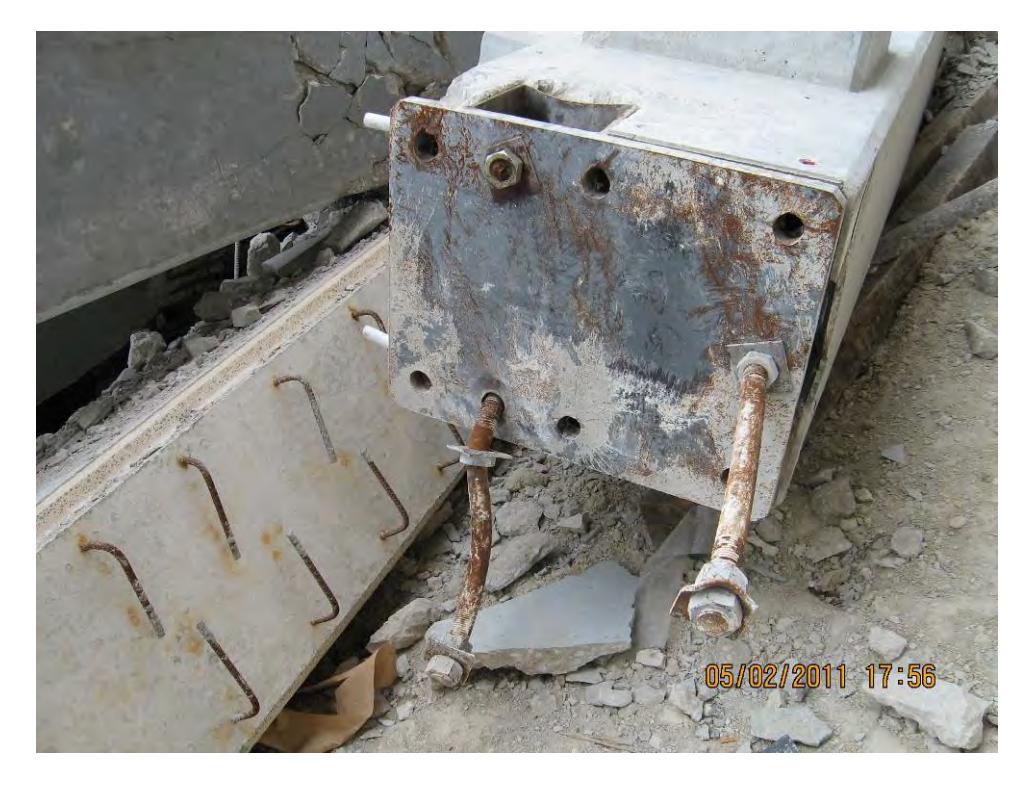
Figure 13. Failed Conditions at the Bottom of Column P3 (Mark No. C-049). Note that the entire south and east anchorage assemblies were still attached to the base plate.

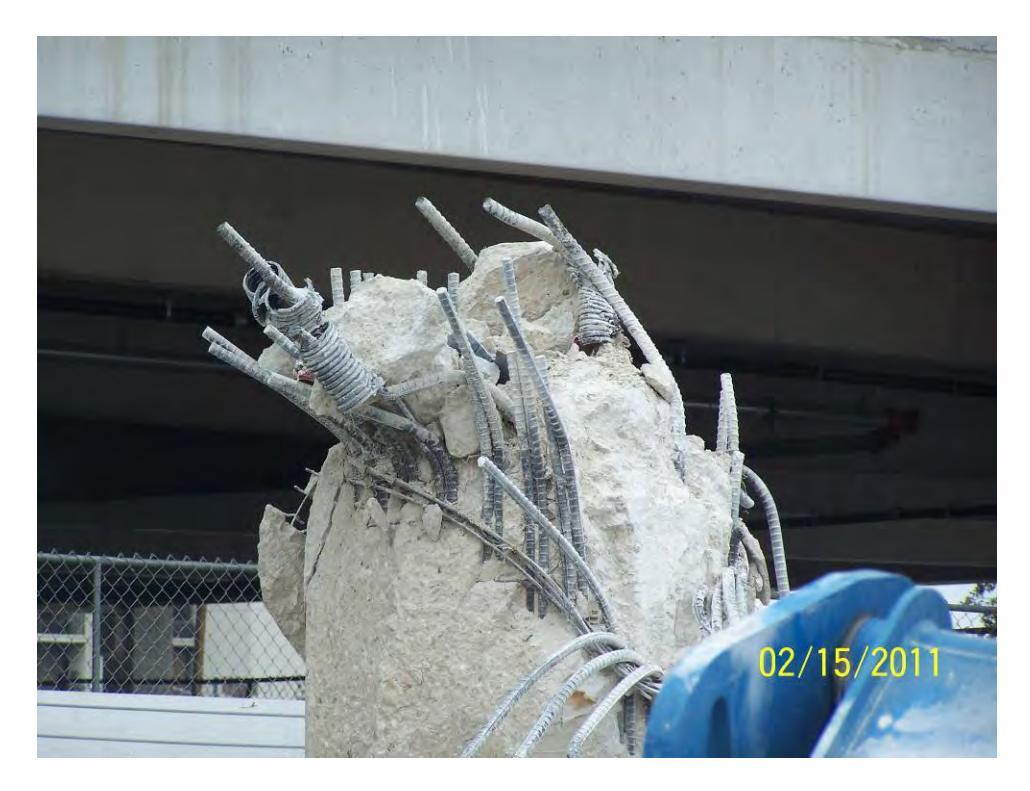
Figure 14. Failed Conditions on Top of CIP Pier Q3.

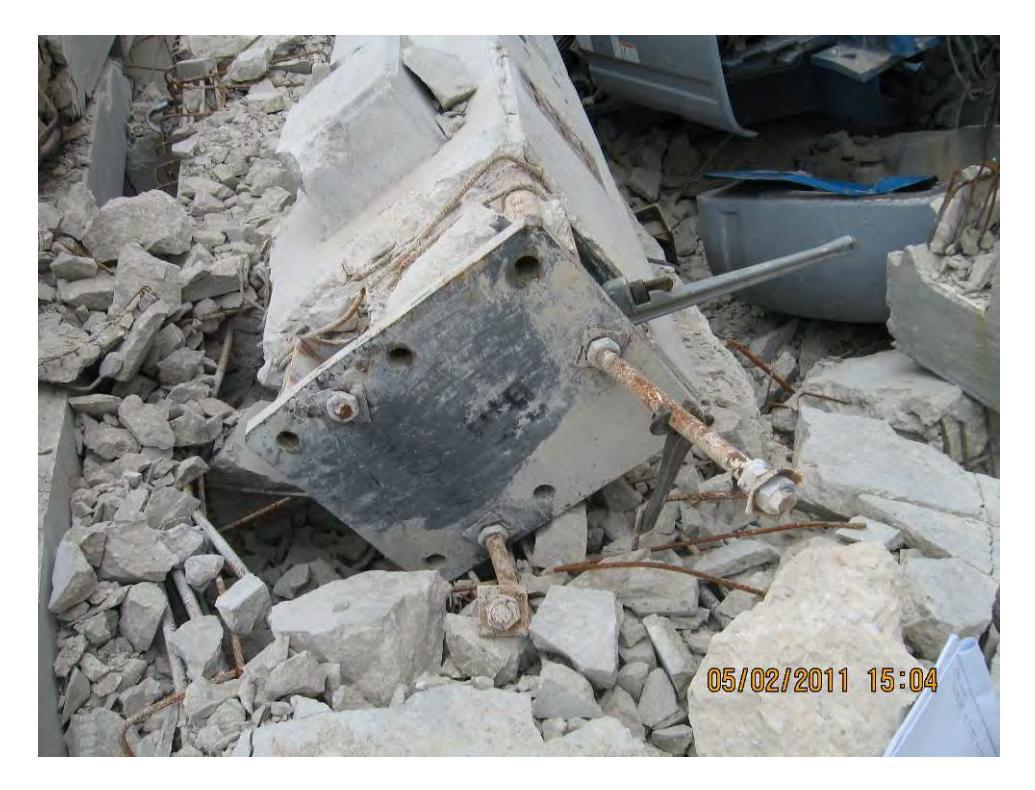
As the tilting continued, the load on Column Q3 caused an overturning moment, which would be proportional to the increase of the tilting angle. When the tilting angle reached approximately 3°, the overturning moment of Column Q3 caused the complete fracture of the west anchor bolt, initiating the collapse. During the collapse, the east side of the base plate cut into the top of the CIP pier and crushed the concrete, pushed the east leveling nut down approximately 3" from its original position and compressed the embedded portion of the east anchor bolt further downward. As a result, both the east and the south anchor bolts and the precast column fell along with the crushed concrete pieces to the ground. As shown in Figure 15, both the east and south bolts were still attached to the base plate of Column Q3 after the collapse.

Figure 15. Failed Conditions at the Bottom of Column Q3 (Mark No. C-050). Note that the entire south and east anchorage assemblies were still attached to the base plate.

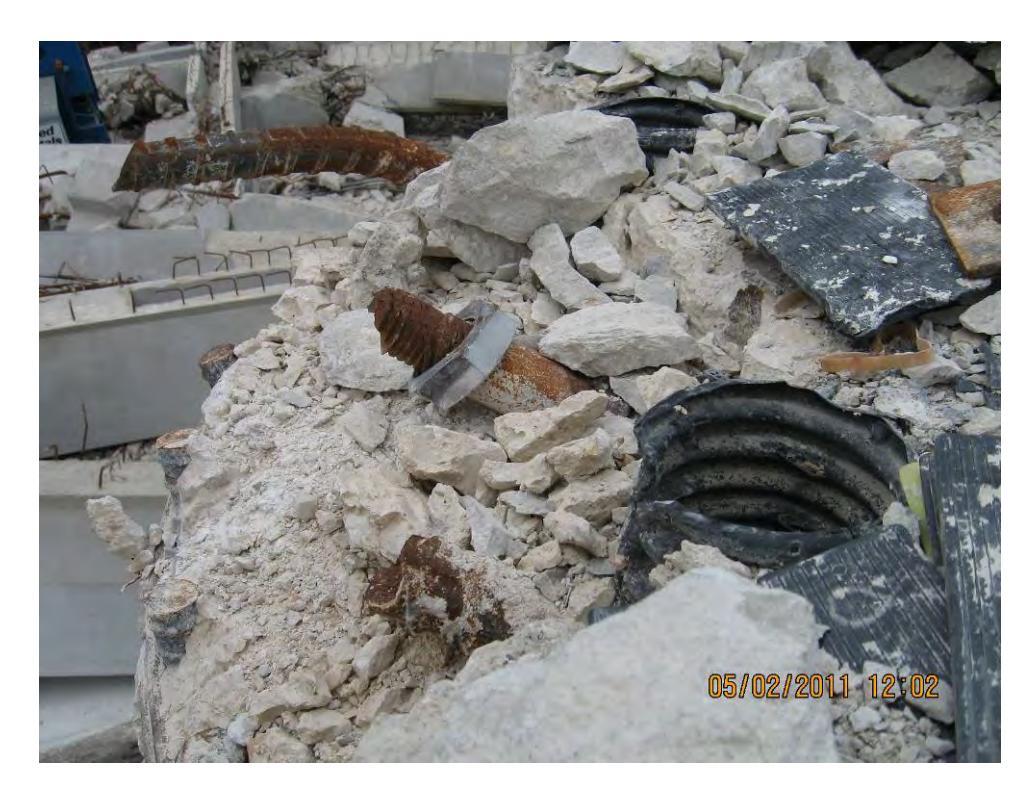
Figure 16. Failed Conditions on Top of CIP Pier R3.

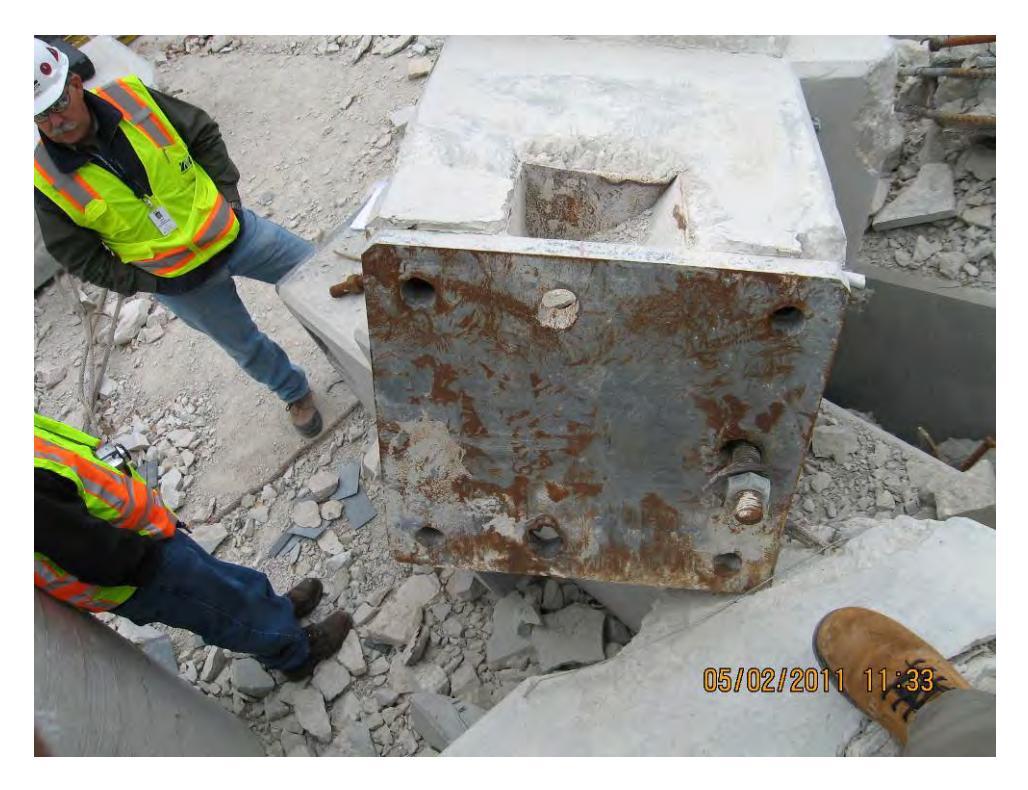
Figure 17. Failed Conditions at the Bottom of Column R3 (Mark No. C-118).

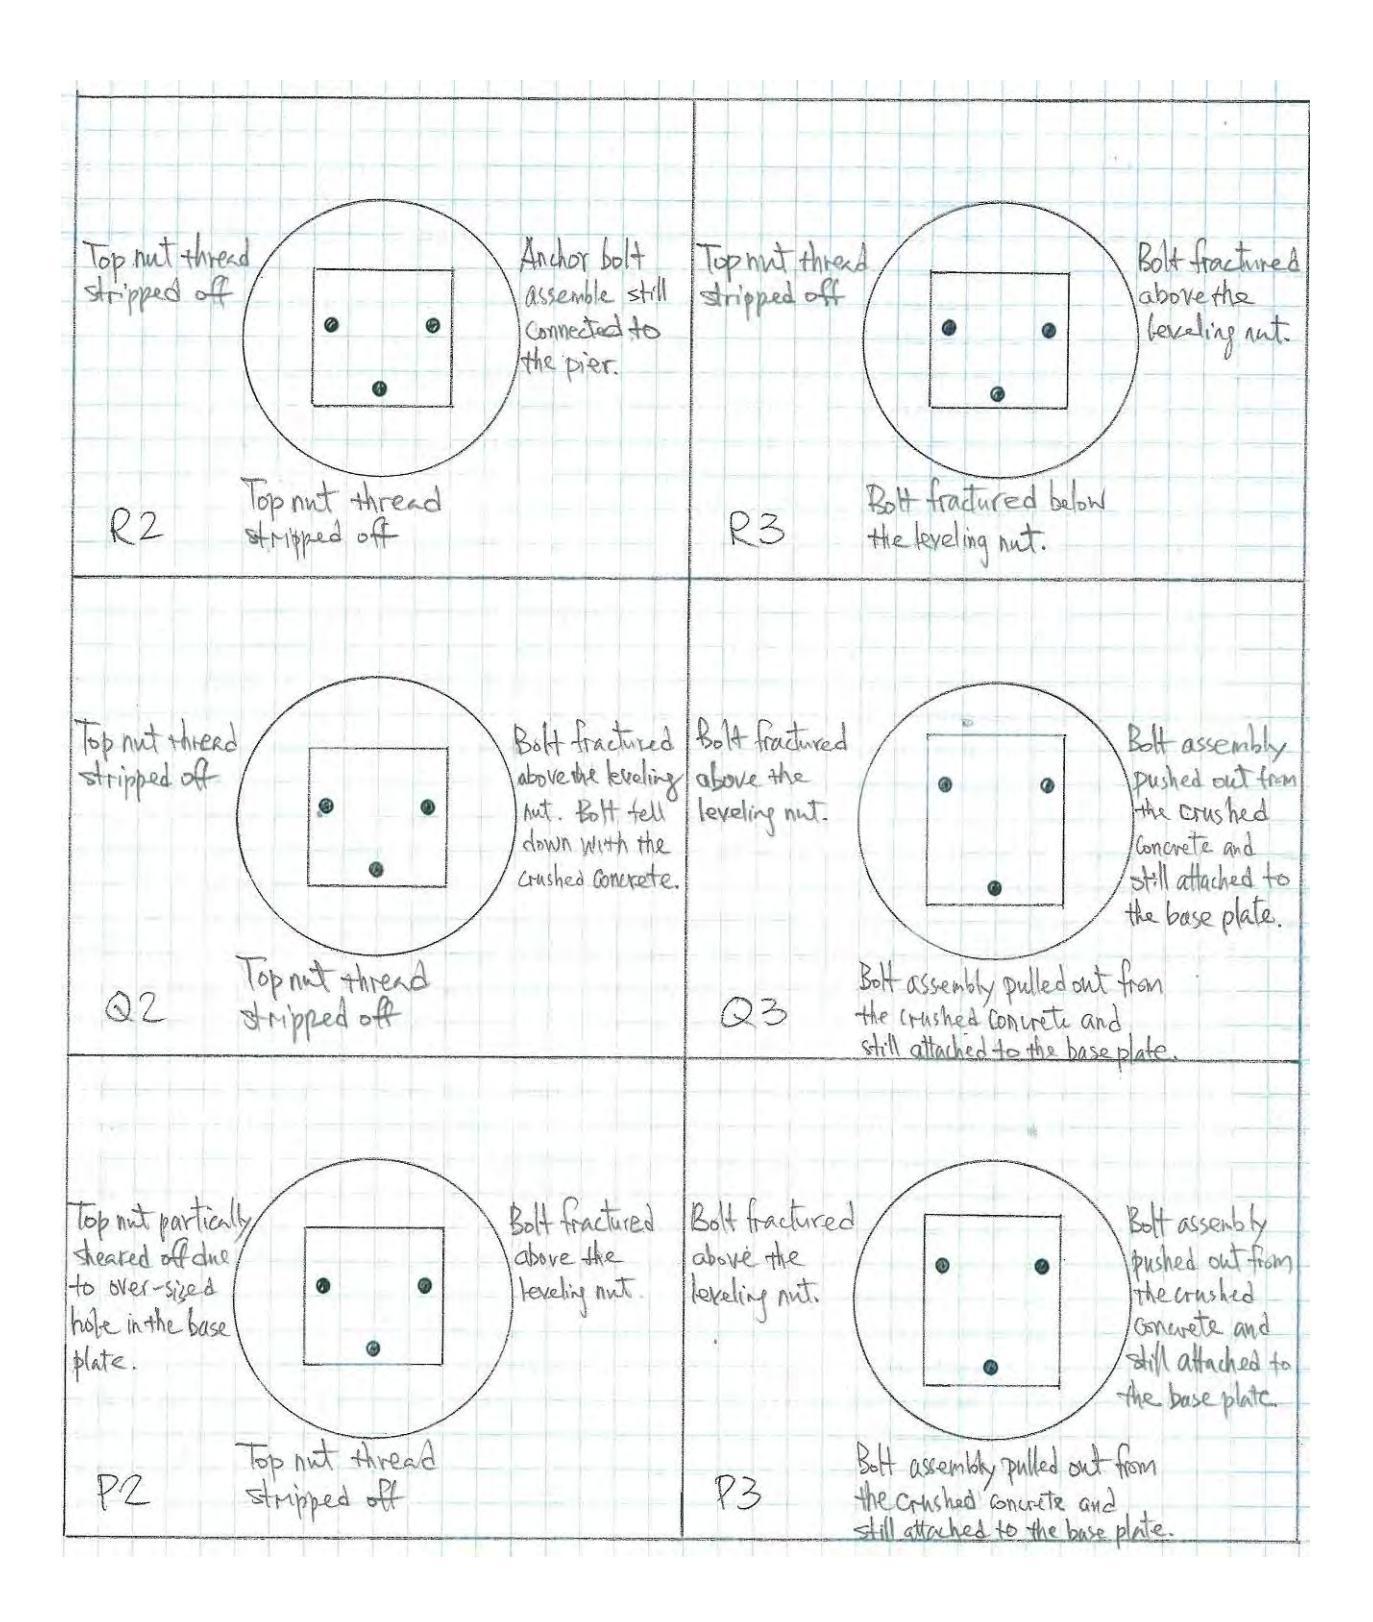
The conditions of the six column-to-pier connections after the collapse are summarized in Figure 18 and described below:

- Since the entire six-column frame fell toward the east direction, the west bolts and south bolts failed in tension, while the east bolts failed in compression or bending.

Figure 18. Summary of the Failure Conditions of Column to Pier Connections Grid P/2 through R/3.

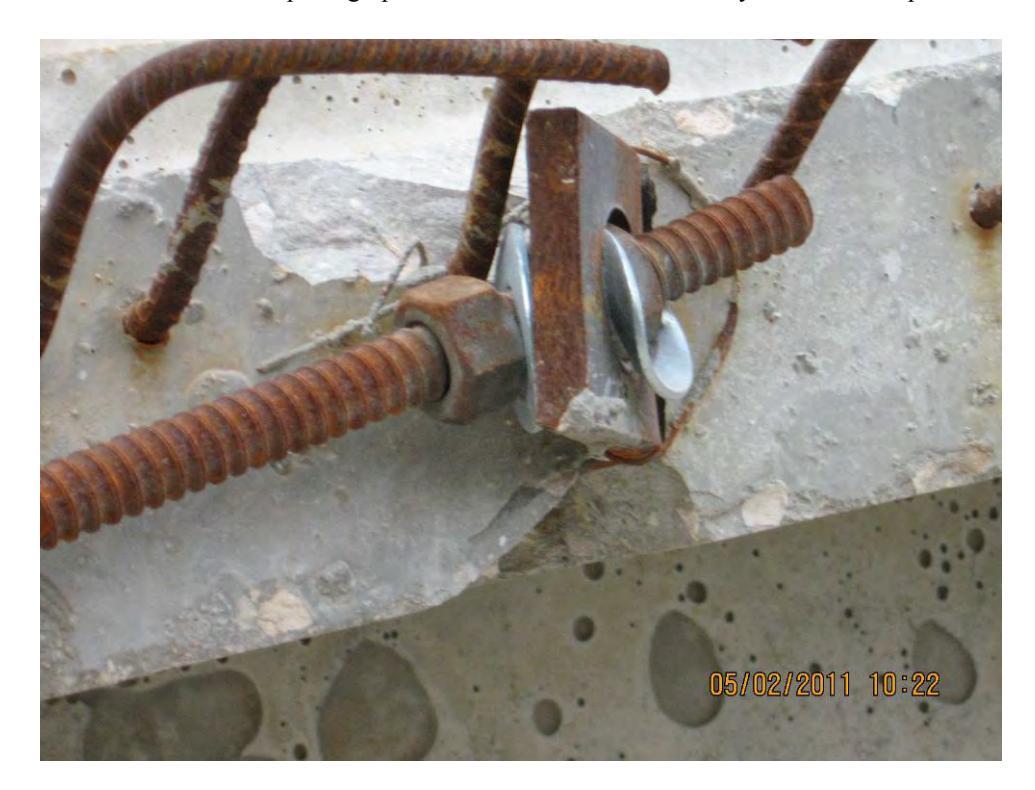
During erection, the temporary column-beam connection consisted of a coil bolt assembly from the side of a column connected to a steel plate projected out from the top face of the beam (See Figure 19). Figure 20 presented the failure condition of this connection. We made the following field measurements:

Figure 20. Failed Conditions of the Column to Beam Connection.

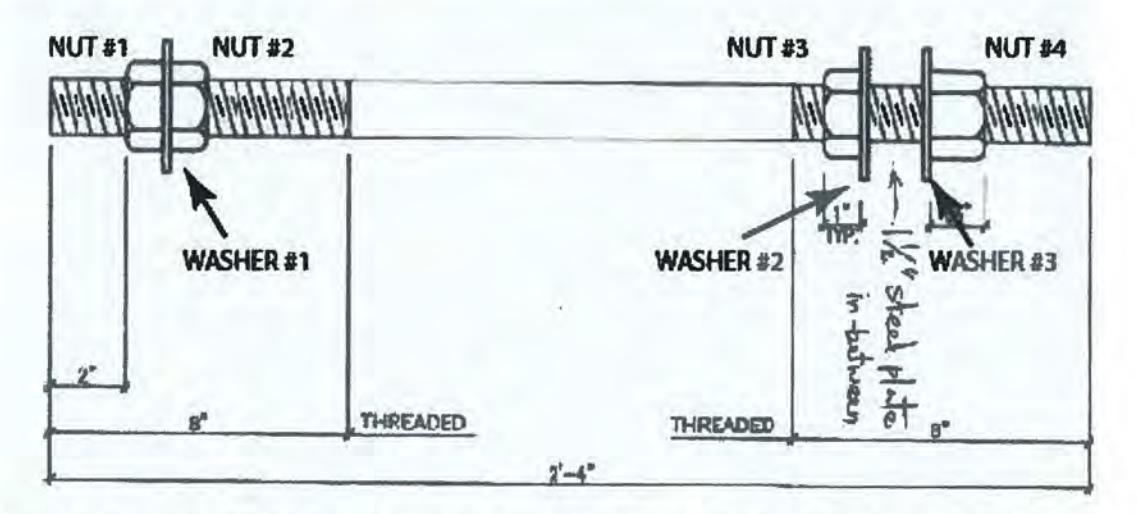
Figure 1: Identification of Nuts and washers on a figure extracted from mechanical drawing AB001 supplied to SLTC by Scott Jin. Note that this is the mechanical drawing. The assembly differed from this in that the threaded end on the left was 5.75 inches on anchor bolt #1 and 5.424 inches on anchor bolt #2. Also, Nut #4 on anchor bolt #2 was 1.276 inches thick and not 1.500 as indicated in AB001.

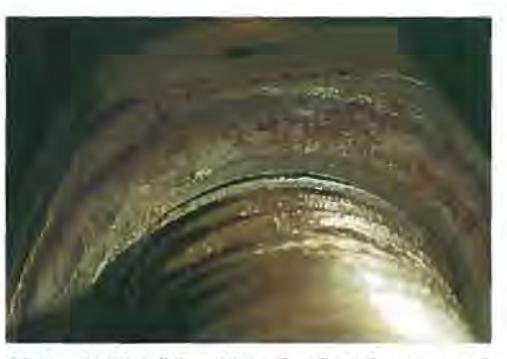
Photo 4: Nut # 3 -- Note the threads separated from the nut at the root of the thread where the rod enters the nut.

Consistent with standard hex nut (A563) B18.2.2. Type O
