INVESTIGATION OF THE SEPTEMEBER 10, 2012 PARTIAL COLLAPSE OF A BUILDING UNDER CONSTRUCTION AT 227 CARLTON AVENUE IN BROOKLYN, NY

U. S. Department of Labor Occupational Safety and Health Administration Directorate of Construction

December 2012

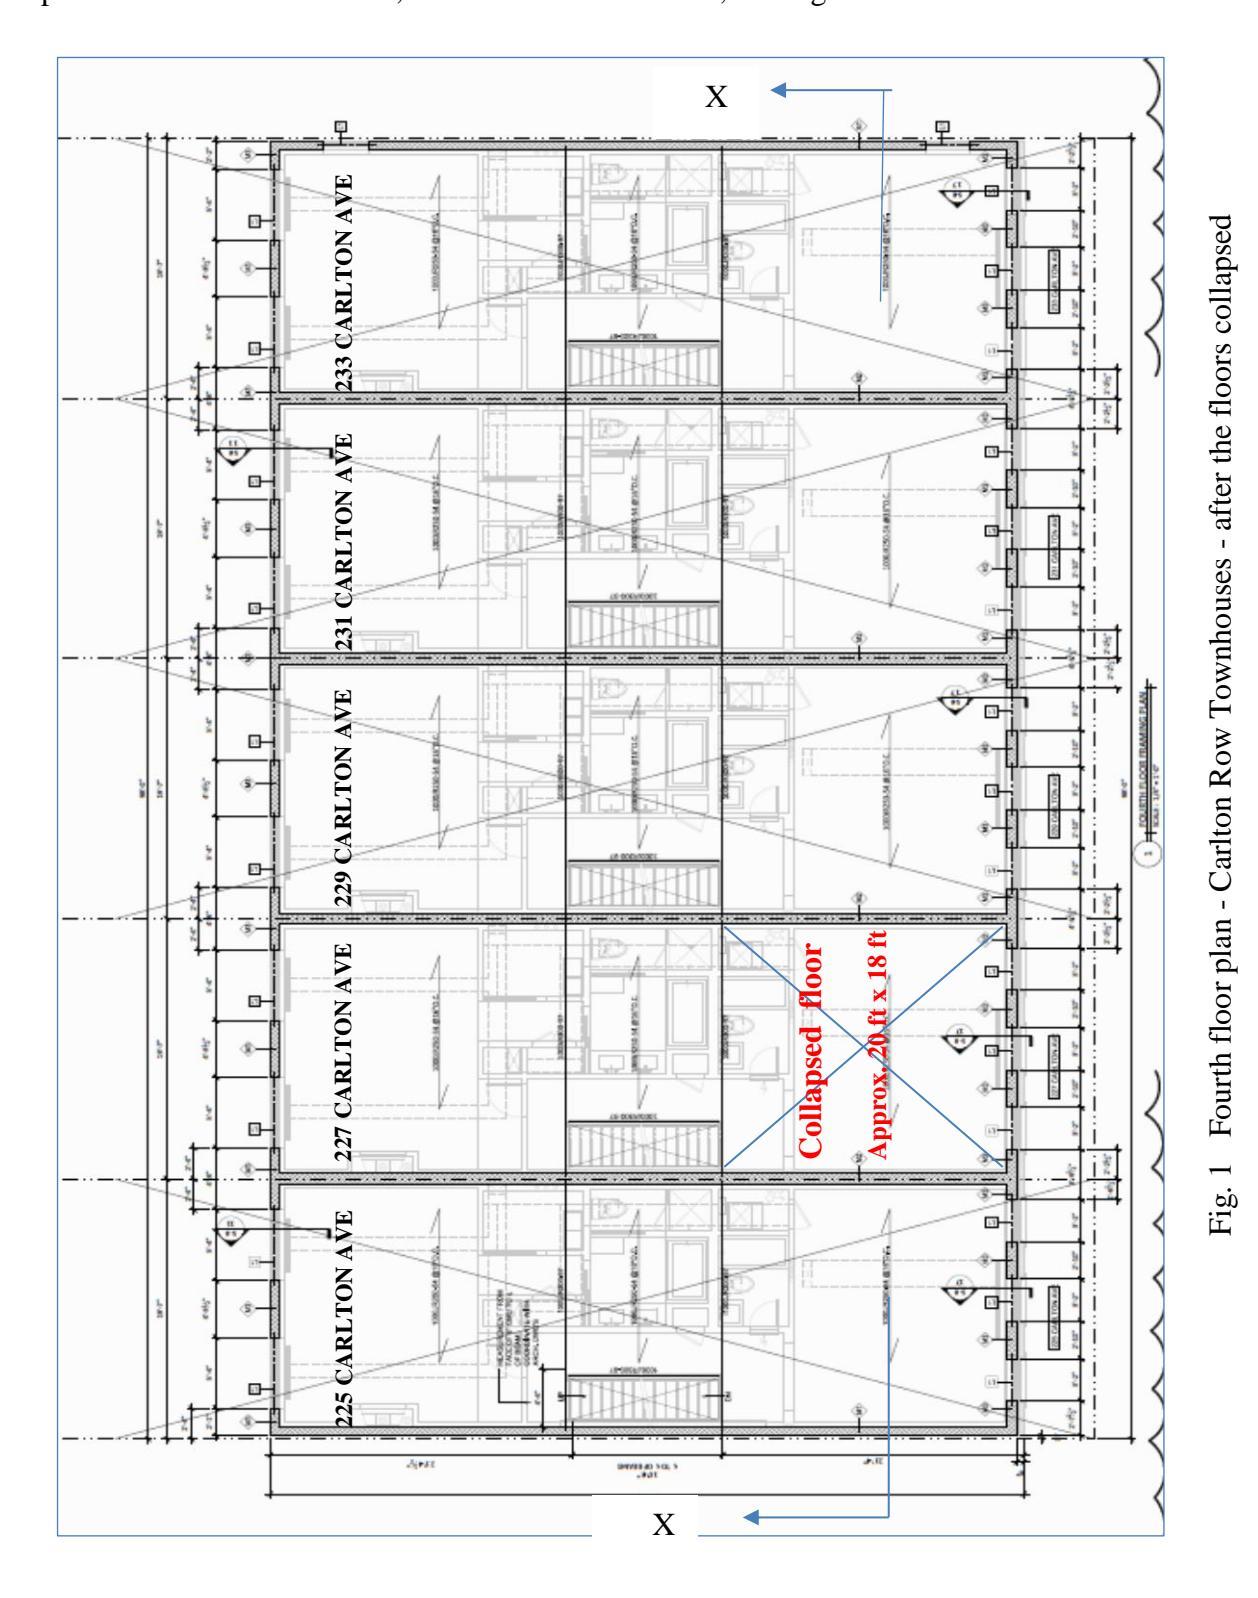
a chain of failures of the floors below, and finally the front 20 feet of all the floors were pancaked into the basement, also known as the cellar, see Fig 1 & 2.

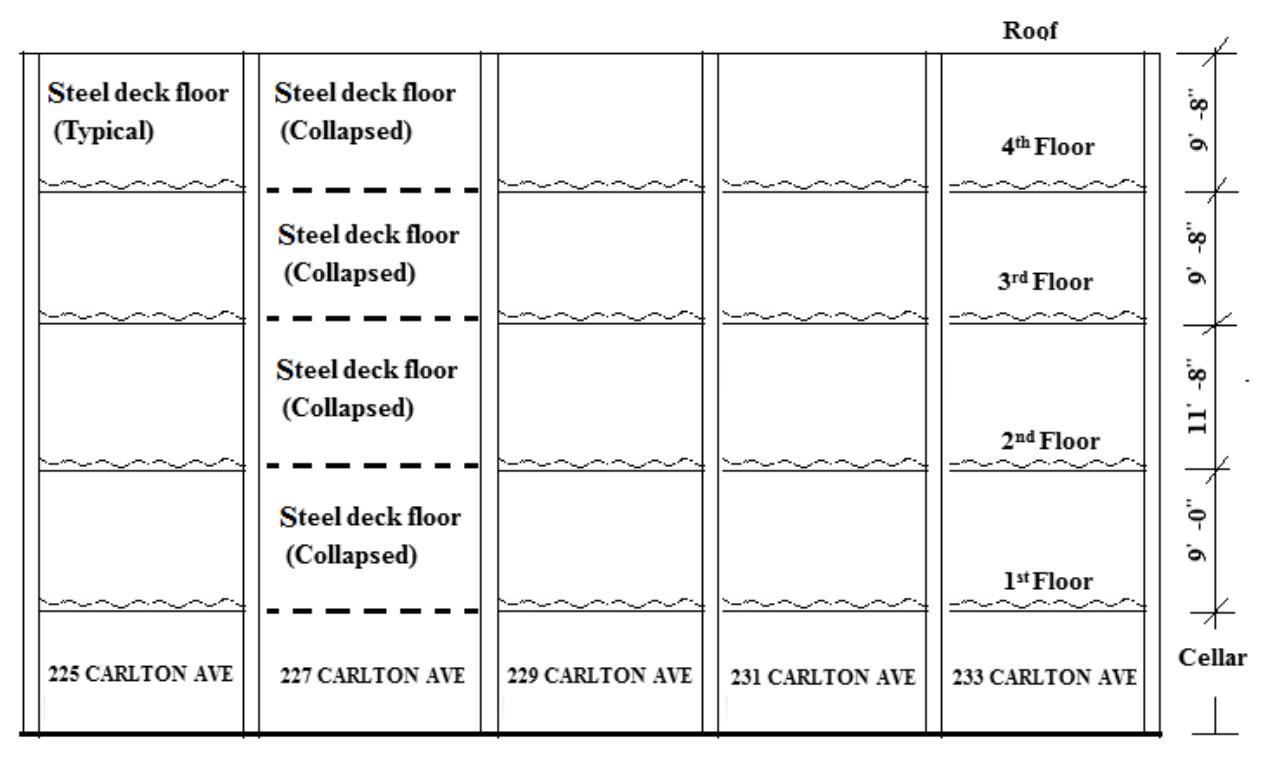
Fig. 2 Vertical section x-x of the building after the floors collapsed.

The failed portion of the deck involved approximately 16 C-Joists spaced at 16[°] o.c. Postincident observations indicated that the joists were bent and were pulled out of their pockets in the masonry walls. The metal (steel) deck fell in straight pieces, indicating that they were not screwed to the top flange of the C-Joists.

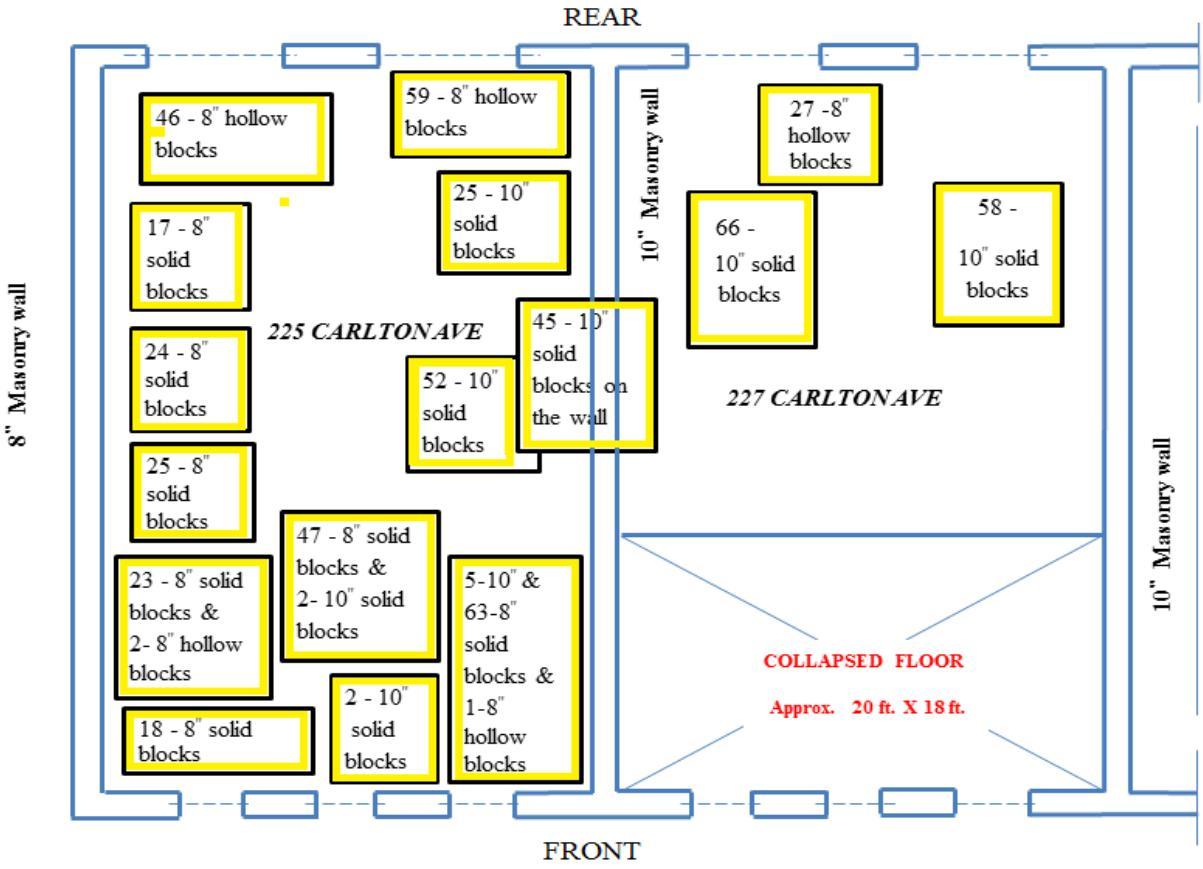
Post-incident observations indicated that the 4th floor deck of the adjoining unit # 225 had 10["] solid, 8" solid and 8" hollow blocks piled at different locations. Some 10" solid blocks were also piled up on the incomplete party wall between units # 225 and 227. On the unfailed portion of the fourth floor deck of unit # 227, there were also 10["] solid and 8["] hollow blocks. Below is the tabulation of the blocks observed on the two 4th floor decks. Fig. 3 shows the approximate distribution of the masonry blocks on the two 4th floors as observed after the incident.

No pallets of cement bags or jumbo bags of sand were found on the 4th floor, either in unit # 225 or unit # 227. This would indicate that all the jumbo sand bags, three according to the majority of the eyewitnesses, and two pallets of cement bags, $10^{"}$ solid blocks, $8^{"}$ hollow blocks which were placed near the front of the 4th floor on unit # 227, and a concrete mixer fell with the collapsing floor.

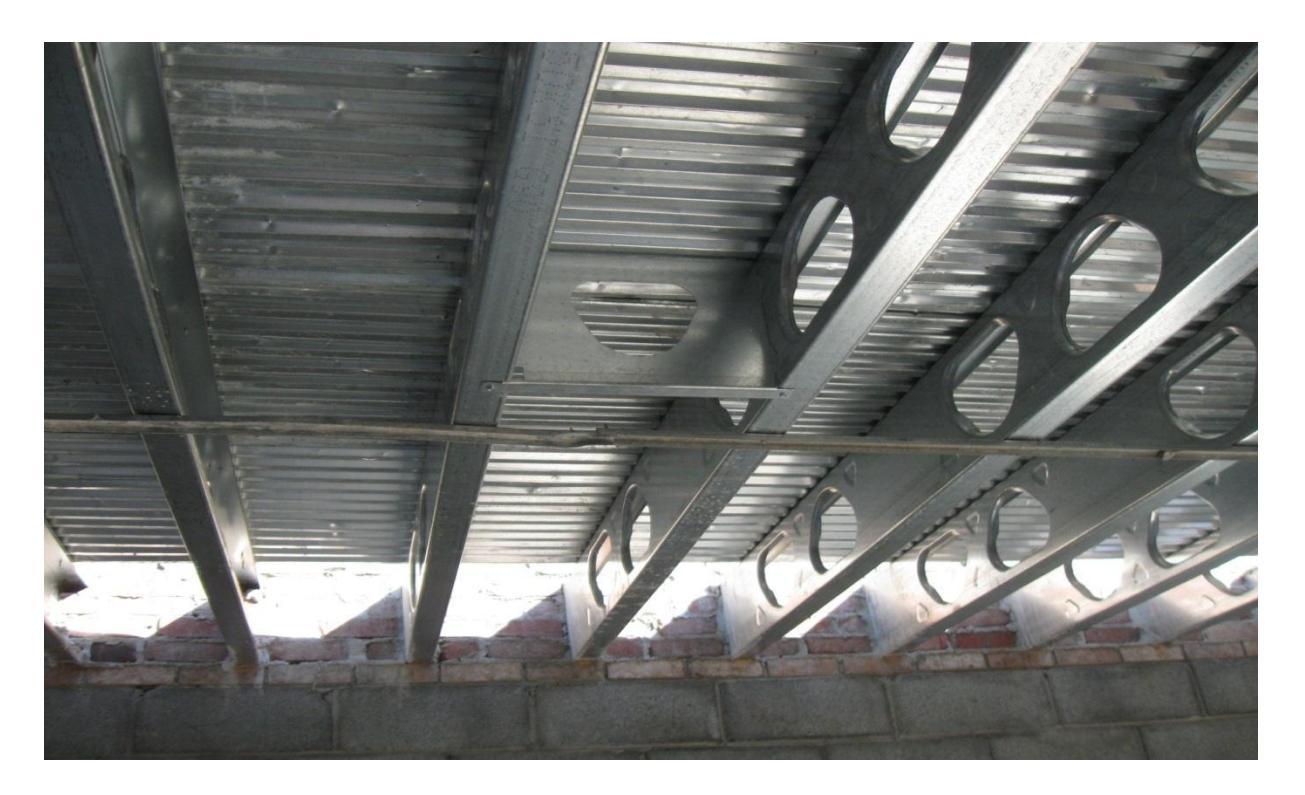
Post-incident observations indicated that there was no uniformity in the providing of lateral bracings to the floor joists. First, the temporary deck which could have provided lateral support to the joists was screwed to the top flange of the joists barely at few locations. Observations on the 4th floor and other floors indicated that the deck was screwed very sparingly, and, therefore, could not be relied upon to provide any lateral support to the floor joists. Second, there was a 2["] wide steel strap screwed to the bottom flange of the joists at most locations. However, the top strap which was critical in providing lateral stability was not provided at most of the locations, see Fig. 4. Third, the blockings were provided only at the ends, but not at every 10[°] as required. Fourth, the straps which were provided at the bottom flange (see Fig. 5) were not spaced at 7[°]

Fig. 4 Floor joists with no straps at the top flange.

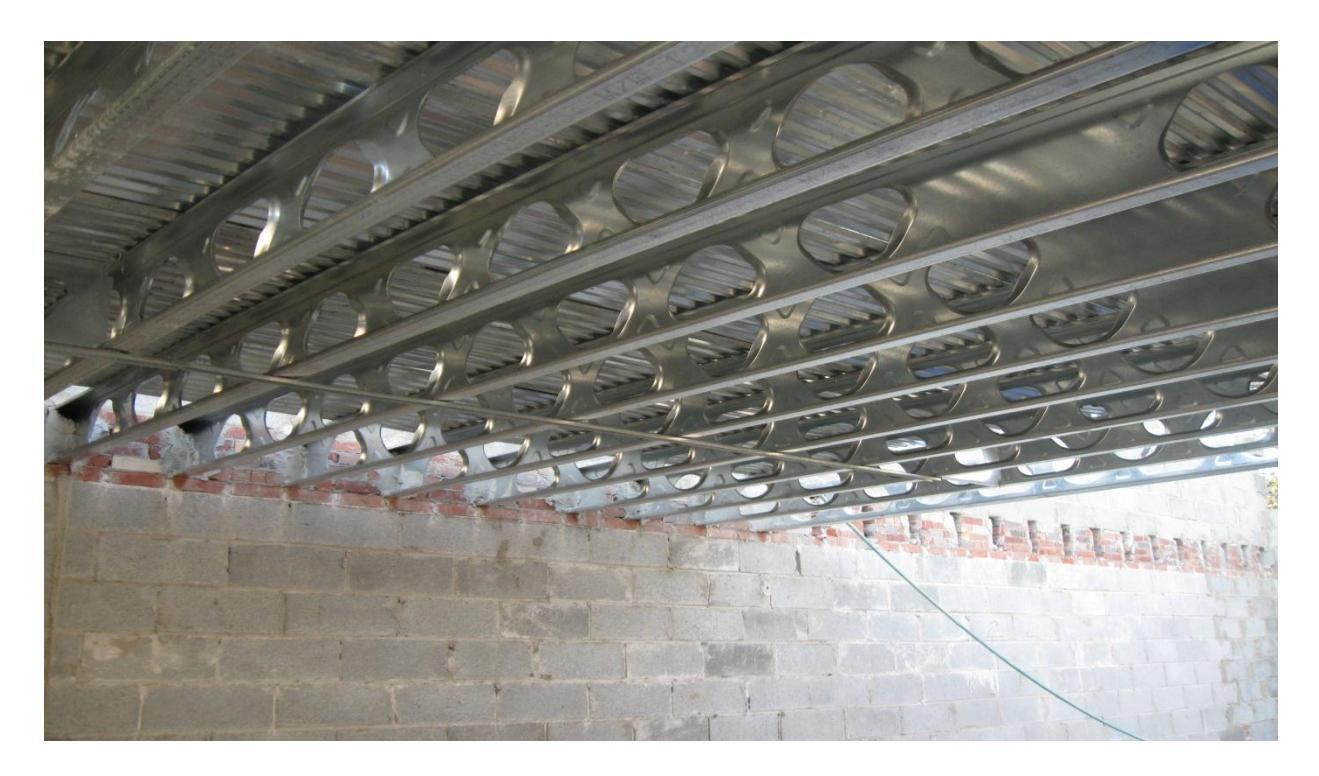
Fig. 5 Floor joists with straps only at the bottom flange.

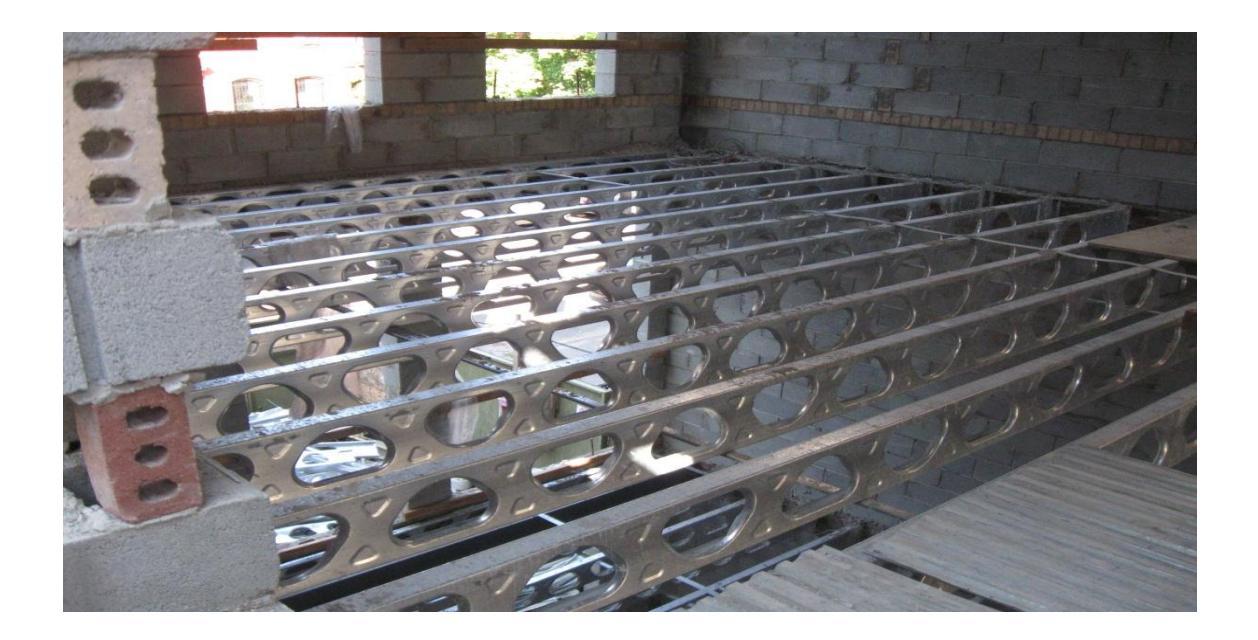
The cold-formed steel joists used to frame the floors of the building were 16-gauge JoistRite sections (Fig. 6 & Appendix) spaced at 16["] o.c. (structural drawings S-002.01 to S-006.01 in Ref. 2). JoistRite is a cold-formed steel section manufactured by Marino WARE, see Appendix. The structural drawings called for plywood sheathings to be placed on the floor joists. The contractor, however, decided to place a temporary steel deck (see Fig. 7) on the floor joists during construction to avoid damaging the permanent plywood floor with construction materials.

Fig. 6 Floor joists spaced at 16["] o/c.

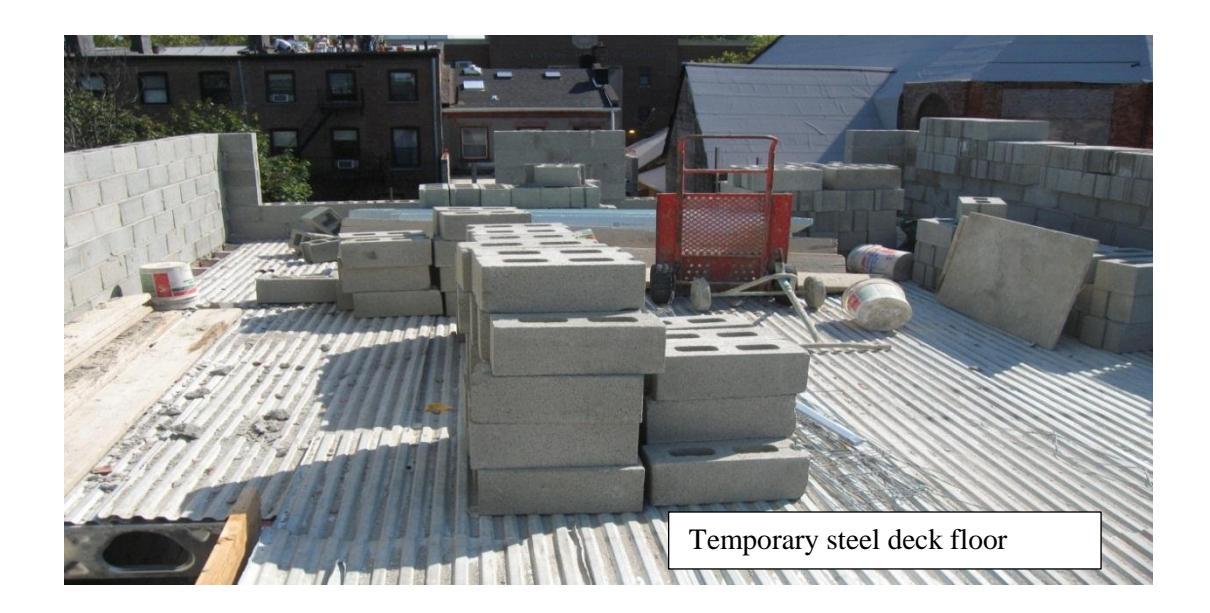
Fig. 7 Temporary steel deck on 225 Carlton Ave. supporting construction loads.

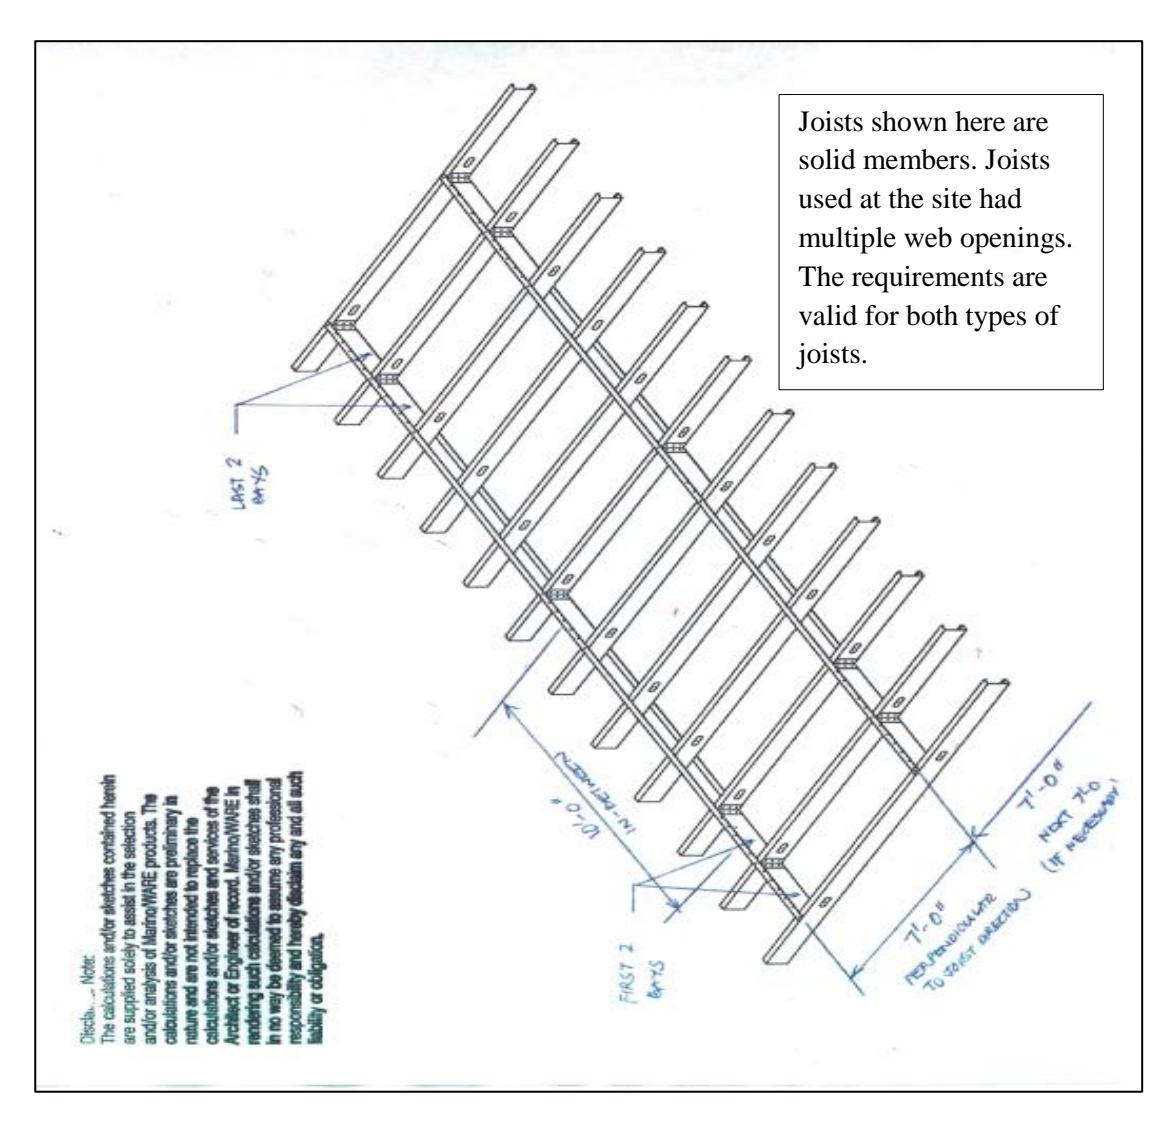
The technical guide specified, "*The compression flange of the section should be braced by the attachment of continuous diaphragm-rated sheathing or decking. The JoistRite blocking shall be located at first and second spaces, each end, and 10[']-0^{''}o.c. between and attached to joists through pre-drilled holes. Additionally, mechanical bridging shall be installed at intervals not to exceed 7'-0" on center. The installation of bridging shall be completed before loading the floor/roof system." (Italics ours). Fig. 8 shows the bridging/blocking requirements for floor joists by Marino WARE.*

Fig. 8 Bridging/blocking requirements by Marino WARE - sketch provided by Marino WARE (Note the 7['] requirements).

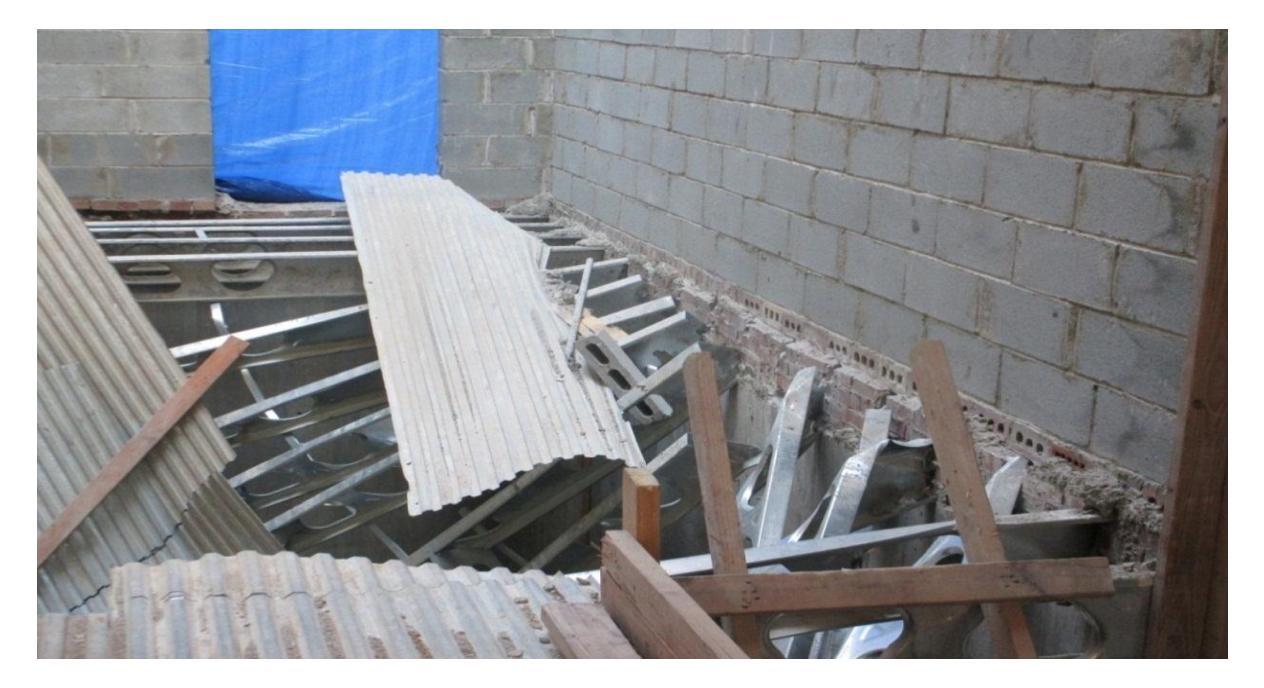
The 4th floor of unit #227 partially failed when construction loads (concrete blocks, bags of sand and masonry cement) were stacked up on the floor and collapsed on the 3rd floor creating a chain reaction on the floors below. All the floors ended up in the basement (cellar). Fig. 9 shows the area of the of the 4th floor unit #227 that collapsed due to construction loads.

Fig. 9 A partially collapsed 4th floor due to construction loads.
