Investigation of the May 28, 2013 failure of gin pole rigging at a cell tower in Georgetown, MS

U.S. Department of Labor Occupational Safety and Health Administration Directorate of Construction

October 2013

Report Prepared by Mohammad Ayub, P.E., S.E. Office of Engineering Services Directorate of Construction

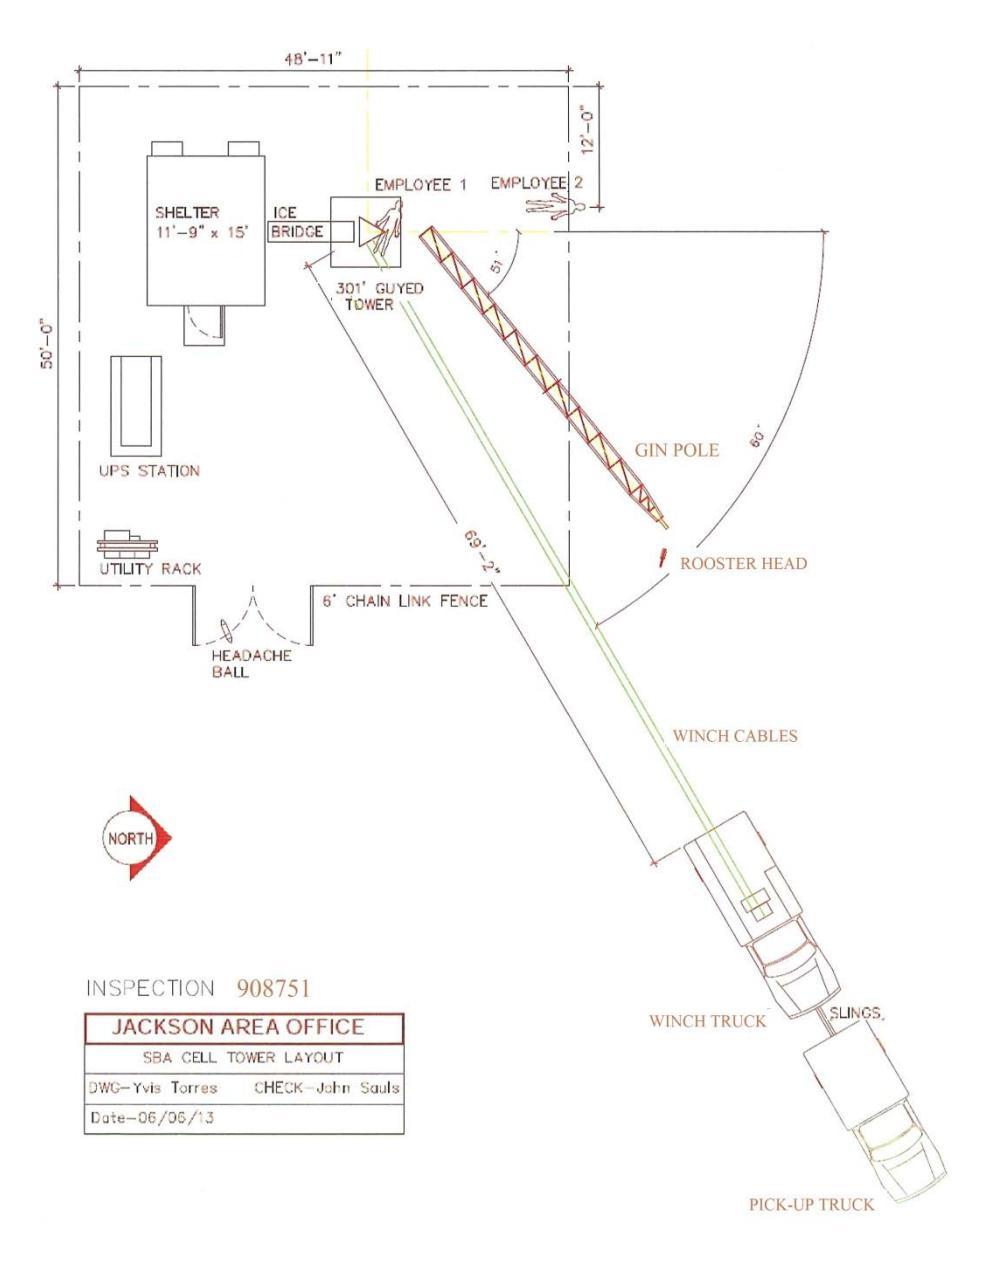
Fig. 4 – Plan view of gin pole and workers after the incident

Michael was fatally struck with the falling gin pole. Both were thrown on to the ground. The gin pole came down in one piece at the foot of the tower, see fig. 4, 5 and 6. The time of the incident was 2:10 P.M..

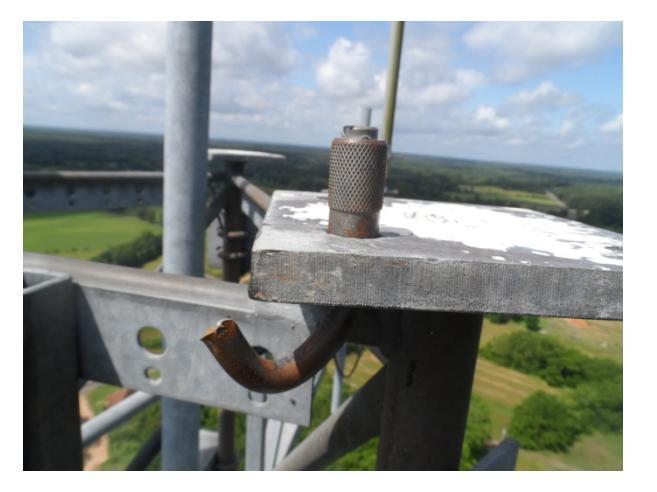
Fig. 16 – View of the failed carabiner

It is believed that the carabiner used at the site was manufactured by PenSafe Inc. of Canada; model Number C 775, see fig. 15. The carabiner has been load-tested by the manufacturer to support a tensile load of 3,600 pounds, and a side load of 3,600 pounds. Using a factor of safety of 2.75, the failure load would be approximately 10,000 pounds. A couple of days after the incident, several photographs were taken of the failed carabiner stuck in the hole of the pad plate, see fig. 16, 17 and 18. The carabiner was taken out and examined, see fig. 19.

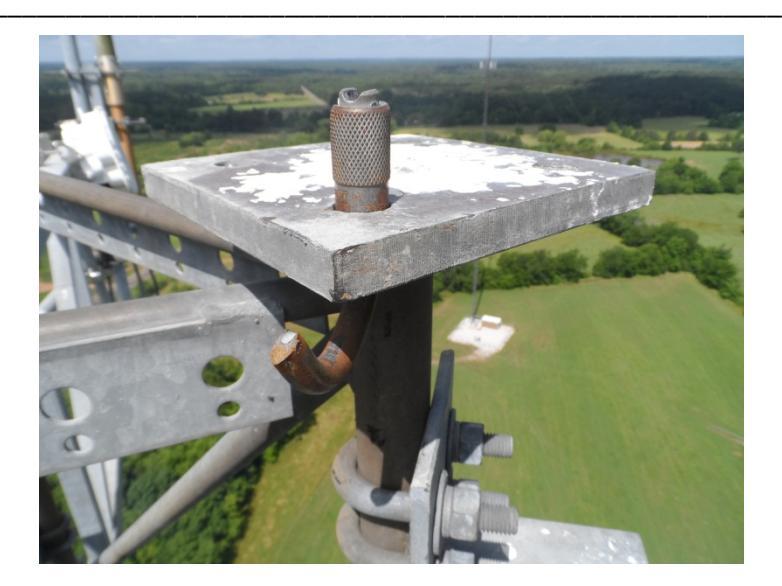
Fig. 18 – Fracture of the carabiner at the hole drilled for captive bar

One possible scenario of the failure is the formation of another plastic hinge in the top portion of the carabiner at the edge of the steel plate; thereafter the failure occurred. The carabiner began to rotate in a counter-clockwise direction. The next failure occurred at the other weaker location, where the hole was drilled for the captive bar in the vertical leg of the carabiner. As soon as the failure at the hole location occurred, the hook came off the broken carabiner, further pushing the remainder of the carabiner up the hole in the plate where it became lodged, as it was found after the incident.

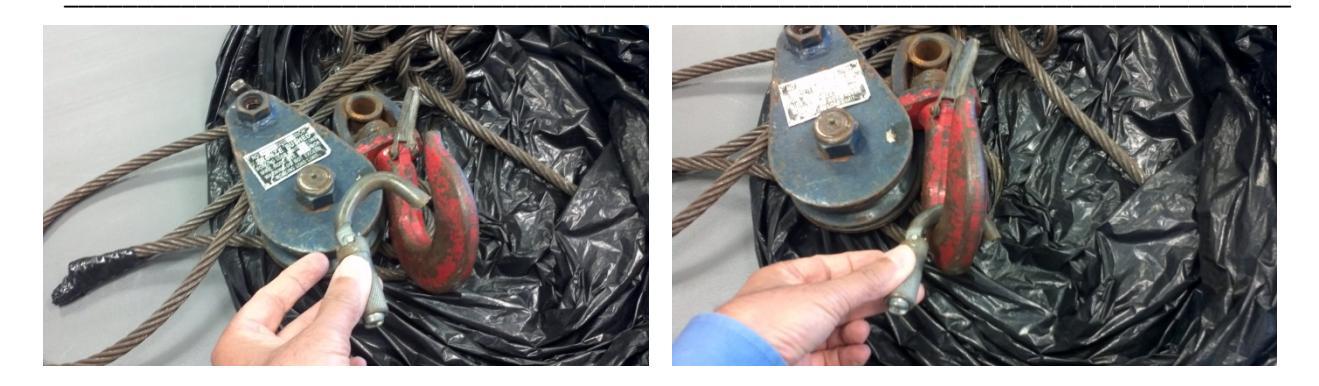
Fig. 20 – Failed carabiner and the hook

<u>First</u>, we examined whether the 13/16" (0.8125") hole in the plate with a clear edge distance of 0.92" would allow for a carabiner to be inserted which has a diameter of 0.78" at its thickest part. It appeared that would be possible. If the narrower part of the carabiner was placed under the plate, there would still be space left to place the $1\frac{1}{2}$ " thick hook, see fig. 20, 21 and 22.

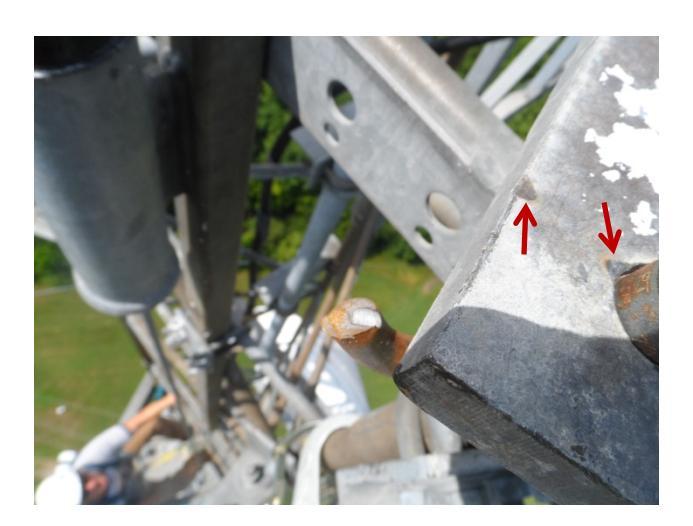
Initially, it is believed that the carabiner supported the load through its contact with the inside surface of the hole in the plate. This subjected the carabiner to a flexural moment greater than its ultimate capacity, resulting in a permanent deformation, and the formation of a plastic hinge in the top portion of the horizontal portion of the carabiner. Immediately thereafter, the carabiner's top portion came into contact with the top surface of the plate, and supported the load at two locations, see fig. 28. It is believed that the line of application of the load almost coincided with the edge of the plate where the carabiner rested which could explain why the carabiner did not fall apart during the initial jumping of the gin pole. Johnny Martone might have been able to notice, if he was attentive, that the carabiner was becoming deformed under the load, but he did not convey any such message to John Davidson. Two gouges and a deep impression of the carabiner could be seen on the top surface of the plate, see fig. 36 and 37, indicating the contact of the carabiner with the plate. There were two weak points in the body of the carabiner, one at the nose (adjacent to the gate opening) due to its reduced cross-sectional area, and one in the body of the carabiner where a hole was drilled for the captive bar, (for the fractured surfaces, see fig. 36. Initially, the nose was subjected to a direct tension plus a horizontal force weakening it considerably because the nose is not designed for bi-axial forces, see fig. 37.

Fig. 36 – View of the top plate showing deep indentation in the steel plate

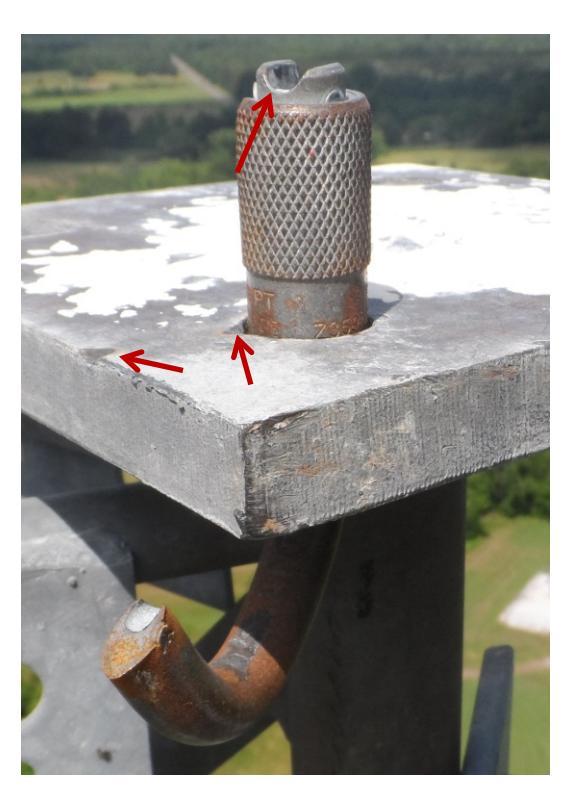
Fig. 37 – Carabiner showing failure near its gate

- The failure occurred because the jump line block was rigged by using a carabiner which was subjected to considerable flexural loads. Carabiners are designed for loading in either the longitudinal or transverse axes with direct tension only.
- 2. The carabiner was used in a manner not recommended by the manufacturer, and contrary to the standard industry practice.
- 3. The carabiner was clearly marked with a stamp Z359.1 (07). The ANSI/ASSE standard Z359.1 (07) states that "the requirements of this standard do not address the construction industry.....", and still the carabiner, not meant for construction, was used to hoist the gin pole at the site.
- 4. The contractor deviated from the standard practice of rigging the jump line block by using chokers on the two tower legs and using a shackle at the center of the face of the tower to hang the block.
- 5. Wind was not the causal factor.
