Investigation of the May 4, 2014 incident at the Ringling Bros. and Barnum & Bailey performance in Providence, RI

U.S. Department of Labor Occupational Safety and Health Administration Directorate of Construction

October 2014

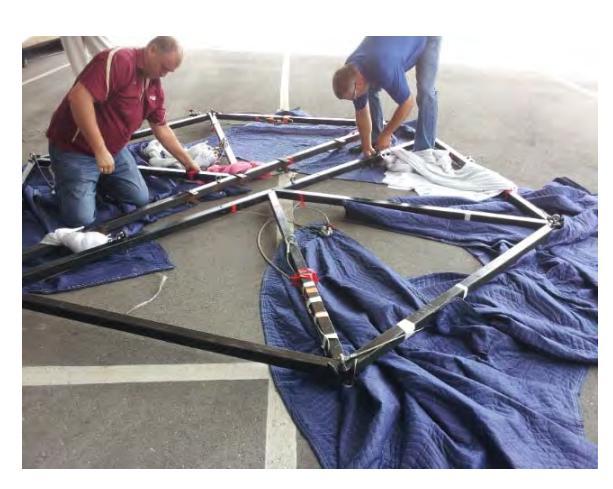
Fig. 7 - Separation of two halves of hexagonal frame

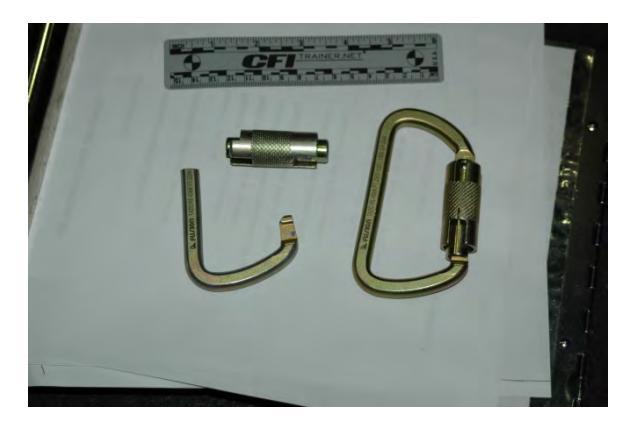
Fig. 31 - Fractured pieces of carabiner and non-failed similar carabiner

The failed carabiner, see Fig.s 31, 32 and 33, was sent to Massachusetts Material Research, Inc. (MMR) of West Boylston, MA for non-destructive testing following usual chain of custody procedures. The general purpose was to examine the fractured surfaces of the carabiner to determine the type, origin and nature of failure. The first six pages of the narrative of the MMR report of September 18 is attached to this report, see appendix A.

The lab determined that the fracture essentially was a result of an overload, with origins at the retainer pin hole. A summary of the findings of the laboratory is reproduced below:

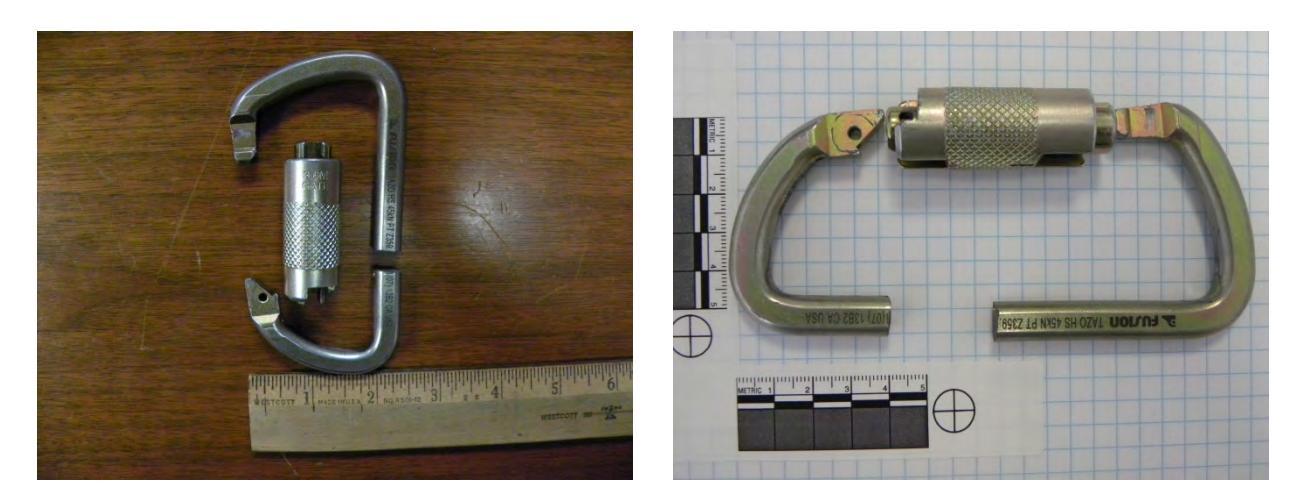
Fig. 32 – Fractured pieces of failed carabiner

Fig. 33 - Fractured pieces of failed carabiner

The carabiner that failed was Fusion TAZO, see Figs. 32 and 33 above. A similar unfailed carabiner is shown in Fig. 34. It was made of alloy steel believed to have an average ultimate tensile strength of 80,000 to 120,000 pound per square inch (psi). The ultimate strength is the maximum stress a material can sustain before breaking due to tensile failure. As discussed earlier, the carabiner is imprinted with a breaking strength of 45 KN (10,000 pounds). Based on the accurate measurement of the net area of the spine taken by OSHA's Salt Lake Testing laboratory, to be 0.1076 square inches, the ultimate tensile strength is determined to be 93,000 psi which is within the range mentioned above.

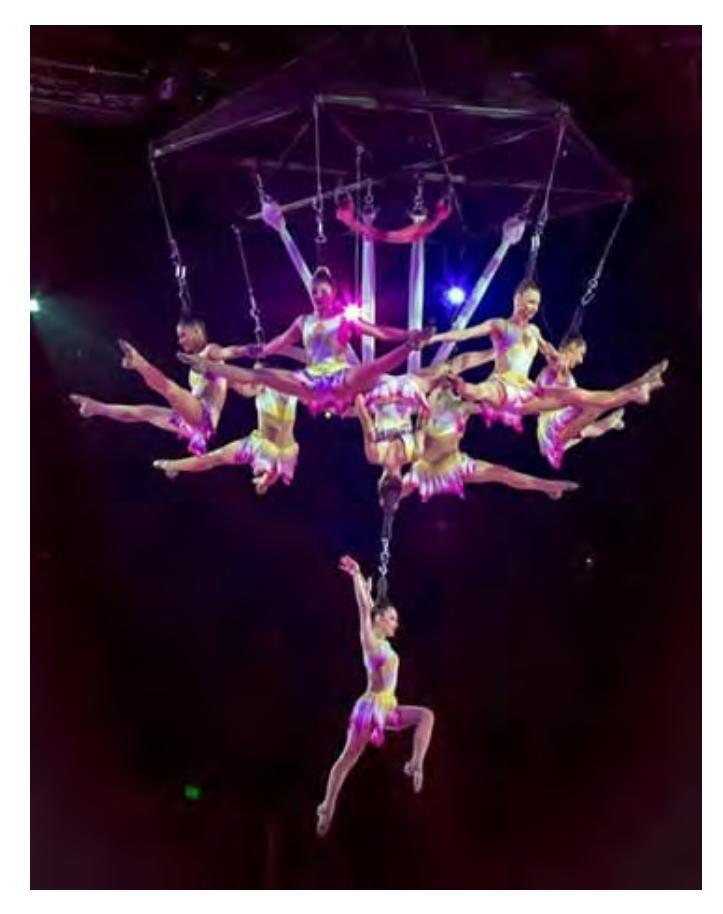
Carabiners, aluminum or steel, are manufactured for the specific purpose of supporting a load in the major axis of the spine of the carabiner. The major axis is along the long spine of the carabiner. The capacity of the carabiners in the minor axis with or without the closed gate is significantly reduced. For example, the carabiner in question had a major axis load carrying capacity of 45 KN (45KN x 224.8= 10,116 pounds) but had a capacity of only 16 KN (3,596 pounds) in the minor axis. The load test confirmed the load capacity of the carabiner along the major axis. It must be noted here that these capacities are not to be considered concurrent. In other words, one can rely on these capacities singularly, but not when simultaneously loaded in both axes. Further, these loads are based on static loading without any impact due to the dynamics of the load being applied. In this instance, the carabiner was subjected to significant impact loads due to twisting, revolving, swinging and acrobatic dancing of the performers while being supported by the carabiner, see Fig. 35.

Fig. 35 – Acrobatic movements subjecting the rigging to significant impact load (File photo; not taken on the day of the incident)

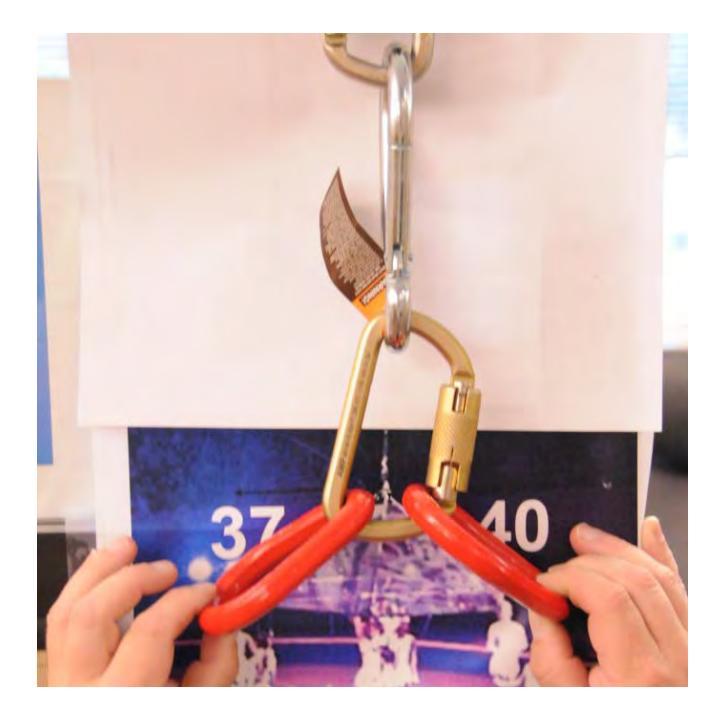
The industry has long recognized that carabiners should not be loaded in a manner that could subject them to what is known as tri-axial loading. It is believed that there is not a single manufacturer that permits the users to load the carabiner in a tri-axial manner. Tri-axial loading subjects the carabiner to forces in its major and minor axes simultaneously, see Fig.36 and 37. This becomes additionally critical because the bottom part of the carabiner is not flat but curved, which shifts the pear rings to different elevations. The different elevations of the pear rings subject the carabiner to additional rotation until equilibrium of forces is achieved. Each pear ring supports three inclined wire ropes connected to three locations on the apparatus frame. This produces inclined force on the carabiner which can be resolved in vertical and horizontal directions. Since there were two rings, at different elevations, the carabiner had to adjust and rotate until all the forces created by the two rings were in a state of equilibrium. The carabiner is constantly undergoing rotations and adjustments due to the dynamic nature of the load.

Fig. 36 – A similar carabiner subjected to tri-axial Loading by similar pear rings (wrong way) (Courtsey: OSHA's Salt Lake Technical Center)

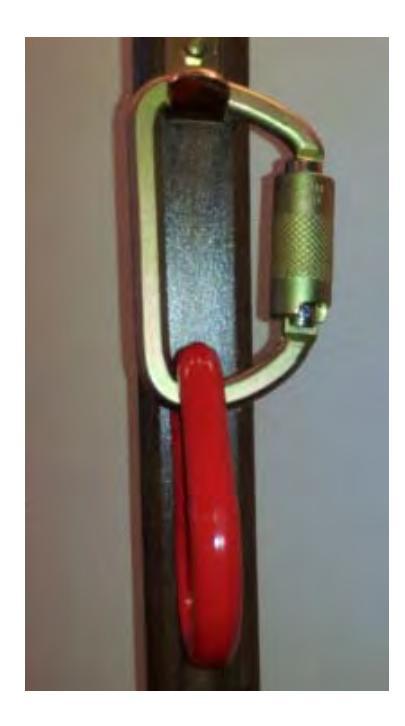
Fig. 37 – A similar carabiner loading in major axis (correct way)

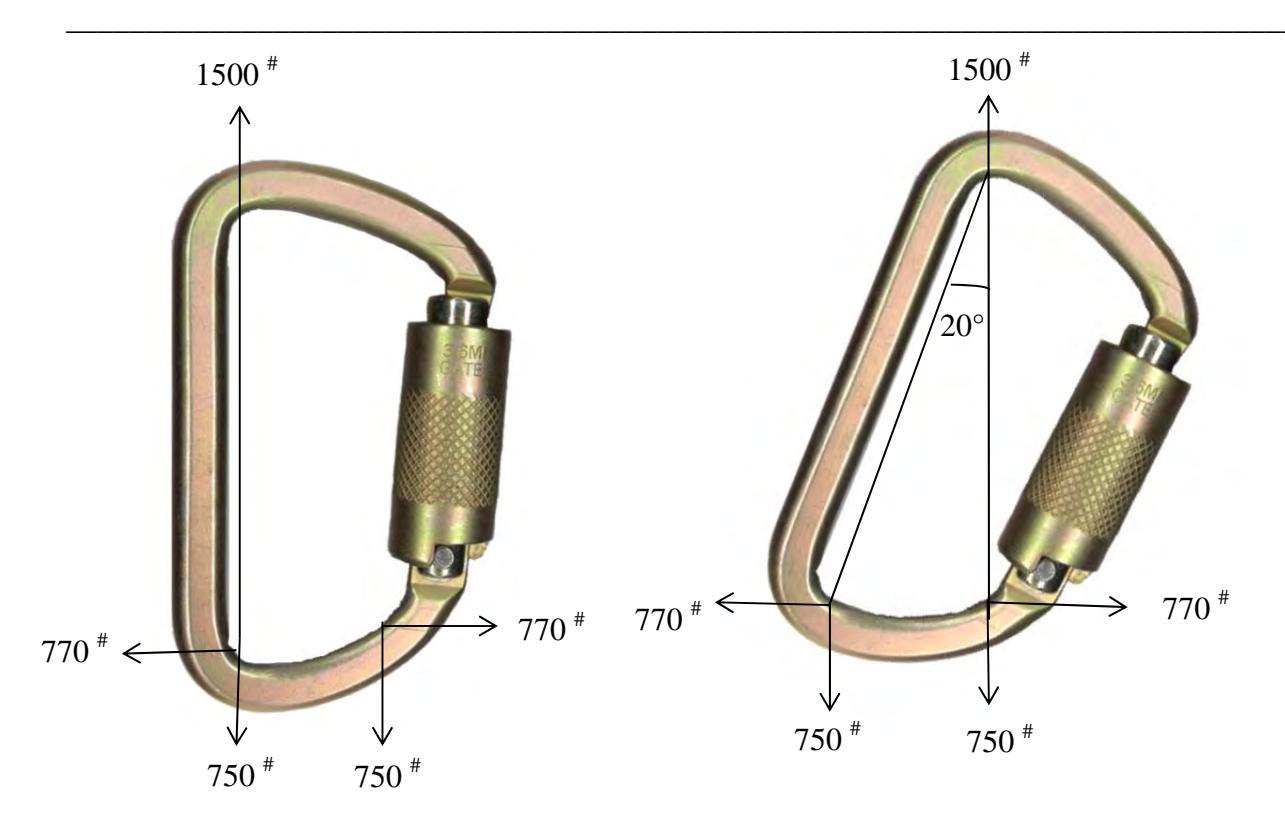
Calculations indicate that each pear ring, when placed in the narrower part of the carabiner, will exert a horizontal force of approximately 770 pounds, and vertical force of approximately 750 pounds on the carabiner. Based on the concept presented above, a number of calculations were done to determine the final resting position of the carabiner where all forces balance each other. Fig.s 38 and 39 indicate the two extreme positions of non-equilibrium at the angles of 0 and 20 degrees. Fig. 40 indicates that at an approximate angle of 10¹/₂ degrees to the vertical, the carabiner will have negligible moment at the top support, see Fig. 40. At this position, the spine of the carabiner where the pin hole for the gate-keeper is located, the weakest point of the carabiner, will be subjected to a moment of 1,100 inch pounds. Adding an impact factor of 25%, the resulting moment is calculated to be 1,360 inch pounds. The section modulus of the spine was calculated to be 0.0075 inch cube taking into account the reduction due to the pin hole in the spine, see Fig. 41 and 42. Elastic section modulus was used instead of the plastic section modulus due to non-symmetrical shape of the spine. The non-symmetrical shape was created by the presence of a pin hole. The stresses were computed to be 183,000 psi, well above the ultimate strength, and this caused the failure. The section modulus was computed based on the accurate measurements taken by Massachusetts Materials Research, Inc. The magnitude of the loads computed above is of an order which will not result in any appreciable deformation of the carabiner, maintaining the original space between the gate and the body of the carabiner.

Fig. 38 – Initial stage- state of unequilibrium

Fig. 39 – Another stage- 20 degrees

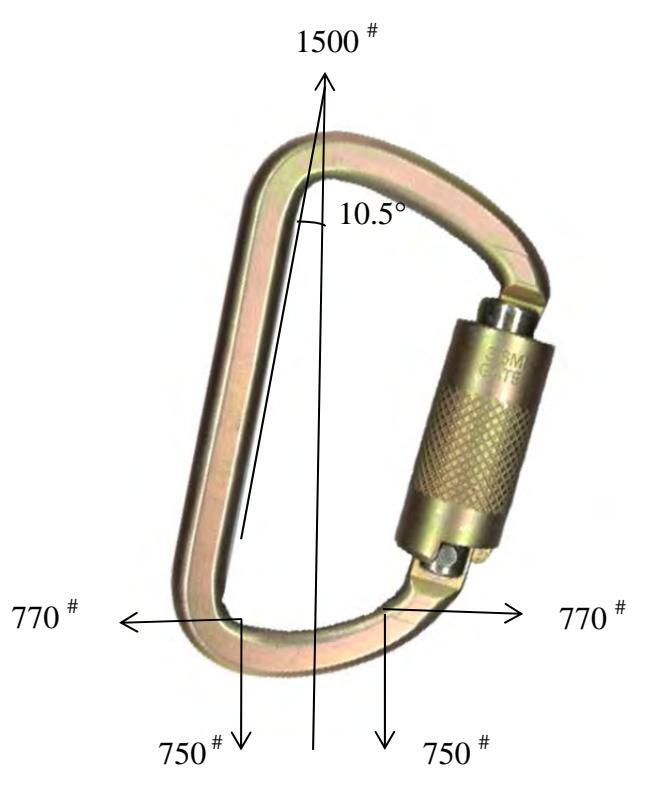
Fig. 40 - Final state at 10.5 degrees - State of equilibrium (rings placed in the narrower part of the carabiner)

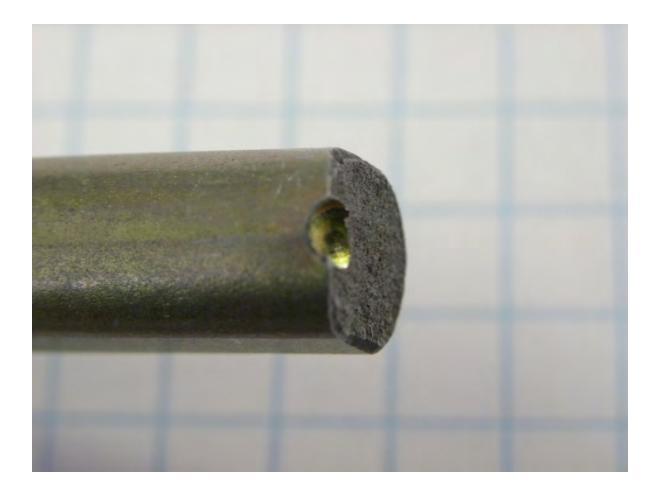
Fig. 41 – Location of the pin hole

The 1/8" diameter rivet pin connecting the gate to the carabiner's lower body is generally made of alloy steel but of a lower strength compared to the high-strength steel of the carabiner because the pin generally is not subjected to any load.

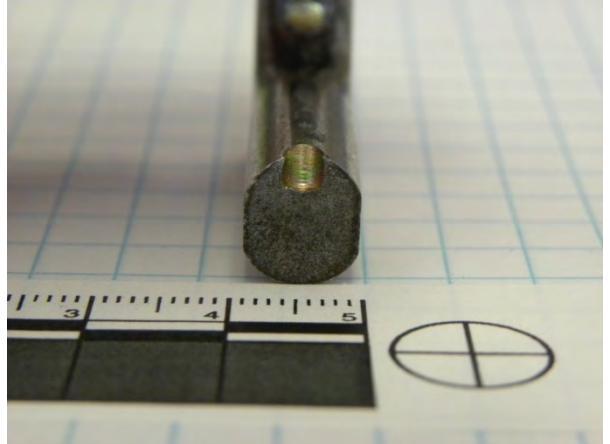
Fig. 42 – Another view of the location of the pin hole

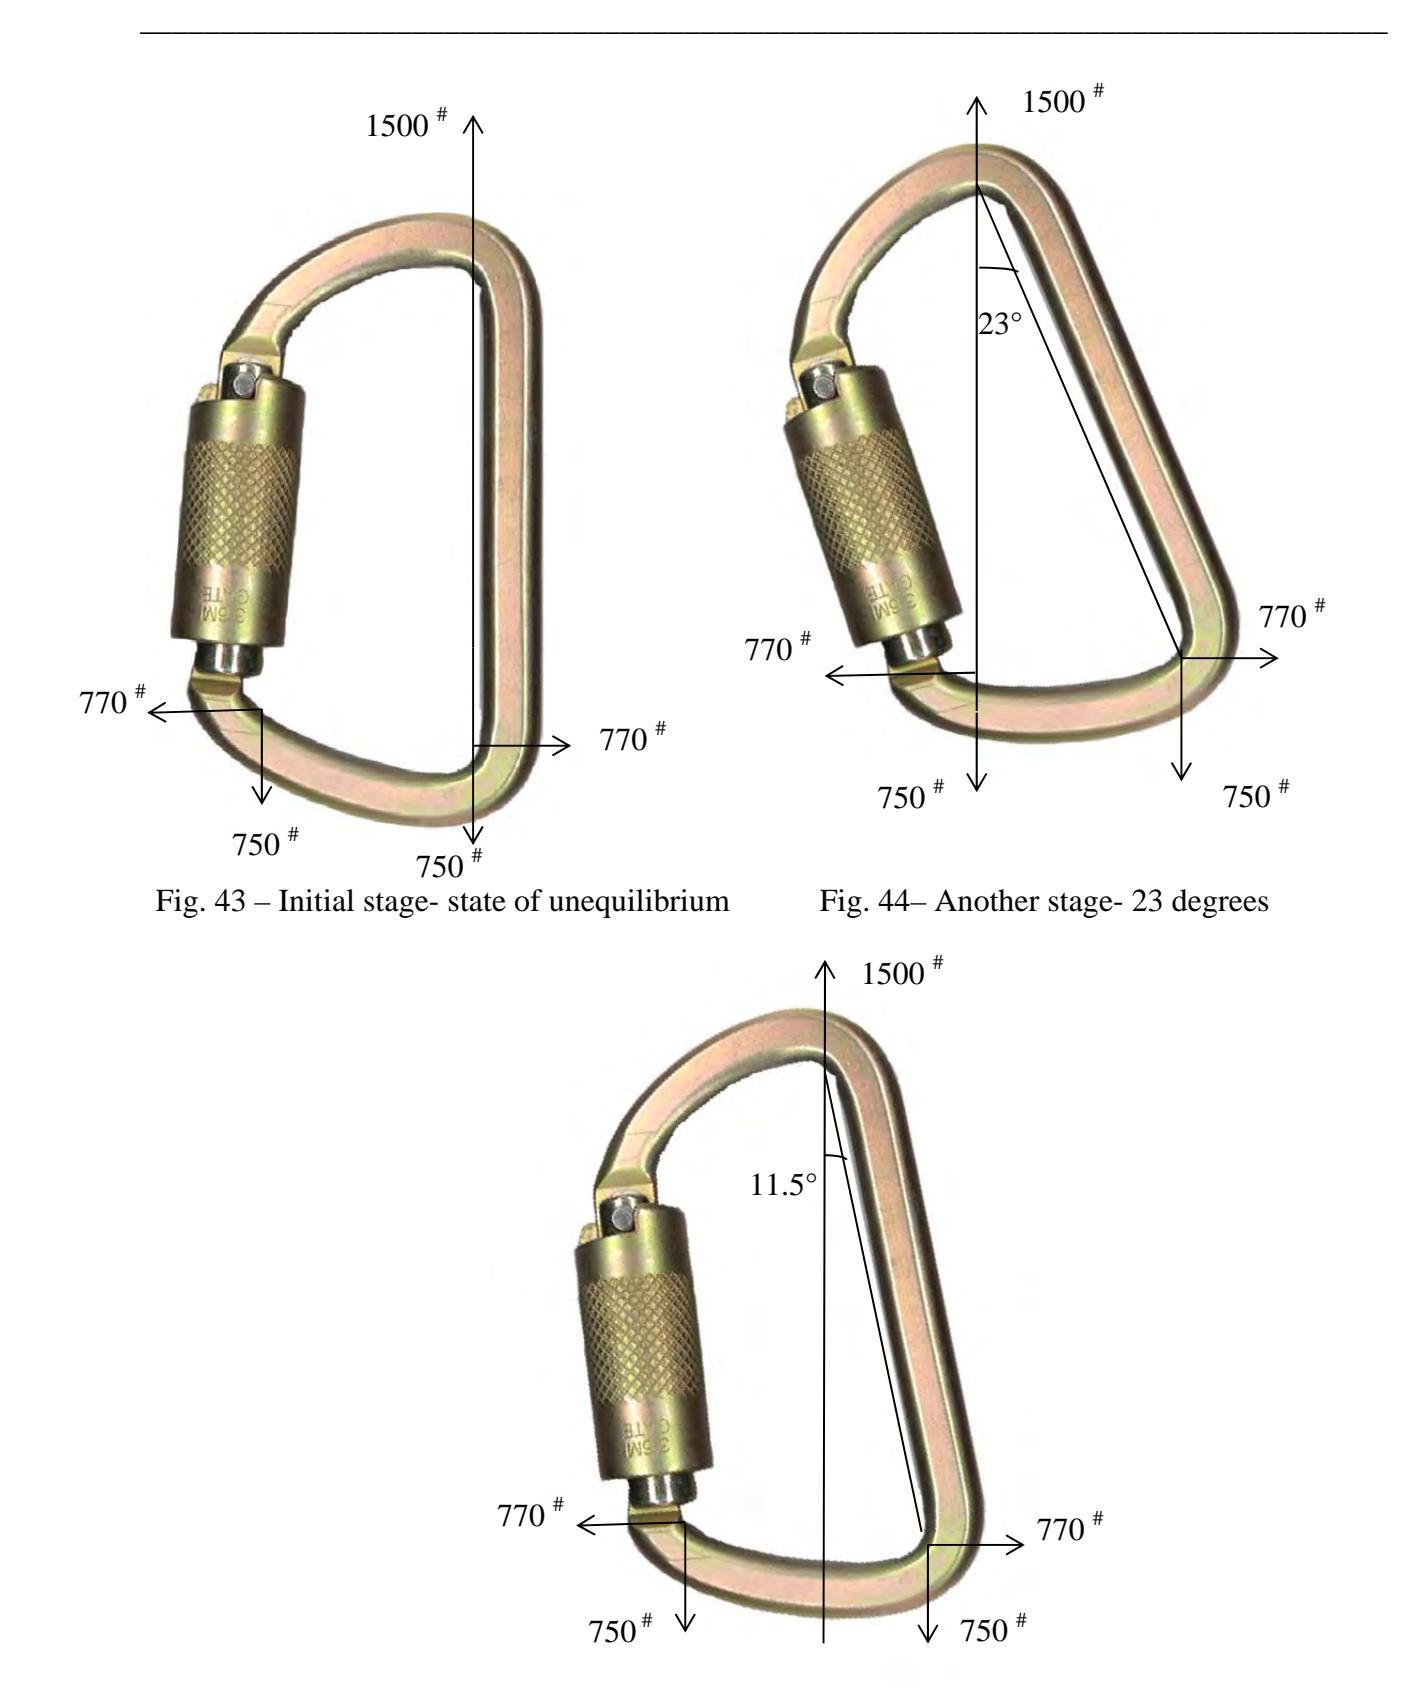
Calculations were also performed to determine the stresses in the carabiner if the pear rings were placed in the wider part of the carabiner instead of the narrower part, as shown in Figs. 43 thru 45. The carabiner became balanced at an angle of 11.5 degrees. The resulting flexural moment was determined to be 780 inch pounds. Adding an impact factor of 25%, the resulting moment was 975 inch pounds with flexural stresses of 130,000 psi, well above the ultimate strength of the material. It is, therefore, determined that failure of the carabiner would occur regardless of where the pear rings were placed either in the narrower or the wider part of the carabiner.

Fig. 45 - Final stage at 11.5 degrees - State of equilibrium (rings placed in the wider part of carabiner)

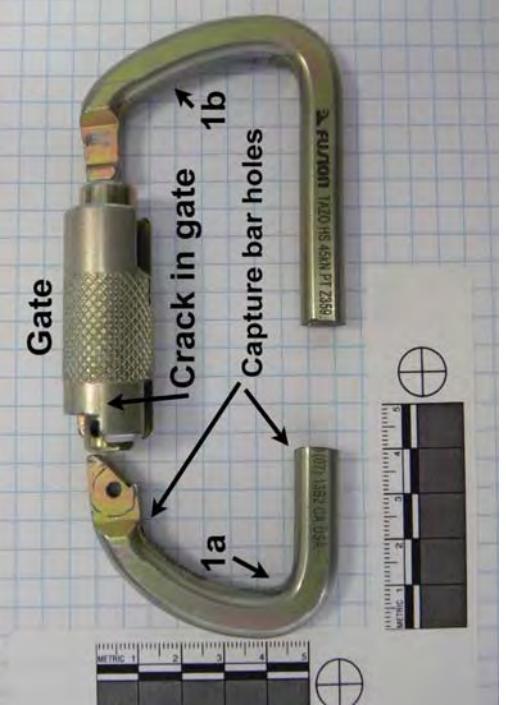
Photo 2: Failed carabiner. This image shows the identification of the parts, the location of the capture bar holes, the location of the crack in the gate and the main fracture in the long side or back of the carabiner.

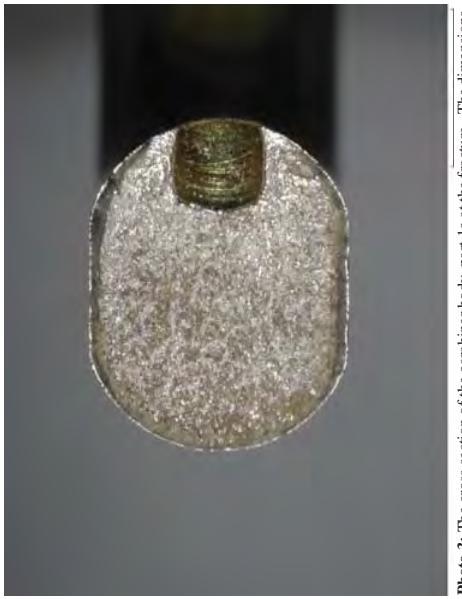
Photo 3: The cross section of the carabiner body, part 1a at the fracture. The dimensions given by MMR are 0.14" by 0.246". Note the hole for the capture bar at the right. Using Photoshop area function, the area of this piece was determined to be 0.119377 in². The area of the hole is 0.012423 in².

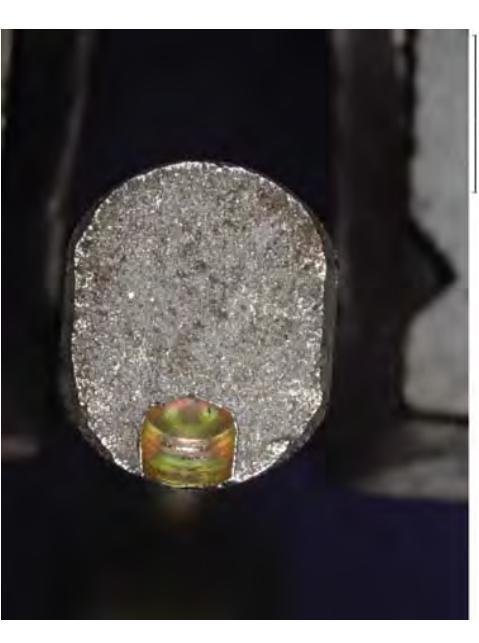
Photo 4: The cross section of the carabiner body, part 1b at the fracture. The dimensions given by MMR are 0.413" by 0.346". Note the hole for the capture bar at the right. Using Photoshop area function, the area of this piece was determined to be $0.120658in^2$.

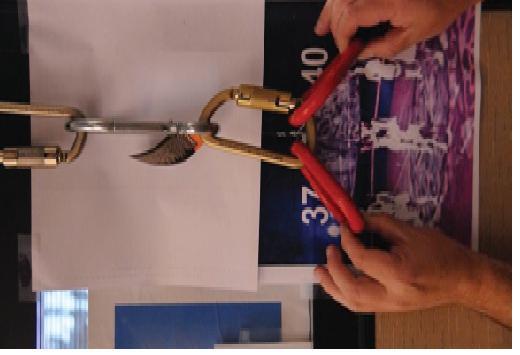
Photo 5: Carabiner with pear rings at the angles noted in the photo in the background. This is a triaxial orientation.

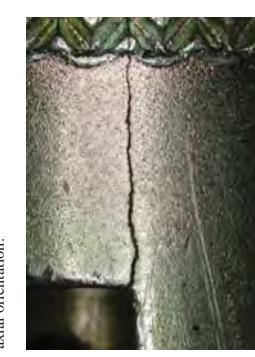
Photo 6: Keyence photograph of the crack in the gate. The crack initiated at an inside corner which is a stress multiplier.

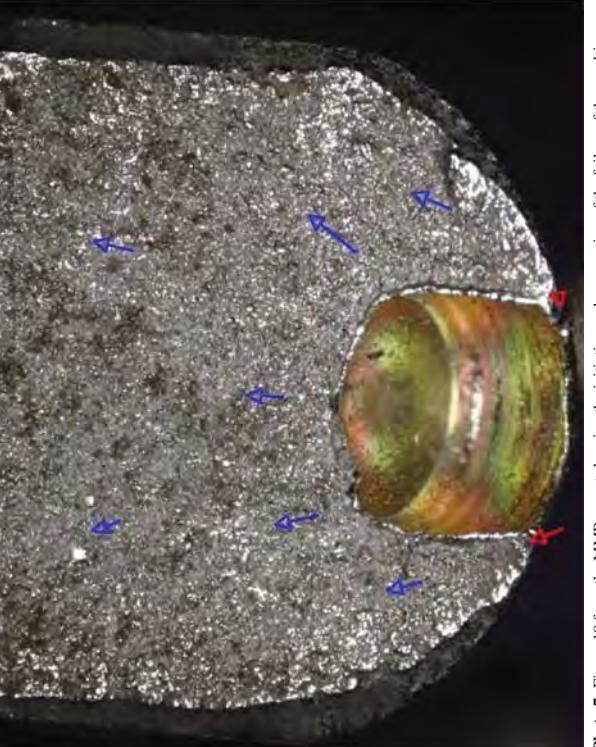
Photo 7: Figure 18 from the MMR report showing the initiation and progression of the failure of the carabiner back.
