Investigation of a Tower Crane Collapse in San Francisco, California-November 28, 1989

U.S. Department of Labor Occupational Safety and Health Administration

May 1990

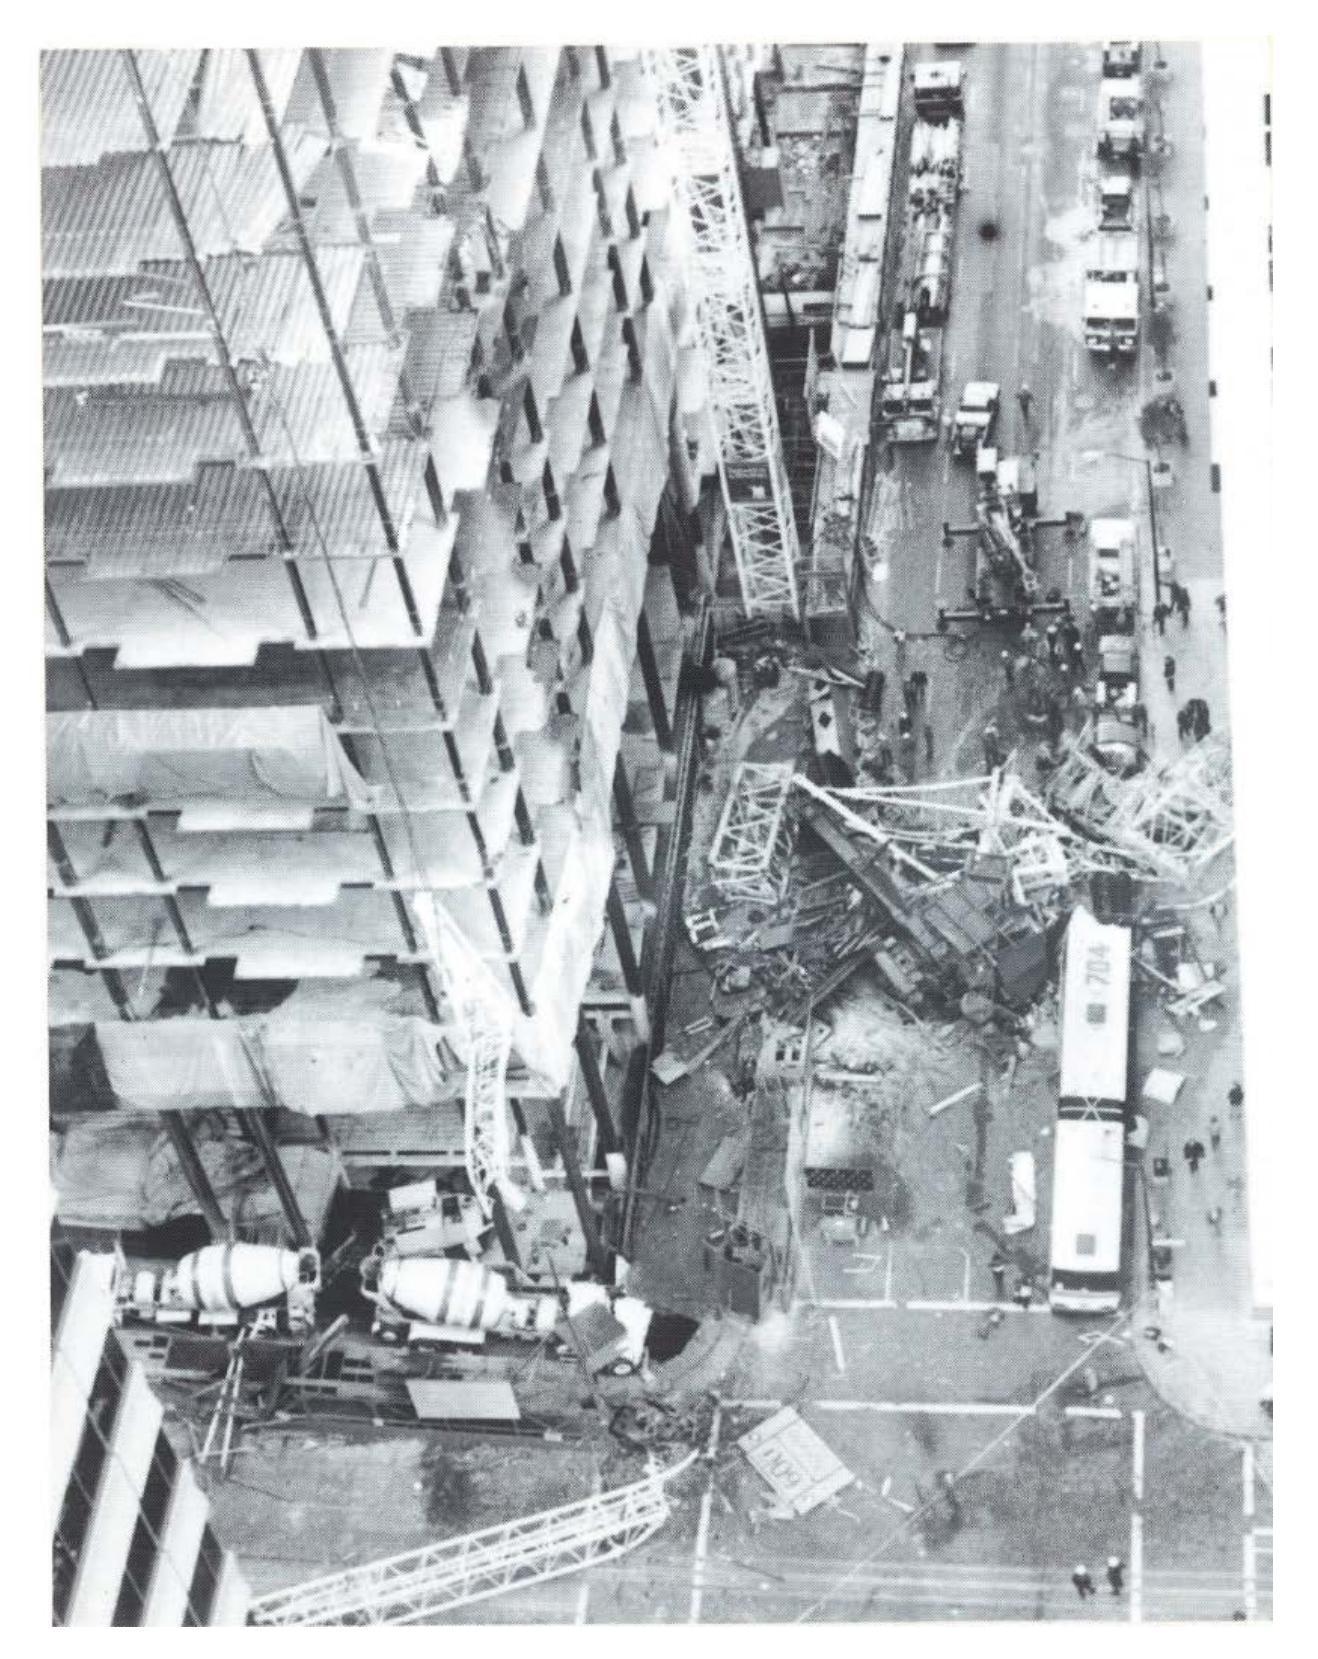
General view of debris after collapse -photo taken before any debris removed. Figure 4.3.1

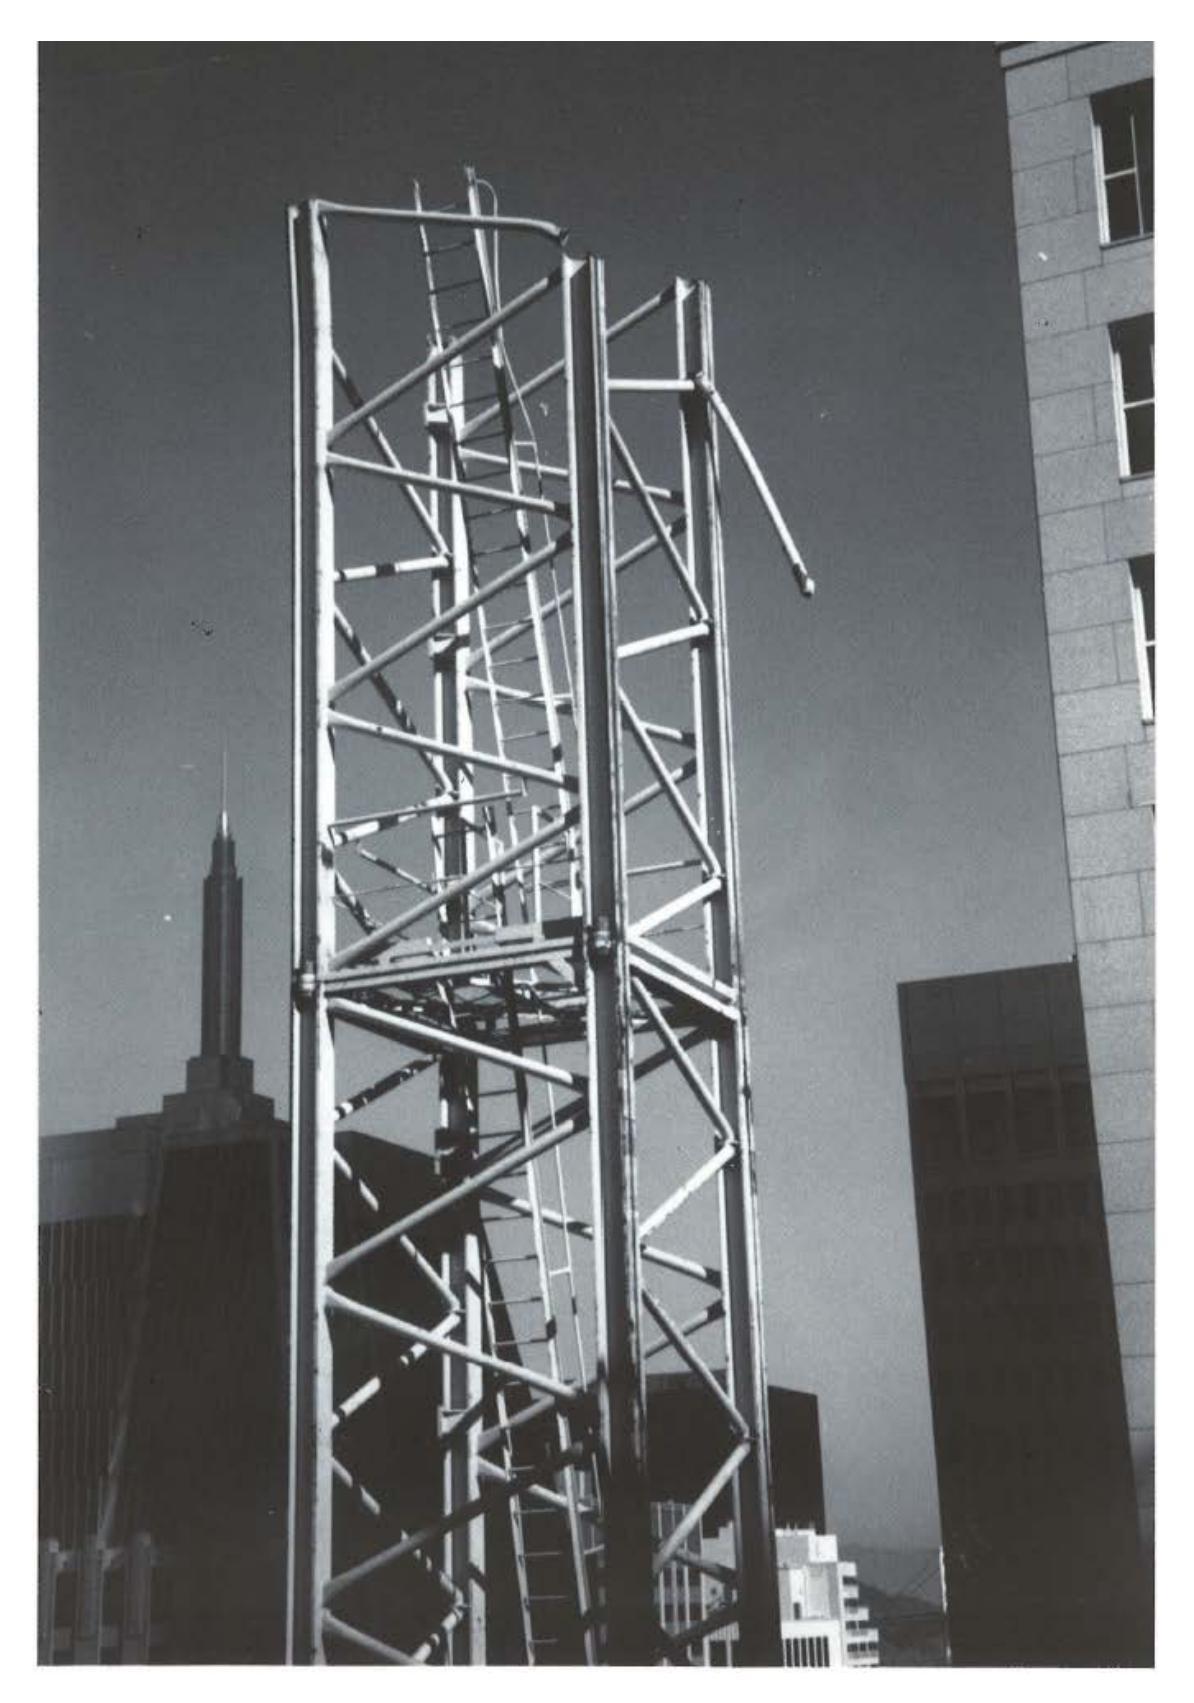
Remaining portion of failed tower -damaged building under construction shown to the left of tower. Figure 4.3.4

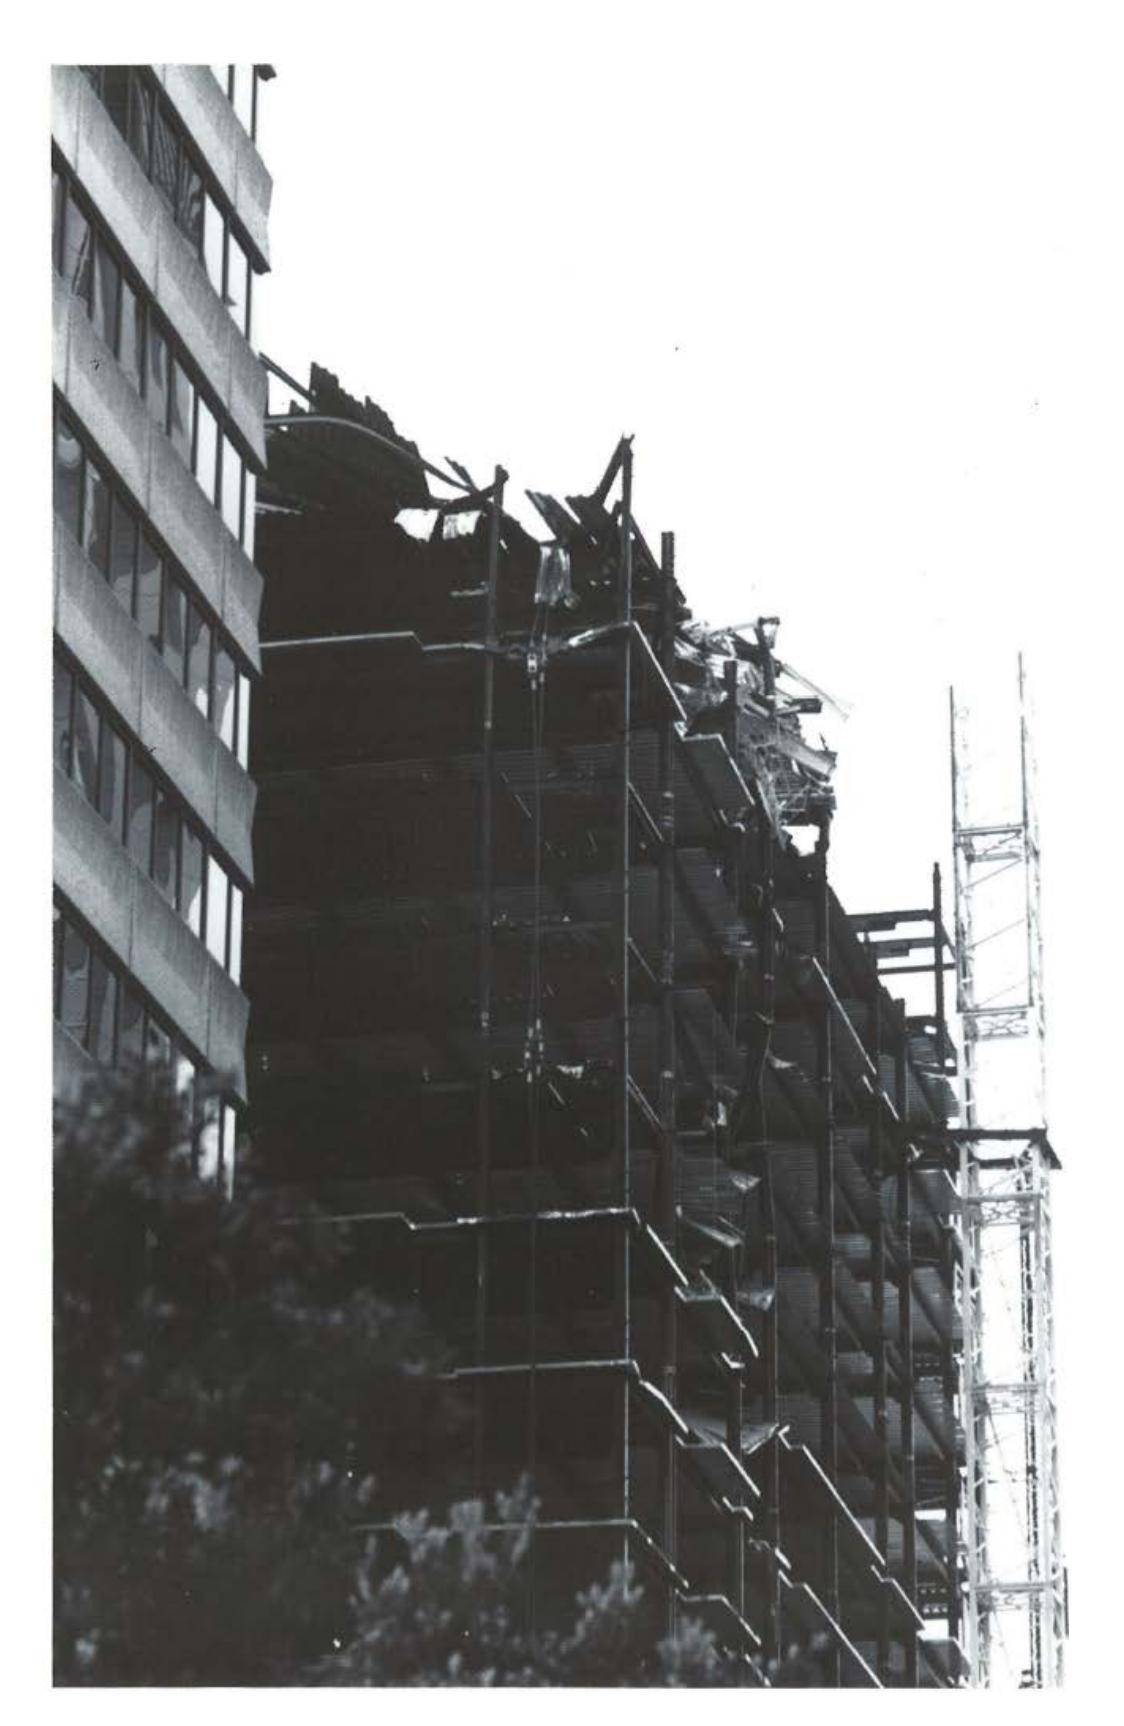
Remaining portion of failed tower -view to Northeast. Top section in photo is remaining part of Section 14.

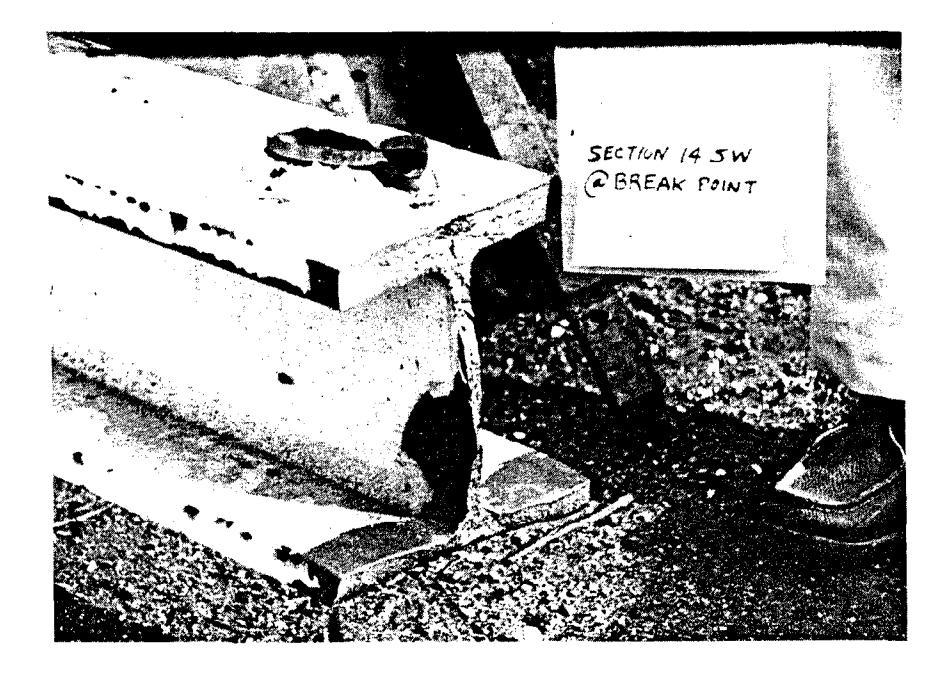
Failure at Section 14 SW leg.

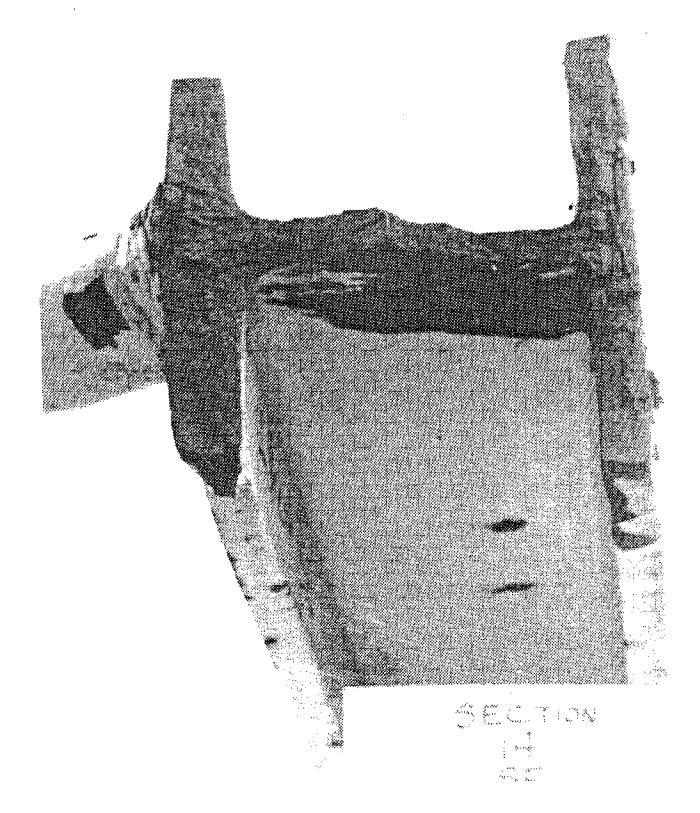
Failure of Section 14 SE leg viewed toward bottom of the section.

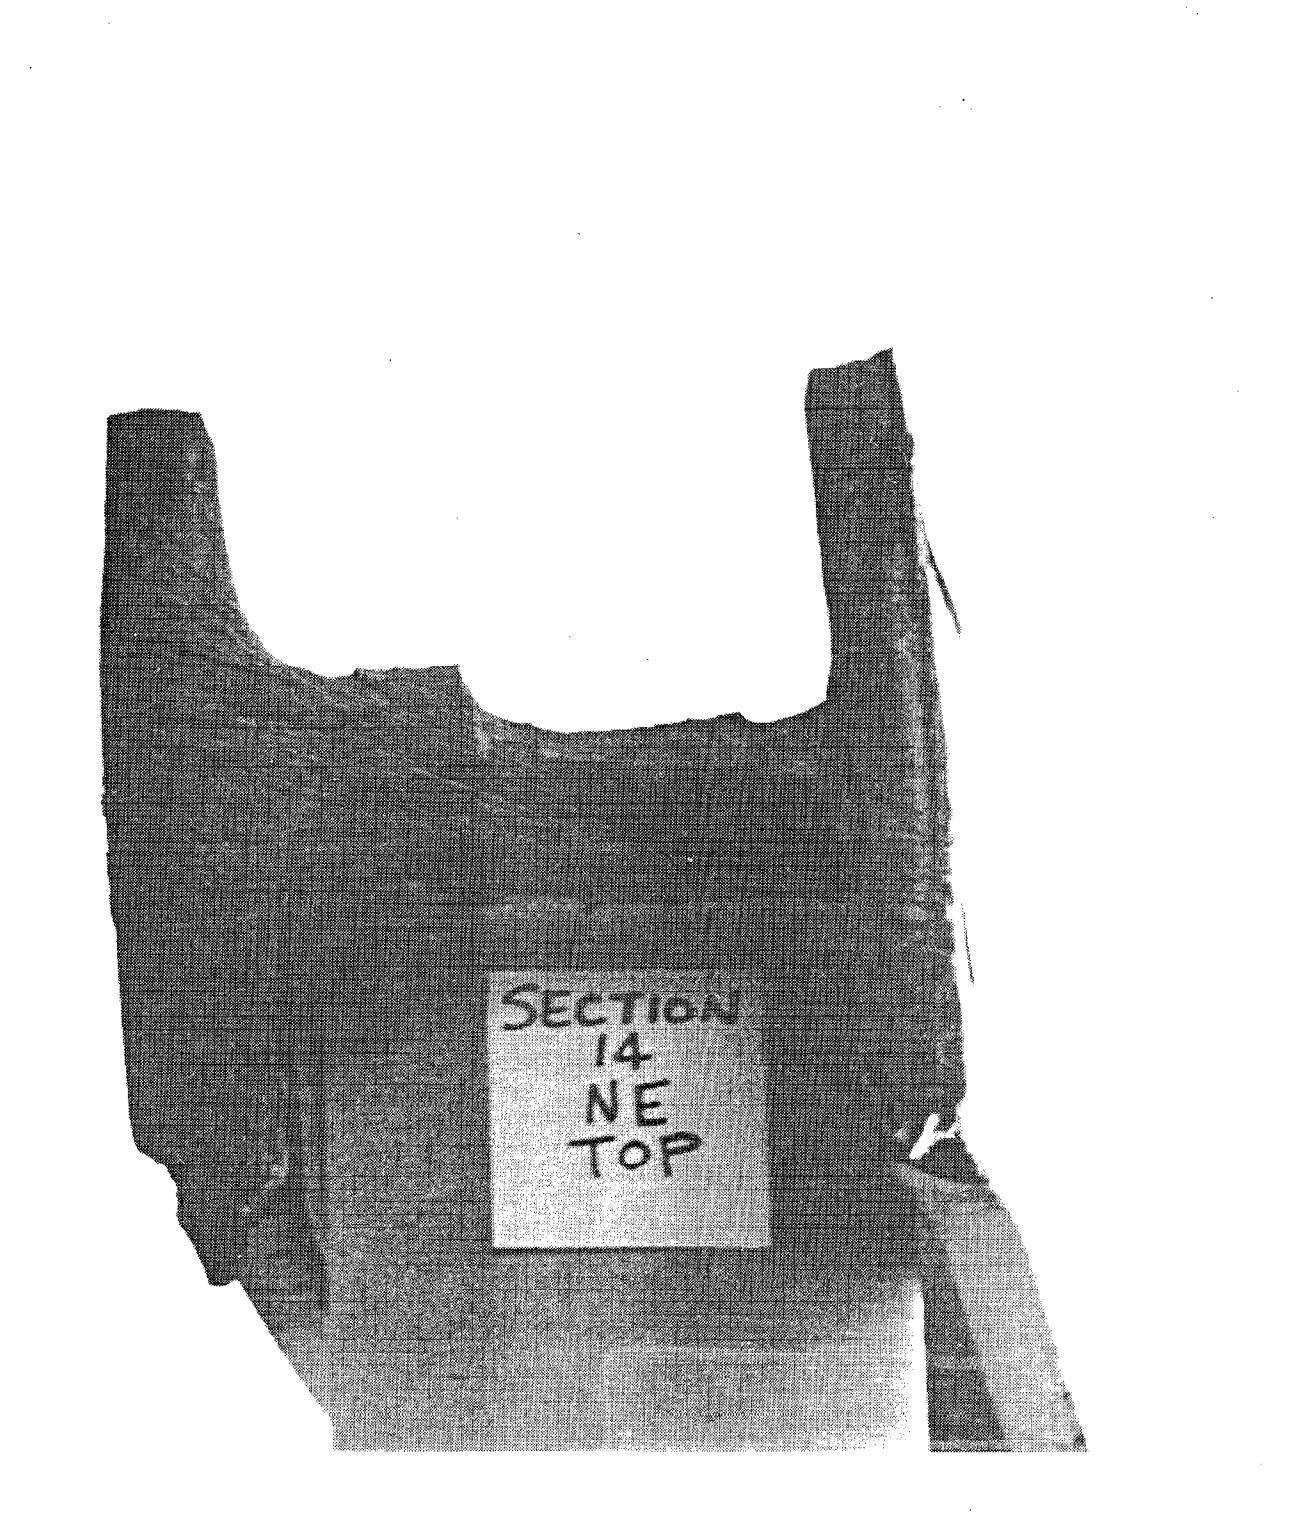
Figure 4.3.8

Failure of Section 14 NE leg -- at top of section.

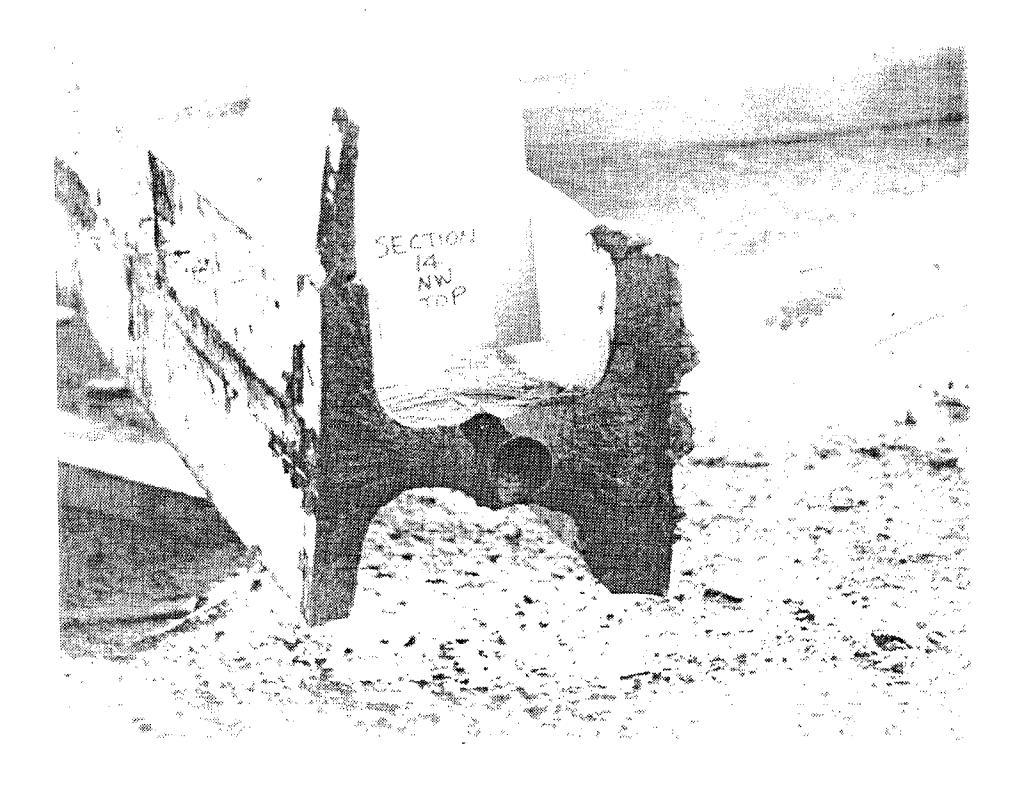
Failure at Section 14 NW leg — viewed from top toward bottom.

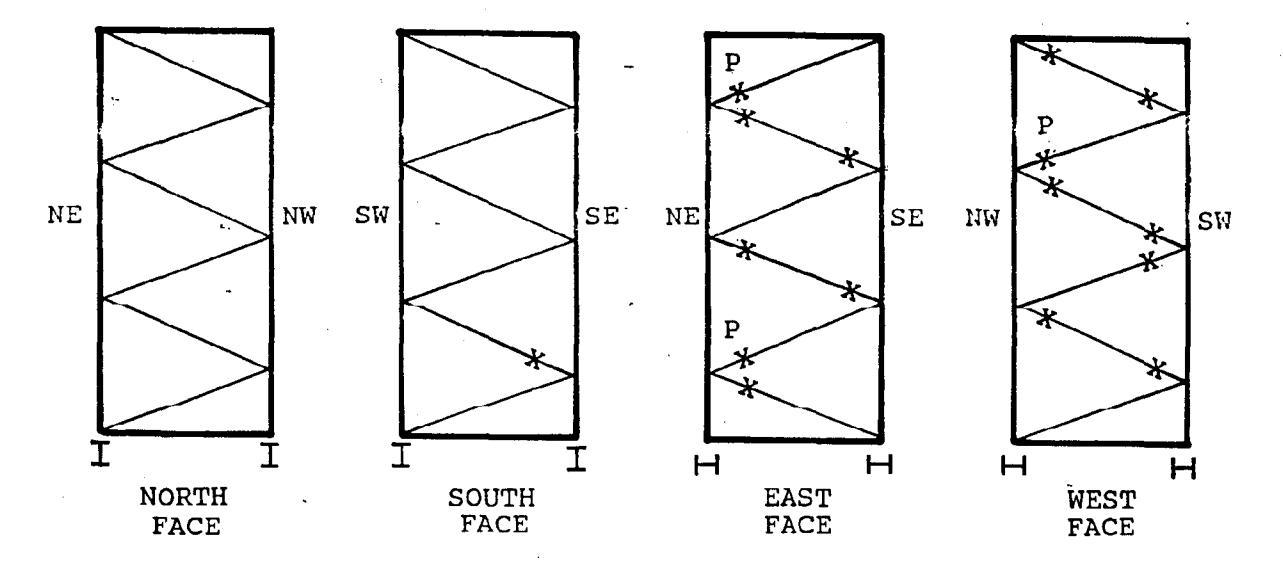
ELEVATION OF FRACTURED DIAGONALS OF TOWER SECTION 15 AFTER COLLAPSE

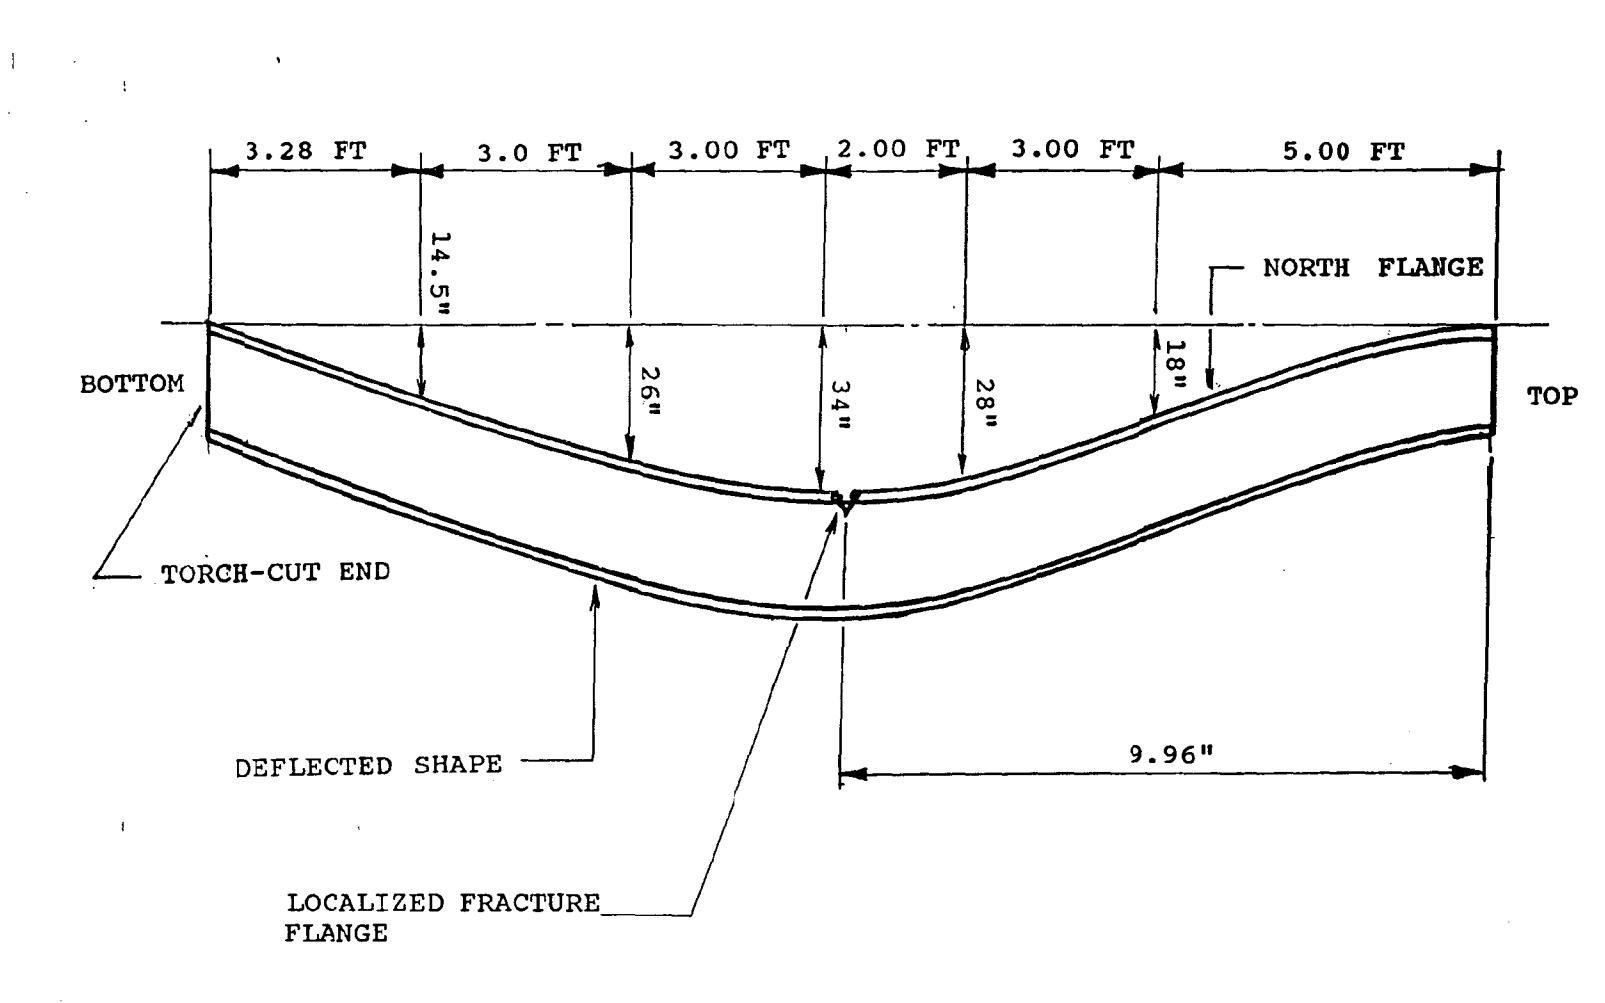
None of the four columns of the climbing section were fractured. The northwest and southwest columns were bent substantially. The southwest column was torsionally deformed. The northeast and southeast columns also showed signs of twisting and bending. Figures 4.3.12, 4.3.13, 4.3.14, and 4.3.15 show the deformed shape of the northeast, southeast, southwest, and northwest columns of the climbing section. The four guide pins at the top of the columns of the climbing section were sheared and bent toward the north as shown in Figure 4.3.16. All 1-1/2 inch ϕ pins were found in place except one which was sheared off.

CLIMBING SECTION; SCUTHWEST LEG LOOKING EAST FIGURE 4.3.14 4

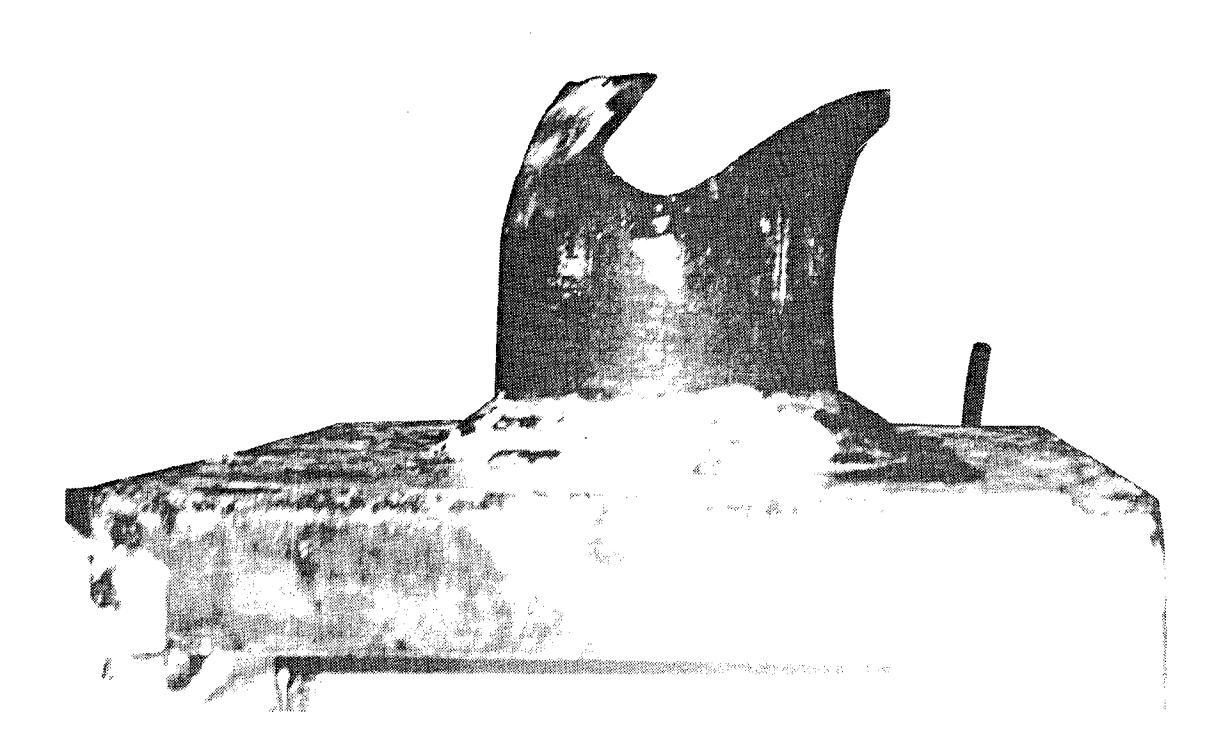
Failure of guide pin of climbing section. Figure 4.3.16

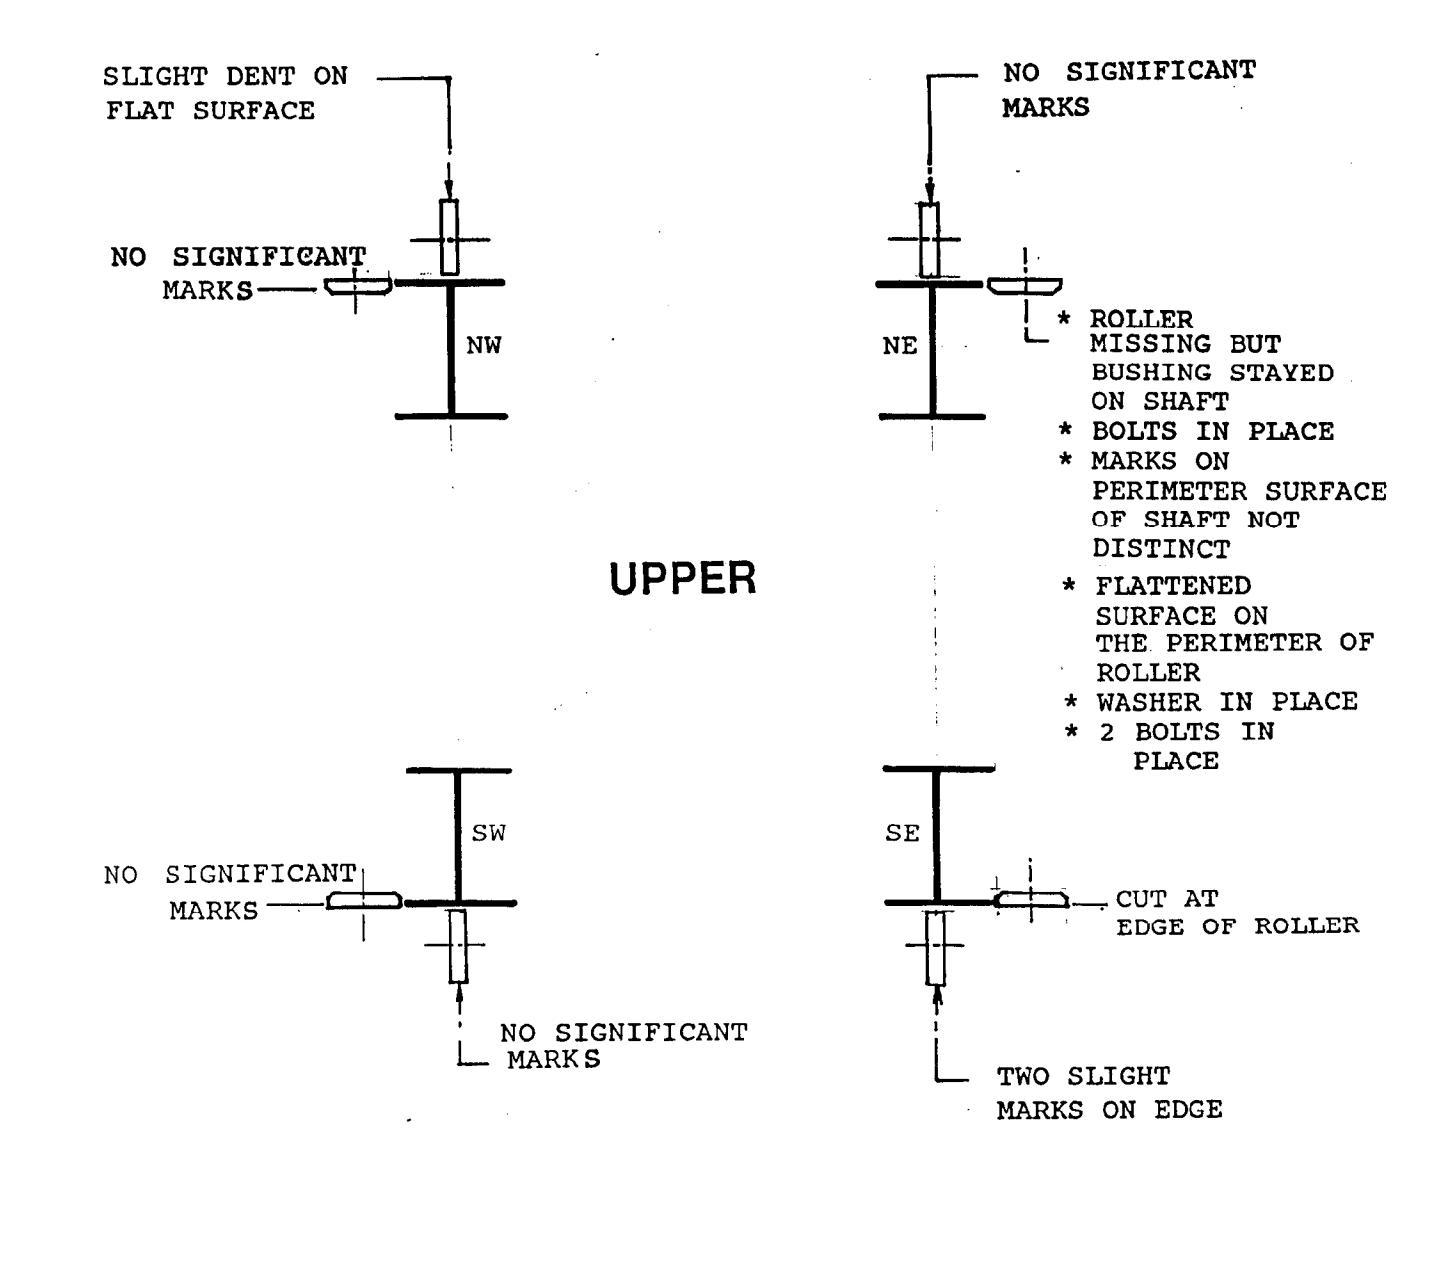
DESCRIPTION OF UPPER ROL	<u>LERS</u>				
AFTER COLLAPSE					
FIGURE 4.3.17	-

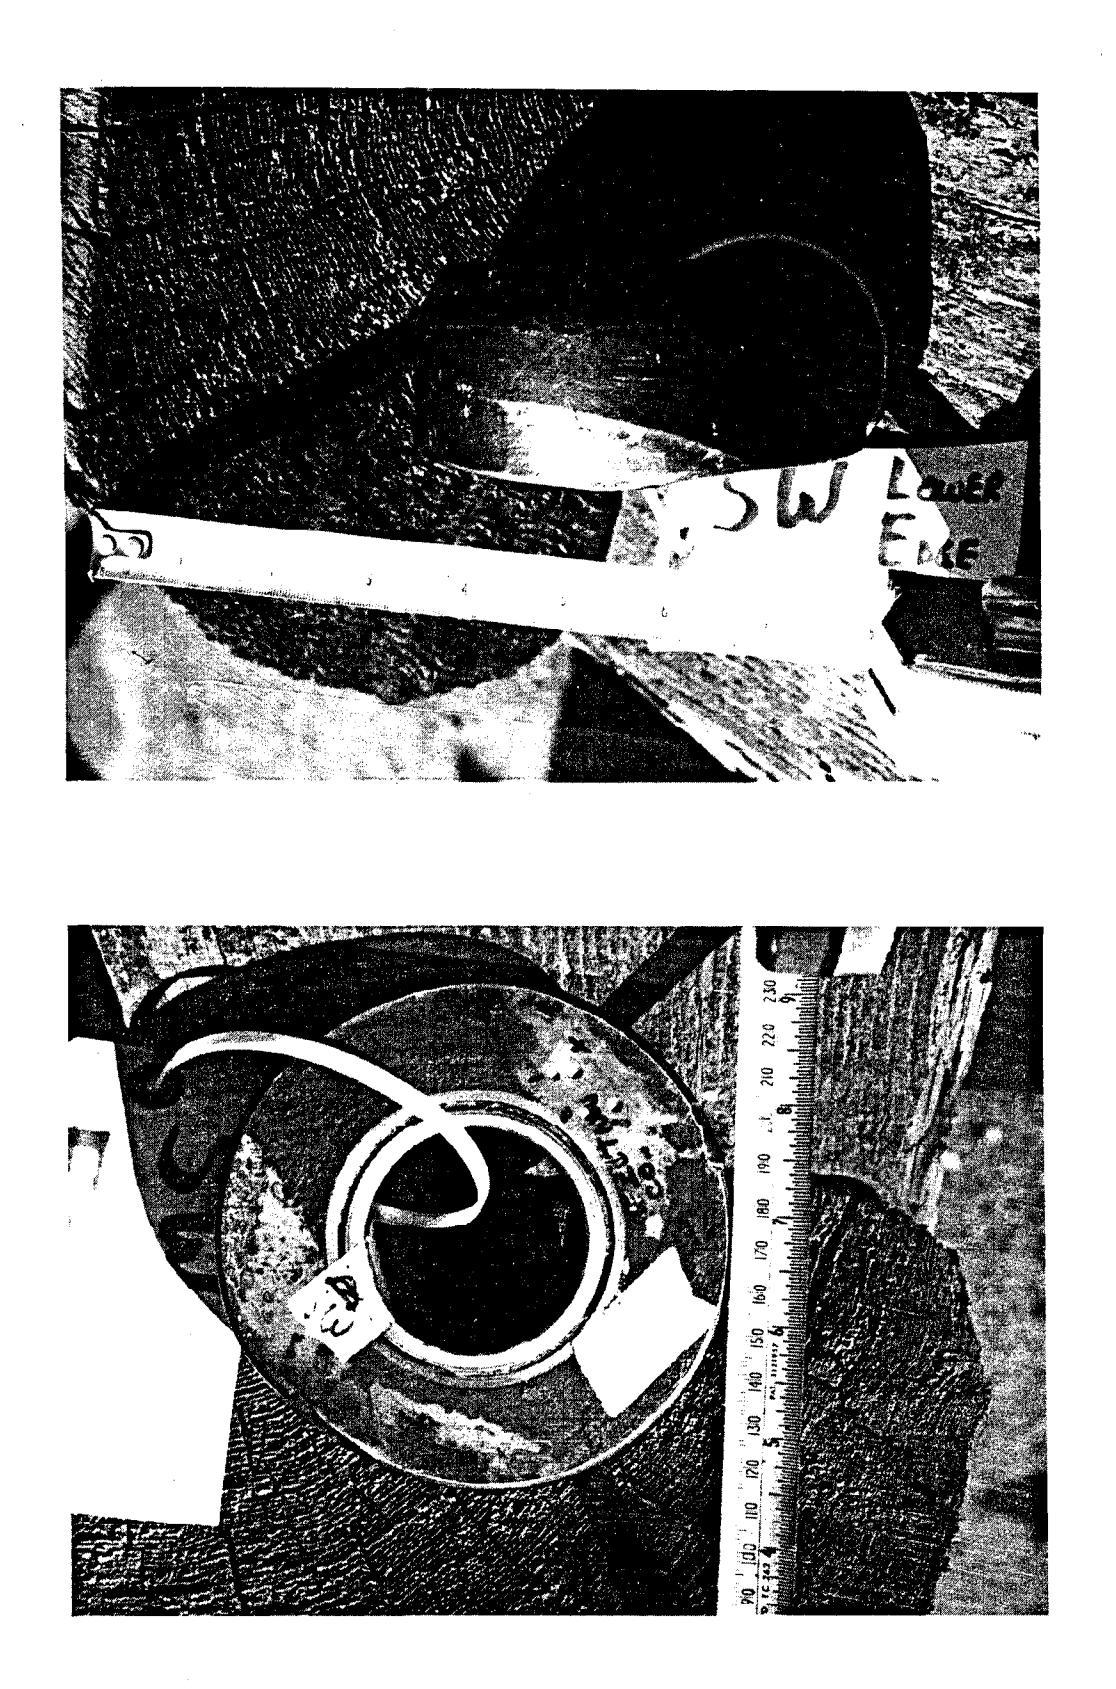
Missing lower SW edge roller.

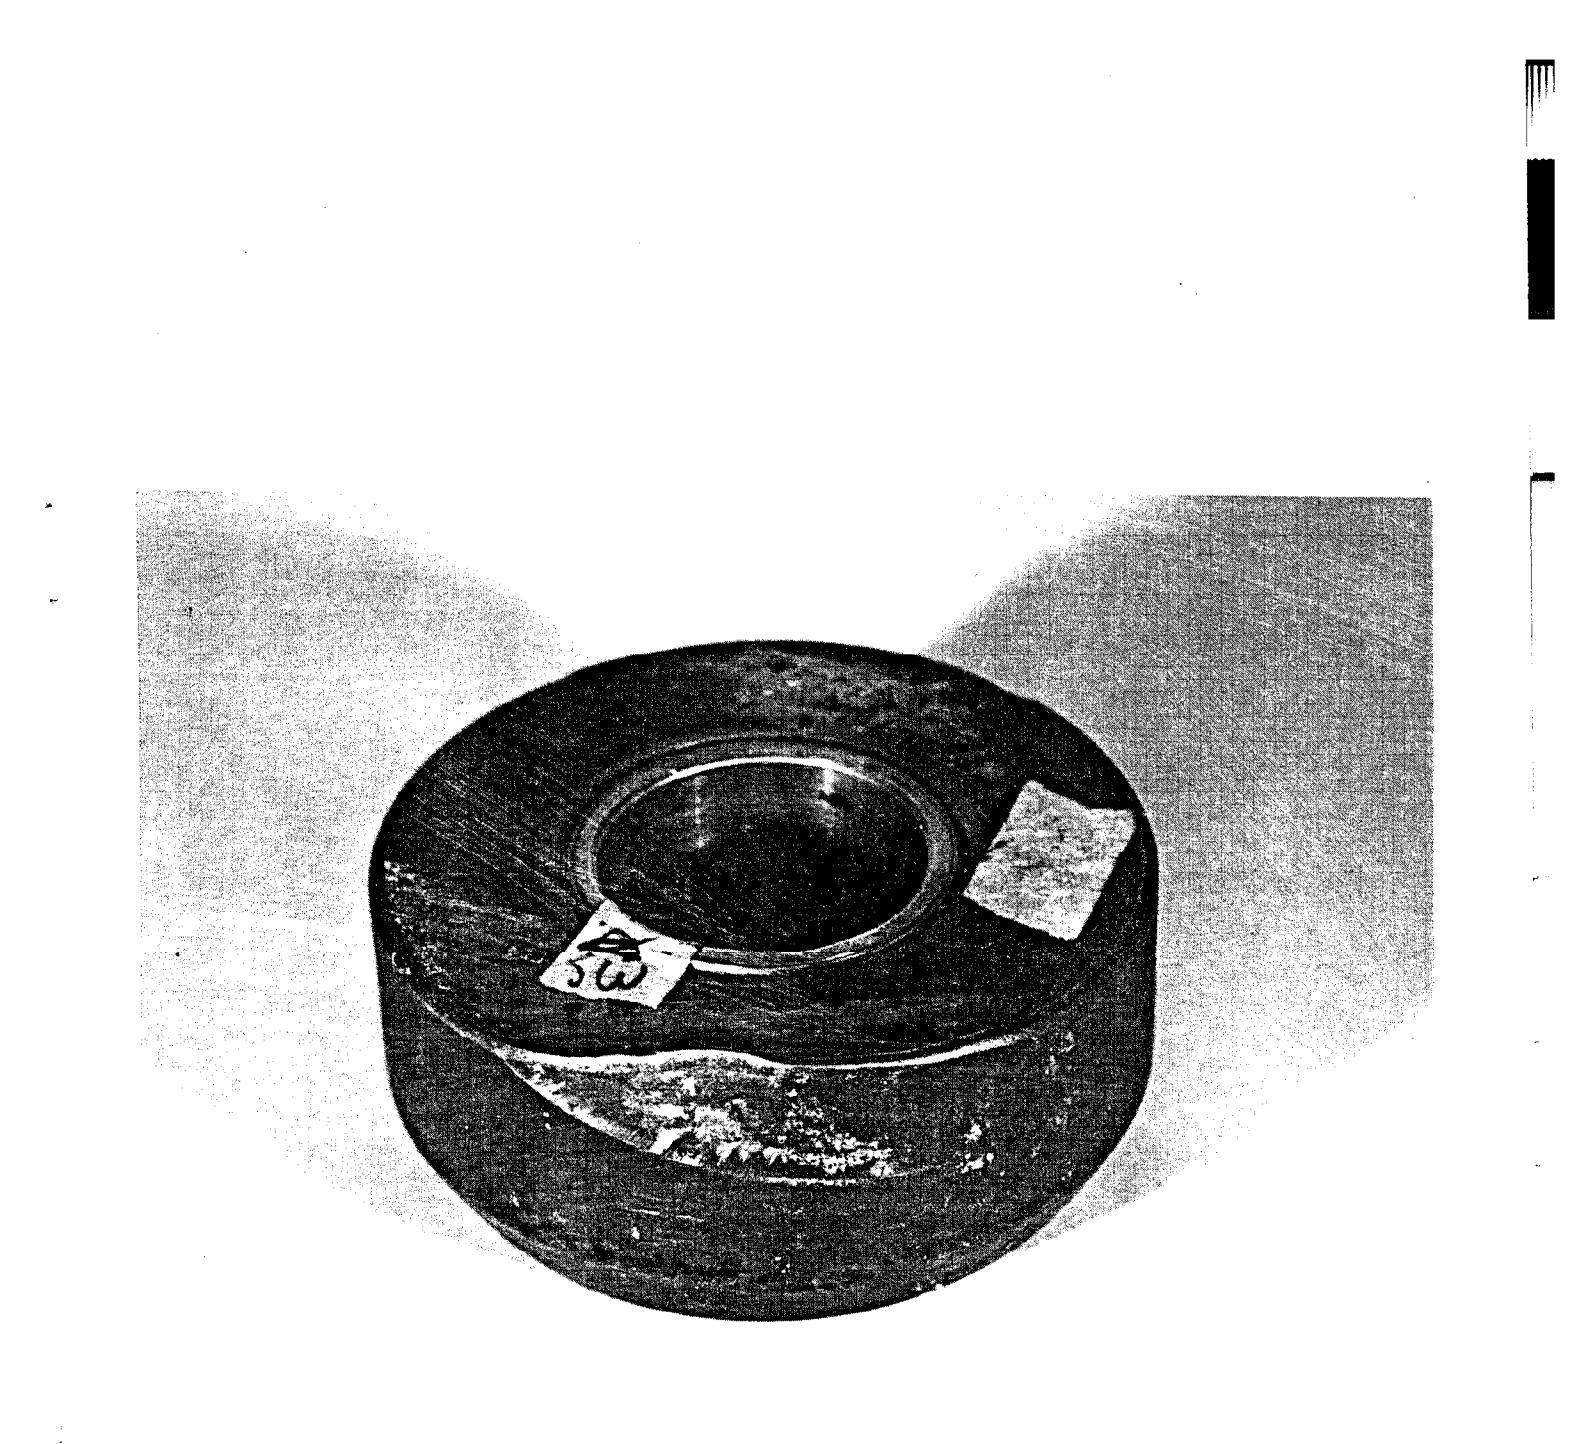
Lower SW edge roller.

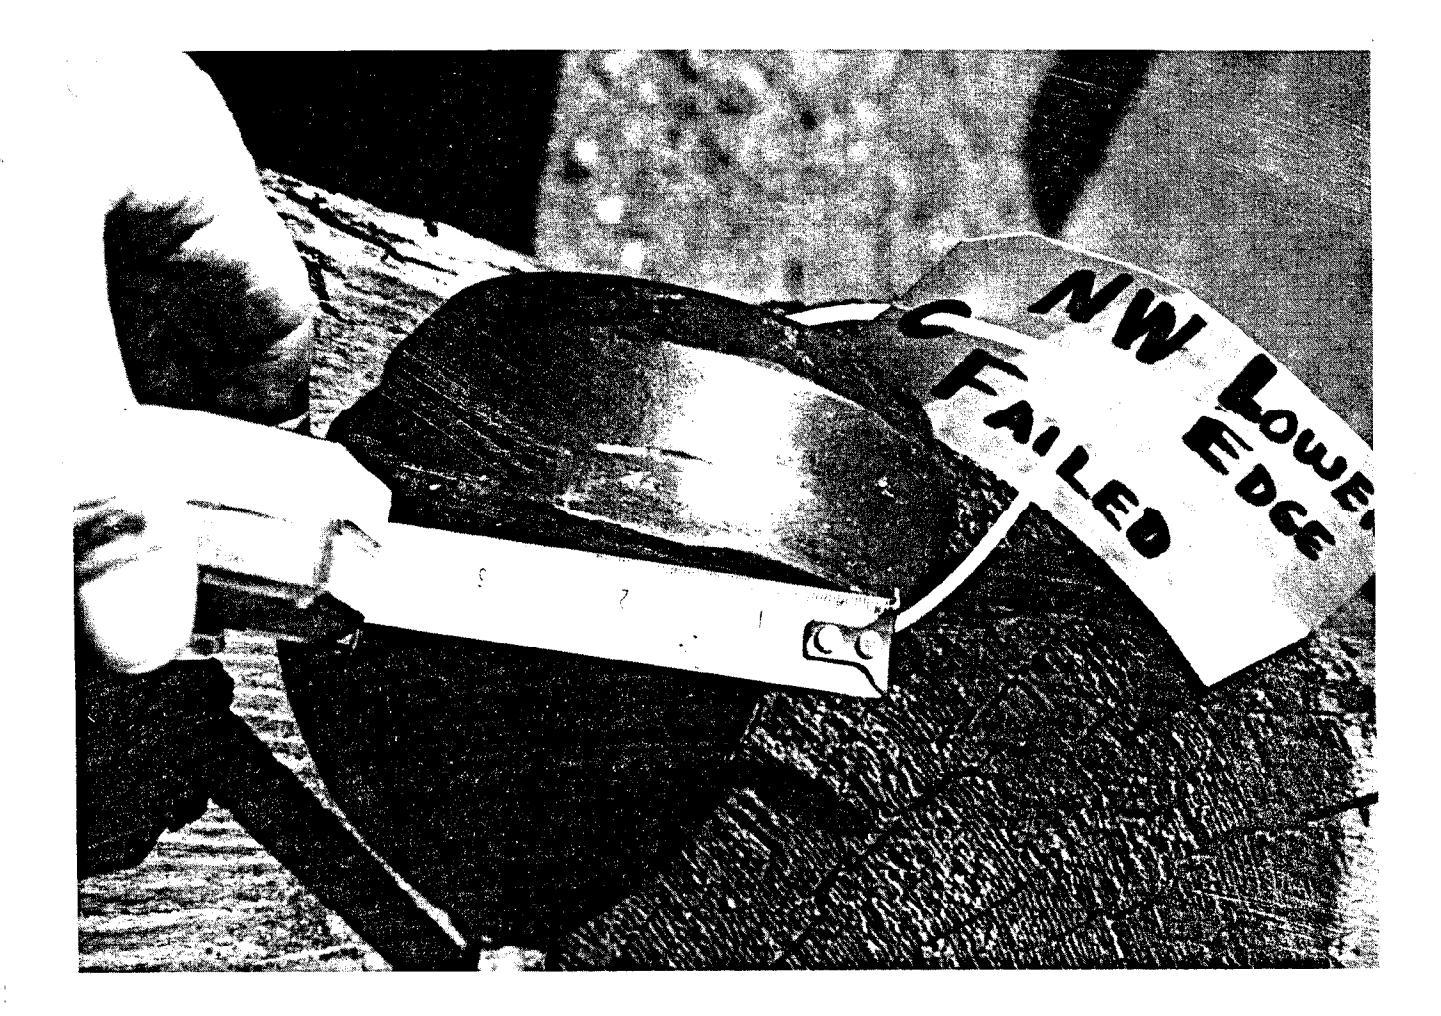
Missing lower NW edge roller.

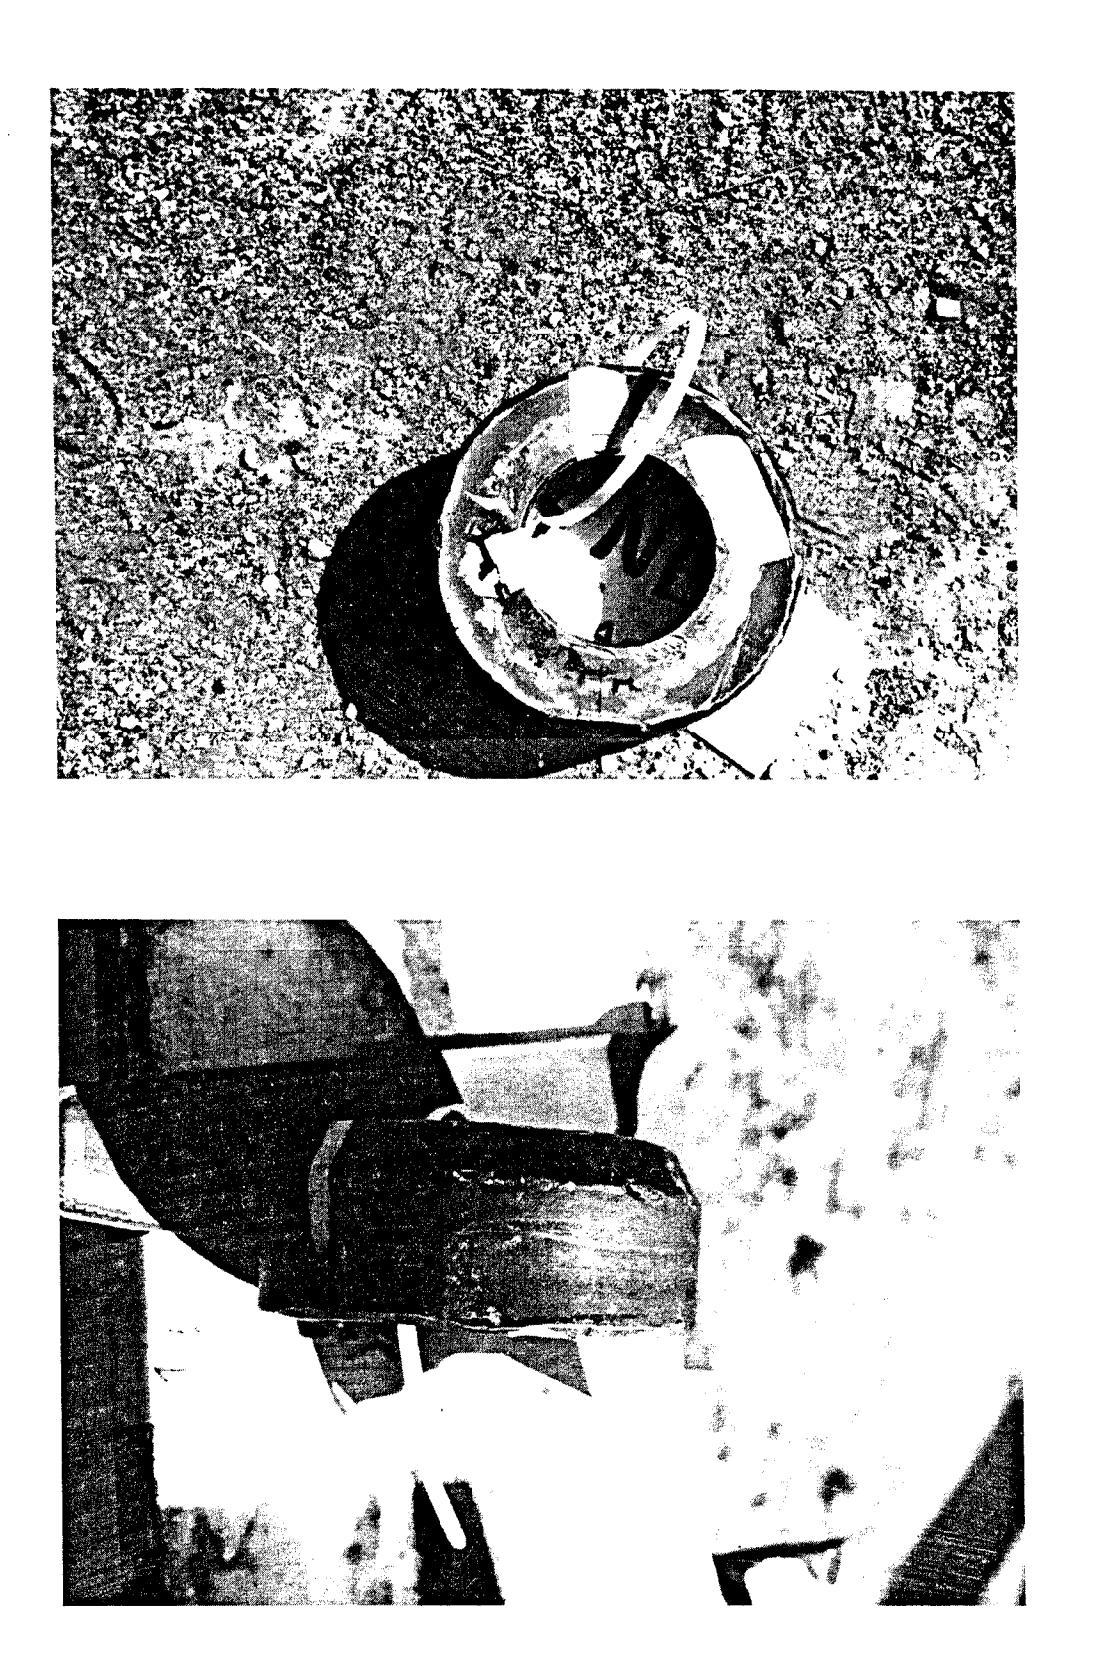
Missing upper NE edge roller.
